REPORT FOR:

Seven Oaks Pool 444 Adsum Drive Building Condition Assessment

Submitted to: City of Winnipeg
Planning, Property, and Development Department
Accommodation Services

Date: April 4, 2019

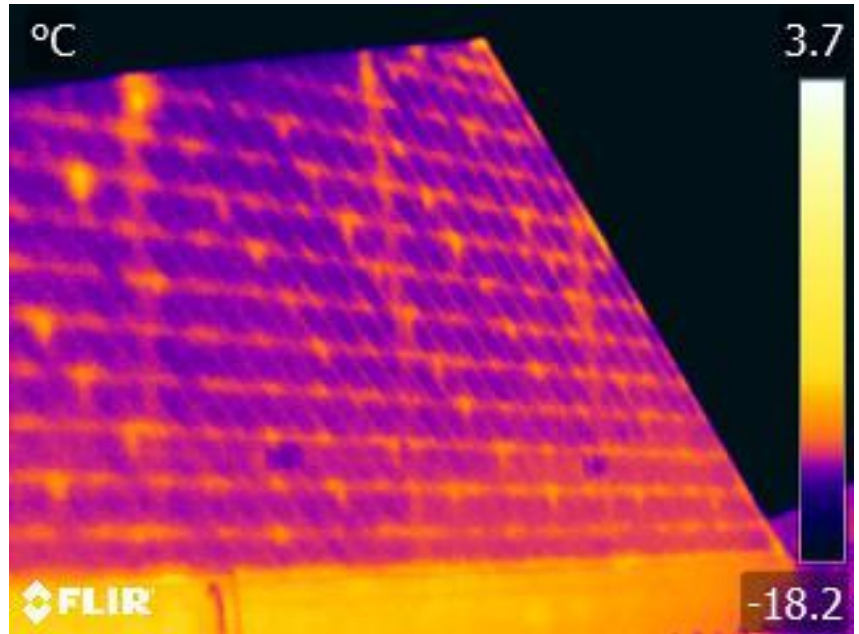
Partial west elevation. Note anomalies on diagonal cladding caused by thermal bridging and air leakage.

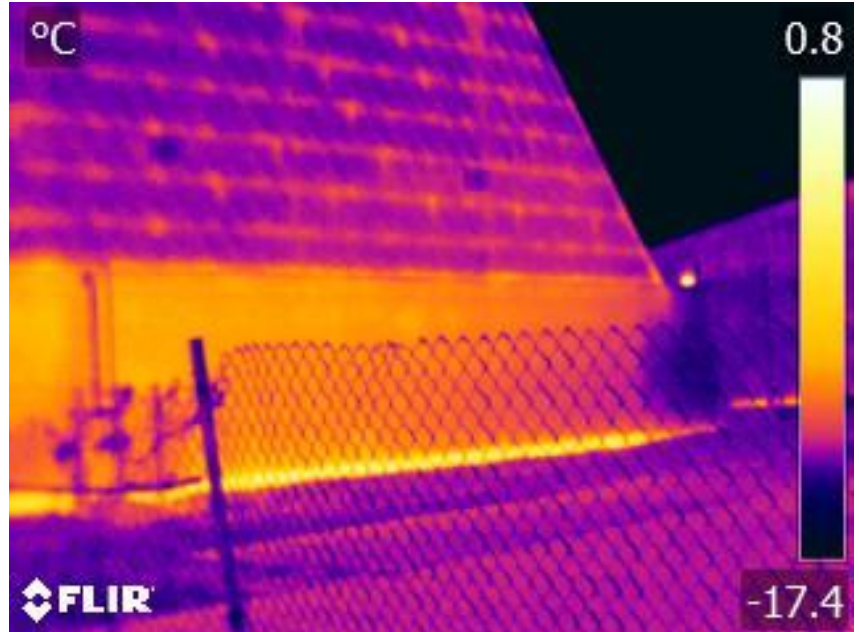
Partial west elevation. Note anomalies on diagonal cladding caused by thermal bridging and air leakage.

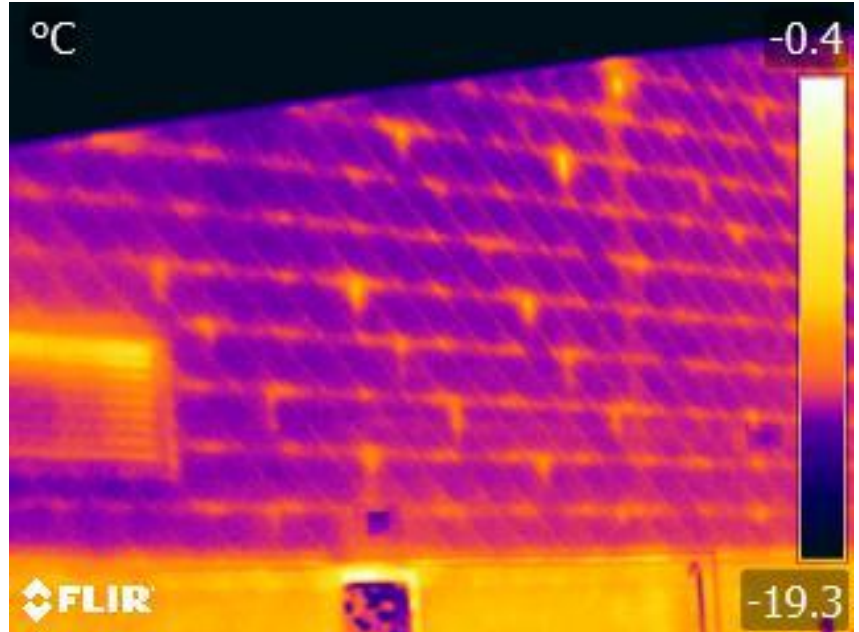
Partial west elevation. Note anomalies on diagonal cladding caused by thermal bridging and air leakage.

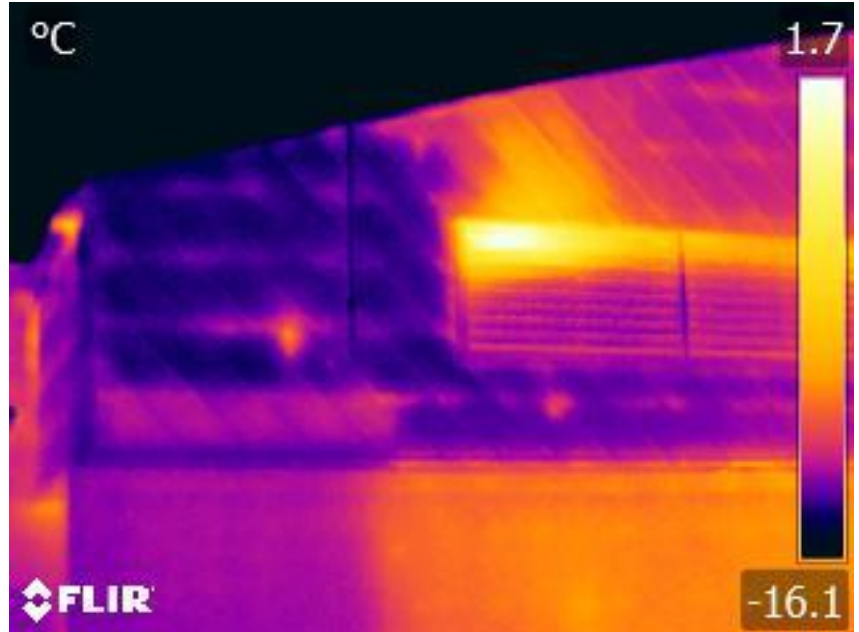
Partial west elevation. Note anomalies on diagonal cladding caused by thermal bridging and air leakage.

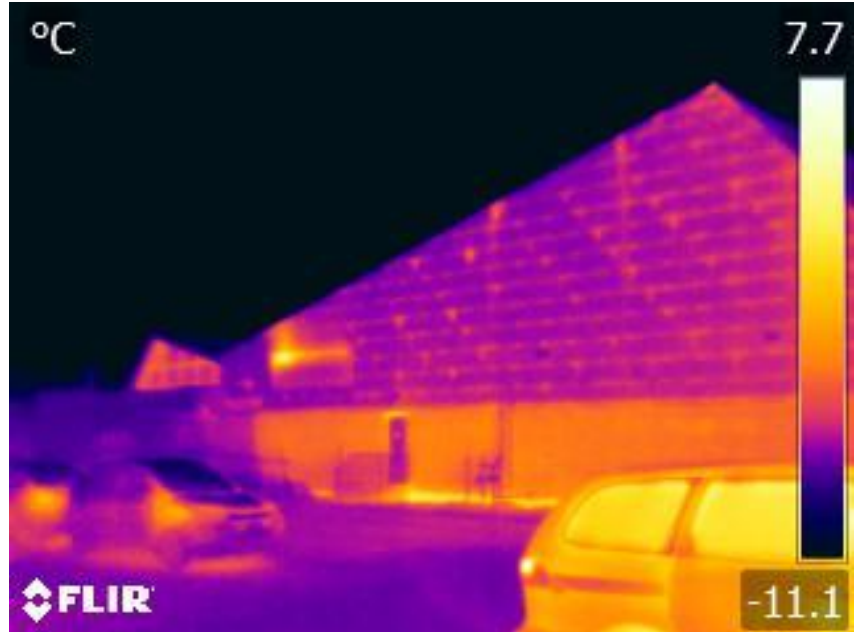
Partial west elevation. Note anomalies on diagonal cladding caused by thermal bridging and air leakage.

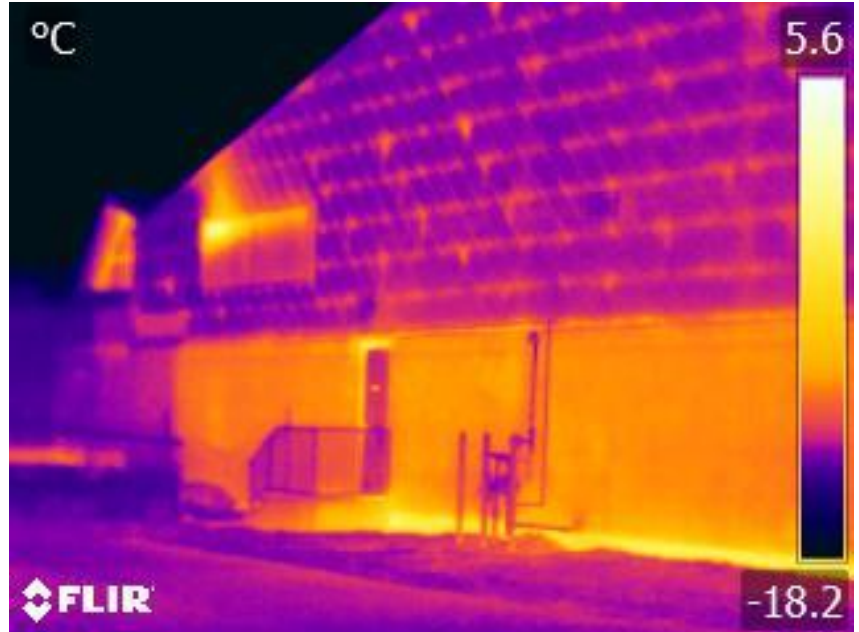
Partial west elevation. Note anomalies on diagonal cladding caused by thermal bridging and air leakage.

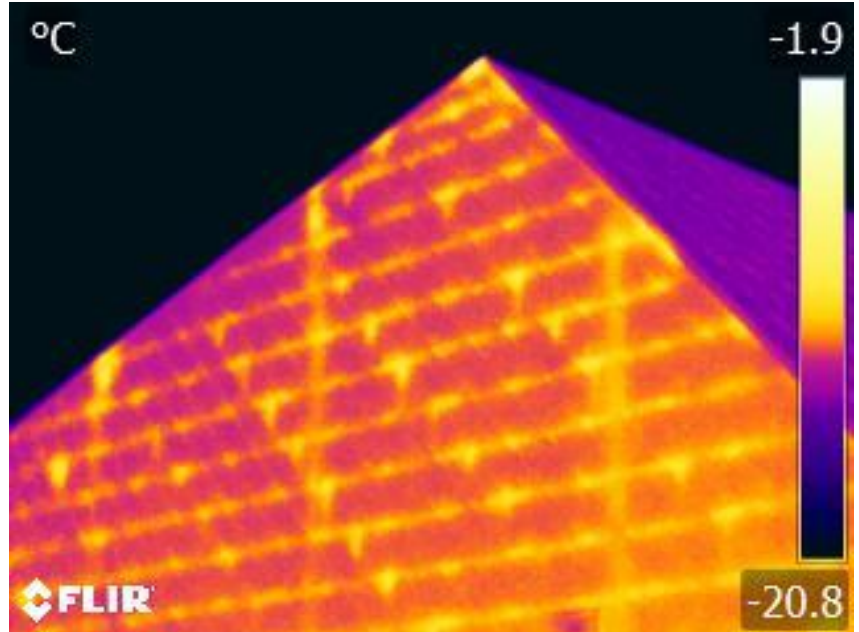
Partial west elevation. Note anomalies on diagonal cladding caused by thermal bridging and air leakage.

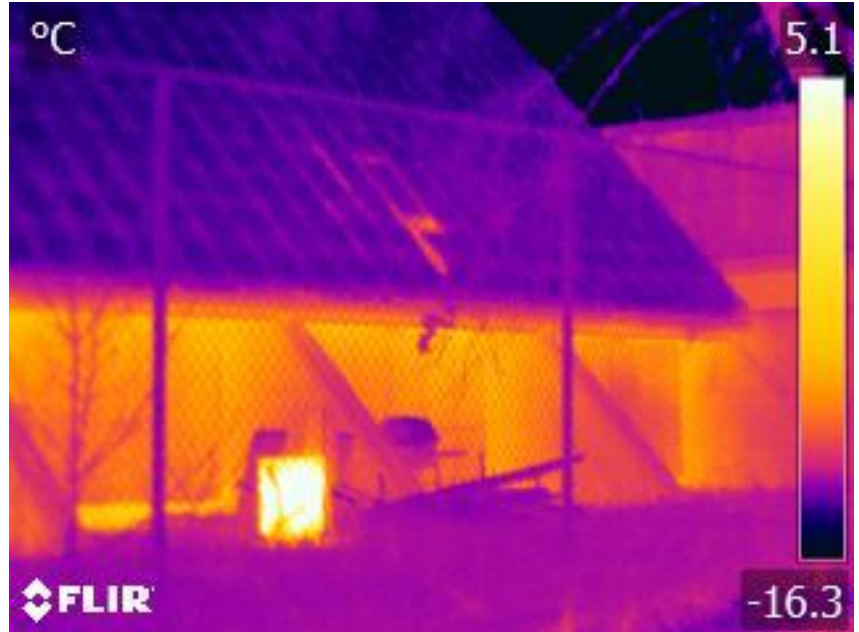
Detail view of east portion of south elevation. Note anomaly at roof panel likely caused by air leakage.

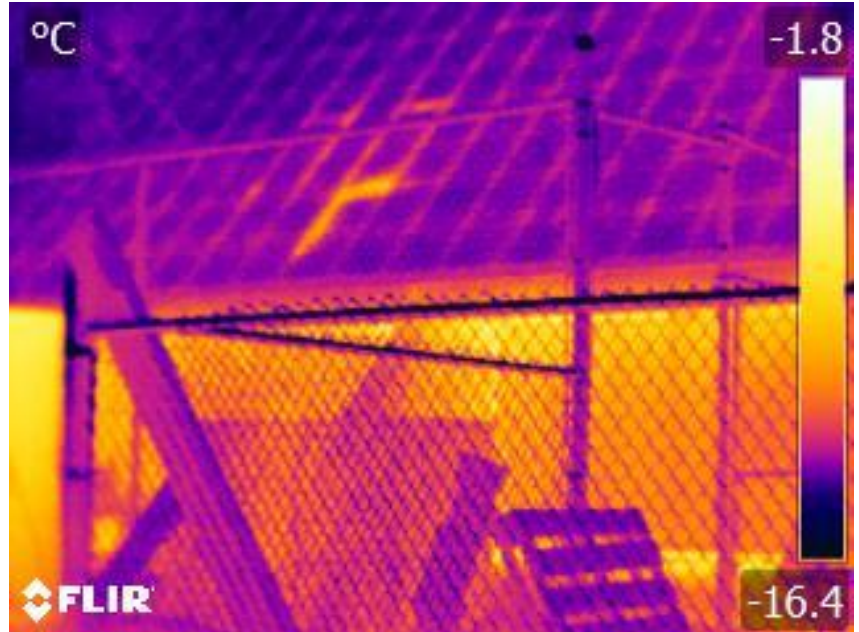
Detail view at east end of south elevation. Note anomaly likely caused by air leakage at roof panel.

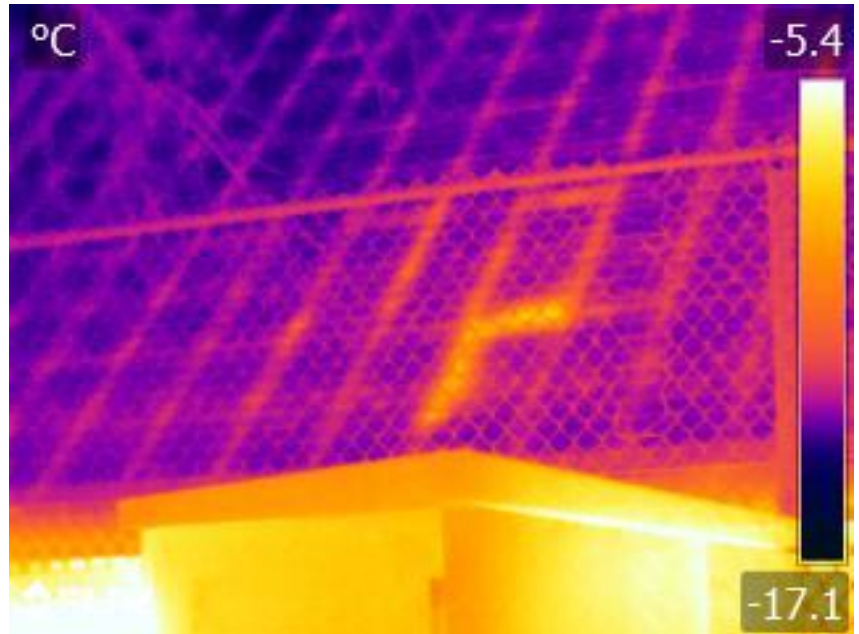
Detail view at east end of south elevation. Note anomaly likely caused by air leakage at roof panel.
