# City of Winnipeg

## 600 mm Kildonan-Redwood Feeder Main

Condition Assessment Report, Standard Analysis

**PICA Project: 8054**

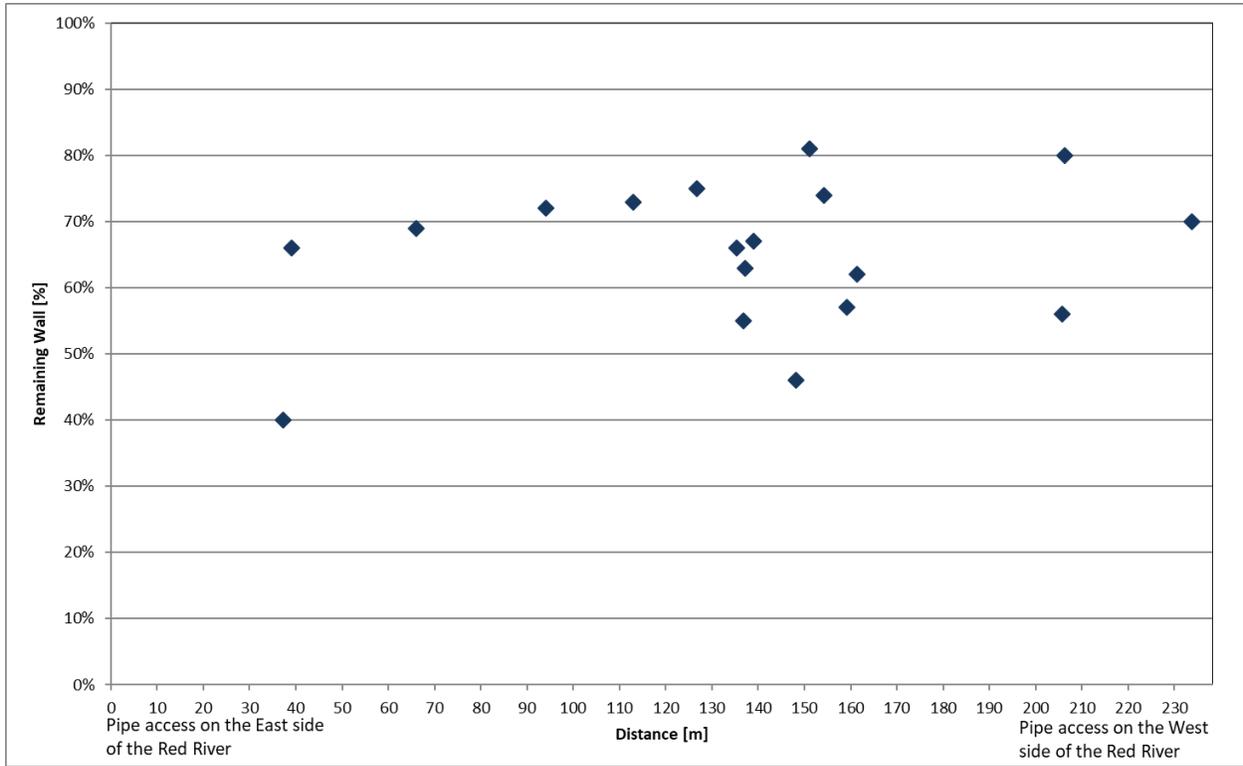
In general, the feeder main was found to be in good condition. Nine (9) pipes were found to show evidence of pitting corrosion with a total of 18 localized pitting indications reported. Of these 18 indications, 11 indications measured to be "shallow" ( $\geq 65\%$  RW), and 7 indications measured to be "medium" (40-64% RW).

Figure 1. Axial distribution of defect indications and remaining wall (%) within the scanned length of the Kildonan-Redwood Feeder Main

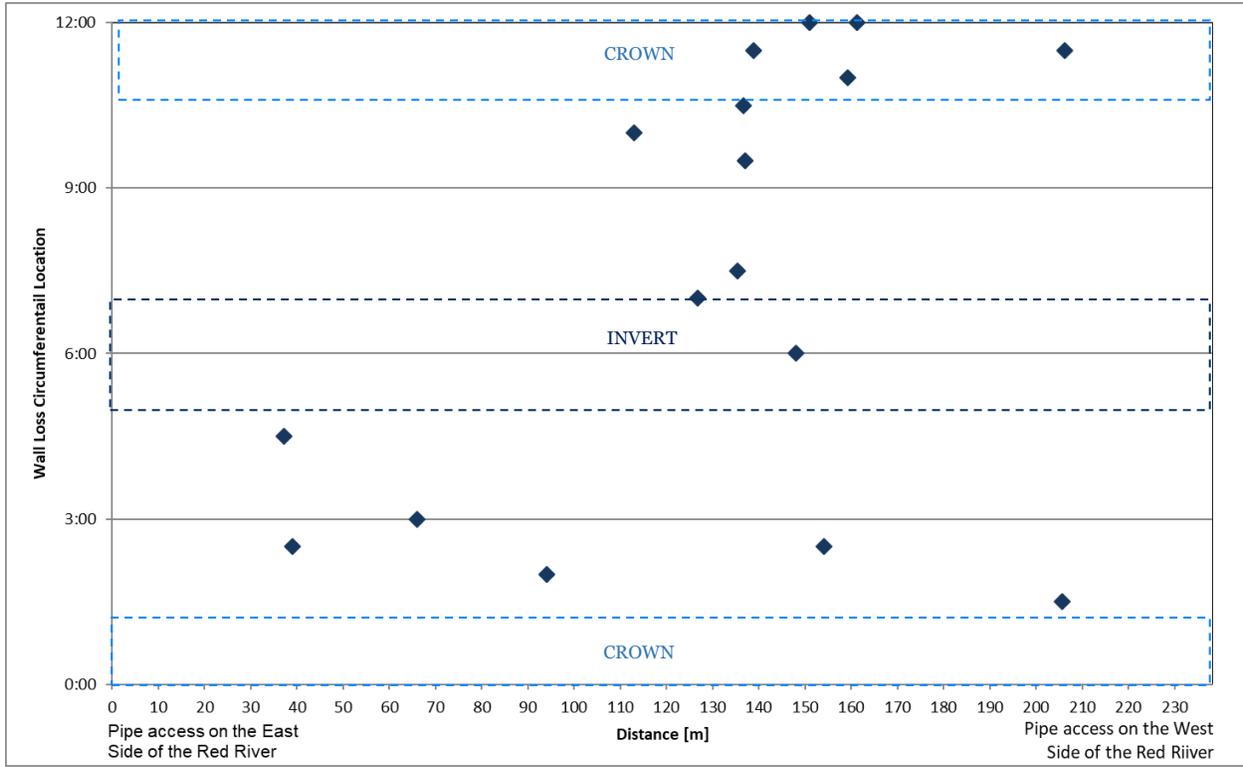
Figure 2. Circumferential distribution of pitting regions along the Kildonan-Redwood Feeder Main, described with clock positions referenced by looking from east to west. Note that the defect reported in pipe 0340 is not included in chart as clock position information is not available for this pipe.

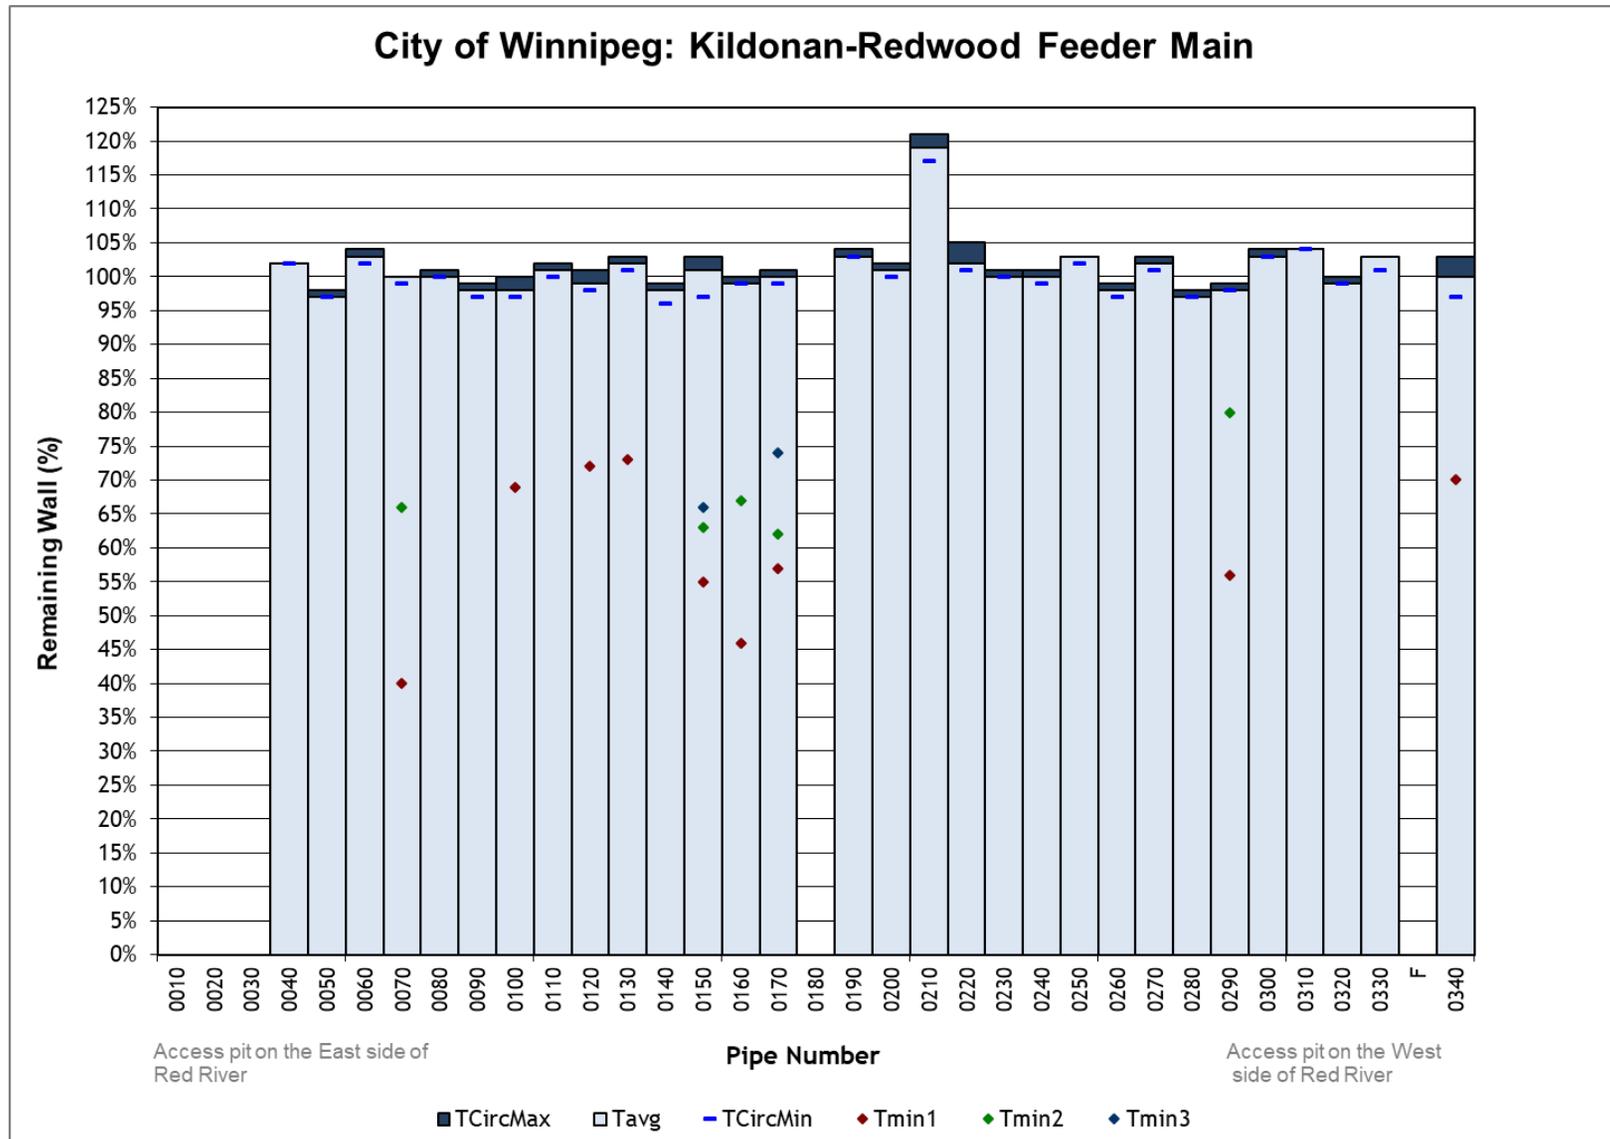
Figure 3. Condition assessment summary for the Kildonan-Redwood Feeder Main. Pipes less than 2.11 meters in length were not analyzed for pipe average remaining wall values. Pipe 0340 is the vertical pipe on the west side of the Red River and has a wall thickness of 12.7mm, differing from 7.9mm pipe wall thickness which was documented for the horizontal piping in drawing 12530. This pipe's Tavg is set to 100%.

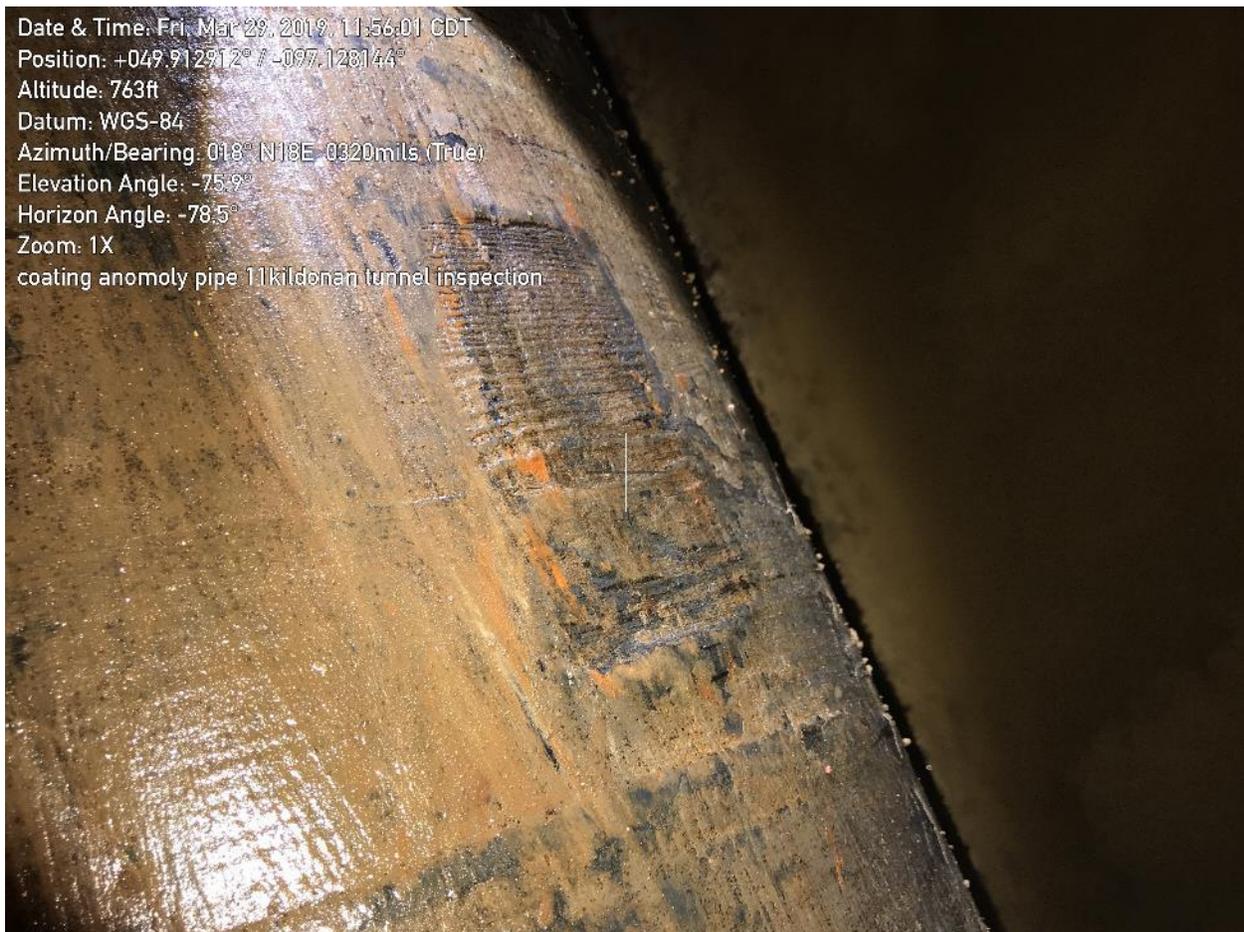
Asphalt-dipped felt was used to coat the exterior of the pipeline during construction of the Main. Though this coating was found to be in good condition over most of the accessible length, multiple areas of interest were identified and recorded. These areas of interest included damage to the coating in the form of gouges and scratches; imprints possibly left from transport or construction equipment; and potential repair points. Figure 19 to Figure 23 show some of the anomalies that were observed during the visual inspection. Note that the distances stated are measured from the 90-degree elbow flange connection at the bottom of the west shaft, east towards the end of the tunnel. Clock positions described are referenced by facing west.

Figure 19. Coating anomaly observed at the 3 o'clock position on pipe 0300, at 13.8m from the center of the flange pair connecting the 90-degree elbow to the first horizontal pipe.

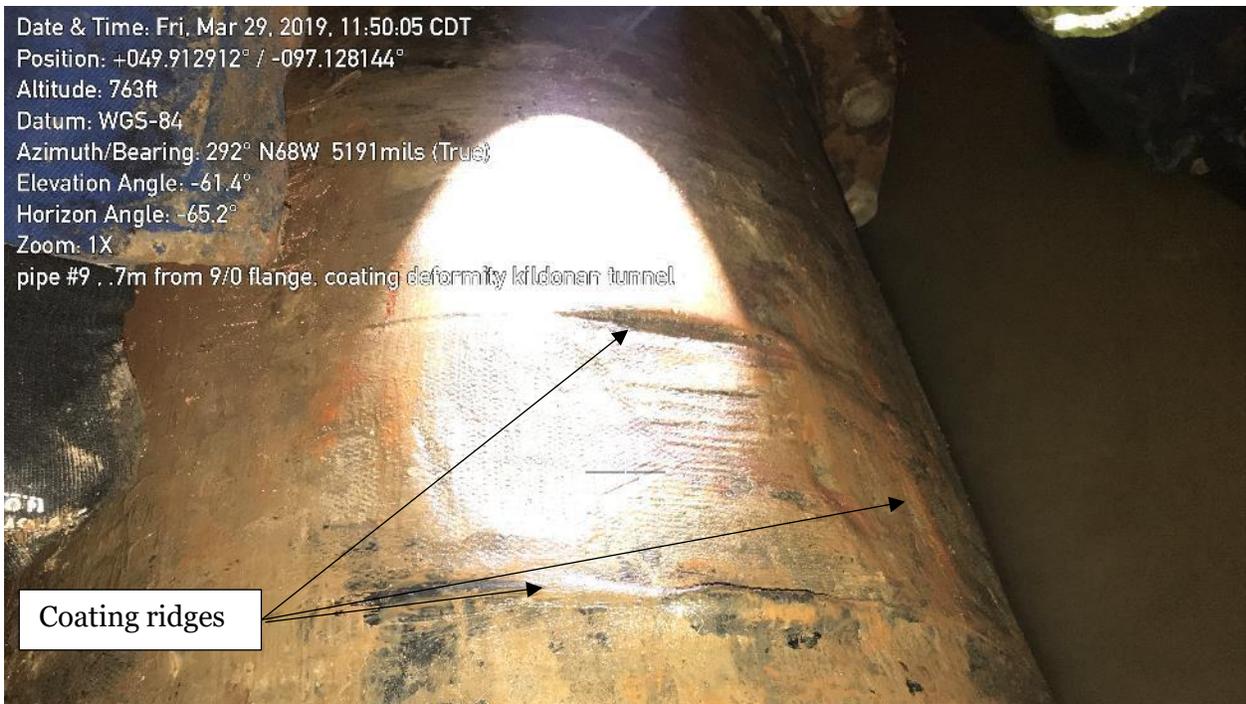
Figure 20. Coating anomaly observed on pipe 0280, at 21.85m from the 90-degree elbow flange. Ridges can be seen pushed up in the coating, as well as what appears to be an imprint resembling fabric, possibly caused by a transport strap.

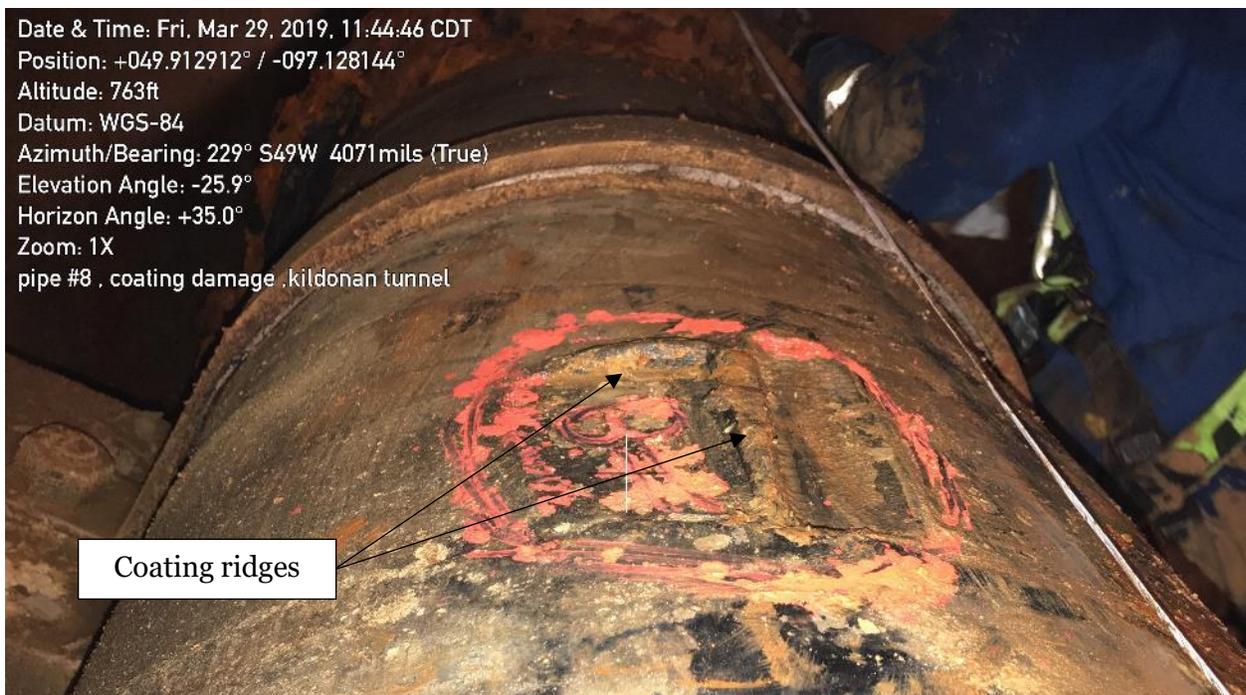
Figure 21. Coating anomaly observed on pipe 0270, at 26.4m from the 90-degree elbow flange.

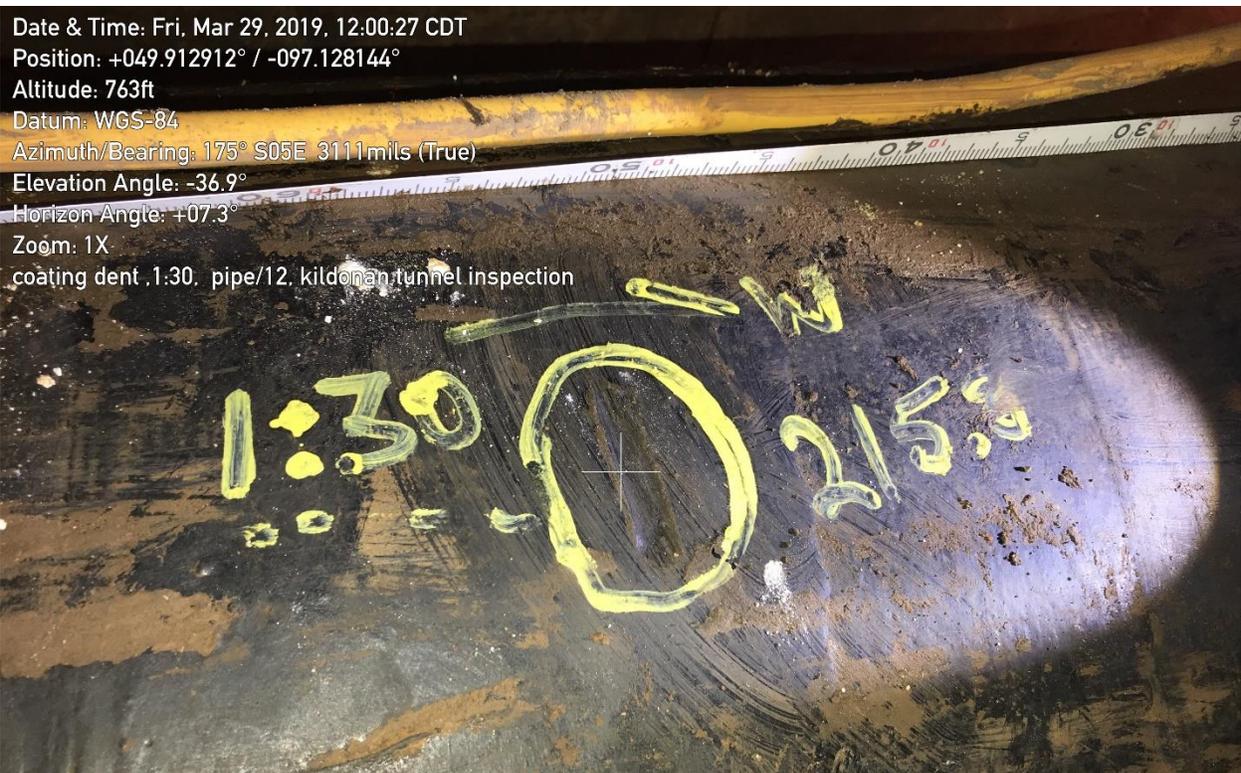
Figure 22. Divot observed in coating material at the 1:30 clock position on pipe 0310, 10.5m west from the 90-degree elbow.

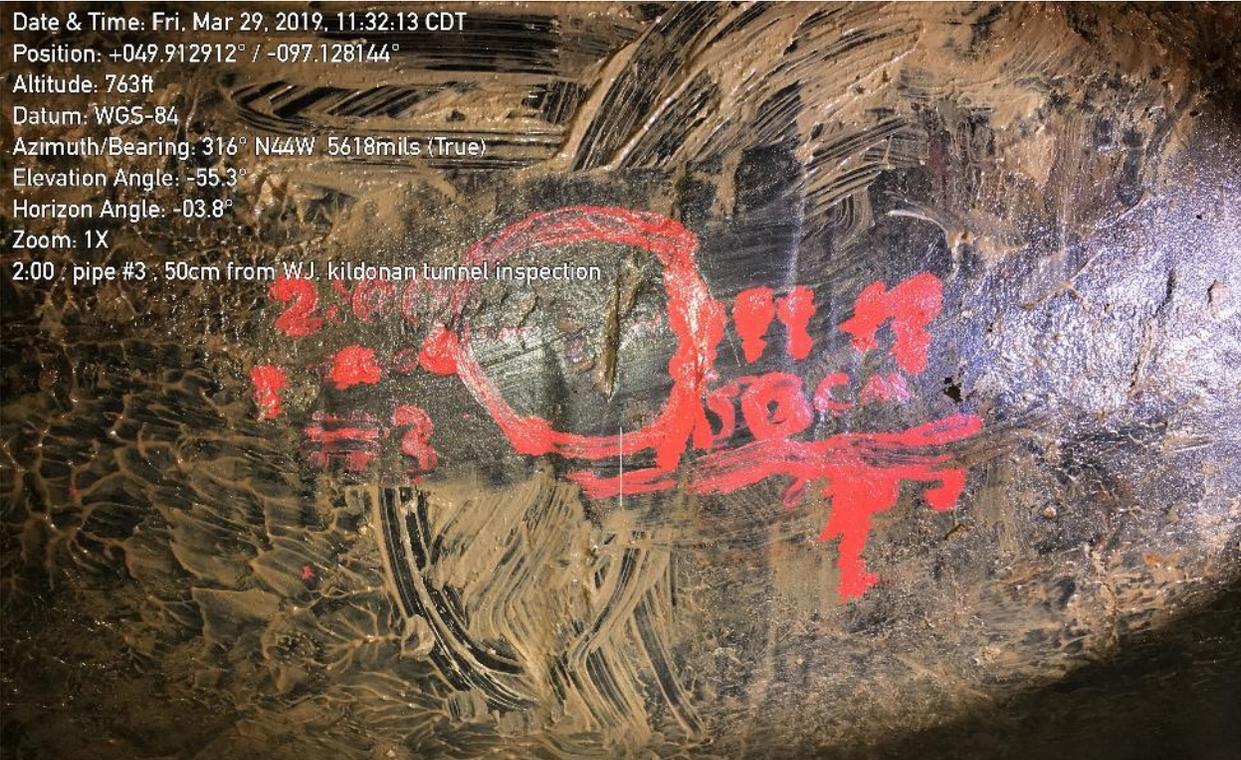
Figure 23. Coating loss at 2 o'clock position on pipe 0220, 47.33m from the 90-degree elbow flange.

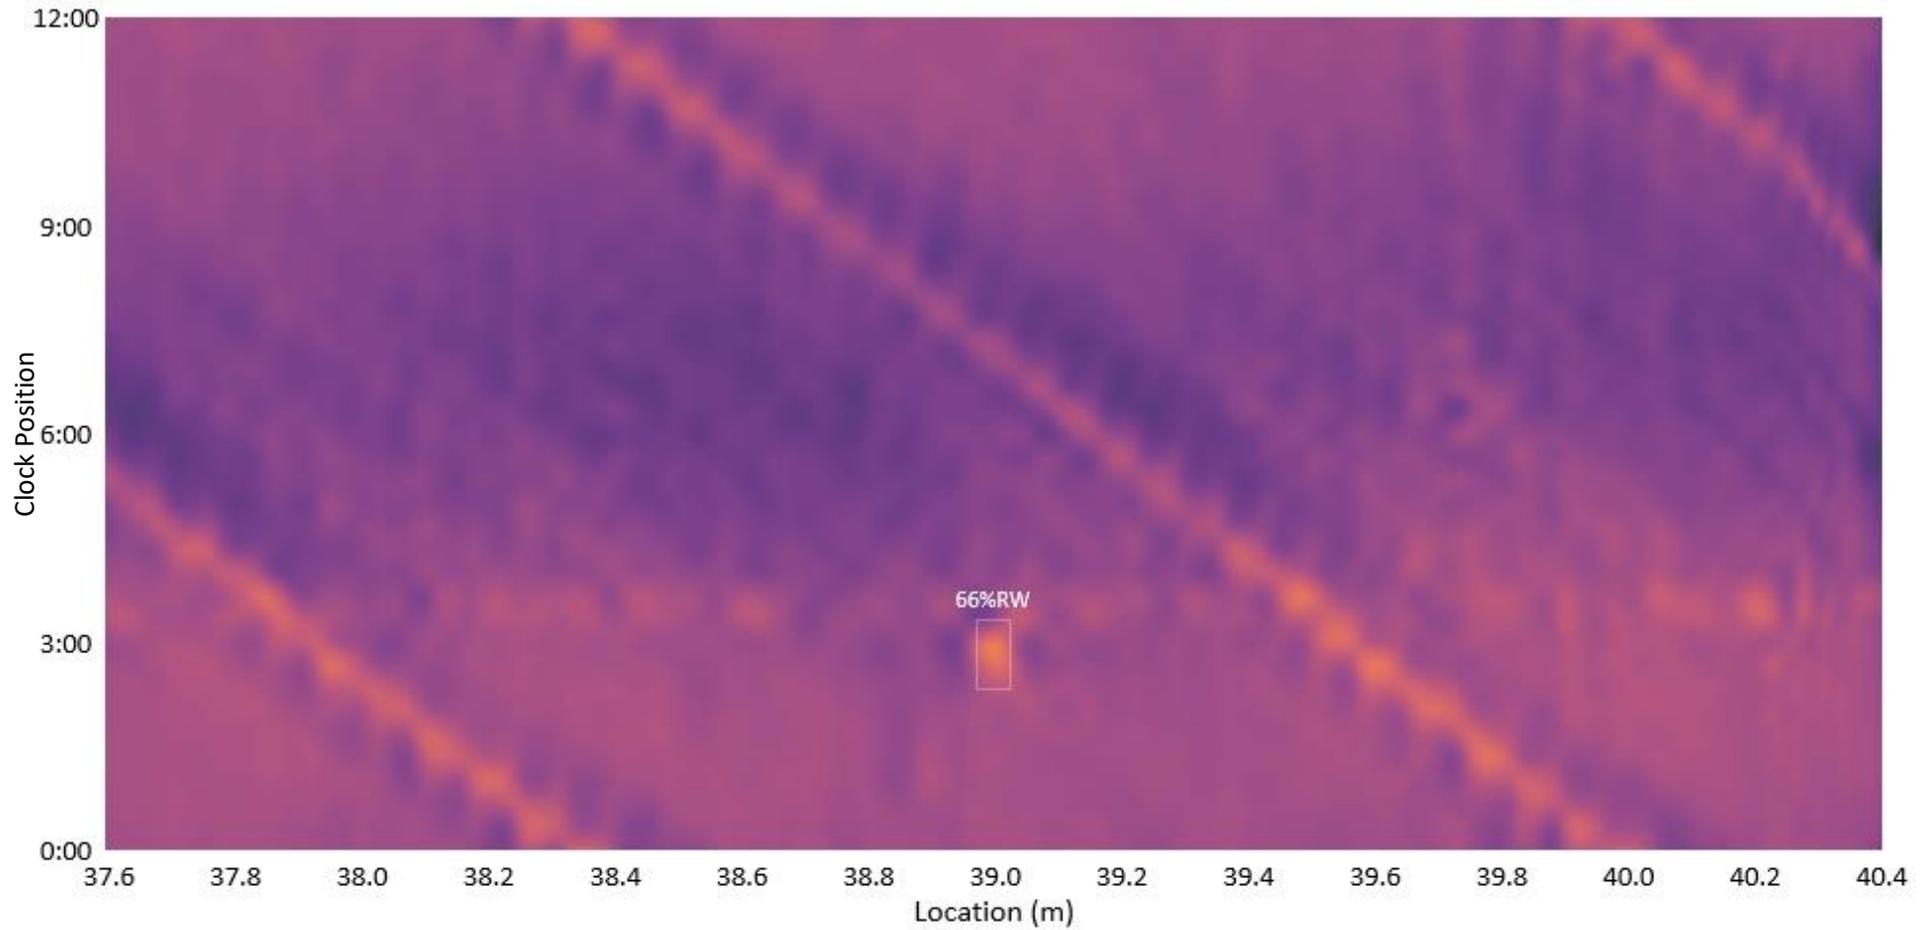
0070	28.57	40.62	12.05	100%	100%	99%	40%	37.20	4:30	66%	39.00	2:30				Two defect indications reported
0080	40.62	52.69	12.07	100%	101%	100%										mitered 6.2° vertical bend and 8° horizontal bend left (south) at start of segment

Figure 24. Pipe 0070 colour map showing 66% remaining wall indication, 39.00 meters from the ZRD.

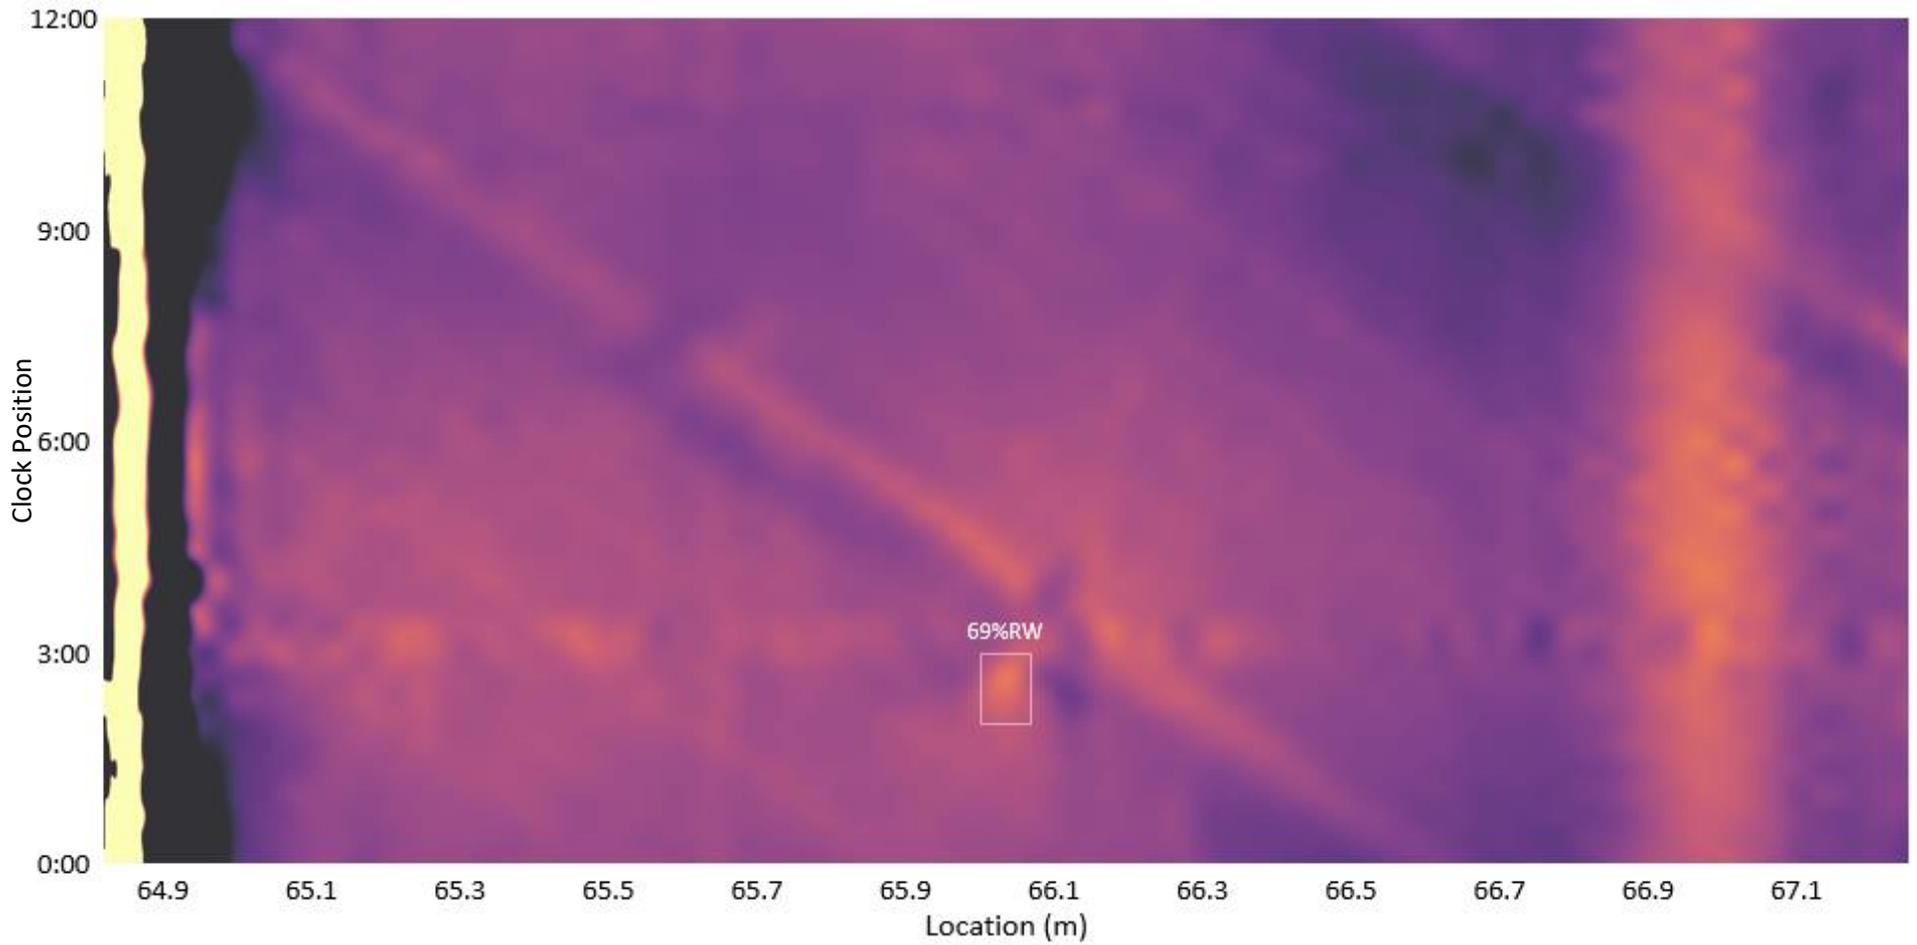
Figure 25. Pipe number 0100 colour map showing 69% RW indication, 66.03 meters from the ZRD.

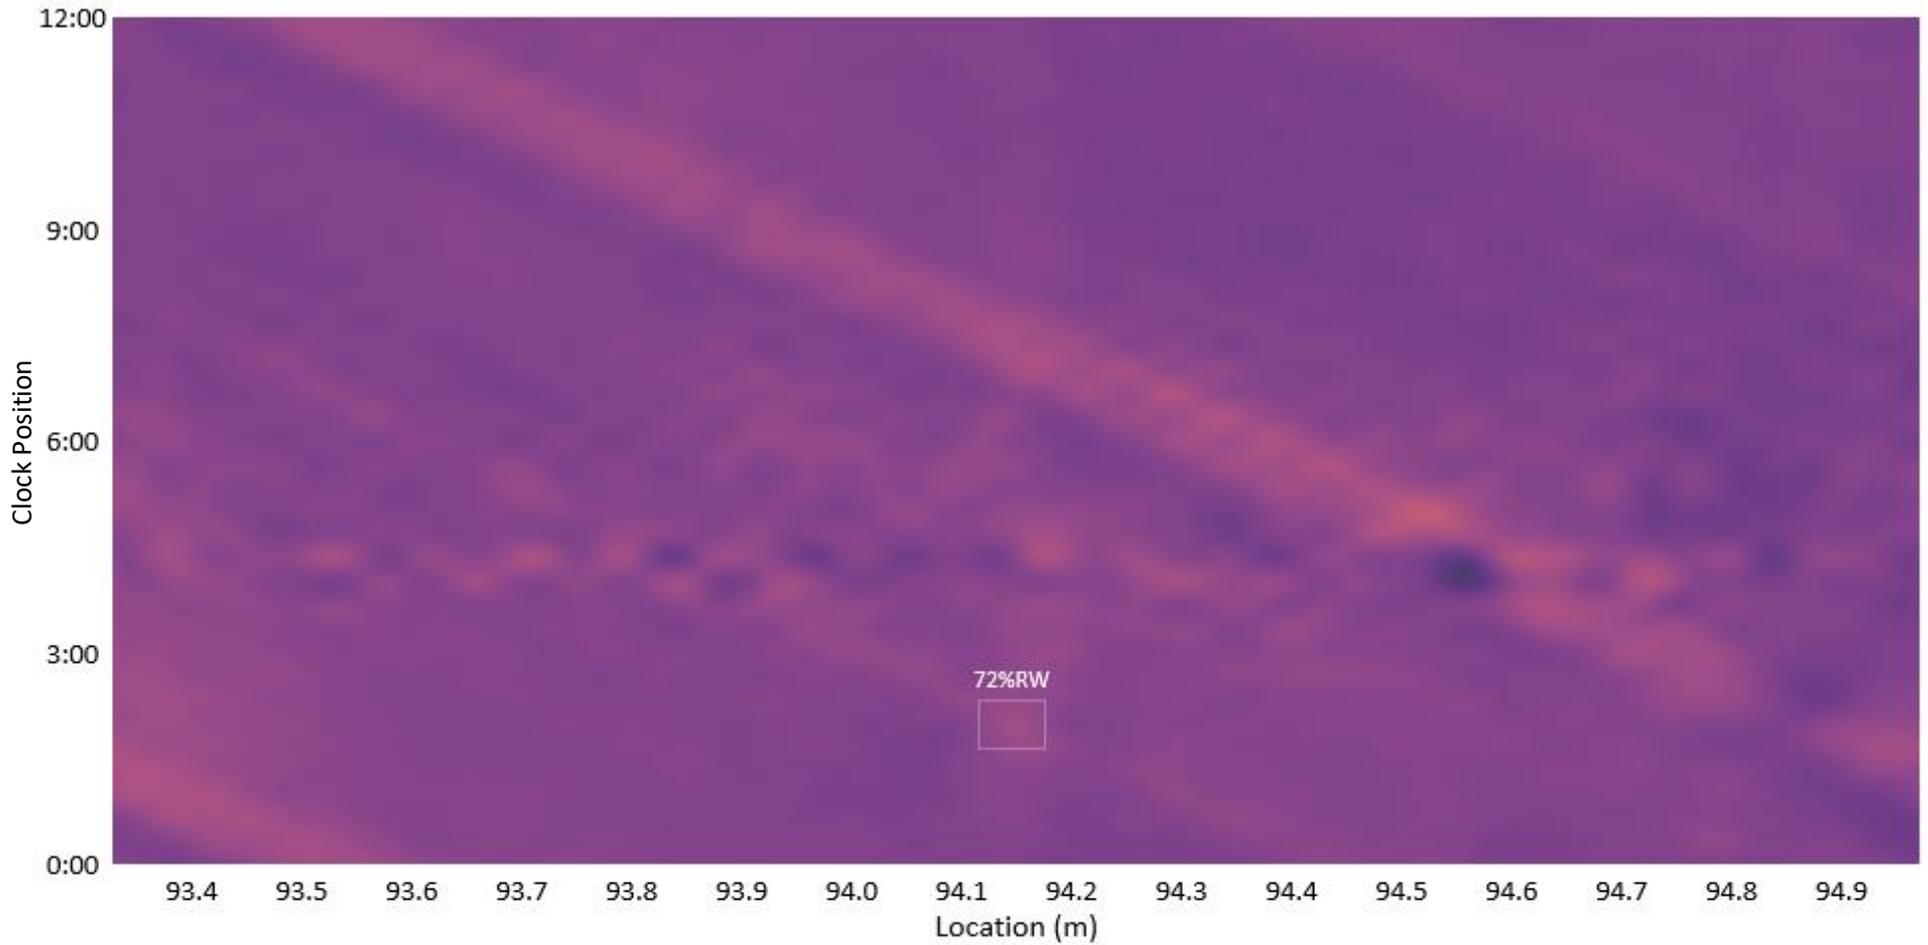
Figure 26. Pipe 0120 colour map of 72% RW indication, 94.15 meters from the ZRD.

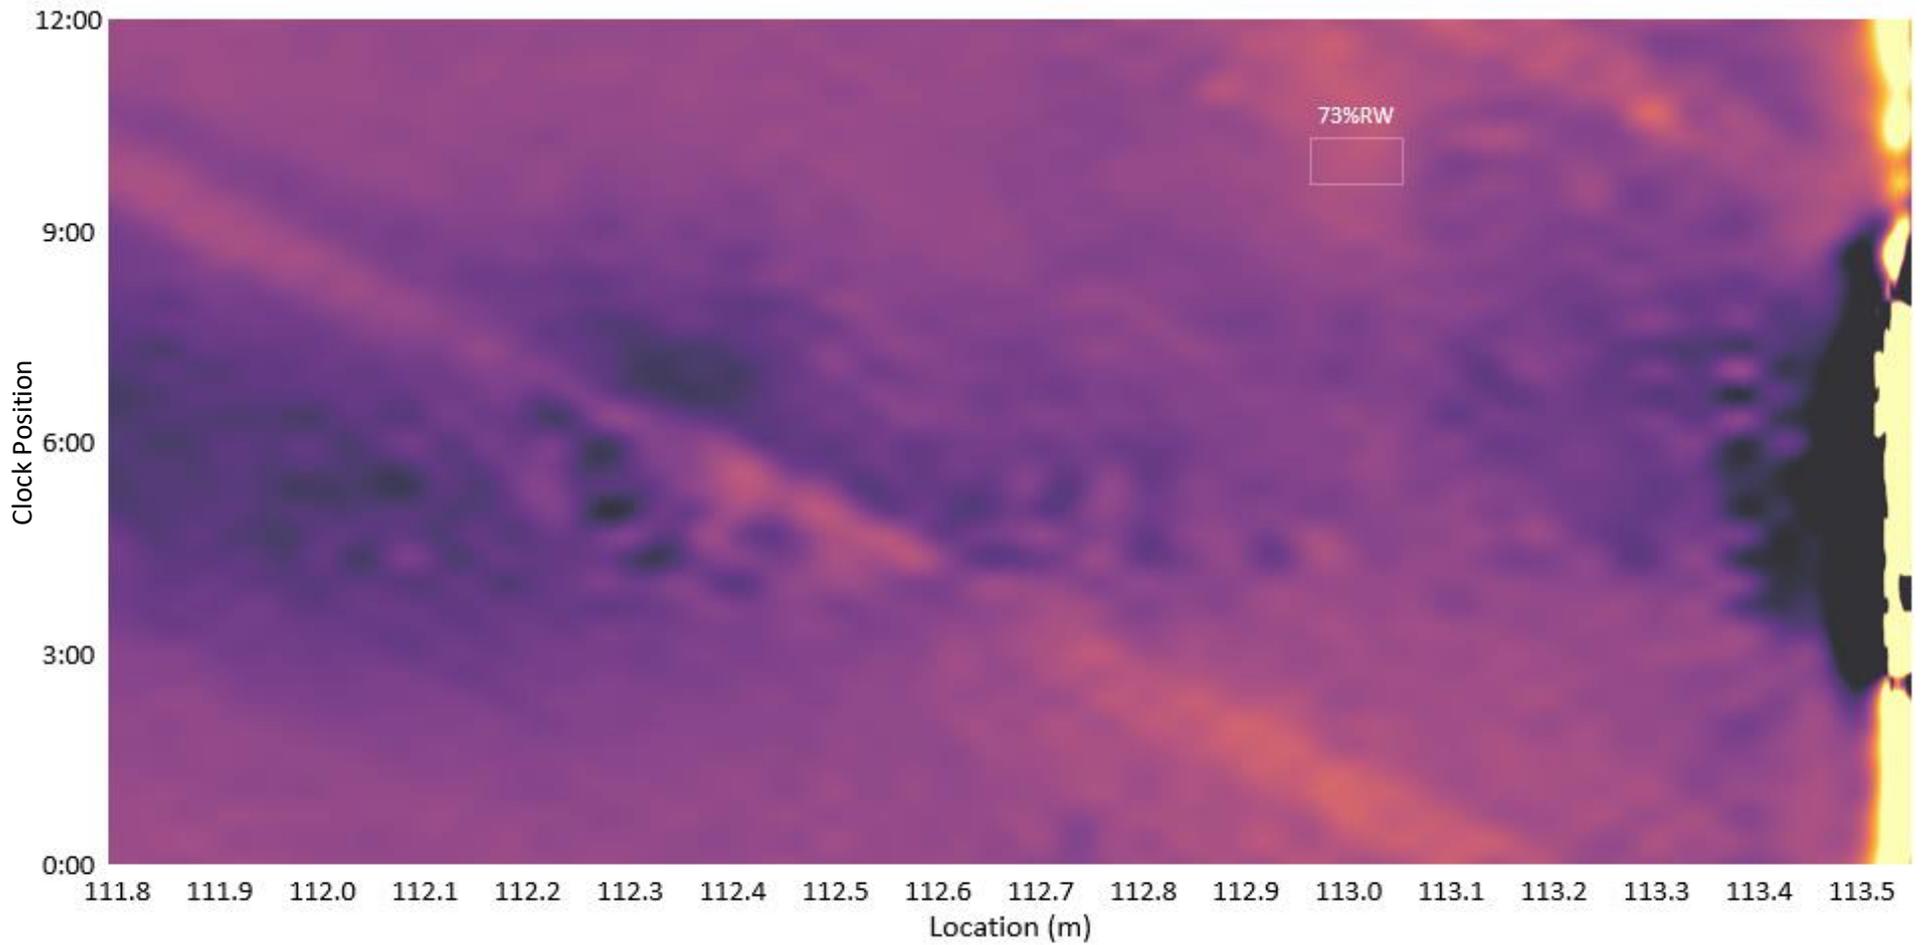
Figure 27. Pipe 0130 colour map showing 73% RW indication at 113.01 meters from the ZRD.

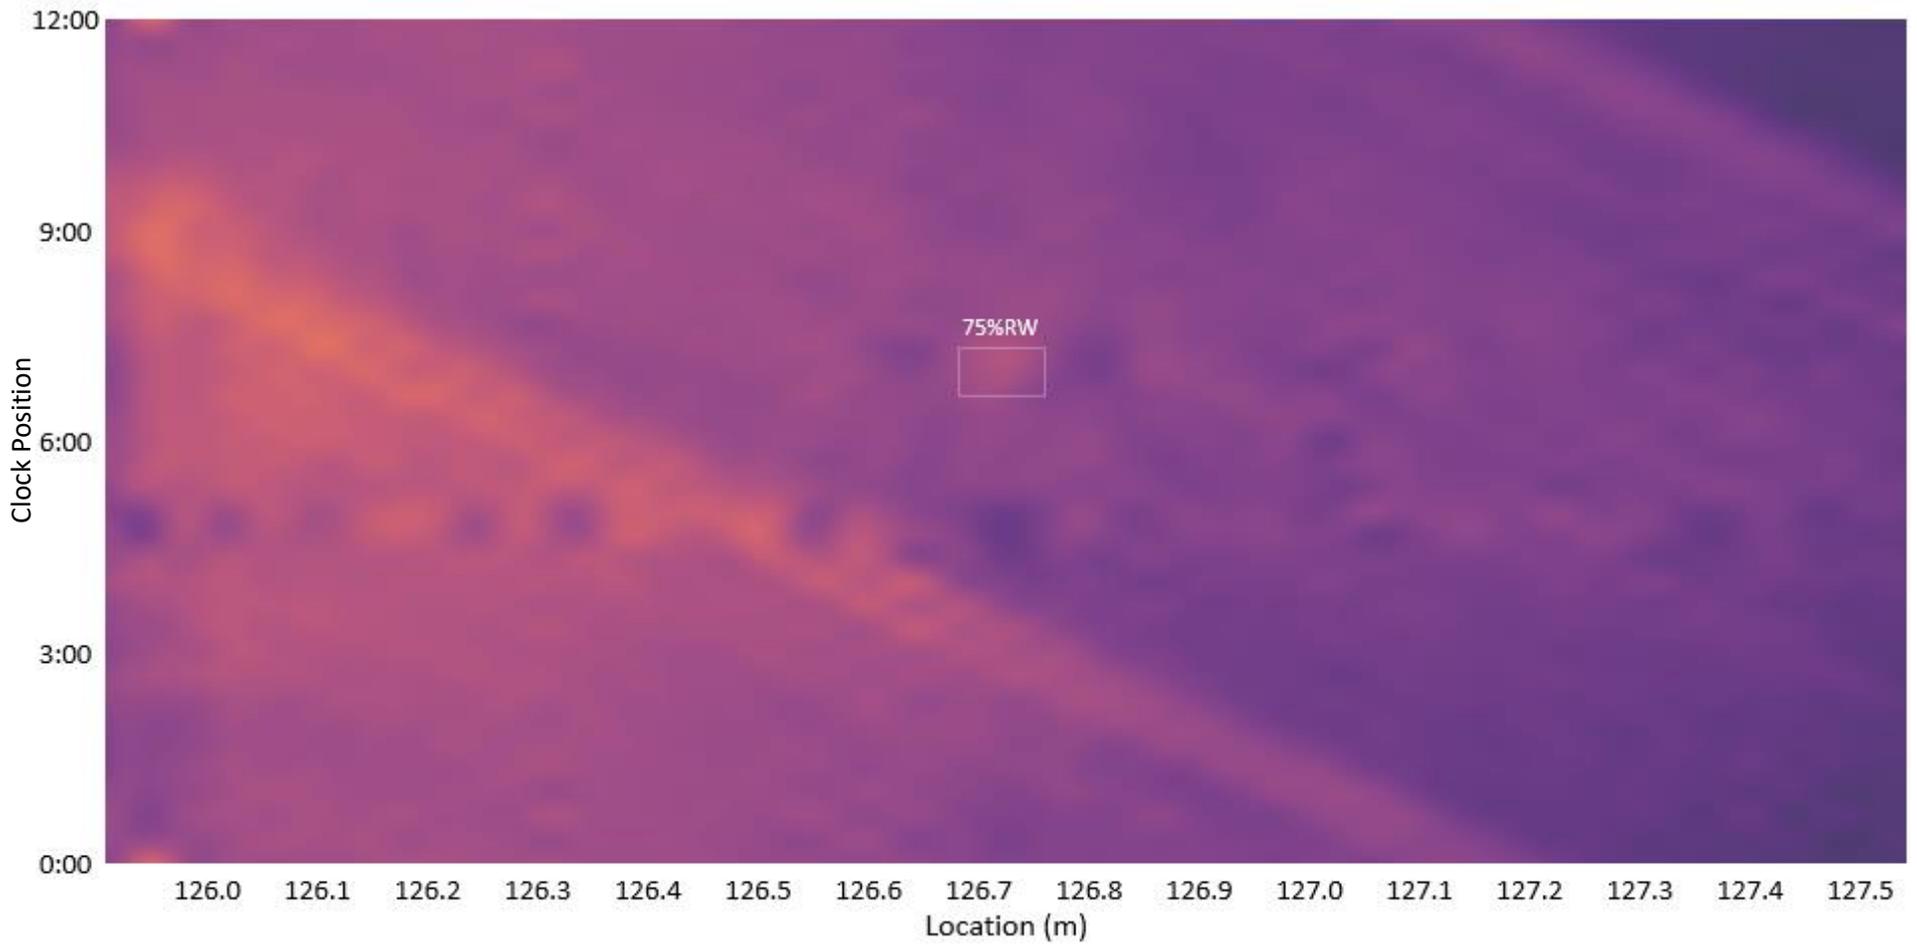
Figure 28. Pipe 0150 colour map showing 75% RW indication, 126.73 meters from the ZRD.

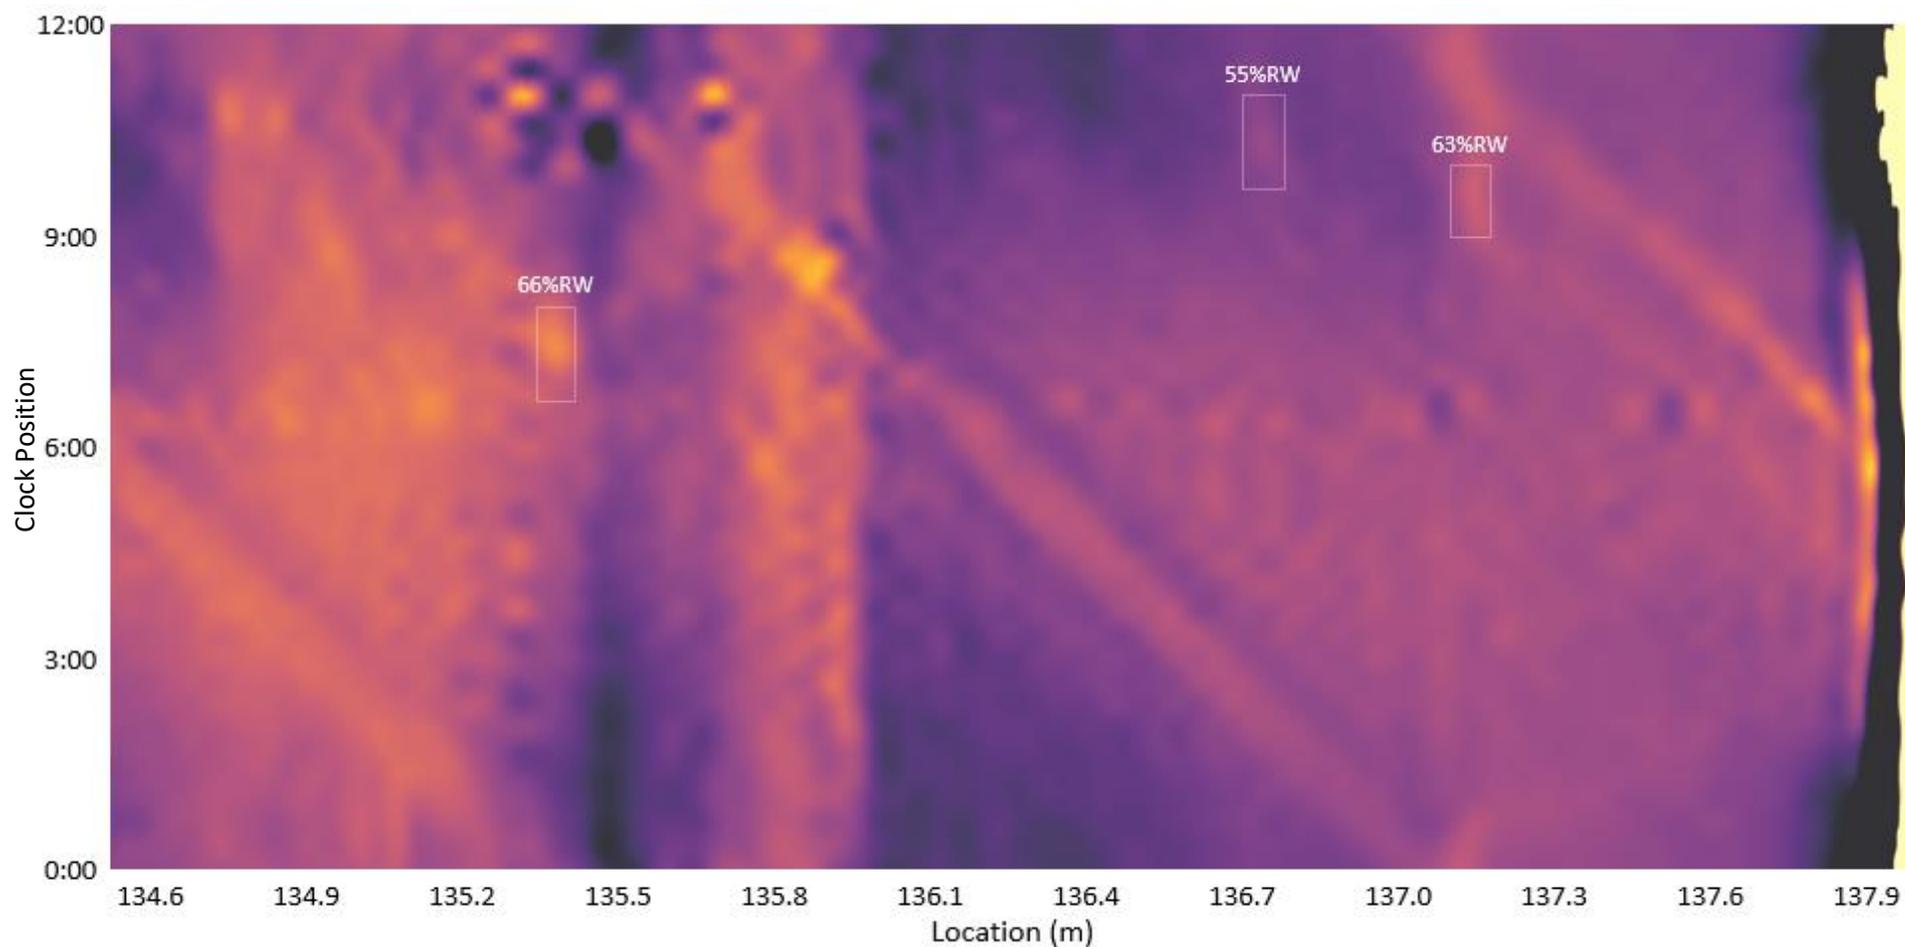
Figure 29. Pipe 0150 colour map showing the 66% RW, 55% RW, and 63% RW indications.

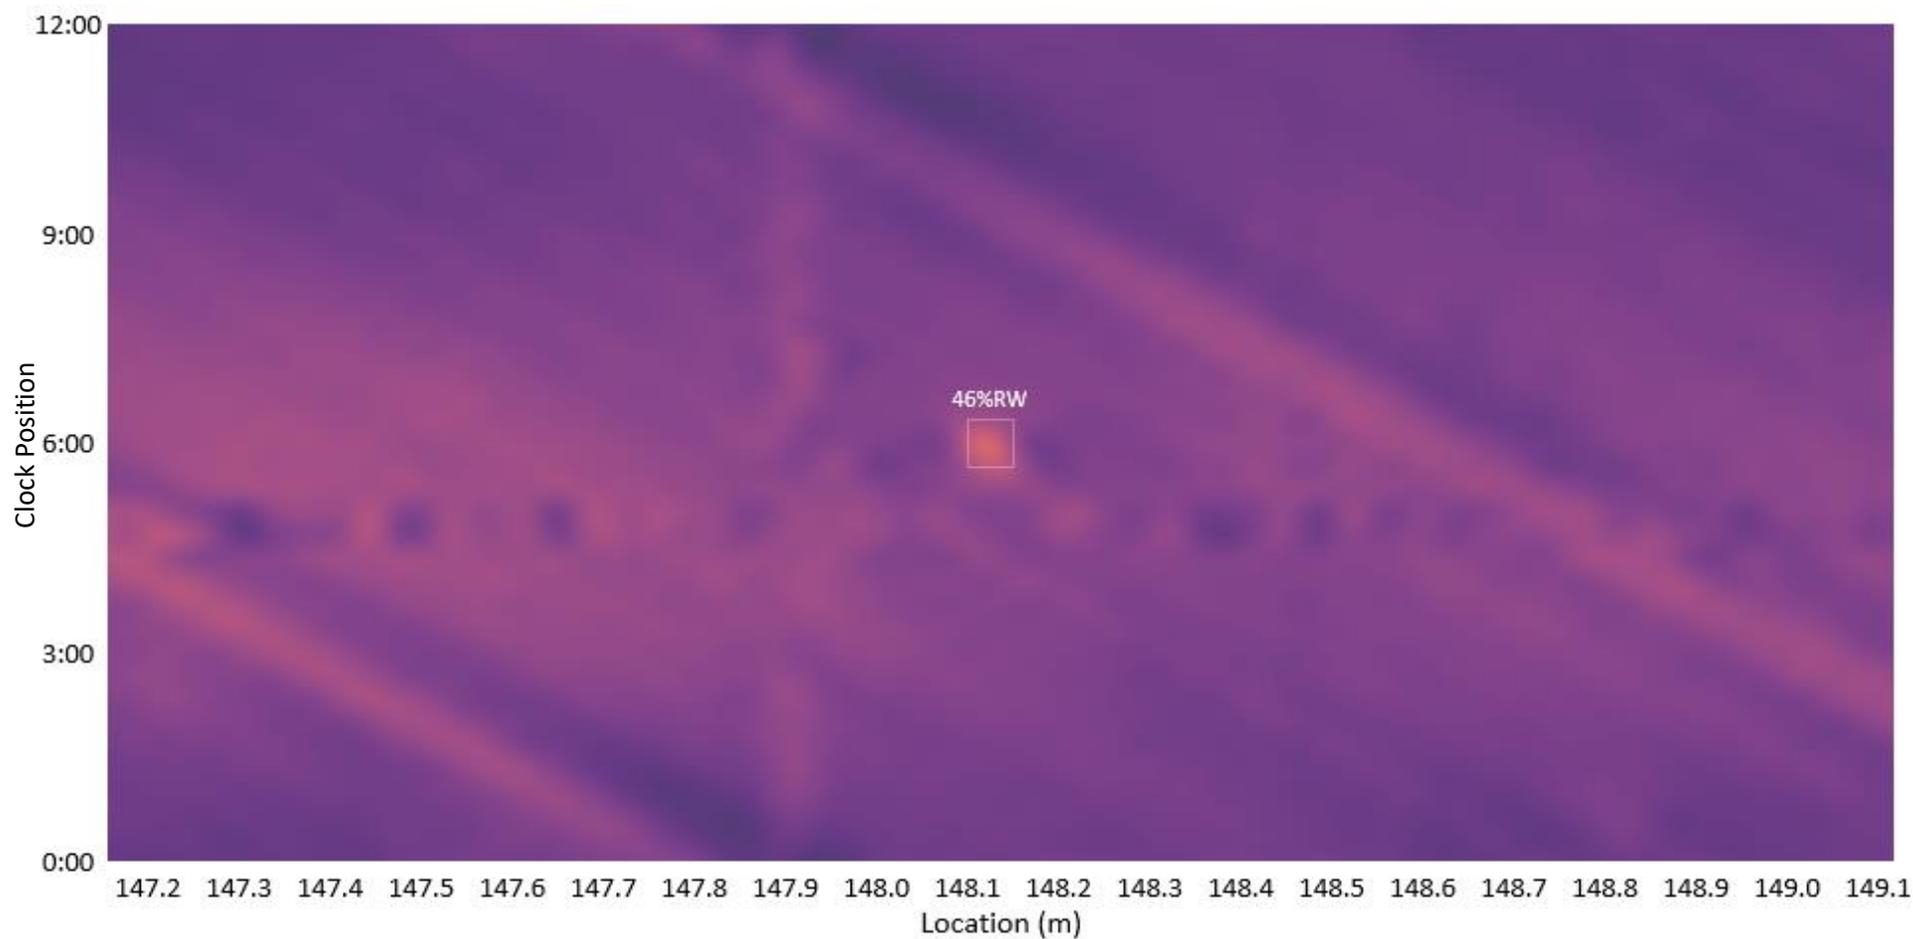
0160	137.94	150.14	12.20	99%	100%	99%	46%	148.13	6:00	67%	138.92	11:30					Two defect indications reported
0170	150.14	162.22	12.08	100%	101%	99%	57%	159.19	11:00	62%	161.37	12:00	74%	154.17	2:30		Four defect indications reported
0180	162.22	163.76	1.54														30.0° mitered vertical bend at start of segment
0190	163.76	166.14	2.37	103%	104%	103%											-30.0° mitered vertical bend at end of segment. Possible water stop at 166.58m.

Figure 30. Pipe number 0160 showing the 46% RW indication, 148.13m from the ZRD.
