# City of Winnipeg

## 600 mm Kildonan-Redwood Feeder Main

Condition Assessment Report, Standard Analysis

**PICA Project: 8054**

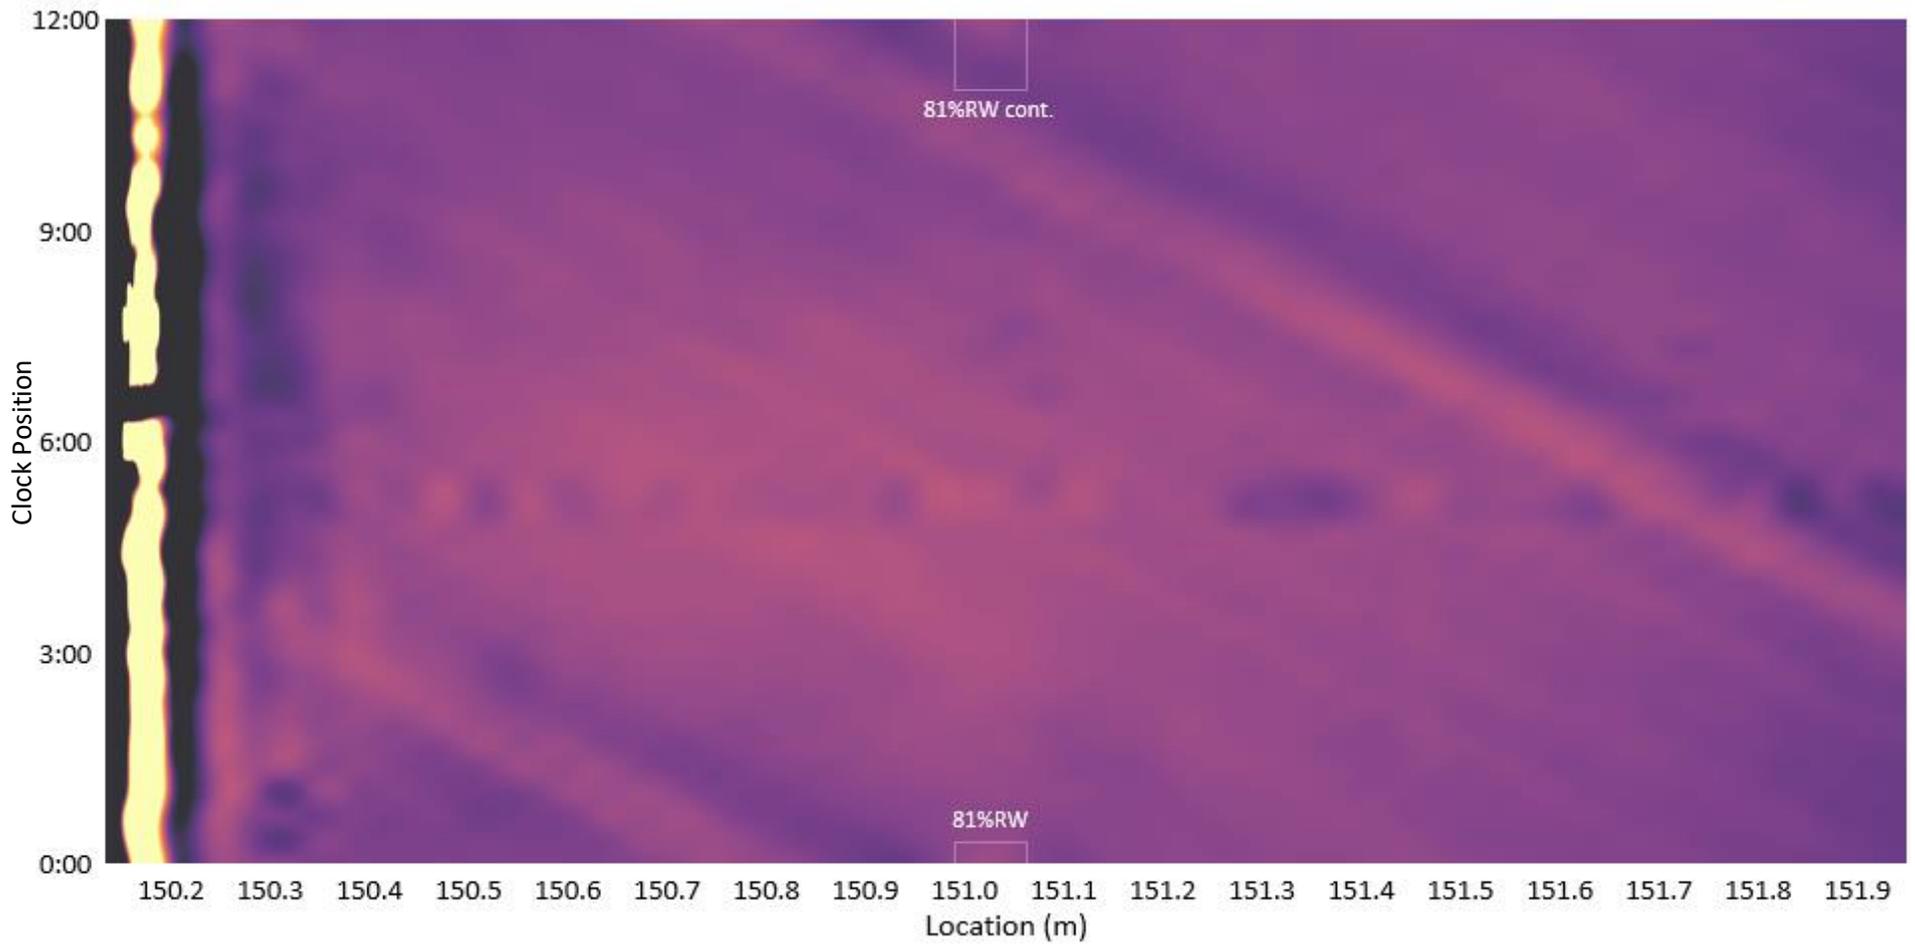
Figure 31. Pipe 0170 colour map showing 81% RW indication at 151.03m from the ZRD.

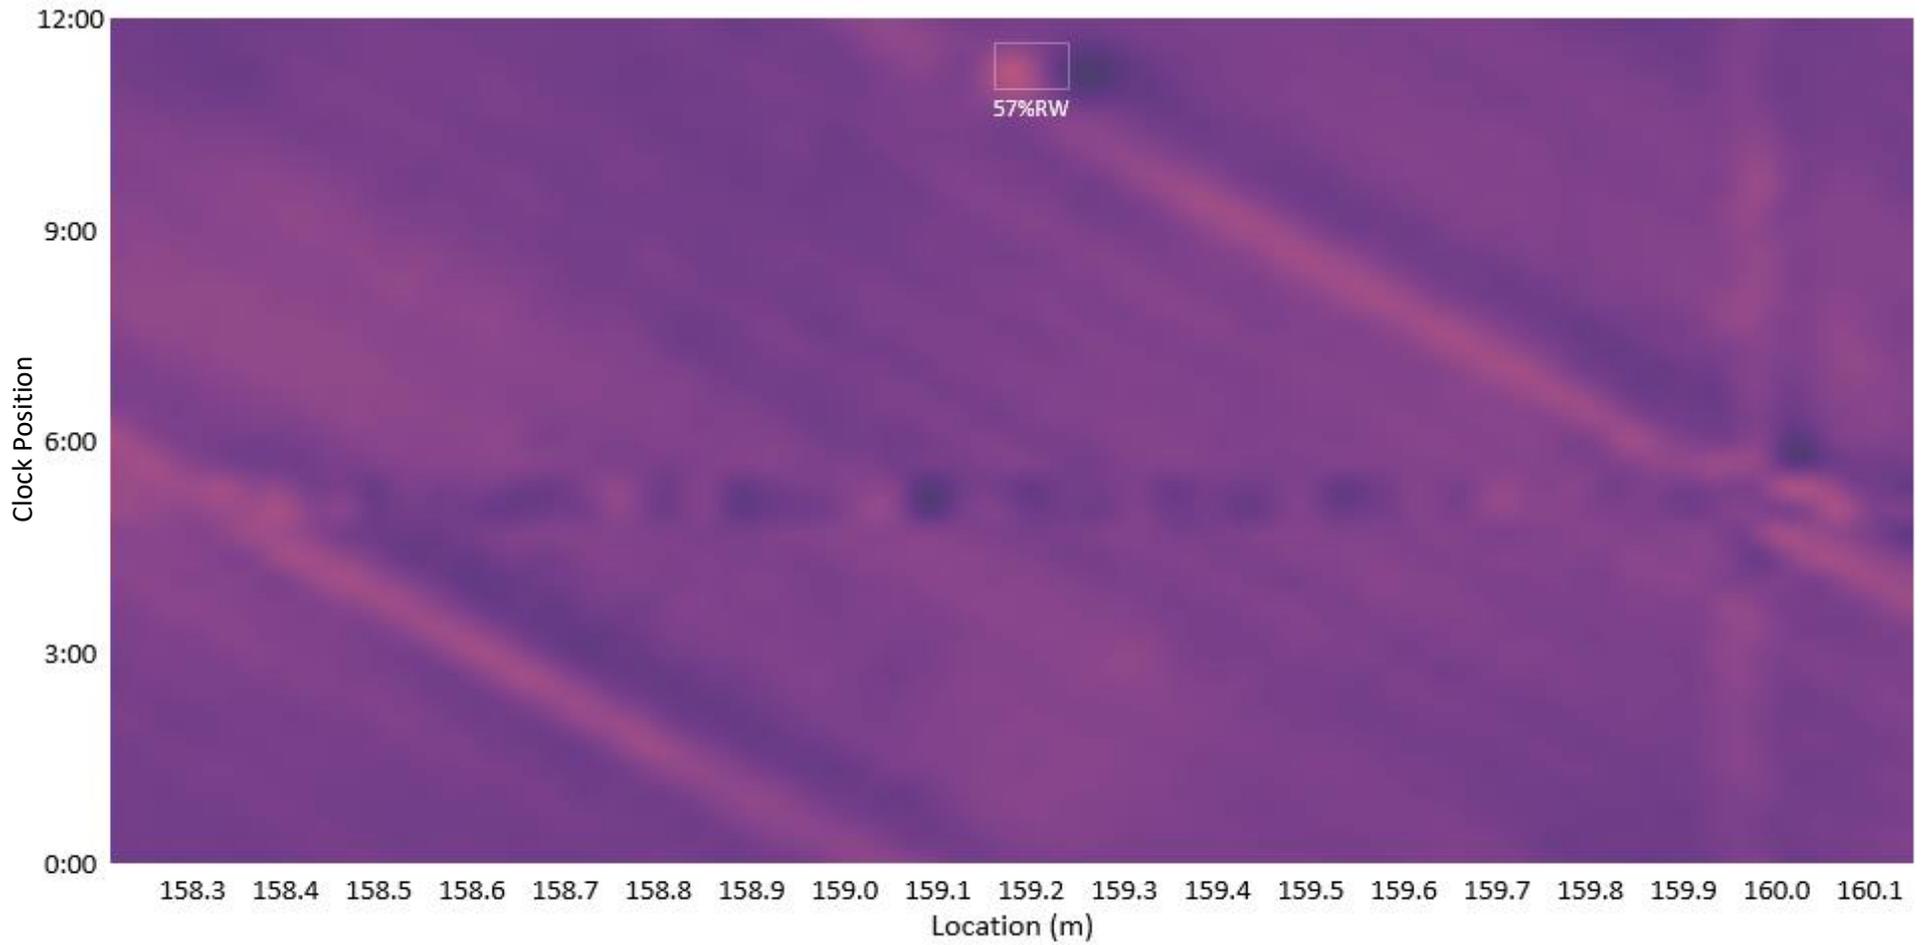
Figure 32. Pipe 0170 colour map showing the 57% RW indication, 159.19m from the ZRD.

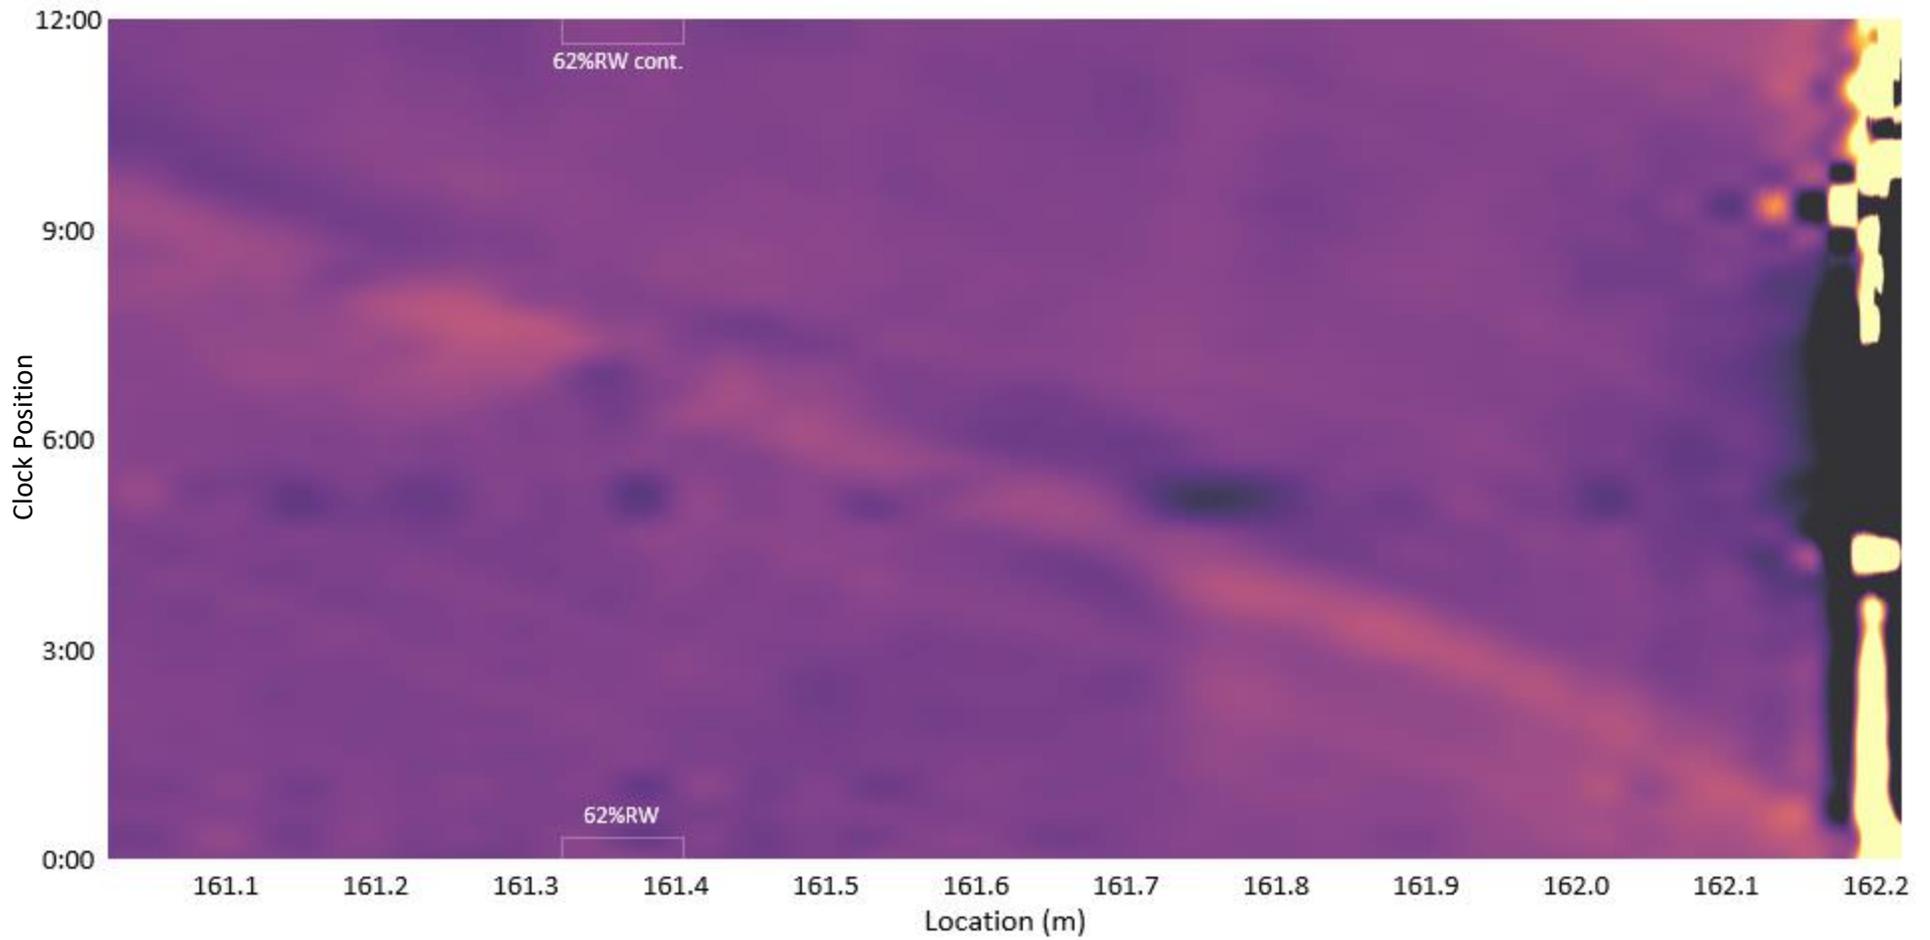
Figure 33. Pipe 0170 colour map showing the 62% RW indication, 161.37m from the ZRD.

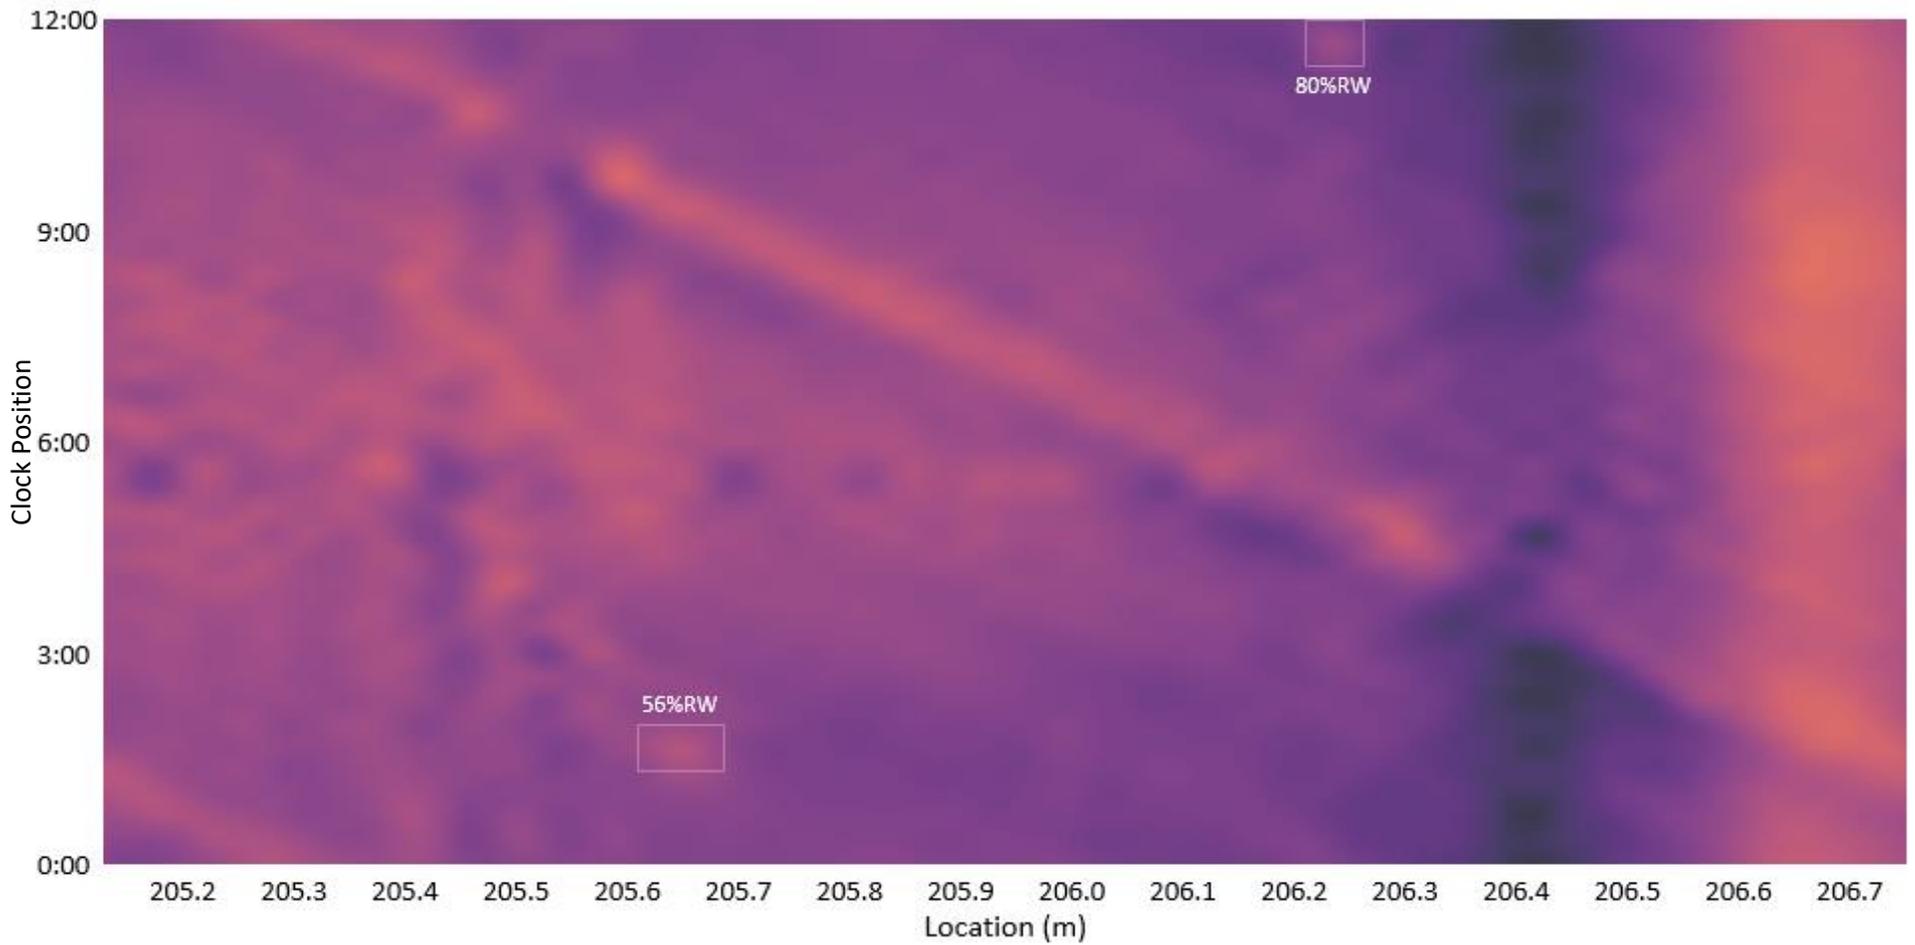
0290	204.57	208.84	4.27	98%	99%	98%	56%	205.66	1:30	80%	206.24	11:30					Strap located at 206.4m Two defect indications reported
0300	208.84	213.11	4.26	103%	104%	103%											Strap located at 212.5m
0310	213.11	217.37	4.26	104%	104%	104%											
0320	217.37	221.65	4.28	99%	100%	99%											Strap located at 219.2m
0330	221.65	225.60	3.95	103%	102%	101%											
F	225.60	226.96	1.36*														90° elbow

Figure 34. Pipe 0290 colour map with 56% RW and 80% RW indications shown.
