## **CITY OF WINNIPEG**

**WASTEWATER LIFT STATION CONDITION ASSESSMENT PHASE II**

**Document III: Conway Lift Station Assessment**

Date: March 16, 2020

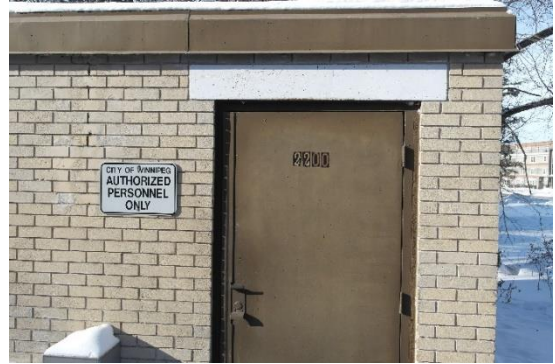
Due to snow cover during the inspection, the site grading conditions were not observable. A Google Maps – Street View image reveals ponding against the side of the structure. The City suggested that the ponding might have been corrected during force main upgrading in the same area. Landscaping consists of a grass area kept mowed and trees overhanging the building that interfere with exhaust, roof drain, and the electrical service.

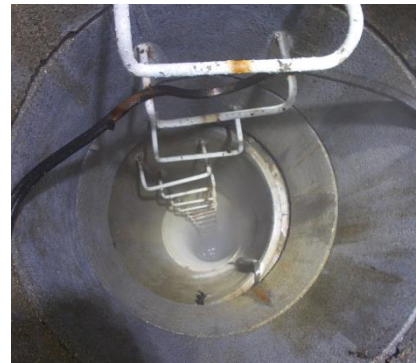
The Conway Lift Station foundation consists of a cast-in-place concrete dry well (a comminutor room and a pump room). A round, buried wet well exists outside of the lift station. The base of the comminutor room is approximately 9.0m below grade. The wet well and pump room bases are approximately 11.6m below grade. The concrete base slab is aged and shows signs of surface deterioration. The sump pit is functional and the floor is sloped for drainage to the sump; however minor ponding was noted near the sump during the inspection.

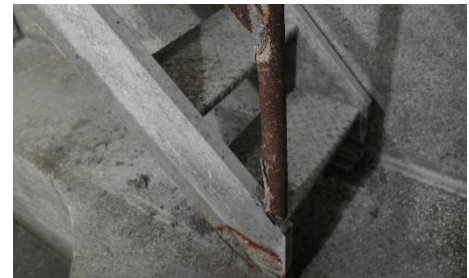
The lower level stairs and rails are corroded and no longer suitable for use. Future renovations should include the replacement of these stairs and rails. Some of the carbon steel bolts used as anchors in various places are also corroding.

Three (3) of the hatch lids are plywood and all unhinged. Square hatch lids are susceptible to falling through openings. There are also no rails or a gate around the opening. The hatches, stairs, and rails are not code compliant and are considered a safety risk.

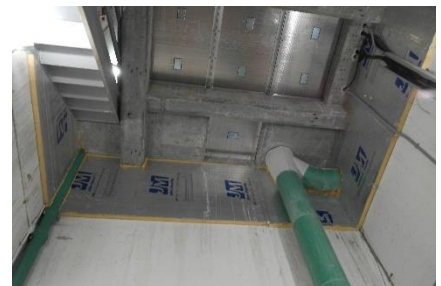
The paint on the floor surfaces has worn off on all levels. An epoxy coating on the floor would be ideal for durability, but will require additional prep work in the lower pump room due to the age of the concrete and the surface deterioration. Walls can be surfaced with a latex or suitable acrylic-latex paint to improve aesthetics and protect the surfaces.

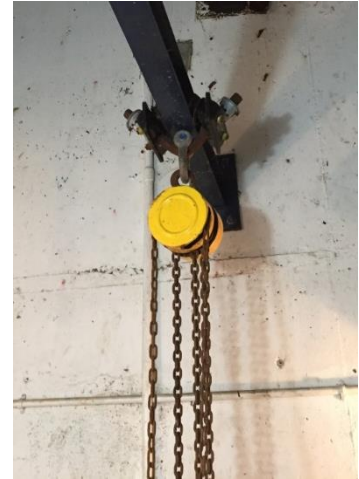
The monorail capacity is written on the protective board wall-covering nearby. The capacity should be written on the monorail. If future renovations include refinishing the walls, they should also include labeling the monorail and lifting lugs properly.

MPE was unable to obtain a copy of the third party monorail and hoist certification.

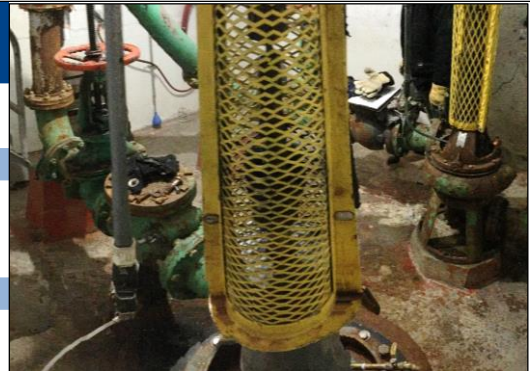
Piping was installed in the Comminutor Chamber in 2015. The Comminutor Chamber was previously an open flume, which caused high levels of H<sub>2</sub>S and resultant corrosion throughout the lift station. No other major process mechanical upgrades have been carried out at the lift station since its original construction. The City Operations and Maintenance Staff have performed tasks to prolong the usable life of the equipment including routine servicing, preventative maintenance, and building cleanup. In general, the equipment is in “Poor” physical condition.

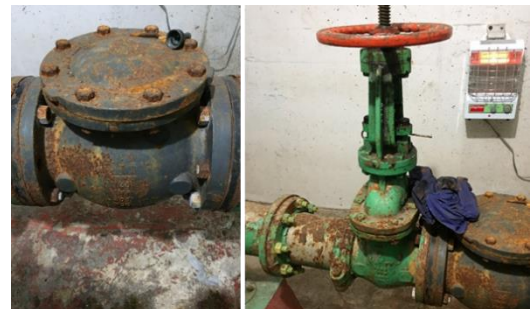
The majority of the valves are original to the building, with the exception of the gate valve in the Comminutor Chamber that was recently installed. The manually actuated gate valves that are used for isolation of equipment for maintenance and are not regularly exercised. The check valves are critical to the operation of the lift station and are exercised regularly through operation. In general, valves are in “Poor” condition. Table 7.5 provides a summary of the condition of the valves at the Conway Lift Station.

TABLE 7.5: CONWAY LIFT STATION VALVE CONDITION ASSESSMENT					
VALVE	DESCRIPTION	SIZE	CONDITION	IMPORTANCE	ACTION
GAV-101A	Gate Valve	150 mm	Poor	Intermediate	Short Term
GAV-101B	Gate Valve	150 mm	Poor	Intermediate	Short Term
GAV-102A	Gate Valve	150 mm	Poor	Intermediate	Short Term
GAV-102B	Gate Valve	150 mm	Poor	Intermediate	Short Term
GAV-201	Gate Valve	500 mm	Excellent	Intermediate	None
CHV-101	Swing Check Valve	150 mm	Poor	Important	Short Term
CHV-102	Swing Check Valve	150 mm	Poor	Important	Short Term

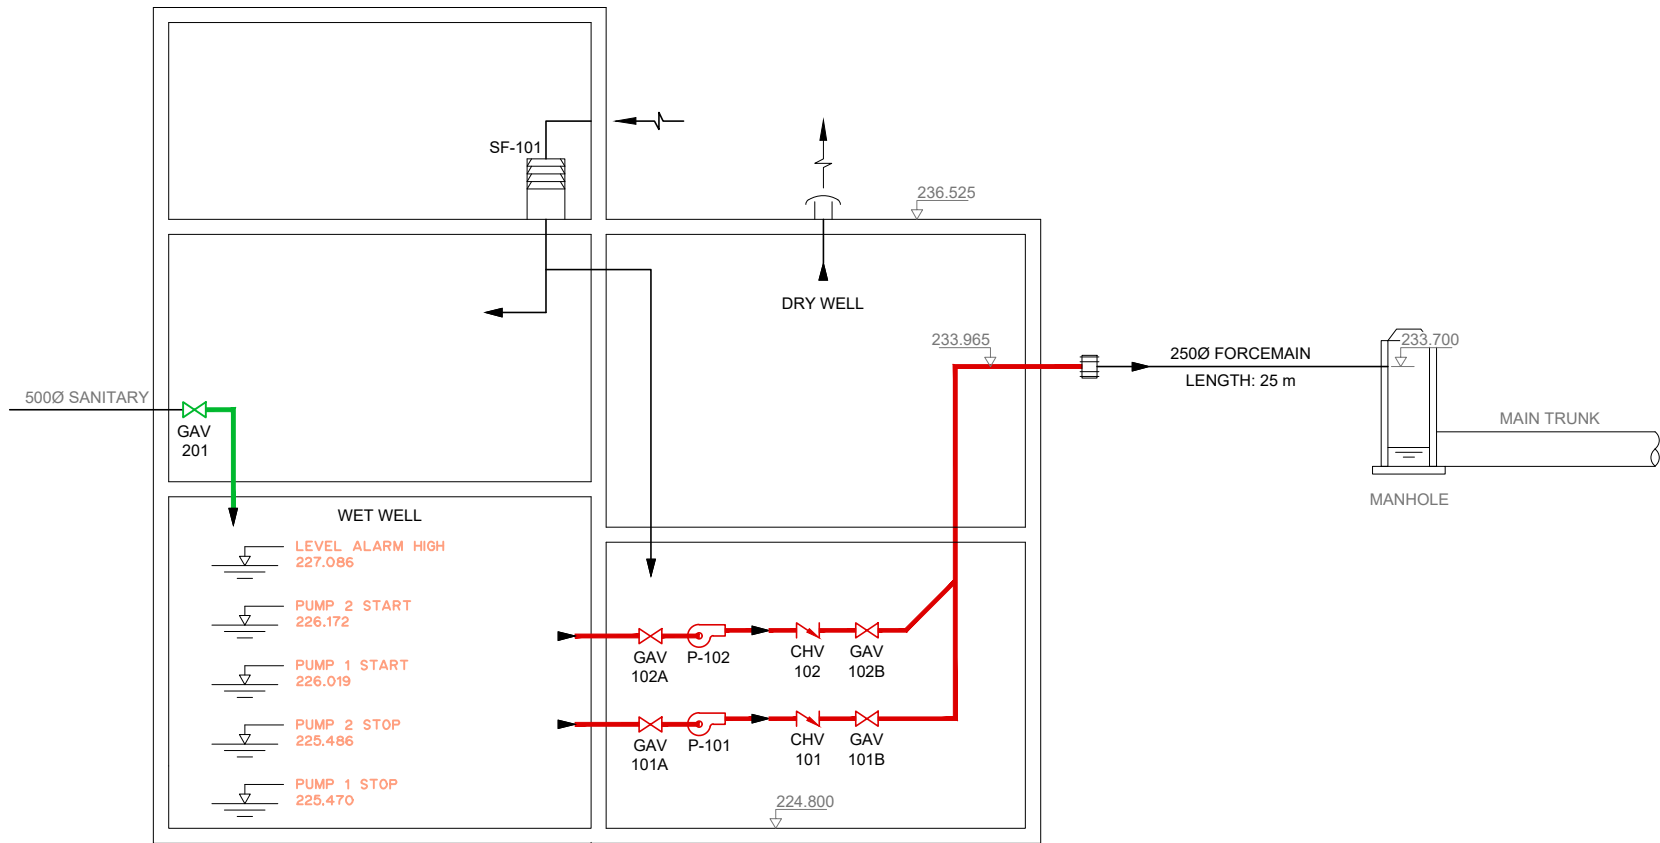
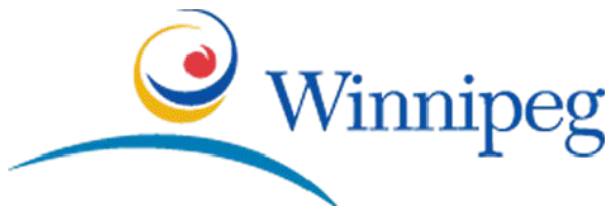
CONWAY  
 CONDITION ASSESSMENT SUMMARY

Figure 7.1 provides a graphical summary of the condition assessment of the mechanical components of the Conway Lift Station.

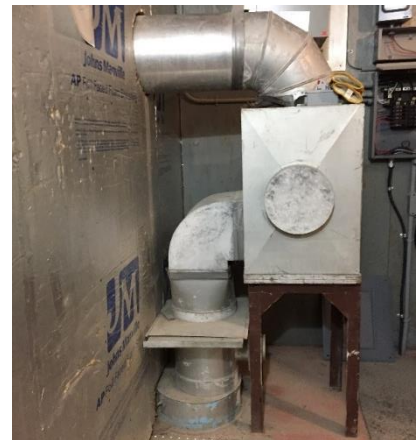
The ventilation system includes ducting for supply and exhaust in the dry well. No concerns were noted with pressurization in the dry well.

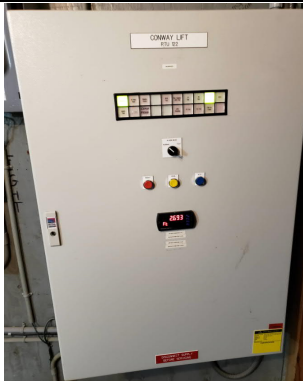
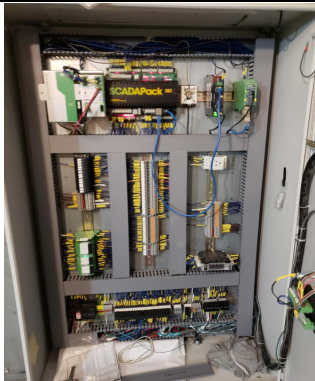
Project No.: 8400-001-00  
 Tag: IC\_Termination\_Panel  
 Facility: Conway Lift Station  
 Assessment Page 1 of 1

Canadian Electrical Code Issues Identified: Issues for Discussion:	Rating 1 (No issues) Rating 3 (Non compliant - current code) Rating 5 (Non compliant - legacy code)	5	0.4					
		Control Wiring Terminations Visual Inspection: Issues for Discussion:	Rating 1 (Connections tight, labelled) Rating 2 (Missing labels) Rating 3 (Loose / disorganized wiring) Rating 4 (Inappropriate wiring) Rating 5 (Combination of above)	1	0.1					
		Occurrences of Maintenance Issues: Issues for Discussion:	Rating 1 (None) Rating 2 (Intermittent) Rating 3 (Consistent but occasional) Rating 4 (Frequent) Rating 5 (Constant)	2	0.4					
		Controls Functioning as Expected: Issues for Discussion:	Rating 1 (Always) Rating 2 (More than half of time) Rating 3 (Half of the time) Rating 4 (Less often than half) Rating 5 (Never)	1	0.3					
Panel is Appropriately Designed: Issues for Discussion:		Rating 1 (Yes) Rating 3 (No - current standards) Rating 5 (No - legacy standards)	1	0.1

Fitness for Purpose	Control Logic is Appropriate for Installation: Issues for Discussion:	Rating 1 (Yes) Rating 3 (No - current standards) Rating 5 (No - legacy standards)	1	0.3						
	Communications Equipment is Appropriate: Issues for Discussion:	Rating 1 (Yes) Rating 3 (No - current standards) Rating 5 (No - legacy standards)	1	0.1						
	Equipment Remaining Service Life: Issues for Discussion:	Rating 1 (> 90% lifecycle remain) Rating 2 (> 75% lifecycle remain) Rating 3 (> 50% lifecycle remain) Rating 4 (> 25% lifecycle remain) Rating 5 (obsolete)	1	0.2						
PHOTOGRAPHS

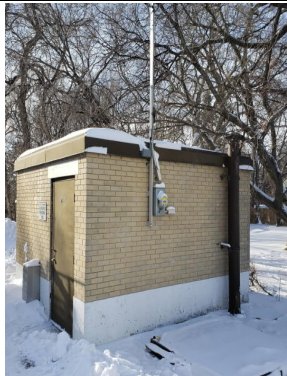
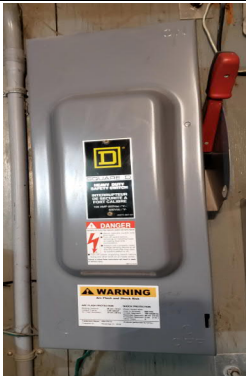
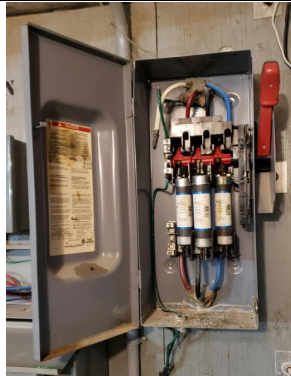
Standby Generator Needed & Present: Issues for Discussion:	Rating 1 (Yes / Not needed) Rating 3 (Needed / Portable Generator) Rating 5 (Needed / Not Available)	3	0.2										
		Is Main Breaker Present & Appropriate: Issues for Discussion:	Rating 1 (Yes) Rating 3 (Present, not appropriate) Rating 5 (Not Present)	3	0.05										
		Is Grounding System Present & Appropriate: Issues for Discussion:	Rating 1 (Yes) Rating 3 (Present, not appropriate) Rating 5 (Not Present)	1	0.1										
		Is Utility Service appropriate: (600V/3PH) Issues for Discussion:	Rating 1 (Yes) Rating 5 (No)	1	0.1										
Has the Service Capacity Been Reached? Issues for Discussion:		Requires review of service calculation. Rating 1 (Service < 85% capacity) Rating 3 (Service 85% - 99% capacity) Rating 5 (Service > 99% capacity)	3	0.1											
Equipment Remaining Service Life: Issues for Discussion:		Rating 1 (> 90% lifecycle remain) Rating 2 (> 75% lifecycle remain) Rating 3 (> 50% lifecycle remain) Rating 4 (> 25% lifecycle remain) Rating 5 (obsolete)	4	0.25
