October 13, 2022 – Revised

Pre-Renovation Hazardous Materials Assessment

Metcalfe Lift Station
600 Lyndale Drive
Winnipeg, Manitoba

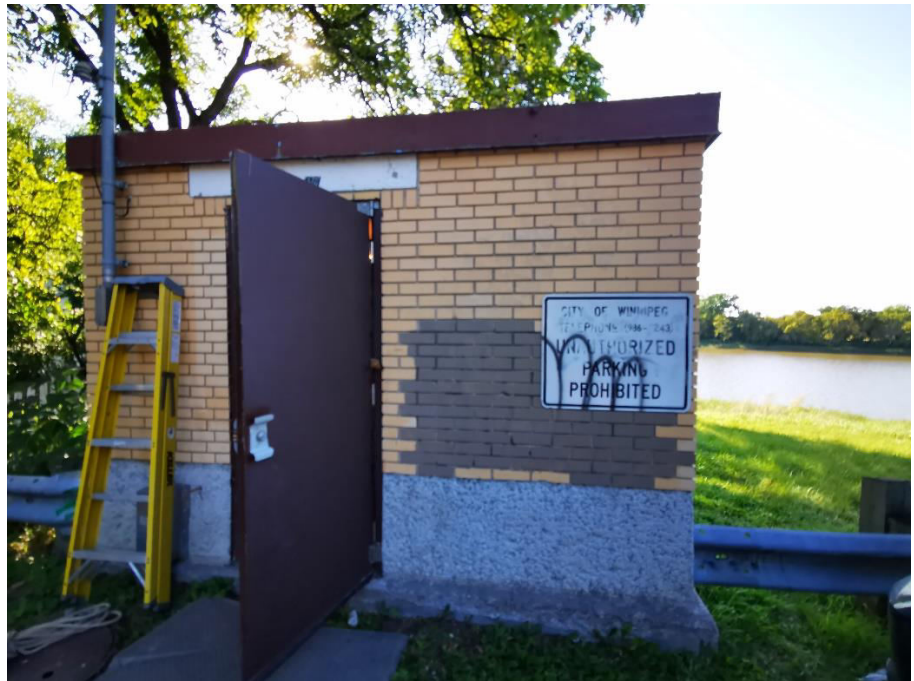
Photo 1:
Metcalfe Lift Station
superstructure.

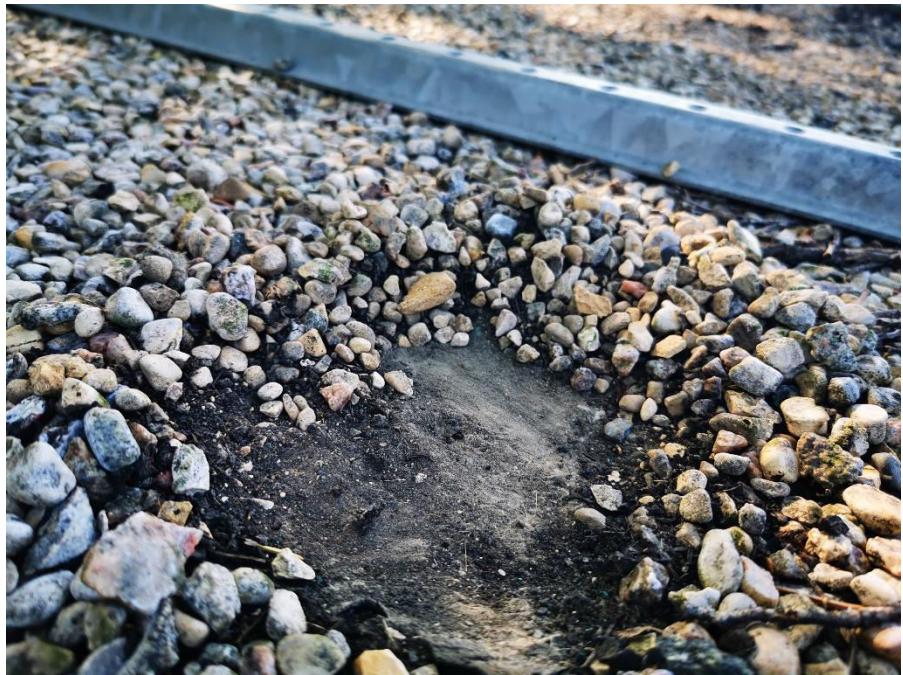
The roof was observed to be tar and gravel and samples of the top layer beneath the gravel (samples MLS-17, MLS-18 and MLS-19) was found to contain no detectable levels of asbestos. To prevent damage to the structure, TEC did not complete destructive sampling of the roofing materials to assess all layers that may be present.

Photo 2:
Tar and gravel roof of the
superstructure. City of
Winnipeg representative
informed TEC that the roof
structure may be in poor
condition – intrusive
sampling was not
completed.

Intrusive sampling of the roofing materials should also be completed prior to tender or the intended demolition of the superstructure.

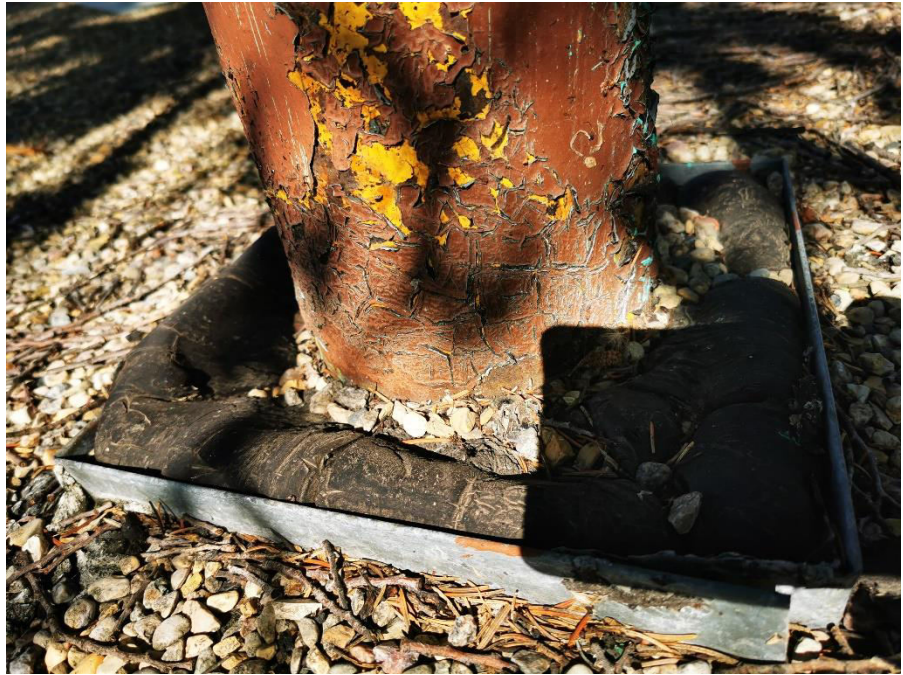
Photo 3:

Around the chimney on the roof, a black sealant was observed and (samples MLS-20, MLS-21 and MLS-22) was found to contain no detectable levels of asbestos.

Non-ACM sealant around the chimney.

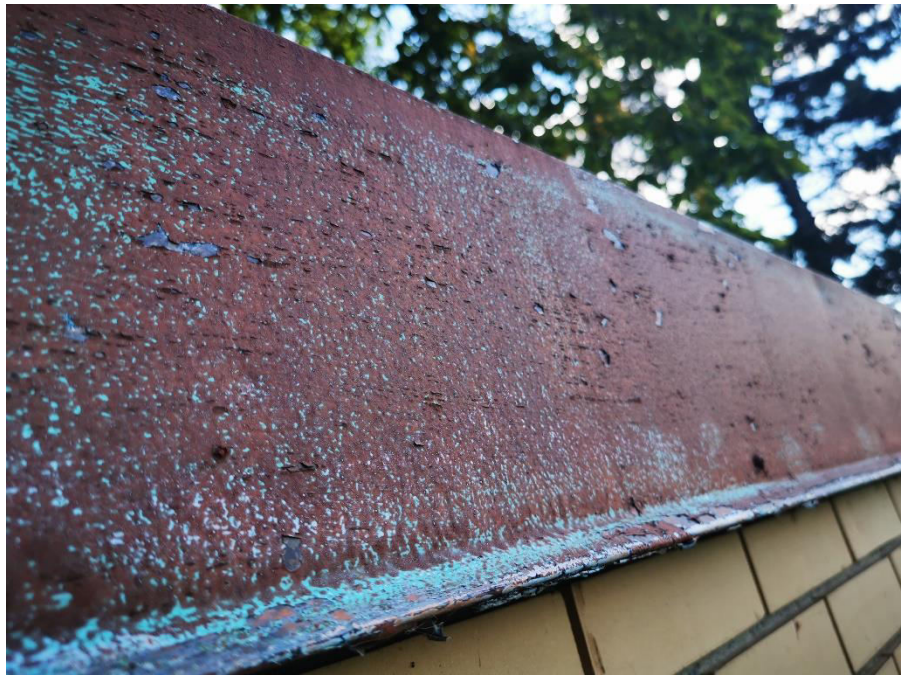
Photo 4:

On the roof flashing, a brown paint with a light blue layer beneath was noted and is considered to be lead-based.

Exterior flashing – brown paint and the blue paint beneath are lead based.

The light brown and light blue paint applied on the flashing on the exterior is considered to be lead-based. Any impact to this material should proceed inside of a negatively pressured enclosure with the exception of manual removal by hand.

Lead leachability testing should be conducted on finishes with lead-containing or lead-based paints applied to determine any additional disposal methods required.

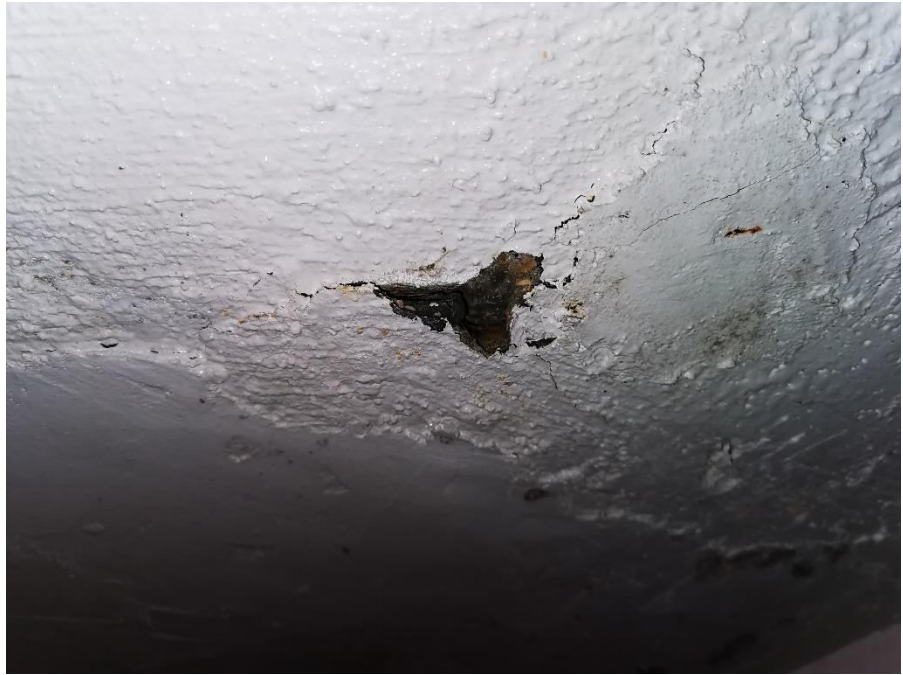
Photo 5:

On the fourth level of the substructure, cementitious patches were observed in the ceiling and (samples MLS-1, MLS-2 and MLS-3) were found to contain no detectable levels of asbestos.

Lowest level of the substructure – non-ACM cementitious ceiling patches.

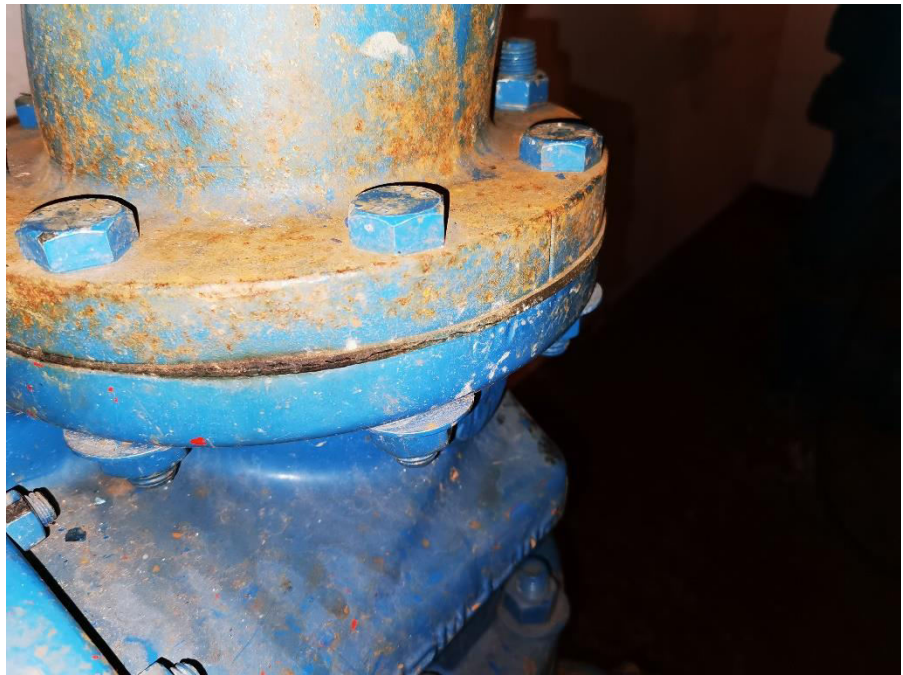
Photo 6:

Gaskets were noted in the flanges of the pump lines and (samples MLS-4, MLS-5, MLS-6 and MLS-7) were found to contain no detectable levels of asbestos.

Accessible gasket materials within the flanges were found to be non-ACM

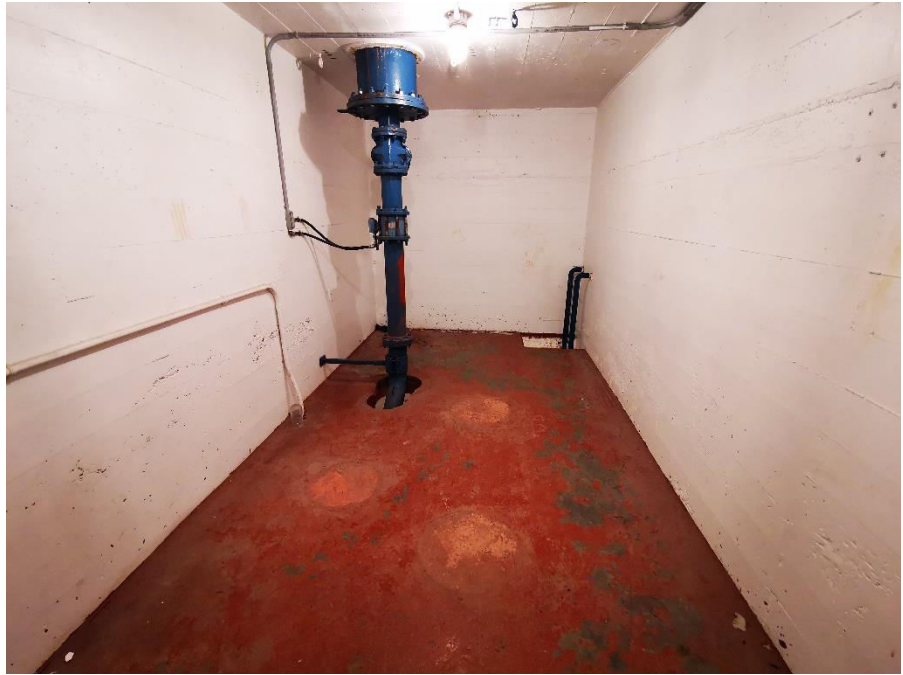
Photo 7:

As such, the red paint applied to the floors and the blue paint applied to the ladders are considered lead-containing. The blue paint applied to the ladders was visually similar to the blue paint applied to the mechanical lines which should also be presumed to be lead-containing as the paints are visually indistinguishable.

Red paint on flooring throughout and blue paint on the ladders and mechanical lines are lead-containing.

The red paint on flooring throughout and the blue paint found on ladders and mechanical items throughout was found to be lead-containing. These finishes may be removed following general demolition methods, provided that abrasive methods such as cutting, grinding and sanding are avoided. If abrasive methods are required, these removals may safely proceed within a negatively pressured enclosure.

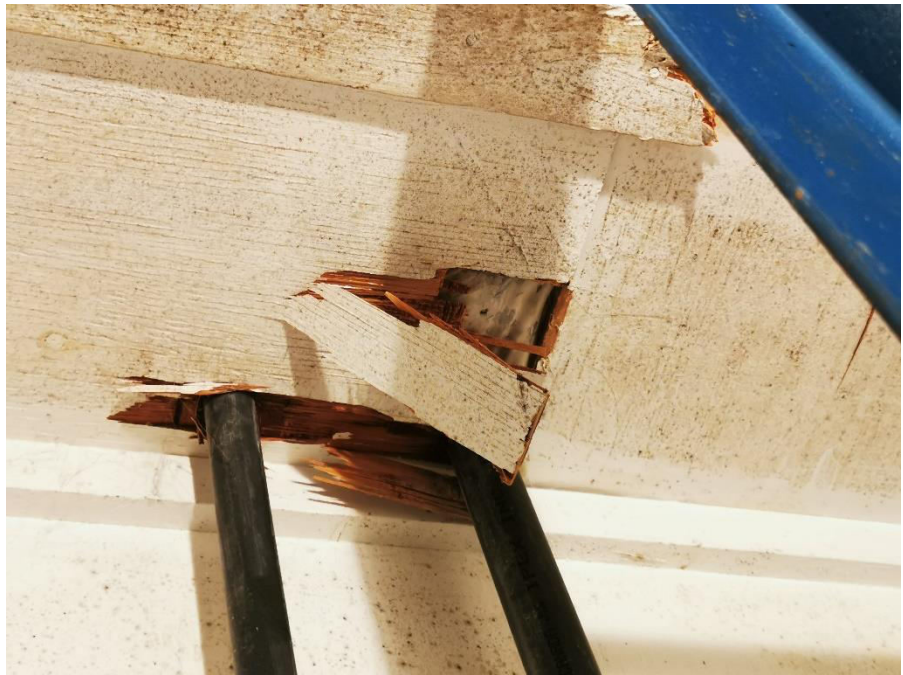
Photo 8:

Walls and ceilings in within the superstructure were found to be non-suspect plywood. Beneath the plywood on the walls was a rigid foam insulation. Walls and ceilings of the superstructure were not opened to assess for the presence of additional suspect hazardous materials within wall and ceiling cavities.

Plywood present on the walls and ceiling of the superstructure and first level of the substructure.

abatement procedures prior to tender. The non-suspect plywood wall and ceiling materials should be removed following **Type 2** procedures to assess and additional materials that may be present within the wall and ceiling cavities.
