The City of Winnipeg High Risk River Crossings – Phase Two Condition Assessment Report

April 2020

Project Number: 60549028

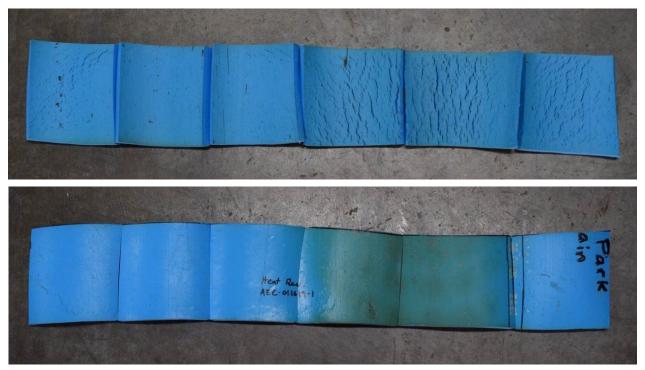
from the Heritage Park Force Main shows extensive evidence of both splitting and burning. Burning is another sign of contamination of the PVC matrix and the exterior pipe burning evidenced in the test samples is similarly located where the worst of the interior splitting is located.

Figure 54: Site 5 - Heat Reversion Test Photos

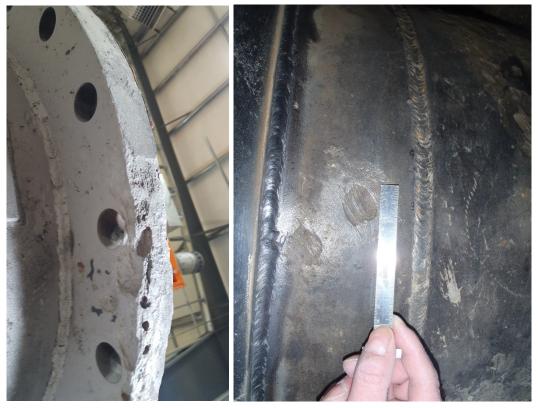
Figure 56: Site 2 - Flange and Fitting Corrosion

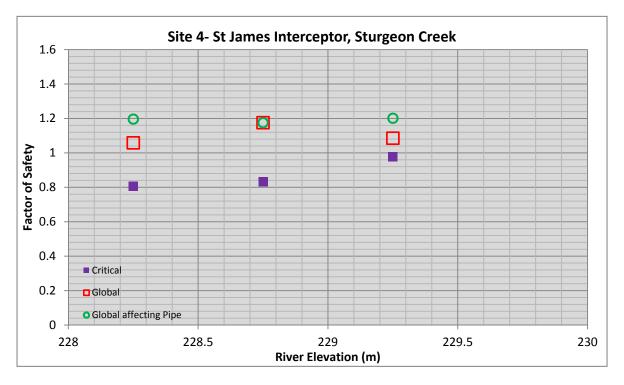
The calculated FS for selected slip surfaces (CS, GS, and GS+P) are presented in Figure 2 for the anticipated range of river water levels. The CS results indicate a case of imminent instability dependent upon the river water level, and is manifested by oversteepened river bank slopes. These CS's are primarily surficial slides which would be limited to shallow slough and can be addressed by undertaking grading works to introduce flatter slopes. The calculated FS for slip surfaces designated as GS and GS+P vary between 1.0 and 1.2. While the slope can be considered marginally stable, the presence of critical assets within the river bank call for improved river bank stability to attain acceptable FS.

Figure 2: Factor of Safety relating to the Current Condition of Site 4

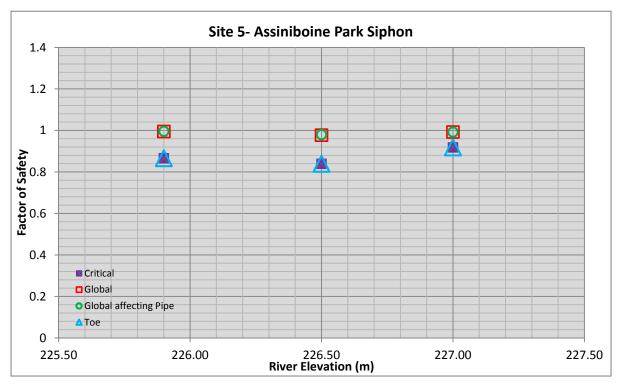
The presented graphical results indicate the trace of the GS and GS+P theoretical slip surfaces are likely to result in global instability that engage the pipe given the depth of the impacted mass. Retrogressive failure at the toe is also further likely to reduce the overall global stability of the riverbank, as potential failure surfaces migrate upslope.

Figure 4: Slope Stability Factor of Safety Relating to the Current Condition of Site 5

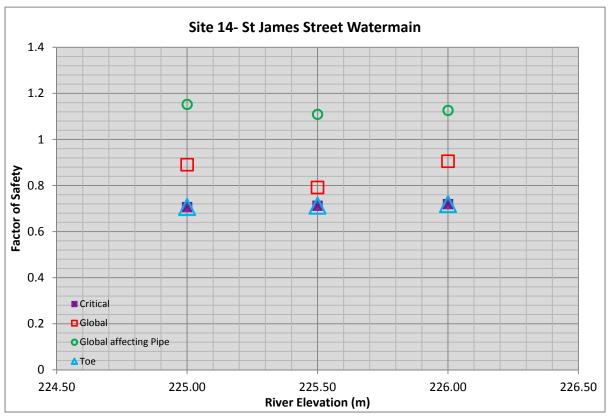
The calculated FS for the critical case and the toe case are equal, and have been calculated as less than 0.8. These failure surfaces are largely a result of the near vertical face at the toe of the riverbank. The FS for global instability has been calculated between 0.8 and 0.9, and the calculated FS for slip surfaces engaging the pipe has been calculated between 1.1 and 1.2. The results of the analysis are presented graphically in Figure 10.

Figure 10: Slope Stability Factor of Safety Relating to the Current Conditions of Site 14

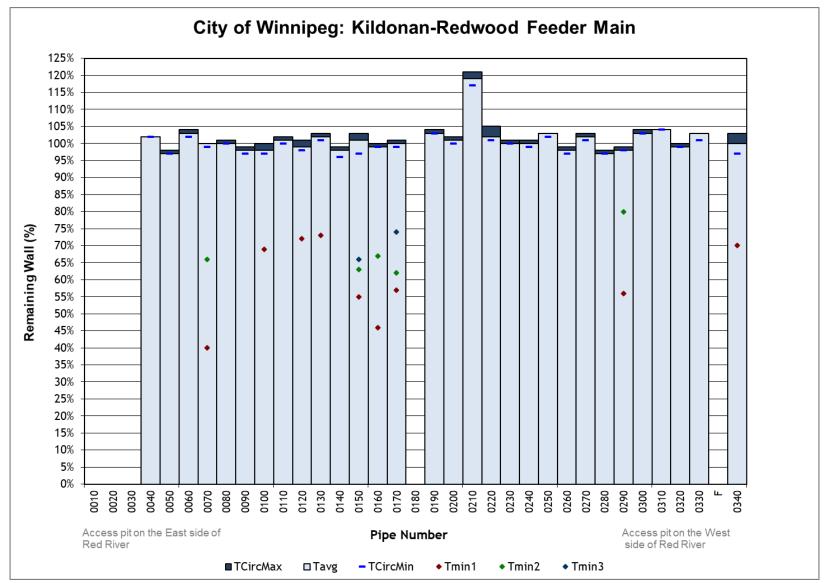
Figure 3. Condition assessment summary for the Kildonan-Redwood Feeder Main. Pipes less than 2.11 meters in length were not analyzed for pipe average remaining wall values. Pipe 0340 is the vertical pipe on the west side of the Red River and has a wall thickness of 12.7mm, differing from 7.9mm pipe wall thickness which was documented for the horizontal piping in drawing 12530. This pipe's Tavg is set to

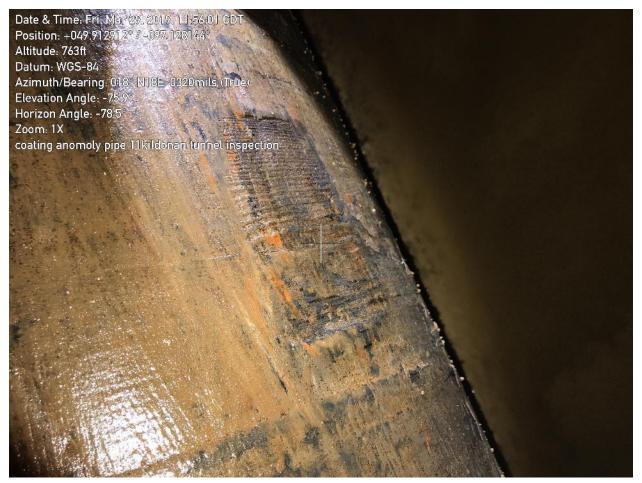
Figure 19. Coating anomaly observed at the 3 o'clock position on pipe 0300, at 13.8m from the center of the flange pair connecting the 90-degree elbow to the first horizontal pipe.

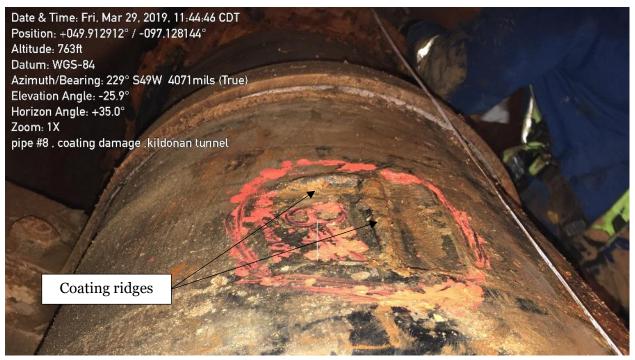
Figure 21. Coating anomaly observed on pipe 0270, at 26.4m from the 90-degree elbow flange.

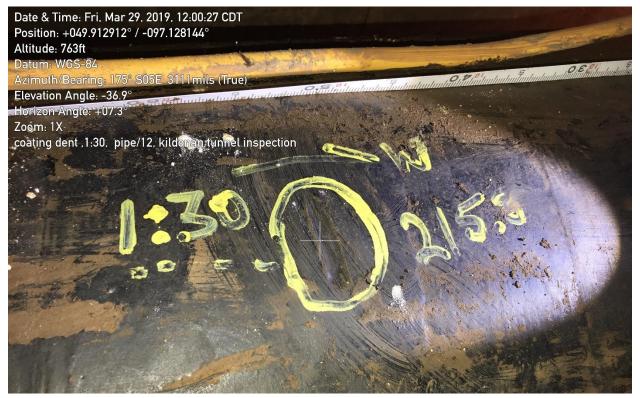
Figure 22. Divot observed in coating material at the 1:30 clock position on pipe 0310, 10.5m west from the 90-degree elbow.

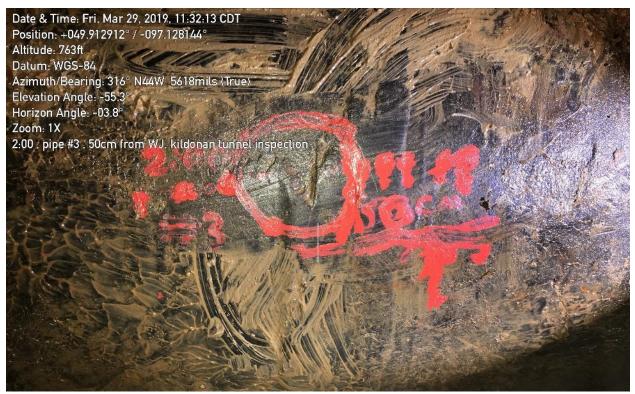
Figure 23. Coating loss at 2 o'clock position on pipe 0220, 47.33m from the 90-degree elbow flange.

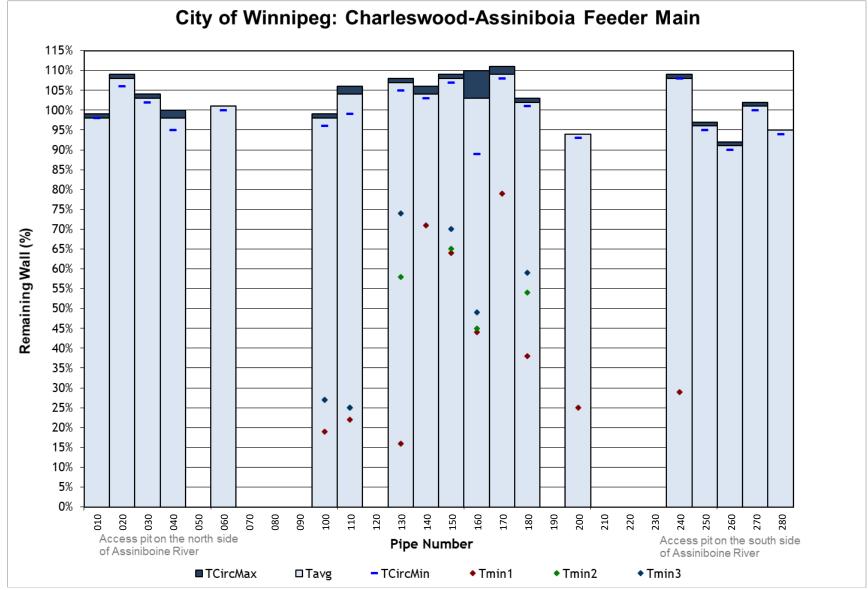
Figure 3. Condition assessment summary for the Charleswood-Assiniboia Feeder Main. Pipes less than 2.4 meters in length were not analyzed for pipe average remaining wall values.

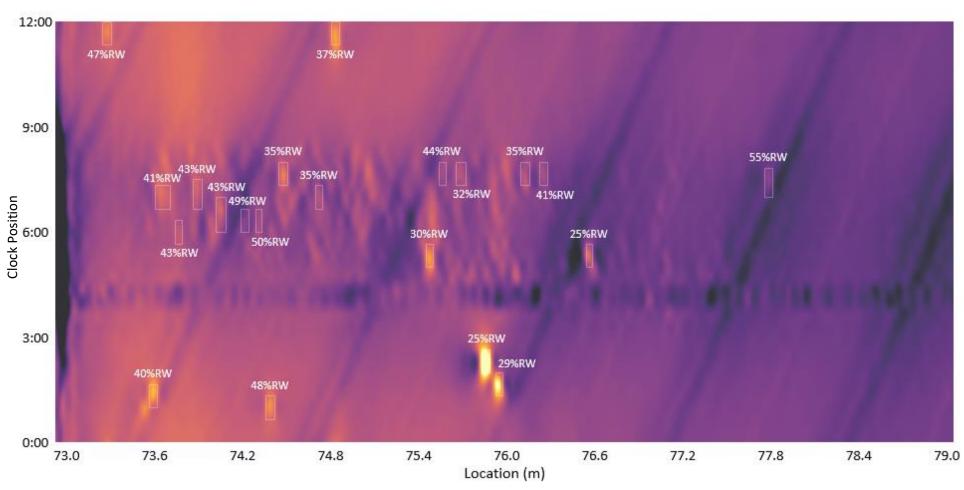
Figure 15. Pipe number 0110 colour map showing defect indication locations. A total of 23 indications have been reported in this pipe segment. Continued in Figure 16. Flange connection at start of pipe shown on left of colour map (72.95m).

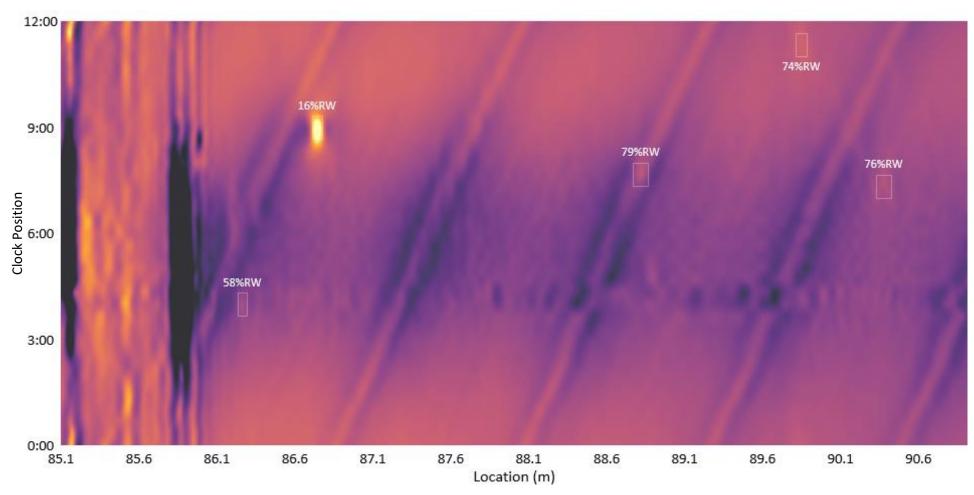
Figure 17. Pipe numbers 0120 (two piece mitered elbow extending from 85.15m to 85.86m) and 0130. A 6.6° pitch change was recorded at the elbow. Five defect indications were reported in pipe 0130, including a 16% RW indication at 86.75m from the ZRD.

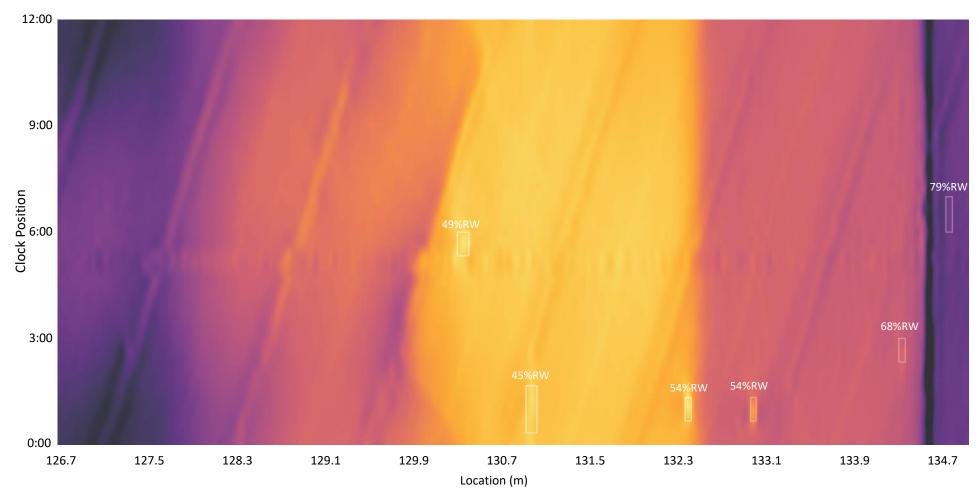
Figure 21. Colour map of pipe numbers 0160 and 0170. Seven defect indications were reported within pipe 0160, along with detected stress located from 129.82m to 134.60m corresponding to the location of an anchor block. The single reported indication within pipe number 0170 is shown past the flange connection at 134.6m.

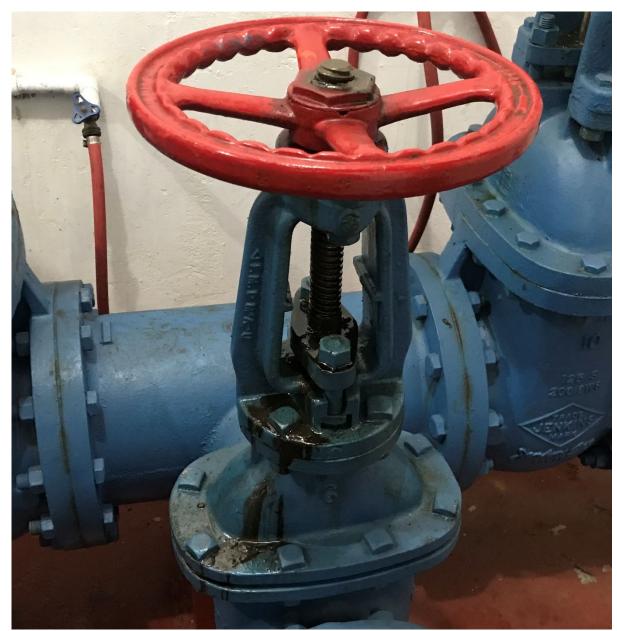
Photo 4 - Slight weeping/leaking detected around valve stems of the three valves indicated in Photo 3.
