RE: Alexander Dock - Inspection and Condition Assessment  
Budget Estimates for the Retrofit Concept and the Dock Demolition and  
Riverbank Stabilization Concept – Final

0	15/06/19	ISSUED FOR INFORMATION	RM
NO.	YY/MM/DD	DESCRIPTION	BY
REVISIONS / ISSUE			
		THE CITY OF WINNIPEG PLANNING AND PROPERTY DEVELOPMENT DEPT.	
ALEXANDER DOCK			
DOCK REHABILITATION AND DEMOLITION CONCEPT SKETCH			
JUNE 2015		FIGURE 2	REV: 0

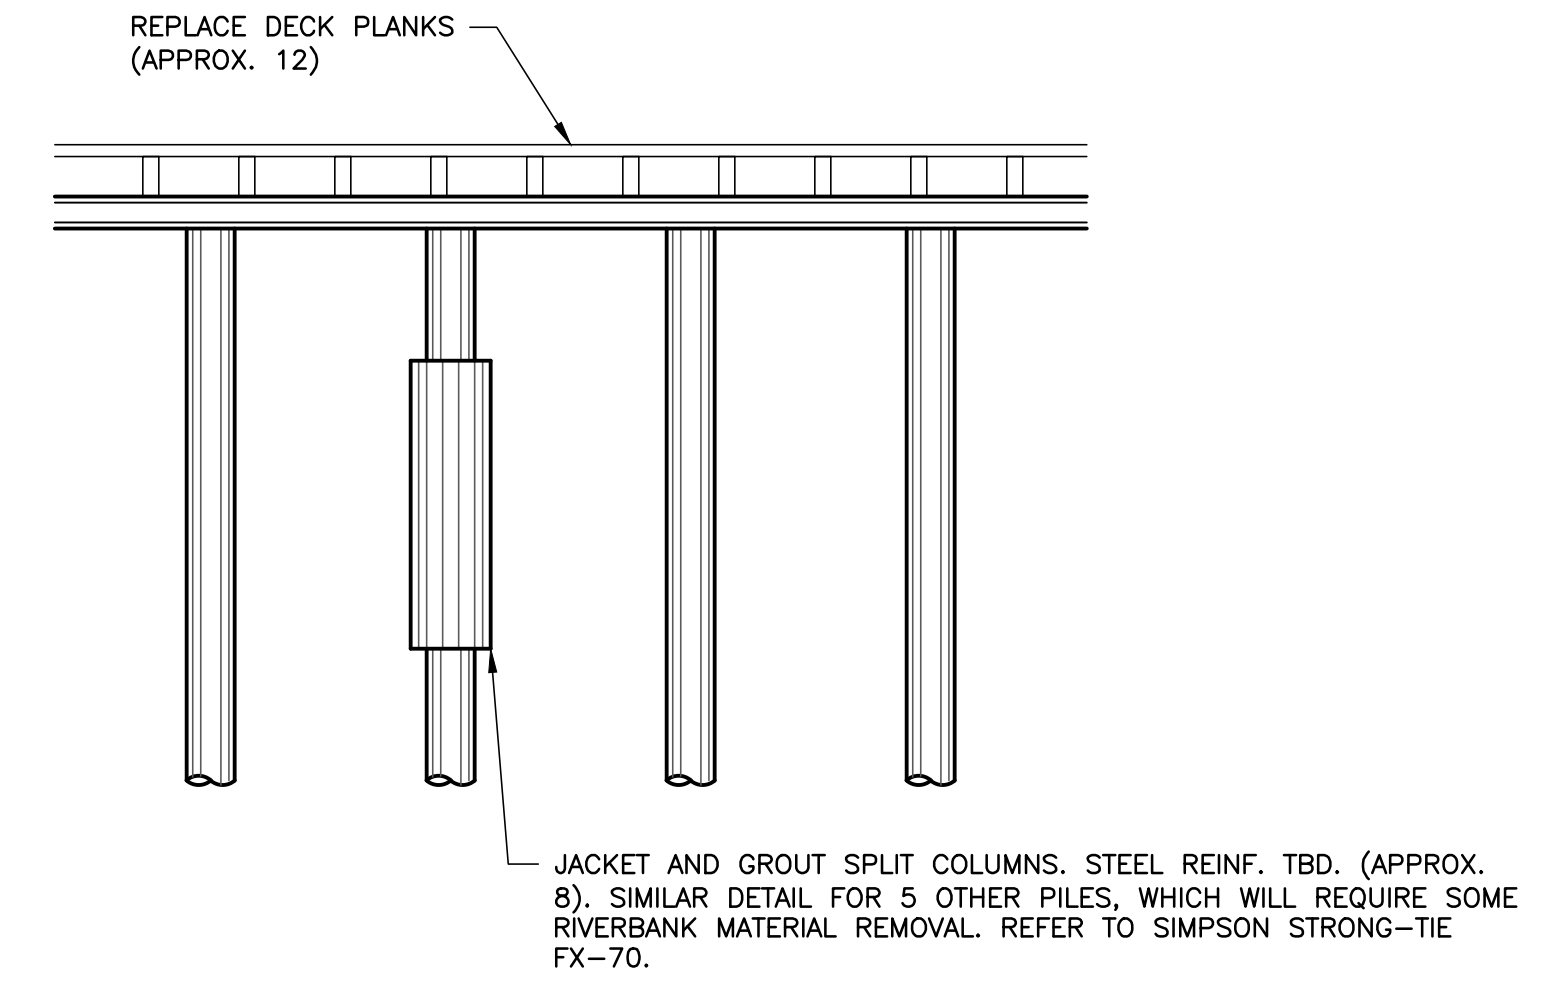
**3 ELEVATION – WITHOUT SKIRTING: SPLIT PILE REPAIR (APPROX. 13 LOCATIONS)**  
 SCALE: 1/4"=1'-0"

- Repair split piles with manufactured reinforcing jackets.
- Install timber pile bracing at select locations.
- Install pile beam seats at select locations.
- Replace damaged skirting.
- Replace damaged decking and stringers.
