GEOTECHNICAL REPORT

November 25, 2022

**Re: 2023 City of Winnipeg Local Street Renewal Program
Report of Geotechnical Investigation and Test Results**

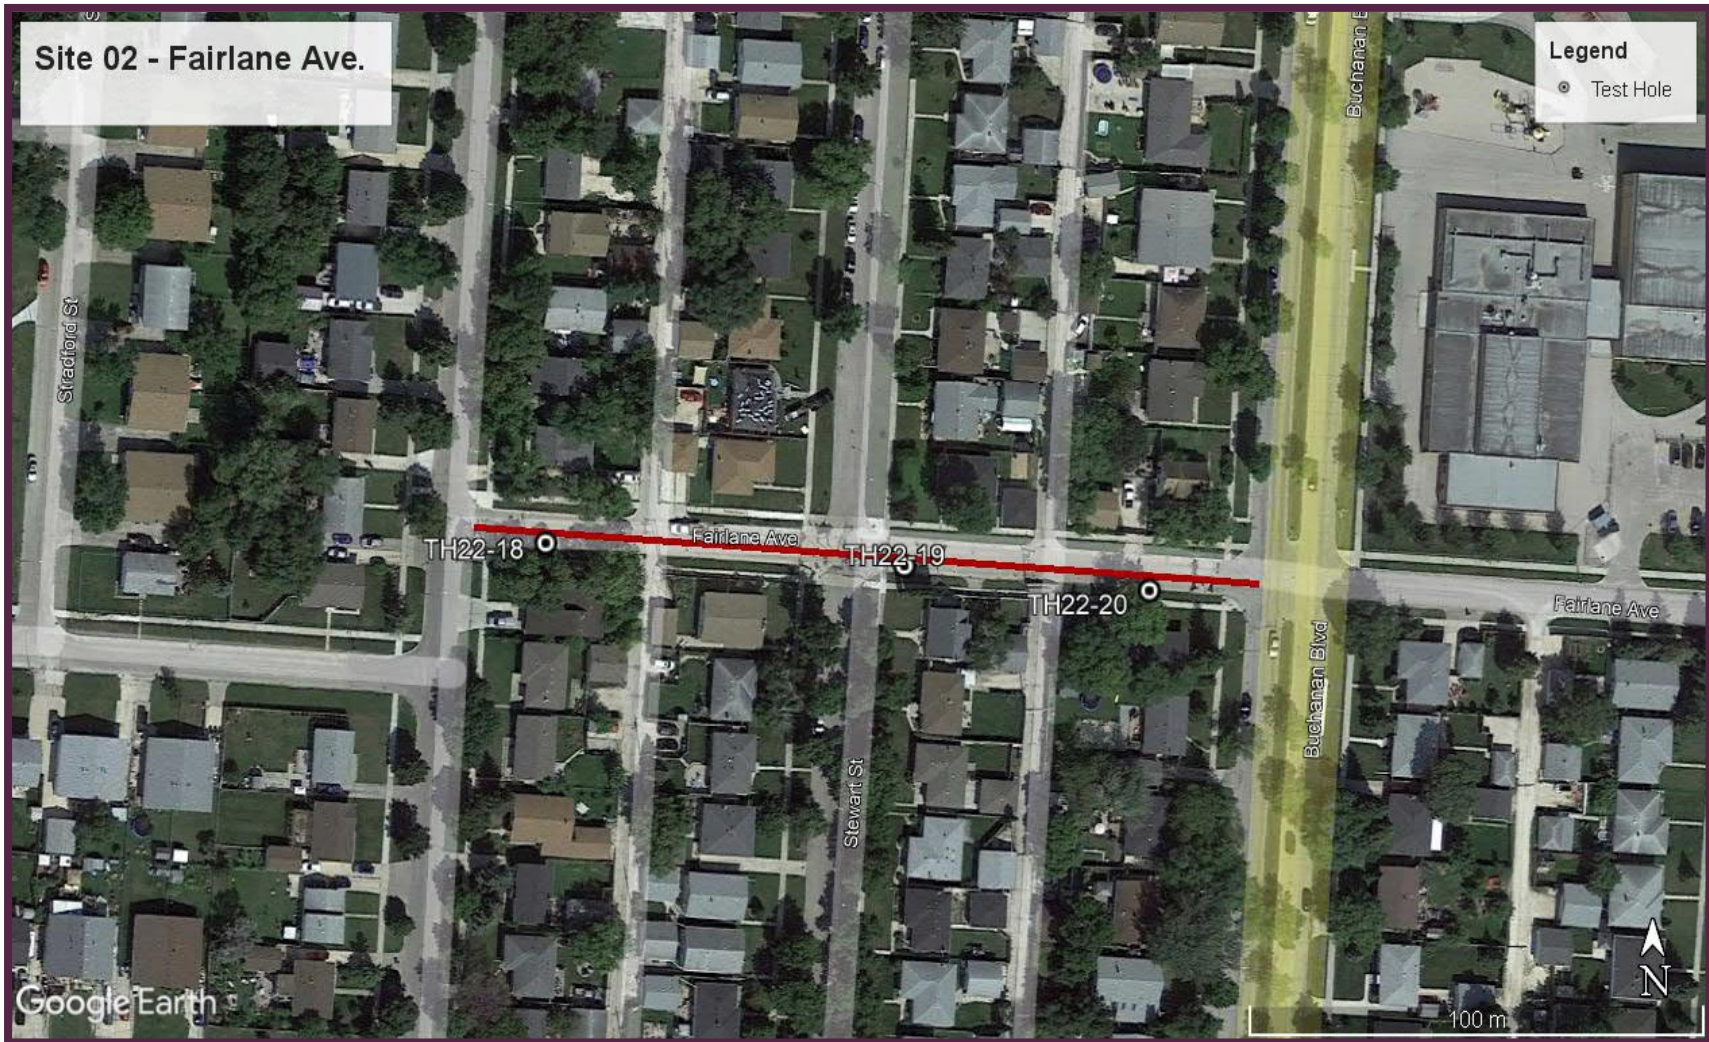
FIGURE 5: Test Hole Locations for Site 2 - Fairlane Avenue

Three (3) cores were completed along Fairlane Avenue; two (2) at joint locations (TH22-18 and TH22-20), and one (1) mid-slab (TH22-19). The pavement surfacing consisted of concrete material ranging in thickness from 152 to 159 mm (6 to 6.75 in). Base material consisted of limestone crush over granular and varied in thickness from 159 to 216 mm (6.25 to 8.5 in). Core locations are shown on Figure 5 attached.

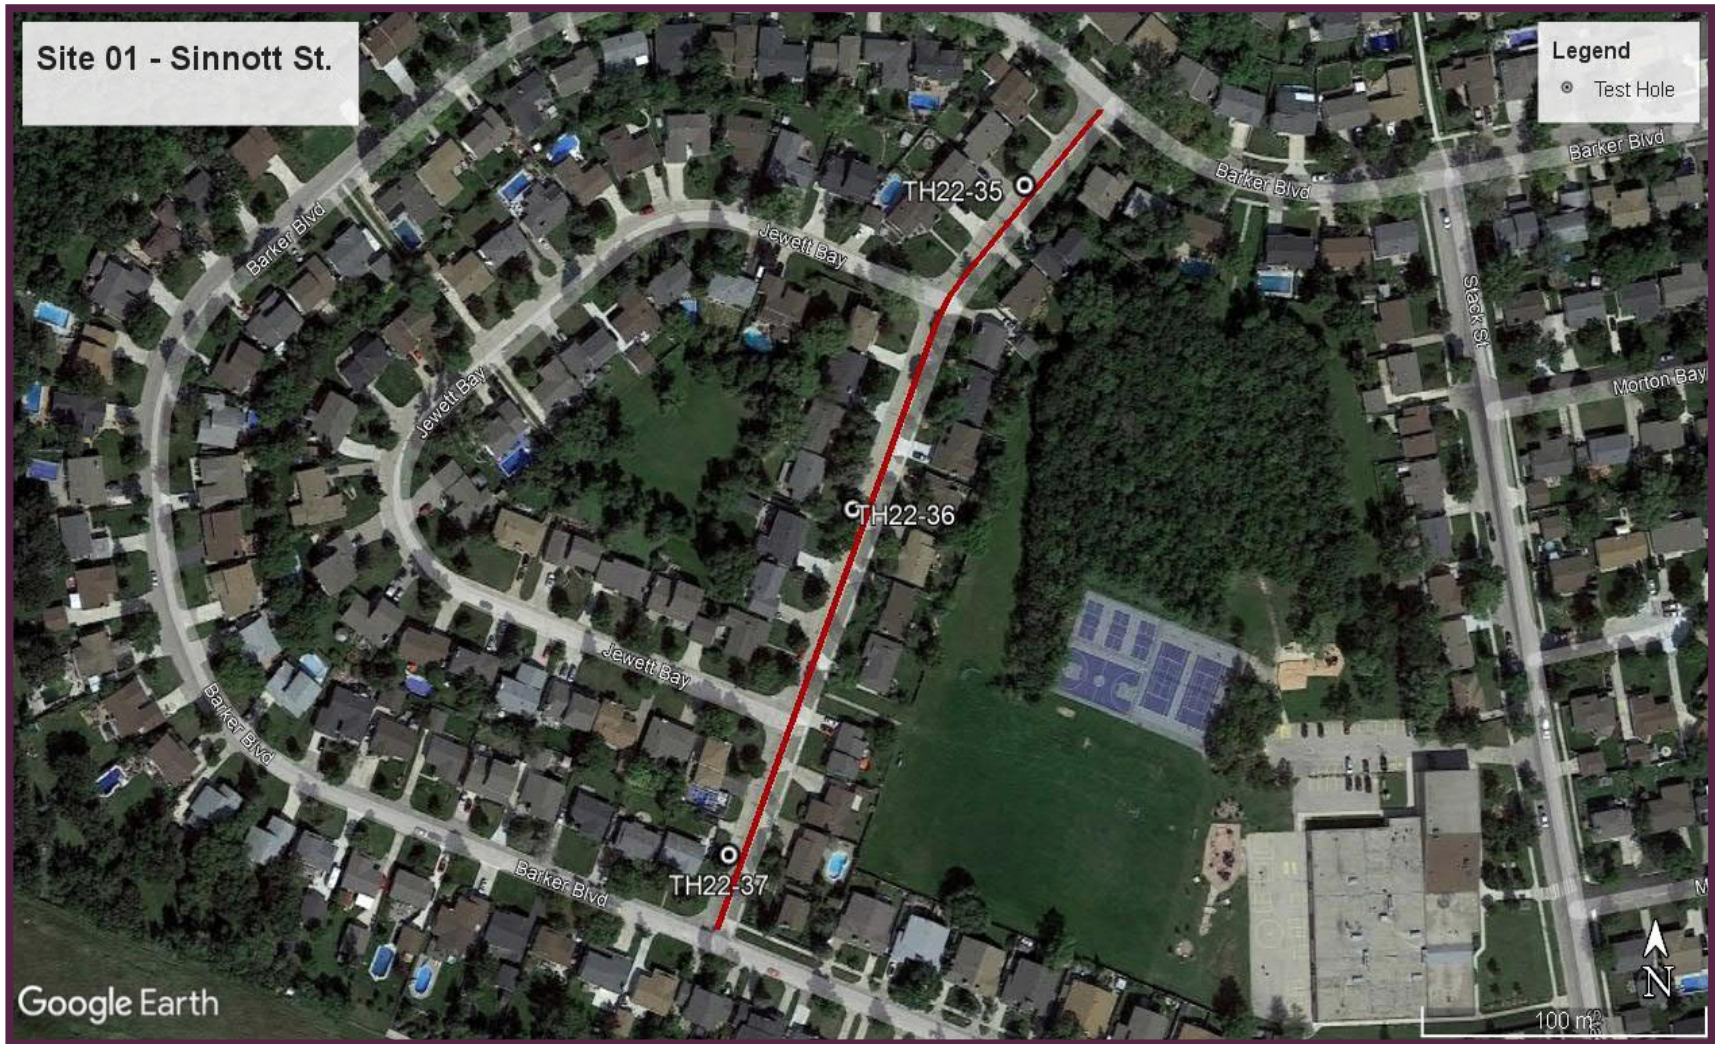
FIGURE 10: Test Hole Locations for Site 1 - Sinnott Street

Three (3) cores were completed along Sinnott Street; two (2) at joint locations (TH22-35 and TH22-37), and one (1) mid-slab (TH22-36). The pavement surfacing consisted concrete with a thickness from 178 to 191 mm (7 to 7.5 in). Granular base material 76 mm (3 in) in thickness was encountered directly below pavement in TH22-35 and TH22-36. Clay subgrade was encountered immediately below pavement in TH22-37. Core locations are shown on the attached Figure 10.

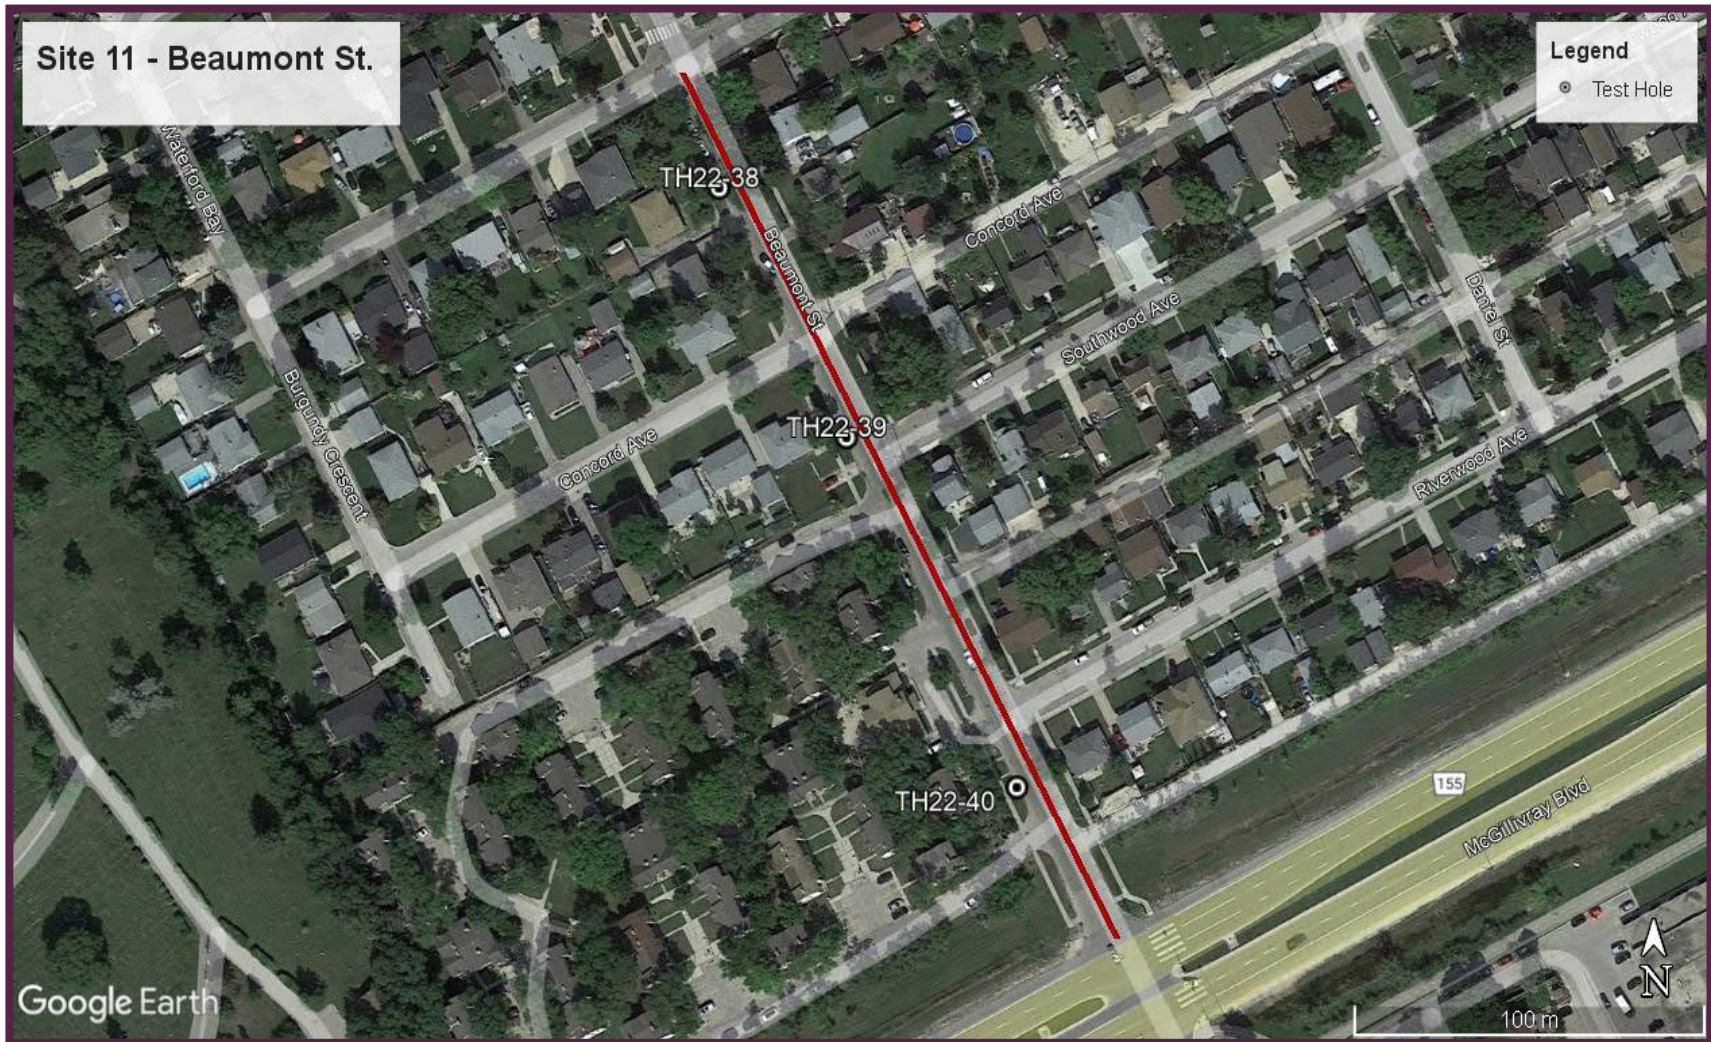
FIGURE 11: Test Hole Locations for Site 11 - Beaumont Street

Three (3) cores were completed along Beaumont Street at mid-slab locations (TH22-38 to TH22-40). The pavement surfacing consisted of asphalt material 114 to 241 mm (4.5 to 9.5 in) thick, with two (2) distinct pavement layers encountered at TH22-38. Base material ranged in thickness from 254 to 343 mm (10 to 13.5 in.) and consisted of granular over sand in TH22-38 and TH22-39, and granular in TH22-40. Core locations are shown in Figure 11 attached.
