CITY OF WINNIPEG

WASTEWATER LIFT STATION CONDITION ASSESSMENT PHASE II

Document IV: Windsor Park Lift Station Assessment

Date: March 16, 2020

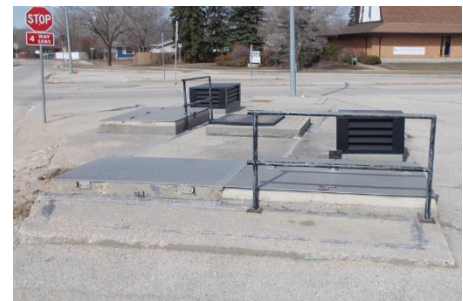
The access hatches to the lift station are protected primarily by guard rails. One (1) of the hatches is protected by bollards. Guardrails are not sufficient protection from vehicle damage. The hatches are properly locked. The lift station structure is considered secure.

There is no perimeter fencing around the generator building. The building does not have windows and is secure. Signage identifies the building as a City of Winnipeg facility, but does not provide emergency contact information.

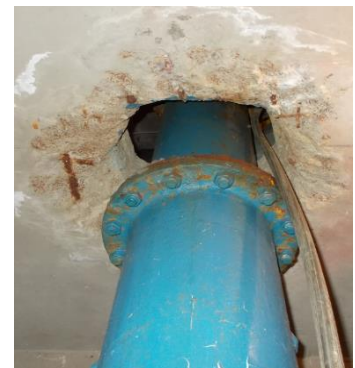
The Windsor Park Lift Station foundation consists of a cast-in-place concrete wet well/dry well configuration. The base is approximately 10.5m below grade. The concrete base slab shows signs of cracking and deterioration but remains in sound condition with no structural concerns. The sump pit is functional though pooling was noted nearby. The generator building base slab is in “Good” condition with minor surface cracking.

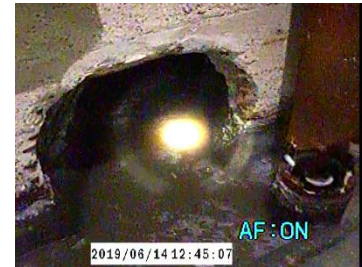
The wet well concrete surface appears to be in “Fair” to “Poor” condition. The drawings provided by the city indicate that the original 1955 structure did not include the 1.5 meter inlet pipe / storage chamber that is currently connected to the west side of the wet well. It was noted during the wet well inspection that the inlet looks to have been poorly cut or hammered when this connection was installed. The concrete around this inlet is in “Poor” condition. The storm pump was also installed after original construction. The storm pump is heavily corroded and no longer usable. The wet well has no ventilation system and the environment is very corrosive. The ladder in one side of the wet well has corroded through its supports and fallen into the wet well. It appears as though a metal rack has also fallen in. One of the wet well inlet gates appears to be seized closed.

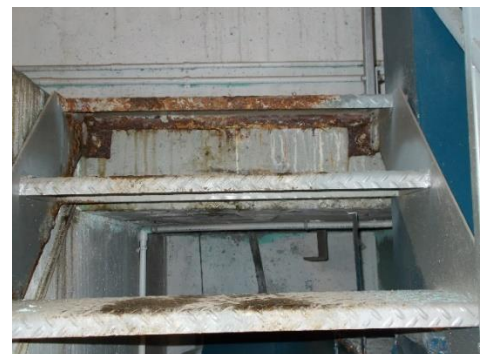
There are numerous Code compliance and safety issues with the ladders, stairs, and rails in the lift station. These can be found in greater detail in **Appendix A**. The stair and ladder systems are extensively corroded and are not considered safe for use. Rails around floor openings do not have swing gates and are not Code compliant. The surface-level entrance hatches are in “Good” condition; however, the main entrance hatch it is not Code compliant. A small metal catwalk that extends into the valve room has begun to corrode. The valve room is considered an unsafe work area.

The wet well access (slide gate operation) chamber is in “Poor” condition. There are signs of heavy corrosion on the metal components. The hatches are square and lids are susceptible to falling through the opening. One of the hatch lids is plywood. The ladder extending down into the wet well is not fit for use.

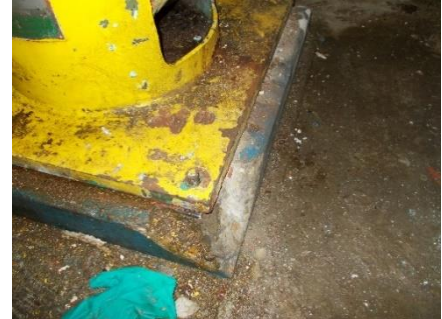
The paint on the floor surfaces has worn off on all levels. The wall and ceiling finishes have exceeded their service life. An epoxy coating on the floor would be ideal for durability, but will require additional prep work in the lower pump room due to the age of the concrete and the surface deterioration. Walls can be surfaced with a latex or suitable acrylic-latex paint to improve aesthetics and protect the surfaces.

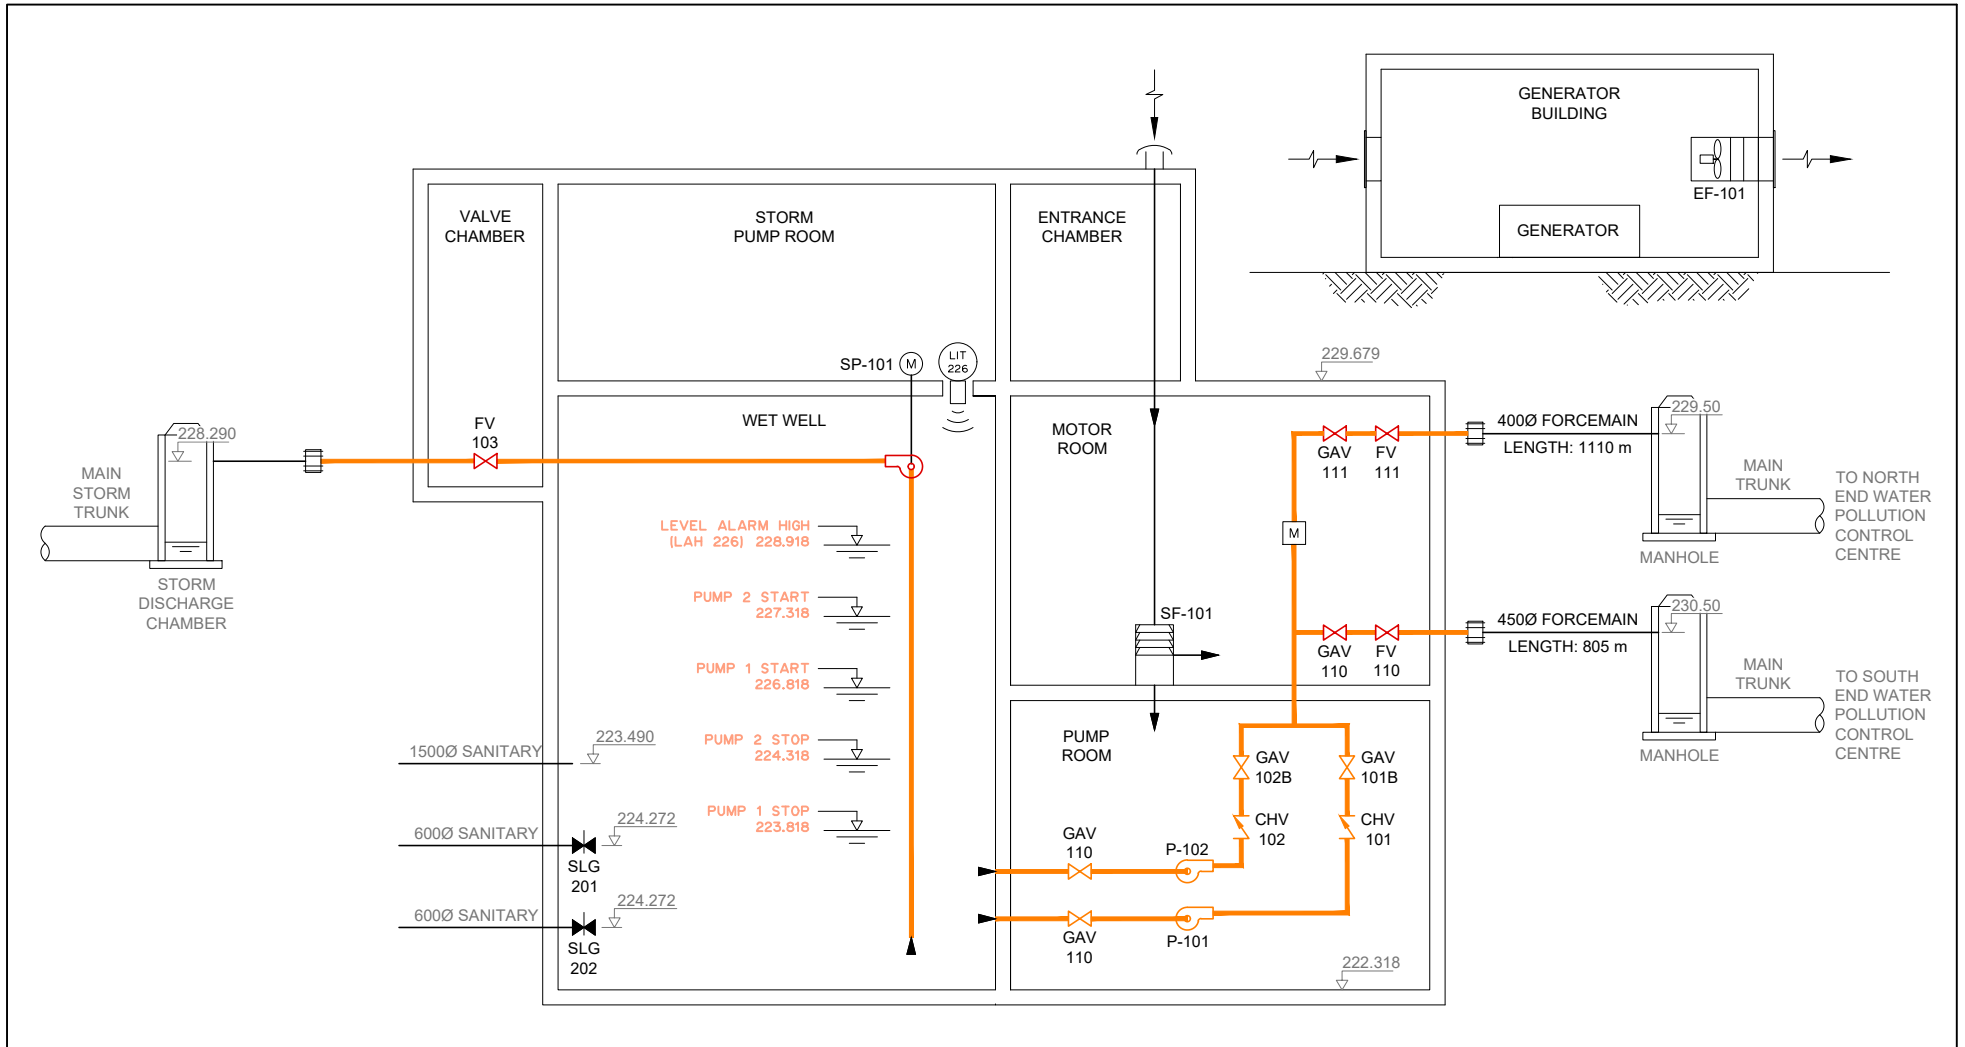
LIFT STATION ASSESSMENTS 2018-2019
 WINDSOR PARK
 CONDITION ASSESSMENT SUMMARY

Figure 7.1 provides a graphical summary of the condition assessment of the mechanical components of the Windsor Park Lift Station.
