# ASBESTOS INVENTORY CONTROL

<b>Building Name:</b>	Seven Oaks Indoor Pool & Bldg	<b>Inspection Date:</b>	December 7, 2022
<b>Building Code:</b>	PI-01	<b>Inspected By:</b>	A Brodbeck & N Richardson
<b>Building Address:</b>	444 Adsum Drive	<b>Construction Date:</b>	1977

# PI-01

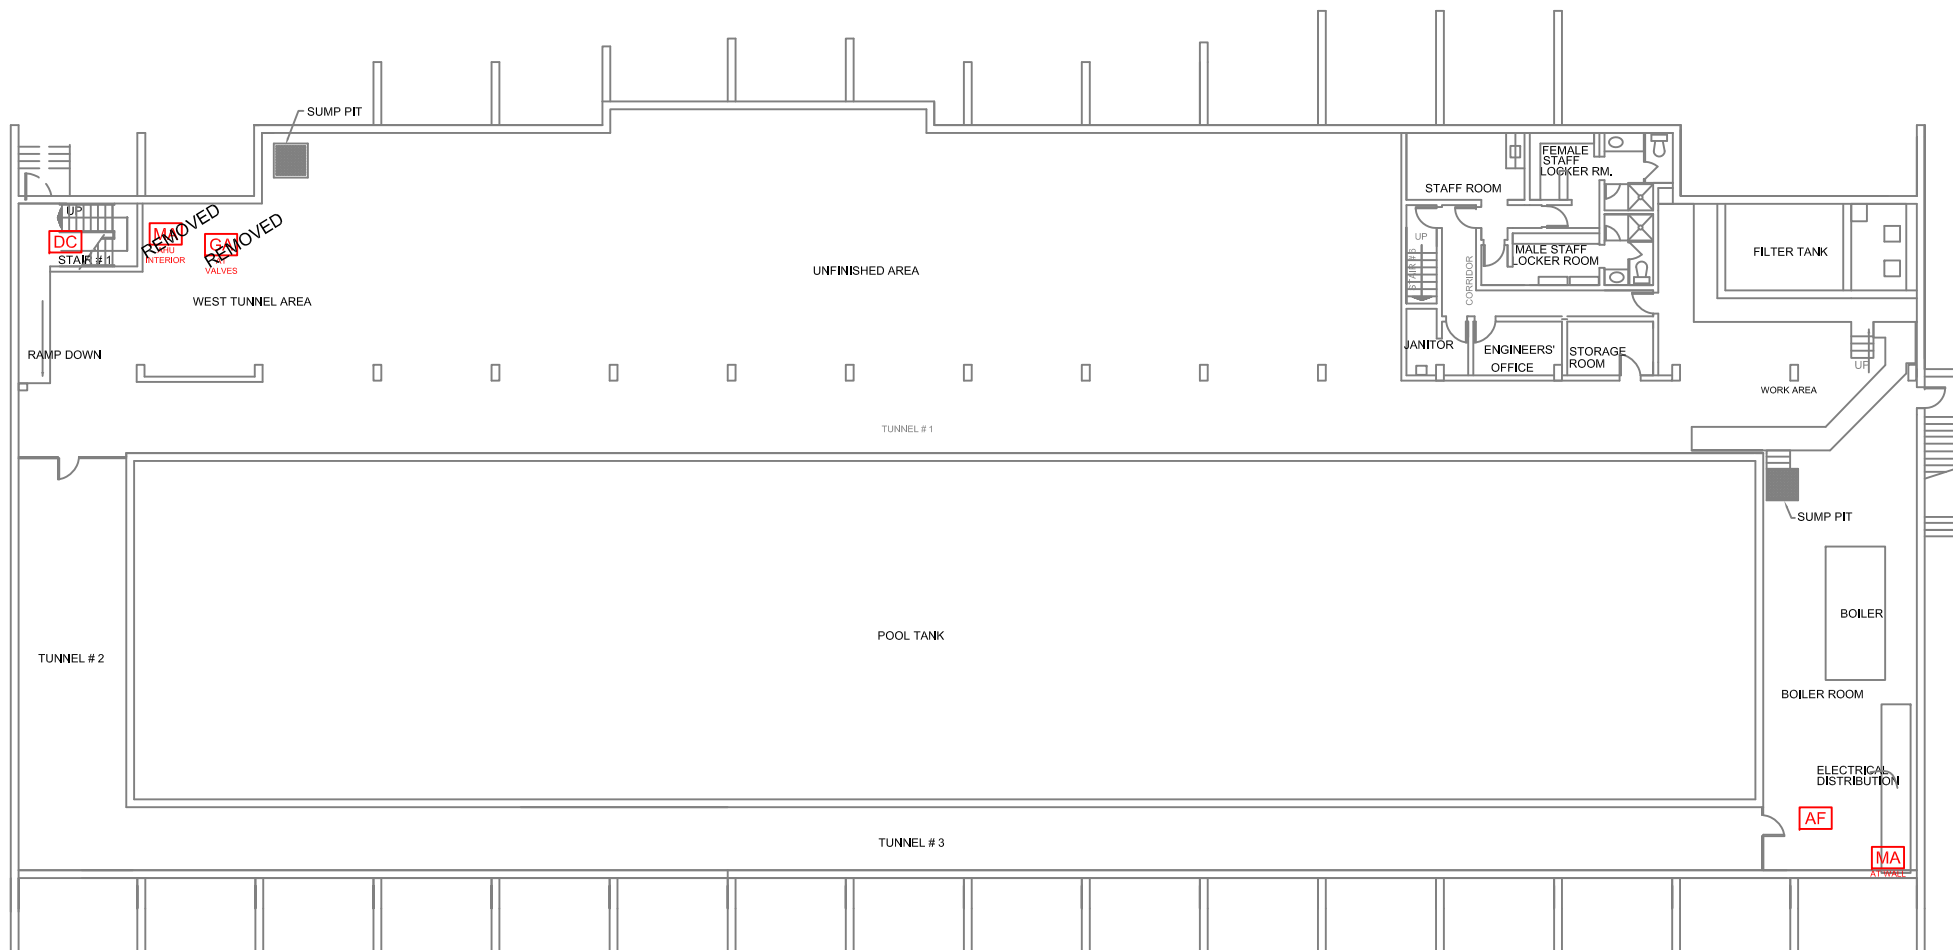
## BASEMENT

DRYWALL COMPOUND THROUGHOUT CONTAINS ASBESTOS
