# Limited Pre-Renovation Hazardous Building Materials Assessment

Seven Oaks Pool, 444 Adsum Drive, Winnipeg, Manitoba

CA0052164.7984

May 8, 2025

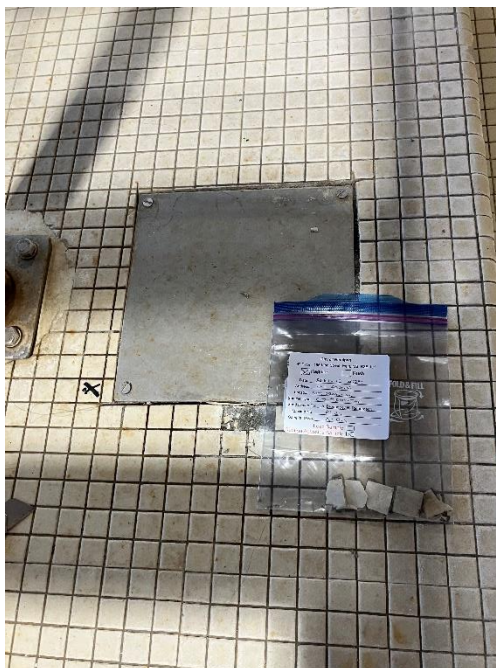
**Photograph 1: Sample Group A-01 - Example of Ceramic Tile, Grout and Mortar, Asbestos Not Detected**

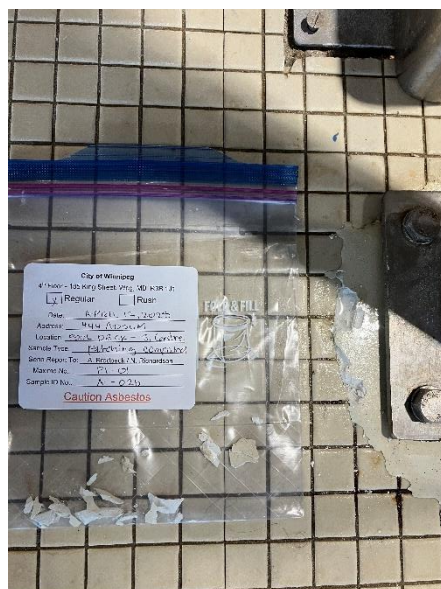
**Photograph 2: Sample Group A-02 – Example of Patch Compound, Asbestos Not Detected**

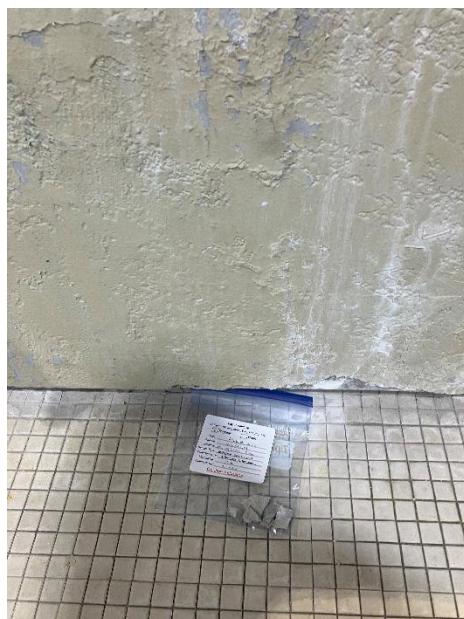
**Photograph 3: Sample Group A-03 – Example of Skim Coat, Asbestos Not Detected**

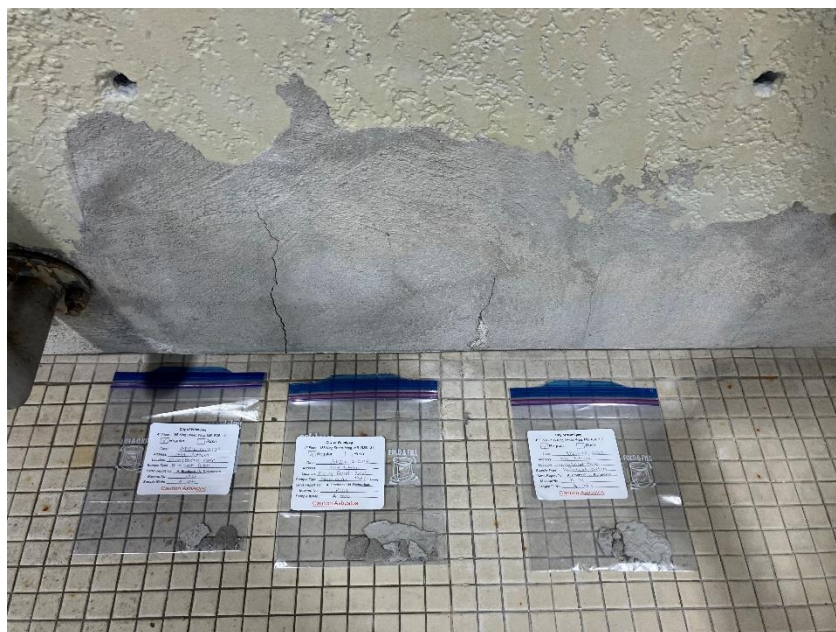
**Photograph 4: Sample Group A-04 – Example of Skim Coat Patch, Asbestos Not Detected**

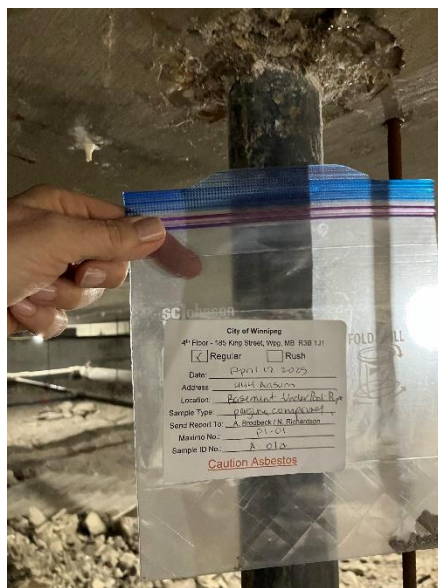
Photograph 7: Sample Group A-07 – Example of Parging, Asbestos Not Detected

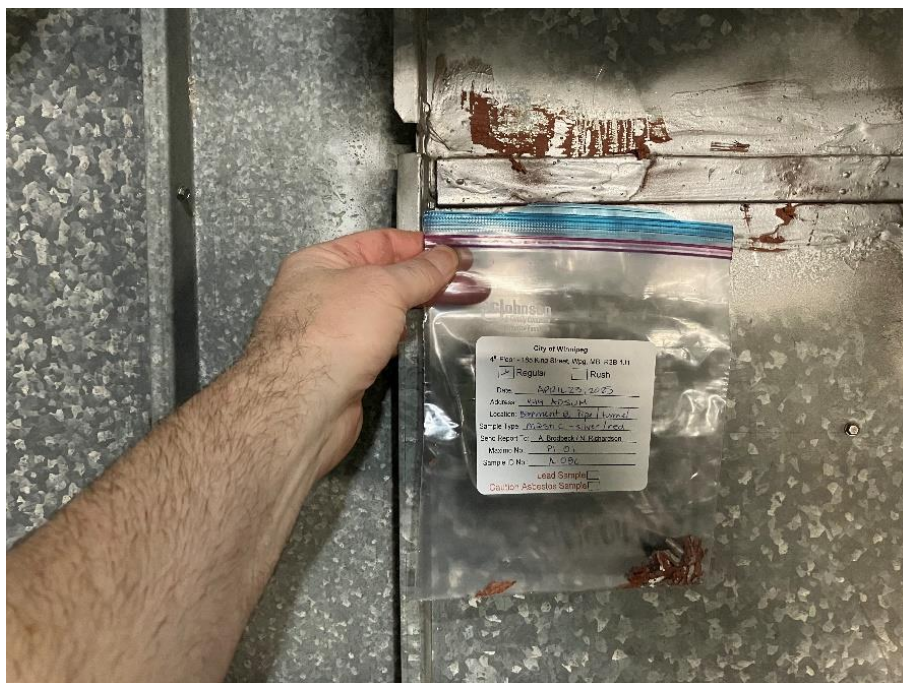
All three mastic samples collected from the HVAC unit in the basement, at the pipe tunnel area were found to contain 5% to 7% chrysotile asbestos.

Photograph 8: Sample Group A-08 – Asbestos-Containing Mastic (Red/Silver) on HVAC

Prior to renovation or demolition, ACMs that will be directly impacted must be removed and disposed of following provincial regulations. Asbestos removal work shall be completed by trained and competent workers as required by Manitoba Safety and Health. Throughout the asbestos abatement activities, appropriate air monitoring and site assessments shall be conducted to assess and document that contamination is contained, and that ACM are removed and disposed of appropriately. When practical, multiple ACMs can be removed within the same containment (provided they do not have other hazardous materials) following the most stringent asbestos removal procedures for the materials scheduled for removal. Asbestos waste must be packaged, transported and disposed of in accordance with provincial and federal requirements.

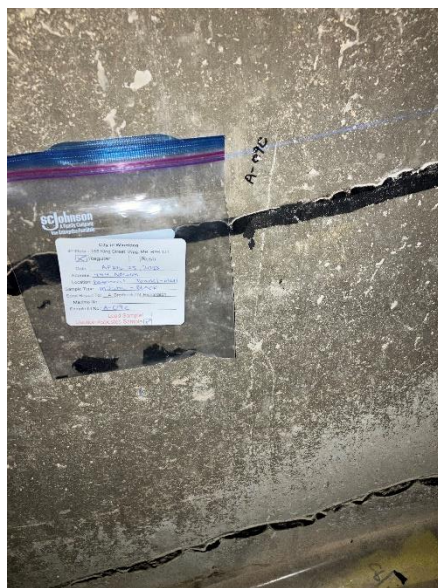
**Photograph 9: Sample Group A-09 – Example of Black Mastic on Basement Tunnel Wall, Asbestos Not Detected**

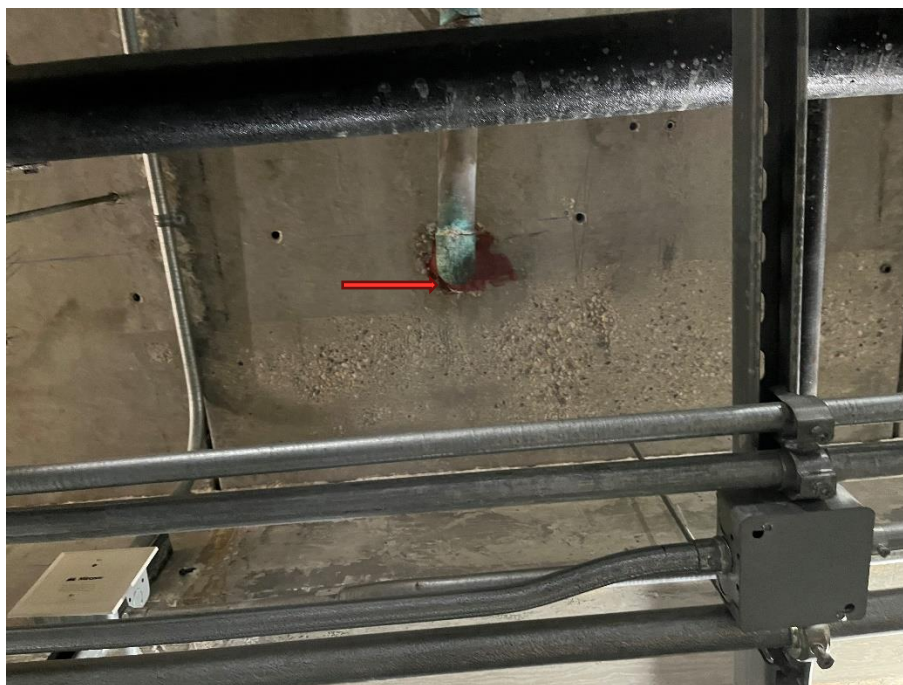
Suspect red fire stopping was observed at pipe penetrations during the site walkthrough. If this material will be impacted by the planned renovations, WSP recommends collecting a minimum of three samples and submitting for asbestos analysis. In the absence of sample results, the red fire stopping should be treated as asbestos containing.

**Photograph 10: Example of Red Fire Stopping at Pipe Penetrations, Presumed to Contain Asbestos**

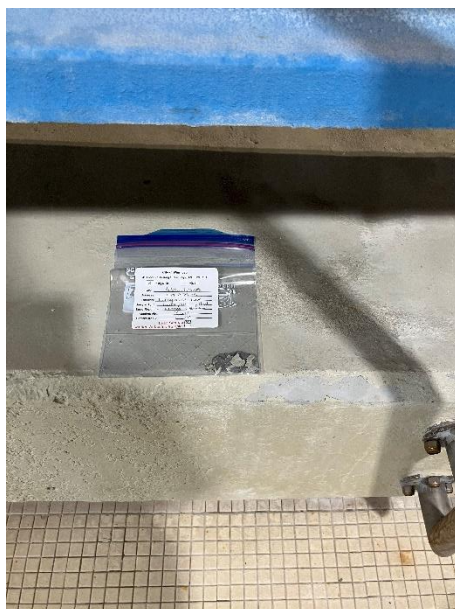
**Photograph 11: Sample L-01 – Yellow Paint on Concrete Base, Not Considered Lead Containing**

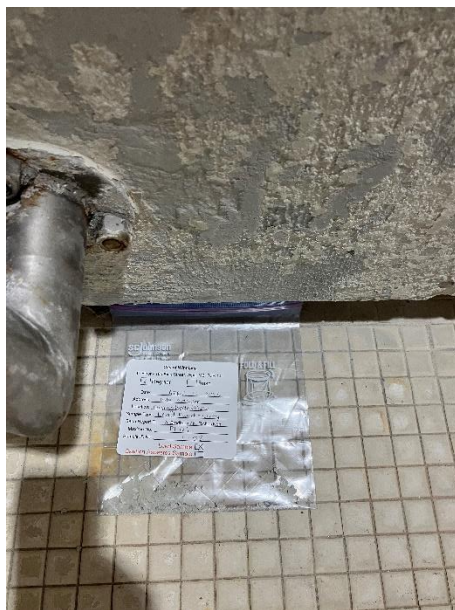
**Photograph 12: Sample L-02 – Grey Paint on Concrete Base, Not Considered Lead Containing**

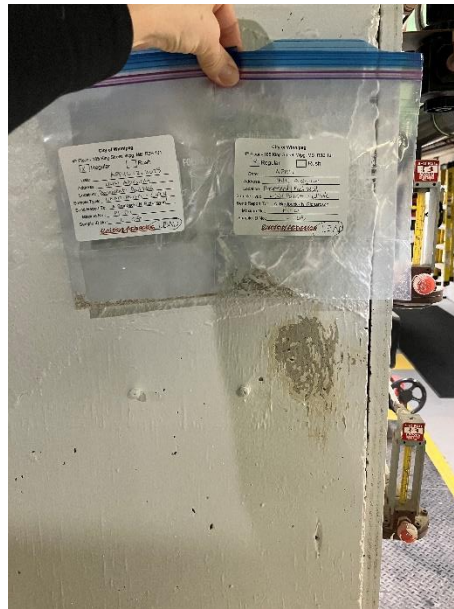
**Photograph 13: Samples L-03 and L-04 – White and Grey Paint on Wood, Not Considered Lead Containing**

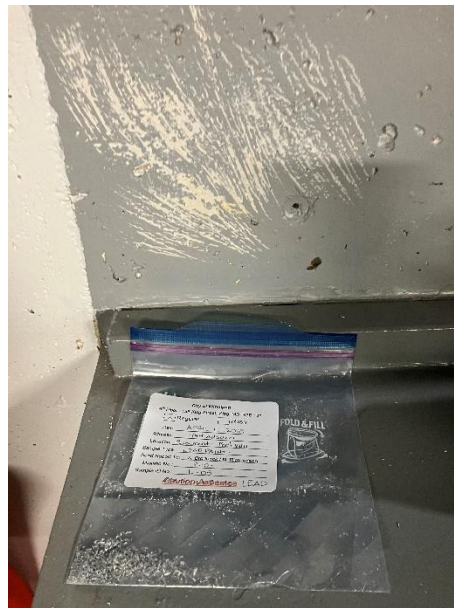
**Photograph 14: Sample L-05 –Grey Paint on Concrete, Not Considered Lead Containing**

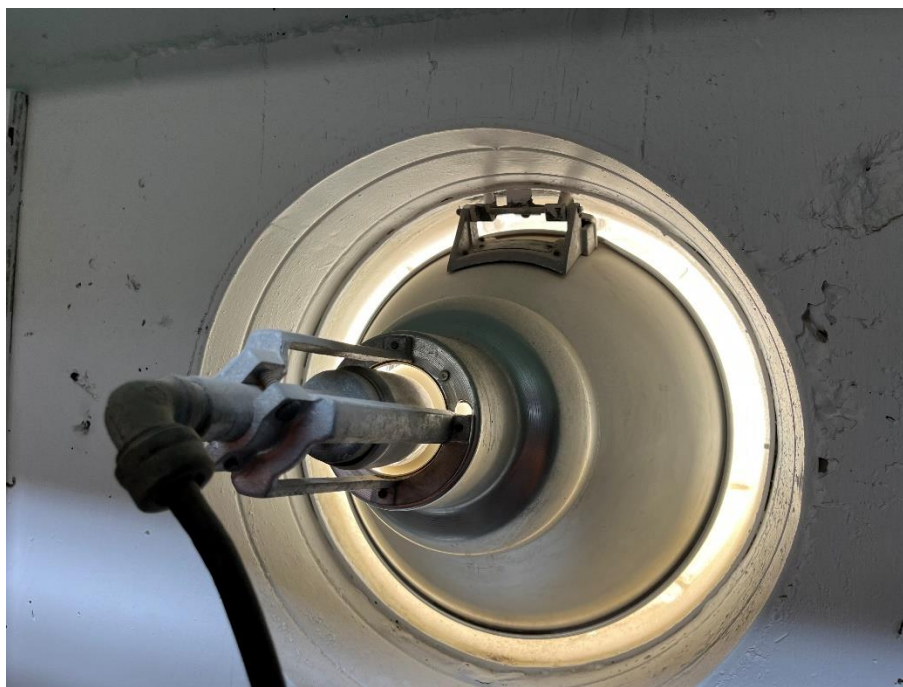
Lighting within the pool could not be assessed but there is a potential that the bulbs contain mercury. Further assessment should be completed once the pool has been closed and emptied.

**Photograph 15: Light Fixture in Pool with Suspect Mercury-Containing Bulb**

If encountered and expected to be impacted by the planned renovations, mercury-vapour in bulbs and mercury-containing thermostat capsules pose a risk to workers when the light bulbs are broken and disturbed. Safe work procedures should be followed when handling suspect mercury-containing fixtures and thermostat capsules and they should be kept separate from all other waste. Mercury-containing fixtures and capsules must be identified, packaged and appropriately labelled, manifested and transported to an approved disposal facility in accordance with regulations specified by Environment Canada.
