## **Hazardous Building Materials Assessment (Pre-construction)**

Conway Lift Station  
2200 Portage Avenue,  
Winnipeg, Manitoba

July 27, 2023

Pinchin File: 326866

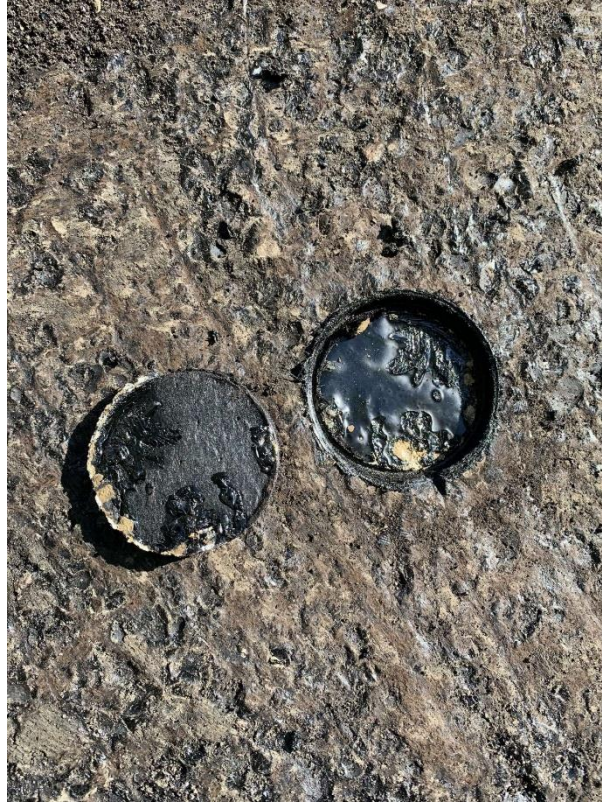
The materials associated with the Built-up roofing do not contain asbestos (samples S0001A-C).

S0001A (None), Roofing material, Roof (Location #: 7)

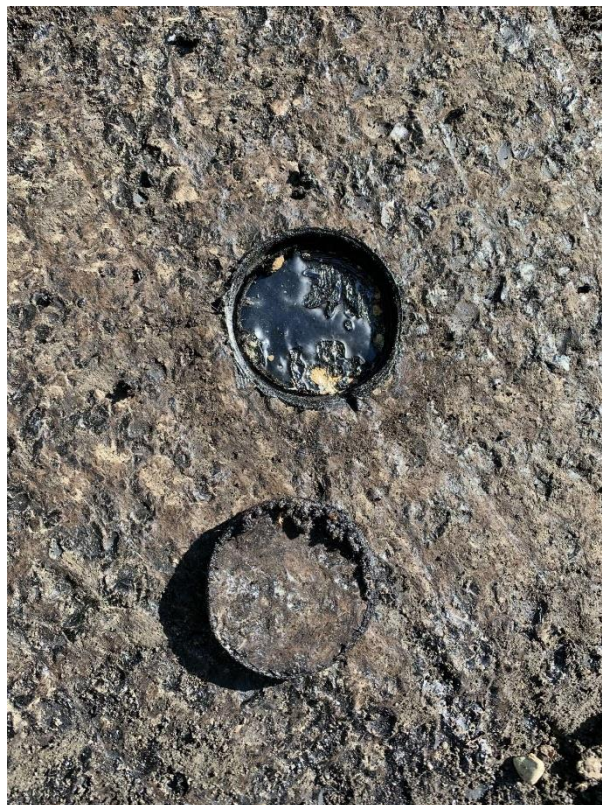
S0001B (None), Roofing material, Roof (Location #: 7)

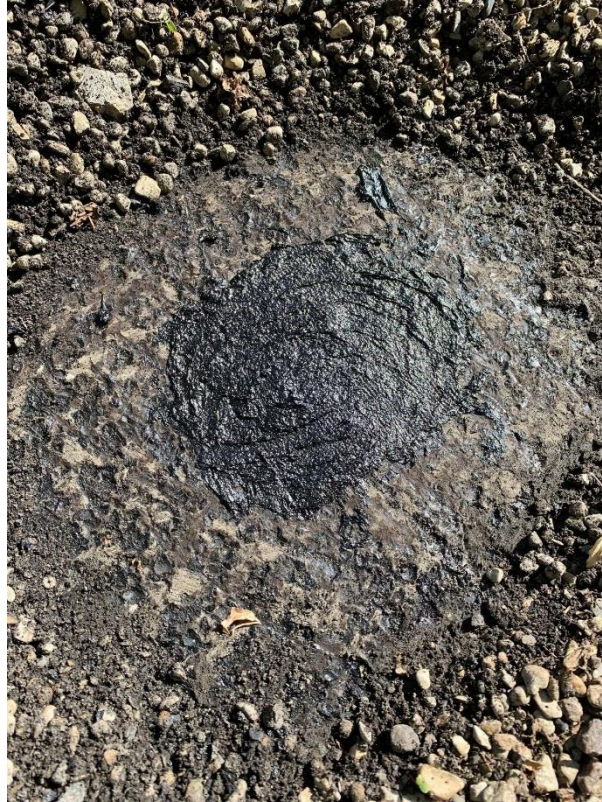
S0001C (None), Roofing material, Roof (Location #: 7)

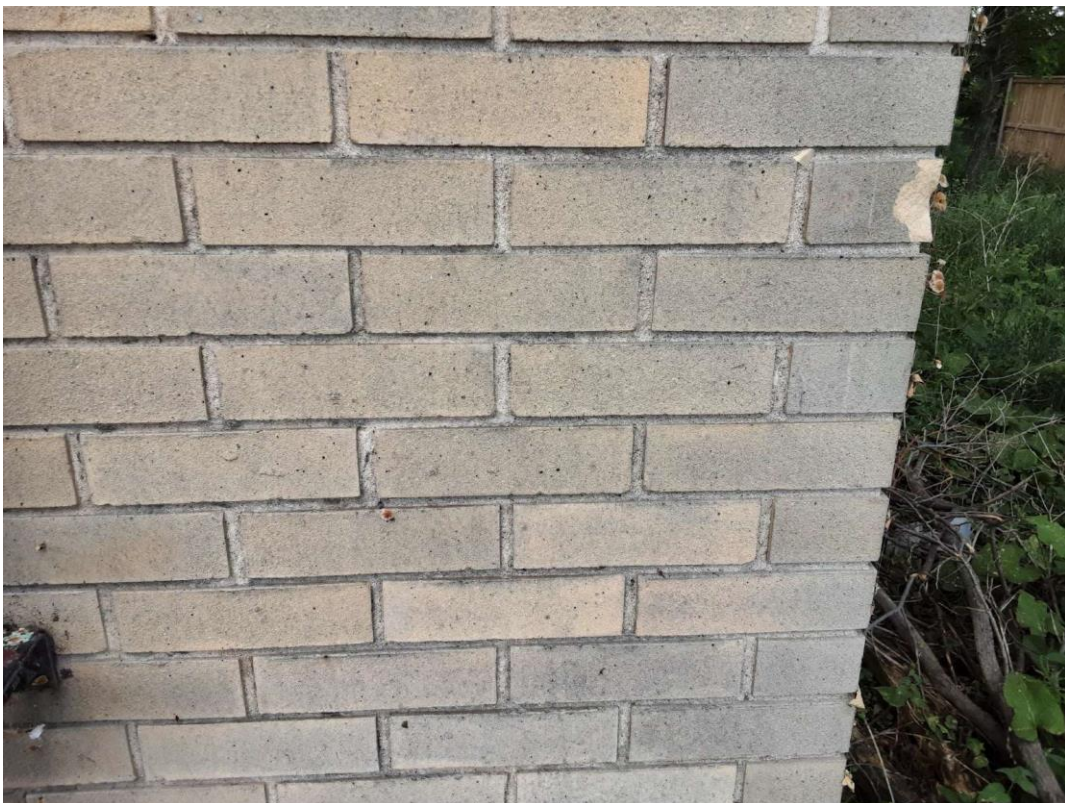
Plaster was reportedly formed and painted to look like bricks on the Exterior of the Control Room (Location 6). Three samples were collected and asbestos was not detected in the samples (samples S0002A-C).

S0002A (None), Wall, All, Plaster, Exterior of Building (Location #: 6)

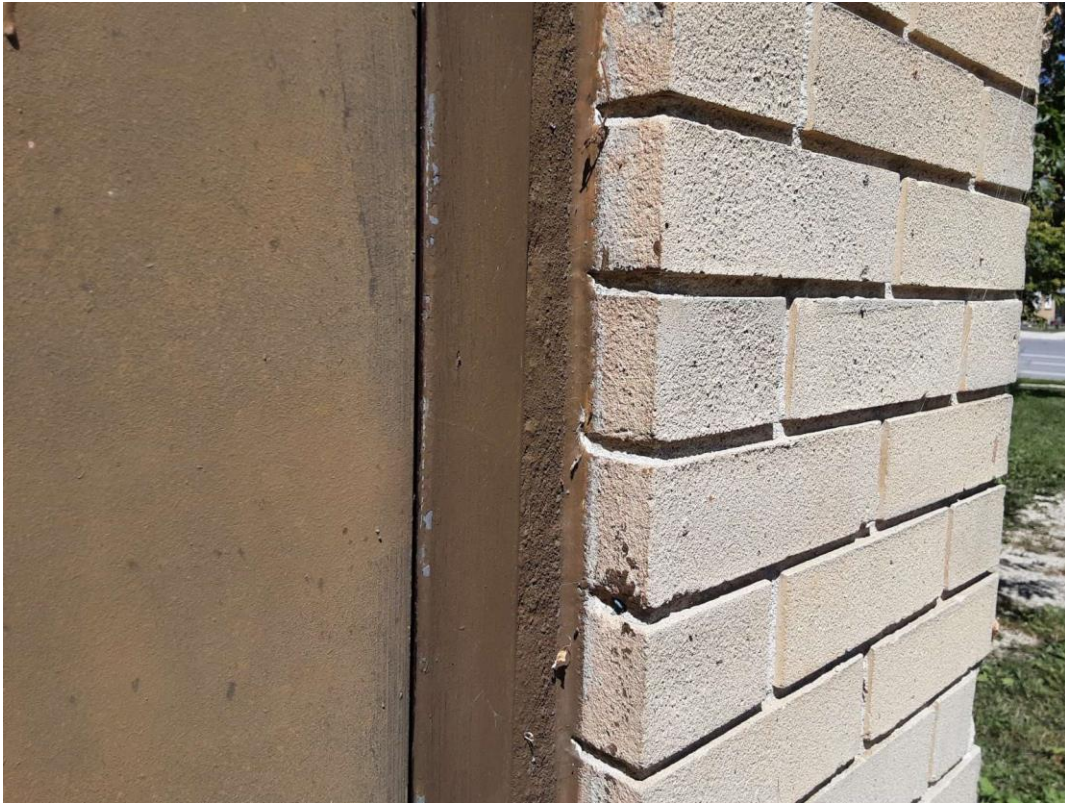
White caulking at exterior door and window frames, expansion joints, does not contain asbestos (samples S0003A-C).

S0003A (None), Other, Caulking, Exterior of Building (Location #: 6)

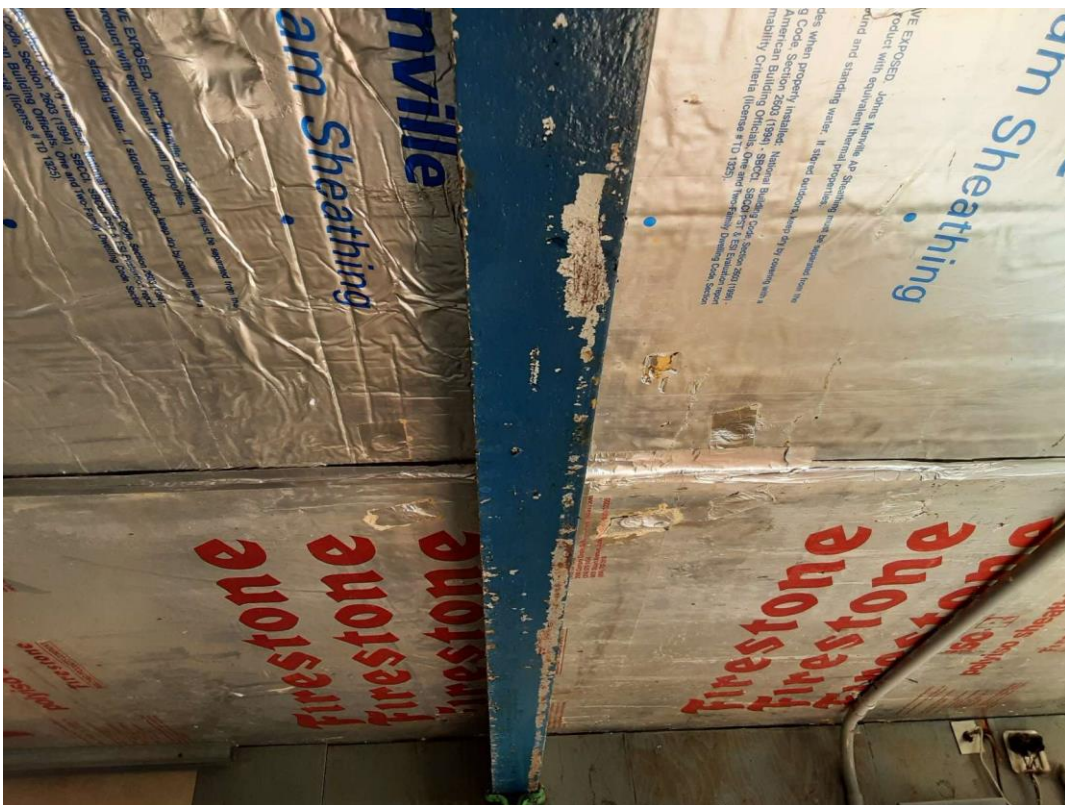
Metal, Blue over silver, L0003(Lead-containing), Control Room (Location #: 1)

Material, Quantity & Condition	Location	Recommended Procedure
Blue over silver paint on structural steel beam, Flaking, 13 SF	Control Room (Loc. 1)	Remove flaking paint in a non-aggressive manner with standard dust control measures in conjunction with Class 1 lead abatement procedures (as per EACC Lead Guidelines)
Red on concrete floor, Flaking, mostly gone, ~510 SF	Control Room, Comminuter Room, Motor Room (Locs. 1,2,4)	
Brown over grey on metal door and windows, Flaking, 8 SF	Exterior (Loc. 6)

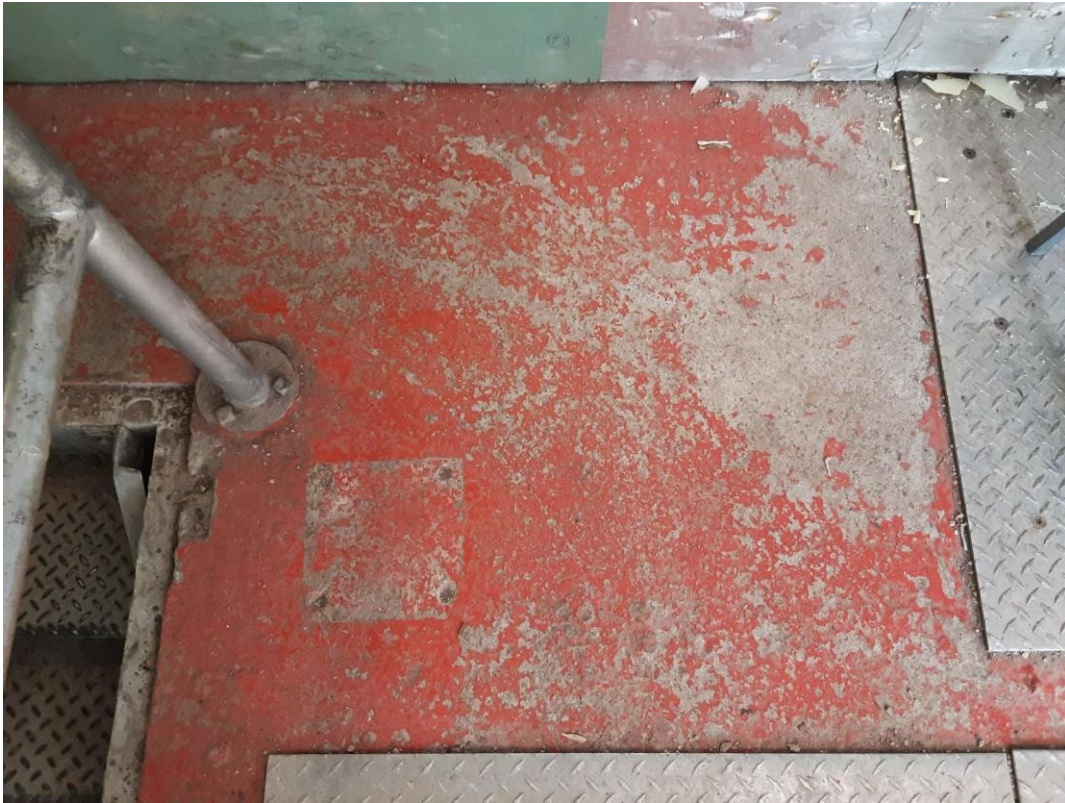
Concrete (poured), Red, L0004(Lead-containing), Control Room (Location #: 1)

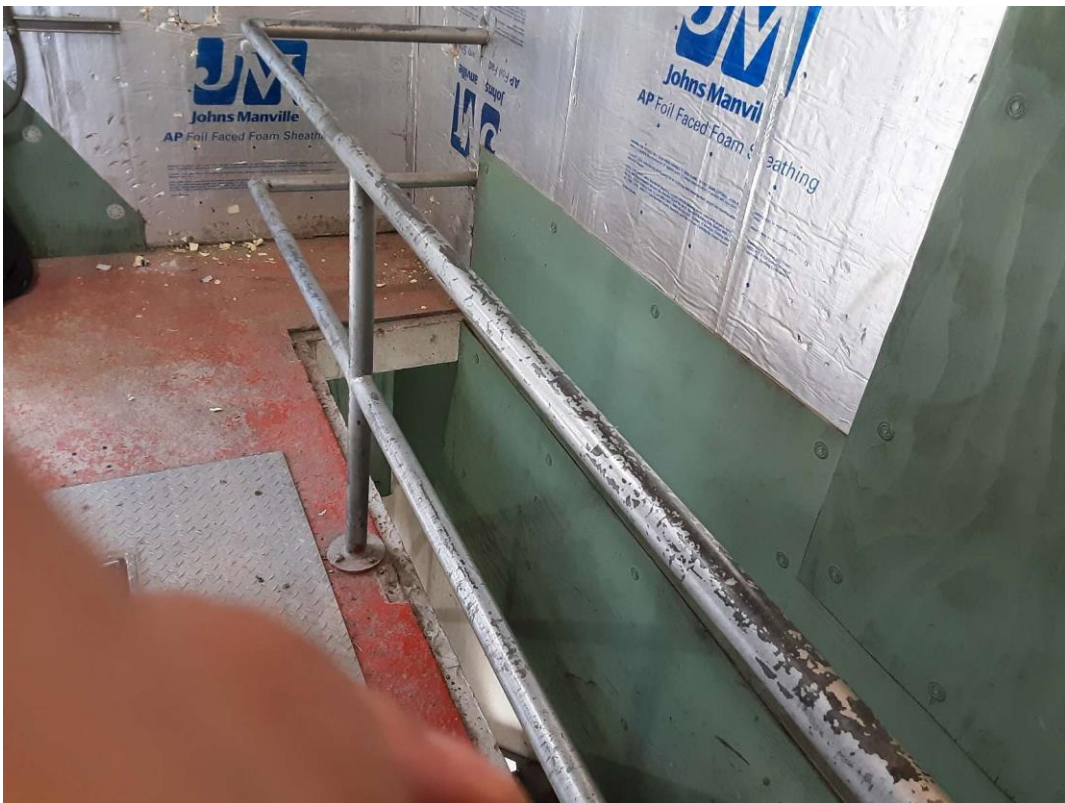
Metal, Silver, L0005(Lead-containing), Control Room (Location #: 1)

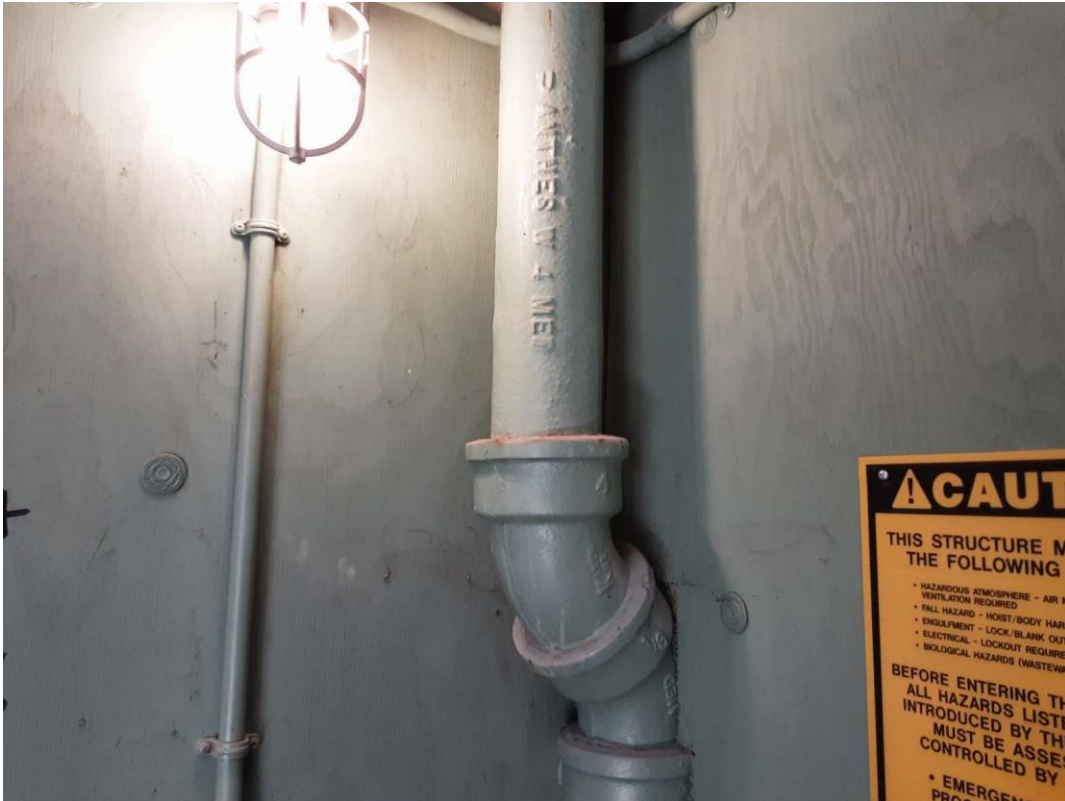
Metal, Green over silver, L0006(Lead-containing), Control Room (Location #: 1)

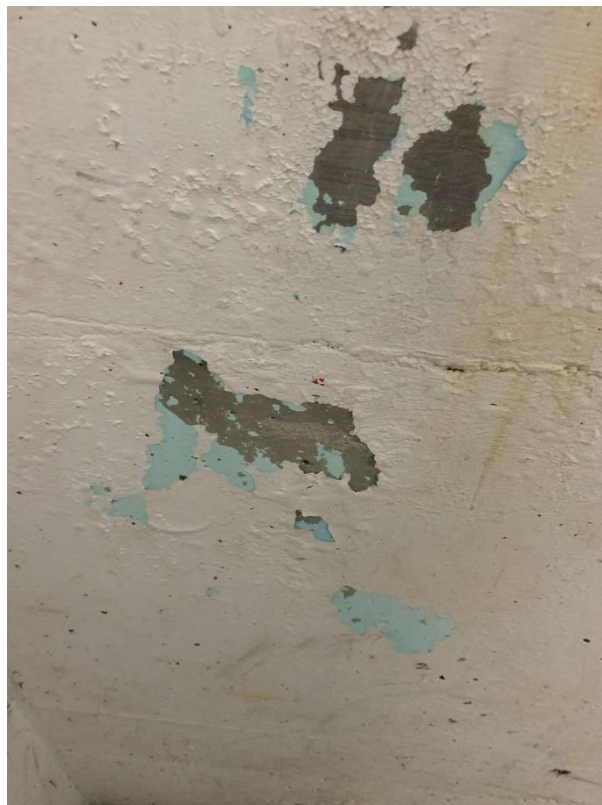
Concrete (poured), White over blue, L0007(None), Pump Room (Location #: 5)

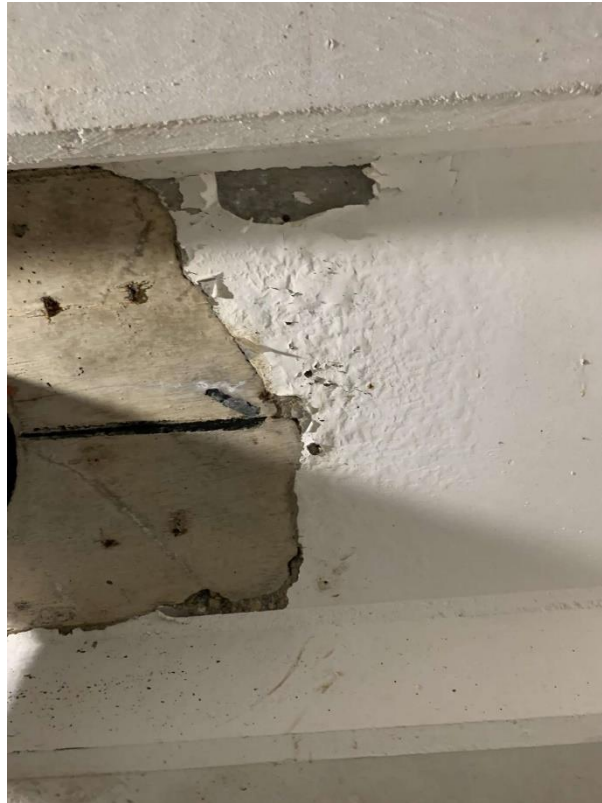
Concrete (poured), White, L0008 (None), Pump Room (Location #: 5)

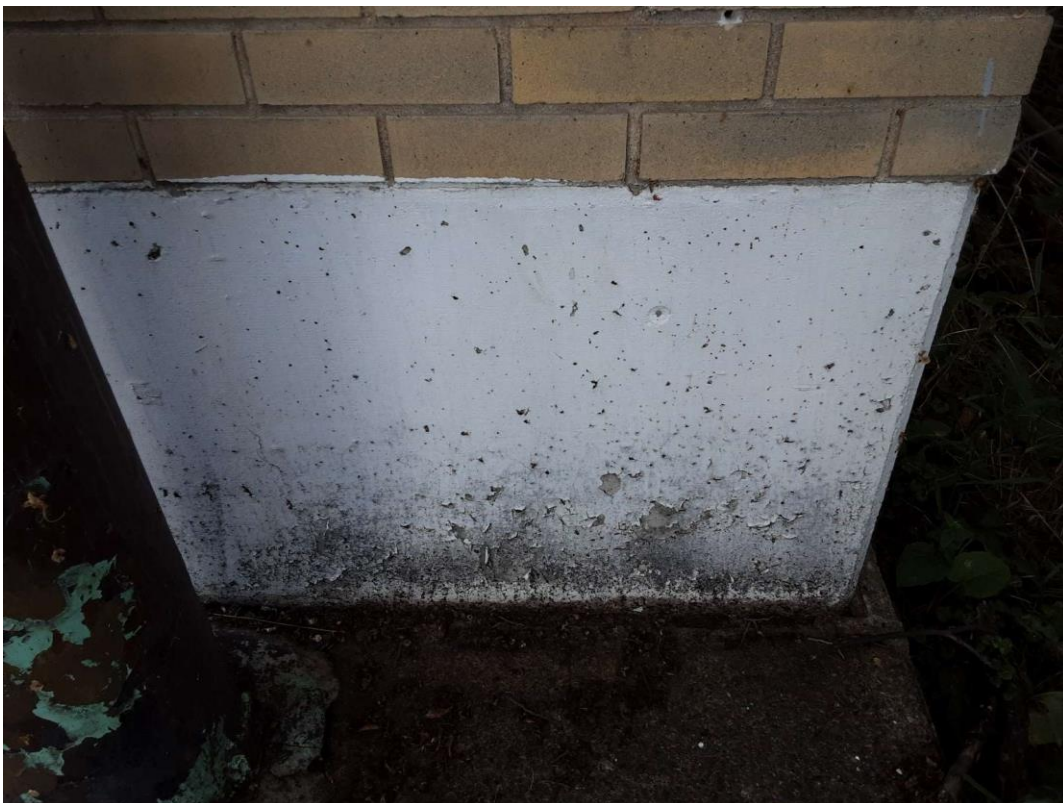
Concrete (poured), White, L0001(None), Exterior of Building (Location #: 6)

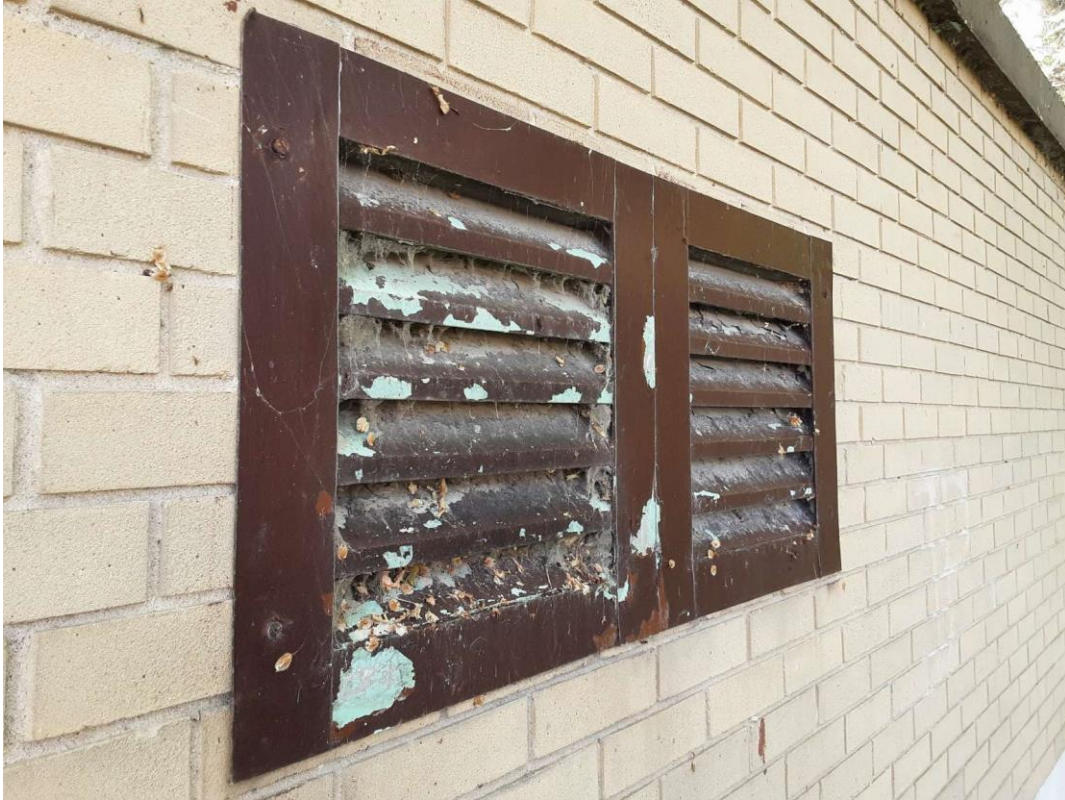
Metal, Brown over grey, L0002(Lead-containing), Exterior of Building (Location #: 6)

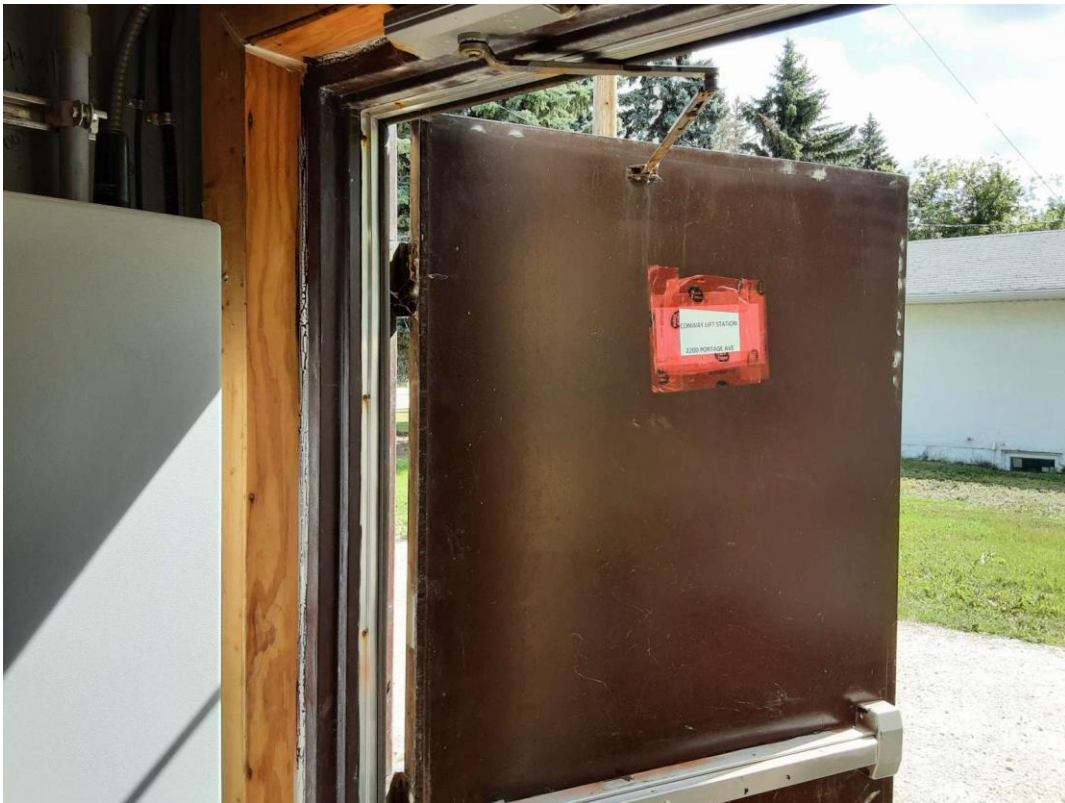
Metal, Brown over grey, V0002(Lead-containing), Exterior of Building (Location #: 6)

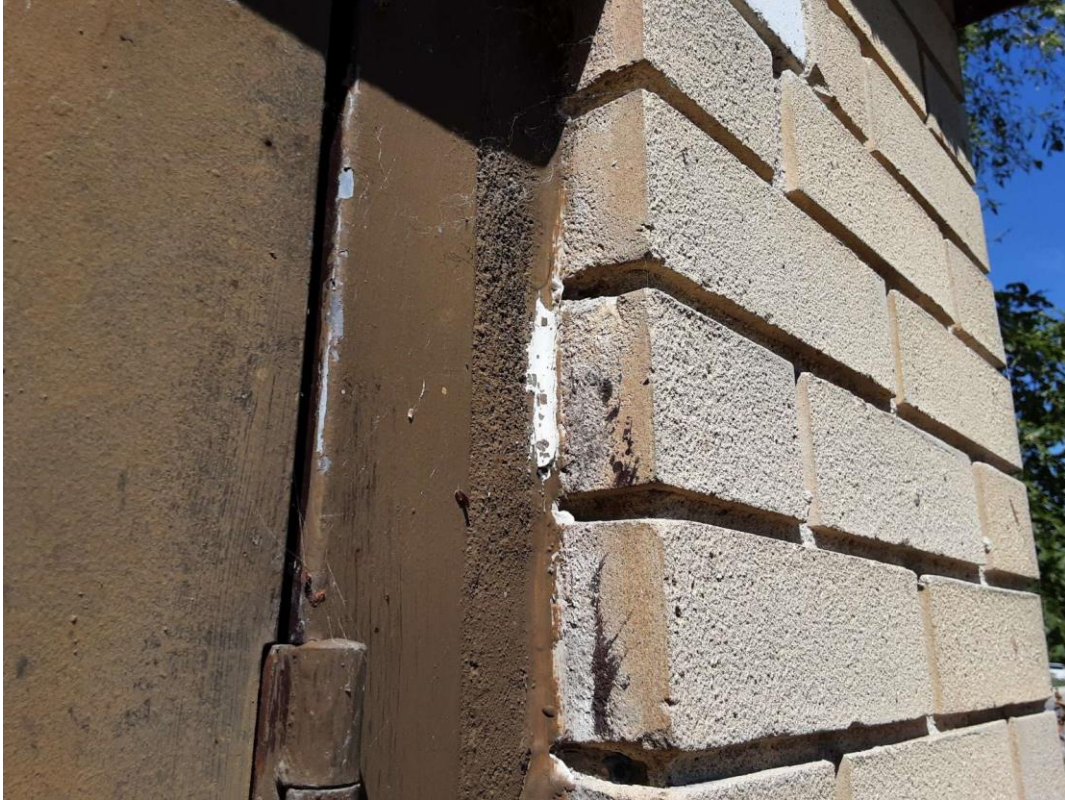
PCB (Non-PCB), Exterior of Building (Location #: 6)
