## Appendix I – Photograph Log

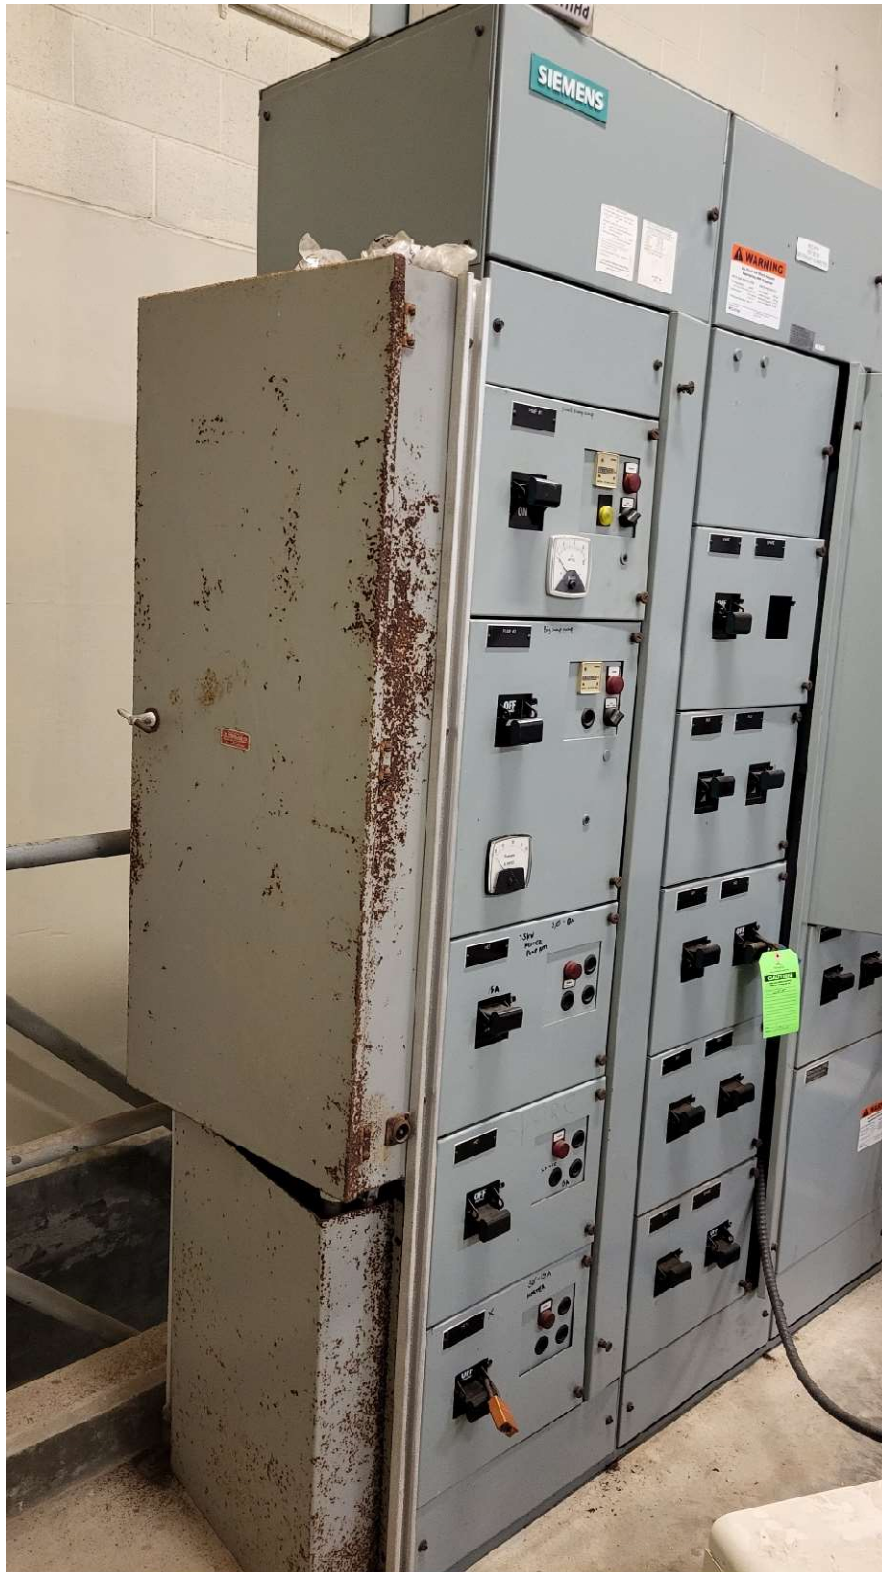
Photograph #1: Existing MCC & terminal Cabinet in the Valve house,

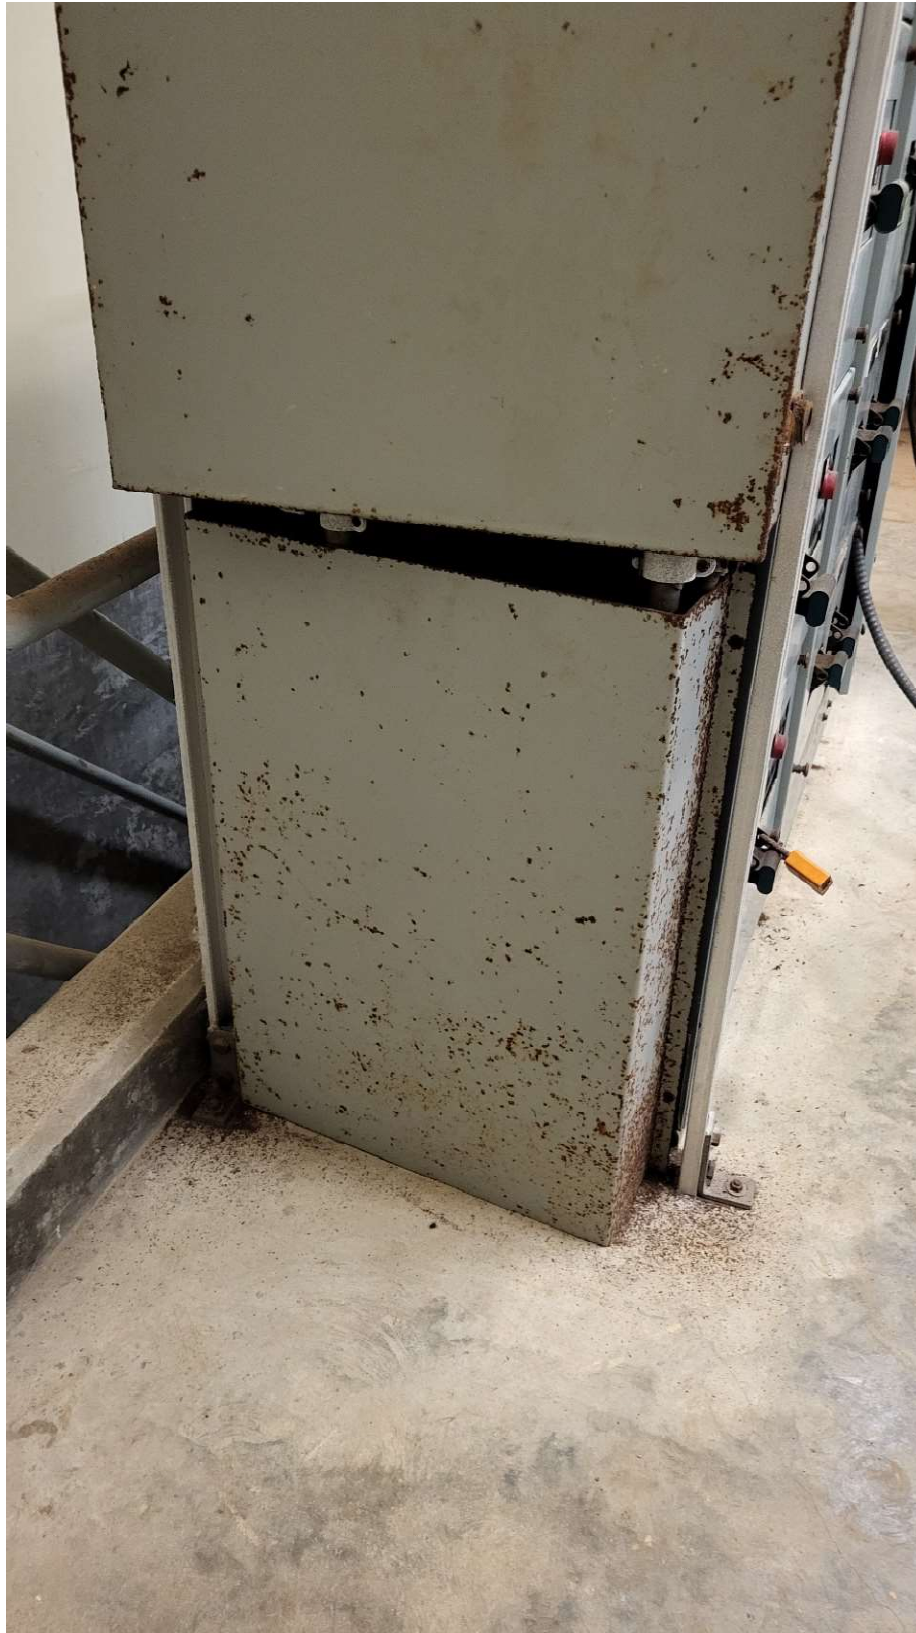
Photograph #2: Valve House Terminal Cabinet

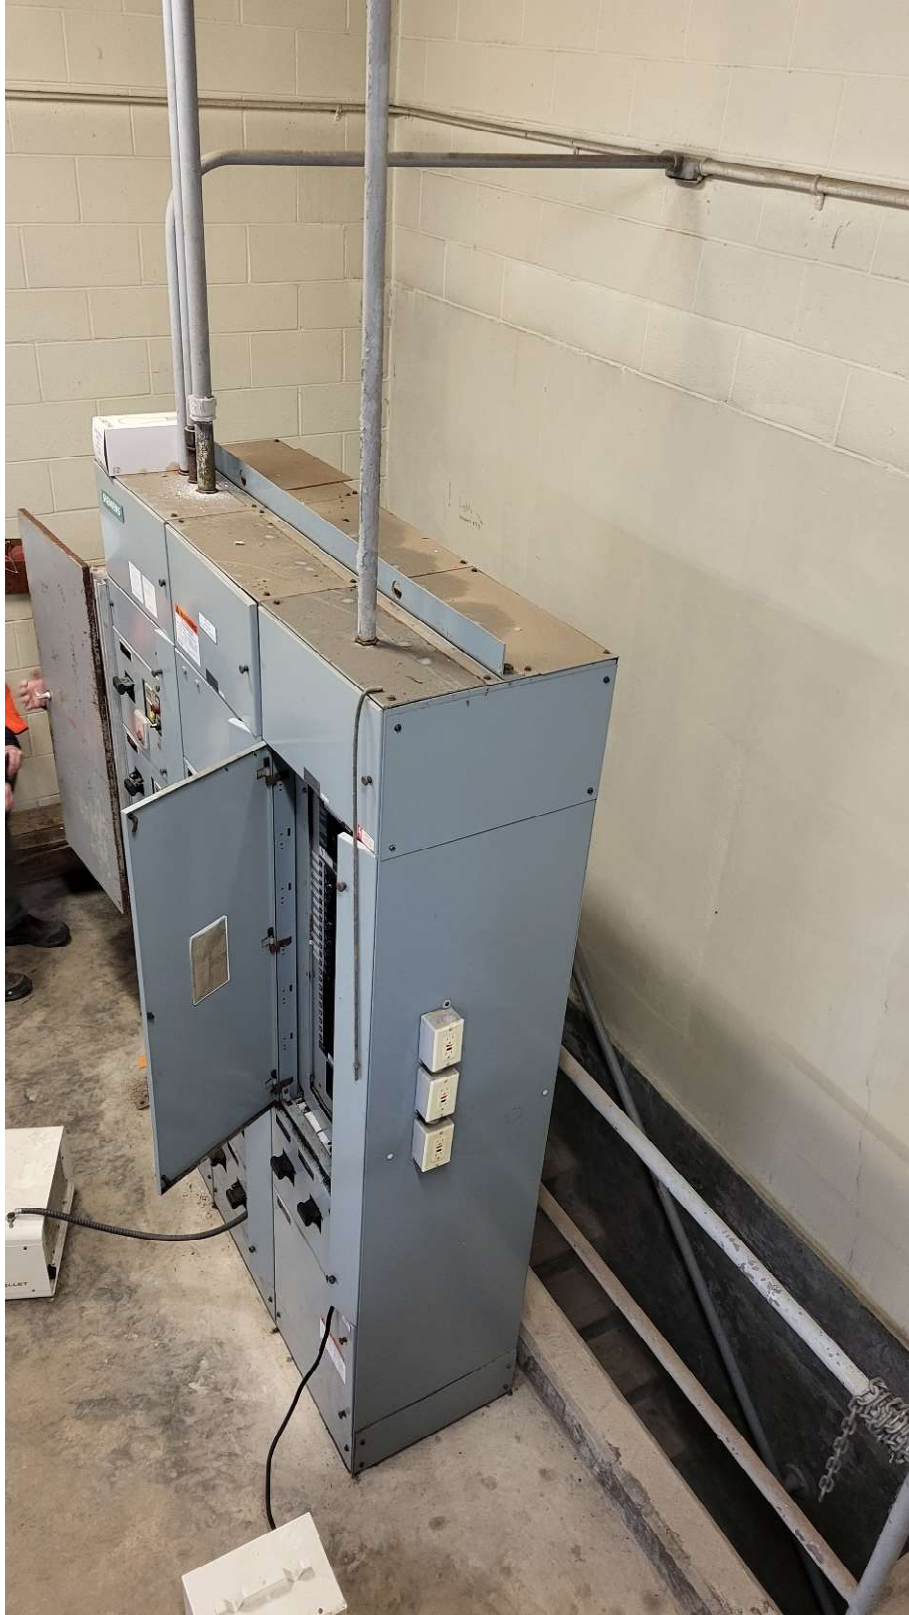
Photograph #3: Top View of Existing MCC in Valve House

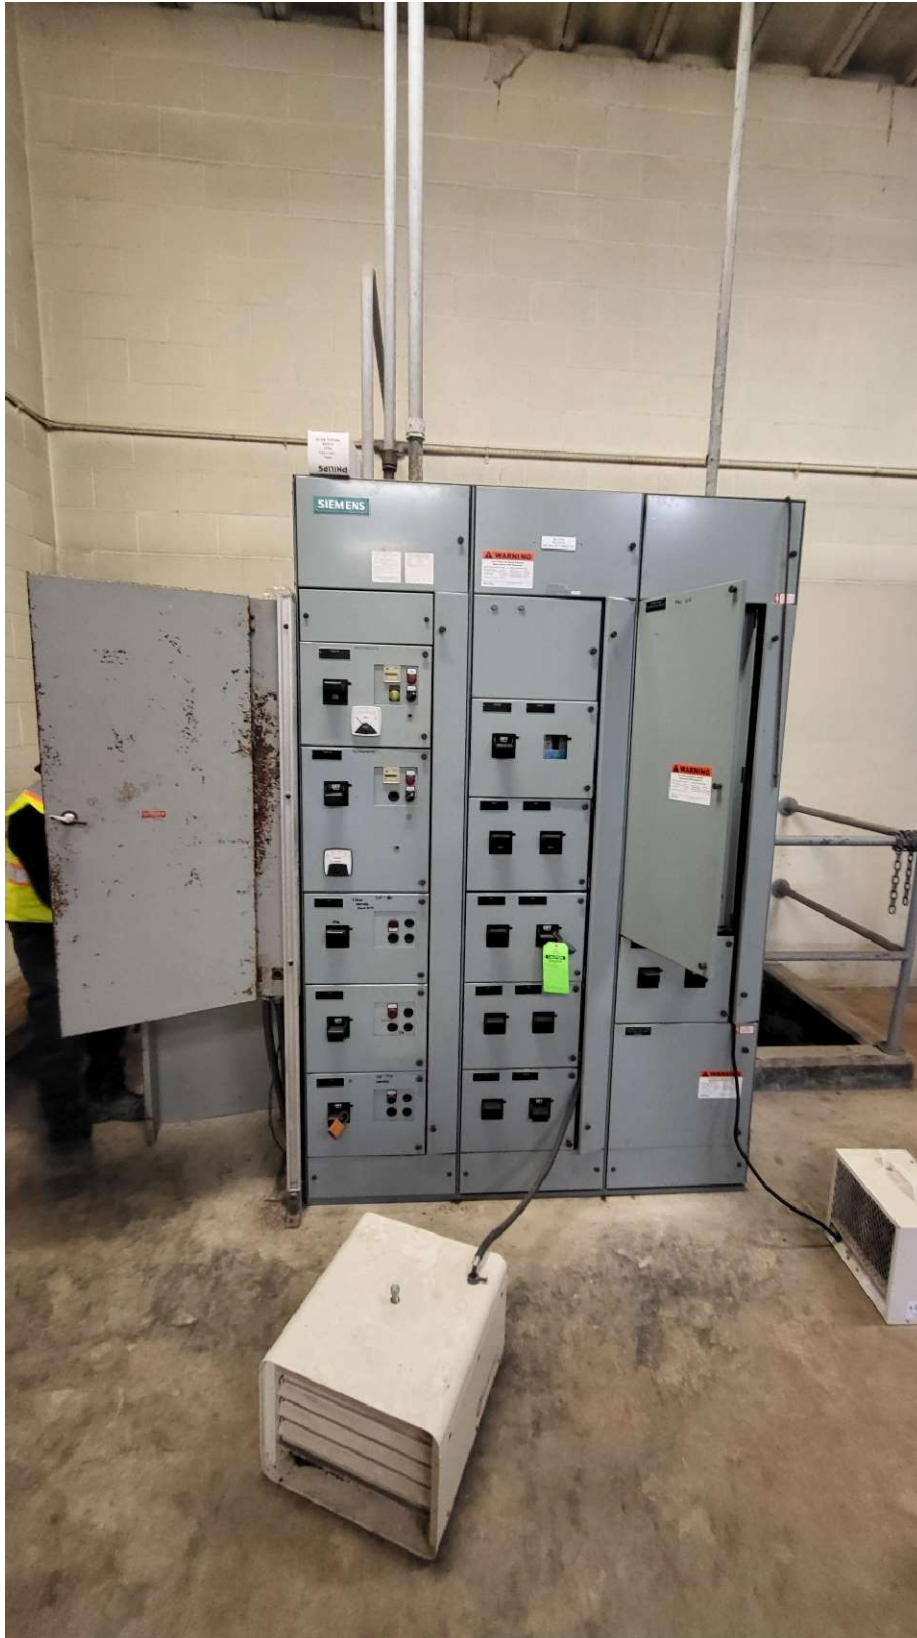
Photograph #4: Existing MCC in Maclean valve house, and temporary unit heater on the ground.

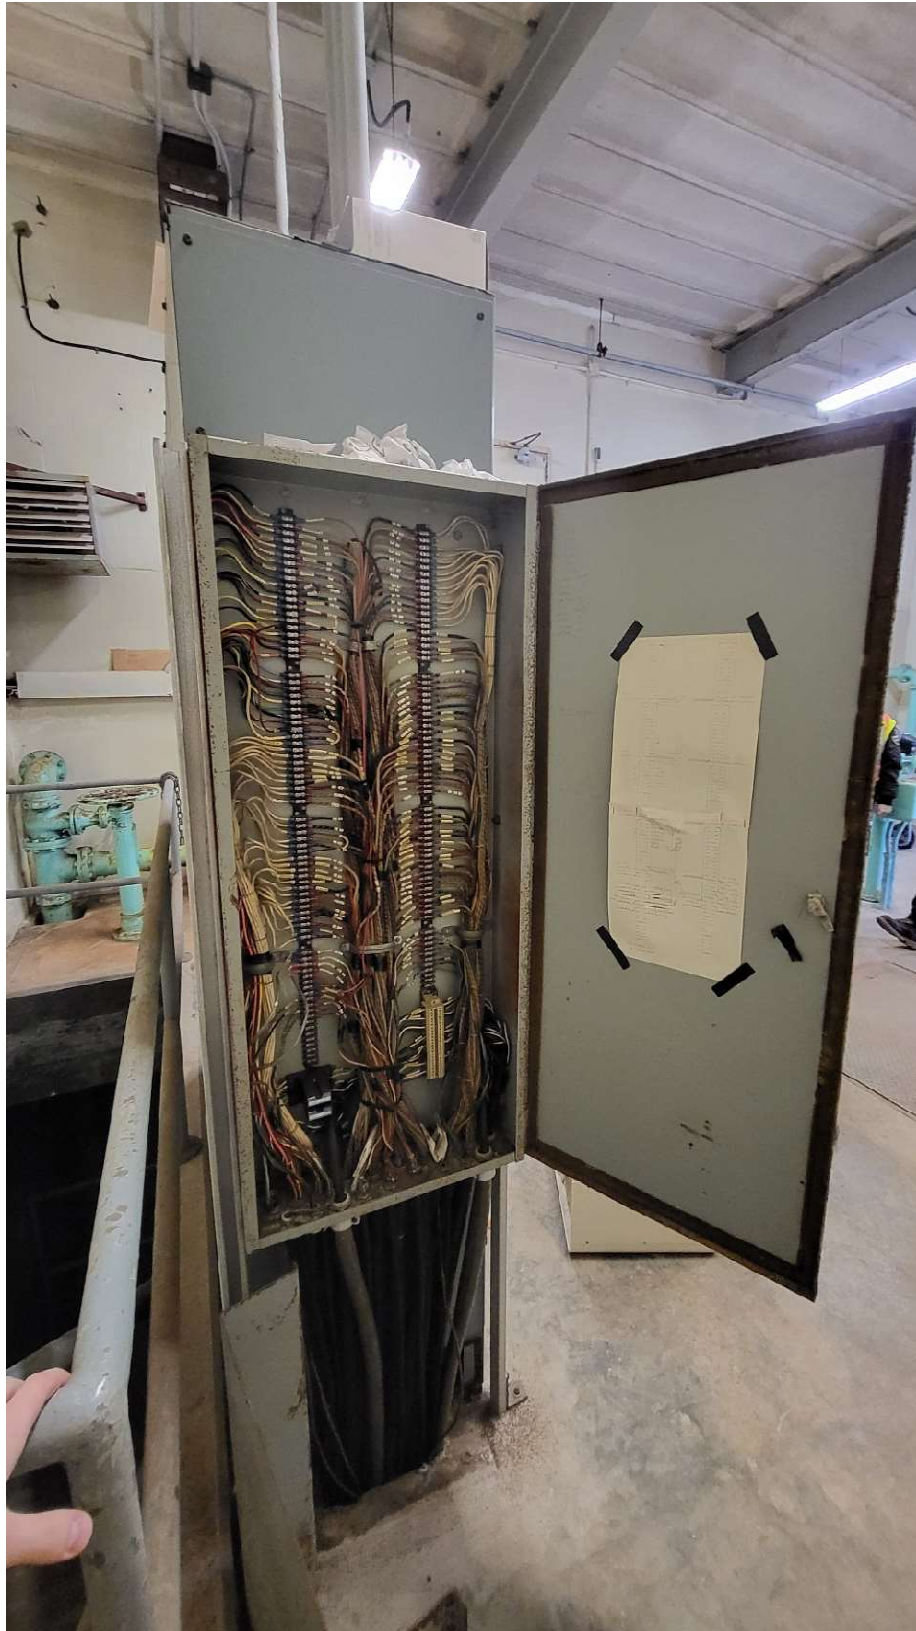
Photograph #5: Valve House Terminal Cabinet

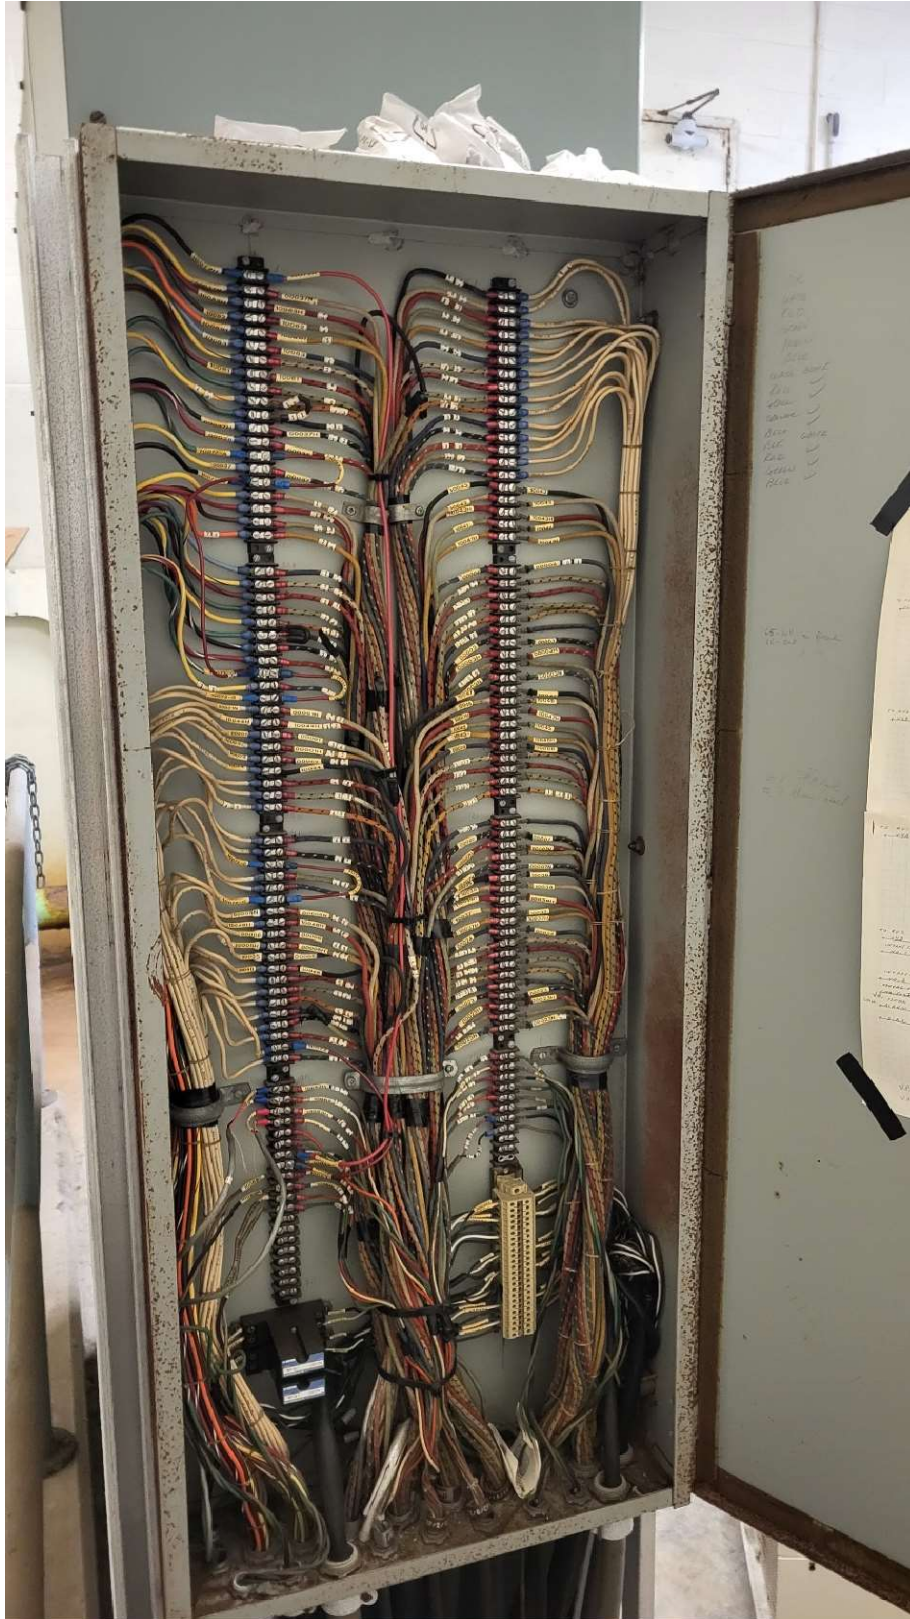
Photograph #6: Valve House Terminal Cabinet

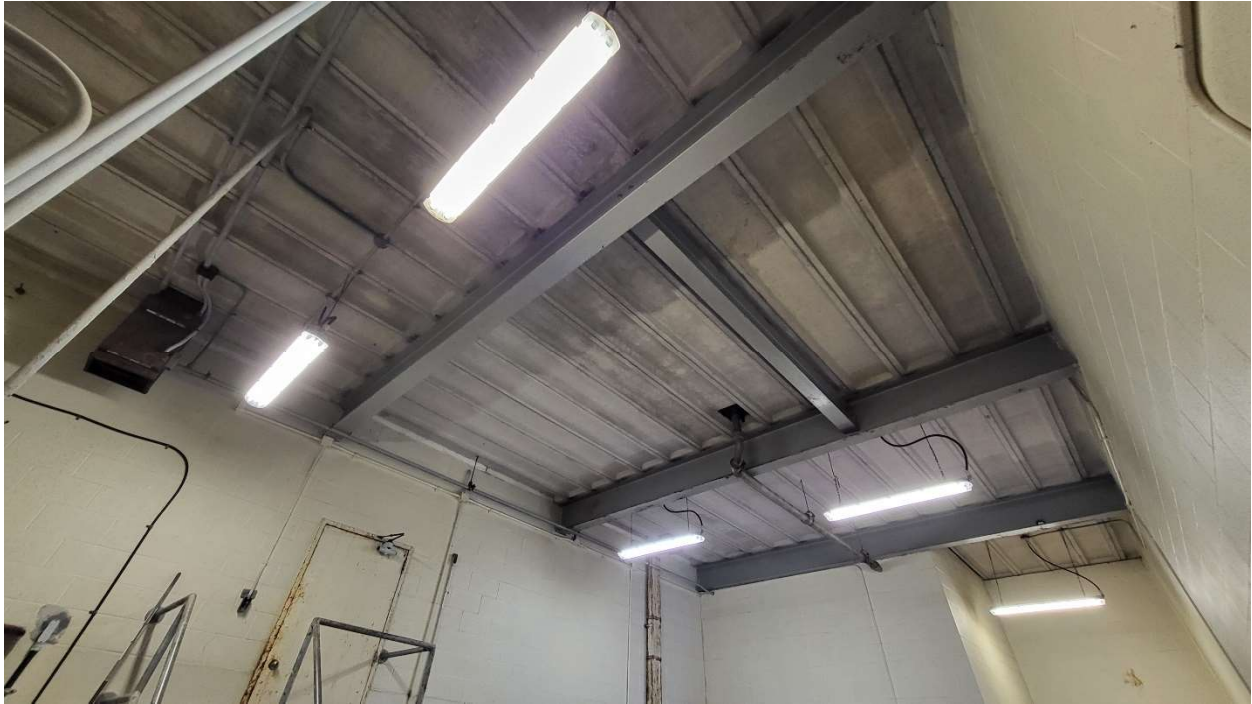
Photograph #8: Valve House Ceiling

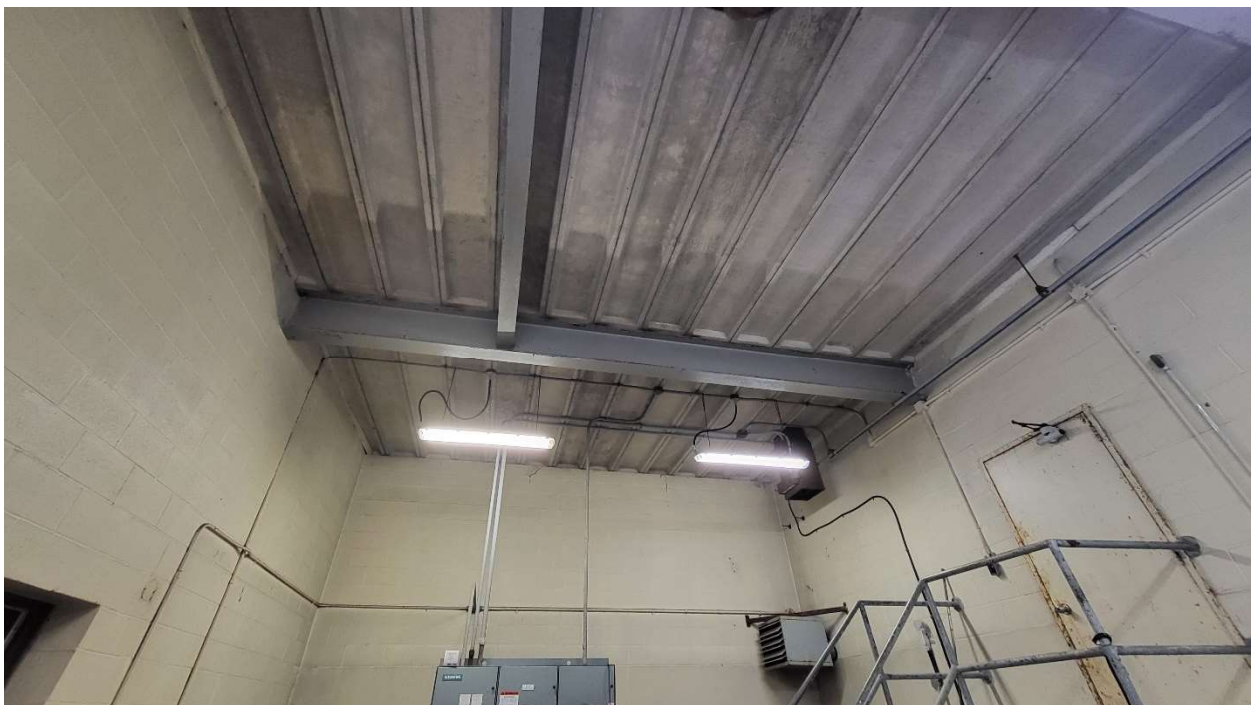
Photograph #9: Valve House Ceiling

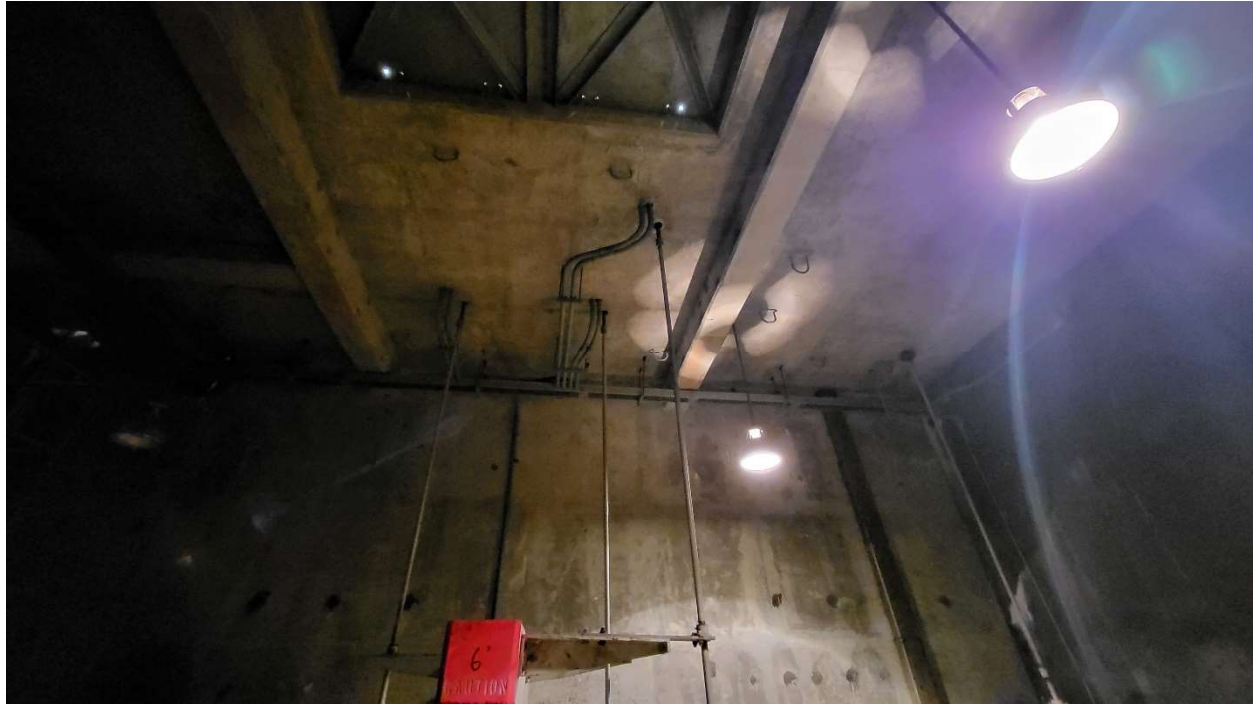
Photograph #10: Valve House Pit

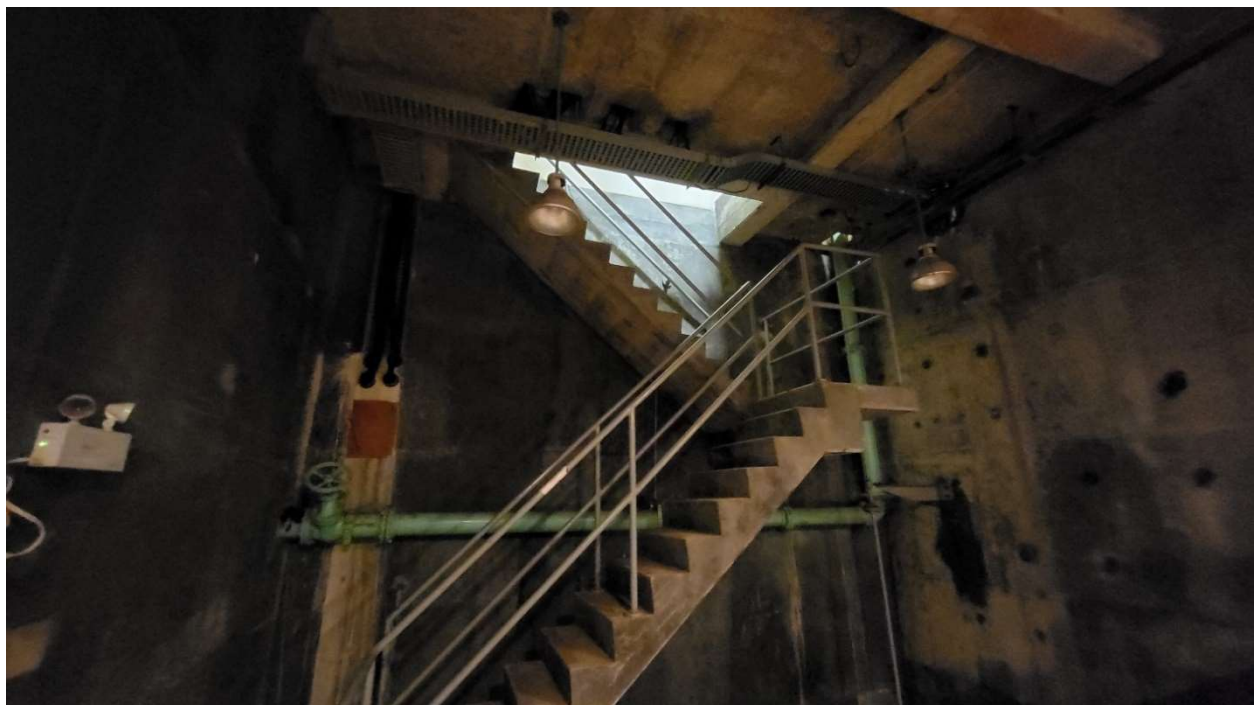
Photograph #11: Valve House Pit Stairs, cable tray, and incoming conduit

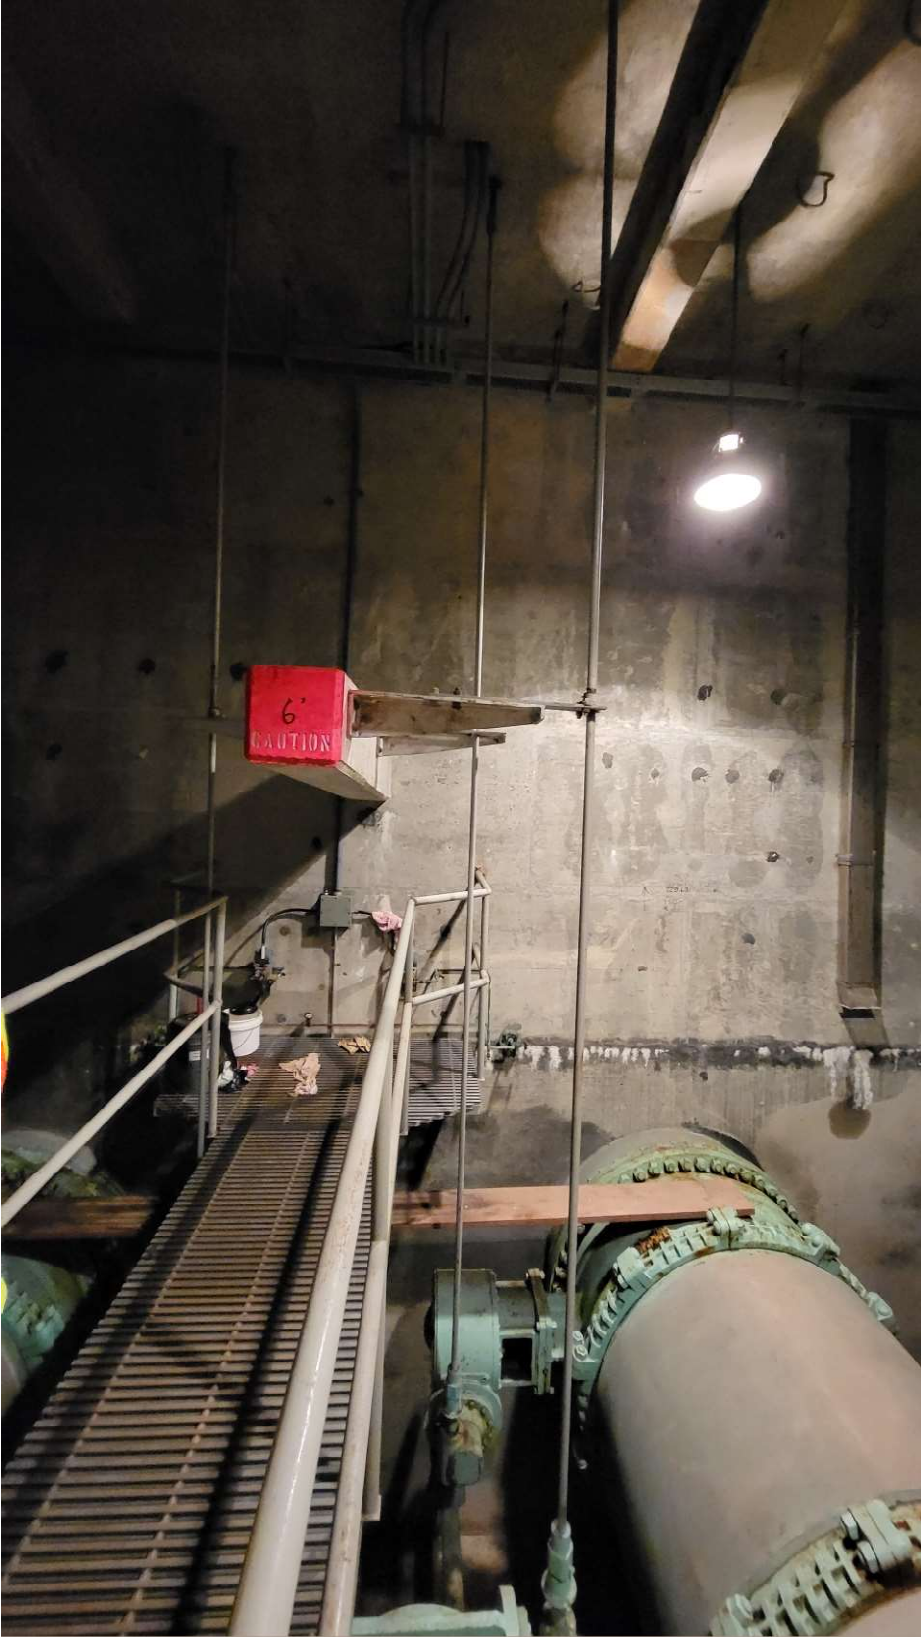
Photograph #12: Valve House Pit

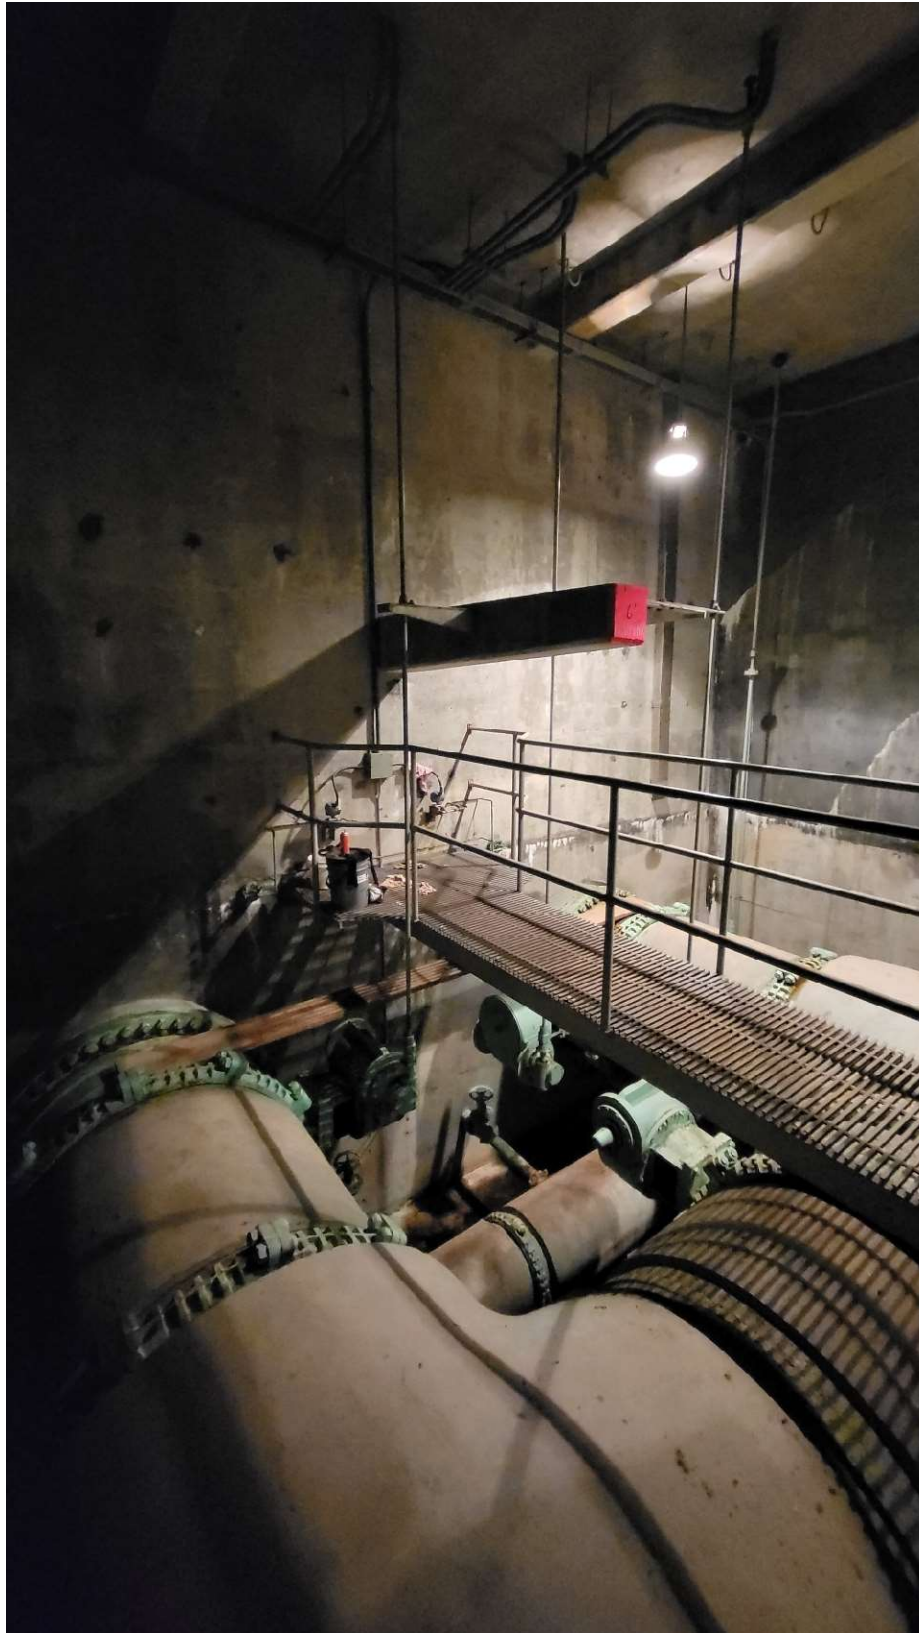
Photograph #13: Valve House Pit

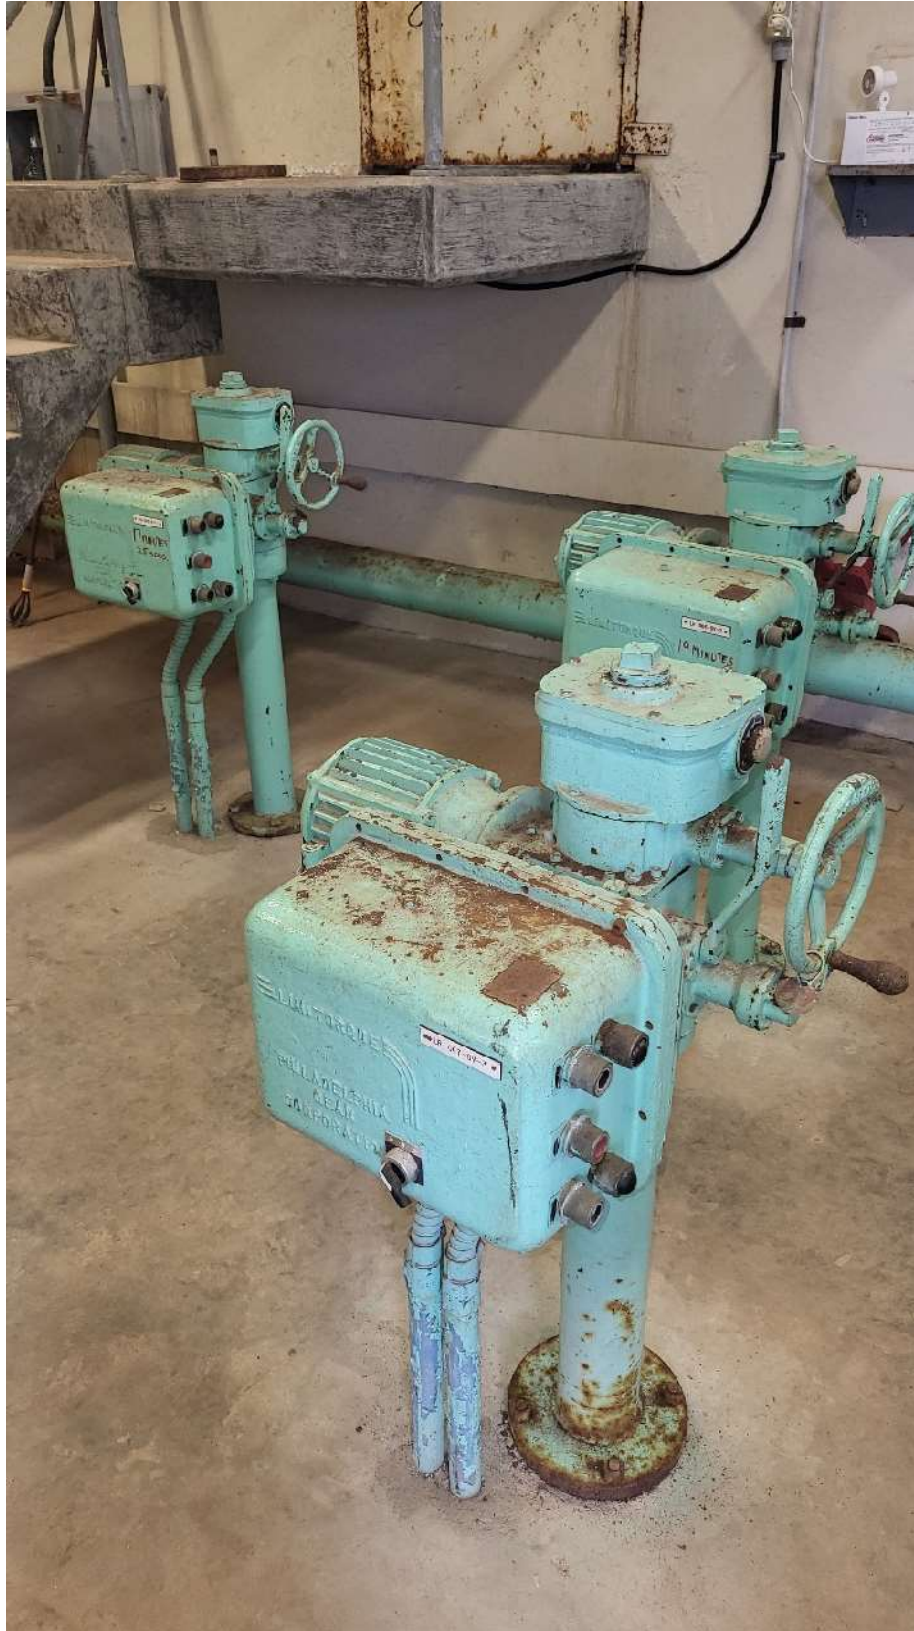
Photograph #14: Valve House Actuator Motor

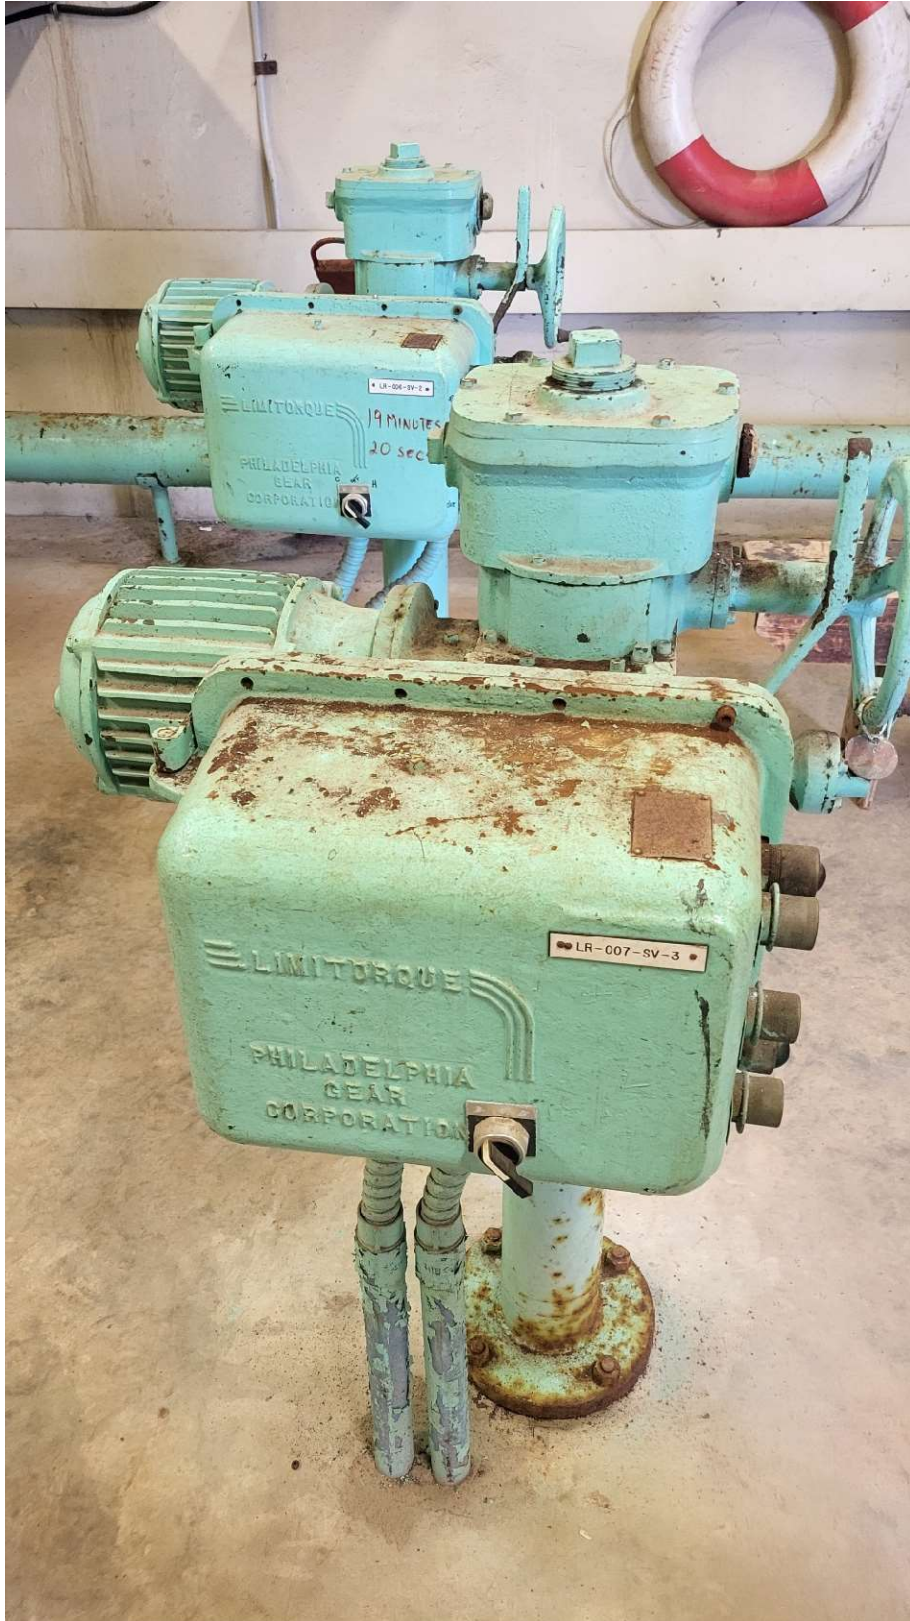
Photograph #15: Valve House Actuator Motor

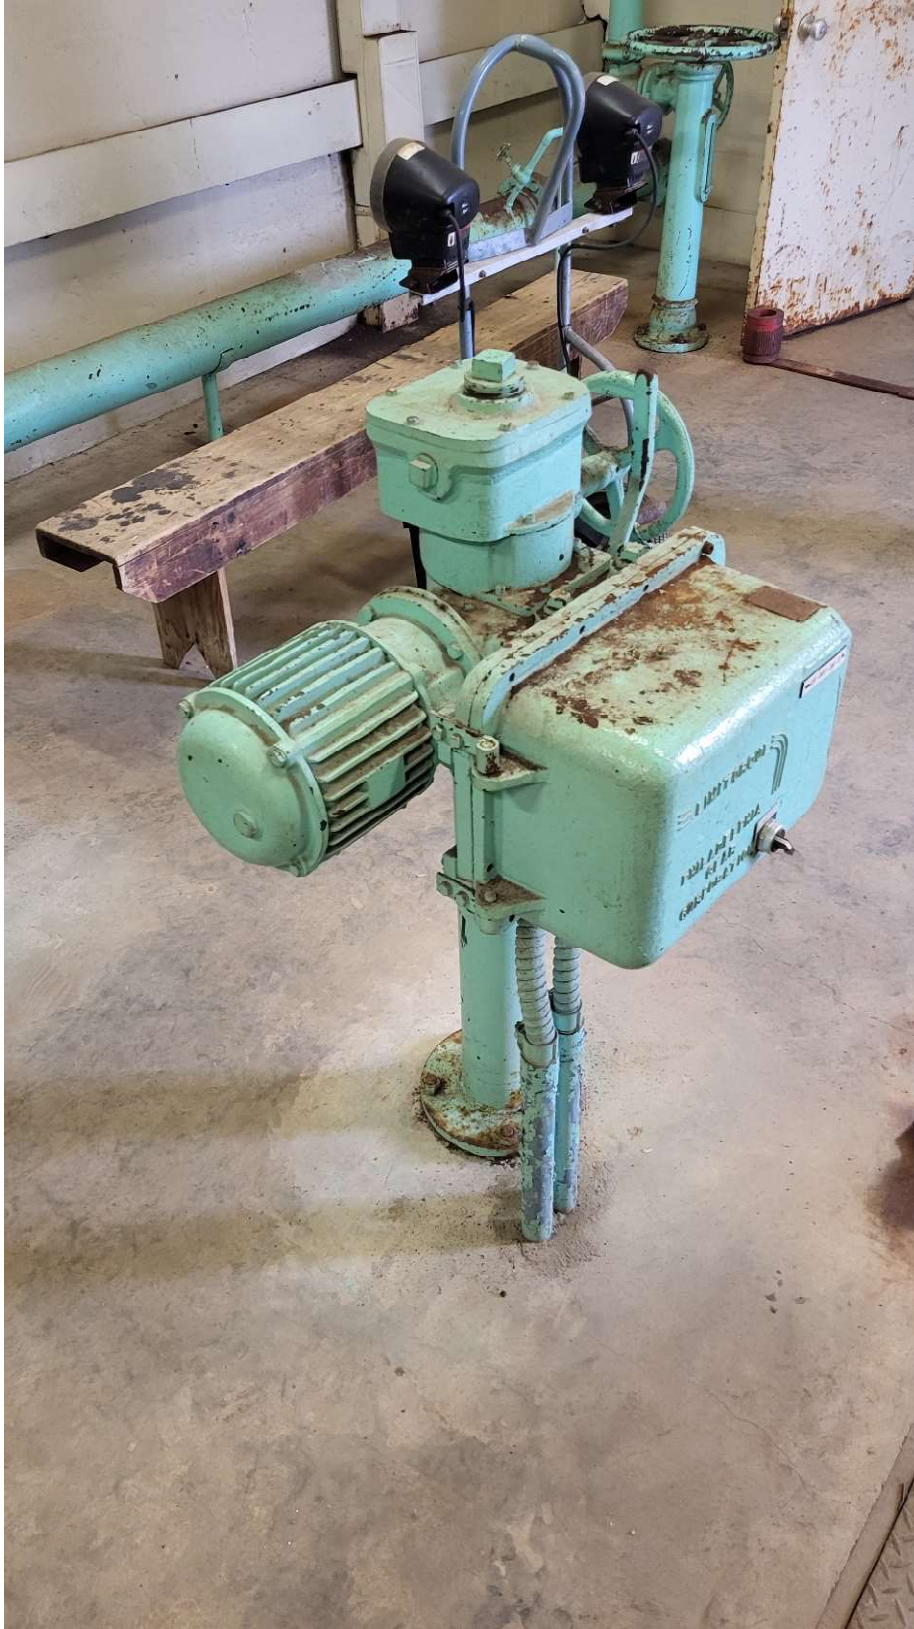
Photograph #16: Valve House Actuator Motor

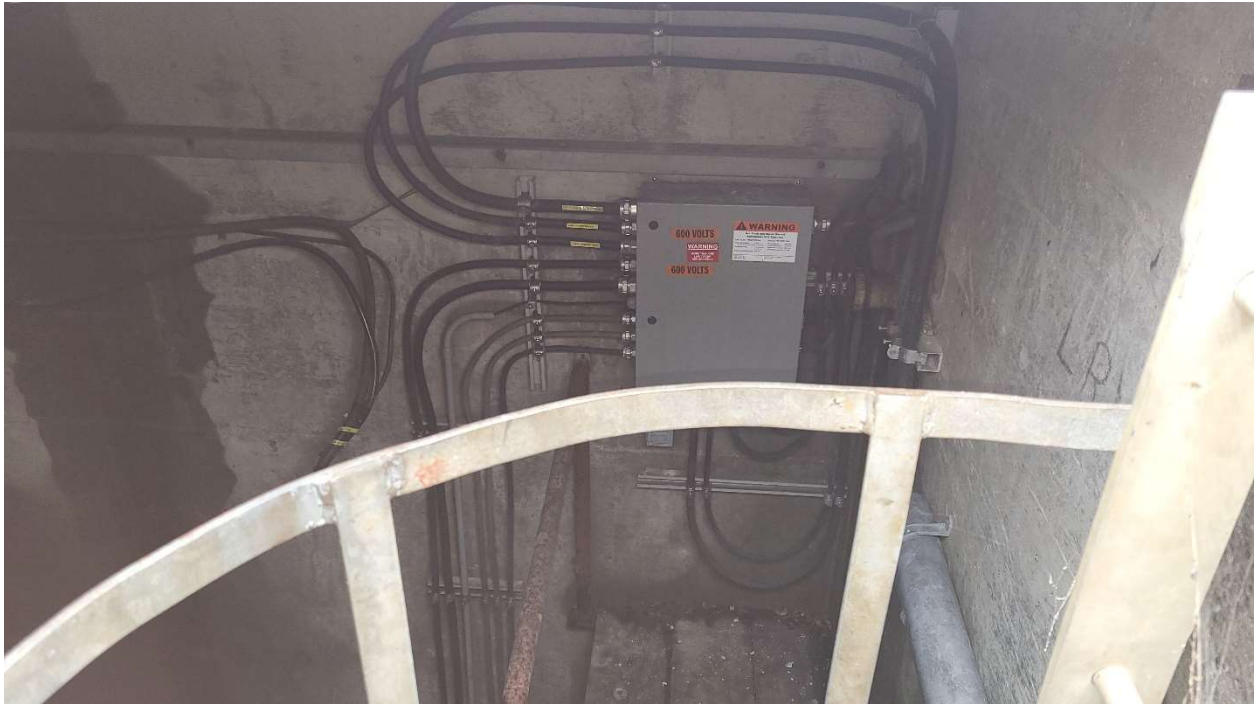
Photograph #19: LAV-1 Valve Pit

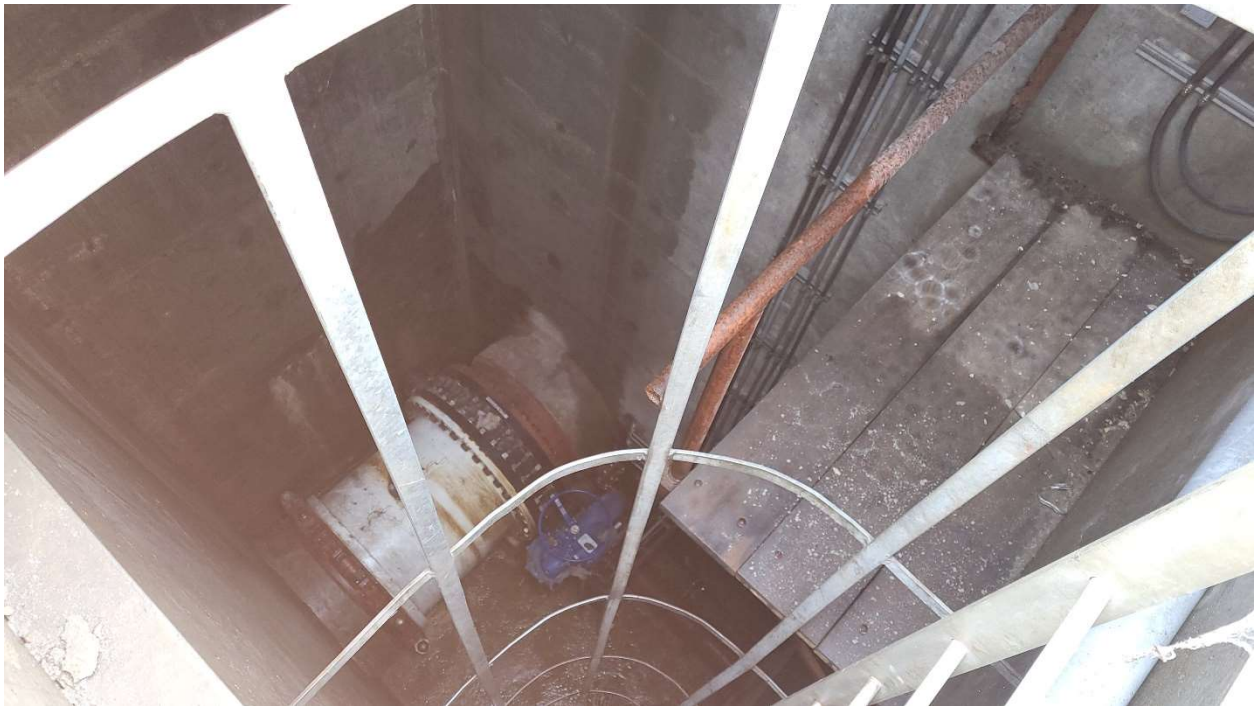
Photograph #20: LAV-1 Valve Pit

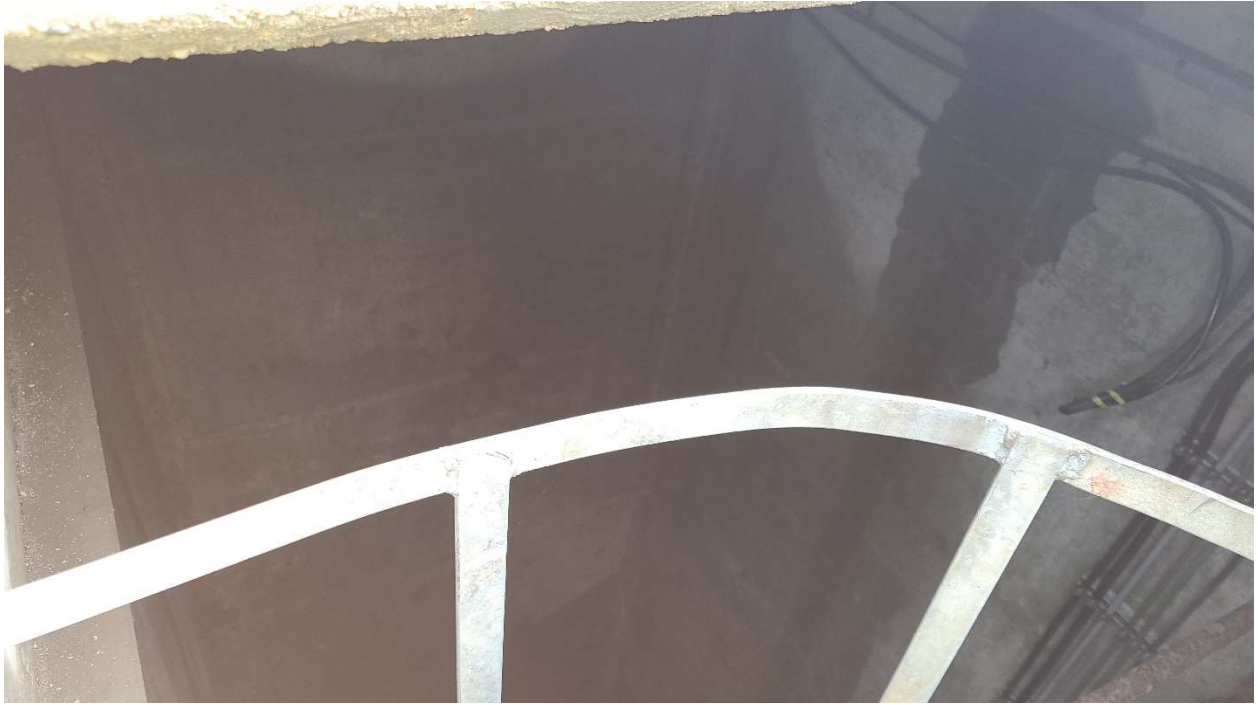
Photograph #21: LAV-1 Valve Pit
