## Appendix I – Photograph Log

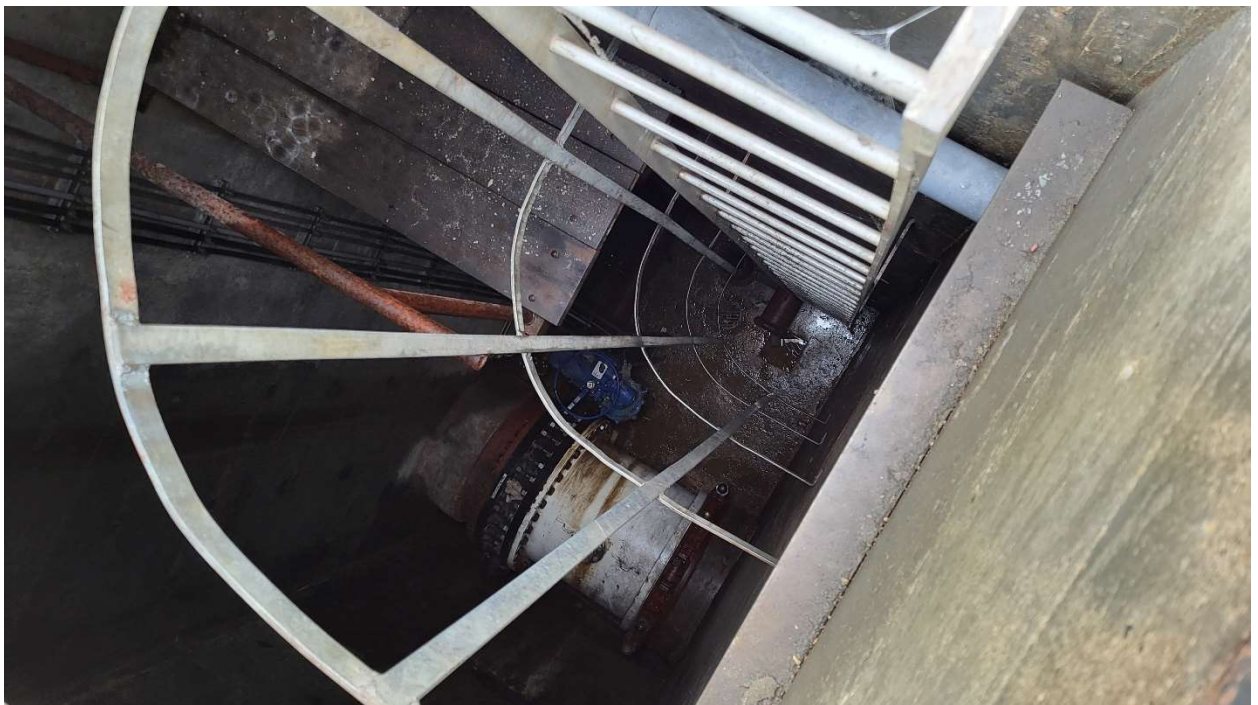
Photograph #22: LAV-1 Valve Pit

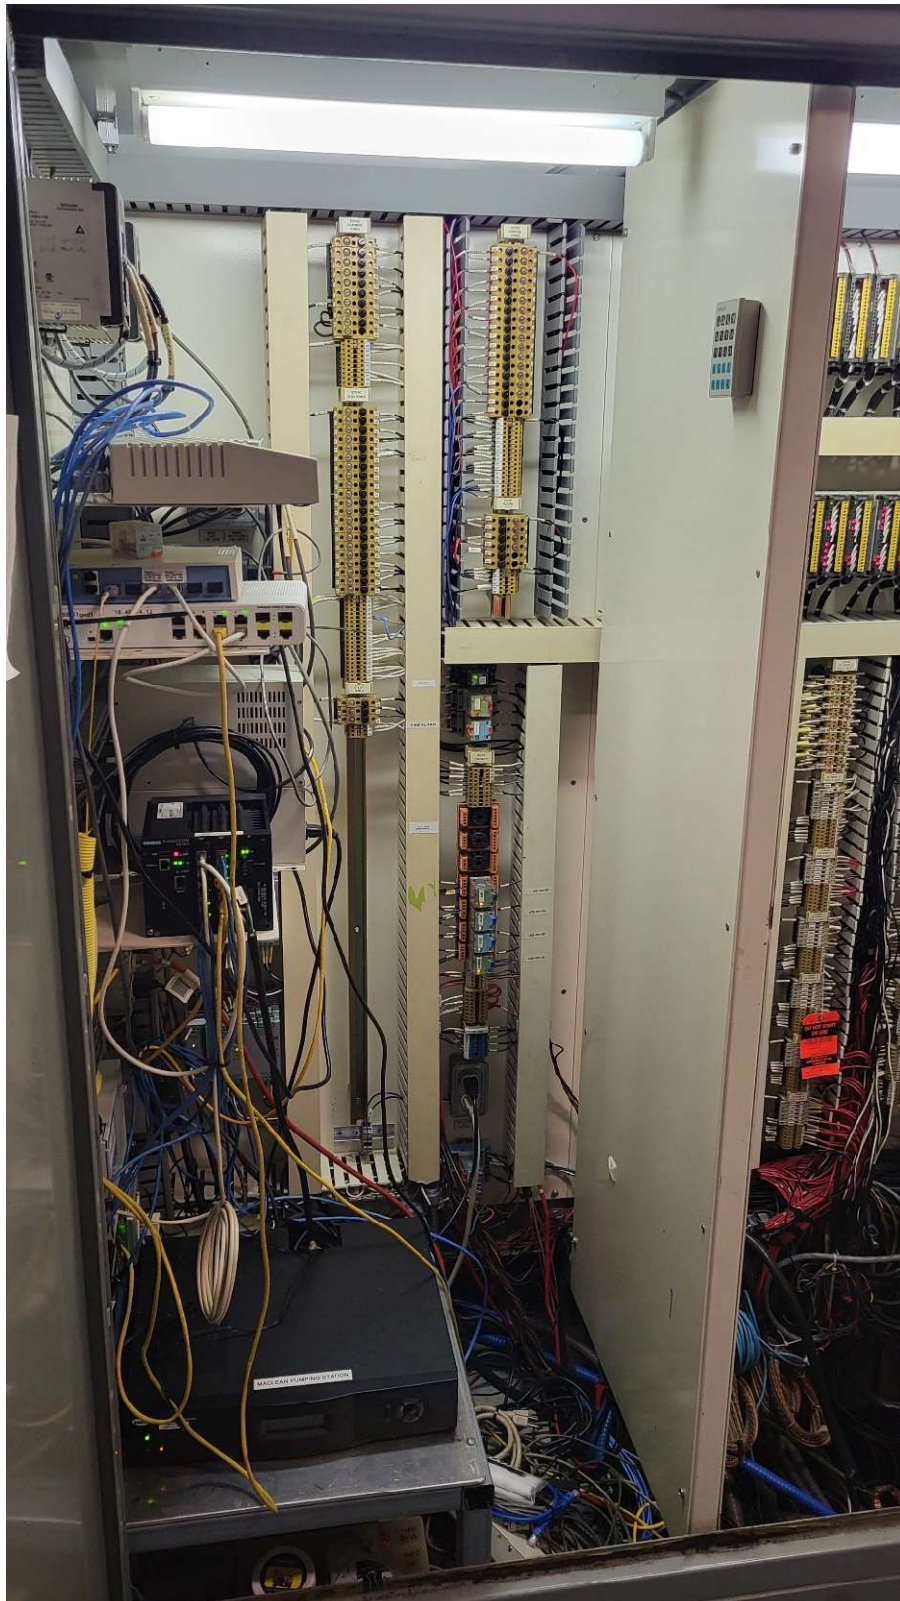
Photograph #23: Maclean Regional Pumping Station Main Control Panel Left Section

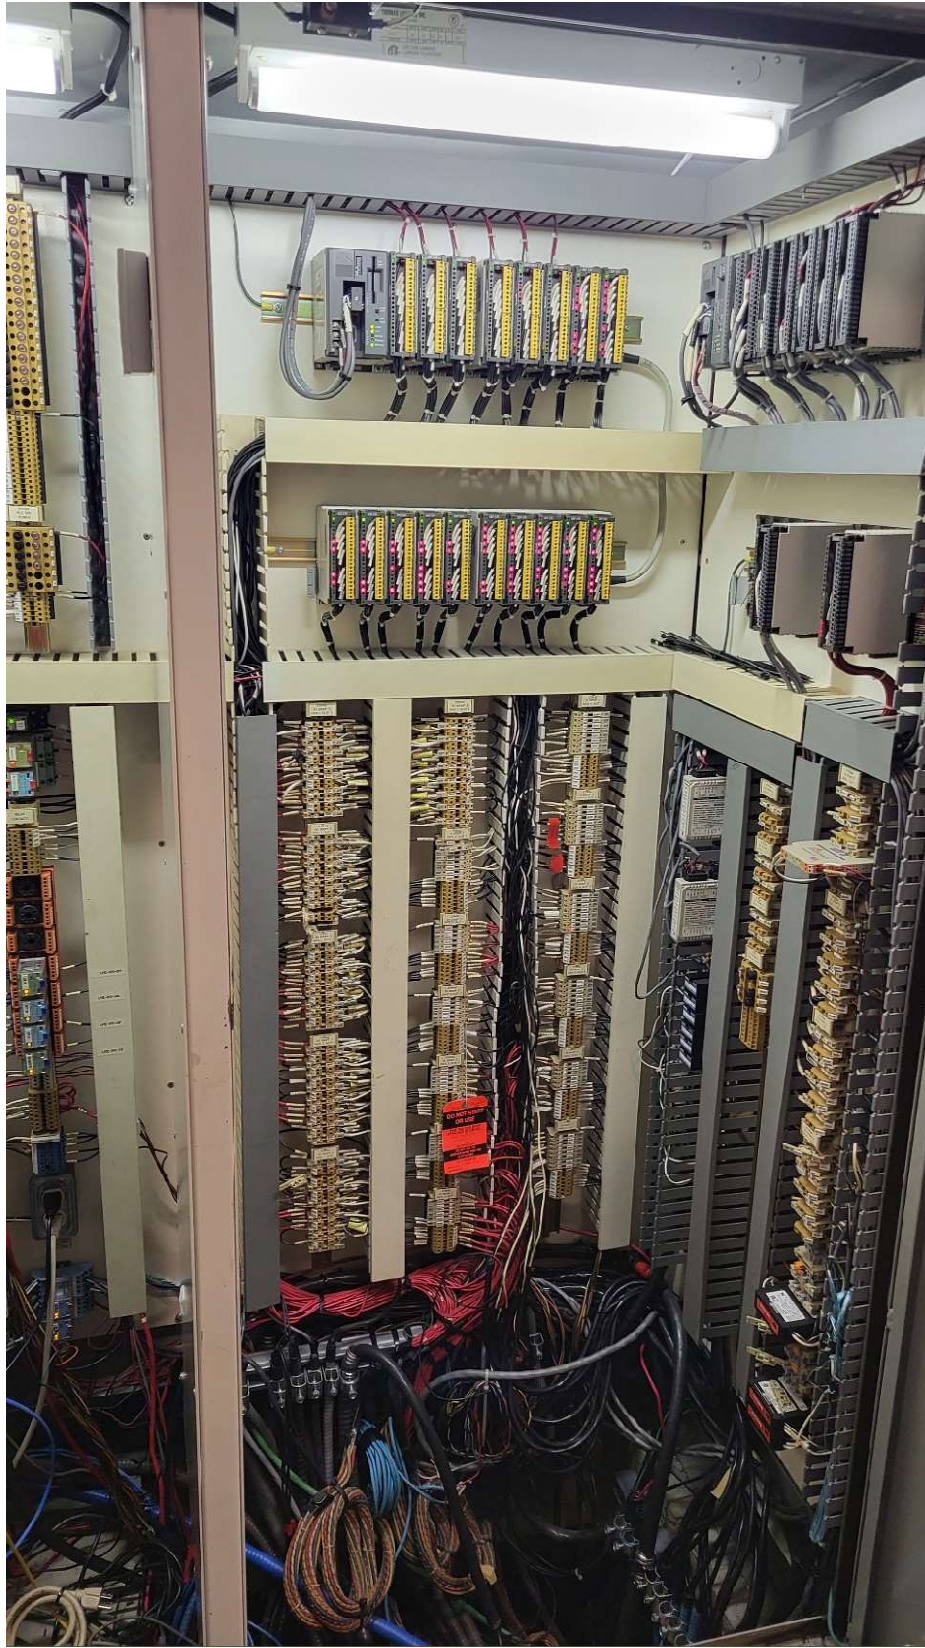
Photograph #24: Maclean Regional Pumping Station Main Control Panel Right Section
