## **APPENDIX 'A' – GEOTECHNICAL REPORT**

## Hartford Avenue - McGregor St / Salter St.

ATTENTION:  
PROJECT: Local Streets Package 24-R-05 (751-2023.5)  
Sanford, Winnipeg, MB

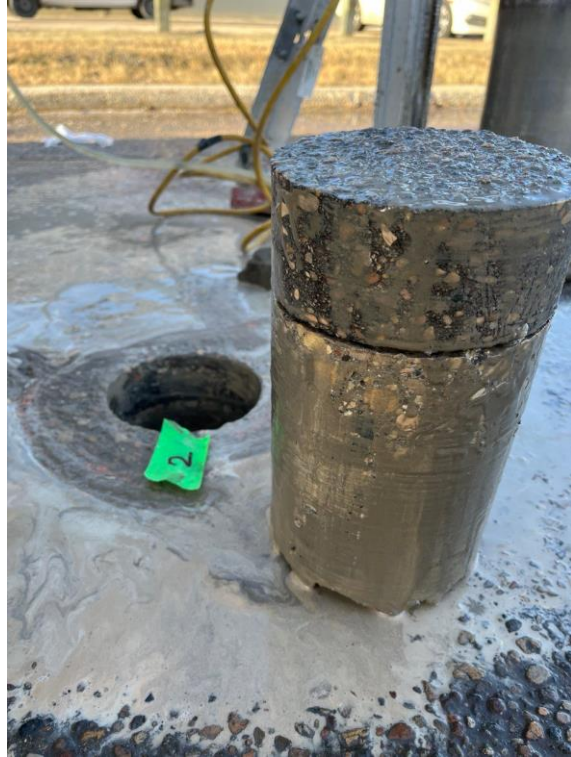
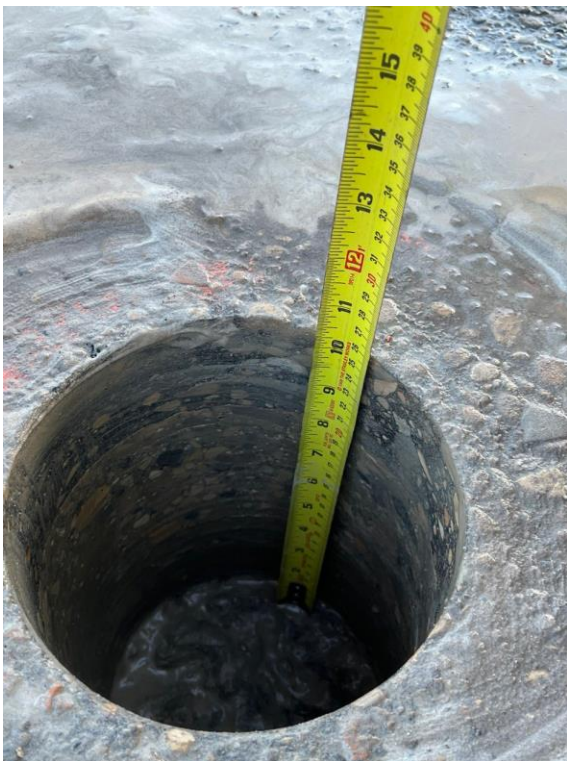
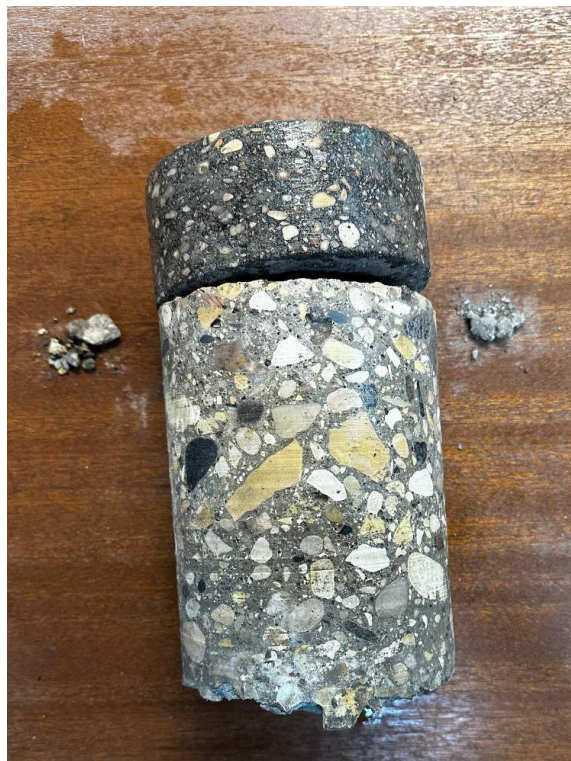
Core 2 – Sanford (SBL)

Figure 2. Photos showing Core 2 pavement surface for compressive strength

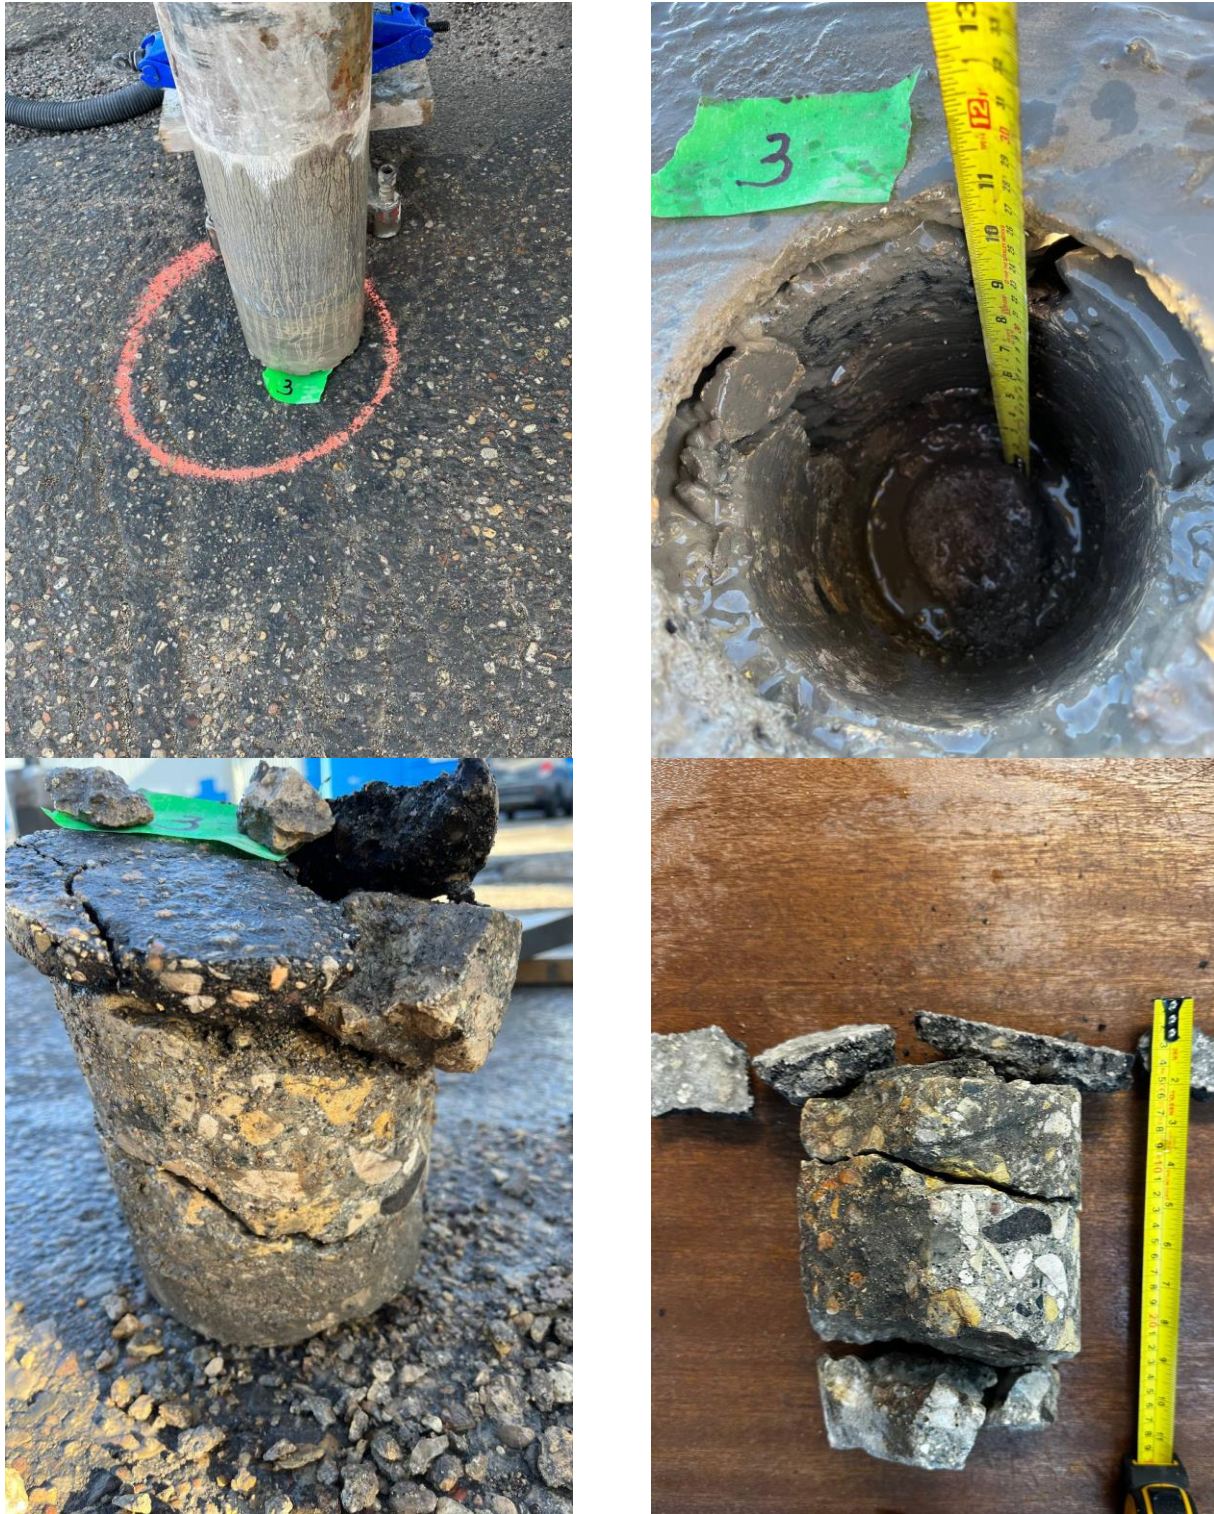
**Core 3 – Sanford (NBL)**

Figure 3. Photos showing Core 3 pavement showing shear stress deterioration of concrete and void between pavement and base surface

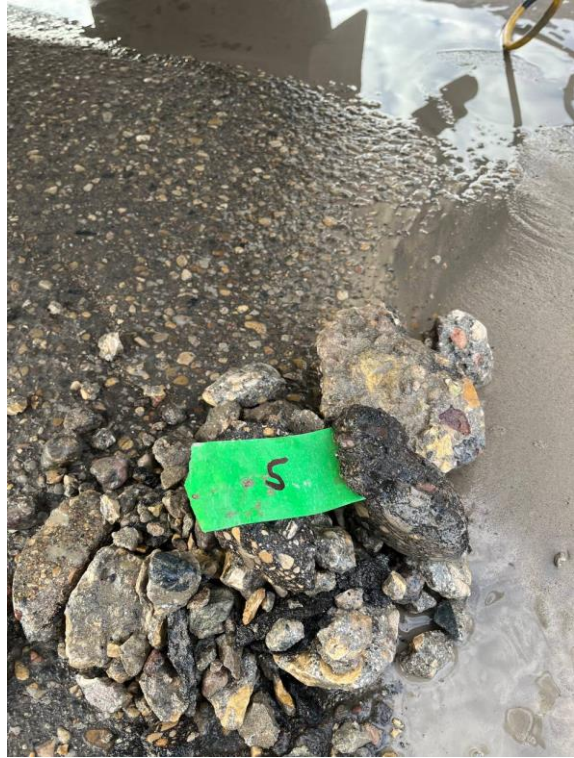
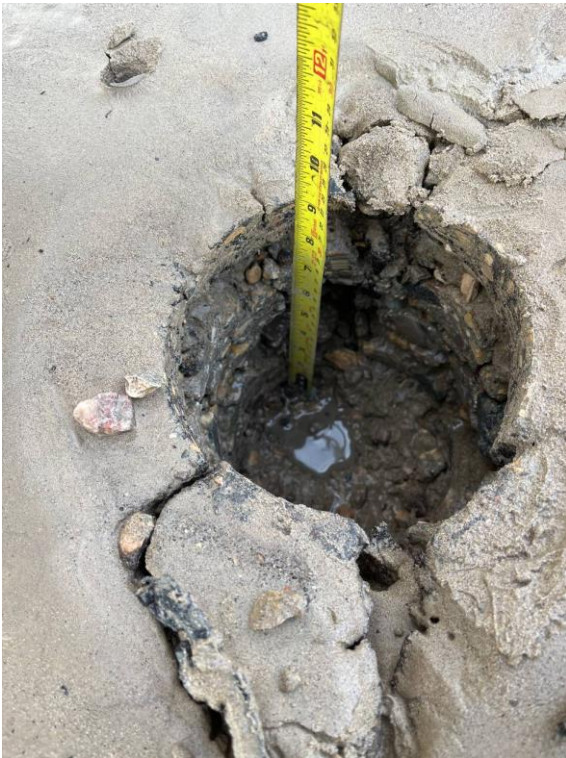
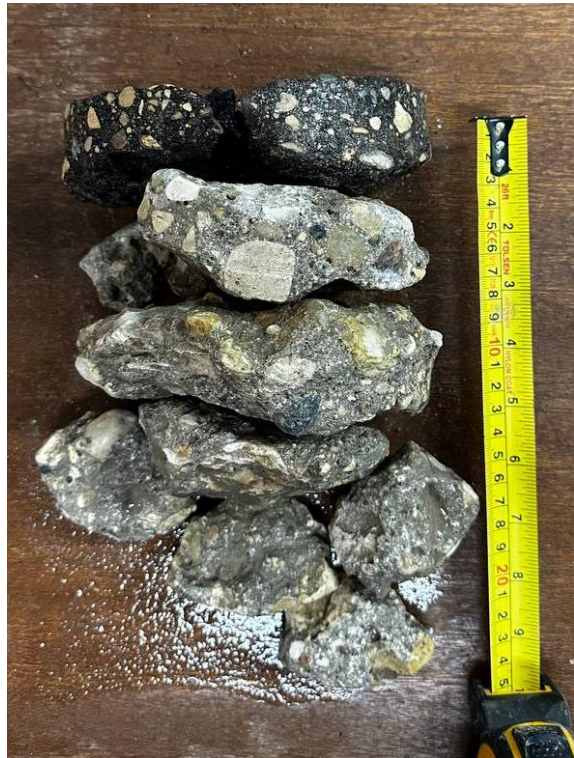
**Core 5 – Sanford (SBL)**

Figure 5. Photos showing Core 5 pavement showing deterioration of concrete and asphalt and void existed between pavement and base surface

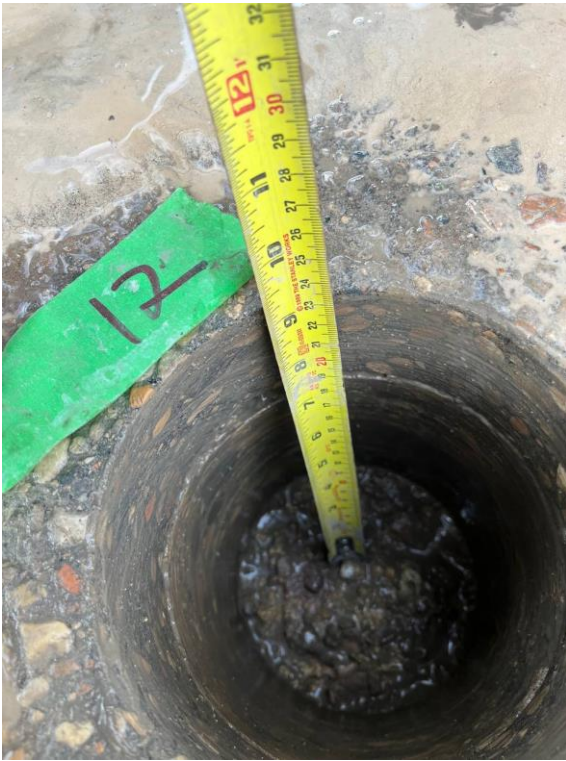
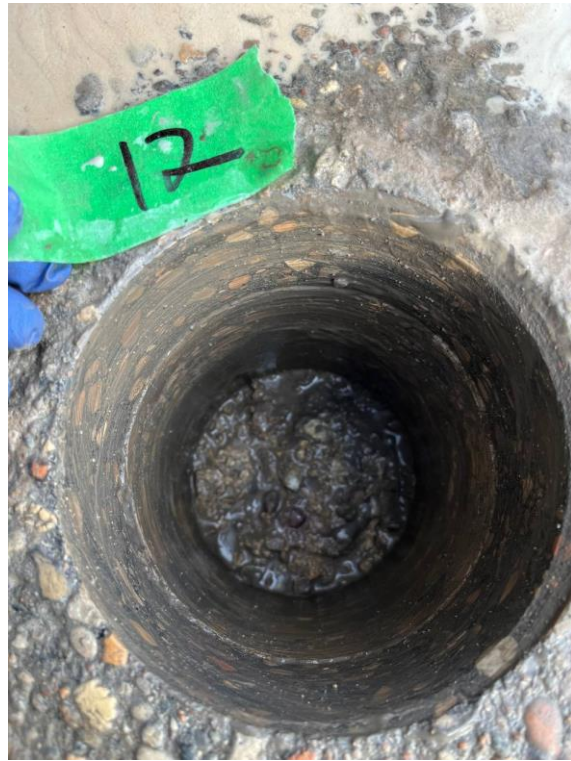
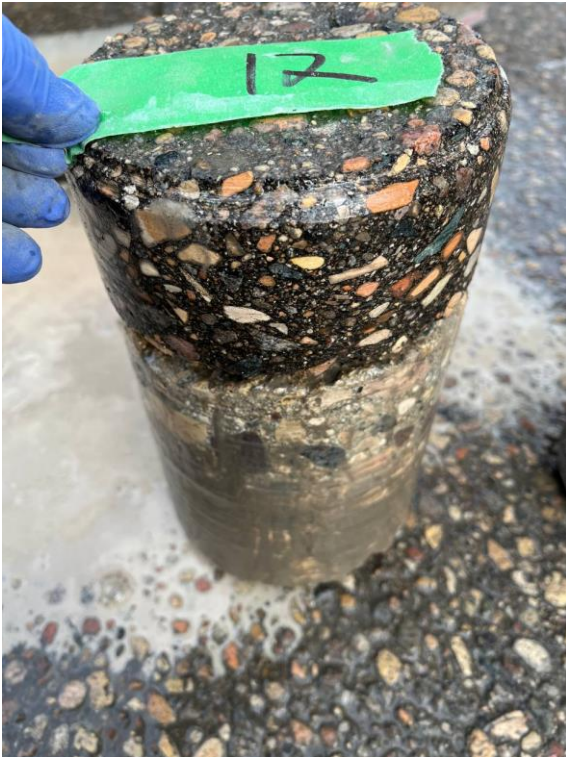
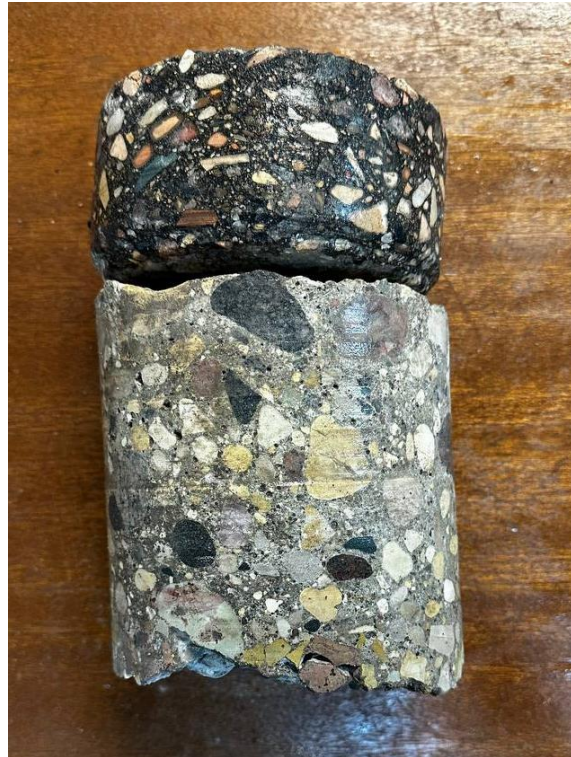
Core 12 – Sanford (SBL)

Figure 12. Photos showing Core 12 pavement surface for compressive strength
