# **GEOTECHNICAL REPORT**

June 10, 2024

**Re: 2024 City of Winnipeg Local Street Renewal Program  
Report of Geotechnical Investigations and Test Results – Rev 1**

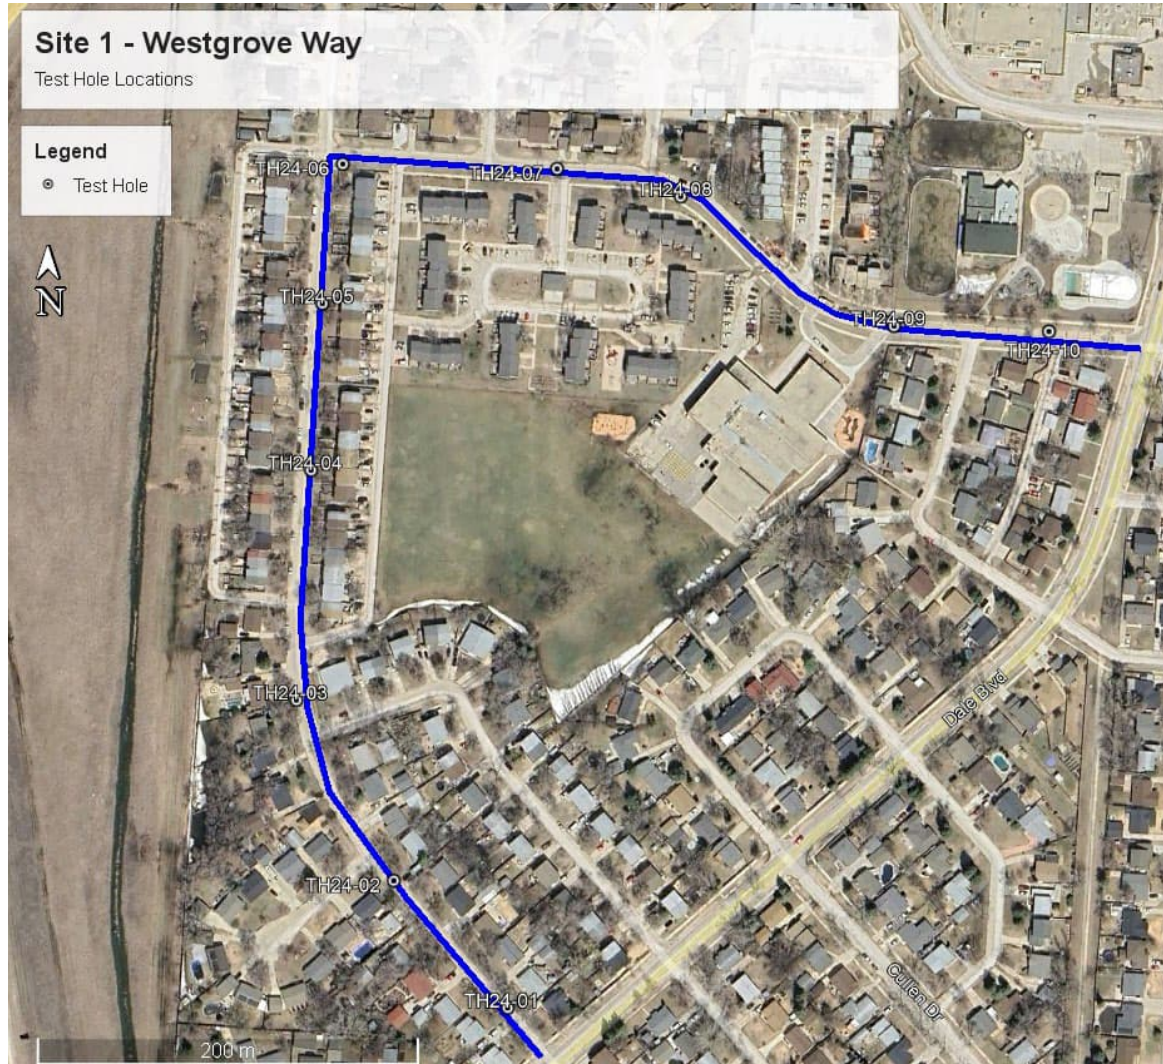
**FIGURE 1: TEST HOLE LOCATIONS FOR WESTGROVE WAY**

A core investigation was conducted along Westgrove Way, involving the extraction of 10 core: five (5) from mid-slab locations and five (5) from joint locations. The pavement surface was composed of concrete with thicknesses ranging from 140 to 203 mm. A granular base was identified at TH24-01, TH24-06, and TH24-07 with thicknesses varying between 38 and 51 mm, while the remaining cores revealed no base material, exposing a clay subgrade beneath the pavement. Detailed core locations are illustrated in Figure 1.

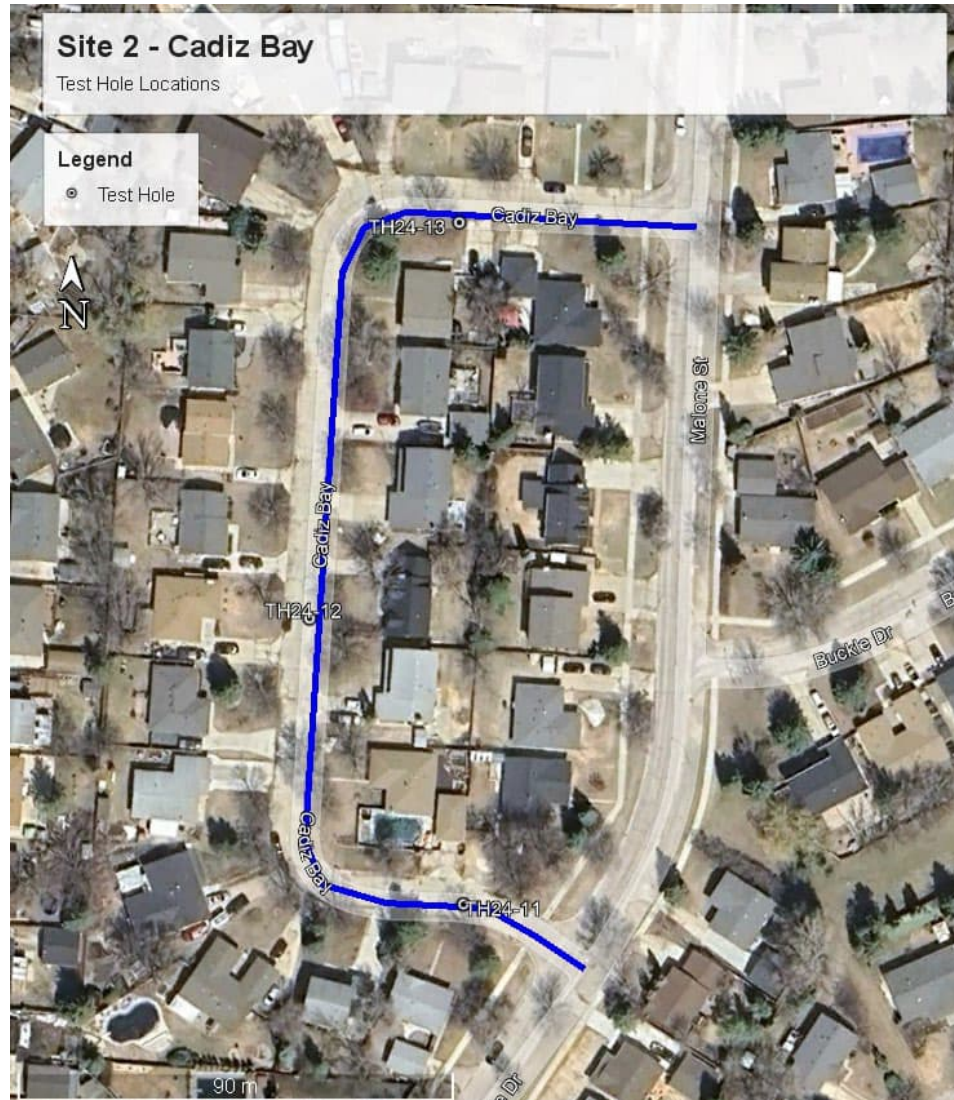
FIGURE 2: TEST HOLE LOCATIONS FOR CADIZ BAY

A core investigation was conducted along Cadiz Bay, involving the extraction of three (3) core: two (2) from mid-slab locations and one (1) from a joint location. The pavement surface was composed of concrete with thicknesses ranging from 133 to 150 mm. A granular base was identified at TH24-11 with a thickness of 76 mm, while the remaining cores revealed no base material, exposing a clay subgrade beneath the pavement. Detailed core locations are illustrated in Figure 2.

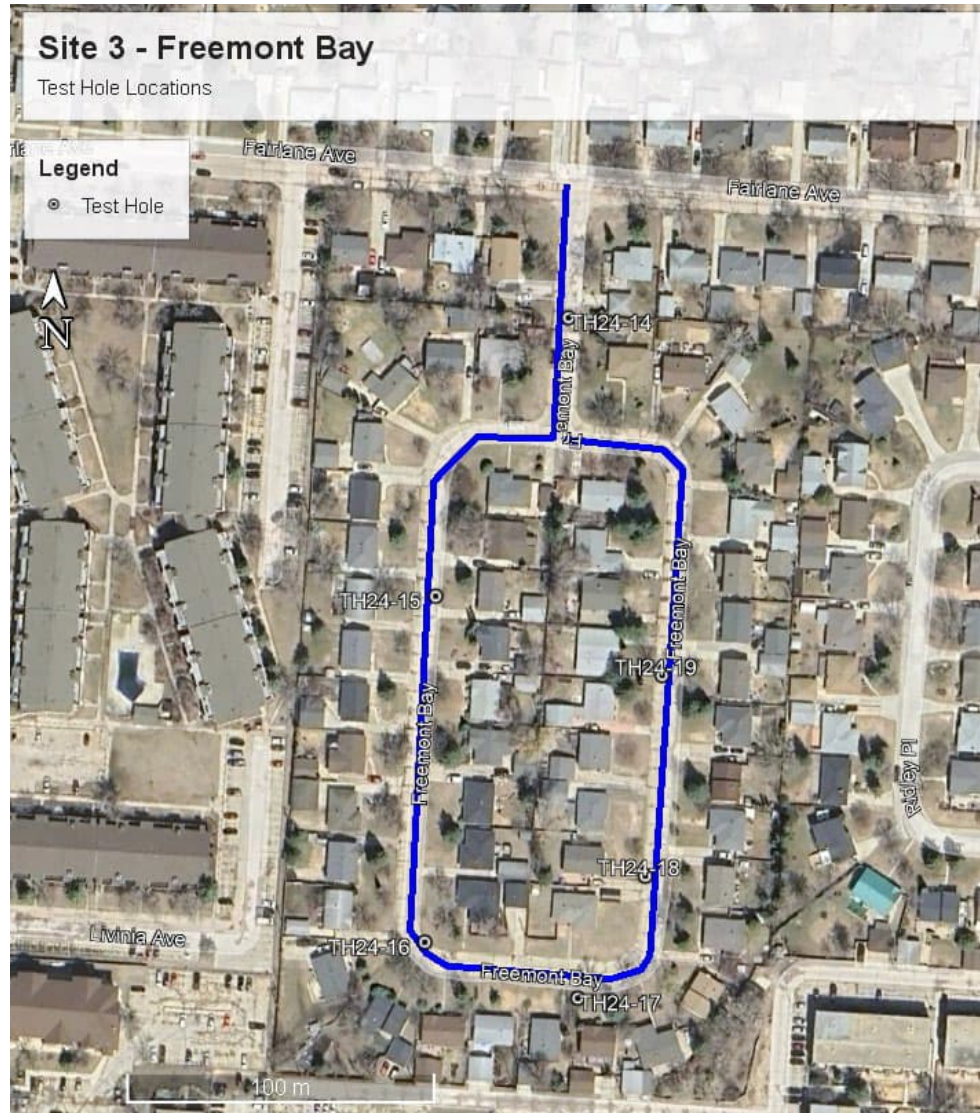
FIGURE 3: TEST HOLE LOCATIONS FOR FREEMONT BAY

A core investigation was conducted along Freemont Bay, involving the extraction of six (6) core: three (3) from mid-slab locations and three (3) from joint locations. The pavement surface was composed of concrete with thicknesses ranging from 150 to 180 mm. Granular base was identified at TH24-14, TH24-15, TH24-16, and TH24-17 with thicknesses varying between 10 and 75 mm, while the remaining cores revealed no base material exposing a clay subgrade beneath the pavement. Detailed core locations are illustrated in Figure 3.

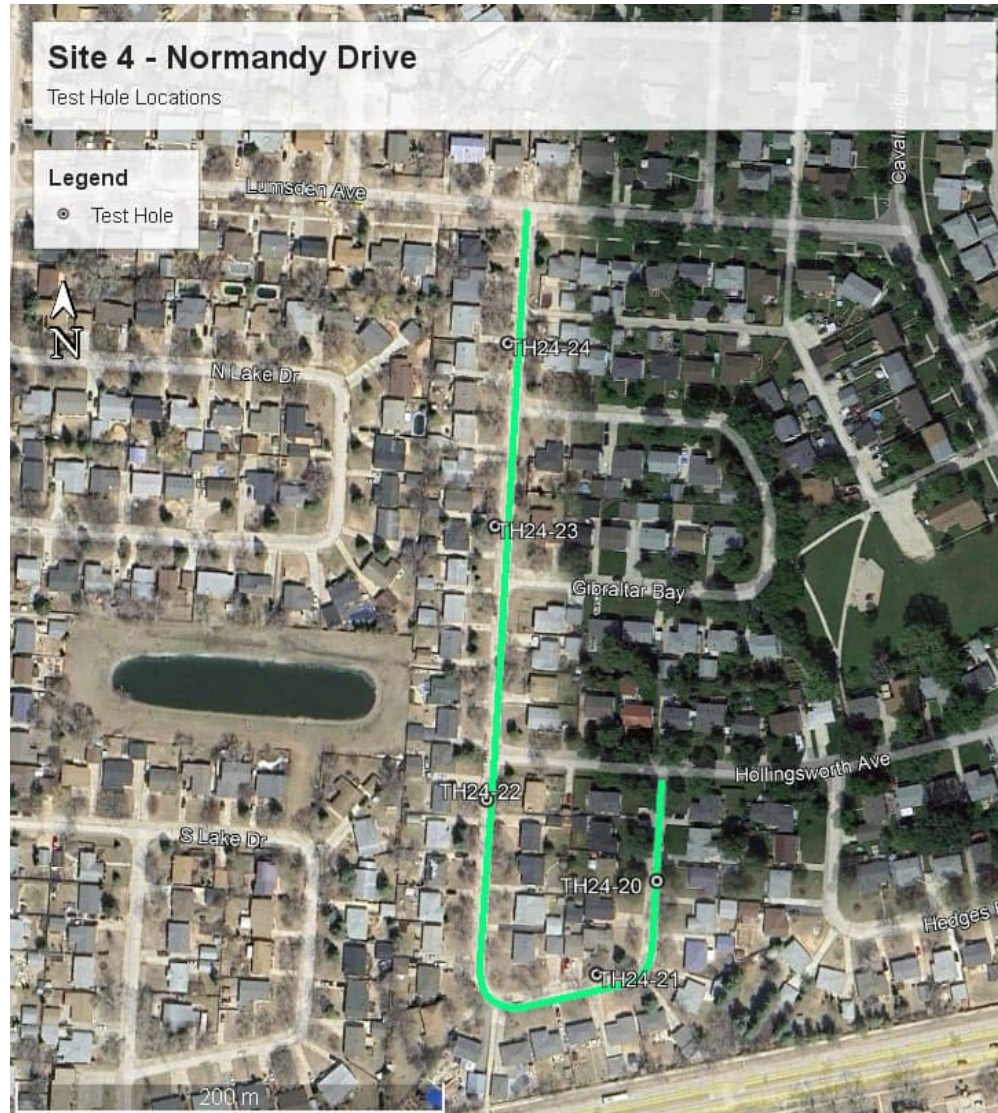
FIGURE 4: TEST HOLE LOCATIONS FOR NORMANDY DRIVE

A core investigation was conducted along Normandy Drive, involving the extraction of five (5) core: three (3) from mid-slab locations and two (2) from joint locations. The pavement surface was composed of concrete with thicknesses ranging from 135 to 150 mm. Crushed limestone base was identified at all core locations, with thicknesses varying between 55 and 152 mm. Detailed core locations are illustrated in Figure 4.

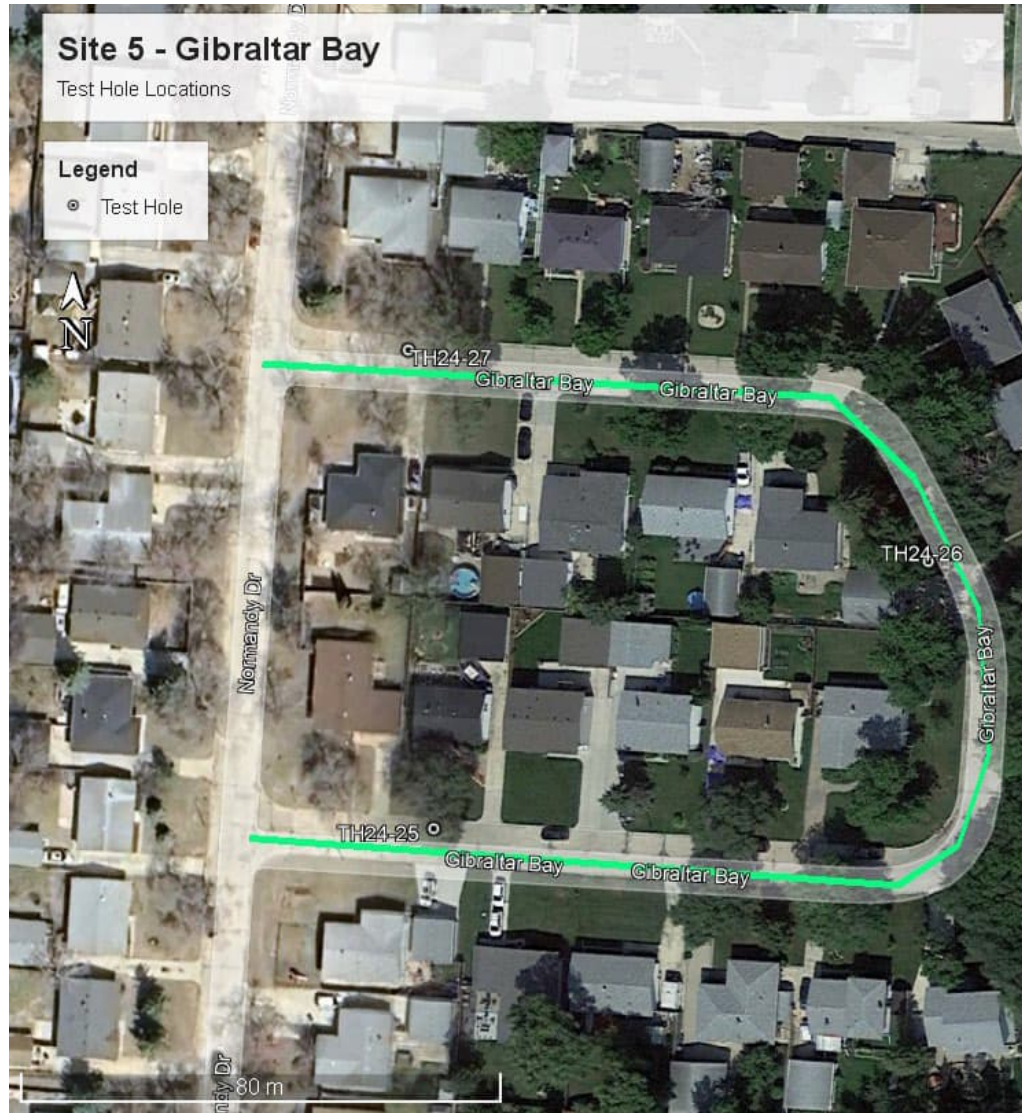
FIGURE 5: TEST HOLE LOCATIONS FOR GIBRALTAR BAY

A core investigation was conducted along Gibraltar Bay, involving the extraction of three (3) core: two (2) from mid-slab locations and one (1) from a joint location. The pavement surface was composed of concrete with thicknesses ranging from 140 to 150 mm. Crushed limestone base was identified at all the core locations, with a thickness of 50 mm. Detailed core locations are illustrated in Figure 5.

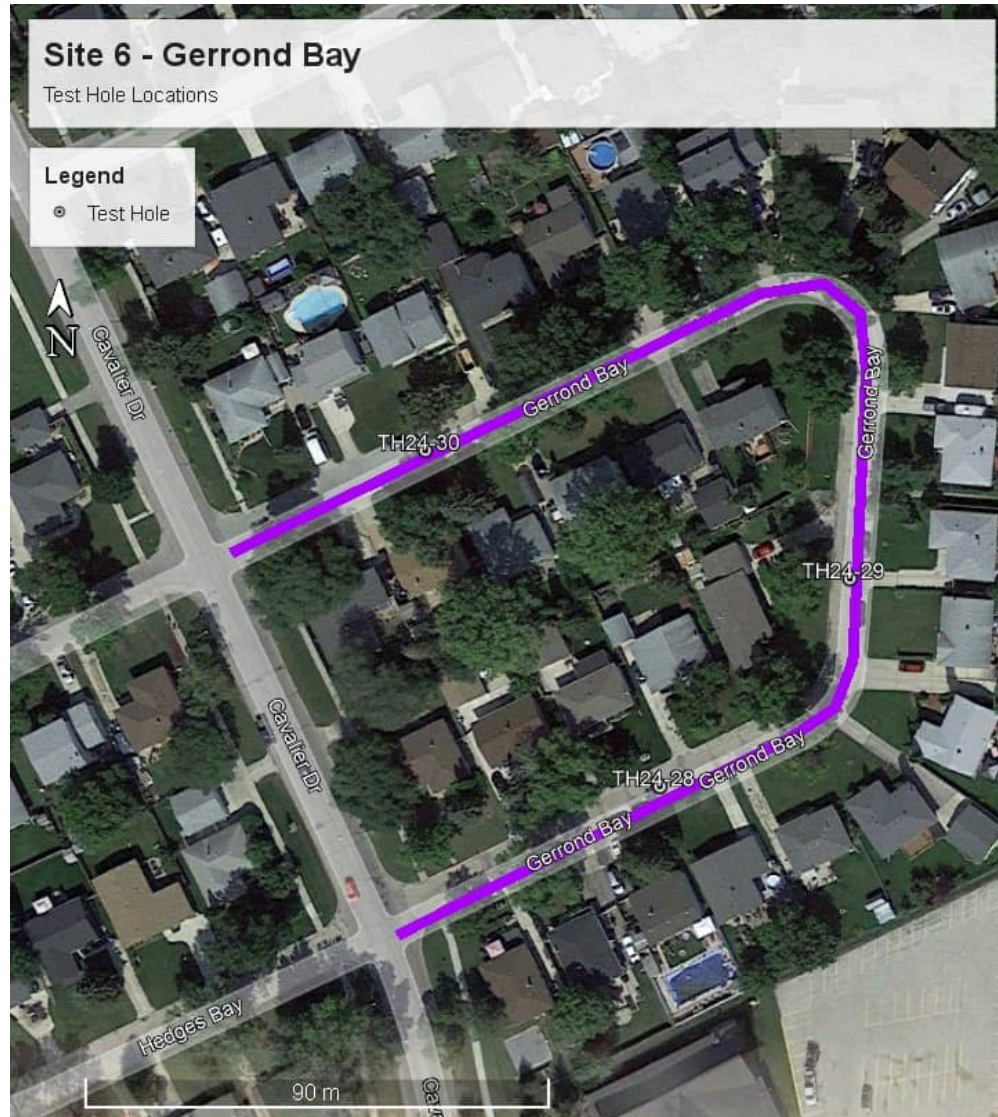
**FIGURE 6: TEST HOLE LOCATIONS FOR GERROND BAY**

A core investigation was conducted along Gerrond Bay, involving the extraction of three (3) core: two (2) from mid-slab locations and one (1) from a joint location. Additional soil investigations were conducted at each of the three (3) test hole locations and were advanced to a depth of 3.0 m (10 ft) below pavement surface using a truck mounted drill rig equipped with 125 mm solid stem augers. The general stratigraphy encountered within the test holes consisted of concrete pavement with granular base overlying fat clay. A further description of each layer is provided below, with test hole logs provided in Appendix B and test hole locations shown in Figure 6.

**Concrete** – The pavement surface consisted of concrete with varying thicknesses of 128 to 204 mm.

**Lean Clay (CL)** – Granular base material was encountered directly below the concrete in all test holes and varied in thickness between 101 to 280 mm. The fill material was brown, low plasticity, with silt, fine to medium sand and frozen. The maximum aggregate size observed was between 30 and 40 mm.

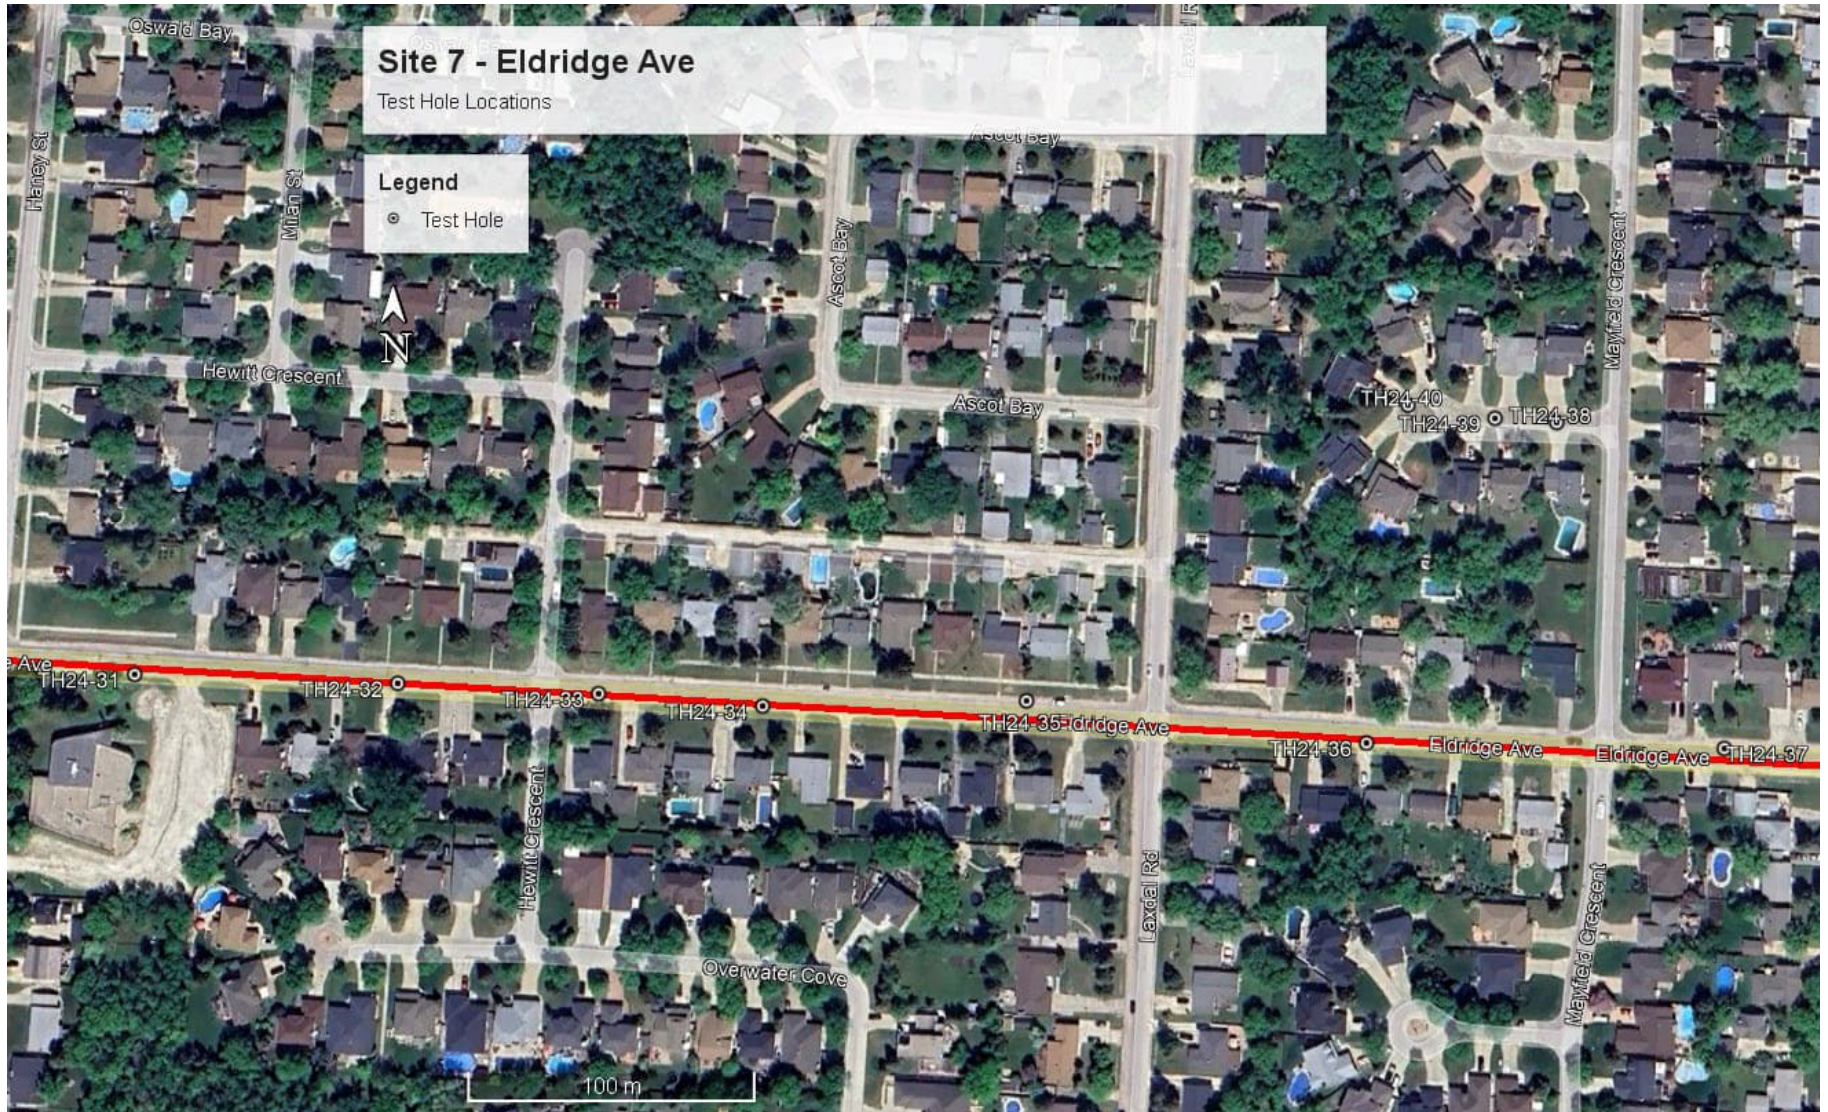
FIGURE 7: TEST HOLE LOCATIONS FOR ELDRIDGE AVEUNE

A core investigation was conducted along Eldridge Avenue, involving the extraction of six (6) core from exclusively mid-slab locations. The pavement surface was composed of asphalt with thicknesses ranging from 100 to 185 mm. Granular base was identified at TH24-32, TH24-33, TH24-34, TH24-35, and TH24-36 with thicknesses of 40 and 185 mm, while the remaining core revealed no base material, exposing a clay subgrade beneath the pavement. Detailed core locations are illustrated in Figure 7.

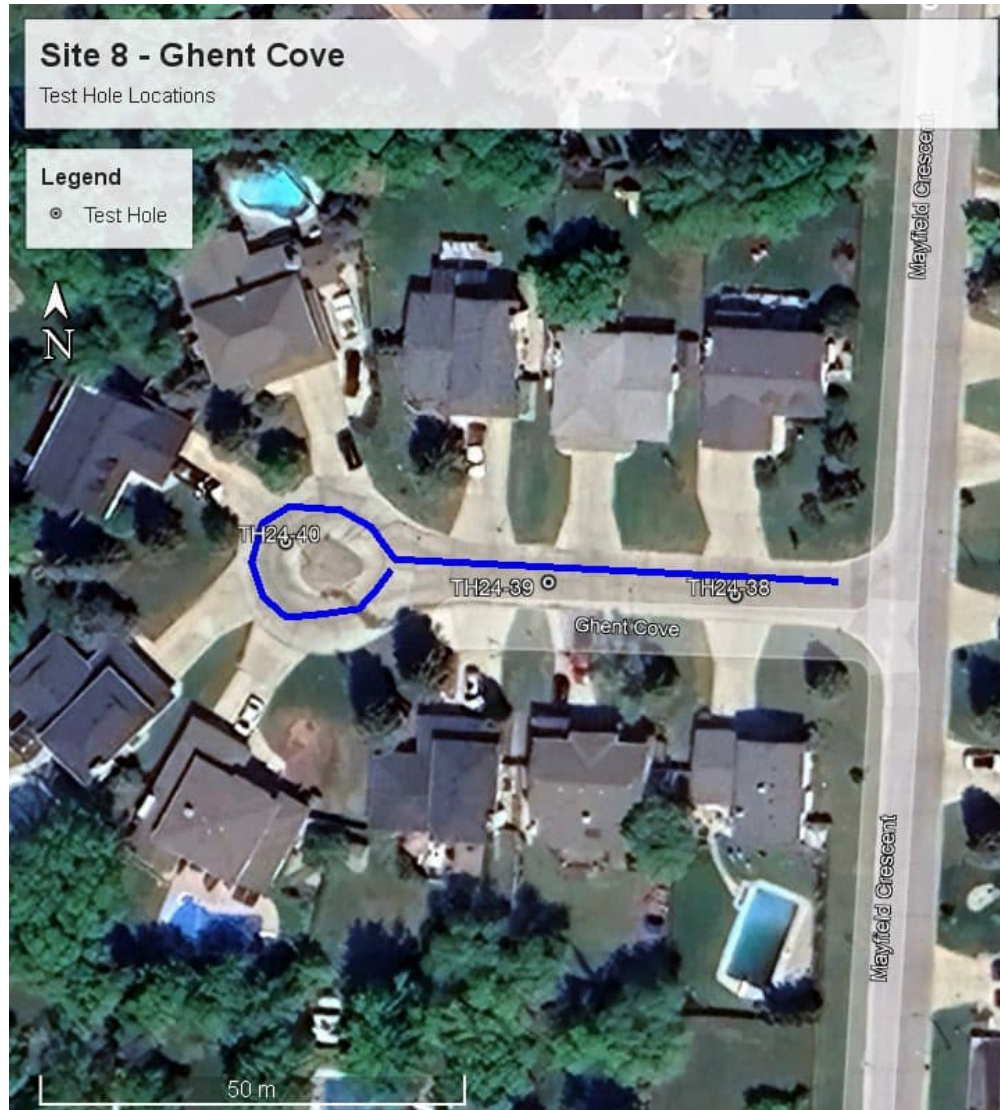
FIGURE 8: TEST HOLE LOCATIONS FOR GHENT COVE

A core investigation was conducted along Ghent Cove, involving the extraction of three (3) core: two (2) from mid-slab locations and one (1) from a joint location. The pavement surface was composed of concrete with thicknesses ranging from 130 to 180 mm. Crushed limestone base was identified at all the core locations, with thicknesses of 30 and 50 mm, overlaying a sandy subgrade material. Detailed core locations are illustrated in Figure 8.

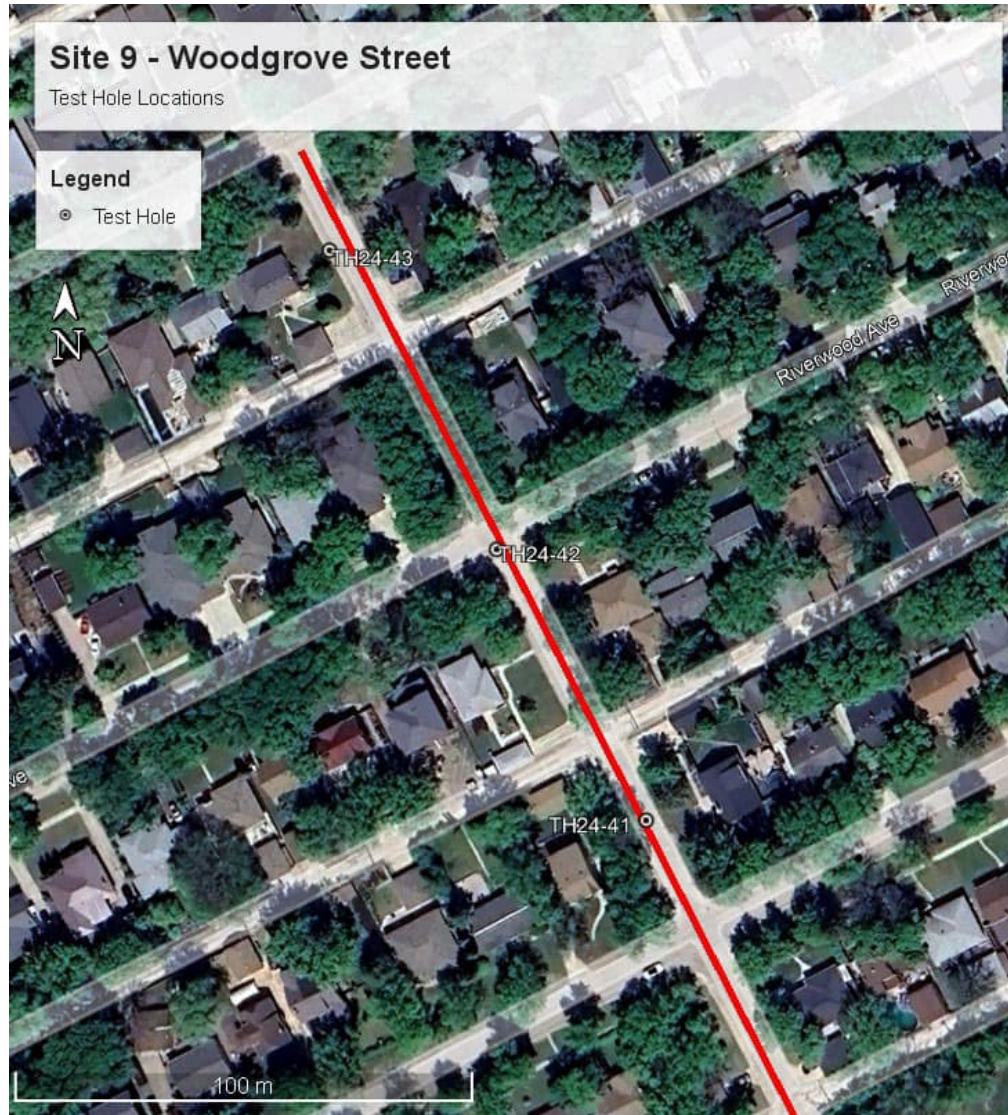
**FIGURE 9: TEST HOLE LOCATIONS FOR WOODGROVE STREET**

A core investigation was conducted along Woodgrove Street, involving the extraction of three (3) core from only mid-slab locations. The pavement surface was composed of asphalt with thicknesses ranging from 60 to 75 mm. No base material was identified at any of the core locations, exposing a sandy clay subgrade beneath the pavement. Detailed core locations are illustrated in Figure 9.

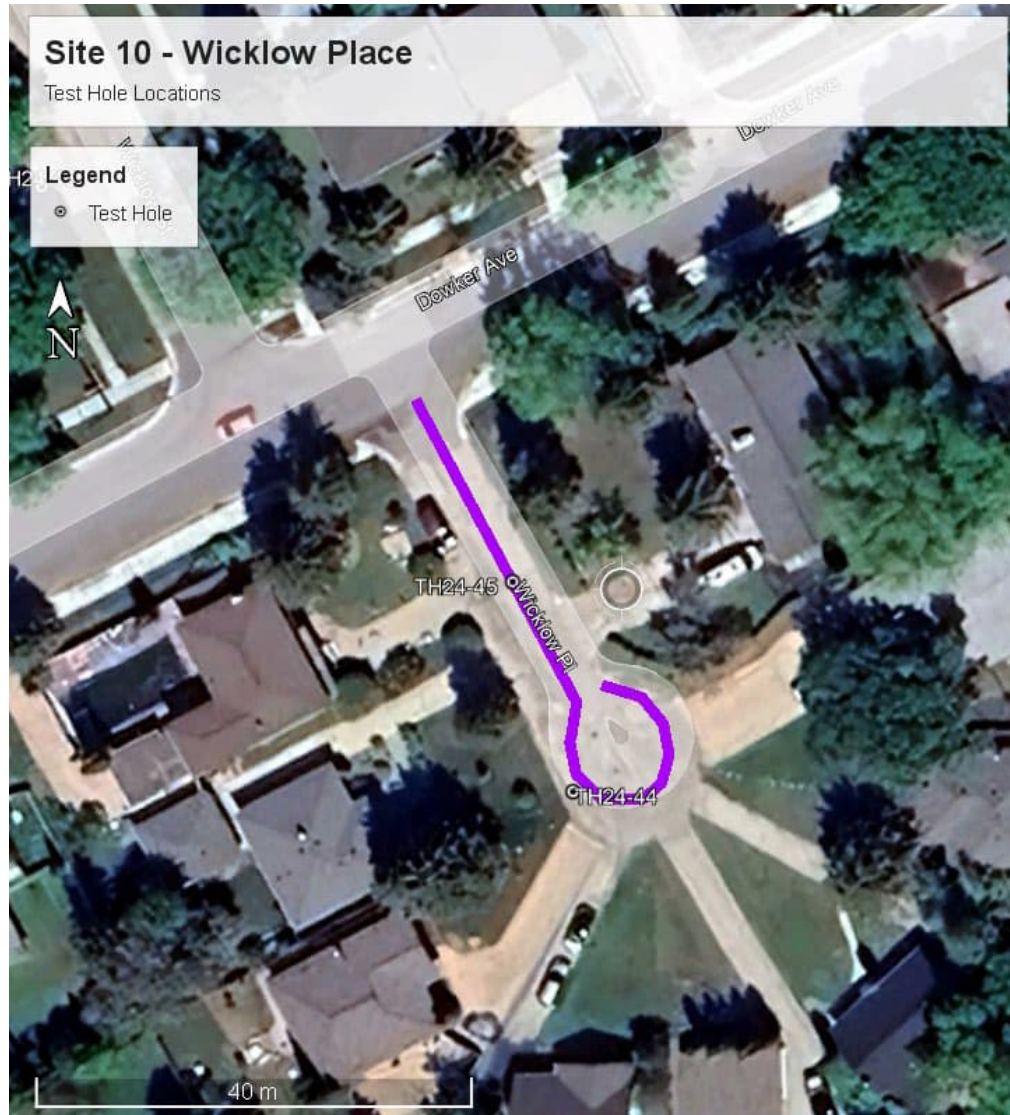
FIGURE 10: TEST HOLE LOCATIONS FOR WICKLOW PLACE

A core investigation was conducted along Wicklow Place, involving the extraction of two (2) core from mid-slab locations. Subgrade drilling was conducted at each of the two (2) test holes and were advanced to a depth of 3.0 m (10 ft) below pavement surface using a truck mounted drill rig equipped with 125 mm solid stem augers. The general stratigraphy encountered within the test holes consisted of asphalt over concrete pavement with crushed limestone base, overlying fat clay. A further description of each layer is provided below, with test hole logs provided in Appendix B and test hole locations shown in Figure 10.

**Pavement Surface** – The pavement surface consisted of an asphalt top with varying thicknesses of 52 to 61 mm, overlying concrete pavement with varying thicknesses of 52 and 61 mm.

**Crushed limestone Gravel Fill** – Crushed limestone base material was encountered directly below the pavement surface in both test holes and was varying in thickness between 73 and 107 mm. The fill material was brown, fine to medium with well graded sand, and frozen. The maximum aggregate size observed was between 30 and 40 mm.

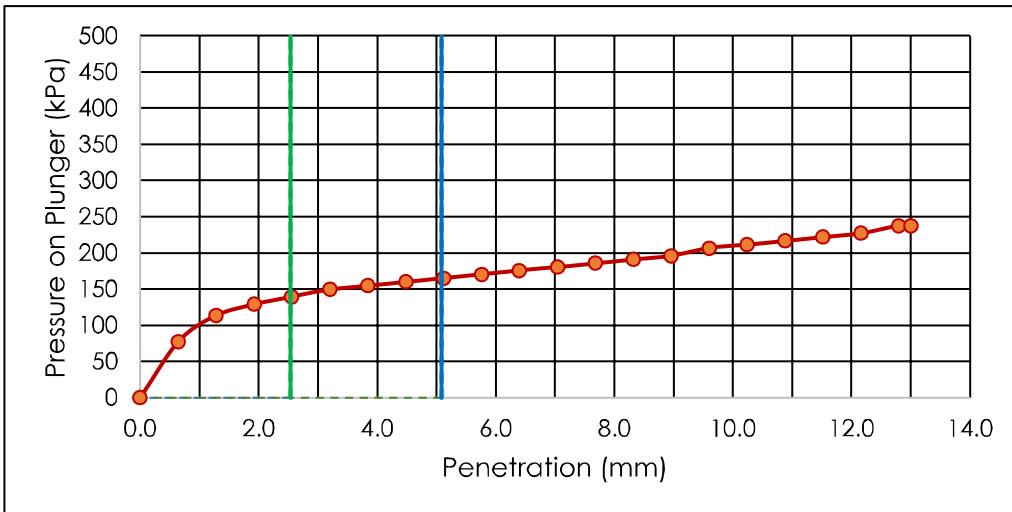
MATERIAL USE	Subgrade	SUPPLIER	Not Applicable
MAX. NOMINAL SIZE	< 4.75 mm	SOURCE	In Situ
MATERIAL TYPE	Clay	SAMPLE LOCATION	Composite Sample, TH24-28, S2 to S4
SPECIFICATION ID	Not Applicable	STANTEC SAMPLE NO.	4211

**CBR VALUE AT 2.54 mm PENETRATION**  
2.0

**CBR VALUE AT 5.08 mm PENETRATION**  
1.6

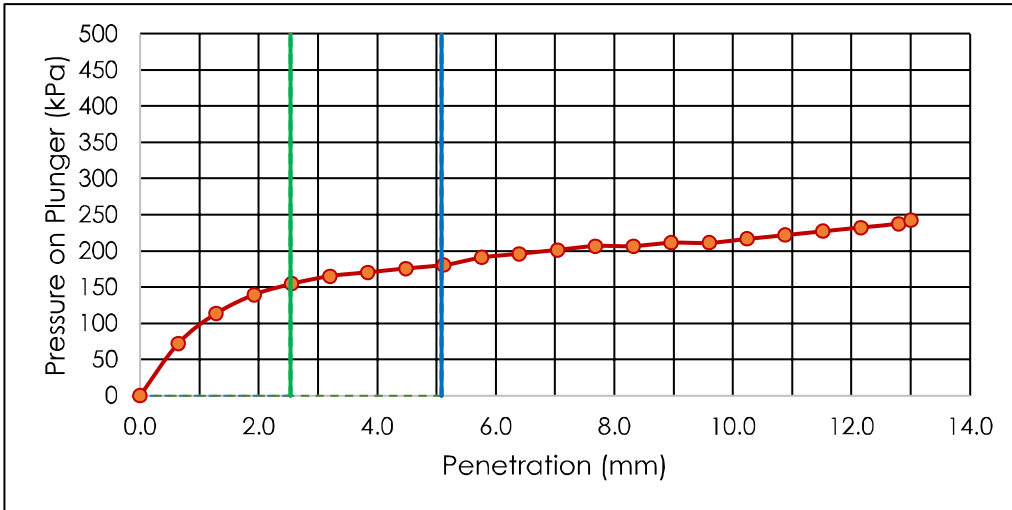
MATERIAL USE	Subgrade	SUPPLIER	Not Applicable
MAX. NOMINAL SIZE	< 4.75 mm	SOURCE	In Situ
MATERIAL TYPE	Clay	SAMPLE LOCATION	TH24-44, S1 to S2 & TH24-45, S1 & S2
SPECIFICATION ID	Not Applicable	STANTEC SAMPLE NO.	4215

**CBR VALUE AT 2.54 mm PENETRATION**  
**2.2**

**CBR VALUE AT 5.08 mm PENETRATION**  
**1.8**

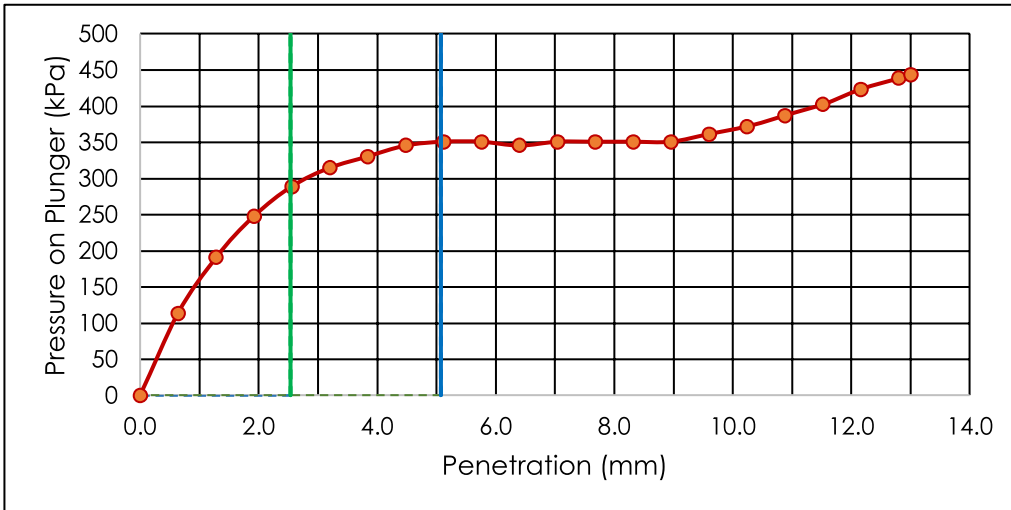
**CBR VALUE AT 2.54 mm PENETRATION**  
**4.2**

**CBR VALUE AT 5.08 mm PENETRATION**  
**3.5**

Sample prepared to 95% of the maximum dry density at the optimum moisture content as determined from ASTM D698.  
 Compiste sample consisting of material taken from; TH24-52 (S4 & S5), TH24-53 (S4 & S5), TH24-54 (S4 & S5).
