## **Hazardous Building Materials Assessment (Pre-construction)**

Jessie Flood Pump Station  
413 Mulvey Avenue East,  
Winnipeg, Manitoba

April 4, 2024

Pinchin File: 338700

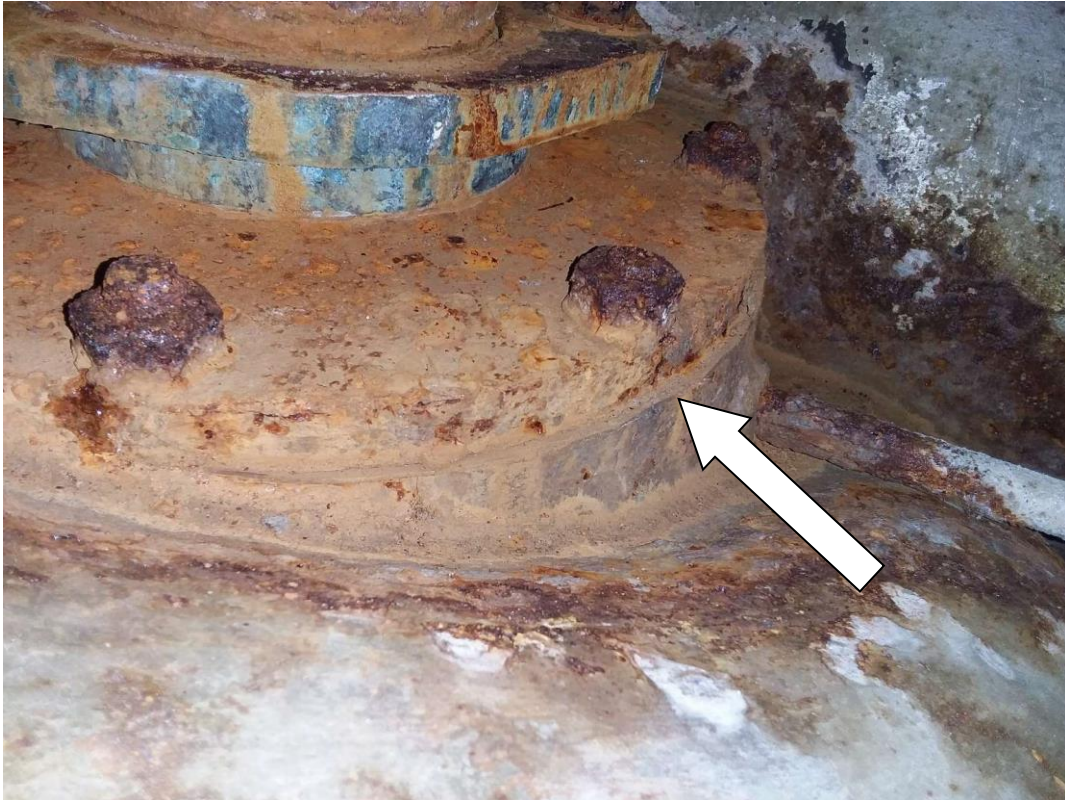
Gaskets on piping connections within the Pump Room (Location 2) do not contain asbestos (samples S0001A-C).

S0001A (None), Mechanical Equipment, Pump, Gasket, Pump Room (Location #: 2)

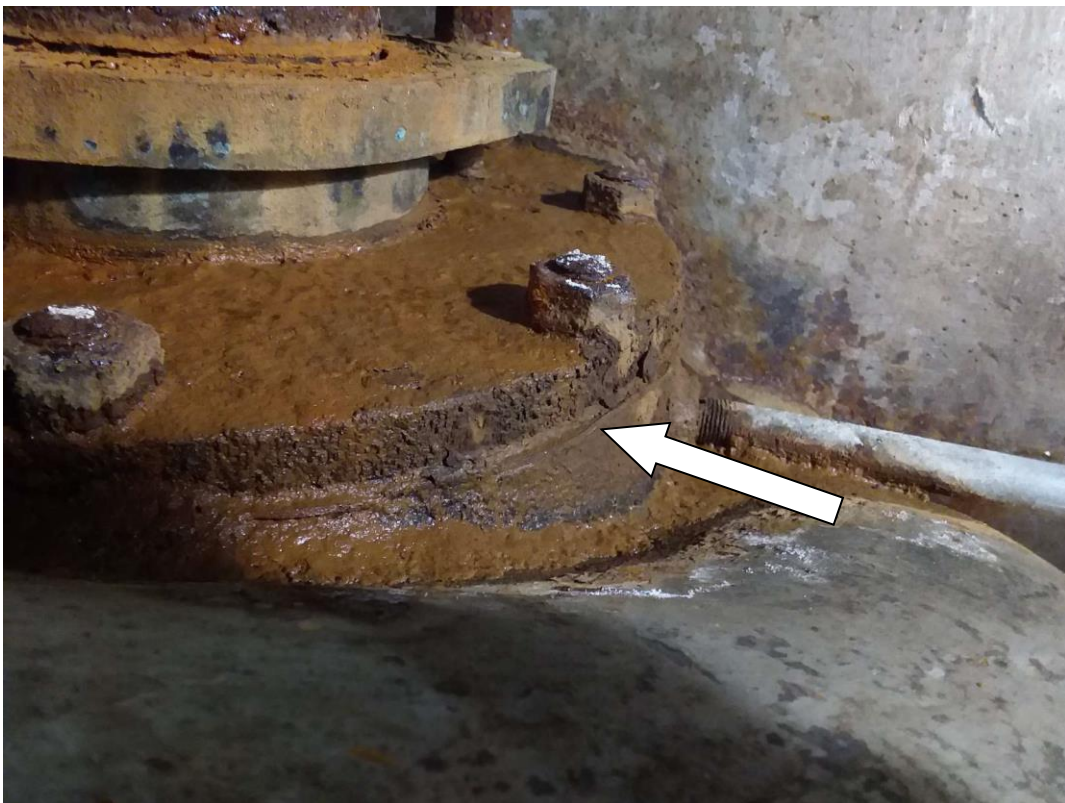
S0001A (None), Mechanical Equipment, Pump, Gasket, Pump Room (Location #: 2)

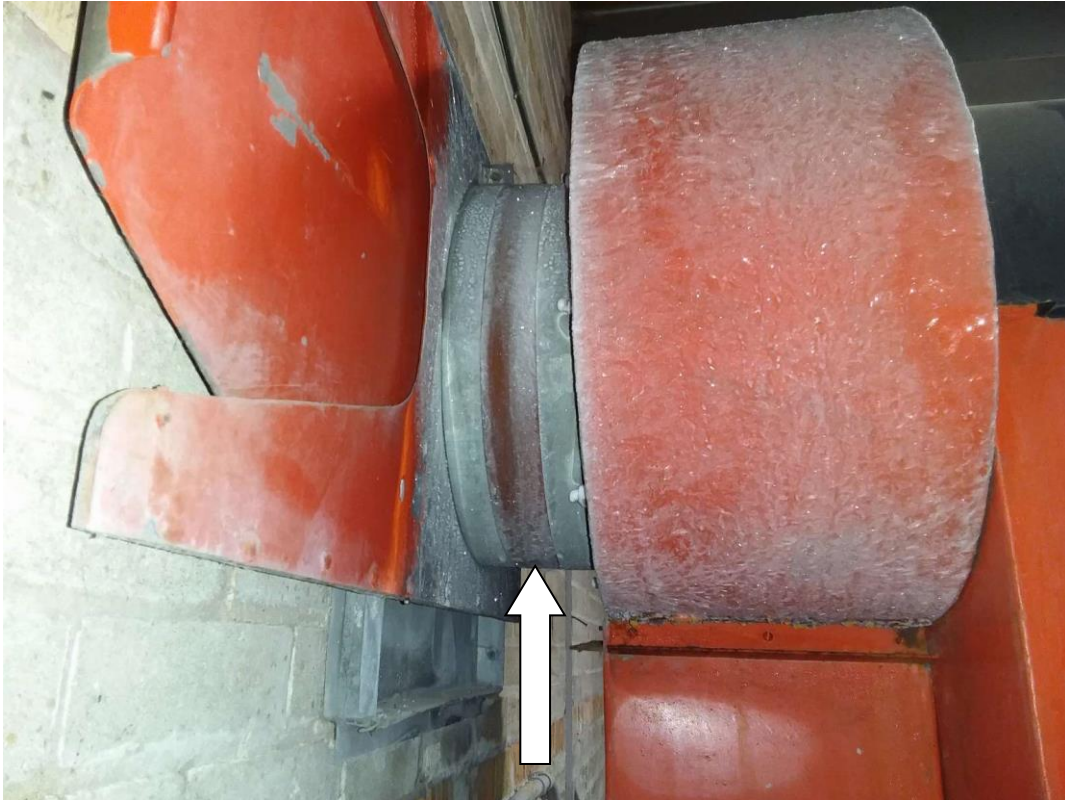
- Textile duct connector within the Control/Motor Room (Location 1) is presumed to contain asbestos, non-friable and maintained in good condition.

Textile vibration dampers, presumed to contain asbestos, are present as duct connectors in the Control/Motor Room (Location 1).

V9500 (Presumed Asbestos), Duct, Duct Connector, Textile, Control/Motor Room (Location #: 1)  
Red

Remove asbestos-containing materials (ACM) prior to renovation, alteration, or maintenance if ACM may be disturbed by the work. If the identified ACM will not be removed prior to commencement of the work, any potential disturbance of ACM must follow asbestos precautions appropriate for the type of work being performed.

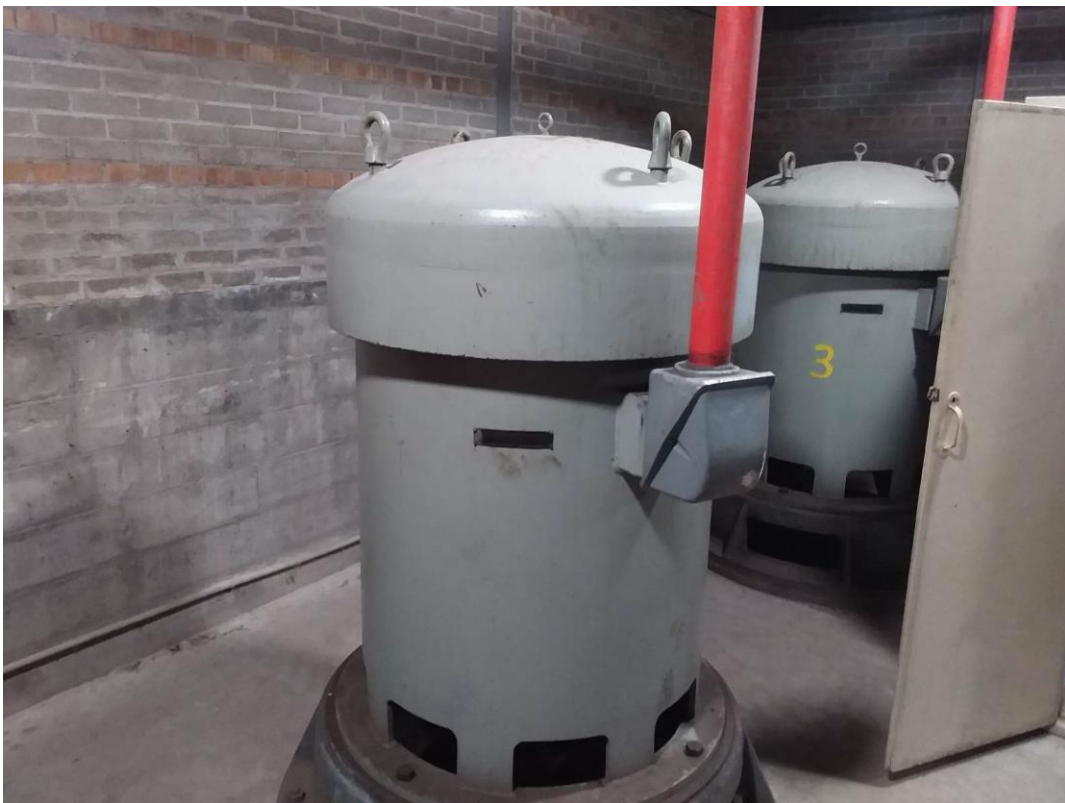
Mechanical Equipment, Not Insulated, Control/Motor Room (Location #: 1)

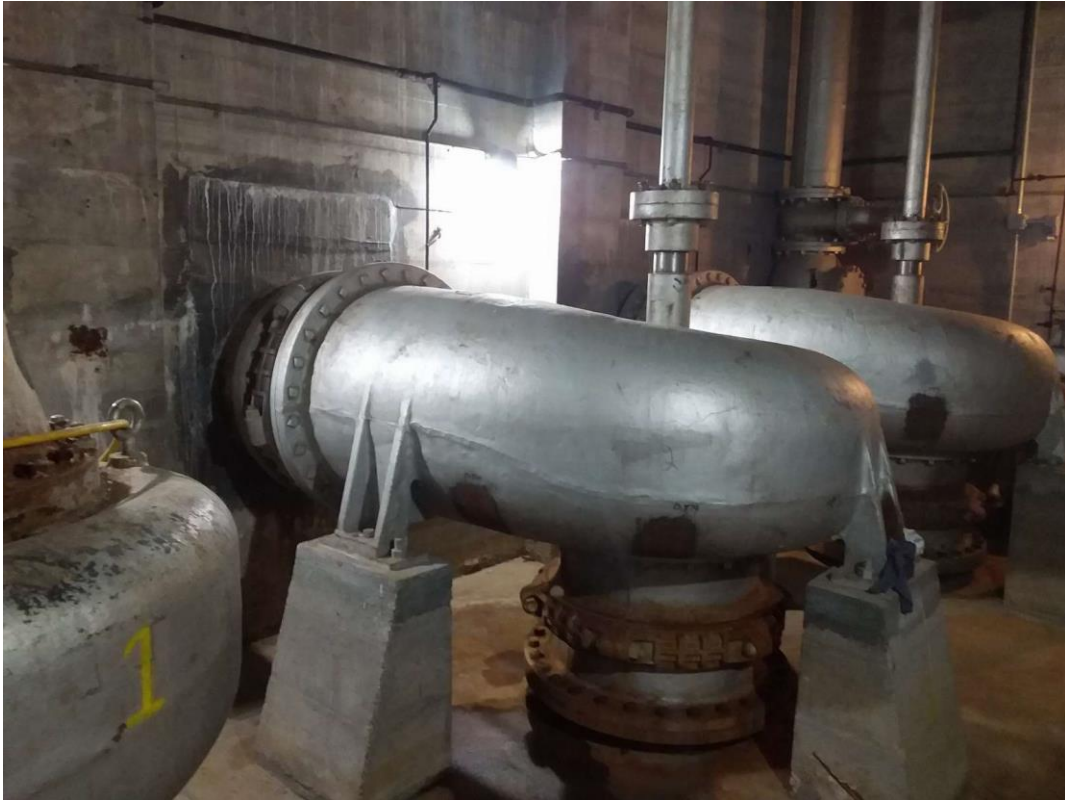
Mechanical equipment (e.g., unit heaters, pumps) is uninsulated.

Mechanical Equipment, All, Not Insulated, Pump Room (Location #: 2)

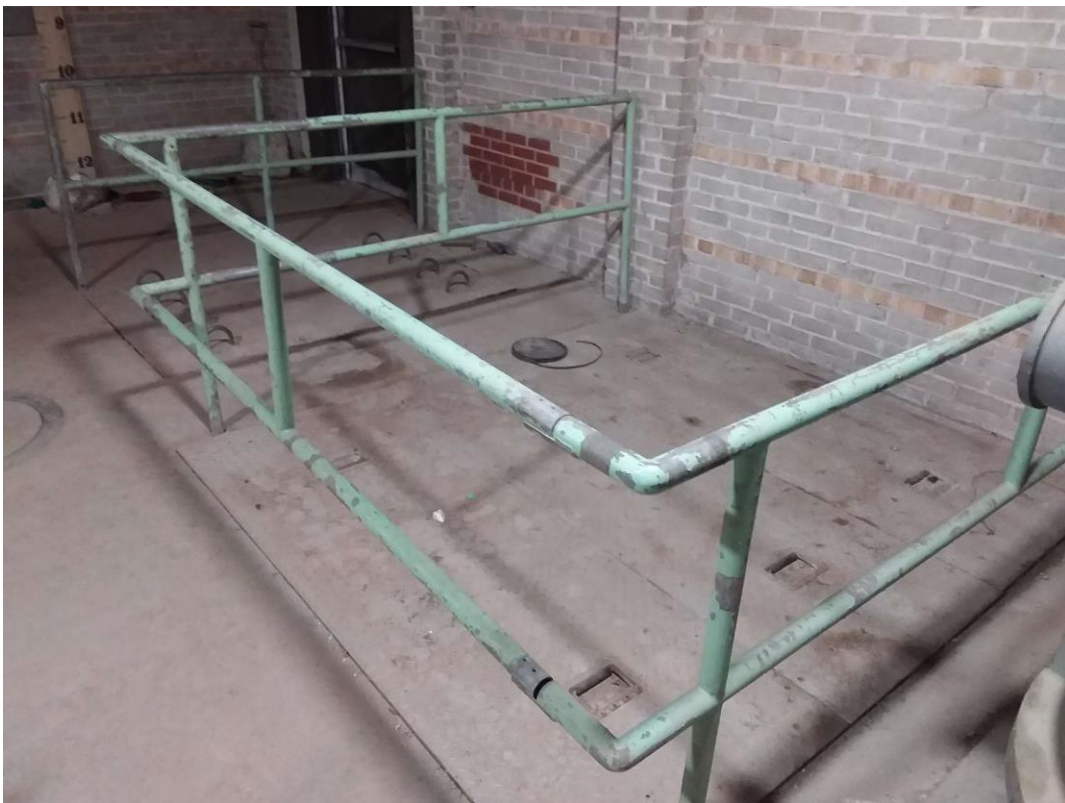
L0001(Lead, Yes), Green, Piping, Control/Motor Room (Location #: 1)  
Green - Handrail

Construction disturbance of lead in paint and coatings (or other materials) may result in exposure to lead dust or fumes and safe work procedures are required. Project specific work procedures, engineering controls and personal protective equipment will need to be assessed and developed as per applicable regulations and guidelines.

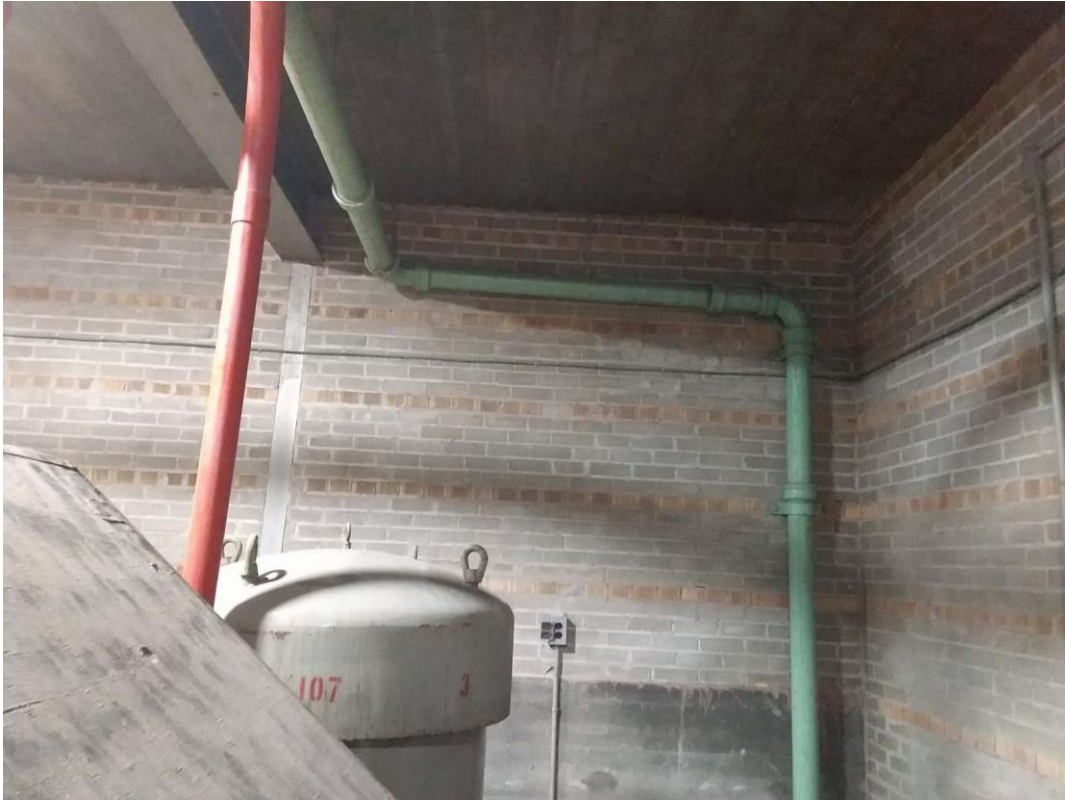
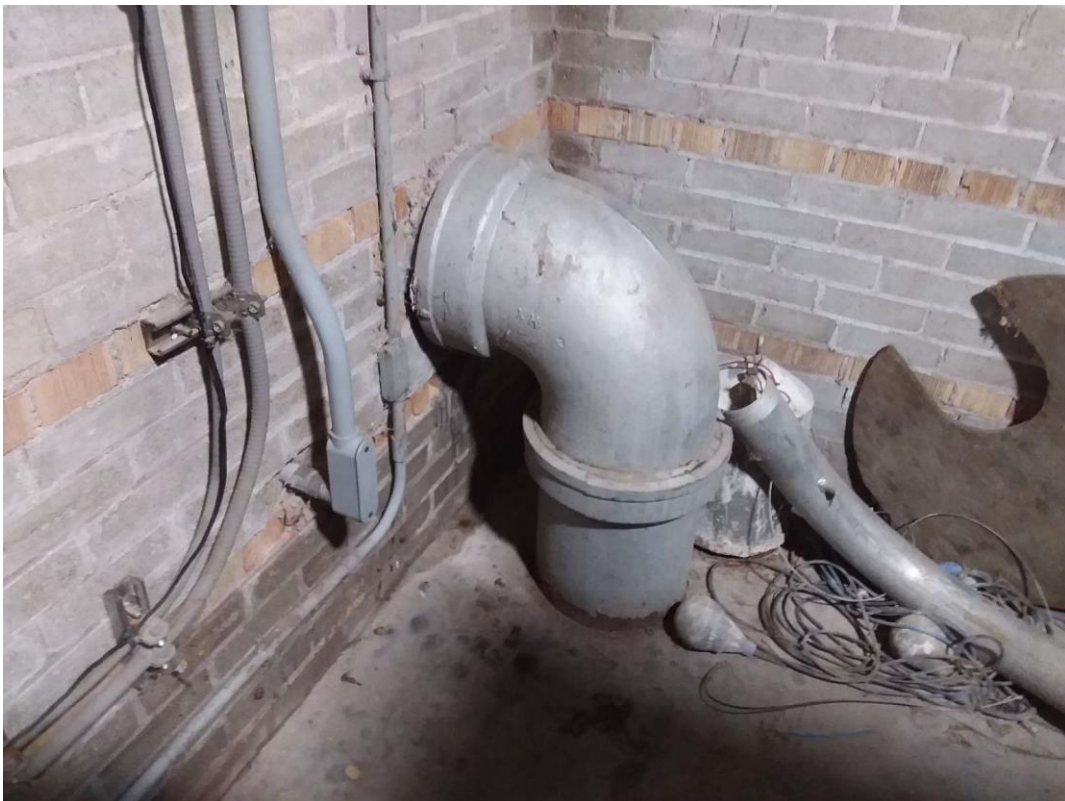
Lead caulking is present in bell and spigot fittings on cast iron pipes.

Pb Products, V9000(Yes), BELL AND SPIGOT FITTINGS, Rainwater leader, Control/Motor Room (Location #: 1)

Lead-containing items should be recycled when taken out of service.

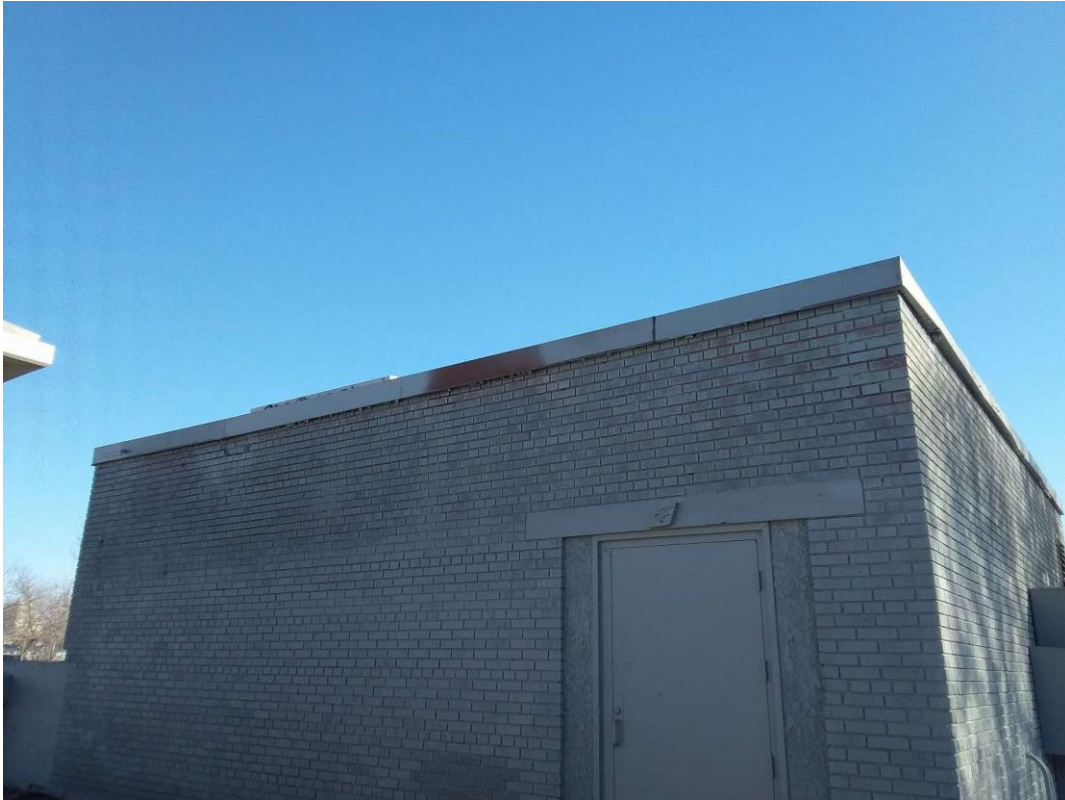
Lead flashings were observed on the perimeter of the roof.

Pb Products, V9000(Yes), ROOF FLASHING, Painted grey, Exterior of Building (Location #: 3)

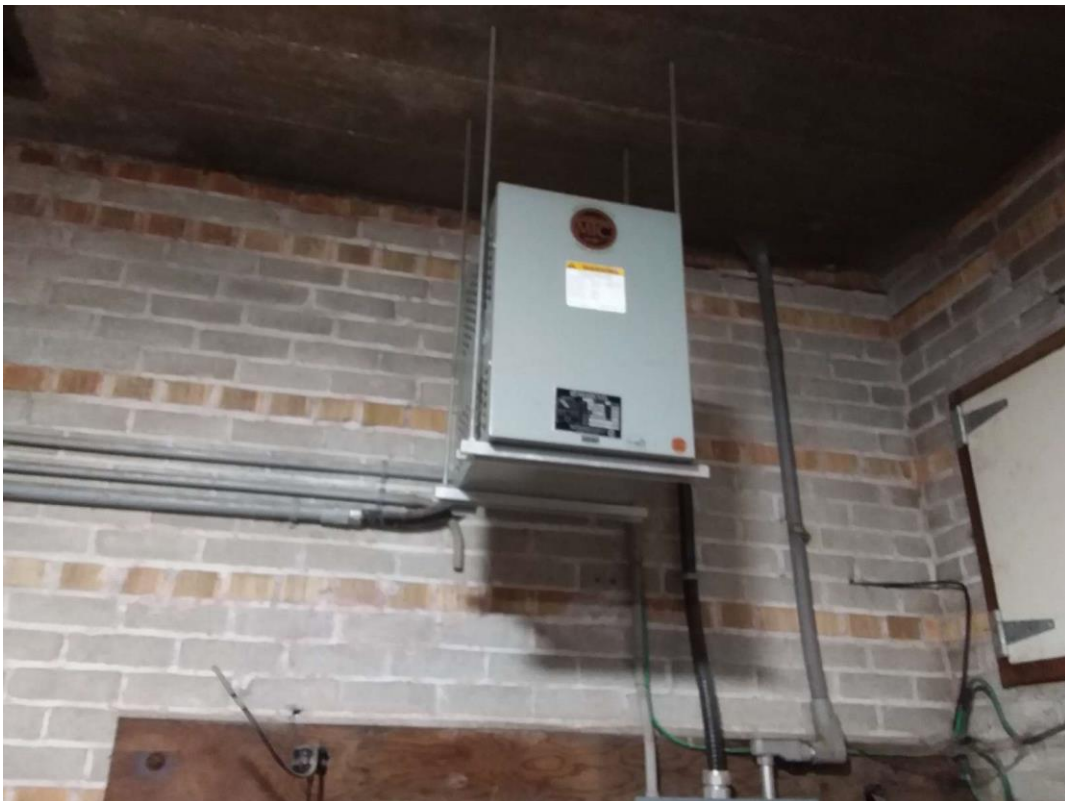
All transformers in the building are dry type transformers and do not contain PCB-containing dielectric fluids; however, may contain capacitors, which could not be assessed for PCBs as the equipment was in service.

PCB, V0000(No), TRANSFORMER, Control/Motor Room (Location #: 1)
