Millennium Library Parkade – 251 Donald St. Parkade Condition Assessment

Submitted to: City of Winnipeg
Attention: Mr. Jason Wiebe C.E.T.
Date: April 1, 2021 (Revised April 8, 2021)
Submitted by: Crosier Kilgour & Partners Ltd.
300-275 Carlton Street
Winnipeg, Manitoba R3C 5R6
Phone: 204.943.7501 Fax: 204.943.7507
Website: www.ckpeng.com
Contact: Derek J. Mizak, P.Eng.
Our File No. 2020-1183

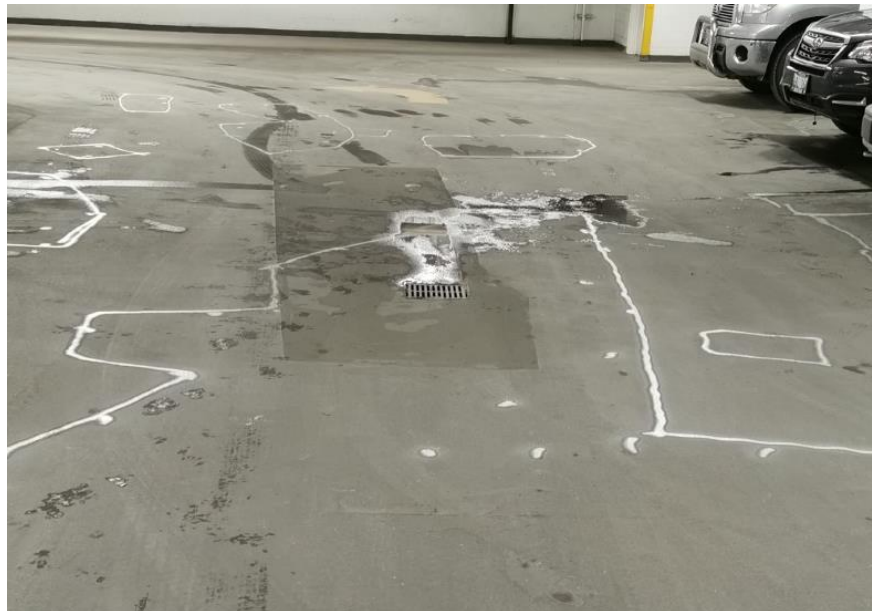
Photograph #2:

Previous waterproofing repair location.

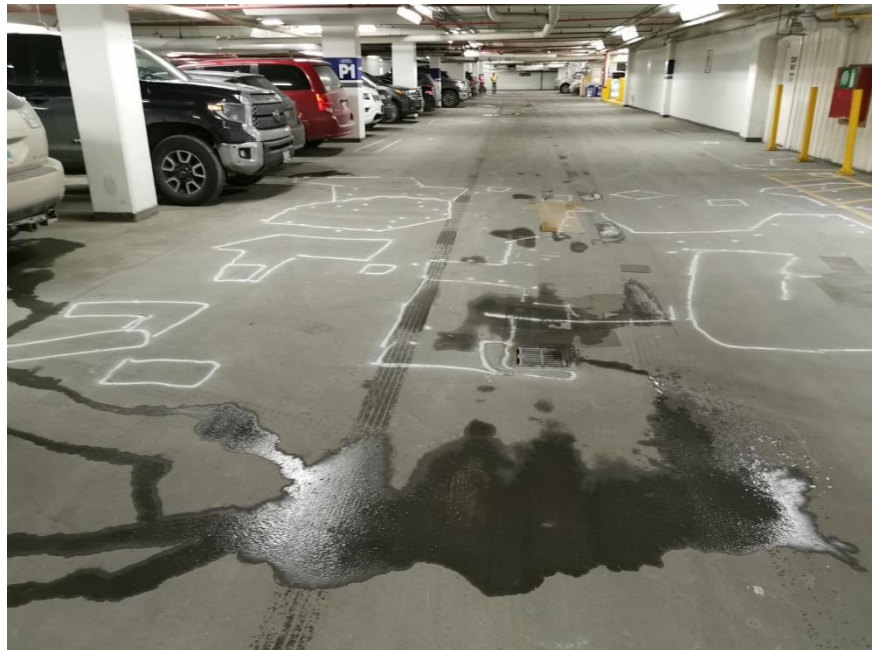
Photograph #4:

Approximate extents of apparent concrete delamination marked onsite.

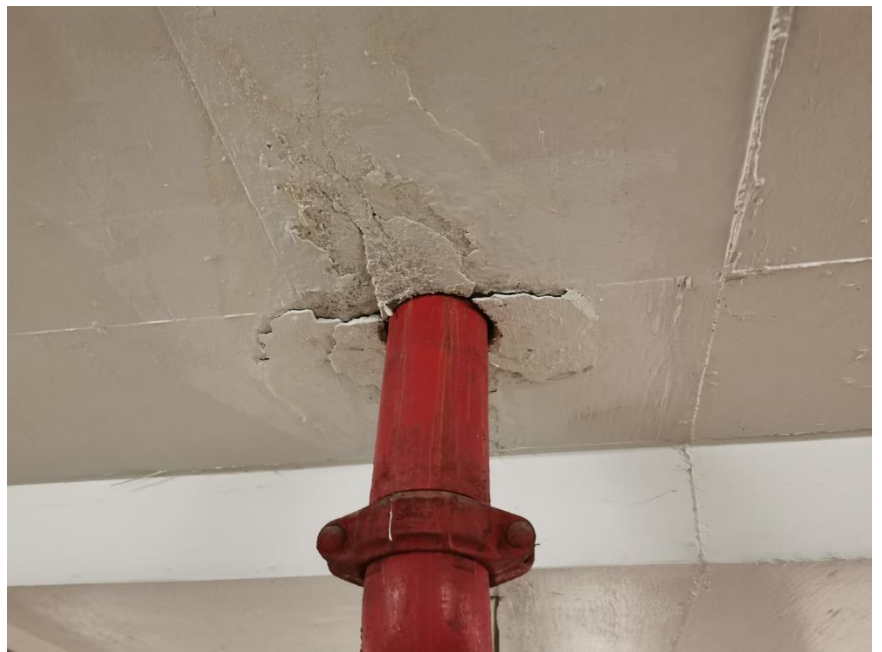
Photograph #6:

Soffit deterioration at mechanical.

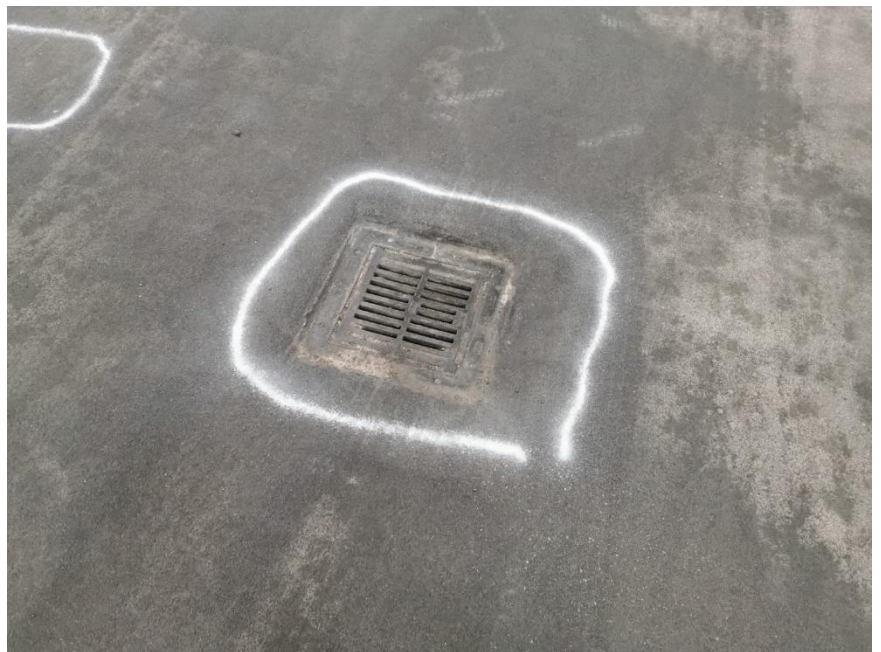
Photograph #8:

Typical condition of observed drains.

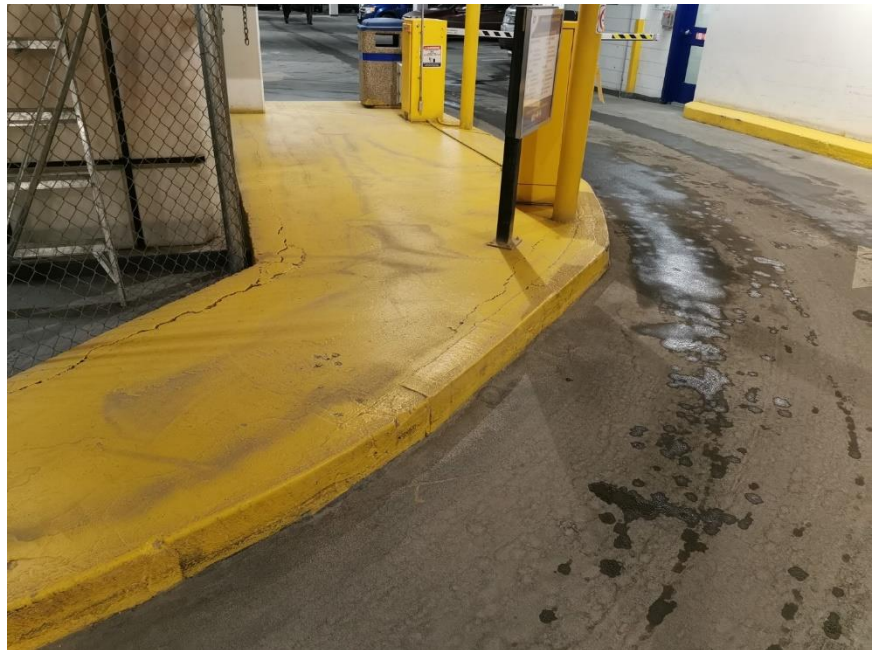
Photograph #10:

Existing concrete curb at Donald street entrance.

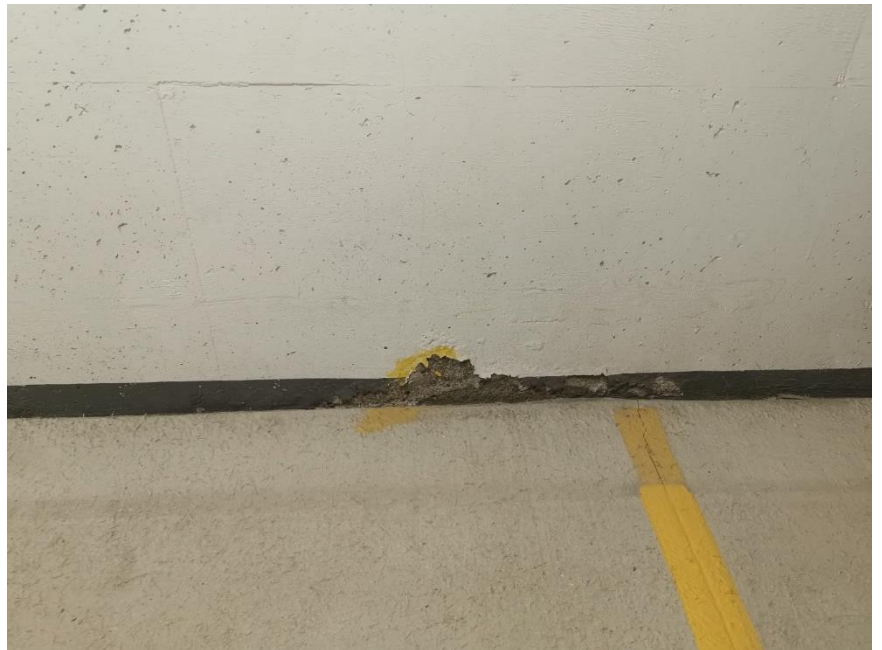
Photograph #12:

Typical scaling along base of wall on Level P2.

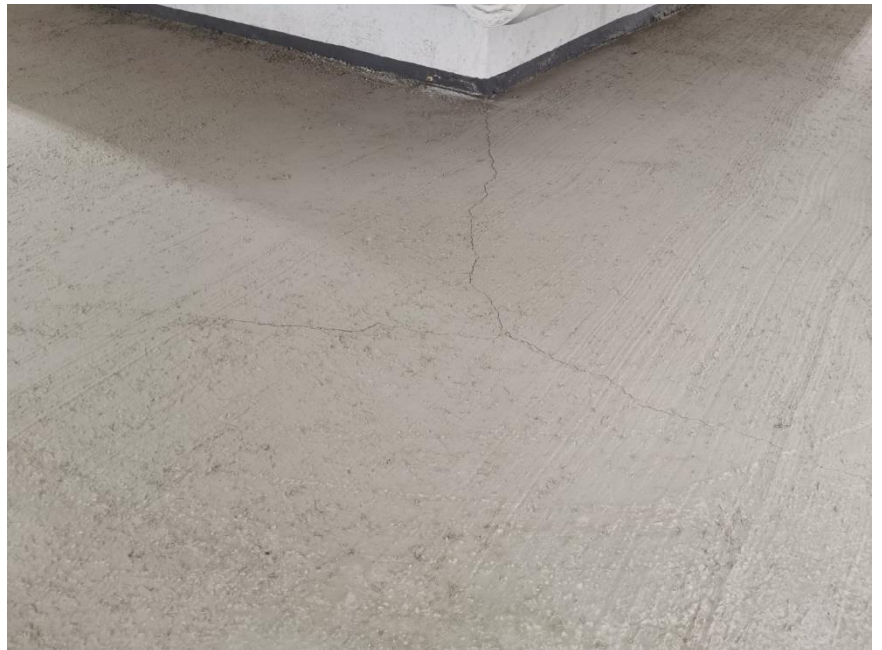
Photograph #16:

Random cracking in slab-on-grade.

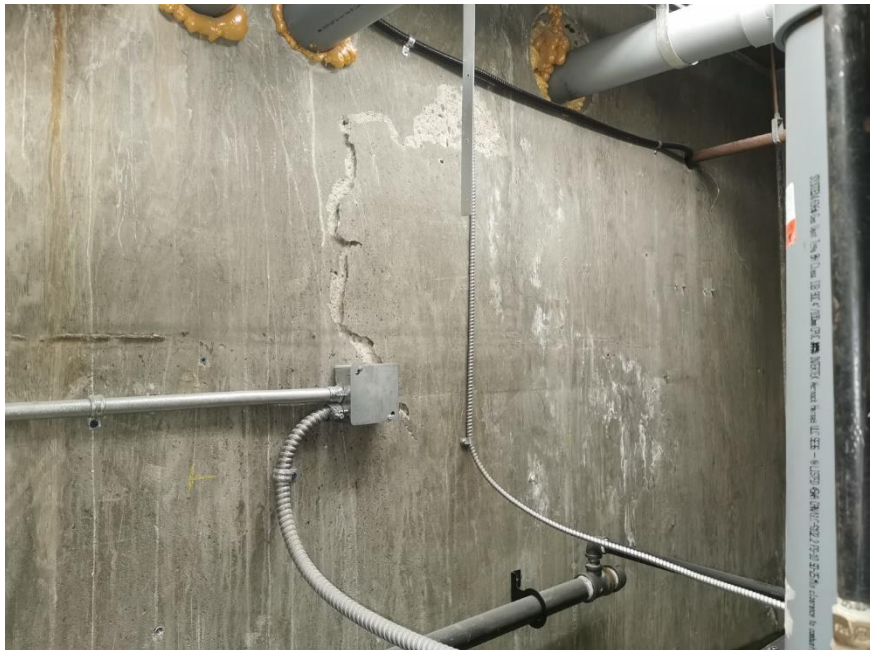
Photograph #18:

Visible concrete wall delamination in mechanical room on side of ramp.

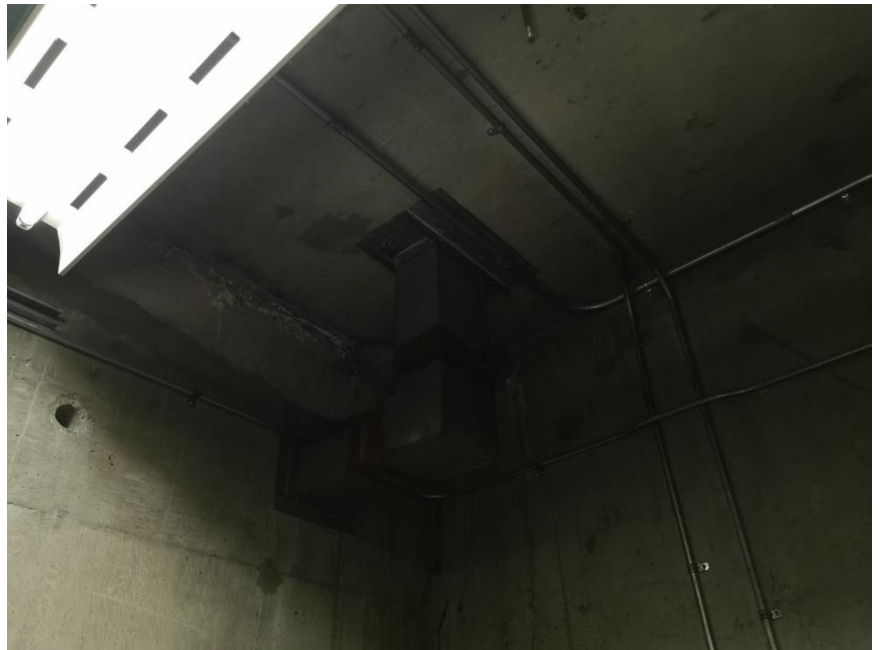
Photograph #20:

Efflorescence visible in top exterior corner of mechanical room.

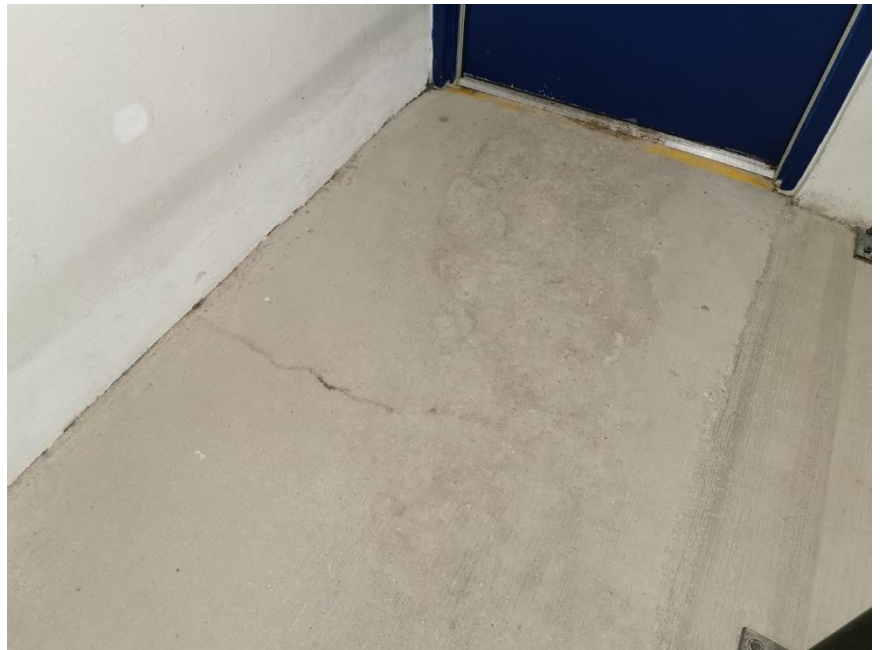
Photograph #22:

Existing crack in concrete stair landing.

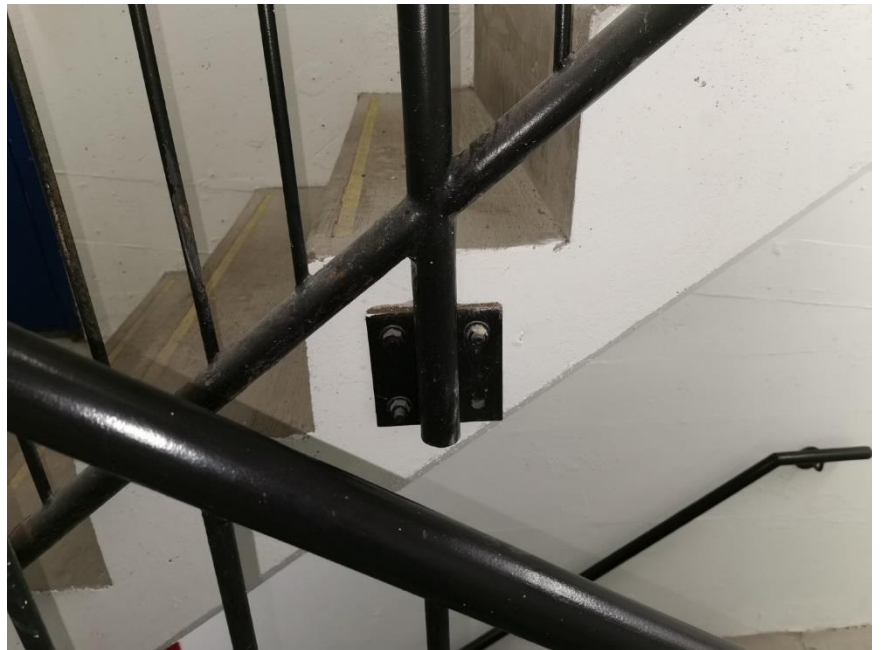
Photograph #24:

Anchor missing from existing stair guardrail.

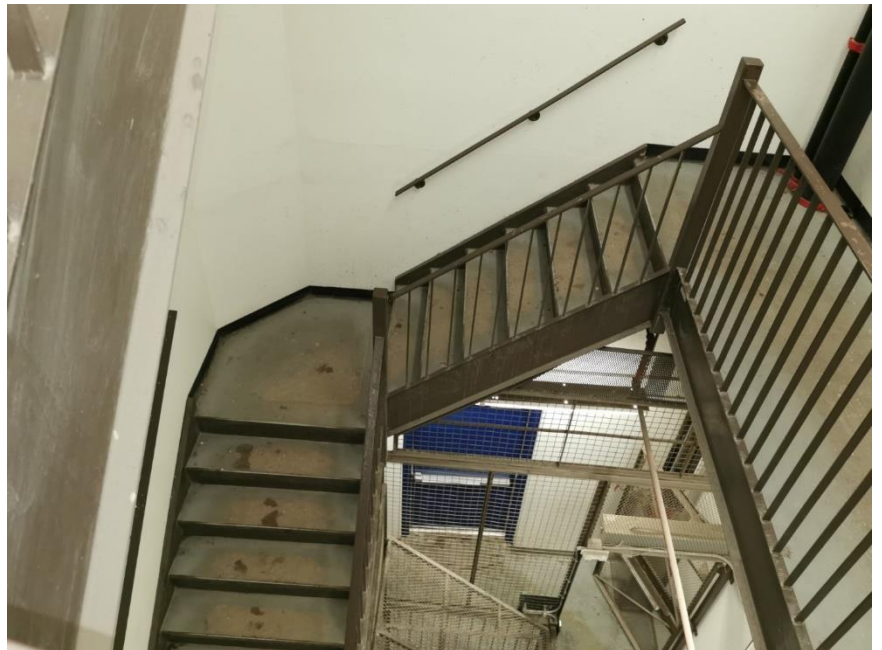
Photograph #26:

Typical condition of concrete stair treads.

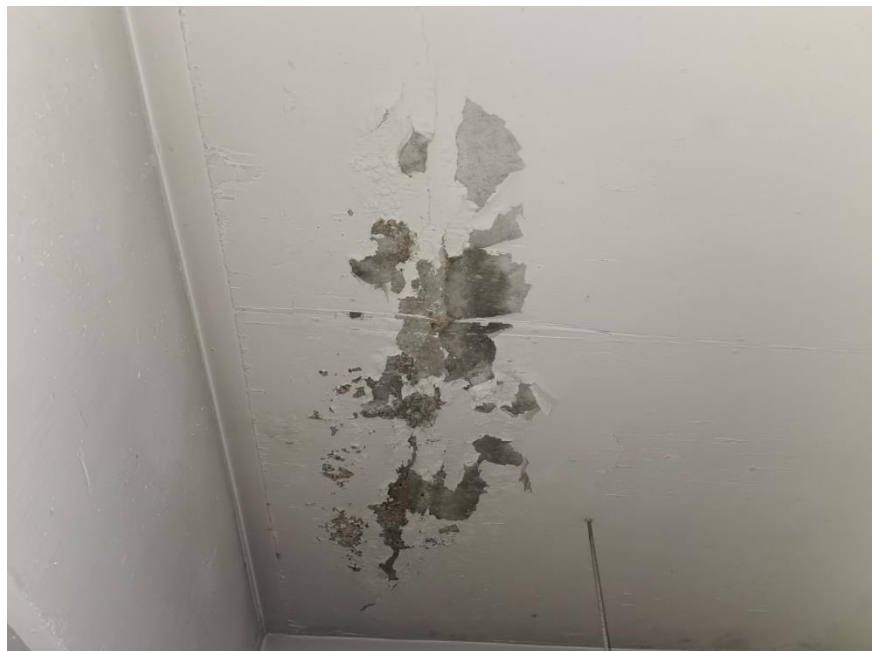
Photograph #28:

Concrete soffit deterioration at underside of exterior plaza.

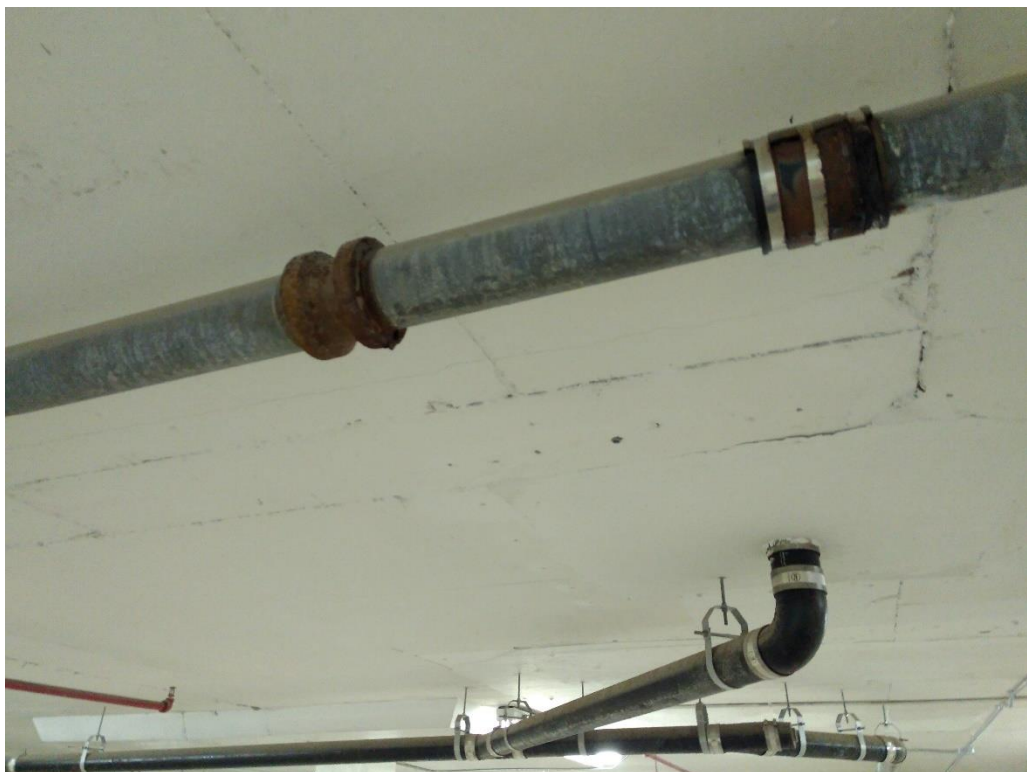
- .2 Some of the sump pump discharge piping is galvanized and is showing signs of corrosion on the pipe and fittings. The piping is believed to be original to the facility and nearing the expected service life of 50 years. Once galvanized piping starts to fail it will fail quickly. It is recommended to replace the galvanized piping.

Figure 2: Galvanized discharge piping from lower level sump pits.

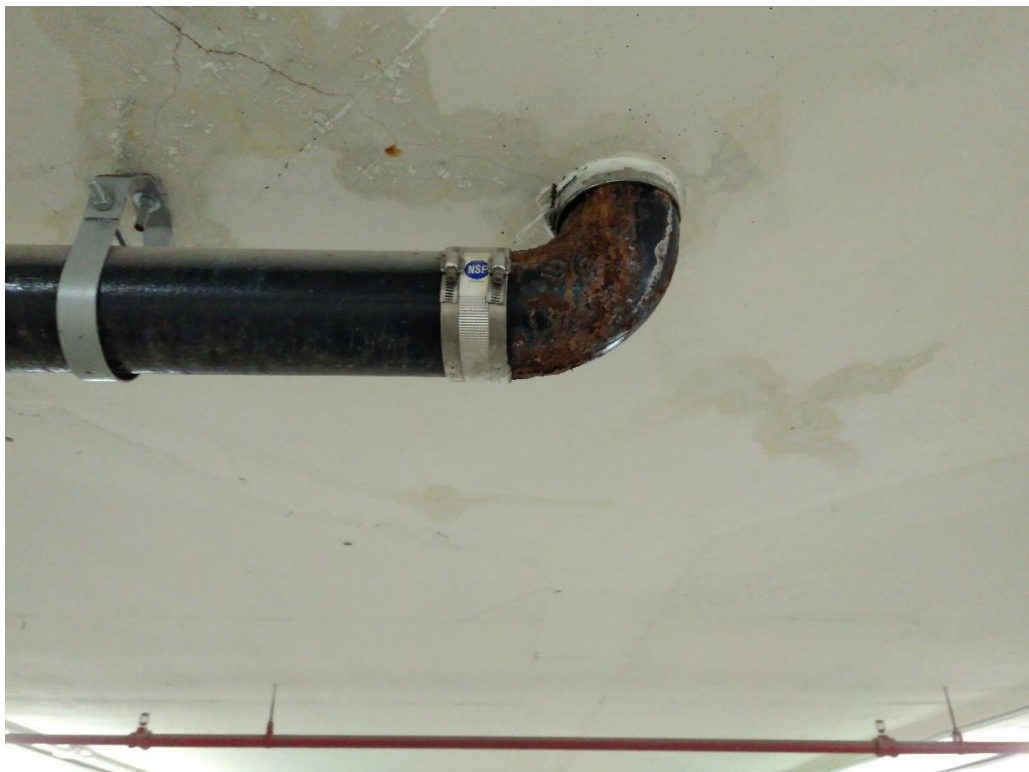
Figure 3: Localized corrosion on new cast iron pipe around drain.

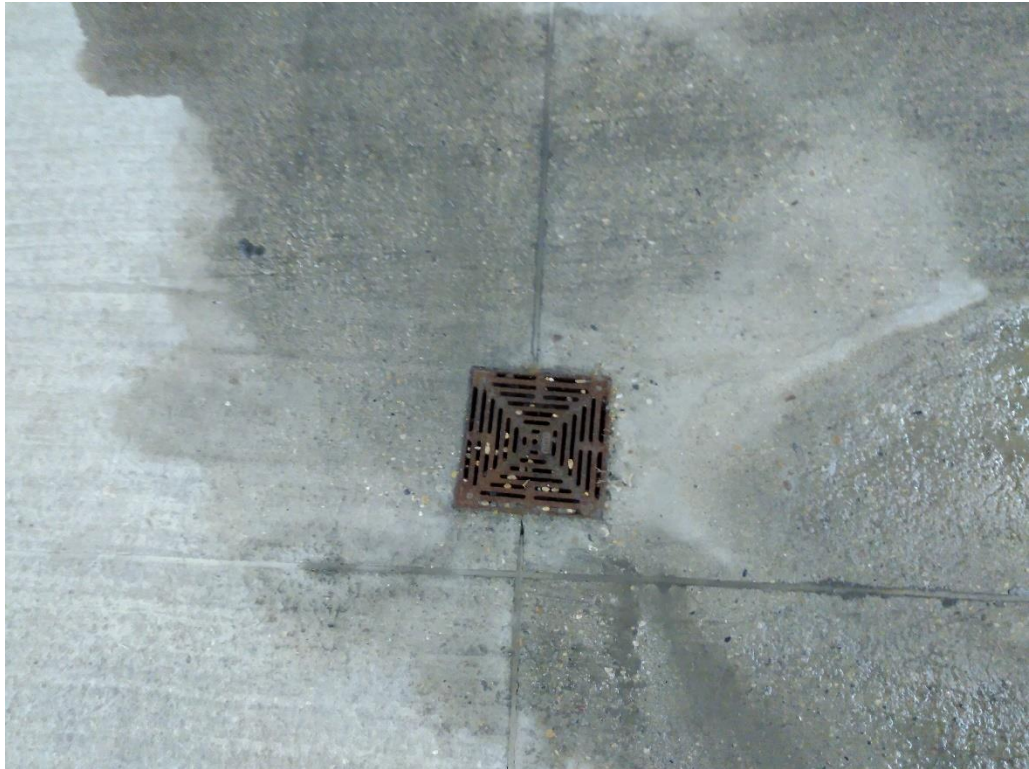
- .3 The drains on the lower level are noted to have been replaced as part of the renovation project in 2015 but show signs of significant corrosion. The drain type from the record drawings appears to be different from the lower level and are not a galvanized rain body. We would recommend monitoring the drains to confirm if the condition worsens.

Figure 5: Drain on lower level showing signs of corrosion.

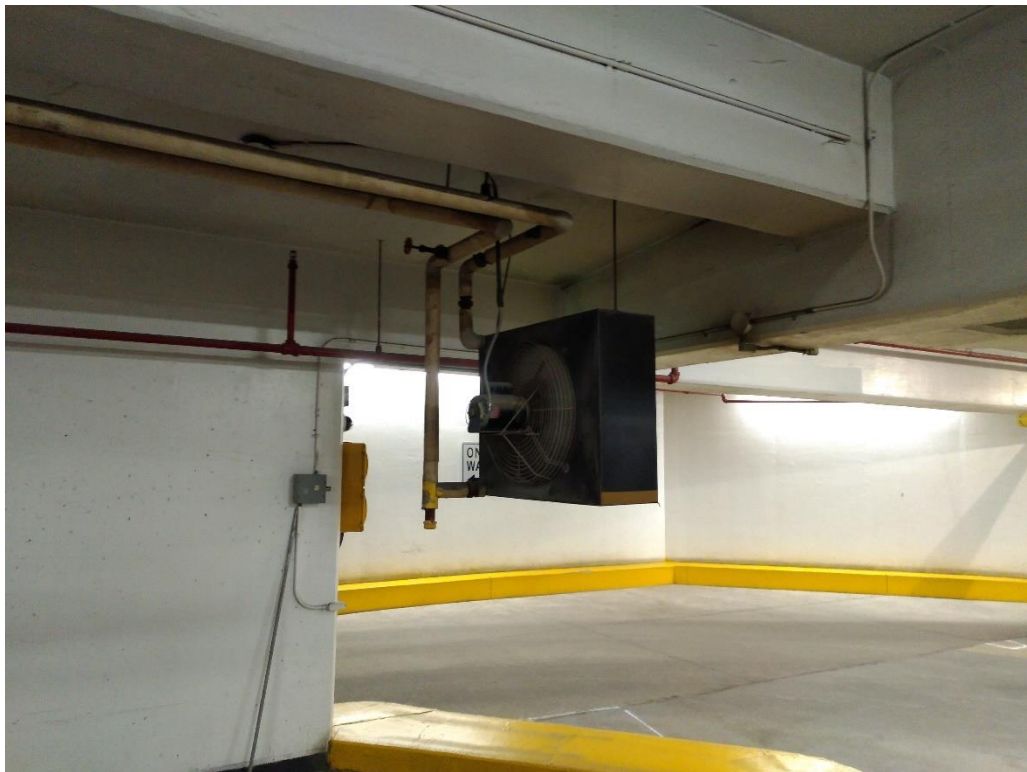
- .1 There are several unit heaters located on both the upper and lower levels for terminal heat. The unit heaters are mostly hydronic and are fed from the library boiler plant. The insulation on the piping is in poor condition and should be replaced. The unit heaters vary in condition from fair to poor. The unit heaters appear to be original to the facility and are beyond the expected service life of 18 years. Replacement is recommended.

Figure 18: Unit heater located on the upper level of the parkade.

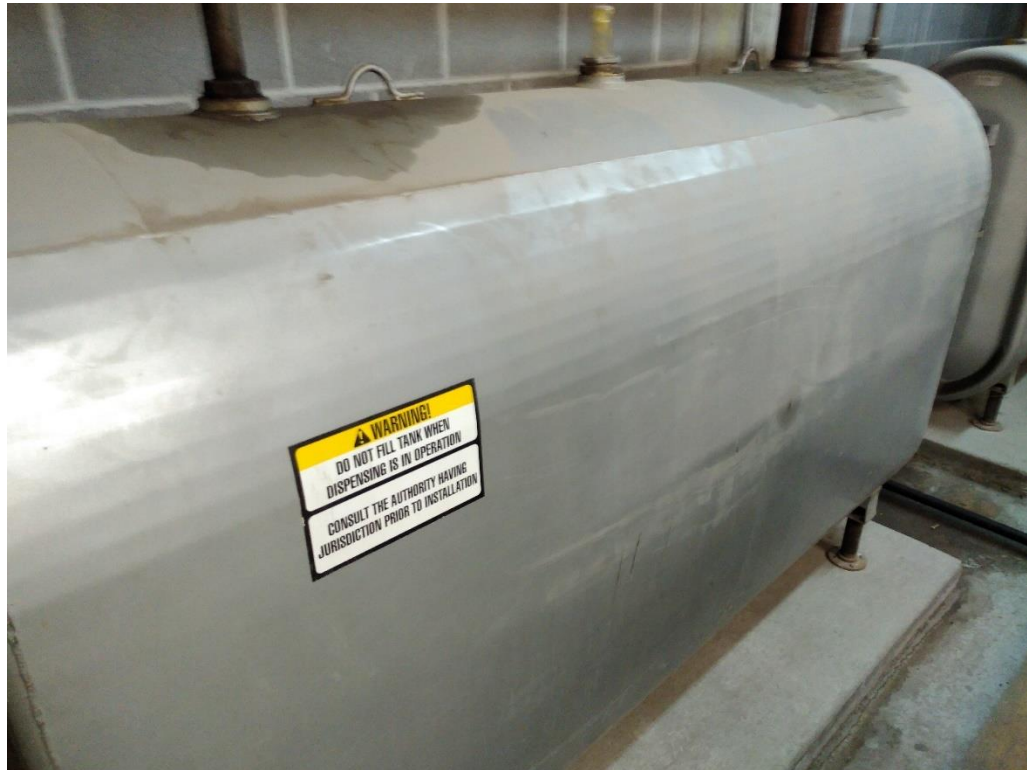
are two supply pumps to the generator and a fill station up on Graham Avenue. There are signs of leaking on the fittings as there is staining on the concrete. The tanks appear have a manufacture date of 2004 on them and would be within the expected service life. Repairs to the piping and cleaning of the spilled fuel oil are recommended.

Figure 19: Double wall tank with signs of fuel oil leaking at tapings.

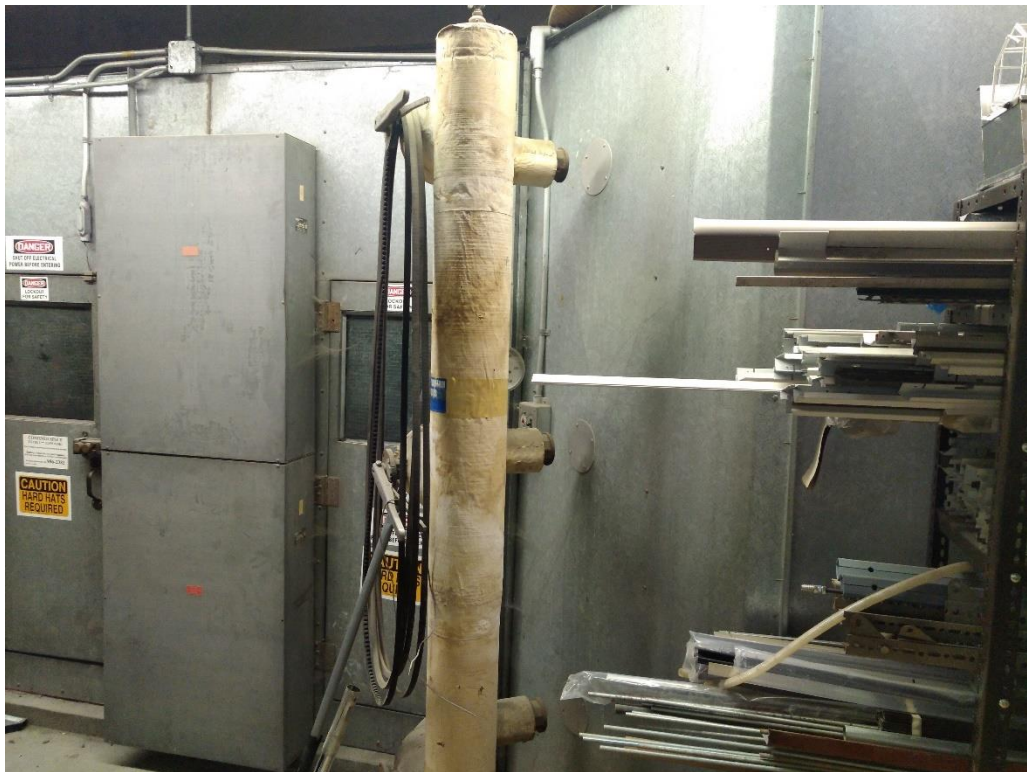
- .4 The glycol heat reclaim coil is no longer in operation and has been capped on both ends.

Figure 21: Capped glycol heat reclaim system.

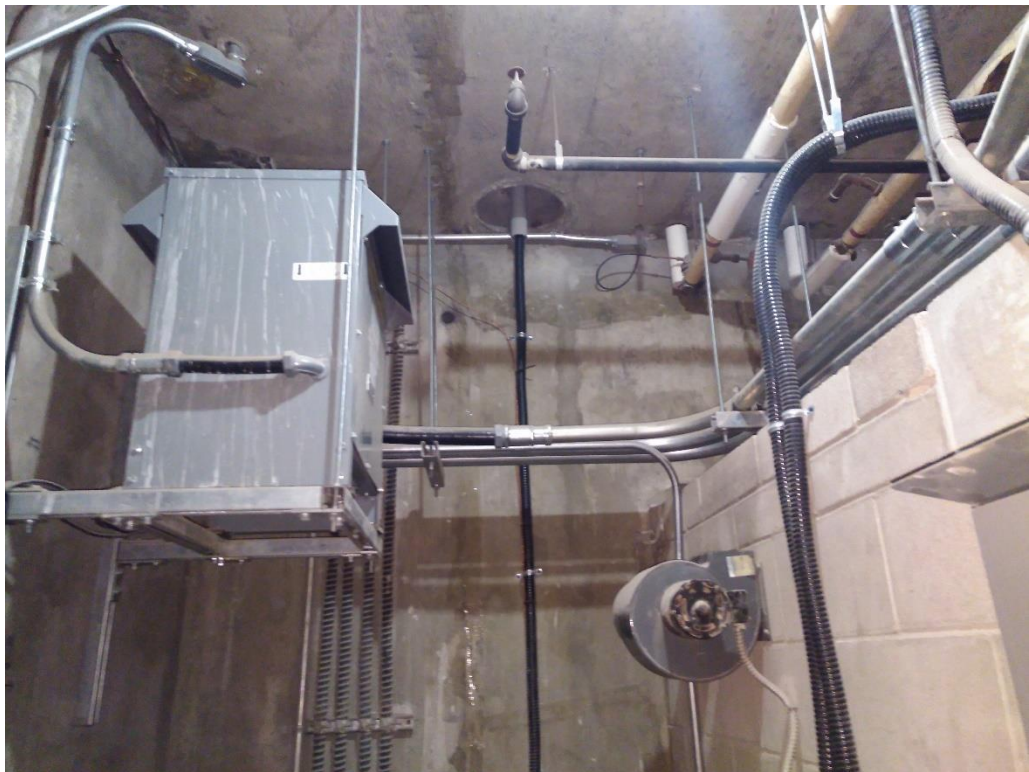
- .4 Adjacent to the Parking Authority office is the main server room and small electrical room. The room is equipped with a small exhaust fan which is not connected to anything and appears to not be operational. The room was quite warm during our visit. It would be recommended to install a ventilation fan or connect ductwork to the existing in order to maintain the temperature of the room.

Figure 24 Exhaust fan not connected to anything in electrical room next to Parking Authority office.

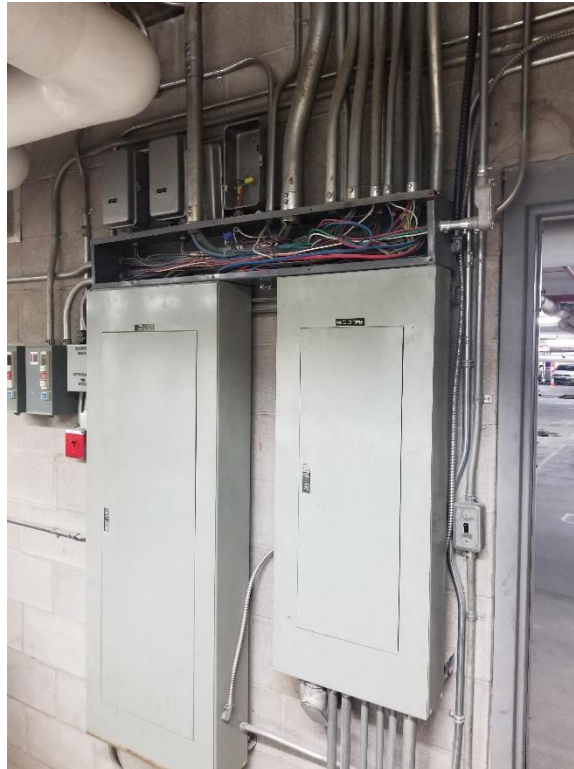
- 5.3.4 Electrical panels and transformers are placed in mechanical/electrical rooms throughout the parkade. There is a significant amount of dust accumulation on the equipment and most equipment requires cleaning. One panel was missing a wireway along the top of the panel exposing the branch circuit wiring. The cover needs to be re-installed to conceal this wiring.

Figure 31: Wire-way missing cover

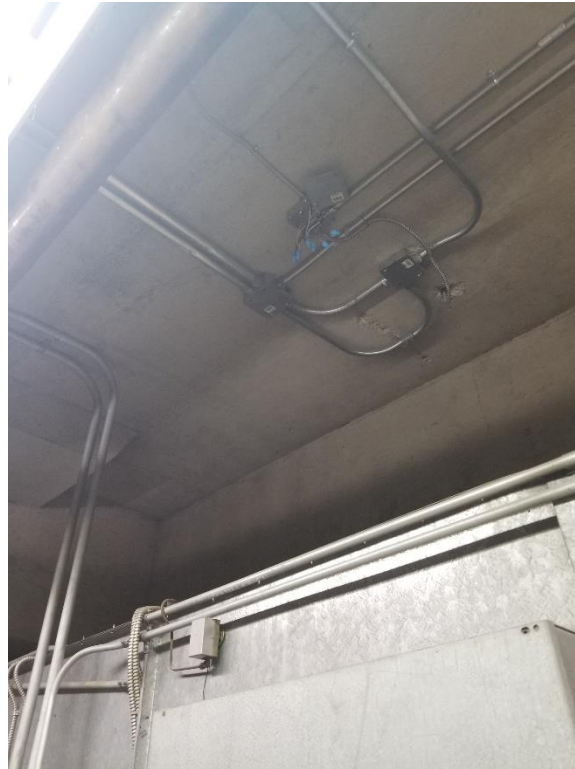
Figure 32: Junction box missing cover.

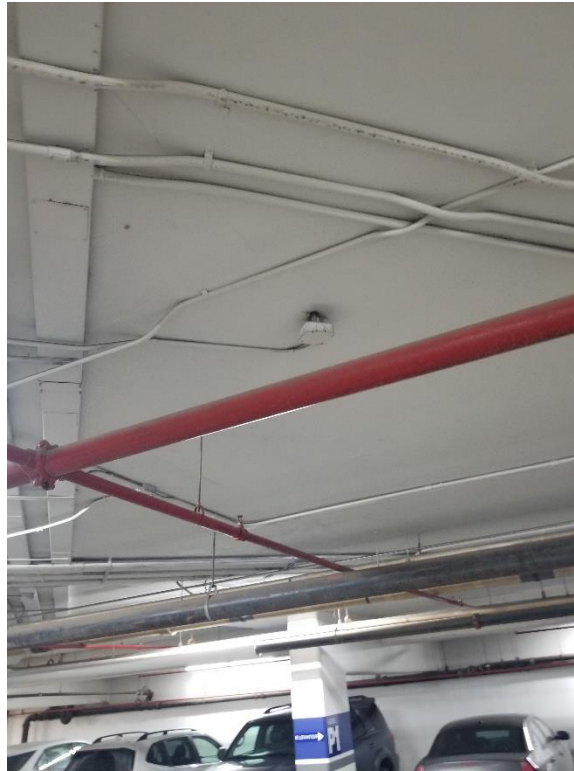
In the general parkade areas, various junction boxes require new supports or need to be re-fastened to the concrete.

Figure 33: Conduit missing supports and anchors.
