Feasibility Study

MILLENNIUM LIBRARY PARKADE | 201 DONALD STREET

Millennium Library Parkade
201 Donald Street

April 22, 2024

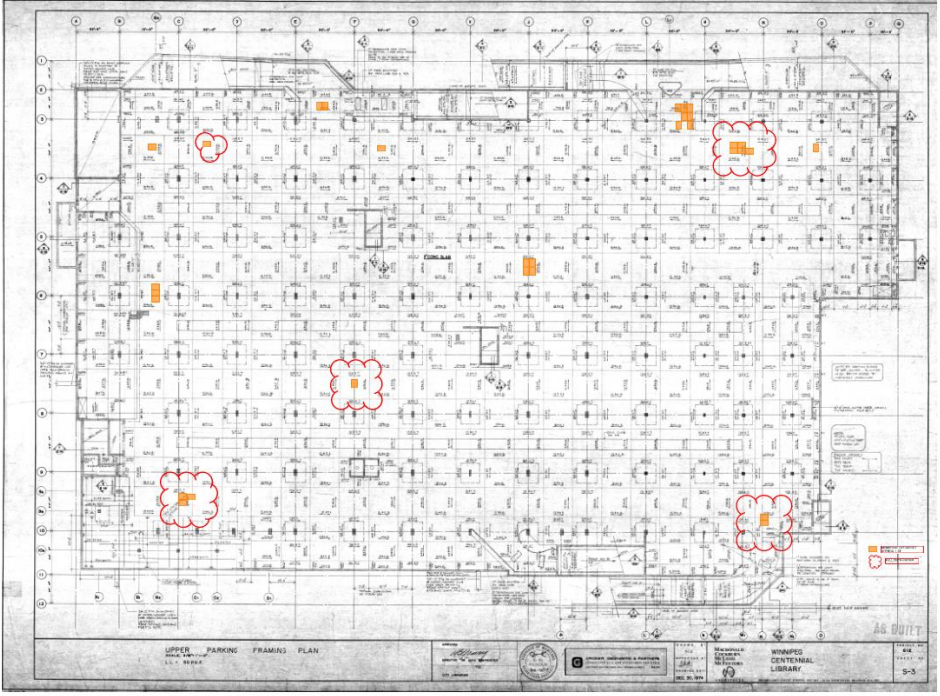
Figure 4: Topside P1 Slab Repair Zones

The membrane on P1 has had numerous repair patches. The P1 concrete top surface was sounded (chain tested) to determine the amount of delaminated concrete in the Parkade. It was previously determined by others that 10% of the slab was debonded while the sketch provided in the older report (noted as S1.1) appears to imply a larger amount. Debonding occurs when a separation forms within the concrete slab creating a hollow which during a chain test (a metal chain dragged across the concrete surface) results in a “drummy” sound (rather than a metallic chain sound in that location) which can be an indicator of damage to the concrete.

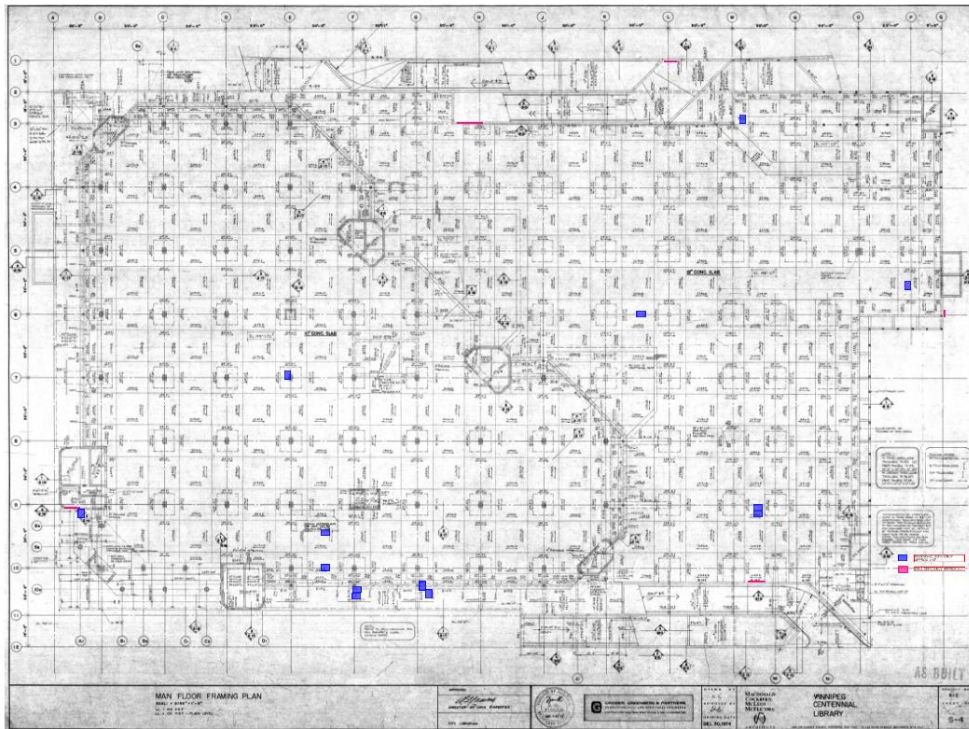
Figure 6: Underside Roof Slab Repair Zones

The roof slab above P1 appeared to be in good condition as viewed from the underside as the top of the slab is covered with ponds, paving stones, grass, concrete over top of insulation and a membrane. We found very few

problematic items in the soffit of the roof slab during the review. The majority of the underside of the roof was painted, and we found the majority of the paint was in good condition.

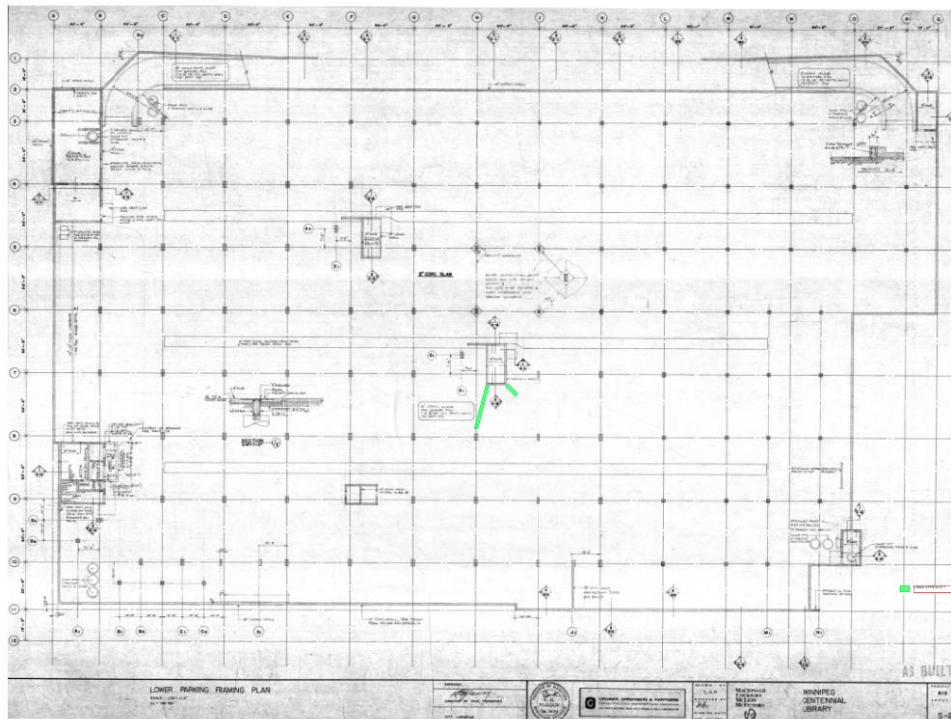
Figure 7: Top of P2 Slab Repair Zones

The lower level P2 slab was in good condition as it was recently replaced. Very few items were found during the review. The owner noted that the P2 slab was constructed with fiber reinforcement and thus membrane was not installed. Based on field observations, the lower level appeared to have significantly less traffic and does not require a traffic membrane on the parking stalls or drive aisles. However, the City should consider installing a traffic membrane on the lower P2 level in order to protect the slab against deterioration and weathering.

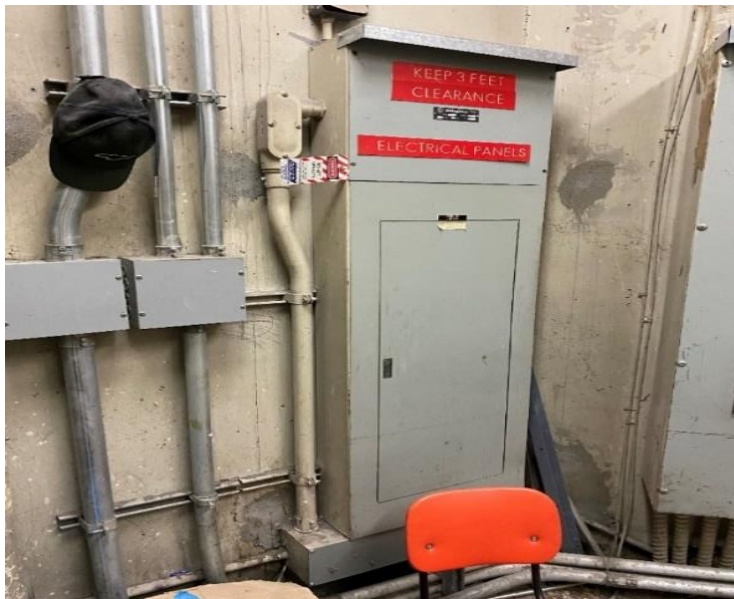
Figure 11: Indicate Essential Panelboard no longer used and obsolete Security Booth Panel

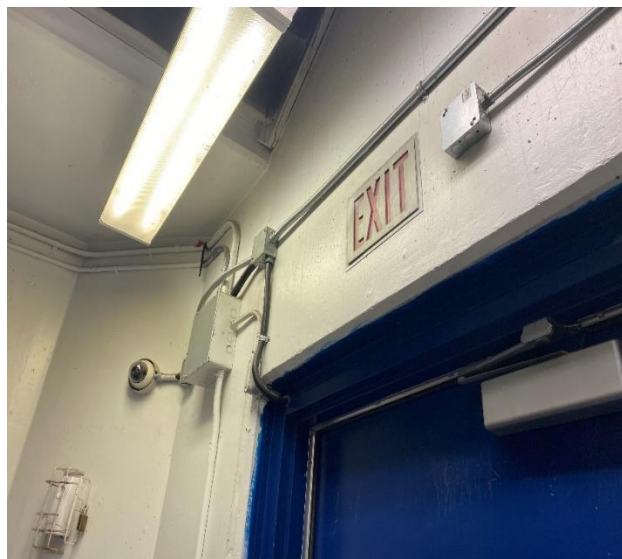
The exit lighting has been fully upgraded to green pictogram (running man) style devices throughout the Parkade. All the Parkade devices are in excellent condition and were all operating during the time of review. The Parkade is serviced by a generator for backup power and the exit lighting is fed from panelboards supplied by the generator. In the mechanical rooms, equipment areas and stairwells, many of the exit signs have not been replaced and are not currently operating. It is recommended that these all be replaced with green running man style to match the Parkade fixtures as soon as possible and any non-functioning units need to be replaced immediately.

Figure 14: Exit Signs in Stairwells not functioning and improper style

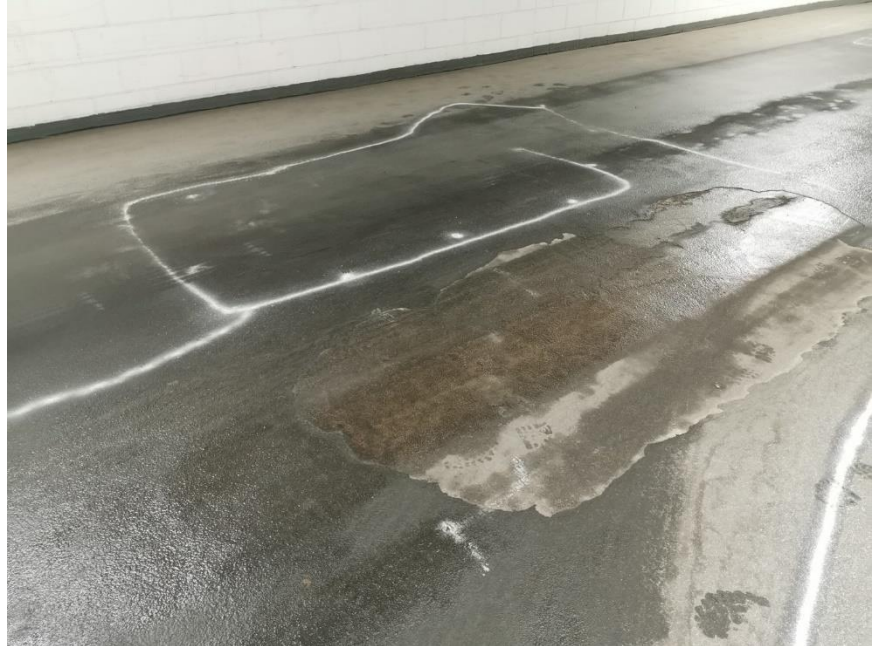
Waterproofing worn down to concrete in north drive aisle

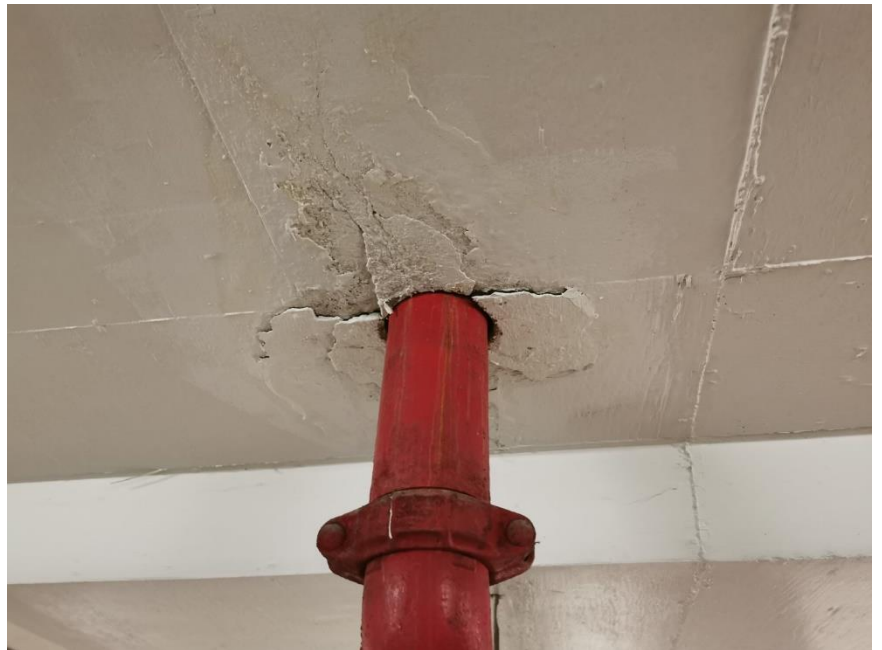
Photograph #6:

Soffit deterioration at mechanical.

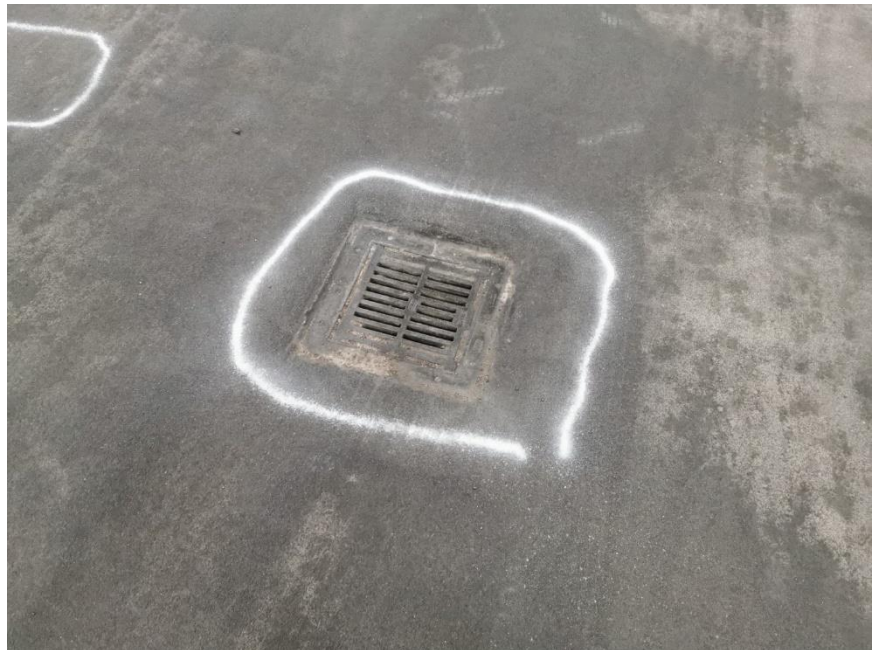
Photograph #8:

Typical condition of observed drains.

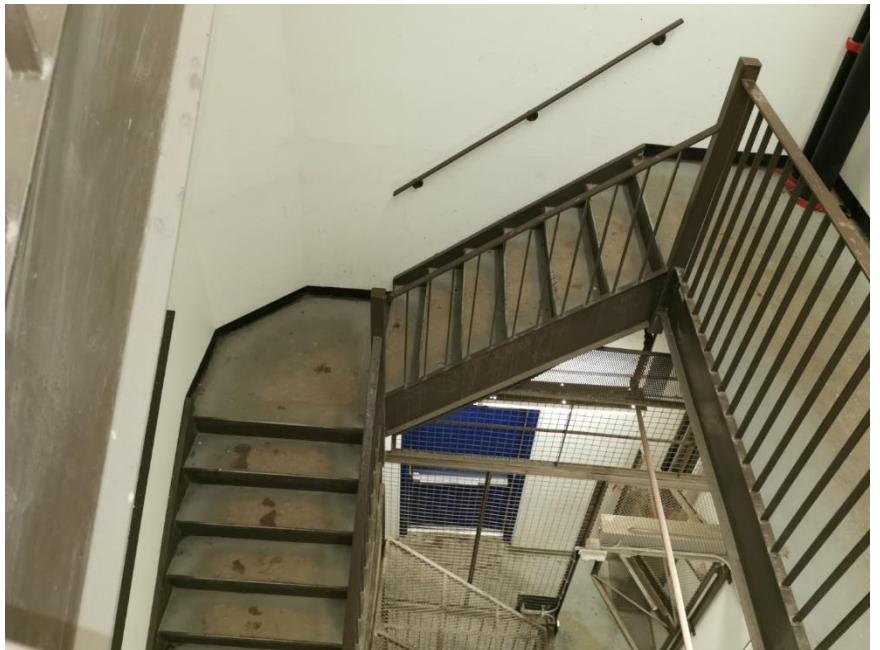
Photograph #26:

Typical condition of concrete stair treads.

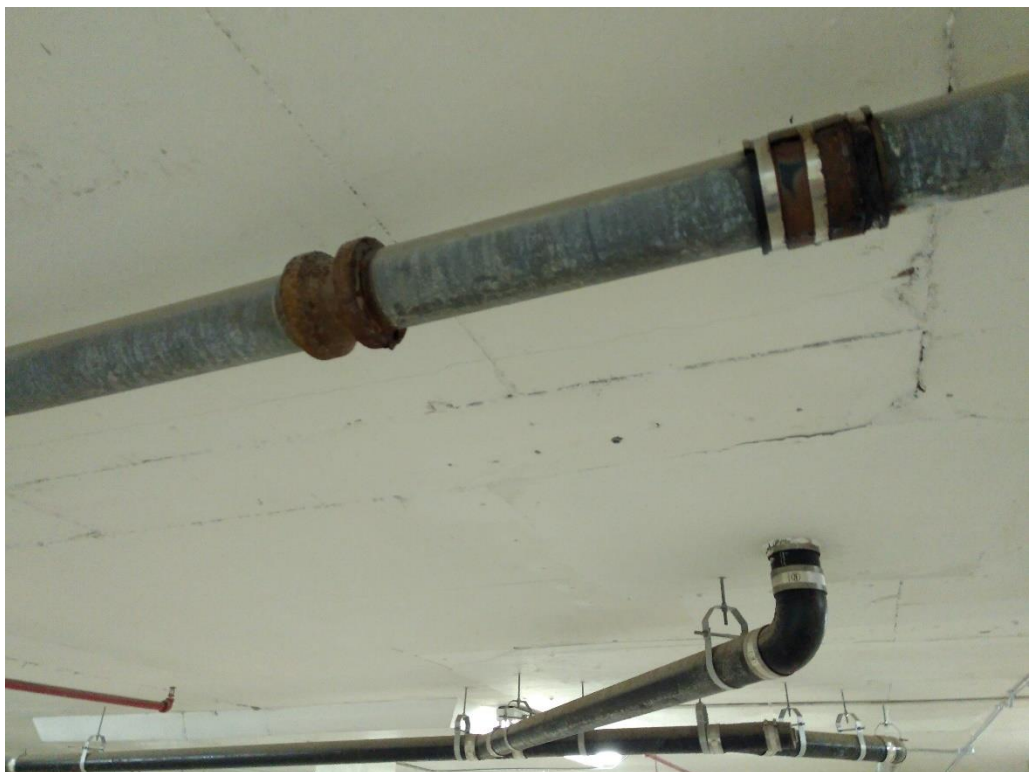
- .2 Some of the sump pump discharge piping is galvanized and is showing signs of corrosion on the pipe and fittings. The piping is believed to be original to the facility and nearing the expected service life of 50 years. Once galvanized piping starts to fail it will fail quickly. It is recommended to replace the galvanized piping.

Figure 2: Galvanized discharge piping from lower level sump pits.

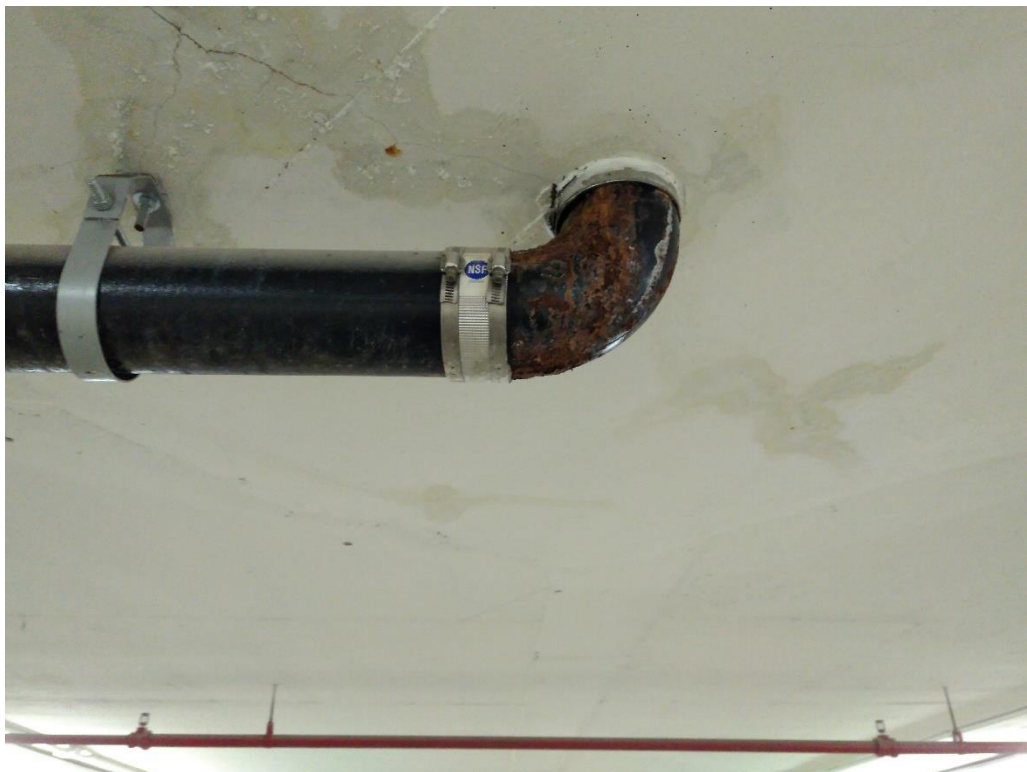
- .2 Piping serving the parkade level drainage is in good condition with the majority of it replaced as part of the parkade renovation work in 2015. The piping serving the upper level was mostly cast iron and is in good condition with some local signs of corrosion. The drains on the upper level are all new galvanized drains and appear in good condition. The drains are well within the expected service life.

Figure 3: Localized corrosion on new cast iron pipe around drain.

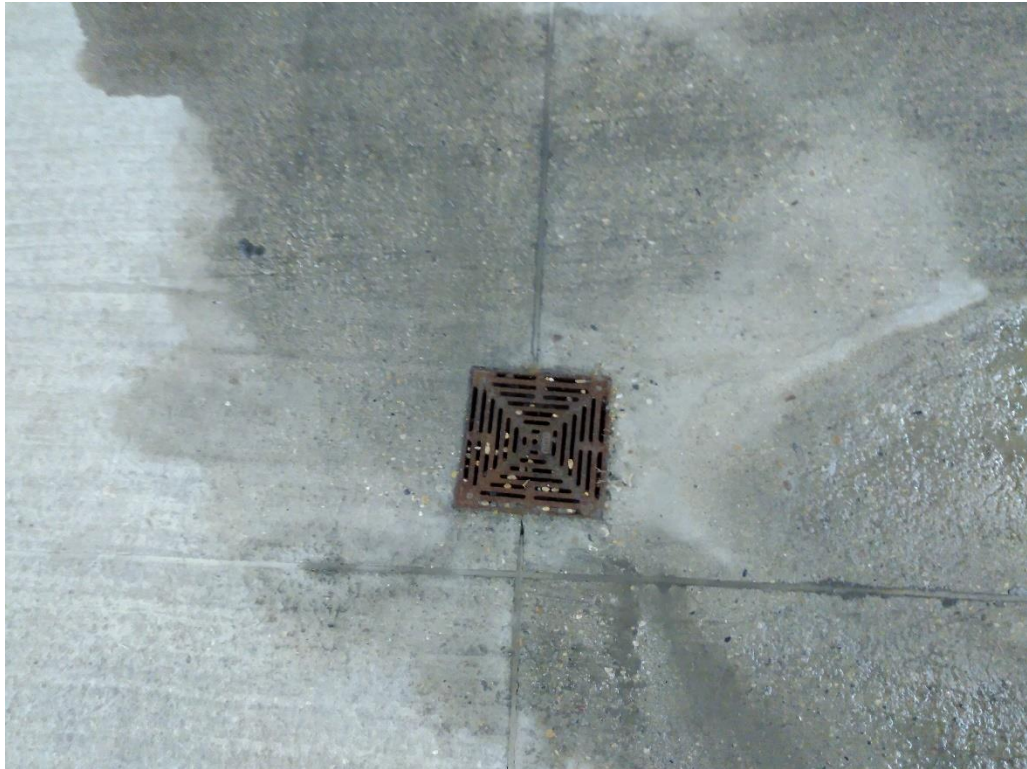
- .3 The drains on the lower level are noted to have been replaced as part of the renovation project in 2015 but show signs of significant corrosion. The drain type from the record drawings appears to be different from the lower level and are not a galvanized rain body. We would recommend monitoring the drains to confirm if the condition worsens.

Figure 5: Drain on lower level showing signs of corrosion.

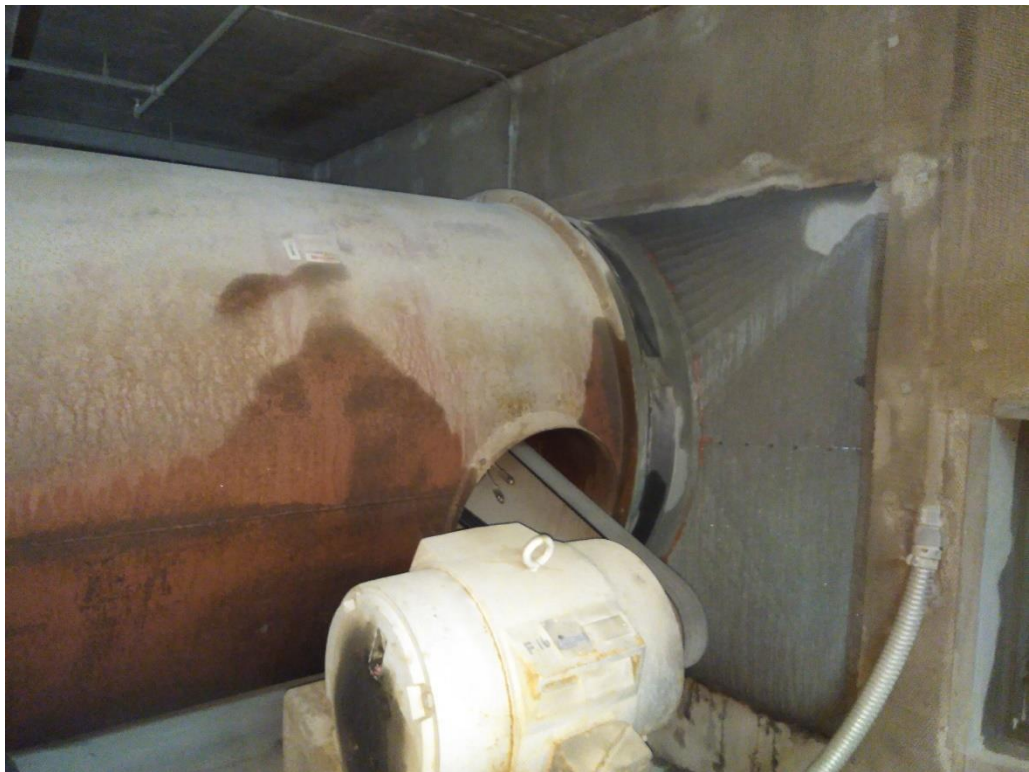
- .1 The make-up air is interlocked to two exhaust fans located on the upper level of the parkade. The exhaust fans are staged similar to the make-up air unit and can be controlled for upper and lower levels. The glycol run-around loop is disconnected similar to the make-up air unit. The fans are installed in a sealed room which acts as a negative air plenum with ductwork connections for the lower level and two branches for the upper level. The exhaust fans are original to the facility and appear to be in fair to poor condition. The fans are undersized based on current code requirements for CO/NO₂ purge systems. The capacity would need to be upgraded. Replacement is recommended.

Figure 22: Exhaust fan serving parkade ventilation system.

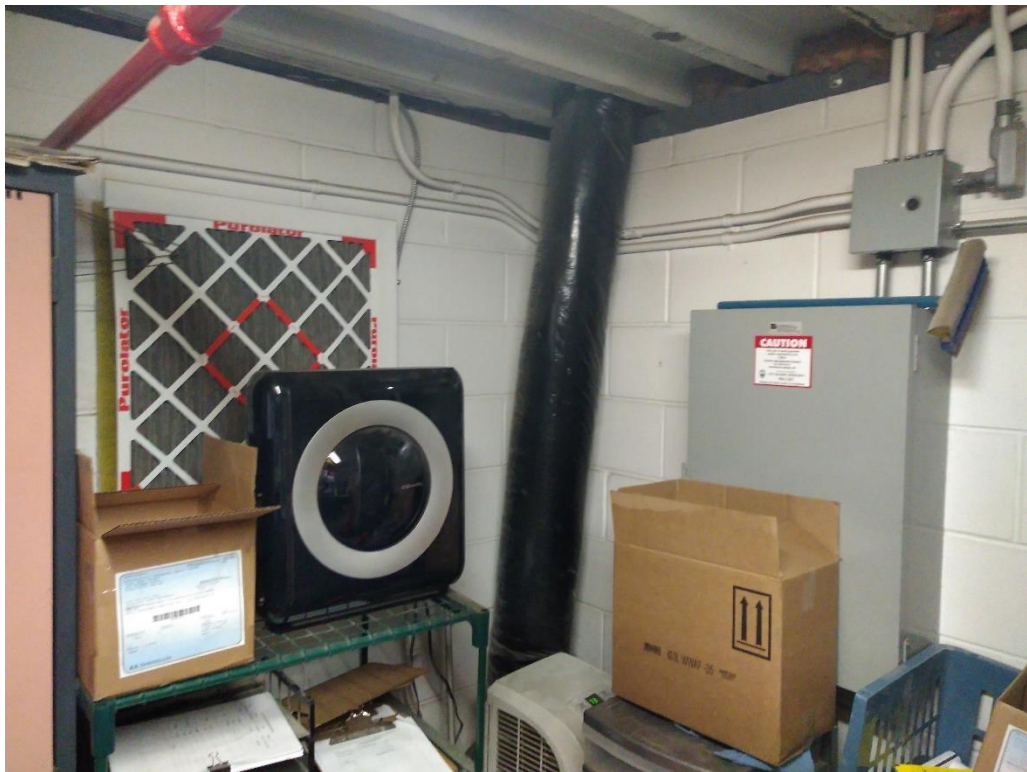
- .3 The Parking Authority offices in the centre of the upper parkade are equipped with fans and filters that draw air from the parkade into the office area and exhaust it to the parkade. There is a portable A/C unit installed in the office area with the heat discharge to the parkade. Ventilating the office area with parkade air is not permissible by current code requirements. It would be recommended to provide dedicated make-up air to the office space in order to meet indoor air quality and current code requirements.

Figure 23: Intake and portable AC unit for Parking Authority office

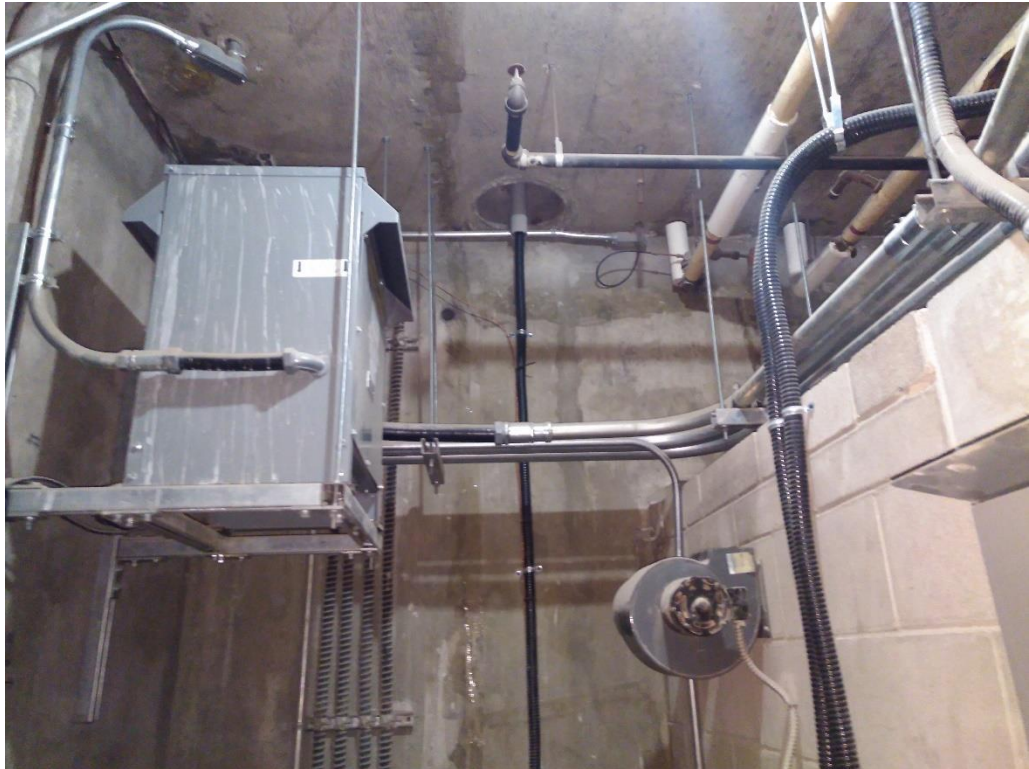
- .4 Adjacent to the Parking Authority office is the main server room and small electrical room. The room is equipped with a small exhaust fan which is not connected to anything and appears to not be operational. The room was quite warm during our visit. It would be recommended to install a ventilation fan or connect ductwork to the existing in order to maintain the temperature of the room.

Figure 24 Exhaust fan not connected to anything in electrical room next to Parking Authority office.

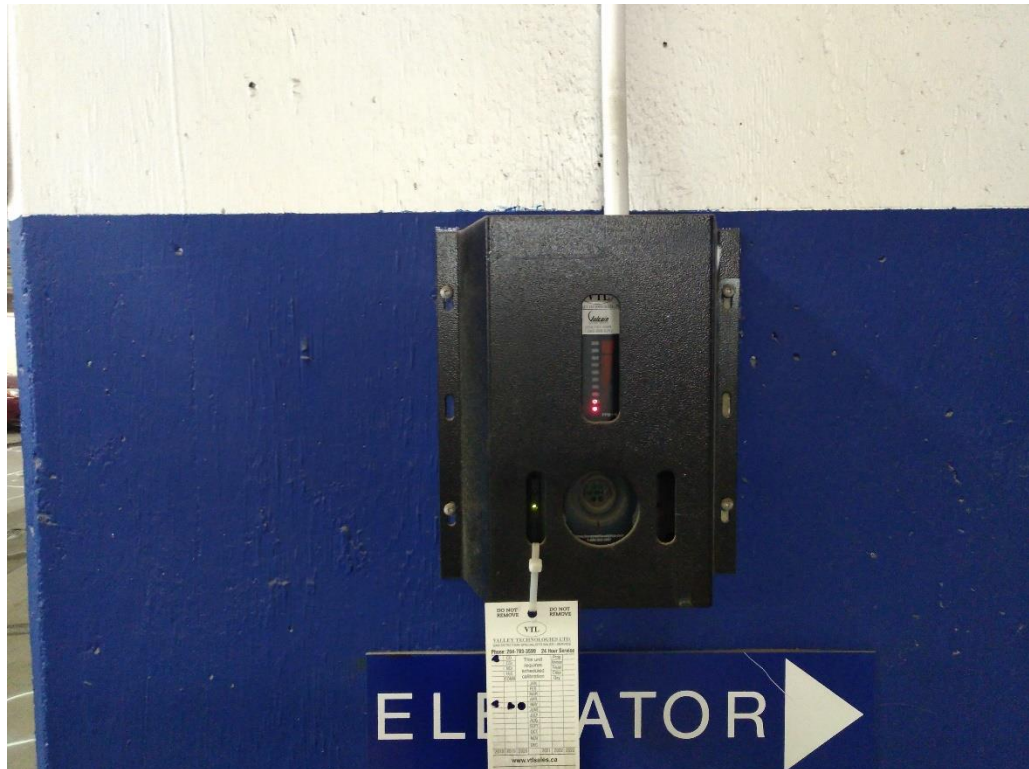
were high level detectors in only portions of the parkade and most detector inspection tags only indicated CO detection. It is recommended that NO₂ detectors be installed to align with proper spacing requirements per manufacturer recommendations.

Figure 25: CO detector located on column in parkade.
