Appendix 'I' – Photograph Log

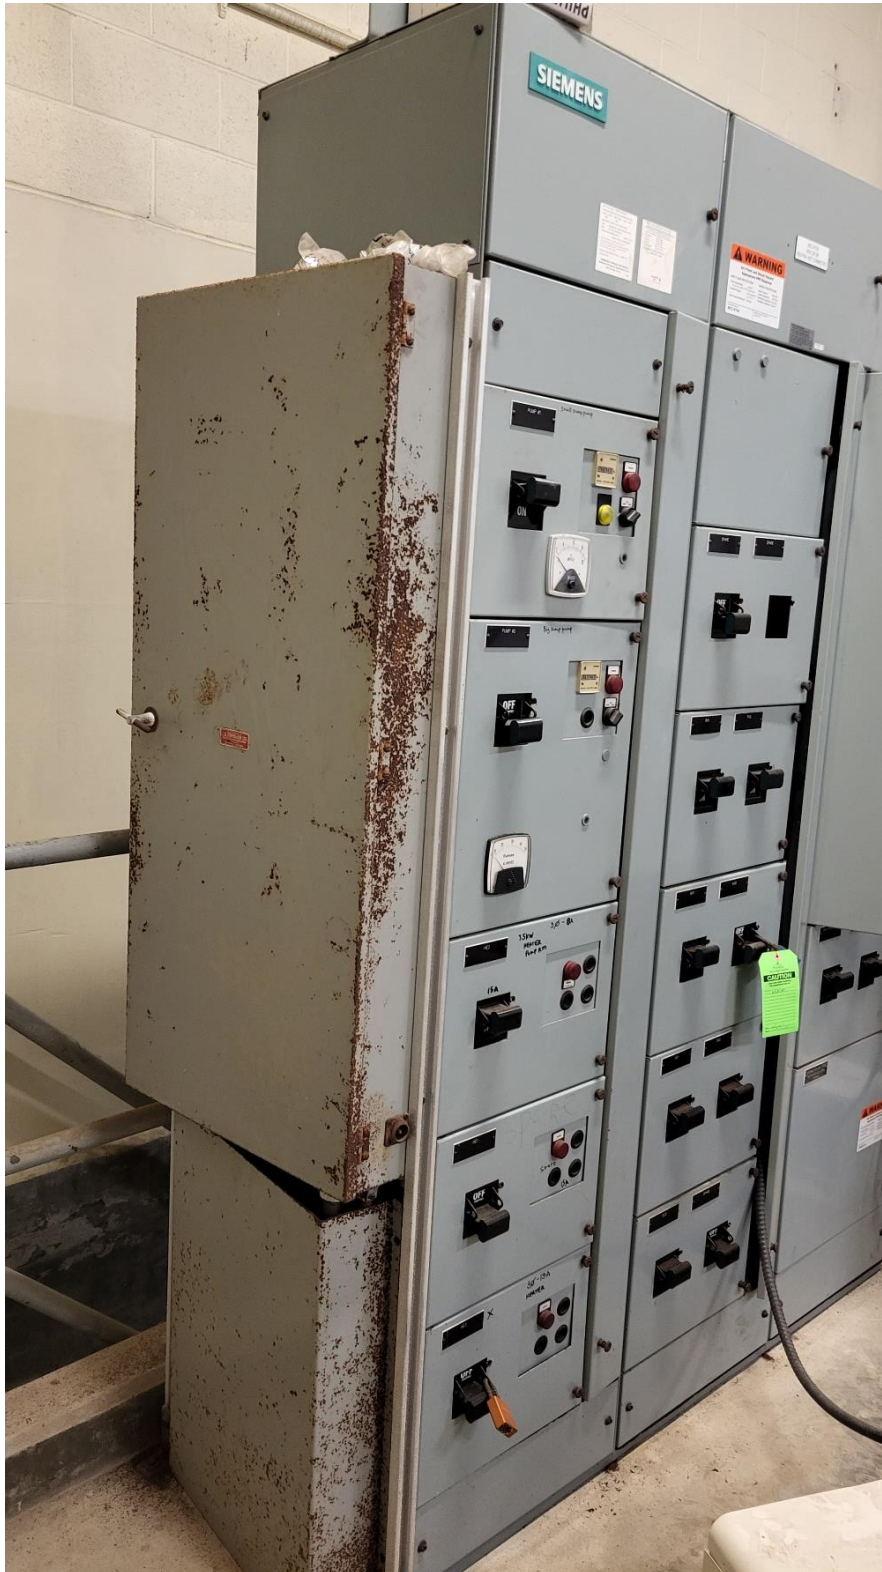
Photograph #1: Existing MCC & terminal Cabinet in the Valve house,

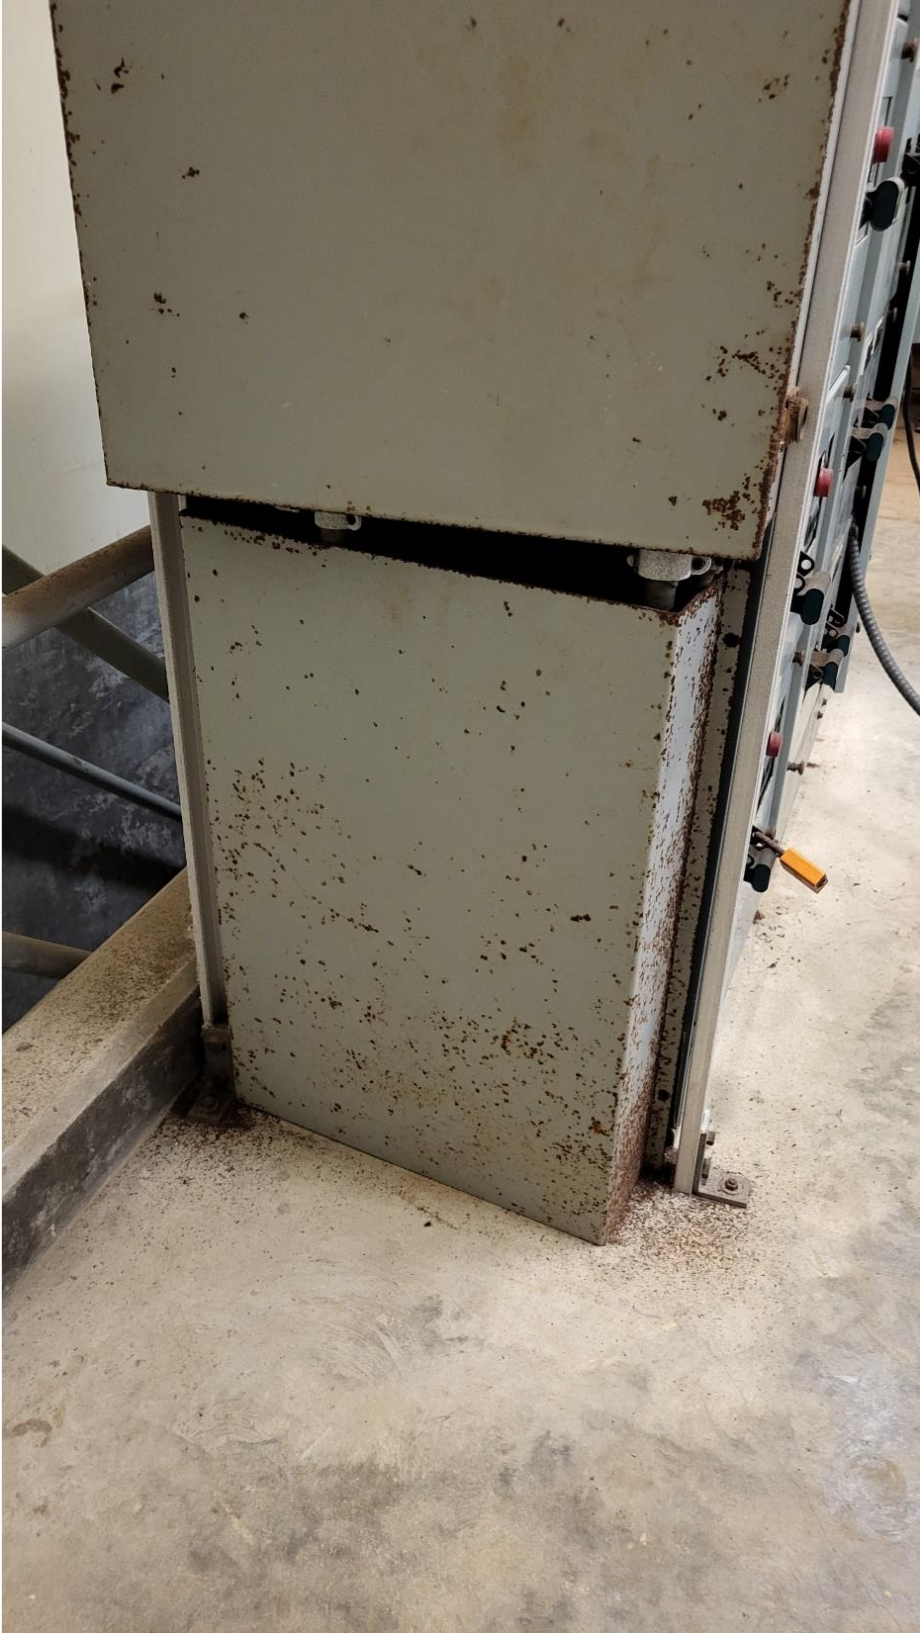
Photograph #2: Valve House Terminal Cabinet

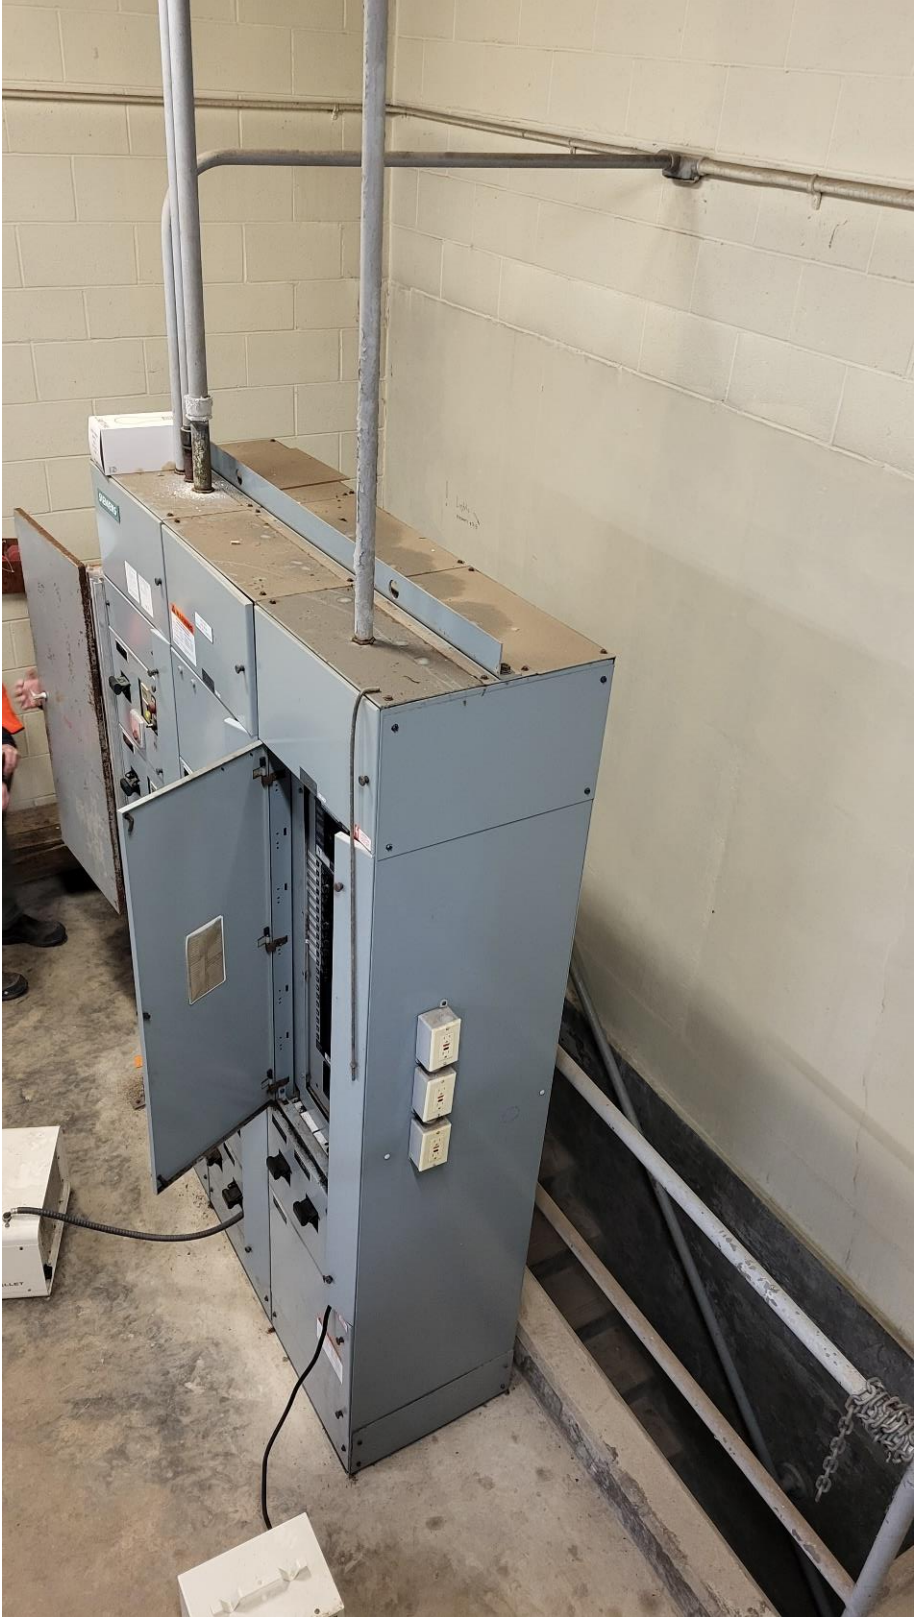
Photograph #3: Top View of Existing MCC in Valve House

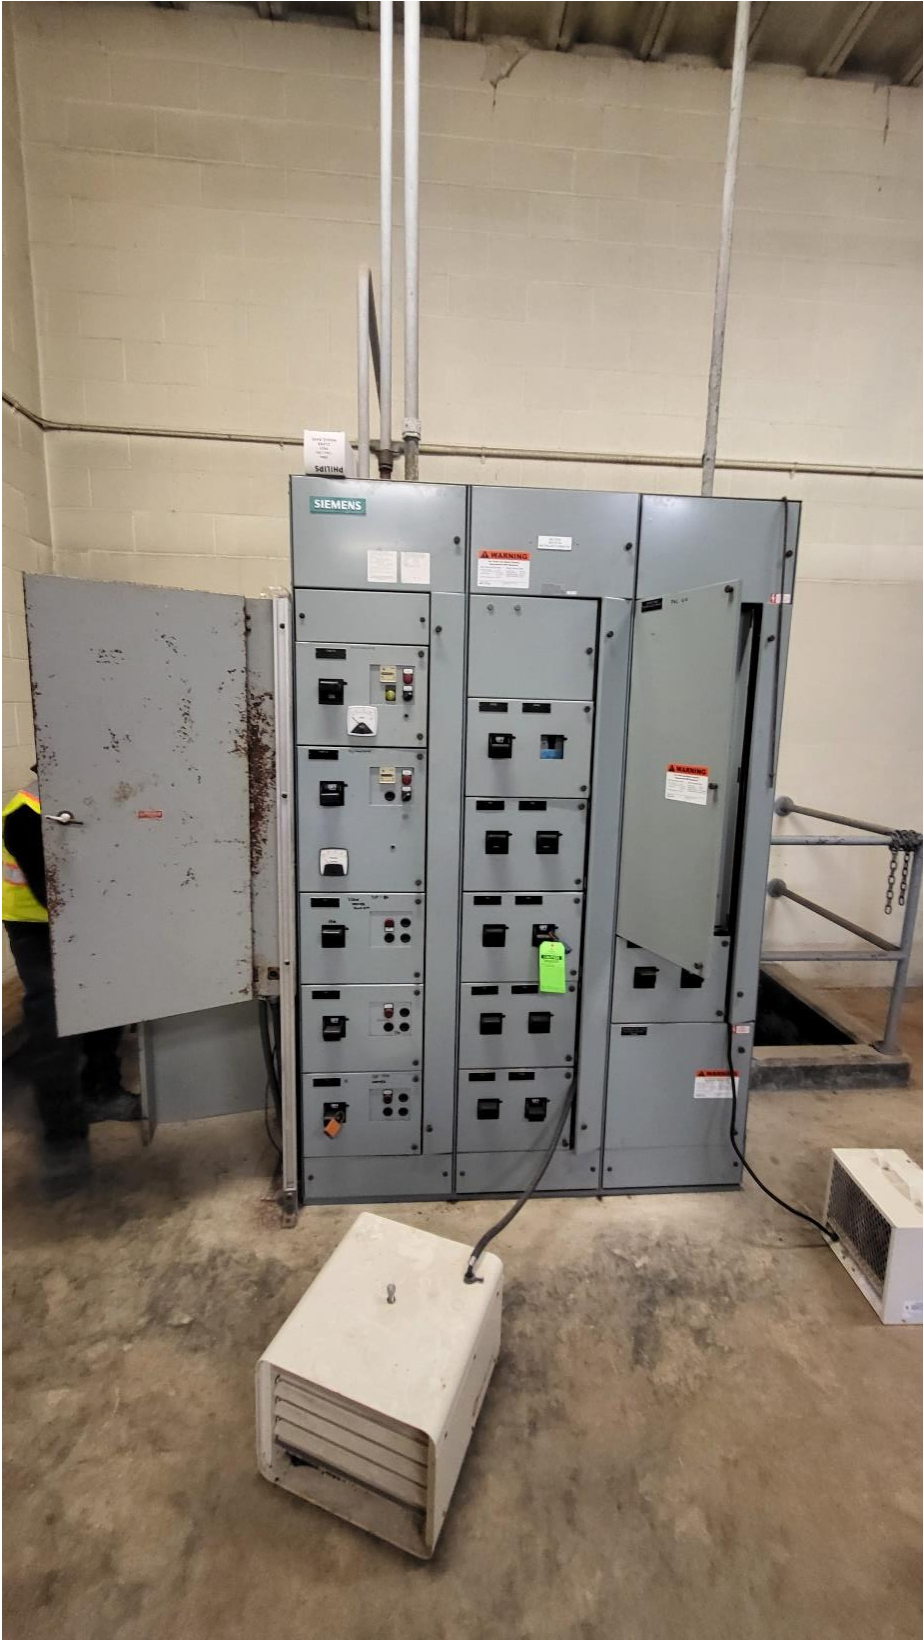
Photograph #4: Existing MCC in Maclean valve house, and temporary unit heater on the ground.

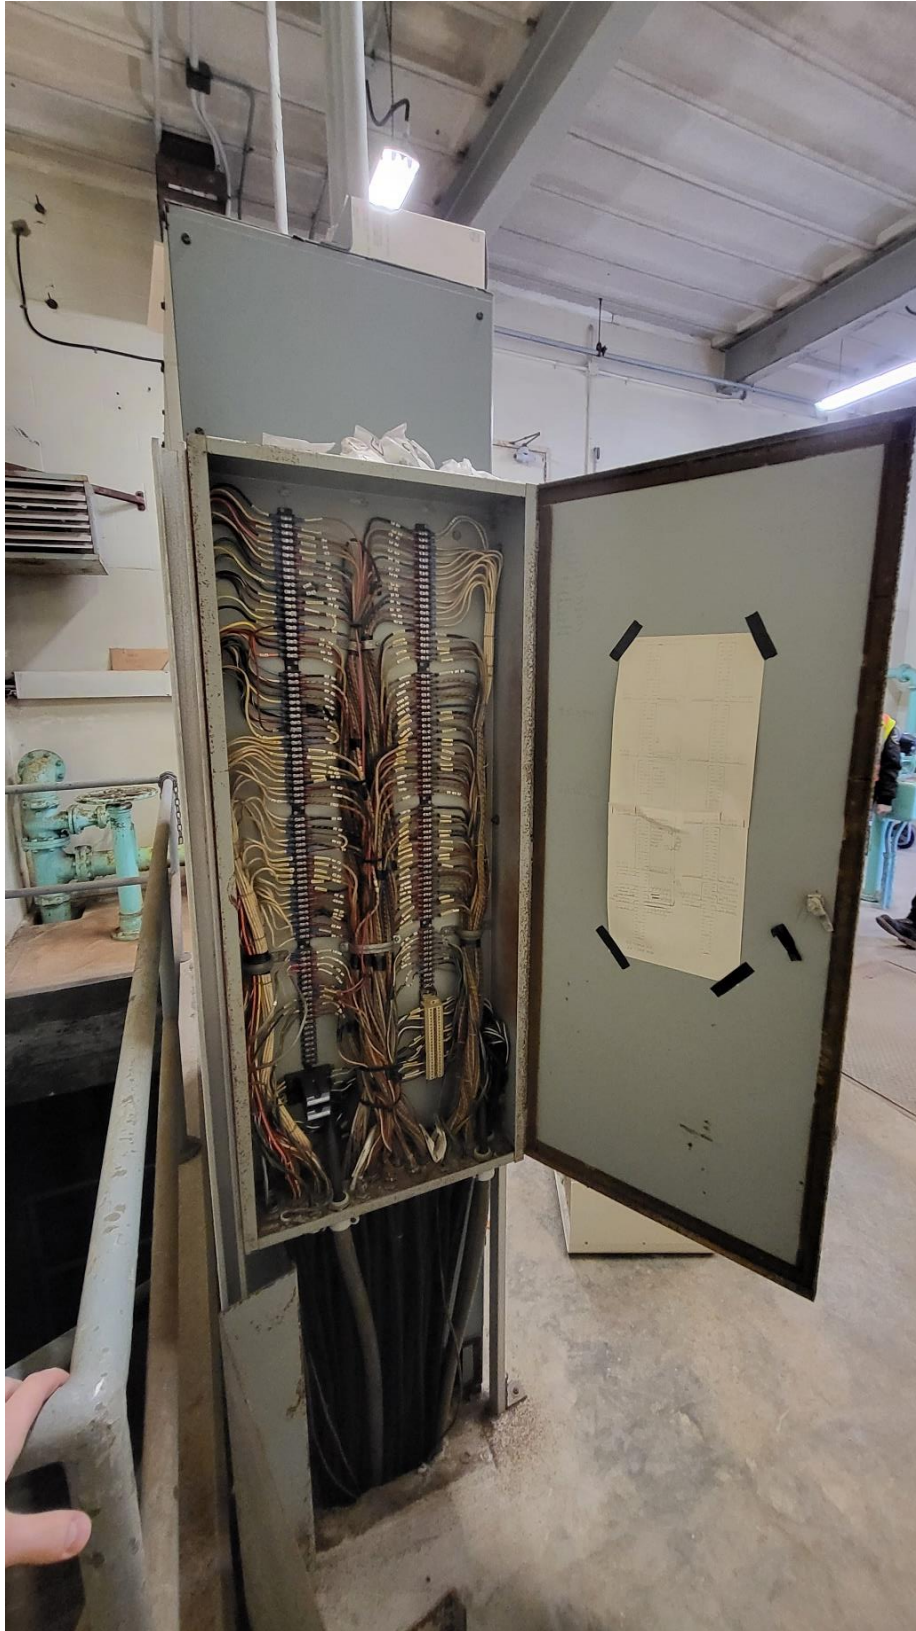
Photograph #5: Valve House Terminal Cabinet

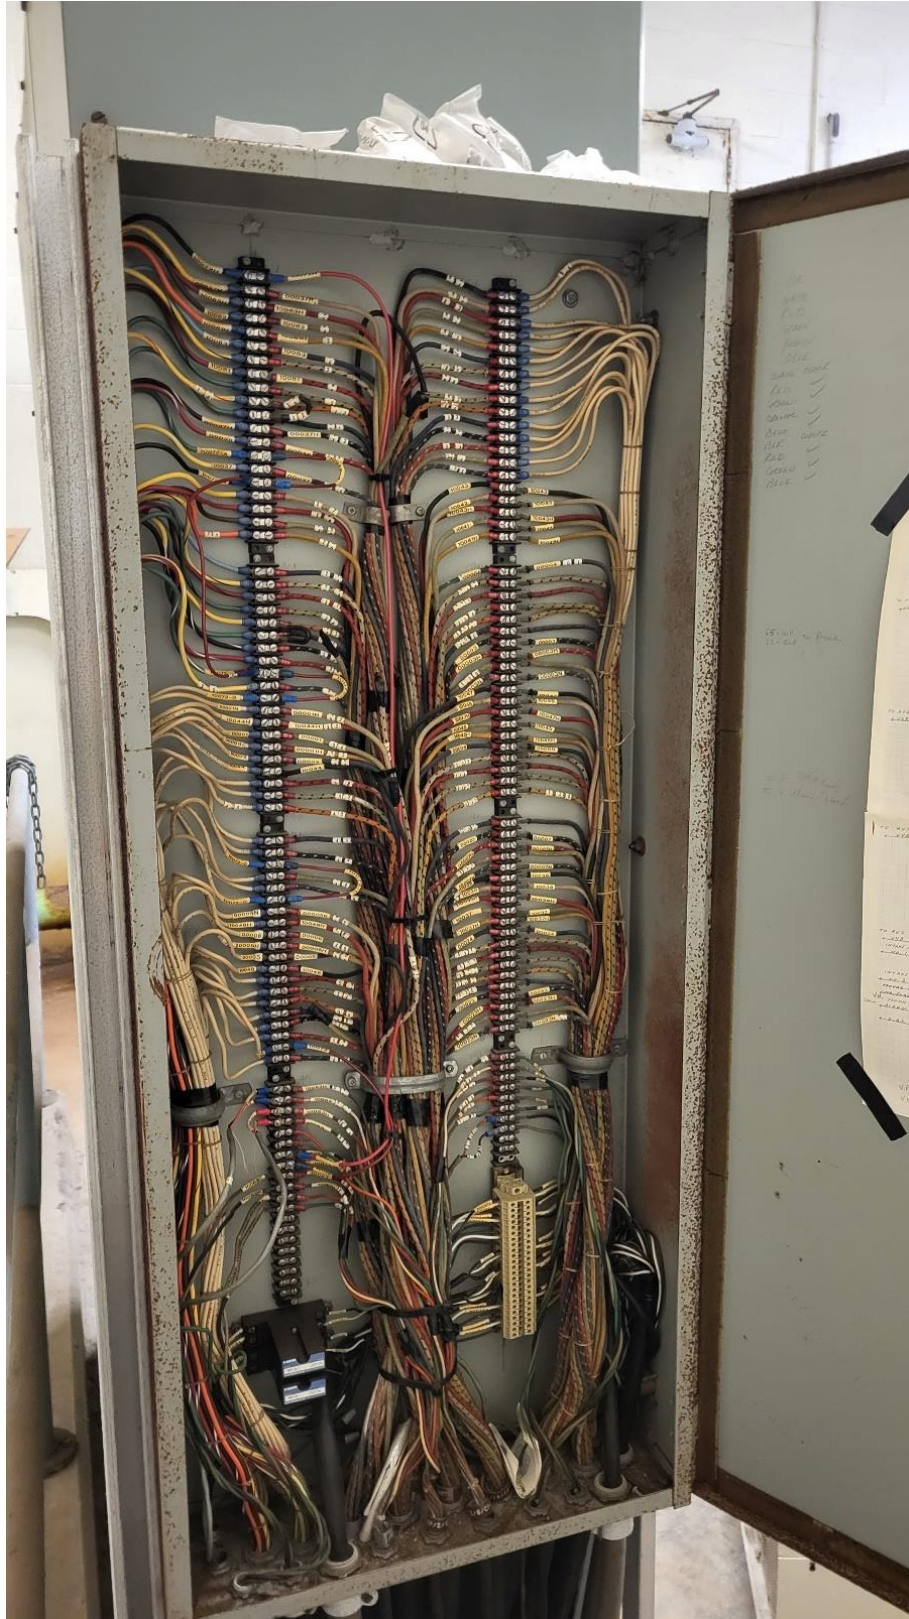
Photograph #6: Valve House Terminal Cabinet

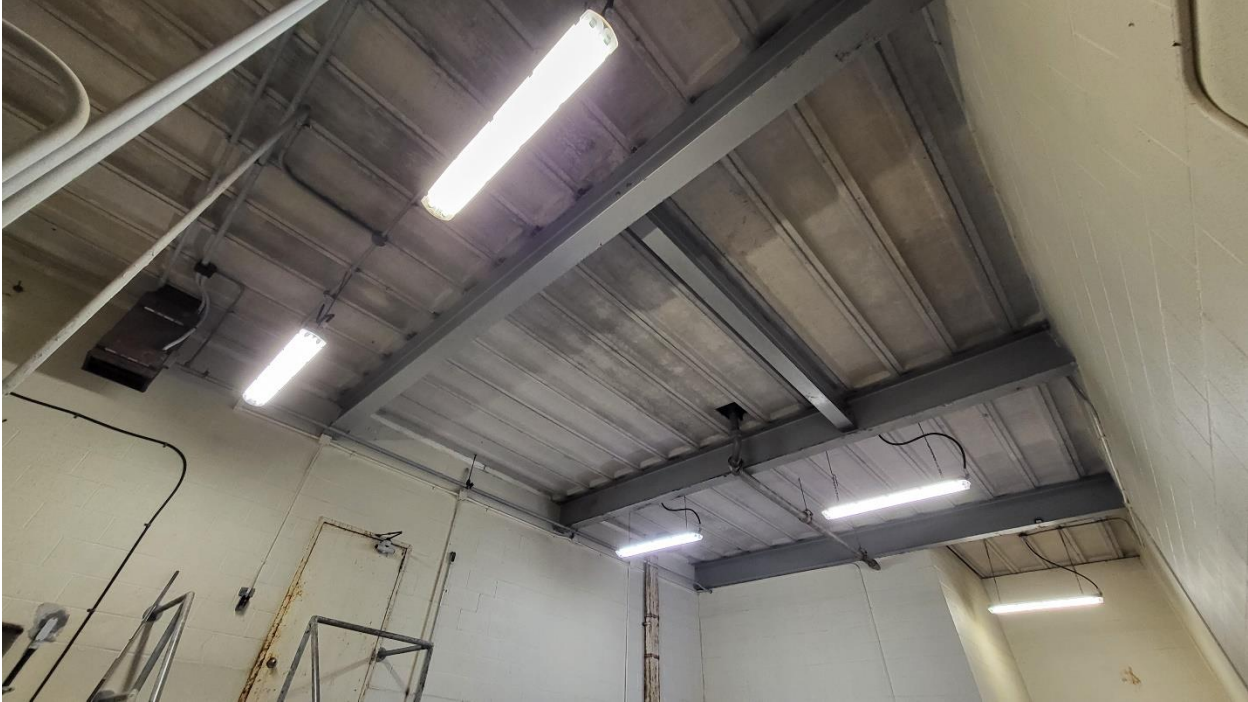
Photograph #8: Valve House Ceiling

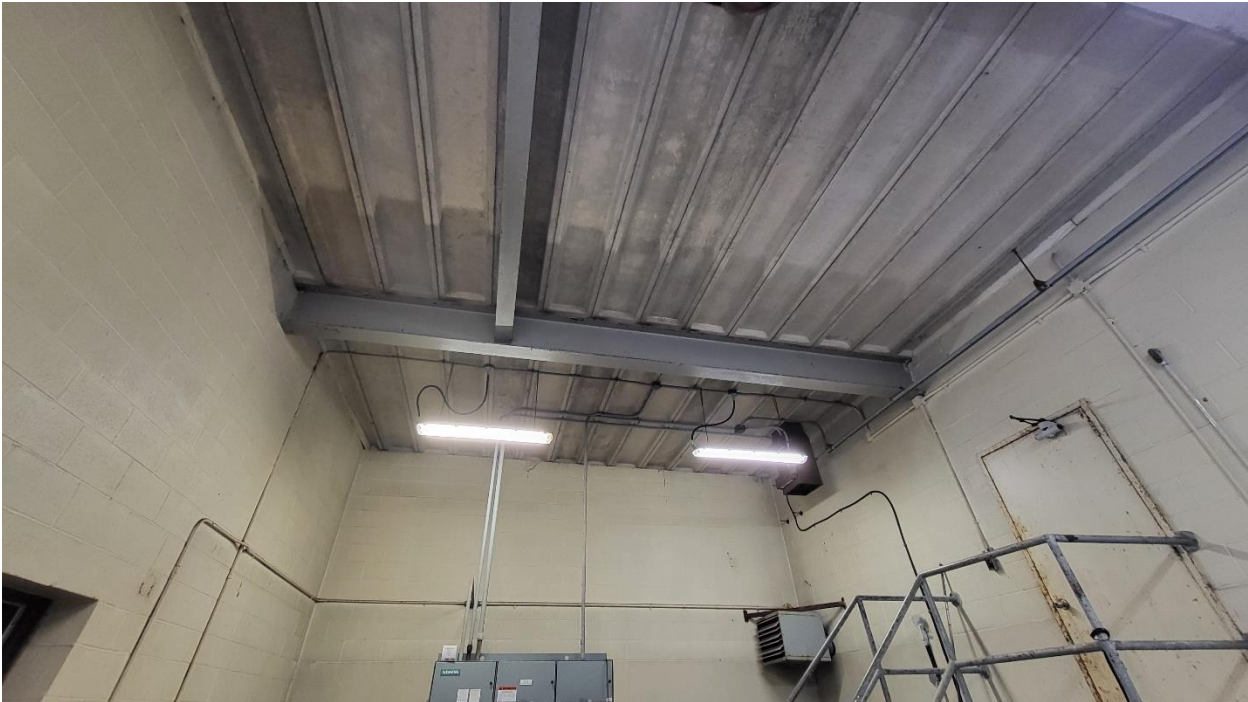
Photograph #9: Valve House Ceiling

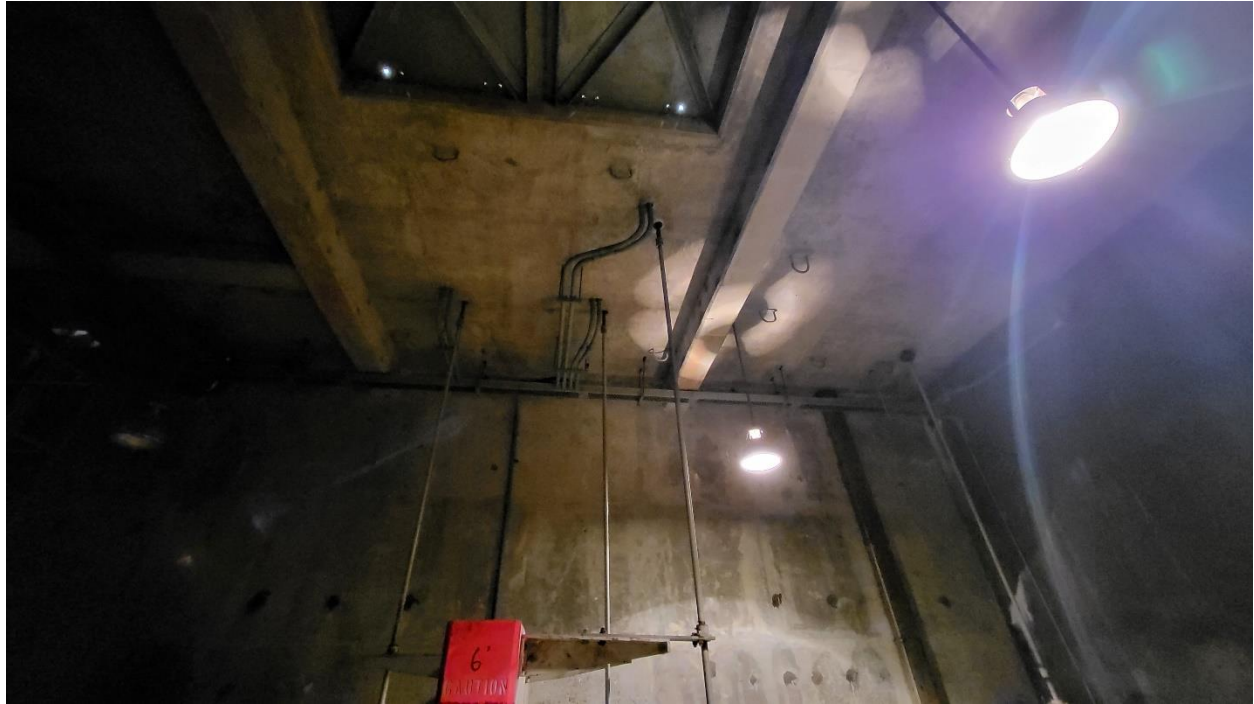
Photograph #10: Valve House Pit

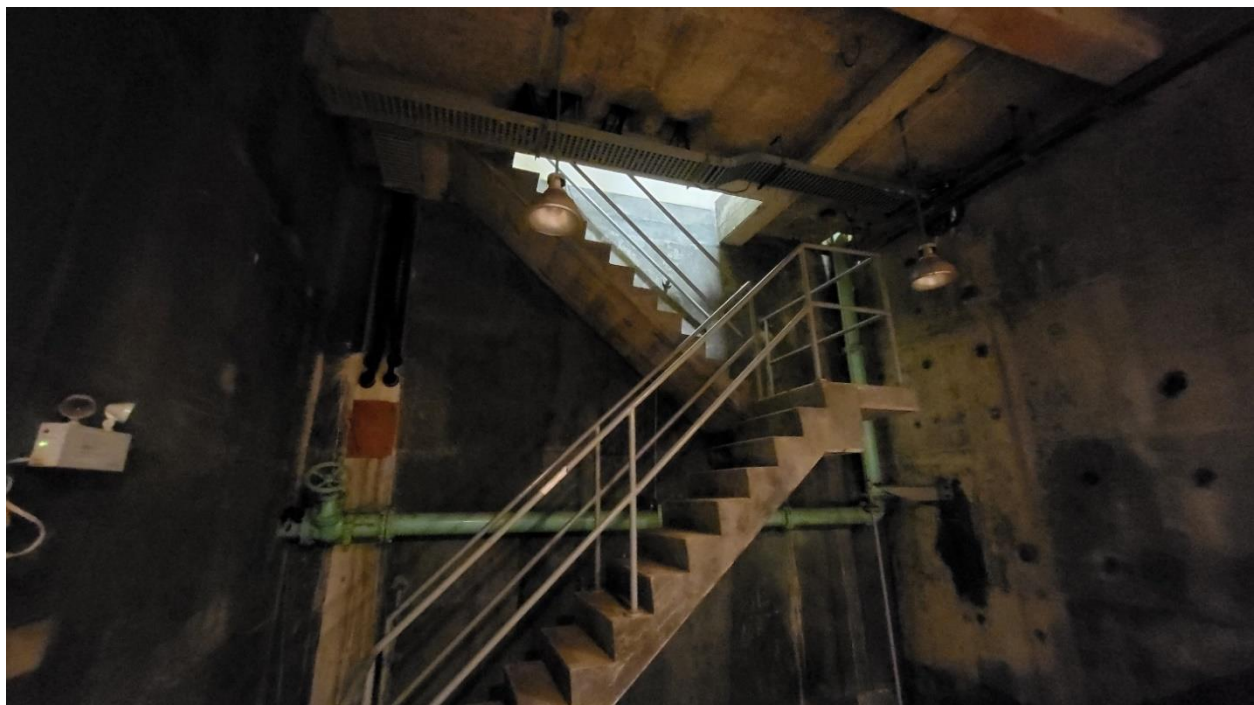
Photograph #11: Valve House Pit Stairs, cable tray, and incoming conduit

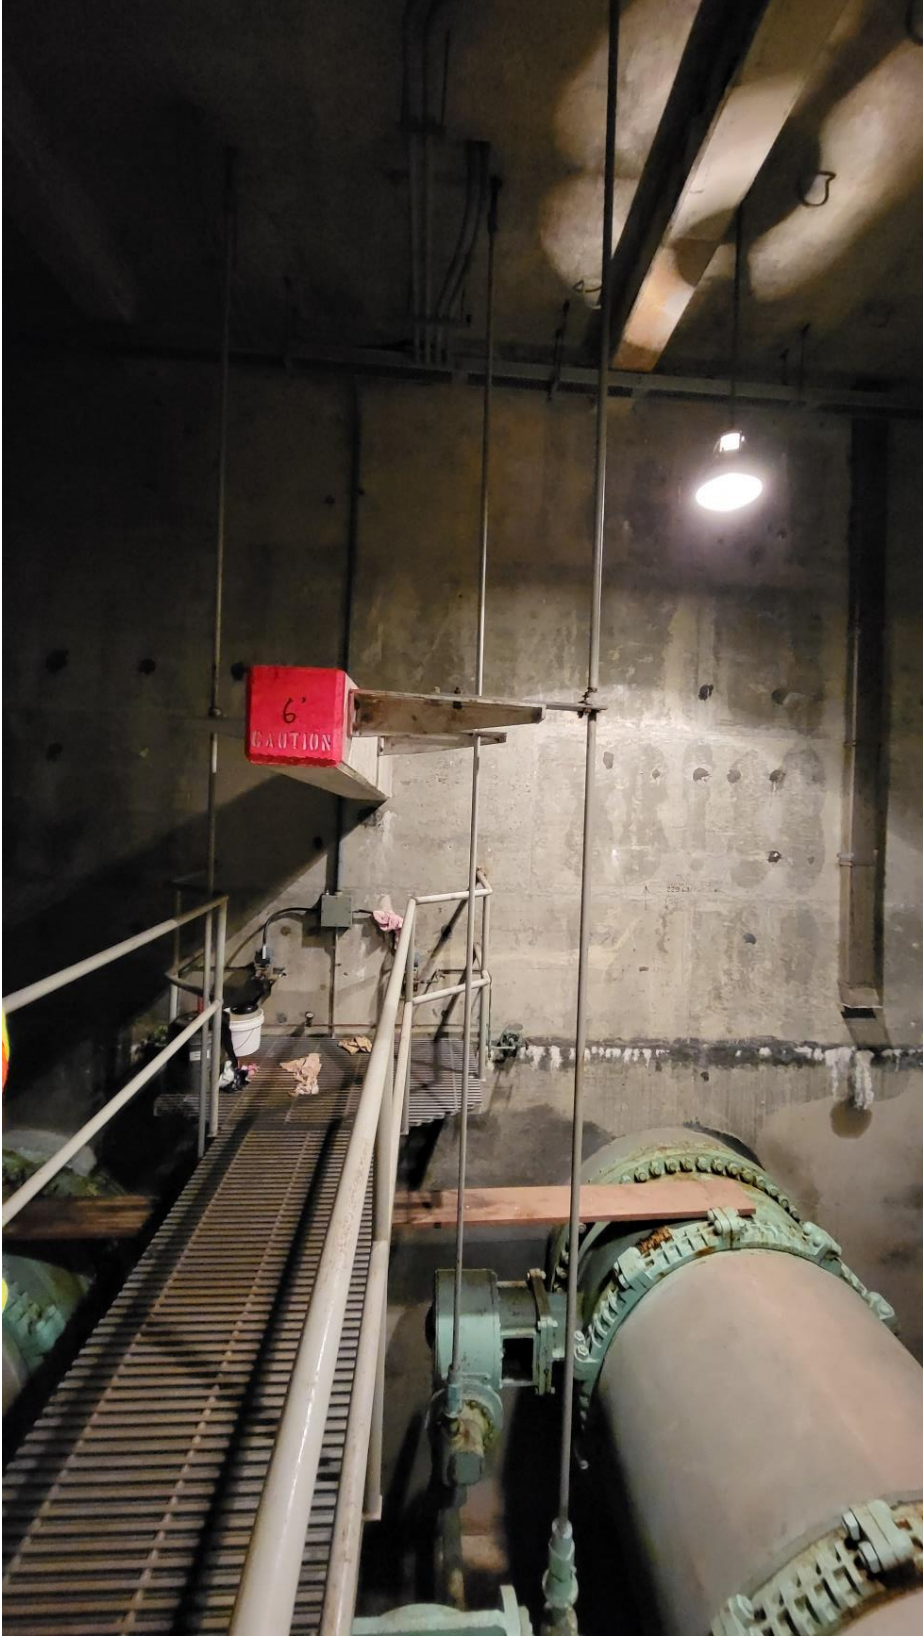
Photograph #12: Valve House Pit

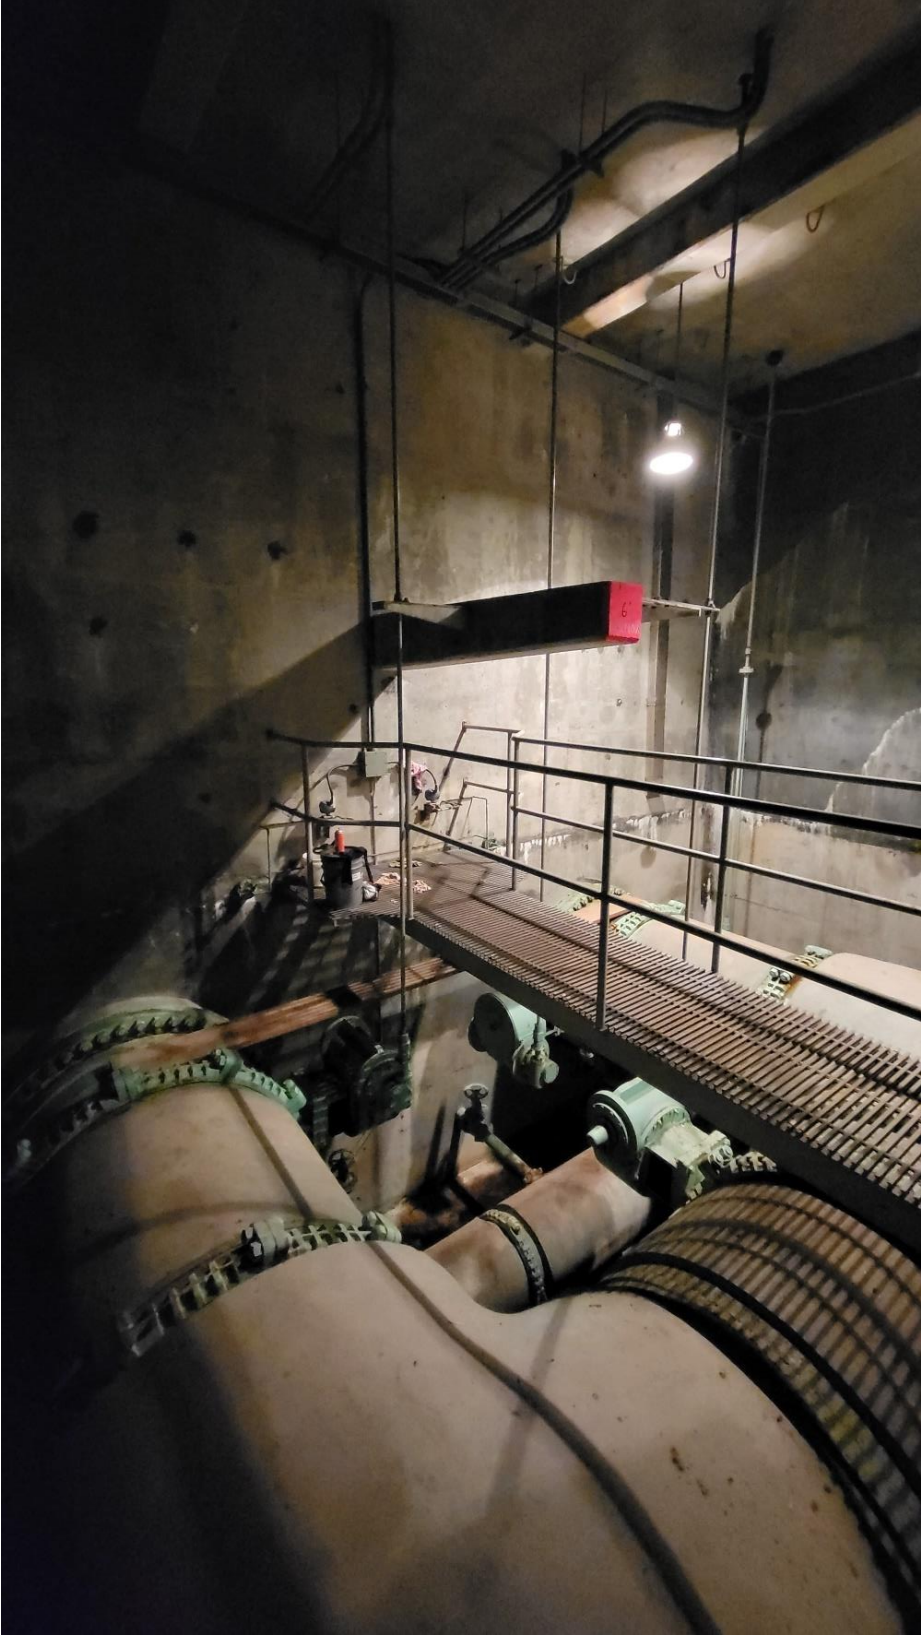
Photograph #13: Valve House Pit

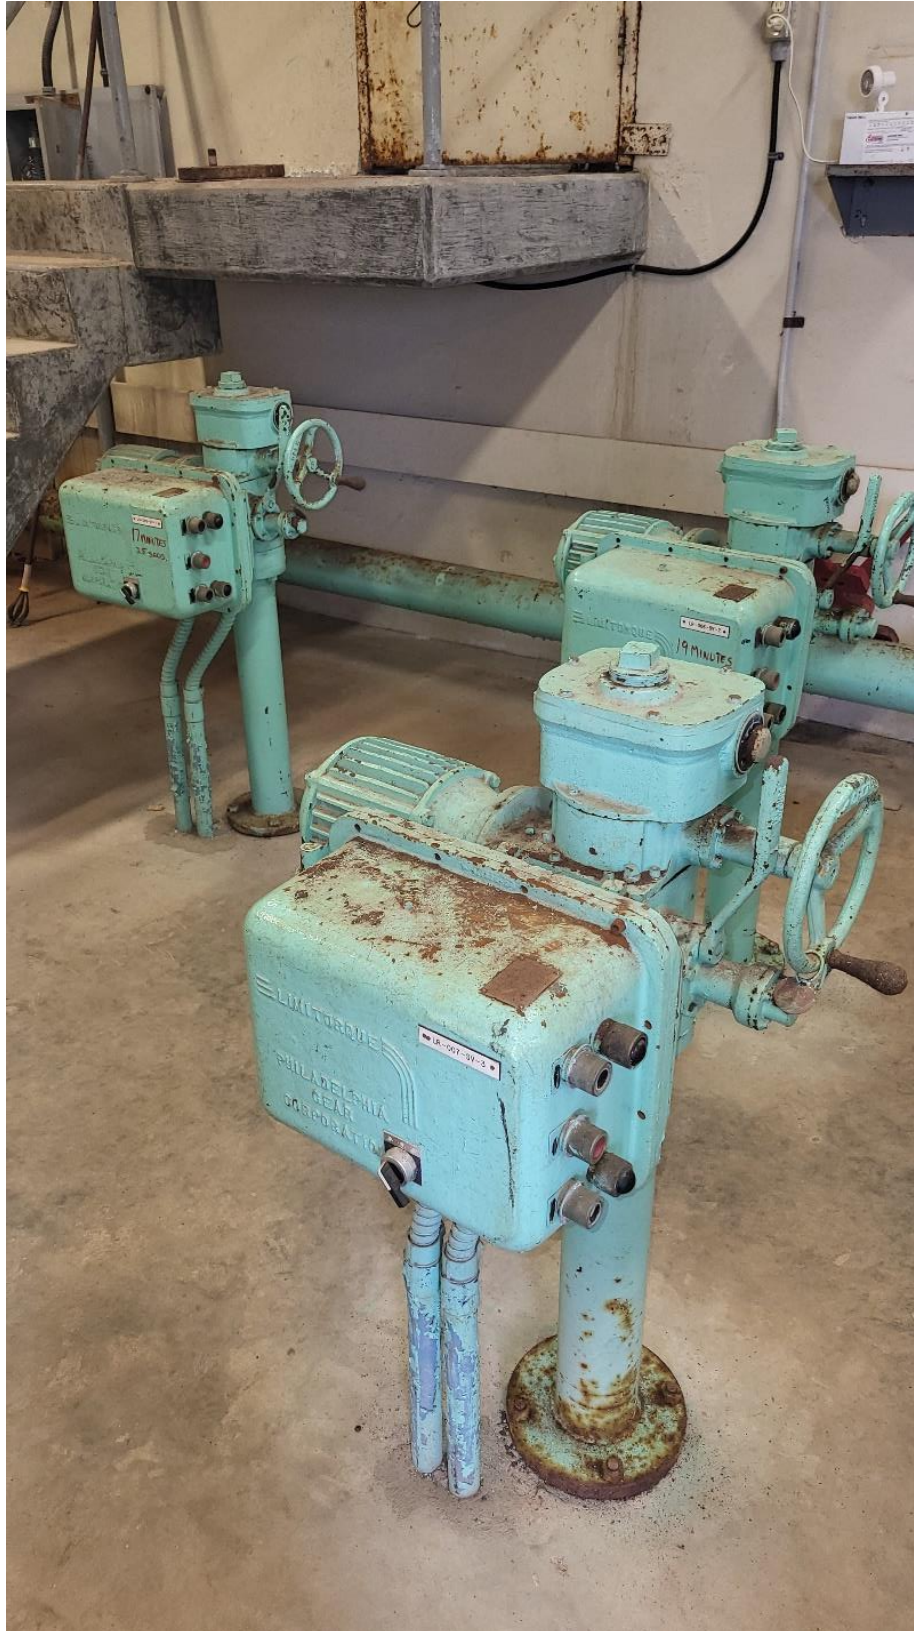
Photograph #14: Valve House Actuator Motors

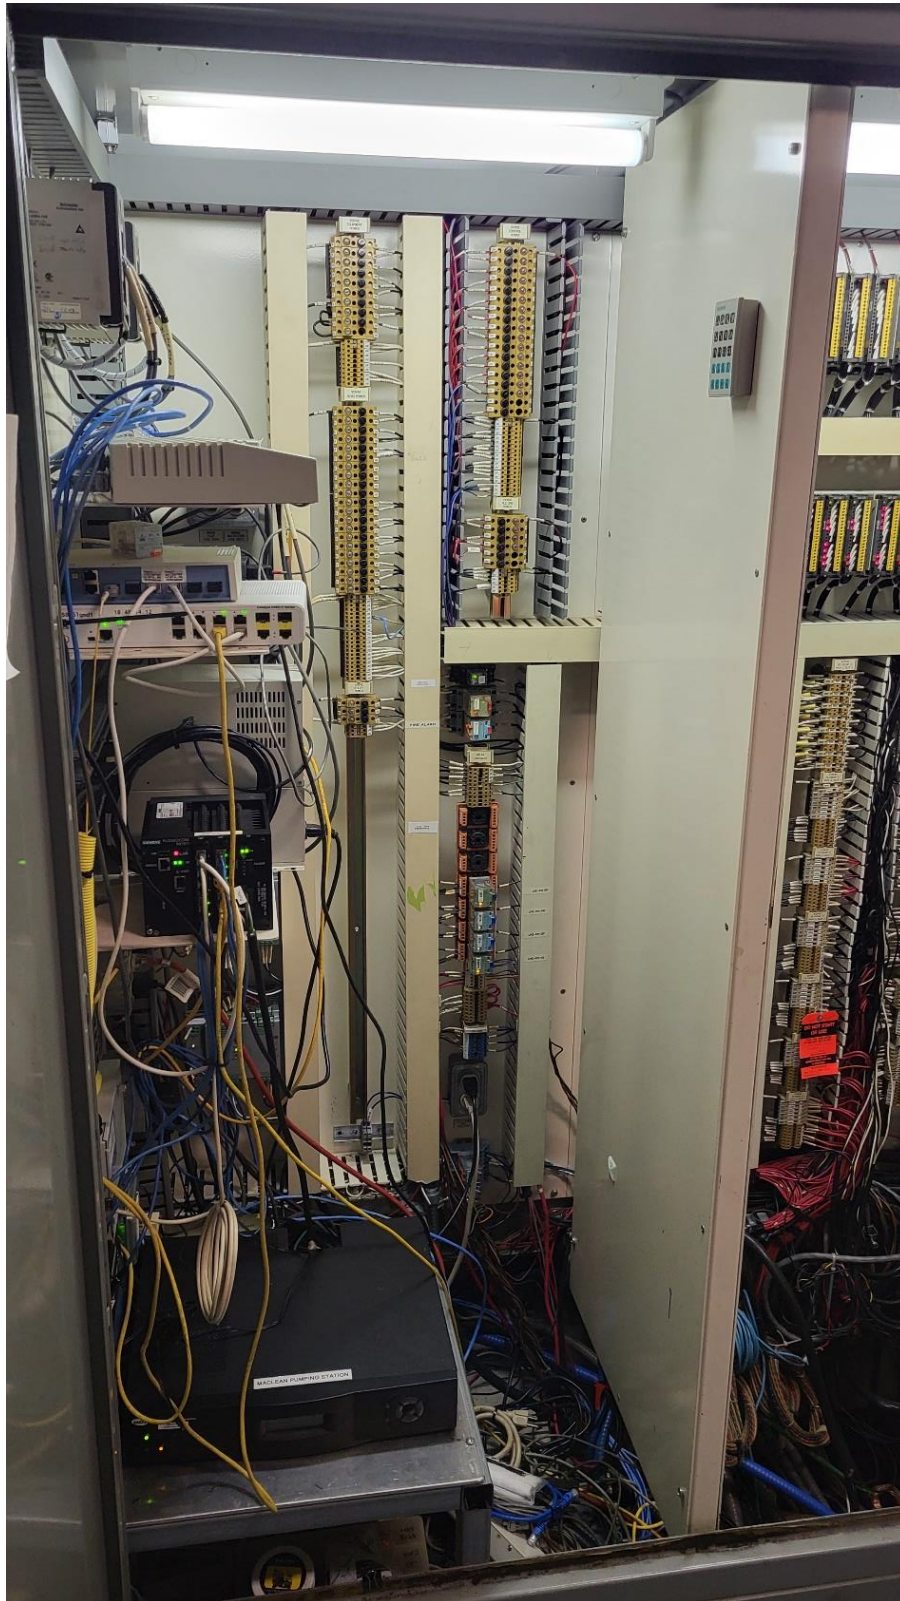
Photograph #17: Maclean Regional Pumping Station Main Control Panel Left Section

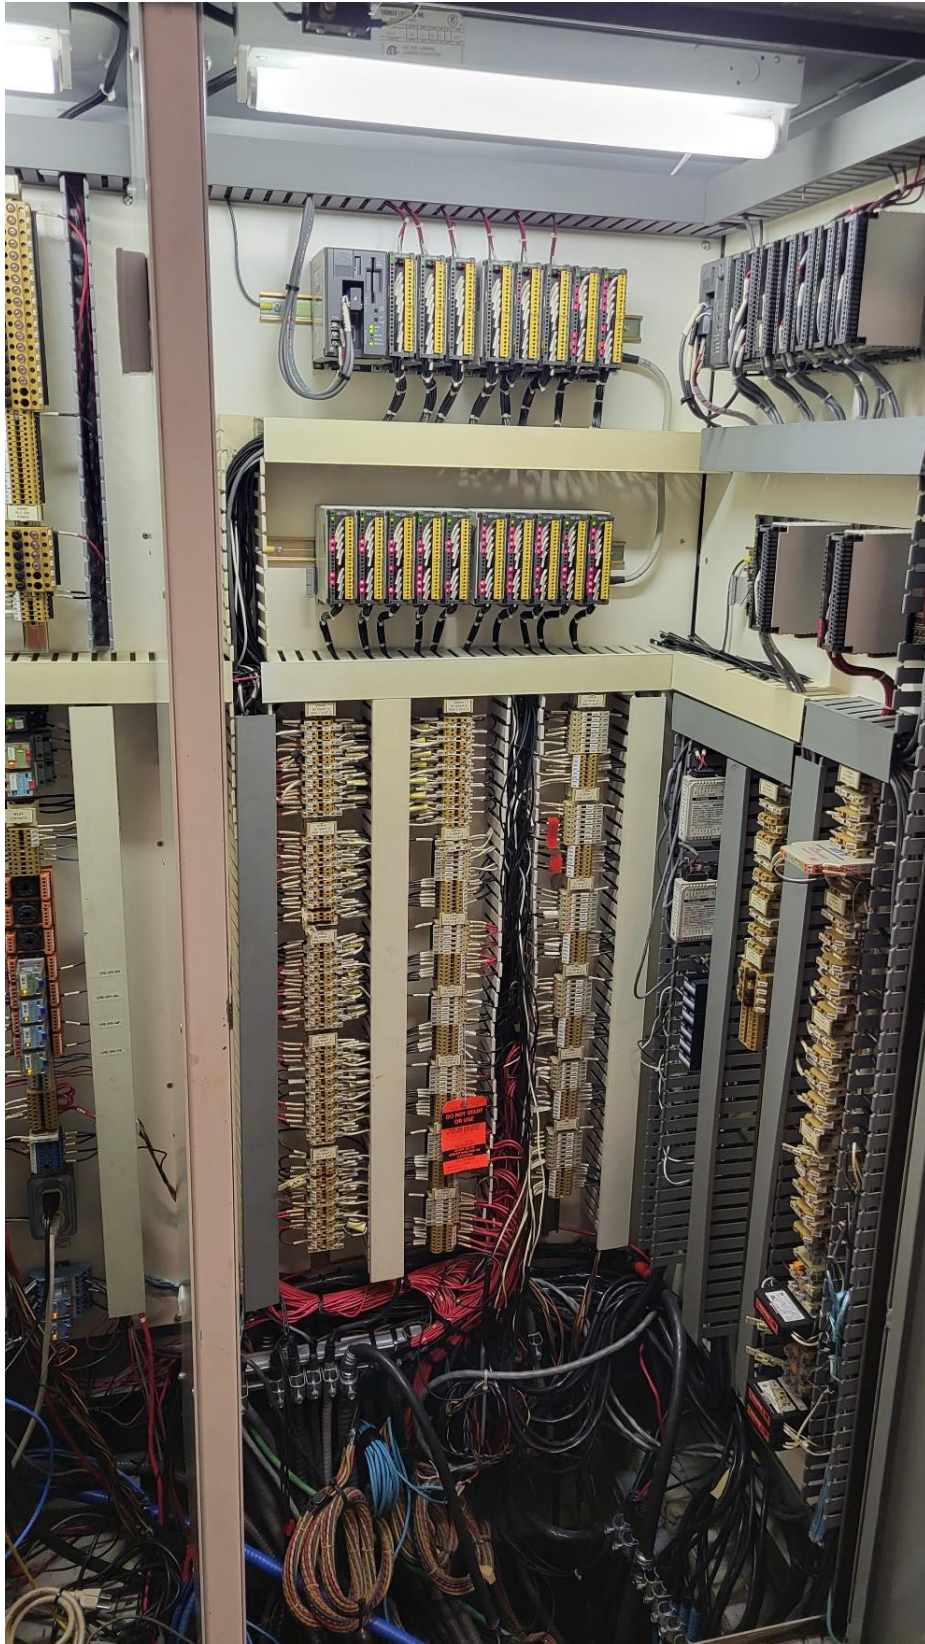
Photograph #18: Maclean Regional Pumping Station Main Control Panel Right Section
