REVISION #2

Hazardous Building Materials Assessment

St. James Civic Centre
2055 Ness Avenue
Winnipeg, Manitoba

October 4, 2018

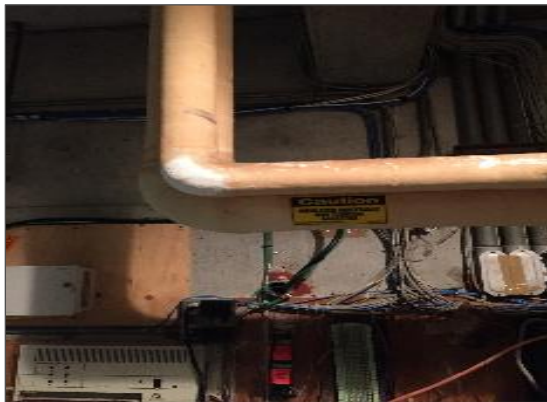
Parging cement, containing chrysotile asbestos, is present on pipe fittings (elbows, valves, tees, hangers etc.) on the domestic (DW), hot water heating (HWH), steam, and rain water leader systems (Samples 0001A-C, 0002A-C, 0006A-C, 0017A-C, 0021A-C, and 0035A-C). Parging cement is a friable insulation, was jacketed with canvas and observed in good condition.

Photograph No. 1: Asbestos-containing parging cement present on fittings, elbows, valves and tee's of the Domestic, hot water, steam system.

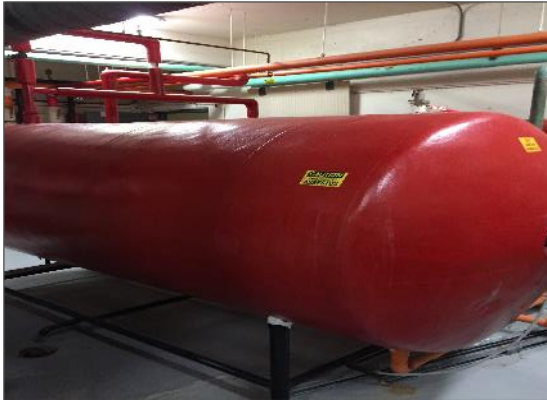
Parging cement, containing chrysotile asbestos, is present as insulation on the hot water tanks (2) within the pool room Loc.13 (Samples 0016A-C). There is approximately 400 square feet of asbestos-containing insulation. Parging cement is friable, was jacketed with canvas and observed in good condition.

Photograph No. 3: Asbestos-containing parging cement present as insulation on the hot water holding tanks within the pool room Loc.13.

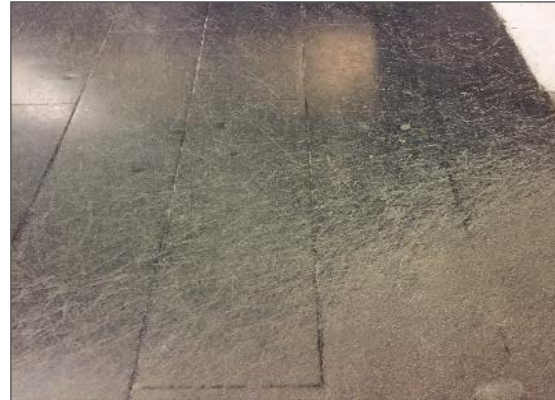
Photograph No. 5: Non-asbestos skate matting within the rink
 Loc.15 (Samples 0019A-C).

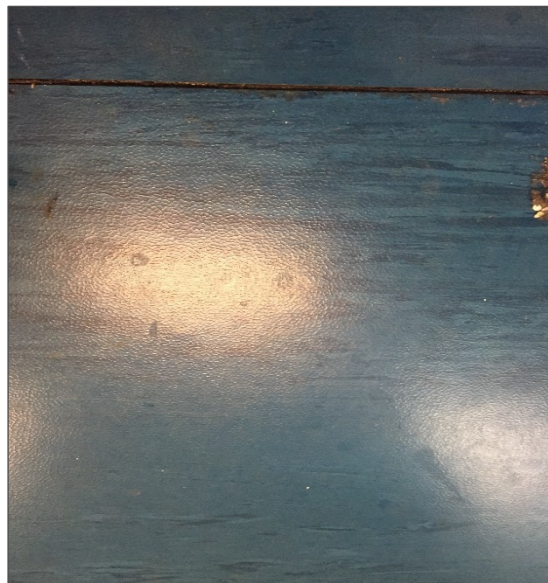
Photograph No. : Non-asbestos blue matting within the Reception area and Gym Loc.'s 30 and 42 (Samples 0030A-C).

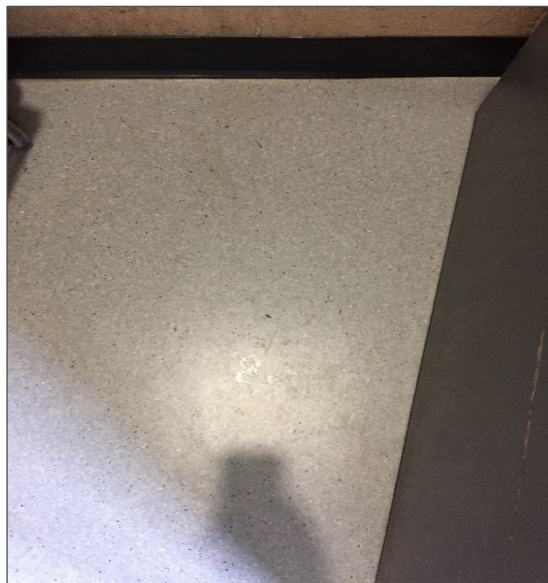
Photograph No. 9: Non-asbestos vinyl sheet flooring within the utility room Loc.53 (Rubber).

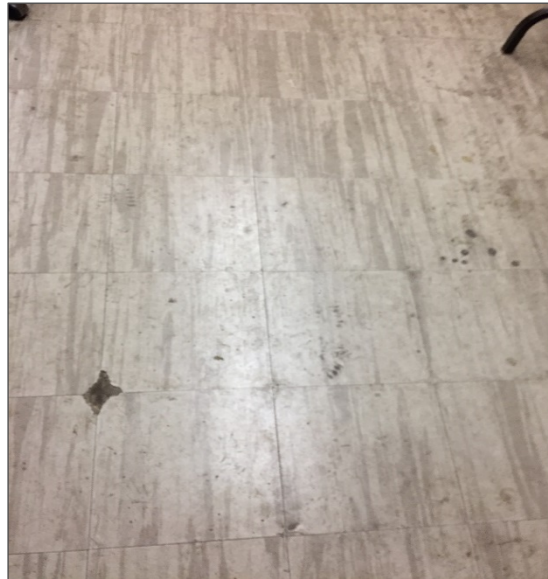
Photograph No. 12: Asbestos-containing vinyl floor tiles within the rink sound room Loc.15 (Samples 0023A-C).

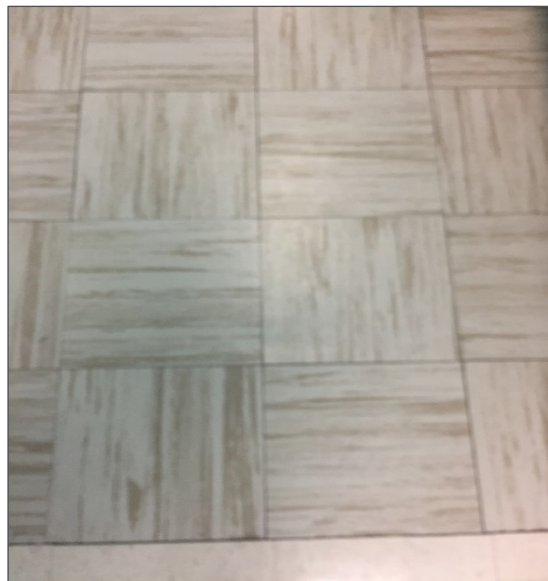
Photograph No. 13: Asbestos-containing vinyl floor tiles within pool corridor and office Loc.'s 38 and 43 (Samples 0033A-C).

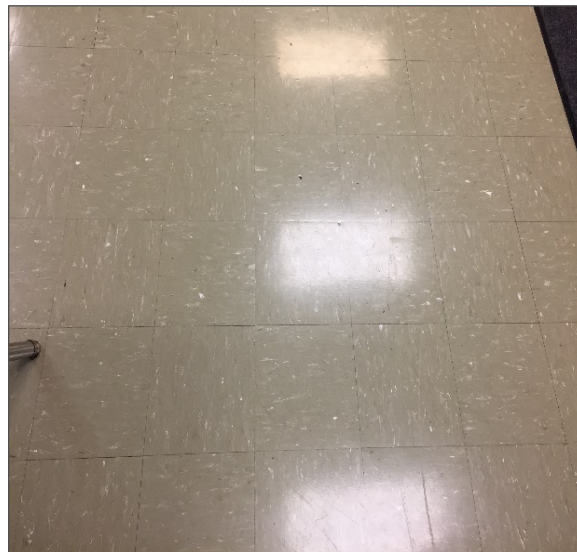
Photograph No. 15: Asbestos-containing vinyl floor tiles within the cloak room Loc.47 (Samples 0038A-C).

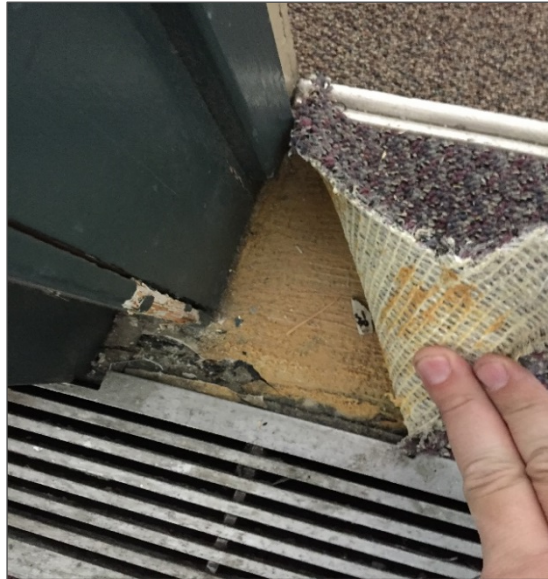
Photograph No. 20: Asbestos-containing vinyl floor tiles within the mezzanine board room and storage room under carpeting Loc.'s 66 and 67 (Samples 0053A-C).

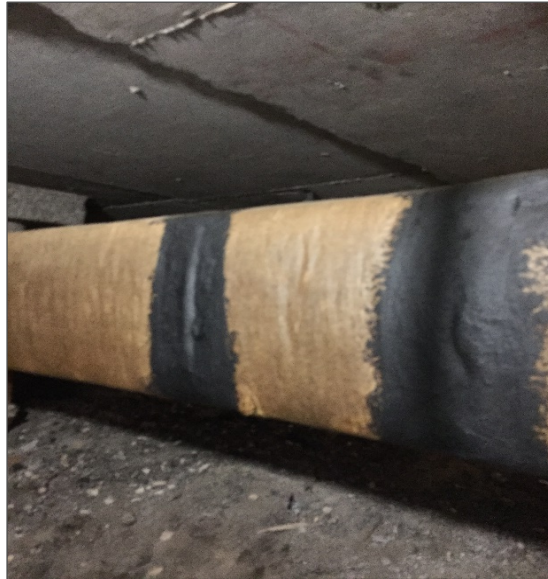
Black tar mastic present on jacketing of duct insulation within South crawl space contains chrysotile asbestos (Samples 0007A-C and 0009A-C).

Photograph No. 24: Asbestos-containing black tar mastic on ducting within the south crawlspace (Samples 0007A-C).
