Hazardous Building Materials Assessment (Pre-construction)

Expansion Project
St. James Civic Centre
2055 Ness Avenue,
Winnipeg, Manitoba

May 23, 2023

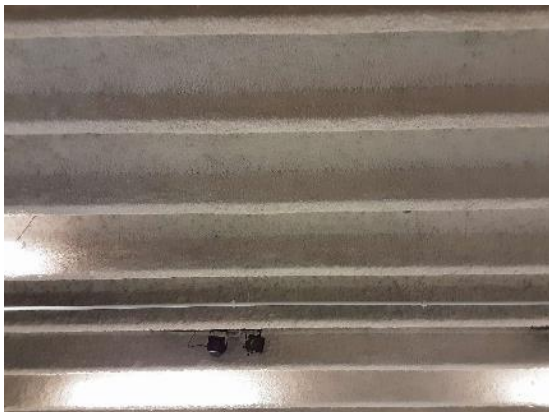
New non-asbestos spray-applied insulation is present on the structure in the Auditorium.

V0000 (None), Structure, Beam, Deck, Acoustic spray, Auditorium (Location #: 1)

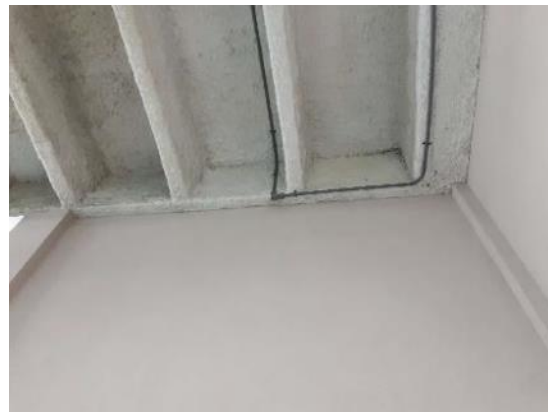
Spray-applied insulation present on the structure throughout the pool area (Location 16) does not contain asbestos (2018 analysis).

V0000 (None), Structure, Fireproofing, Pool Exterior Walls (Location #: 16)

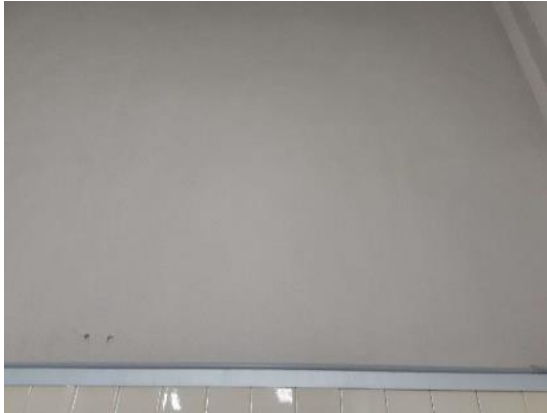
Texture finish wall in the Pool Area (Location 16) does not contain asbestos (samples S0011A-B and 2018 analysis).

S0011A (None), Wall, Texture Coat, Pool Exterior Walls
(Location #: 16)

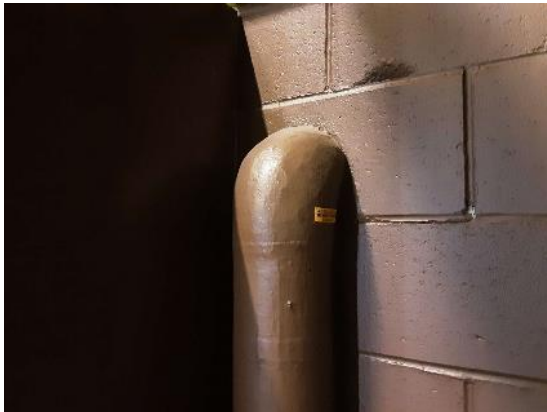
V9000 (Confirmed Asbestos), Piping, Parging Cement, Stage
(Location #: 2)

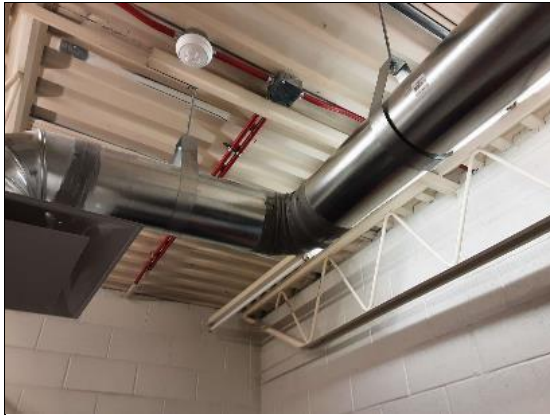
Grey and black duct mastic present at seams / joints on the exterior of ducts throughout the assessed area does not contain asbestos (2018 analysis).

V0000 (None), Duct, Mastic, Grey,
Storage Room (Location #: 3)

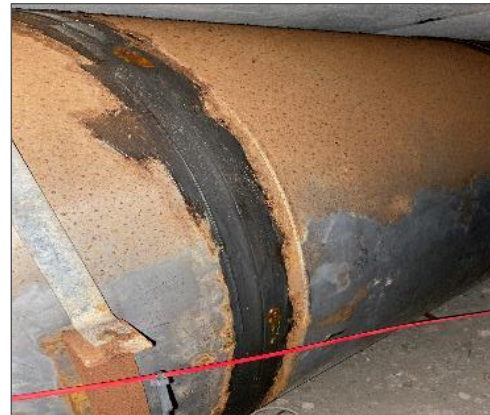
V0000, (None), Duct, blackish grey mastic,
Crawlspace (Location # 20)

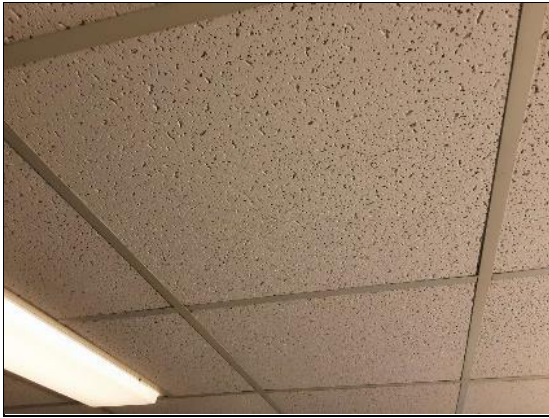
Ceiling tiles were determined to be non-asbestos by analysis (2018 analysis) or presumed to be non-asbestos based on the date of manufacture determined from the date stamp applied to the top of the tiles or by the composition of the tiles (gypsum). The tiles with date codes were manufactured after asbestos stopped being used in acoustic ceiling tiles.

V0000 (None), Ceiling, Ceiling Tiles (lay-in), Men's Washroom
(Location #: 10)

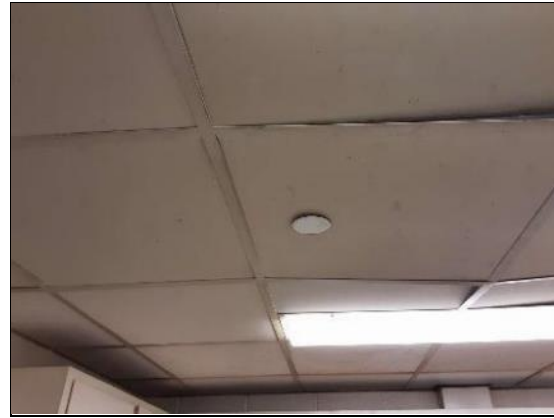
V0000 (None), Ceiling, Ceiling Tiles (lay-in),
Kitchen (Location #: 9)

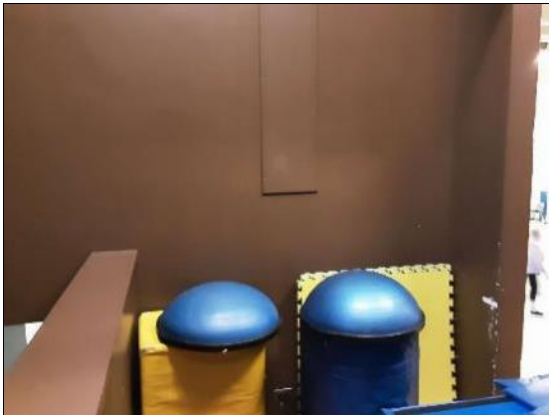
Plaster present on walls throughout the assessed area does not contain asbestos (samples S0002A-B and 2018 analysis).

S0002A (None), Wall, Plaster, Stage (Location #: 2)

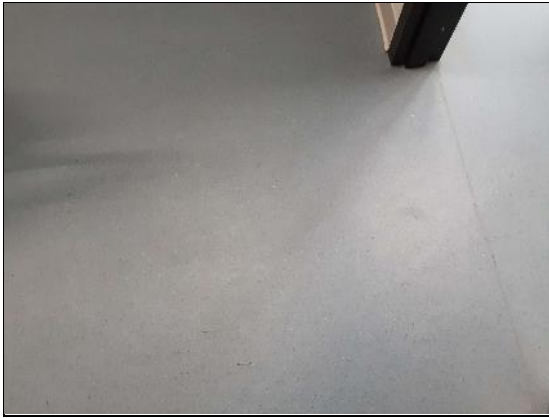
Vinyl sheet flooring and skate matting throughout the assessed area does not contain asbestos (2018 analysis or has been newly installed since the 2018 survey).

V0000 (None), Floor, Vinyl Sheet Flooring, Stairway To Stage
(Location #: 5)

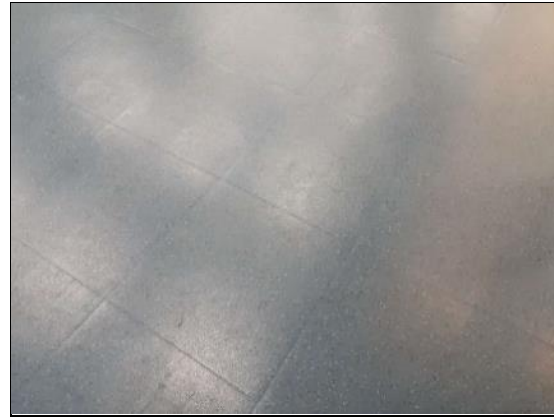
V0000 (None), Floor, Matt Flooring,
Foyer (Location #: 15)

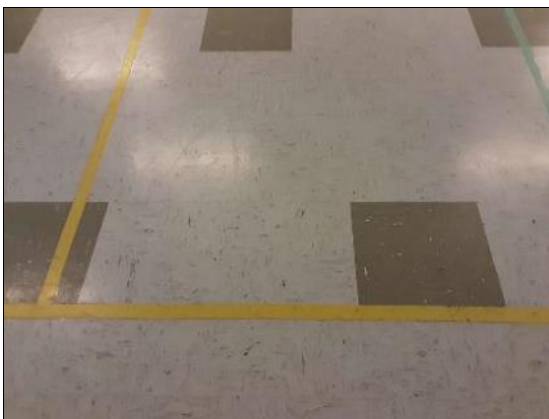
V9000 (Confirmed Asbestos), Floor, Vinyl Floor Tile and
Mastic, Auditorium (Location #: 1)

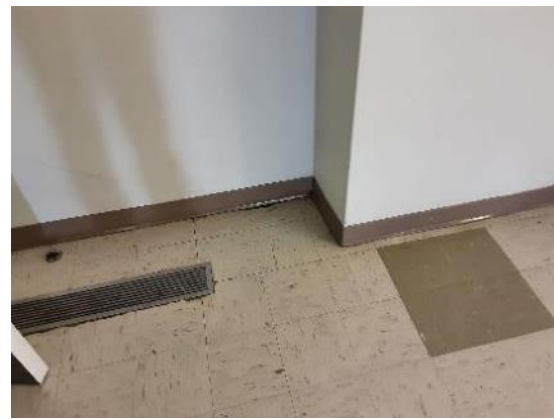
Adhesive behind tan, beige and black baseboards does not contain asbestos (Samples S0001A-C, S0004A-C and S0005A-C).

S0001B (None), Wall, Base, Adhesive/mastic, Auditorium
(Location #: 1)

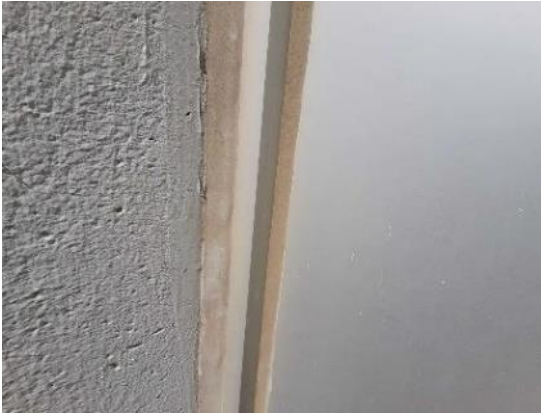
Grey, beige and black caulking at window frames, on the building exterior and roof does not contain asbestos (samples S0009A-C, S0012A-C and 2018 analysis).

S0012A (None), Wall, Caulking,
 Exterior Of Building (Location #: 19)

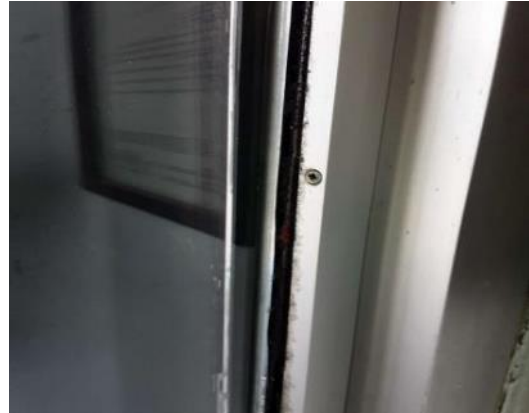
S0009C (None), Other, Caulking,
 Foyer (Location #: 15)

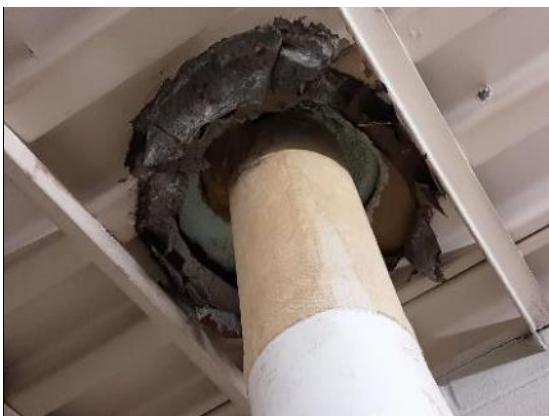
Tar paper located above the metal deck found at a pipe penetration does not contain asbestos (samples S0003A-C).

S0003C (None), Other, Tar Paper,
 Storage Room (Location #: 3)

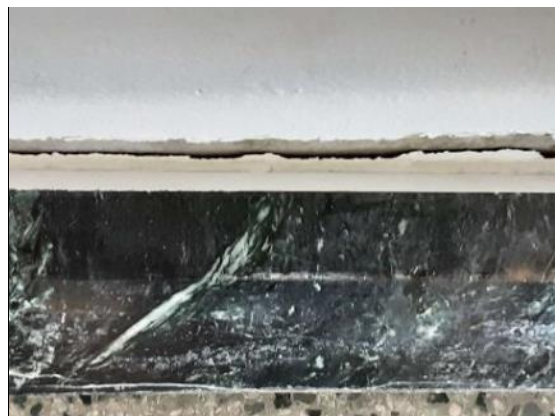
S0007C (None), Wall, Base,
 Thin-Set Behind, Foyer (Location #: 15)

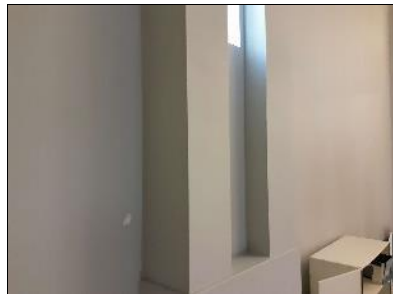
Sample Number	Colour, Substrate Description	Sample Location	Lead (%)	Photo
L0001	Light grey, plater	Auditorium (Loc. 1)	0.0047

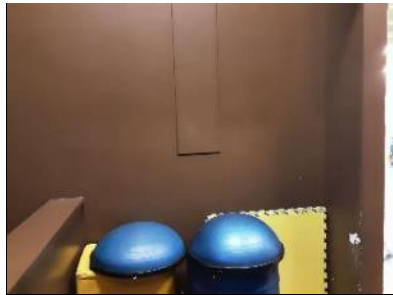
L0002	Brown, plaster	Stage (Loc. 2)	0.32

Items painted with paints containing elevated levels of lead may be a hazardous waste. Test lead-painted materials for leachable lead and other metals prior to disposal. Metallic components coated with lead paint do not require leachate testing and can be disposed of as non-hazardous construction and demolition (C&D) waste.

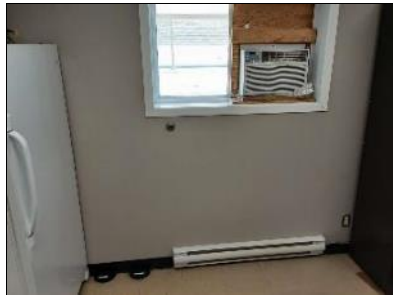
L0003	Grey, drywall	Kitchen (Loc. 12)	0.0072

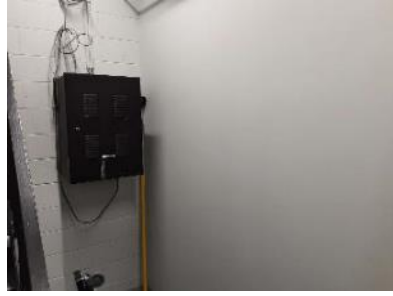
Sample Number	Colour, Substrate Description	Sample Location	Lead (%)	Photo
2018 Analysis	White, drywall	Stairway to Stage	<0.0047

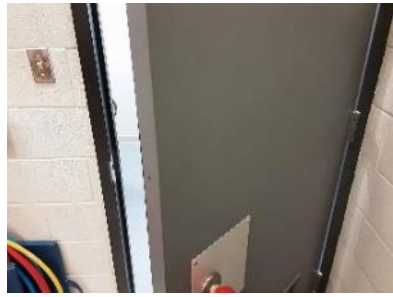
2018 Analysis	Grey, wood door, black paint has been applied over the door in several locations since the 2018 survey	Storage Room (Loc. 3)	0.28

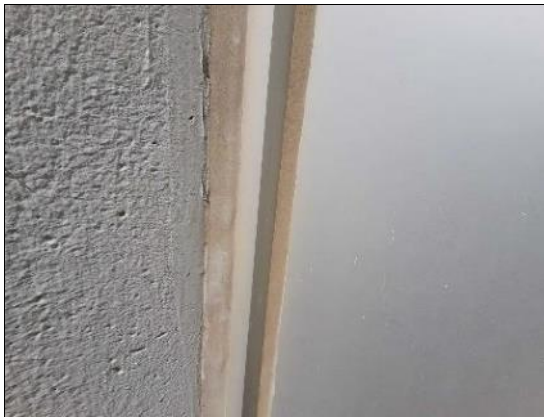
Grey caulking is present at the building exterior (sample P0002) and contains 58 mg/kg PCBs. The material is considered a PCB solid based on the threshold (50 mg/kg).

P0001 (PCB), Wall, Grey Caulking, Exterior Of Building
(Location #: 19)

Remove PCB caulking prior to building demolition. PCB caulking is a hazardous waste, package, and ship for destruction at a federally permitted facility.

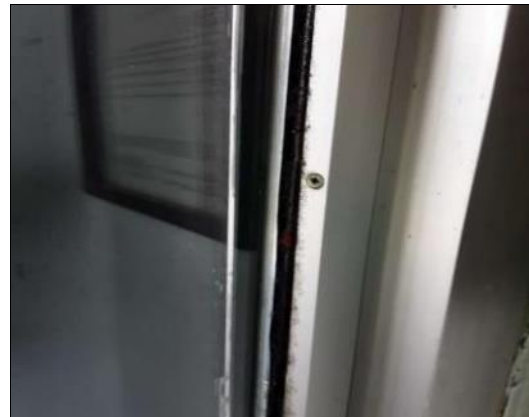
Black caulking is present at window and door frames at the Main Entrance (sample P0001) and contains <0.2 mg/kg PCBs. The material is a non-PCB solid based on the threshold (50 mg/kg).

P0002 (None), Caulking, Foyer
(Location #: 15)

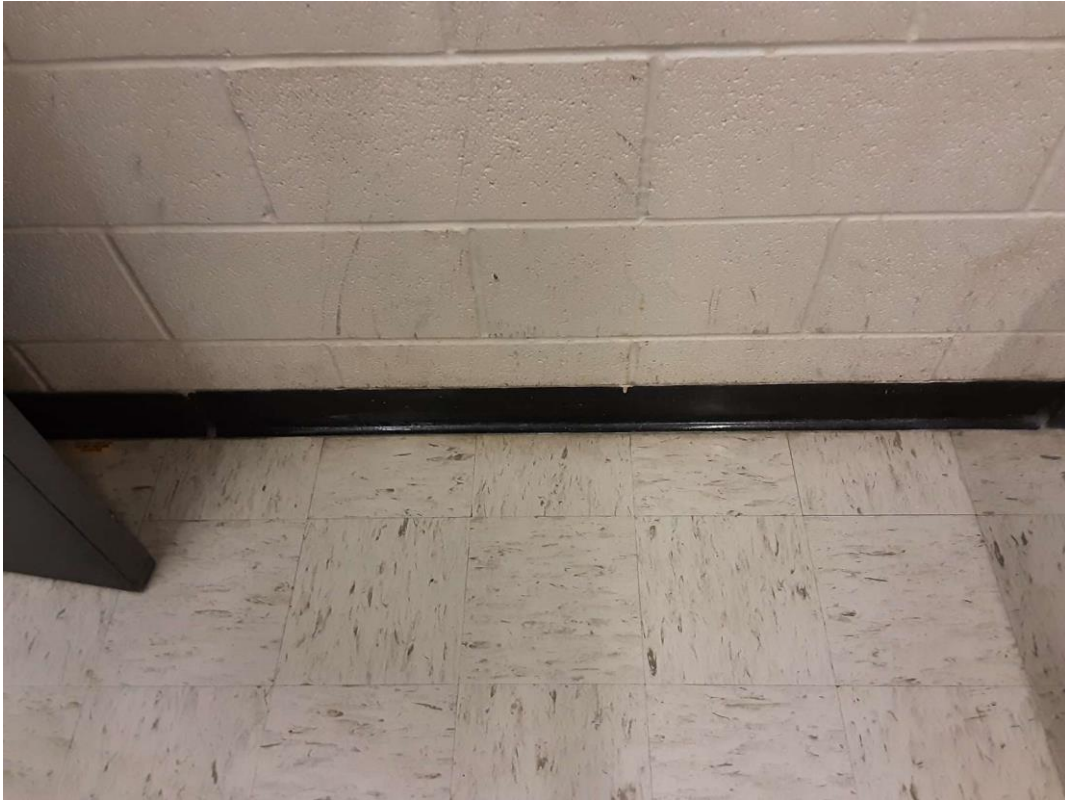
S0004A (None), Wall, Base, Adhesive/mastic, Storage Room (Location #: 3)

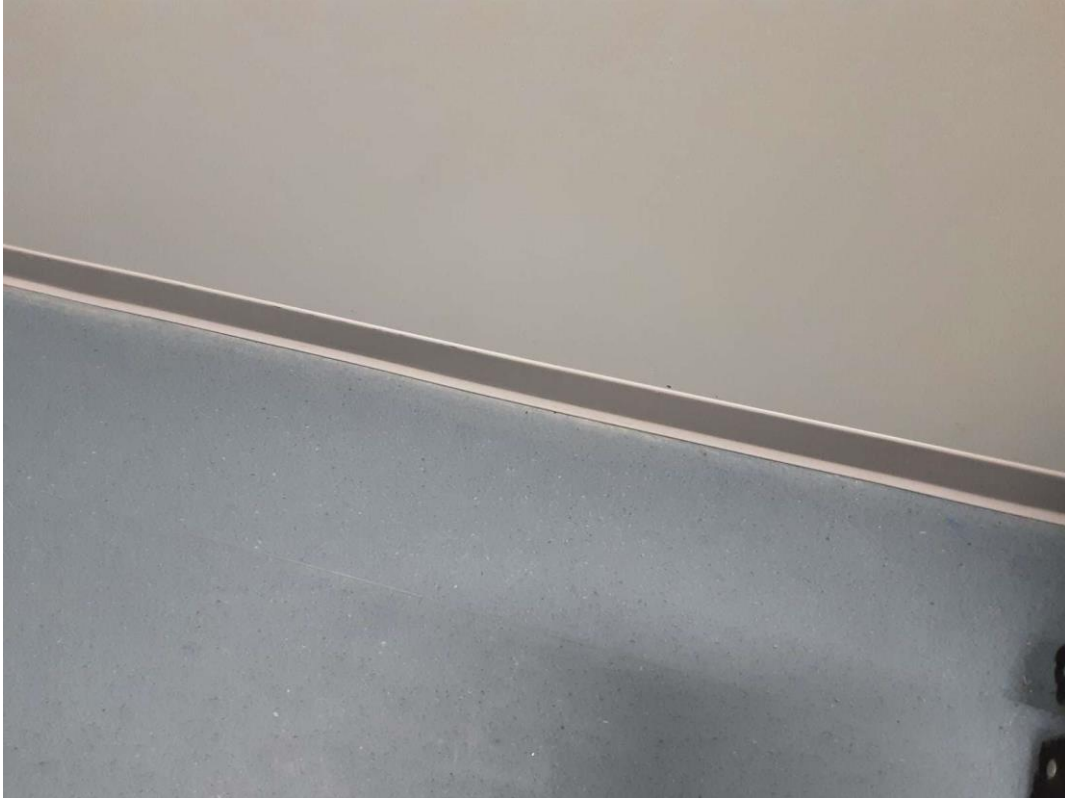
S0005A (None), Wall, Base, Adhesive/mastic, Stairway To Stage (Location #: 5)

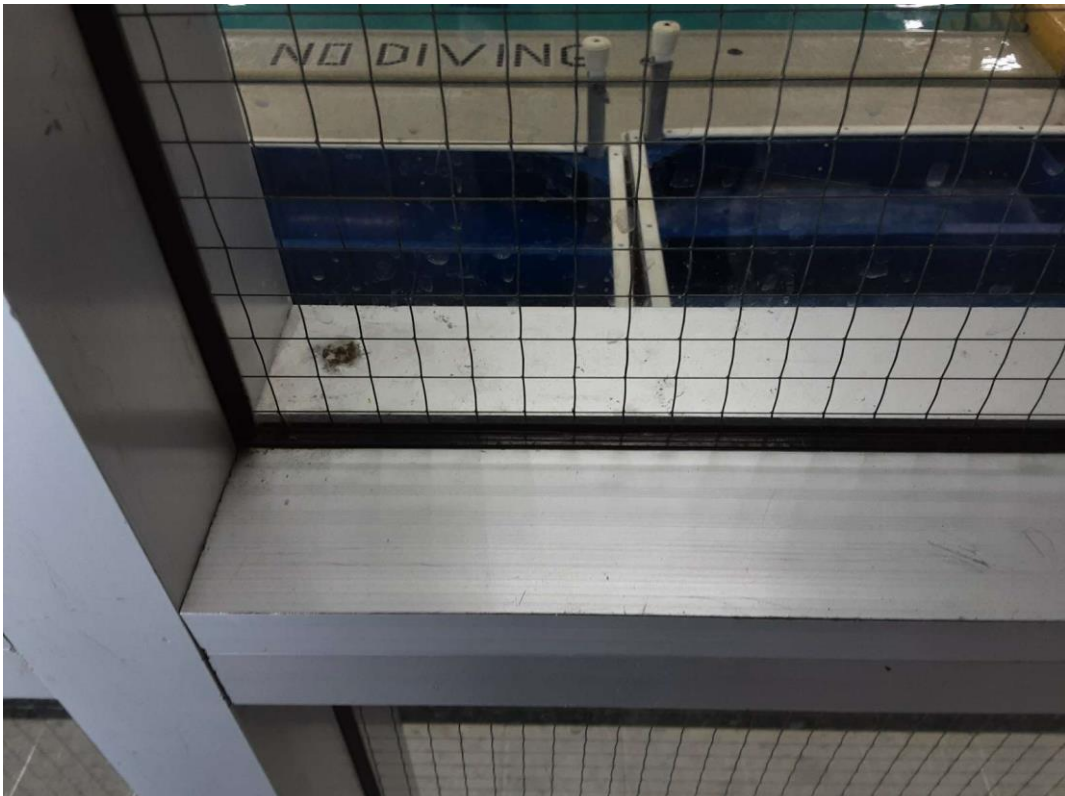
Butyl tape at window frames does not contain asbestos (samples S0008A-C).

S0008C (None), Other, Window, Butyl Tape, Foyer (Location #: 15)

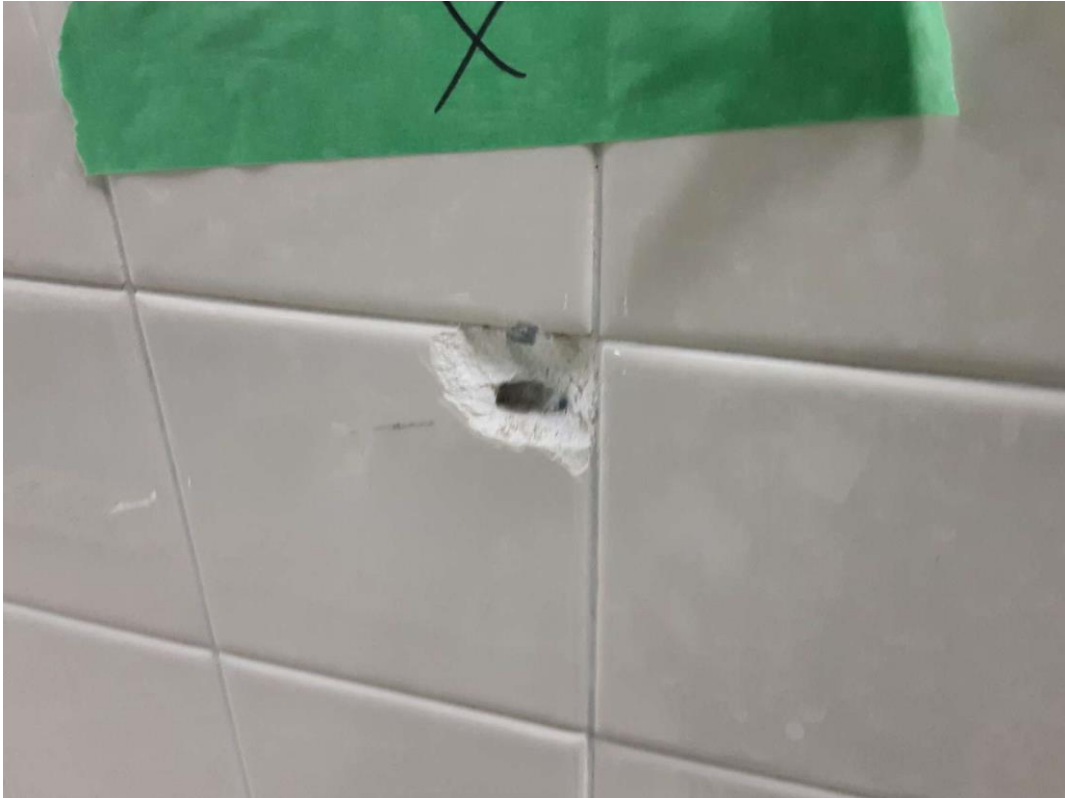
S0010A (None), Wall, Ceramic Tile Thin-Set, Pool Exterior Walls (Location #: 16)

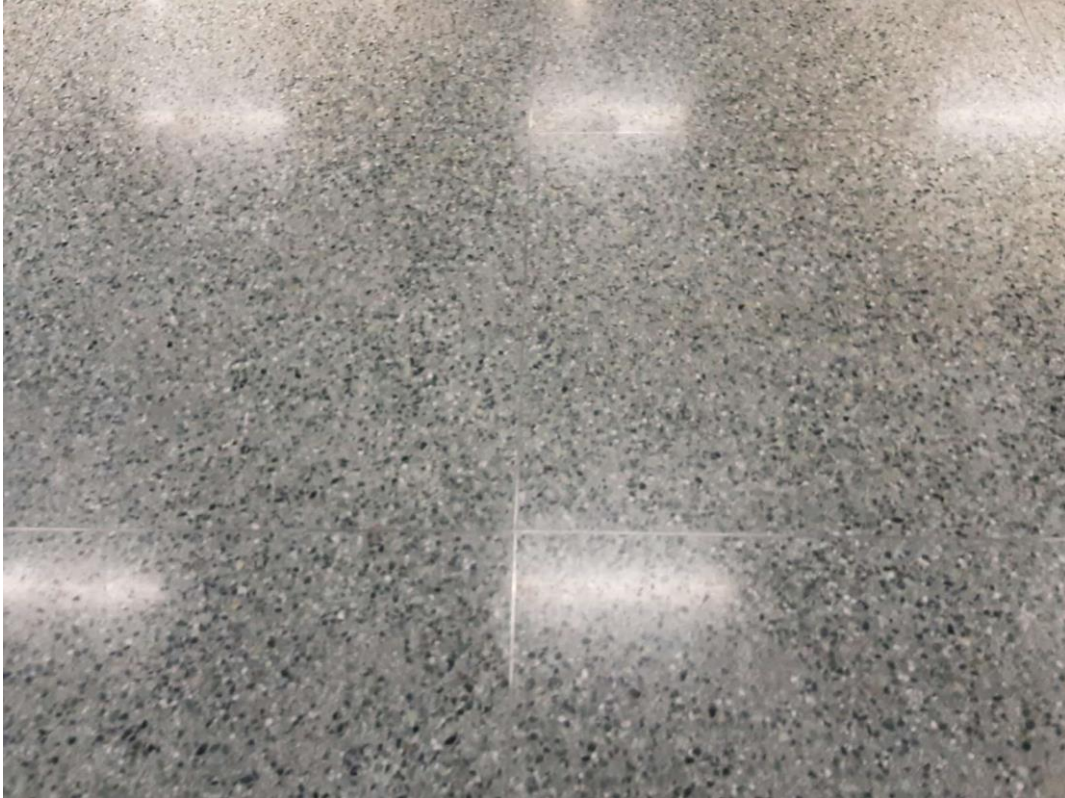
Terrazzo located at the Main Lobby is presumed to contain asbestos.

V9500 (Presumed Asbestos), Floor, Terrazzo, Foyer (Location #: 15)

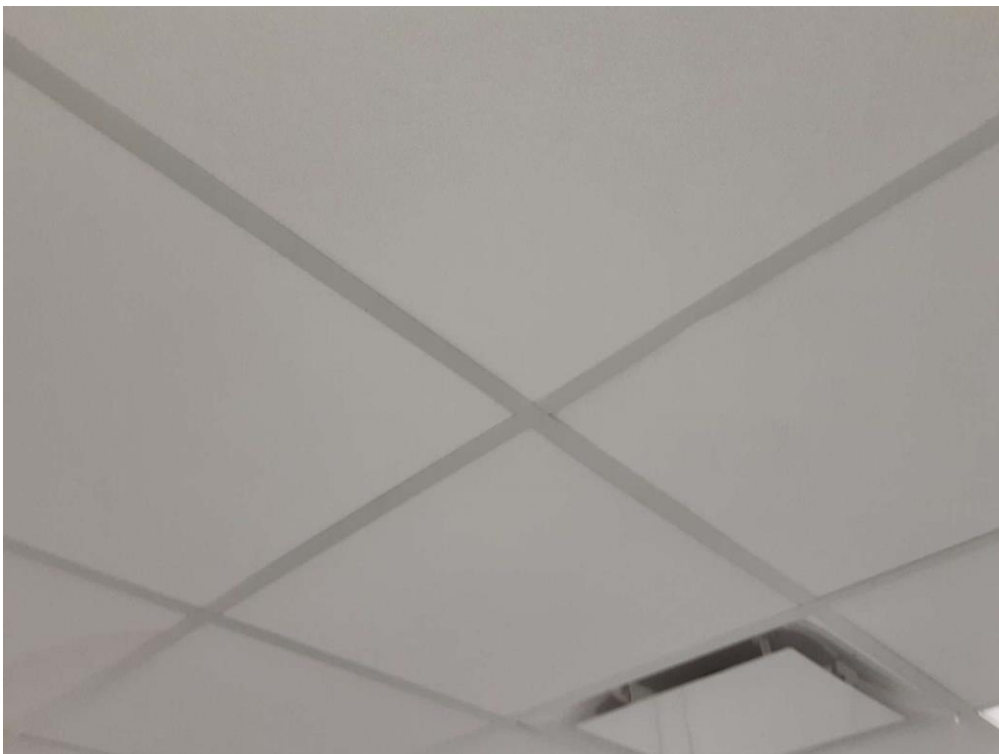
V0000 (None), Ceiling, Ceiling Tiles (lay-in), Classroom (Location #: 14)

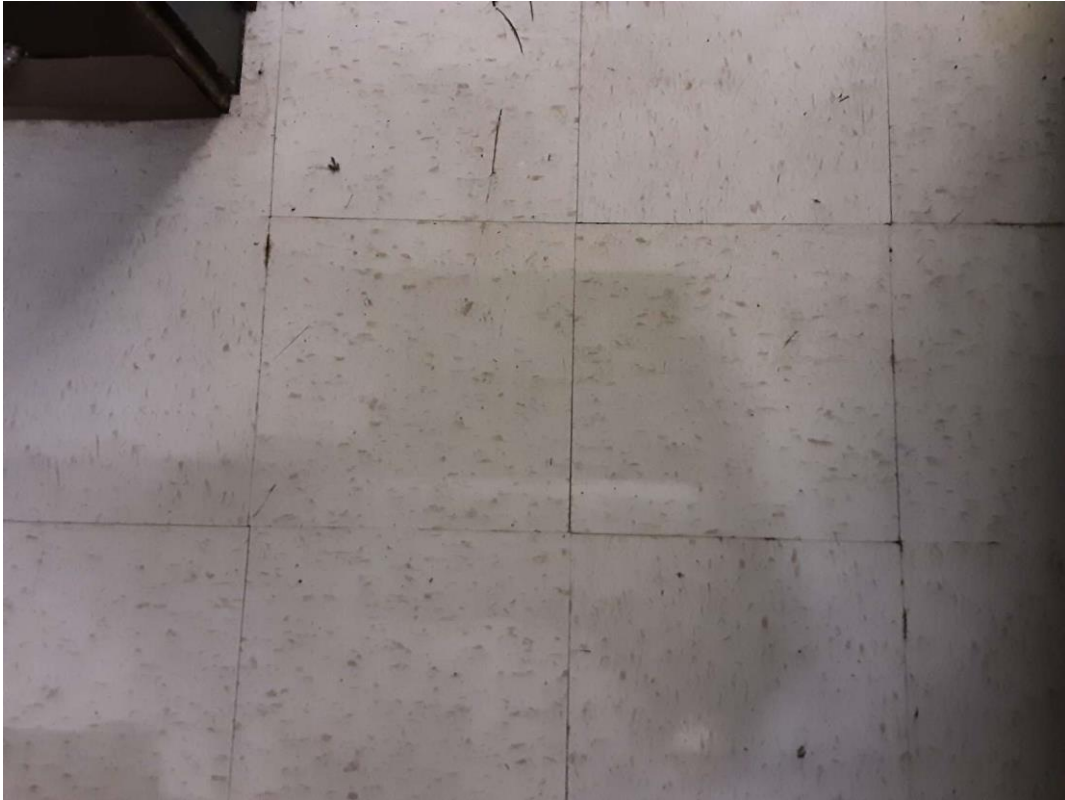
V0000 (None), Floor, Vinyl Floor Tile and Mastic, Stage (Location #: 2)

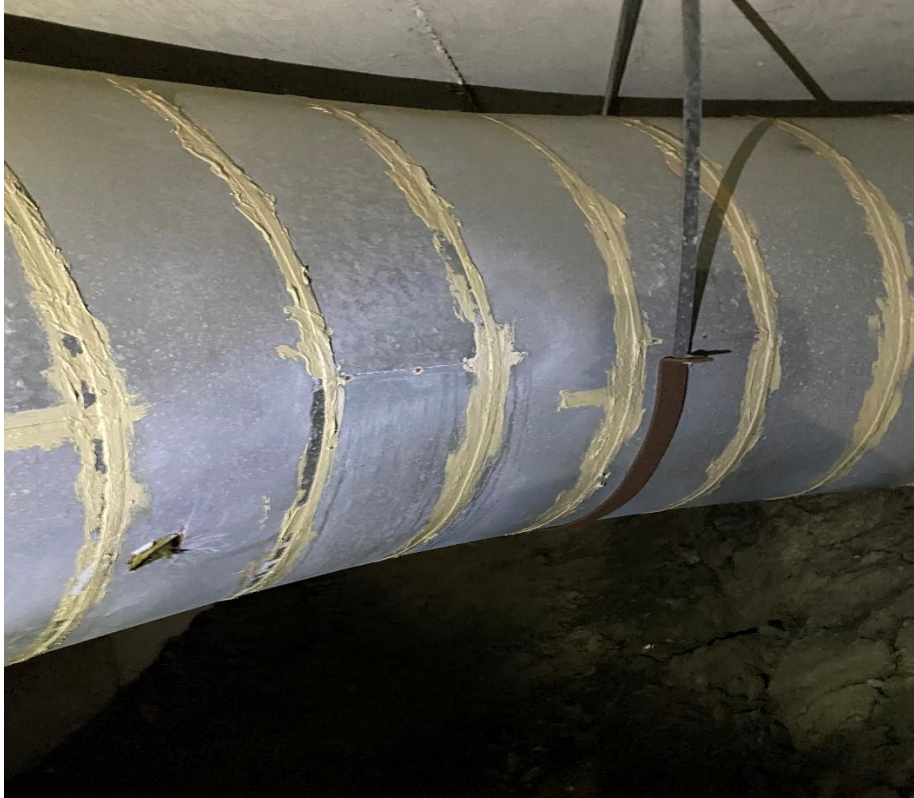
V9000, (Asbestos), Duct, beige mastic, Crawlspace (Location # 22)

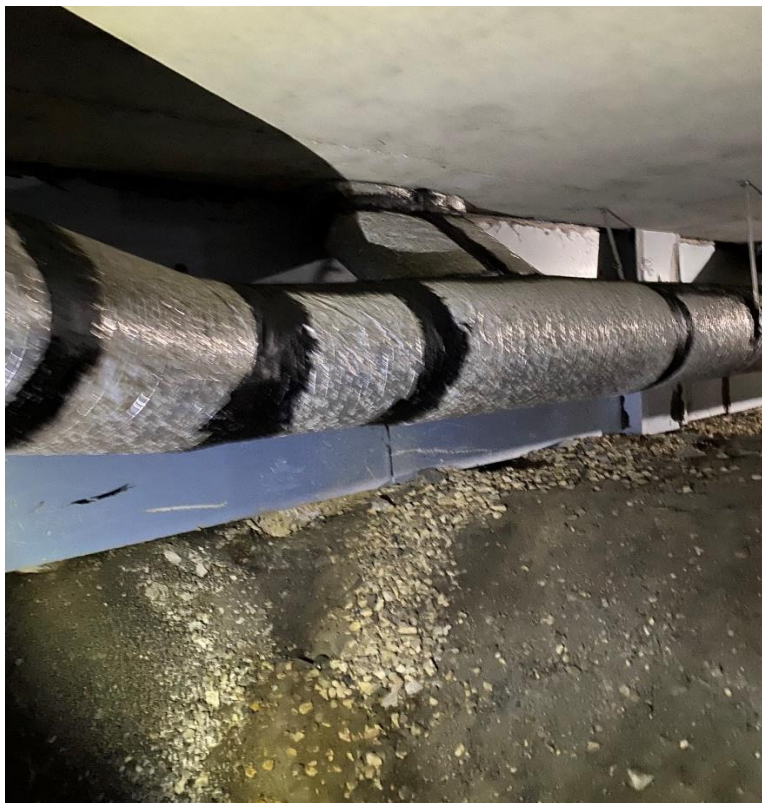
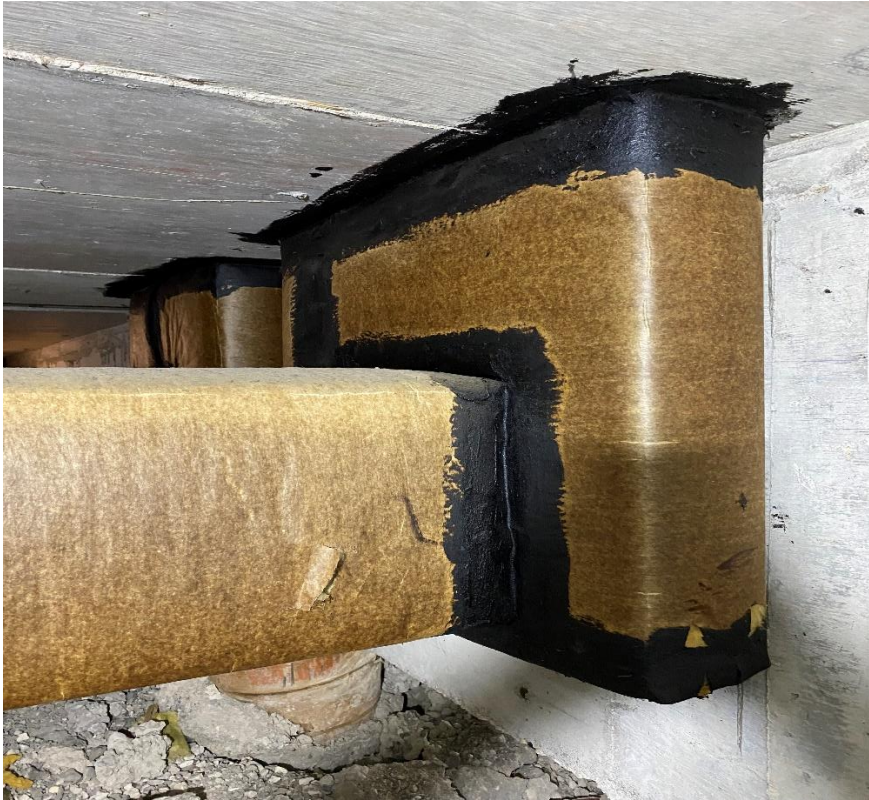
V9000, (Asbestos), Duct, black mastic, Crawlspace (Location # 22)
