THE CITY OF WINNIPEG  
**ST JAMES CIVIC CENTRE FACILITY EXPANSION**  
**2055 NESS AVENUE**

# **APPENDICES**

City of Winnipeg  
**St. James Civic Centre New Additions and Building  
Geotechnical Investigation**

# **Hazardous Building Materials Assessment**

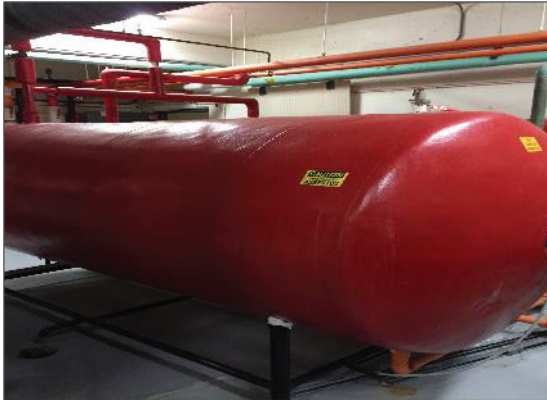
Photograph No. 3: Asbestos-containing parging cement present as insulation on the hot water holding tanks within the pool room Loc.13.

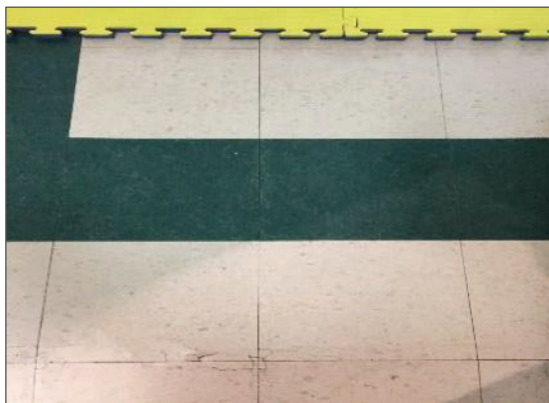
Photograph No.10: Non-asbestos vinyl floor tiles in the basement yoga room Loc. 9 (Samples 0012A-C).

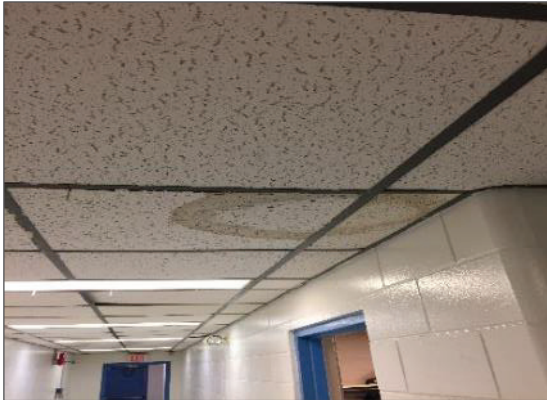
Photograph No. 28: Mouldy/water stained ceiling tiles in various locations.

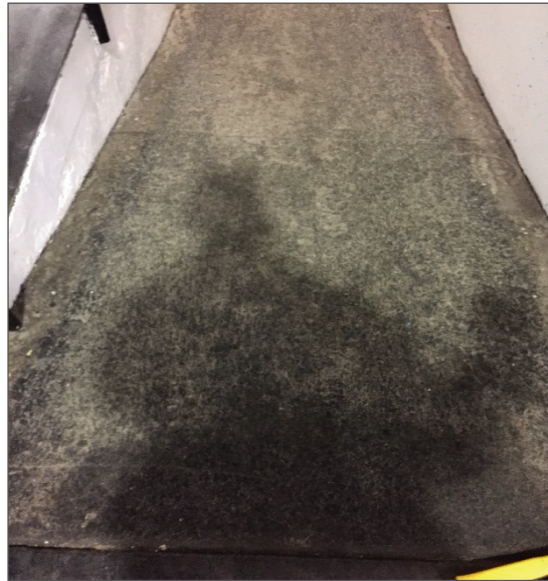
Photograph No. 6: Non-asbestos skate matting within the rink Loc.15 (Samples 0020A-C).

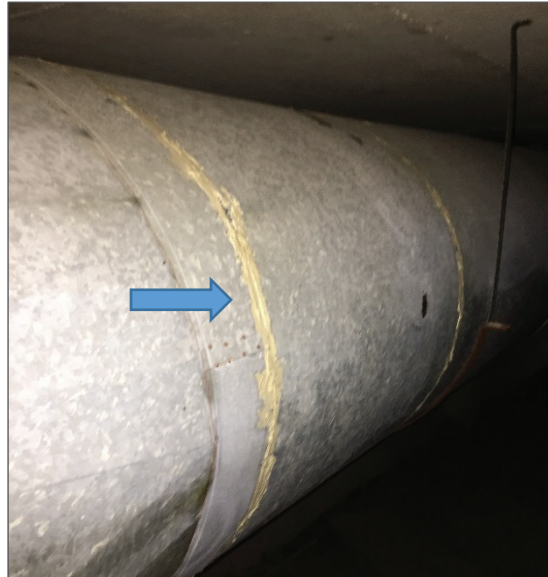
Photograph No. 26: Asbestos-containing beige mastic present on uninsulated ducting within the south crawlspace and basement board room (Samples 0008A-C).

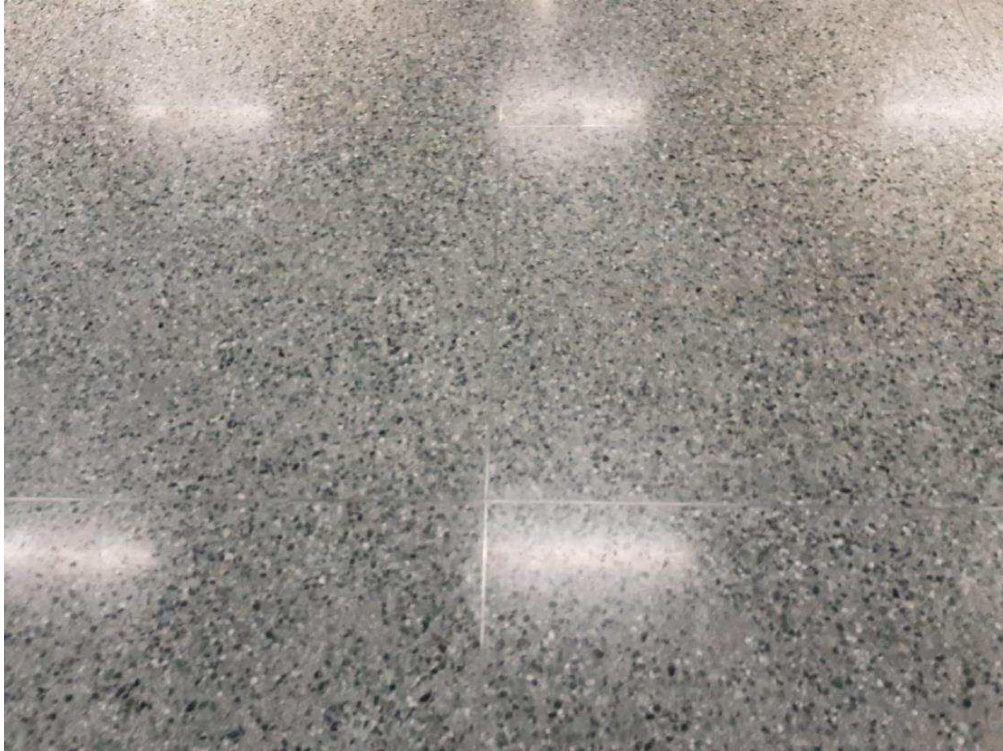
V9500 (Presumed Asbestos), Floor, Terrazzo, Foyer (Location #: 15)

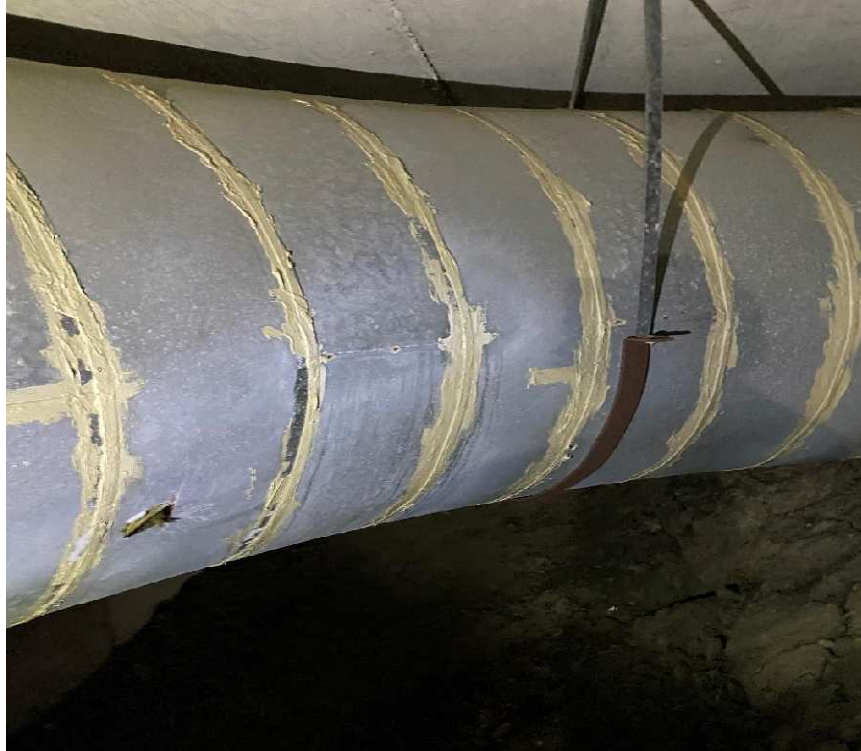
V9000, (Asbestos), Duct, beige mastic, Crawlspace (Location # 22)

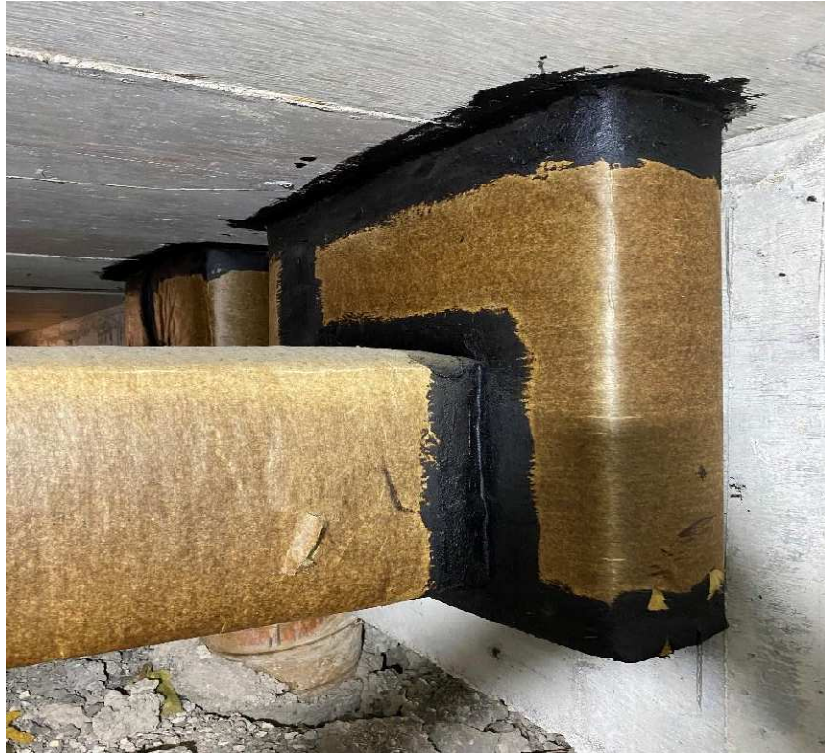
V9000, (Asbestos), Duct, black mastic, Crawlspace (Location # 22)

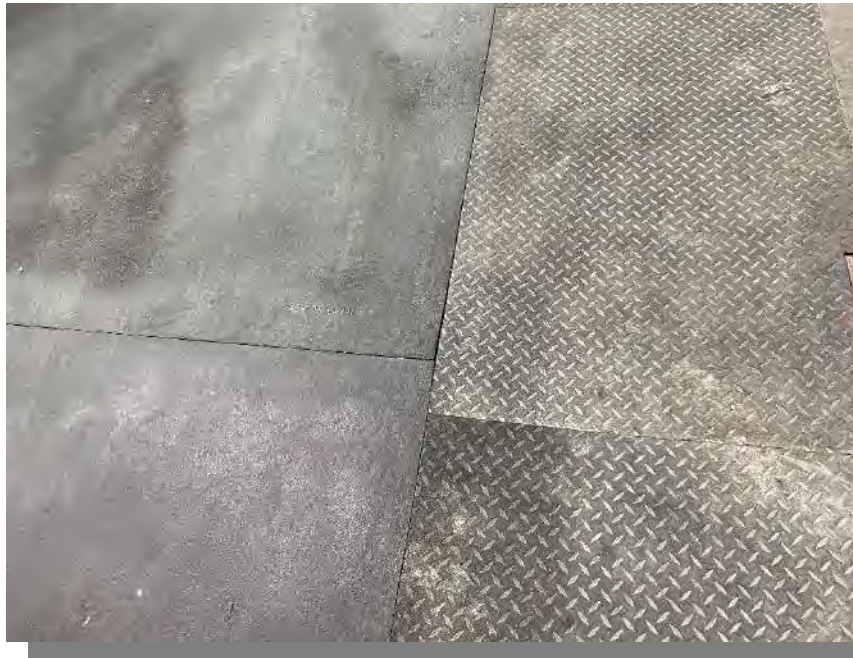
Photograph 34 – Interior, Arena flooring

*Looking at the flooring in the Arena that may contain asbestos.*

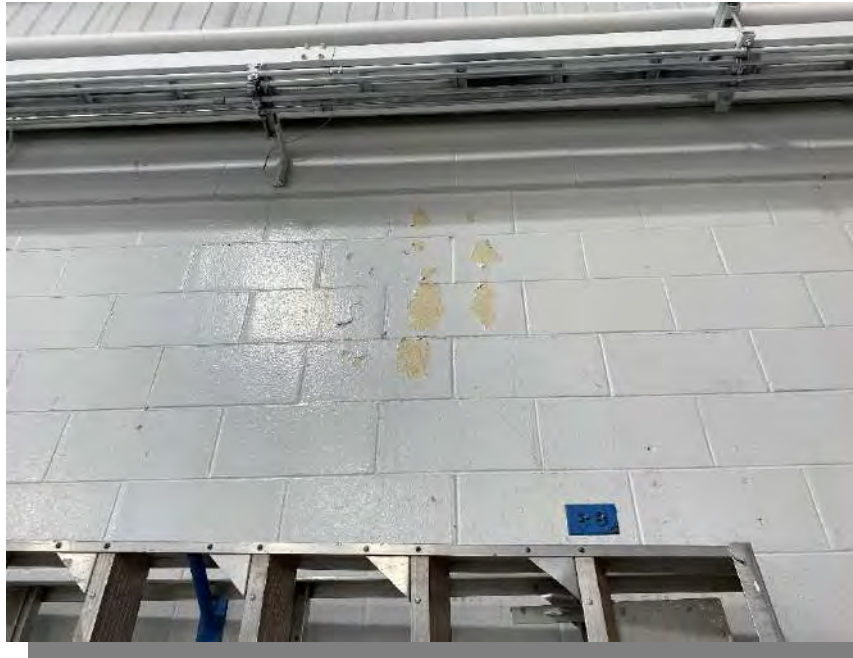
Photograph 35 – Interior, Arena north wall

*Looking at paint peeling on the north wall of the Arena that is revealing potentially lead-containing paint.*

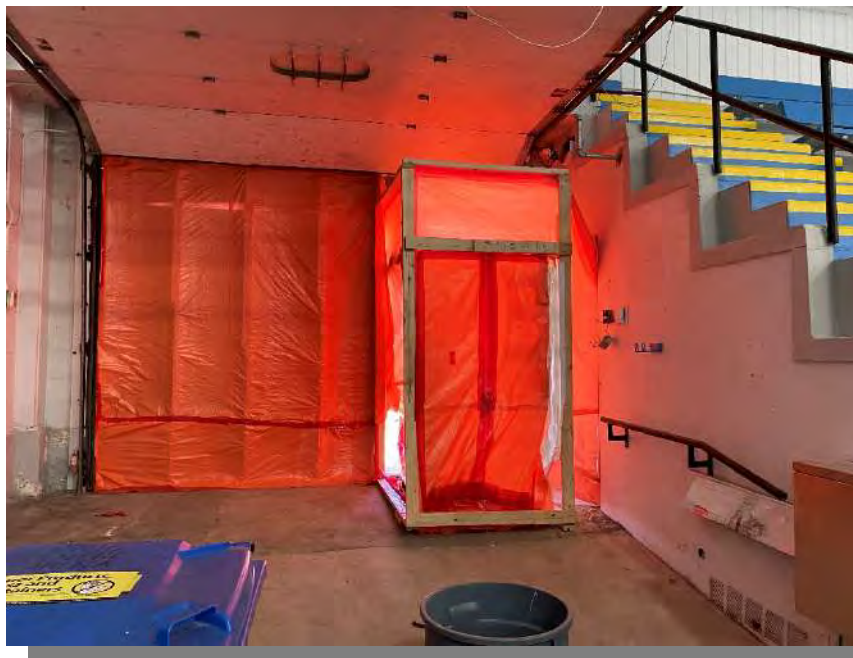
Photograph 36 – Interior, construction area in Arena

*Looking at the northeast corner of the Arena where construction is occurring for the underlying crawlspace, with enclosure set up to prevent silica dust contamination.*

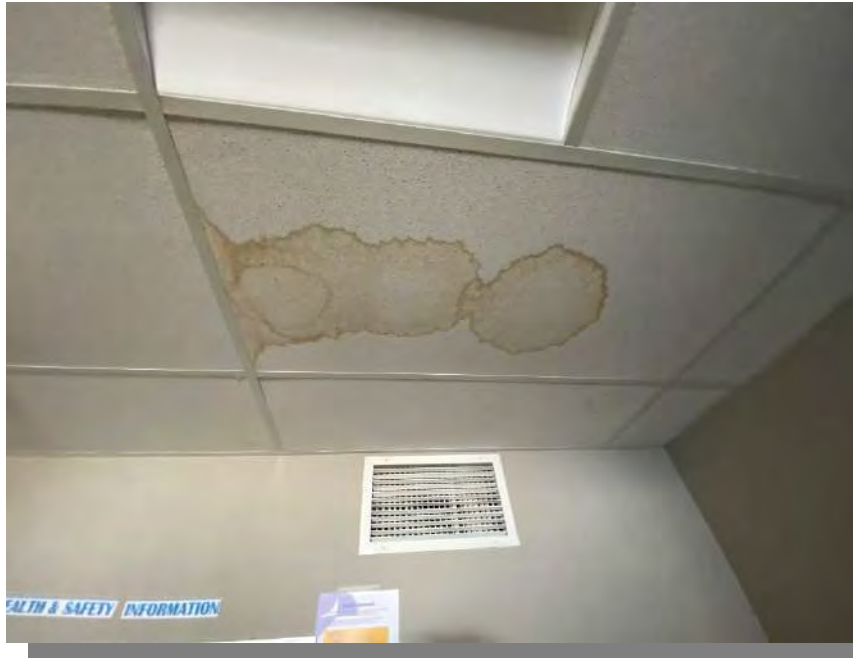
Photograph 41 – Interior, ceiling stain  
*Looking at water damage stains on the ceiling of the staff kitchen that is to be removed.*

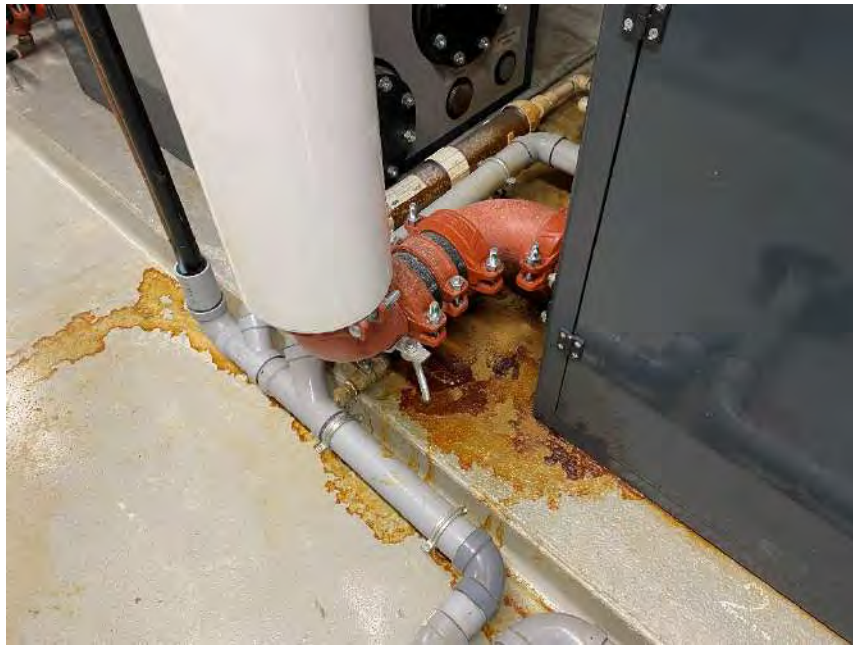
Photograph 44 – Interior, boiler room  
*Looking at unknown stains located in the boiler room floor.*

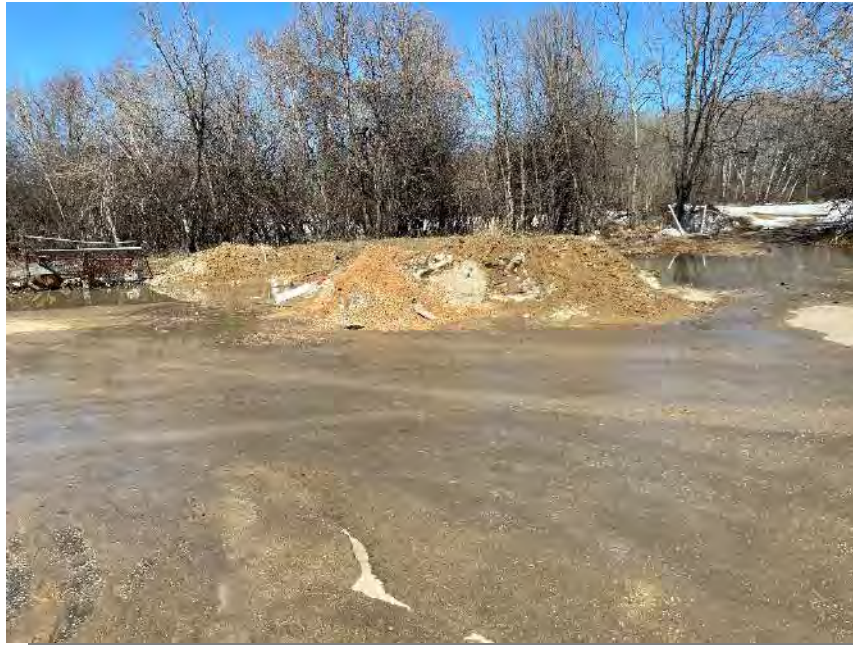
Photograph 45 – Exterior, fill piles

*Looking at unknown fill piles located at the northeast corner of the building.*
