# Bridgwater Forest Fountain Rehabilitation Study 71 Bridlewood Road Winnipeg, MB R3Y 0K4

Prepared For:
Jason Bell
Parks Capital Projects Manager
City of Winnipeg

Prepared By: Richard Granger, P. Eng. DGH Engineering Ltd. 12 Aviation Blvd. St. Andrews, Manitoba R1A 3N5

Submission Date: 2023-01-17

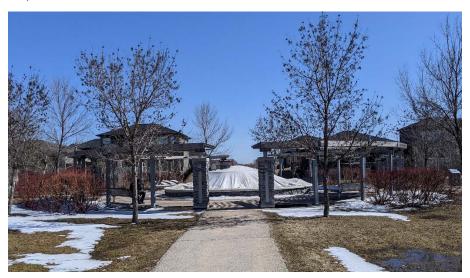
Figure 3: Initial Visit Site Conditions

On April 25, 2022, David Dy, P. Eng. visited the Bridgwater Fountain to review the documents on site, have discussions with personnel from Public Works and City Representatives to visually evaluate the existing water feature and all supporting infrastructure. The City was represented by: Rob Zanewich (Project Coordinator), Jason Bell (Project Manager), Mike Mudry (Superintendent of Park Services), Glen Stefanyshen (Superintendent of Building Services), and Todd McDonald (Supervisor of Area and Aquatic Assets).

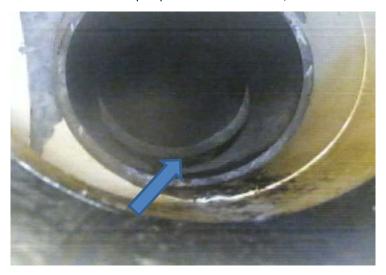
• A significant break was identified at approximately 0.30 meters into the return pipe (measured from the scope point of entrance).

Figure 4: Break Identified at 0.30 meters (Return Pipe)

- 1. Disconnecting the supply and return pipes from the nozzle discharge in the water feature basin.
- 2. Dig up a large identified break in the return water pipes and repair the single location with a SCH80 pipe.
- 3. Complete 5 selective repairs on the return pipes as identified by Mr. Rooter using CIPP.
- 4. Complete 7 selective repairs on the supply pipes as identified by Mr. Rooter using CIPP.
- 5. Reconnect the supply and return pipes to the nozzle discharge in the water feature basin.
- 6. An allowance of \$10,000 has been included for landscape restoration.

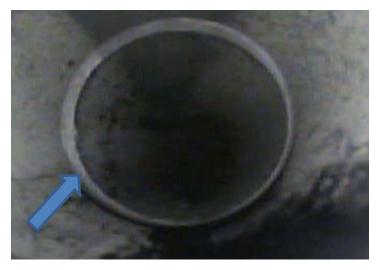
- Five breaks were identified in the return pipe at various distances.
- Seven breaks were identified in the supply pipe at various distances.

Figure 5: Break Identified in the Supply Pipe
