# **APPENDIX 'B'**

## **SITE PHOTOS**

**Branch I Aqueduct Underdrain Outfall Repairs**

**Tender 694-2024 - Appendix B – Site Photos**

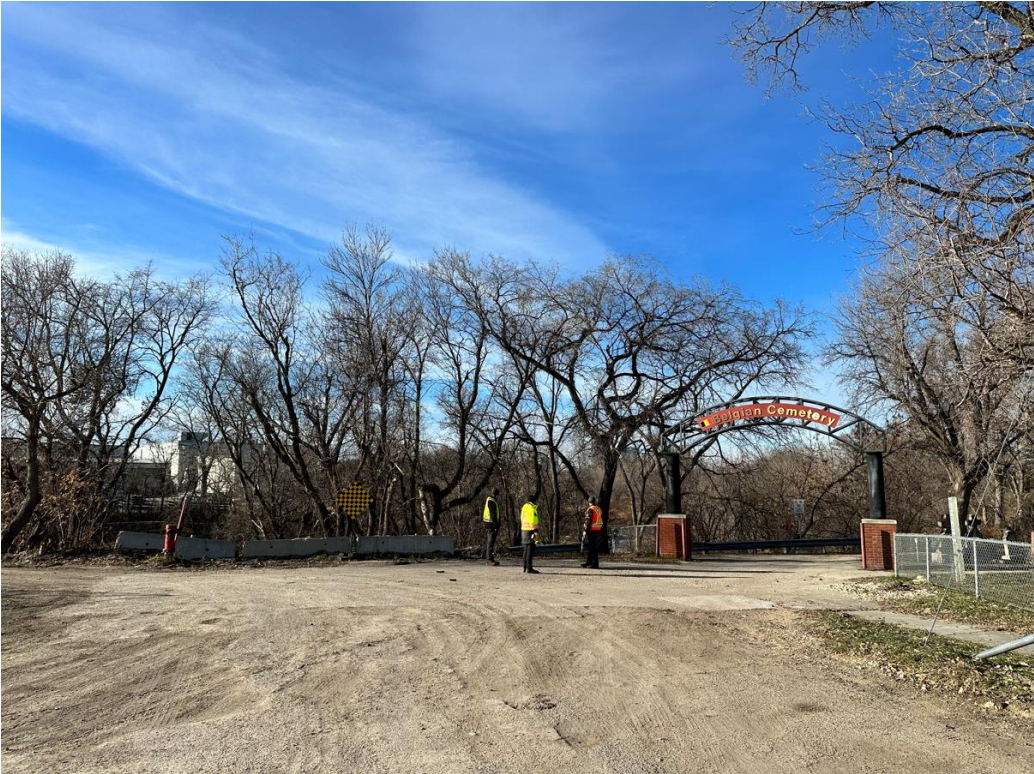
*Figure 1 – Rue Plinguet Underdrain Outfall Site, looking west.*

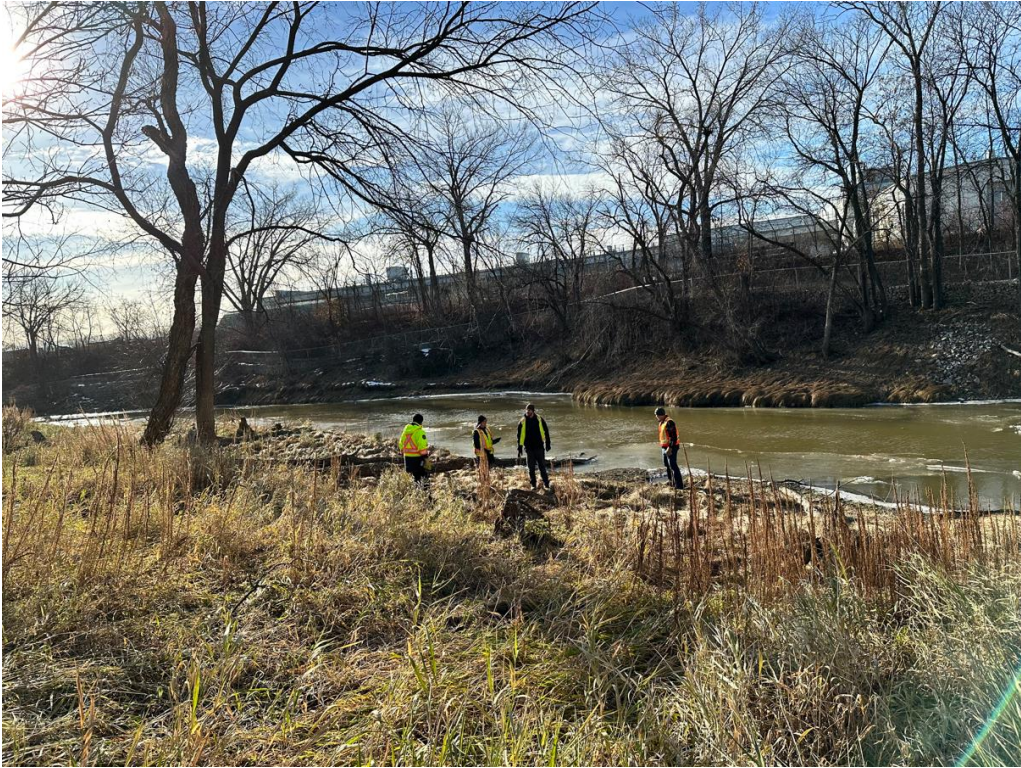
*Figure 2 – Rue Plinguet Underdrain Outfall- Seine River, looking southwest.*

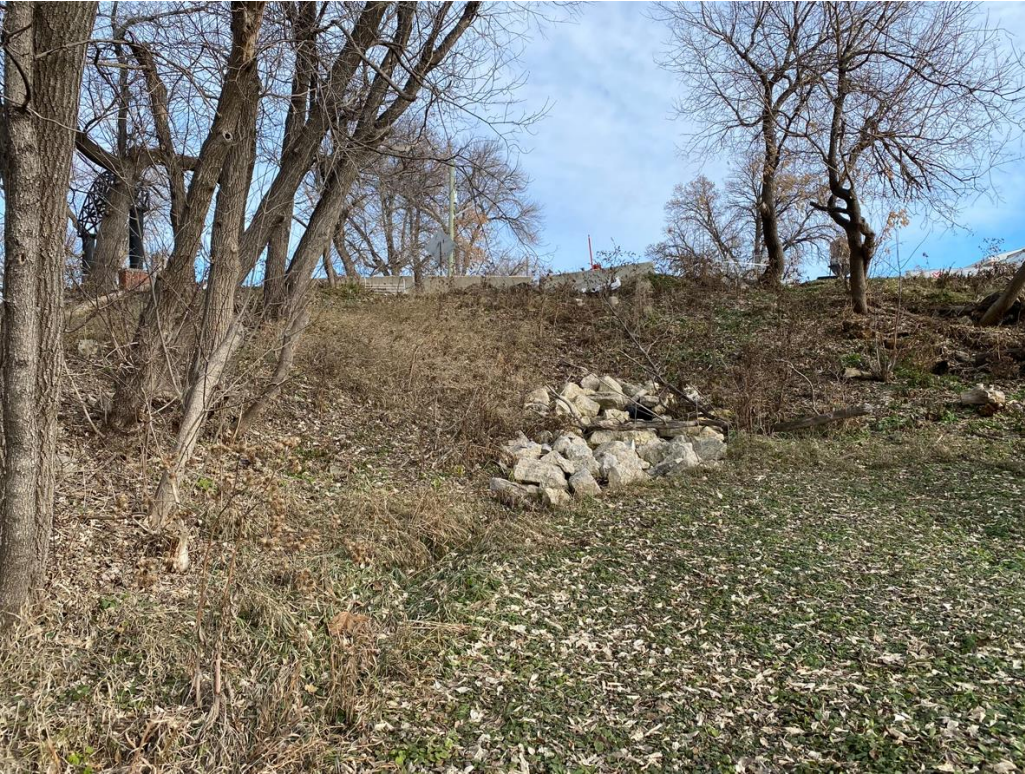
*Figure 3 – Rue Plinguet Combined Sewer Outfall, looking east.*

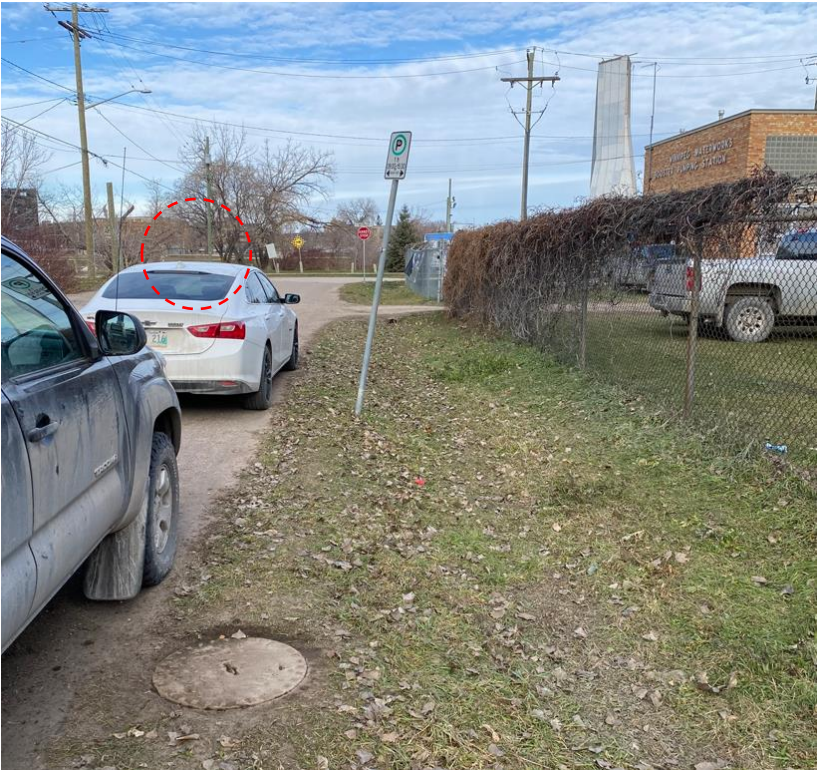
*Figure 4 -Avenue Tache UMH110-0001, looking north.*

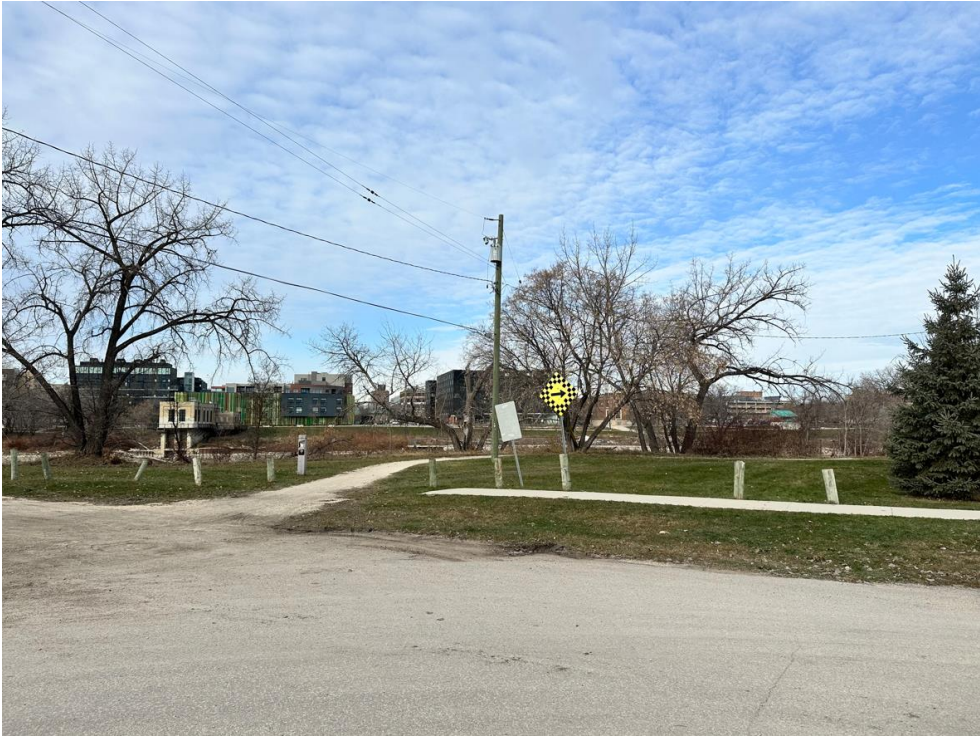
*Figure 5 – Avenue Tache Underdrain Outfall Site, looking northwest.*

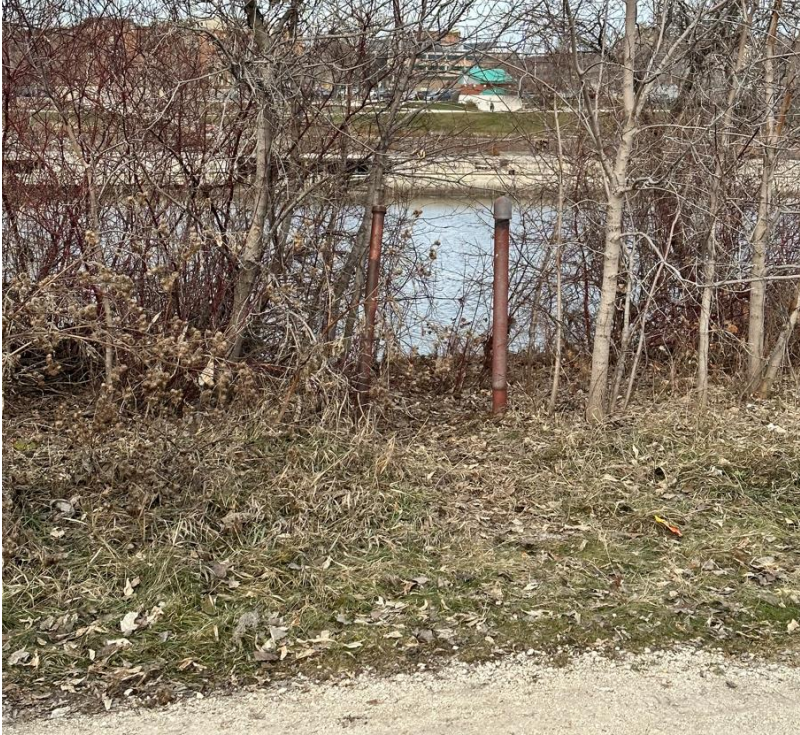
*Figure 6 - Avenue Tache Underdrain Outfall – Vent Pipes, looking north.*

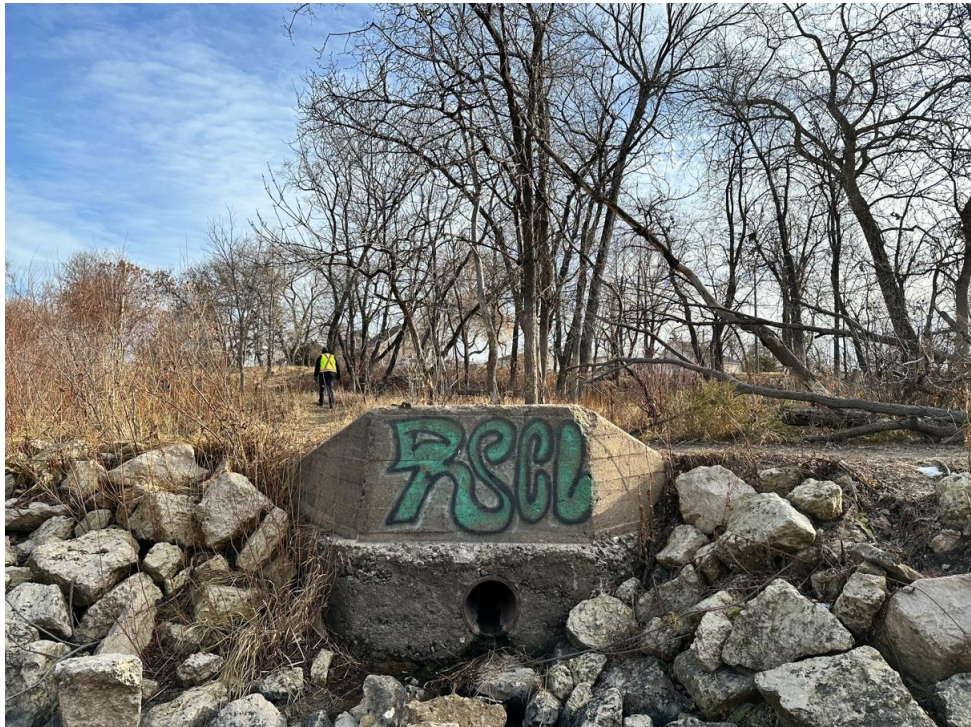
*Figure 7 – Rue Notre Dame Underdrain Outfall, looking east.*

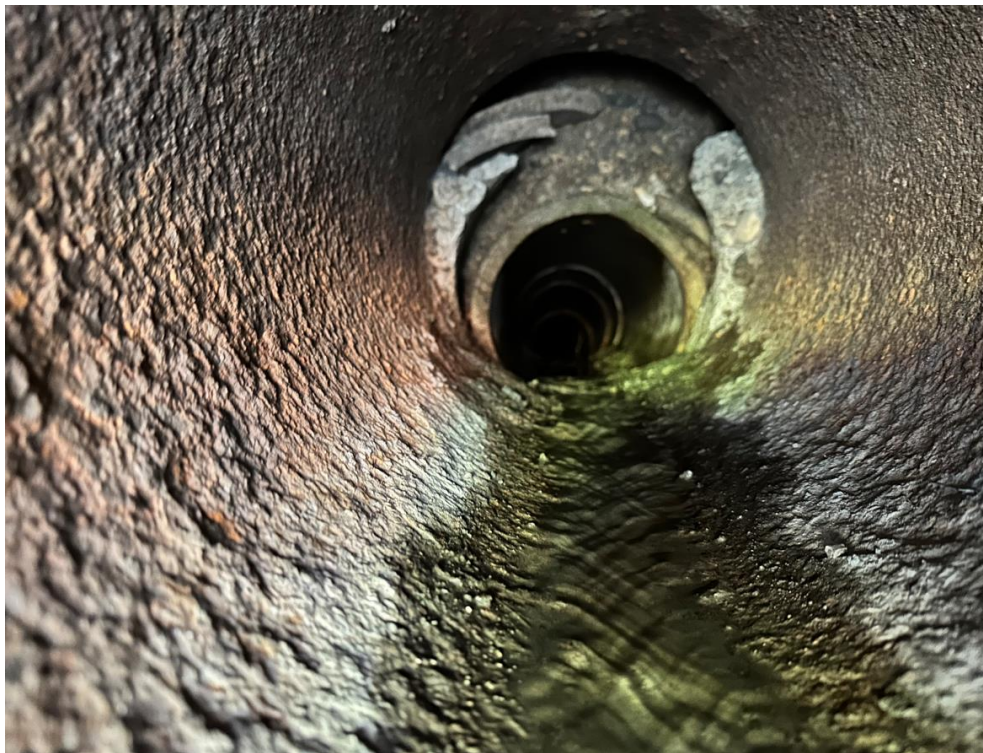
*Figure 8 – Rue Notre Dame Underdrain, looking east at headwall.*

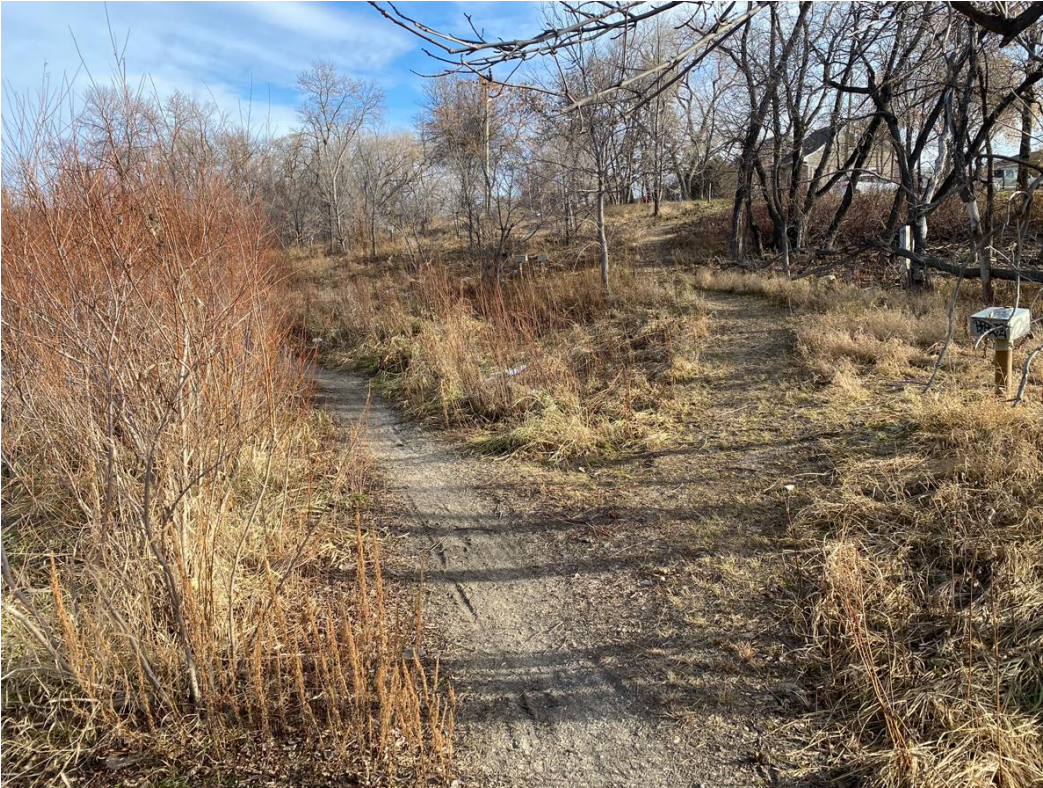
*Figure 9 – Rue Notre Dame Underdrain Outfall, looking east.*

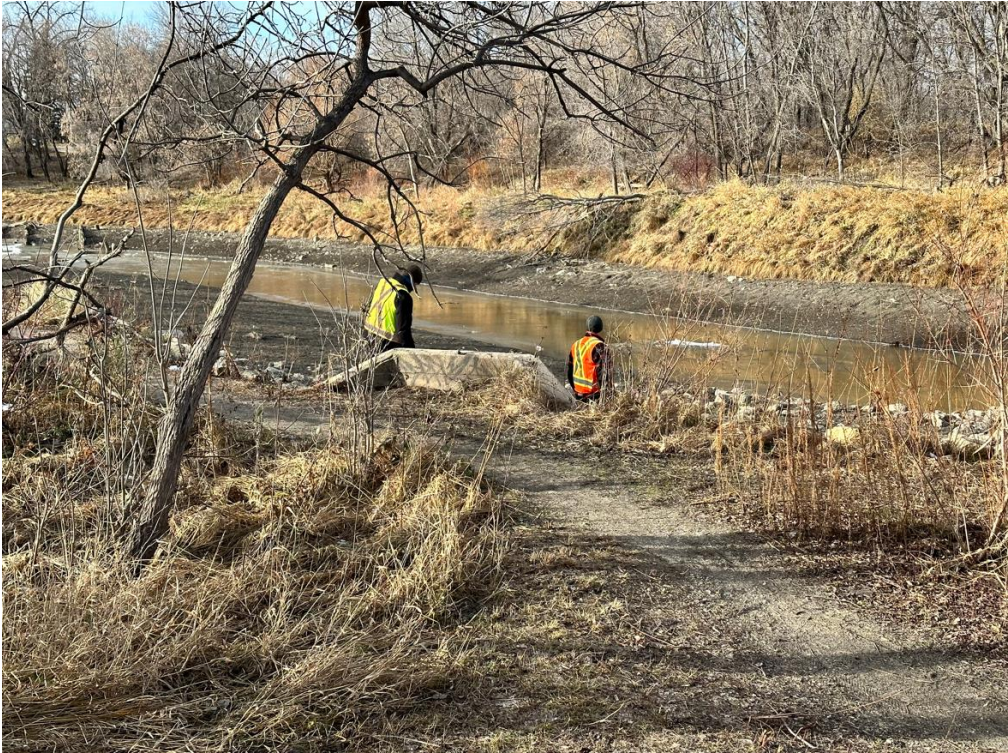
*Figure 10 – Rue Notre Dame Underdrain Outfall, looking west.*

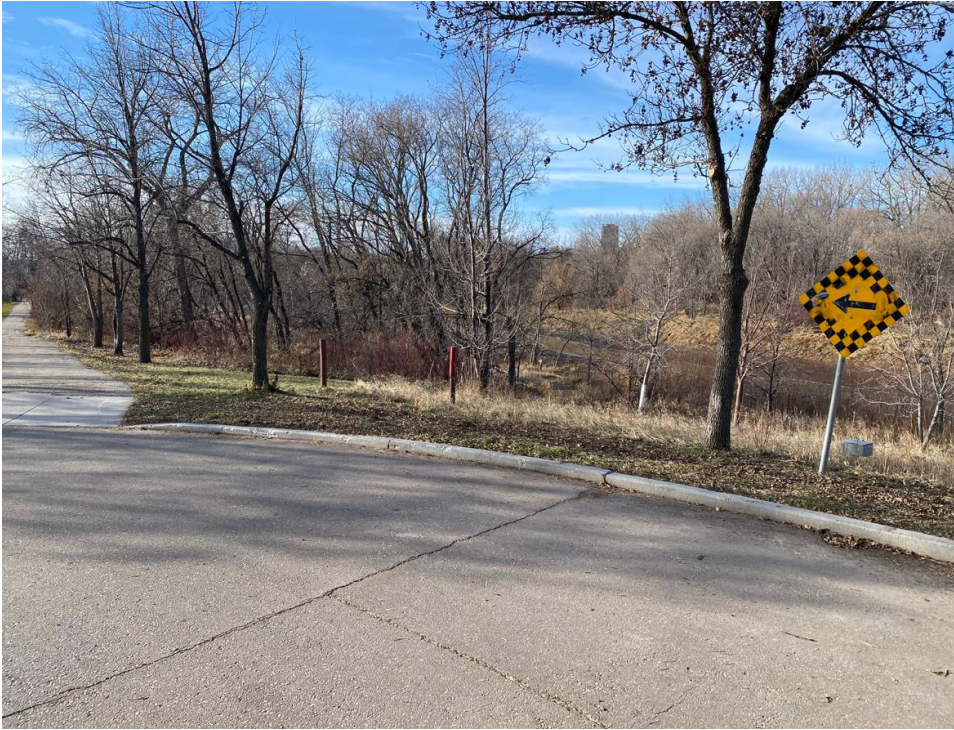
*Figure 11 – Rue Notre Dame Underdrain Outfall Site, looking west.*

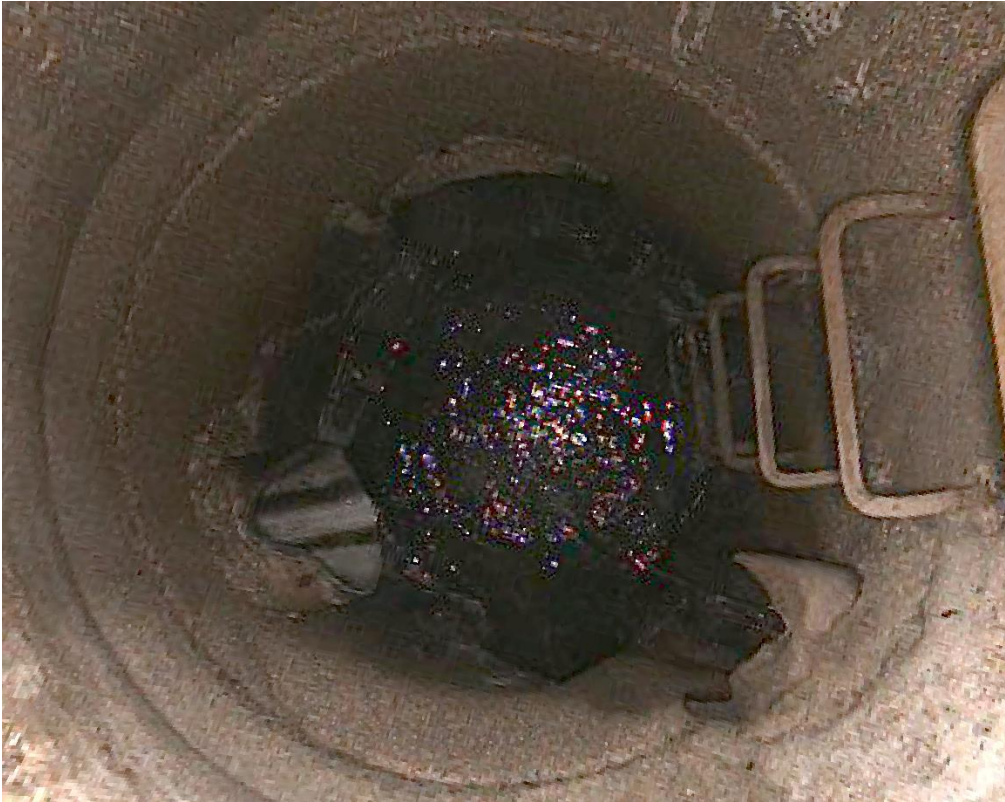
*Figure 12 – S-MH50008084 (Archibald Street & Rue Notre Dame) underdrain and sewer connections.*

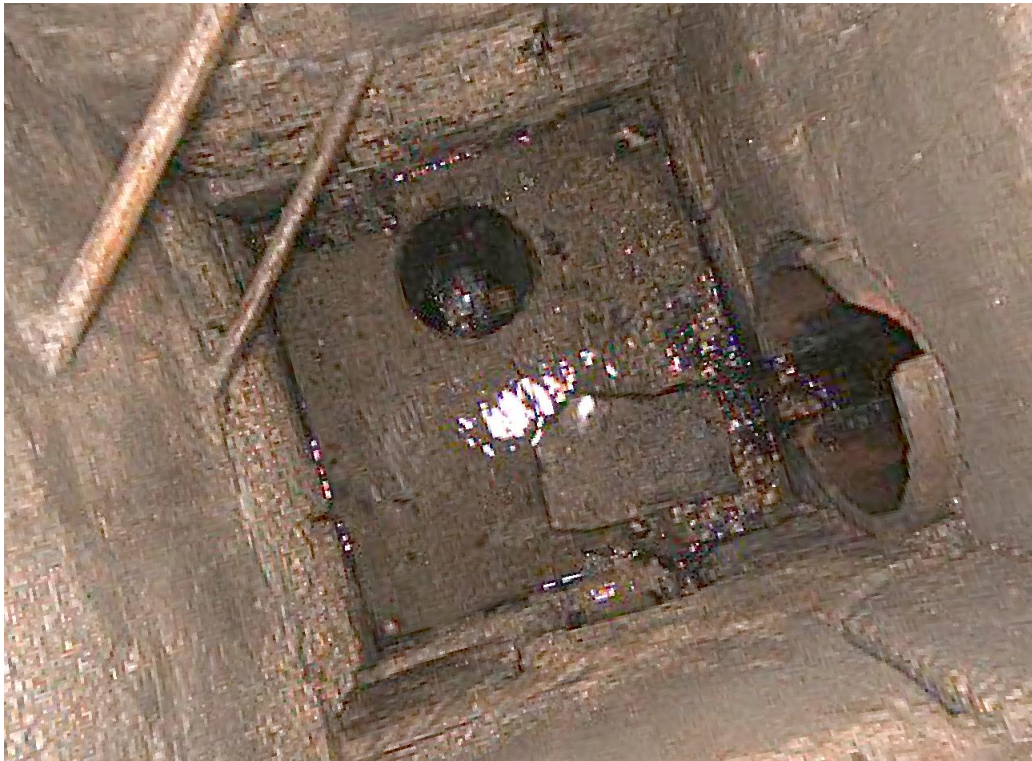
Figure 13 – UMH119-0137 (Dawson Rd) existing connections and floor drain.

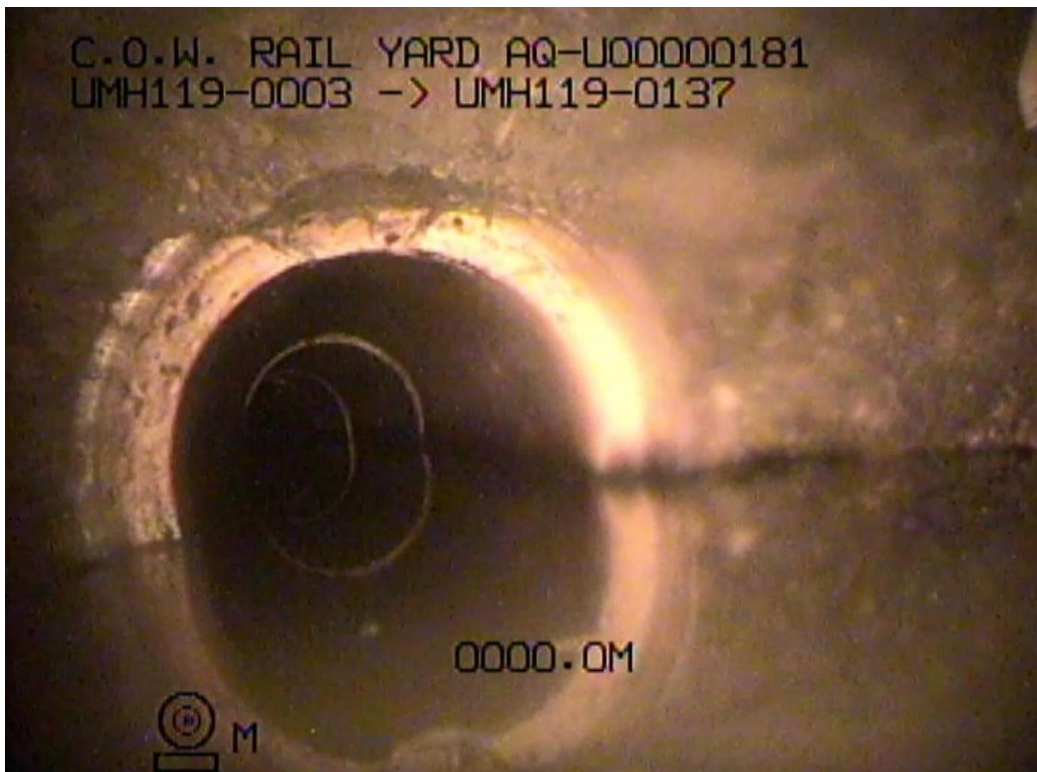
Figure 14 – AQ-U00000181 (GWWD Railyard) void around missing underdrain
