## **Hazardous Building Materials Assessment (Pre-construction)**

Windsor Park Lift Station and  
Generator Building  
945 Cottonwood Road,  
Winnipeg, Manitoba

June 6, 2024

Pinchin File: 338686

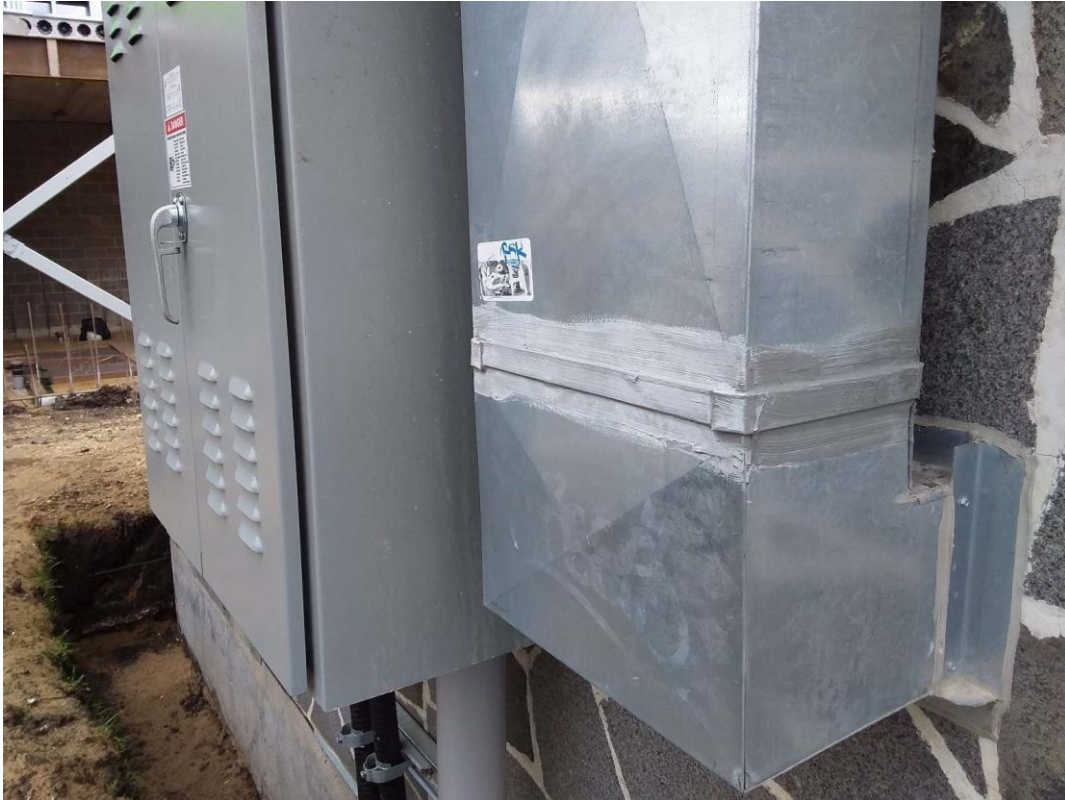
Grey duct mastic present at seams / joints on the exterior of ducts at the exterior of the Generator Building (Location 3) assessed area does not contain asbestos (samples S0001).

S0001 (None), Duct, Mastic, Grey, Generator Building (Location #: 3)

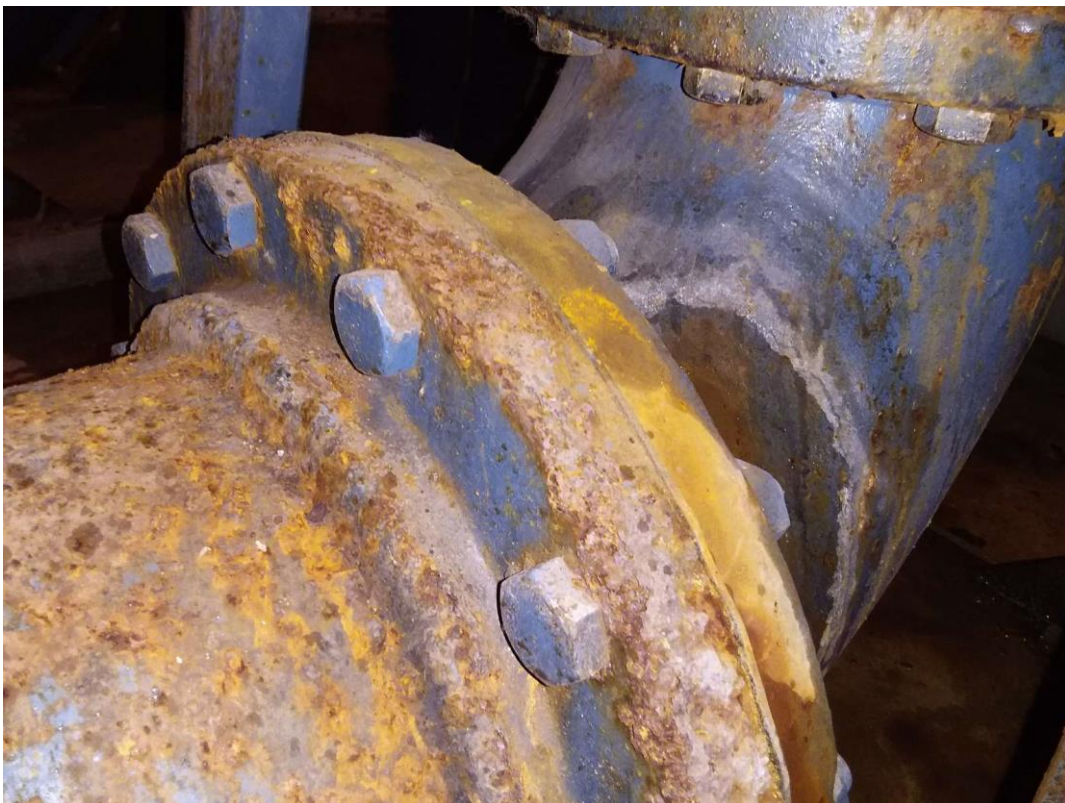
Gaskets on pumps within the Pump Room (Location 4) do not contain asbestos (samples S0003A-C).

S0003A (None), Mechanical Equipment, Pump, Gasket, Pump Room (Location #: 4)

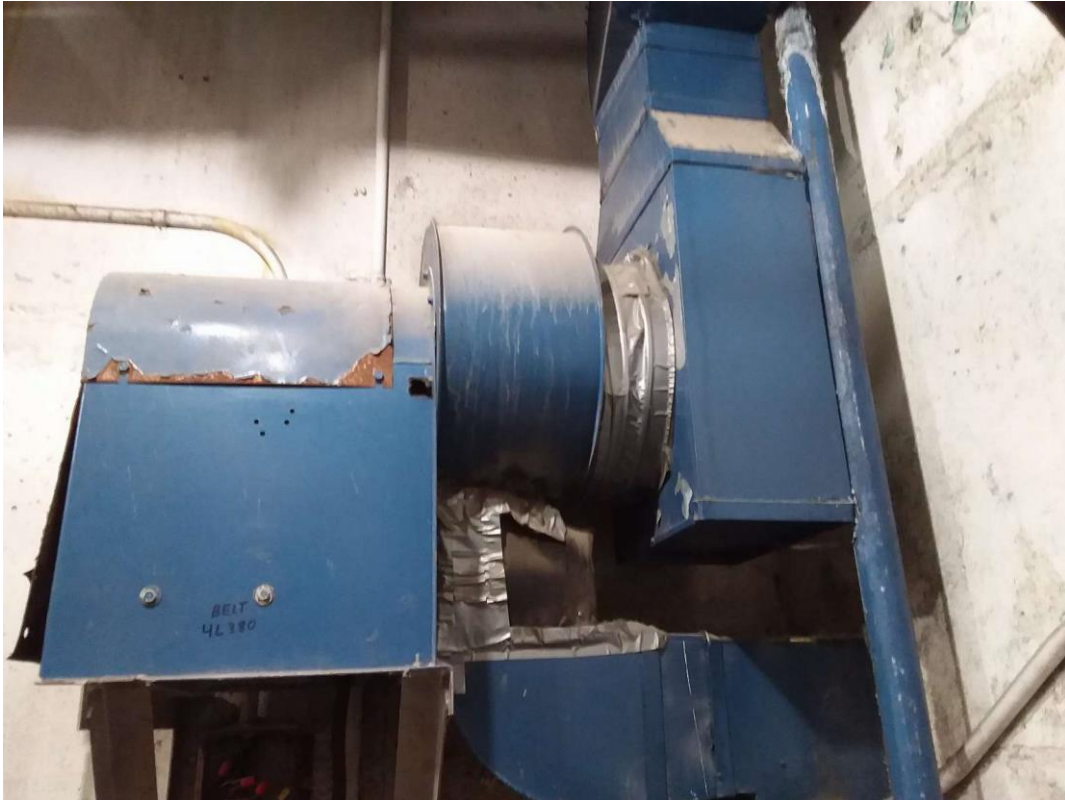
Textile vibration dampers, presumed to contain asbestos, are present as duct connectors in the Motor Room and Decommissioned Entrance Chamber (Locations 1 and 2).

V9500 (Presumed Asbestos), Duct, Duct Connector, Textile, Motor Room (Location #: 1)

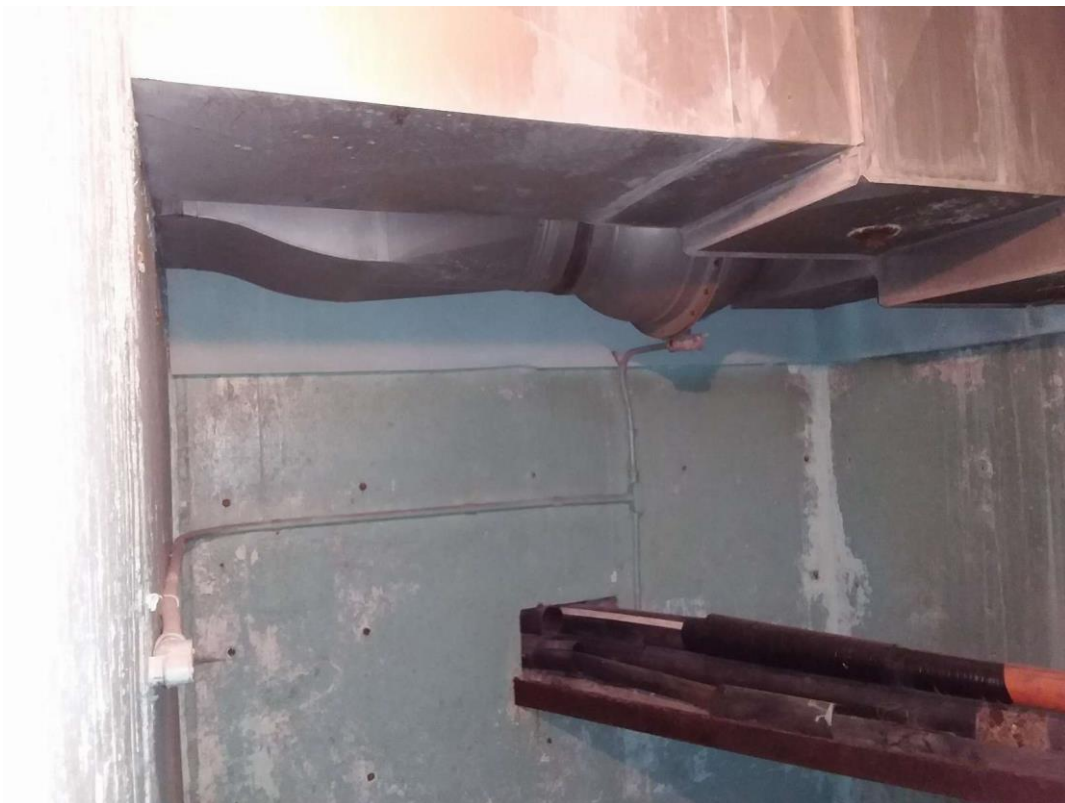
V9500 (Presumed Asbestos), Duct, Duct Connector, Textile, Decommissioned Entrance Chamber (Location #: 2)

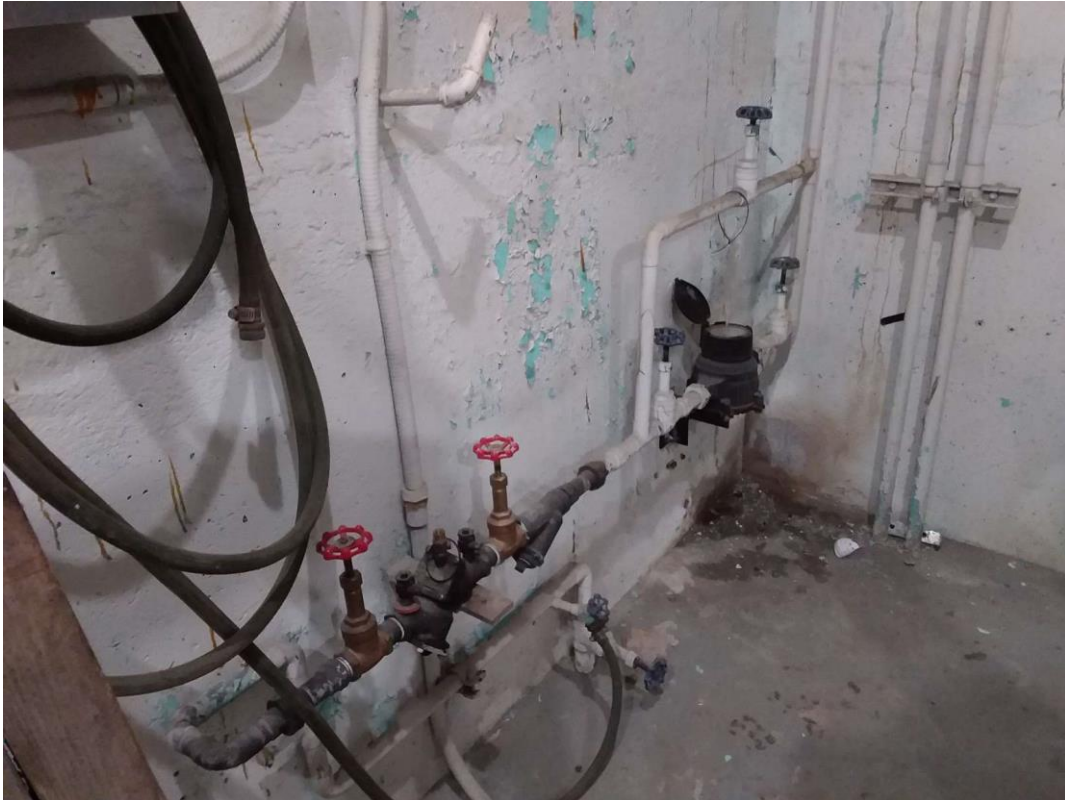
Piping, All, Not Insulated, Motor Room (Location #: 1)

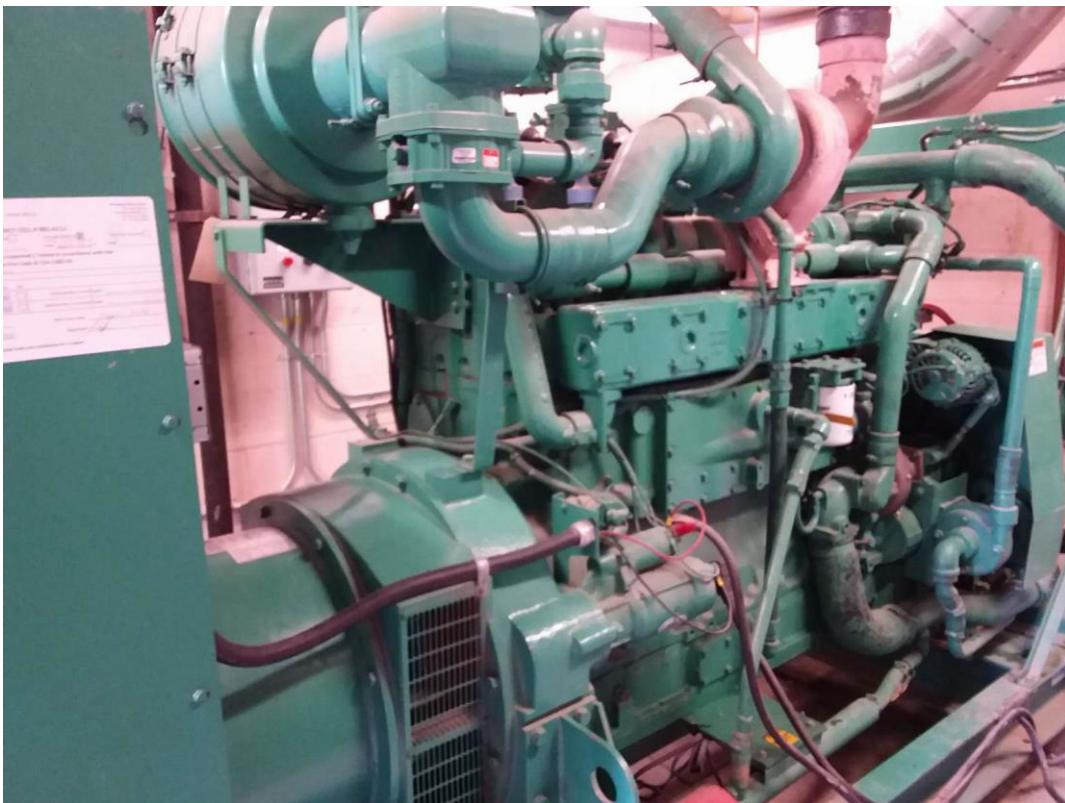
Mechanical Equipment, Motor Generator, Not Insulated, Generator Building (Location #: 3)

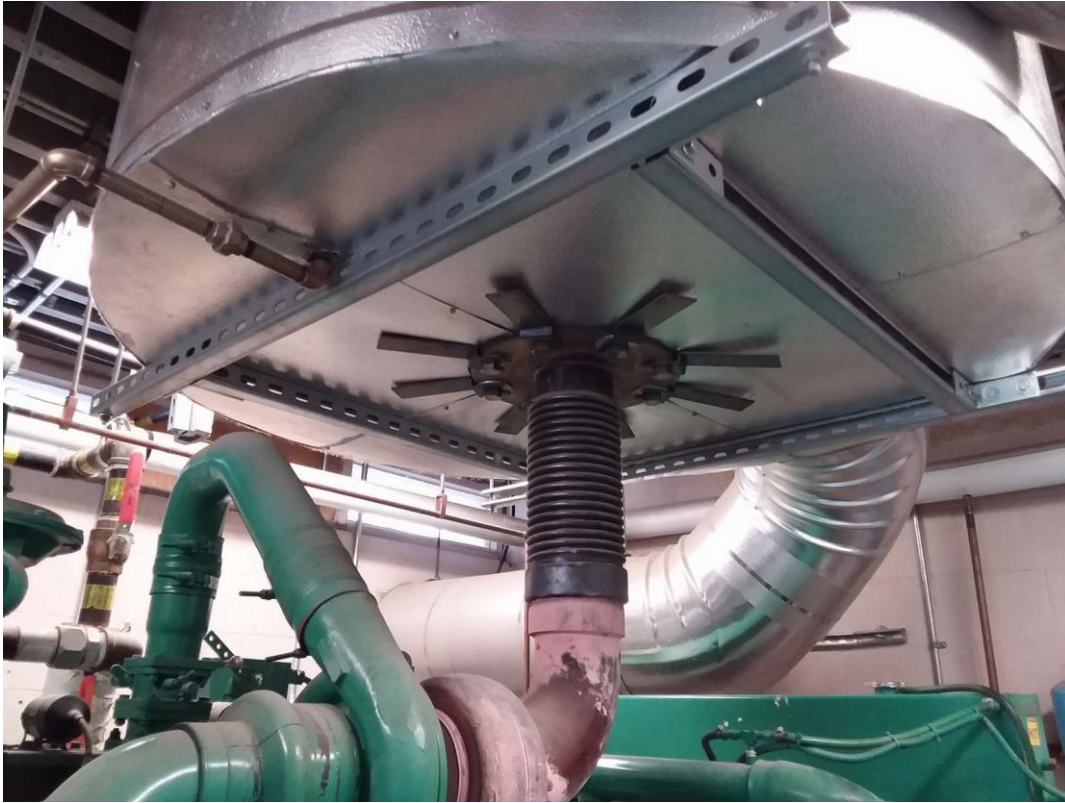
Duct, Exhaust, Not Insulated, Generator Building (Location #: 3)

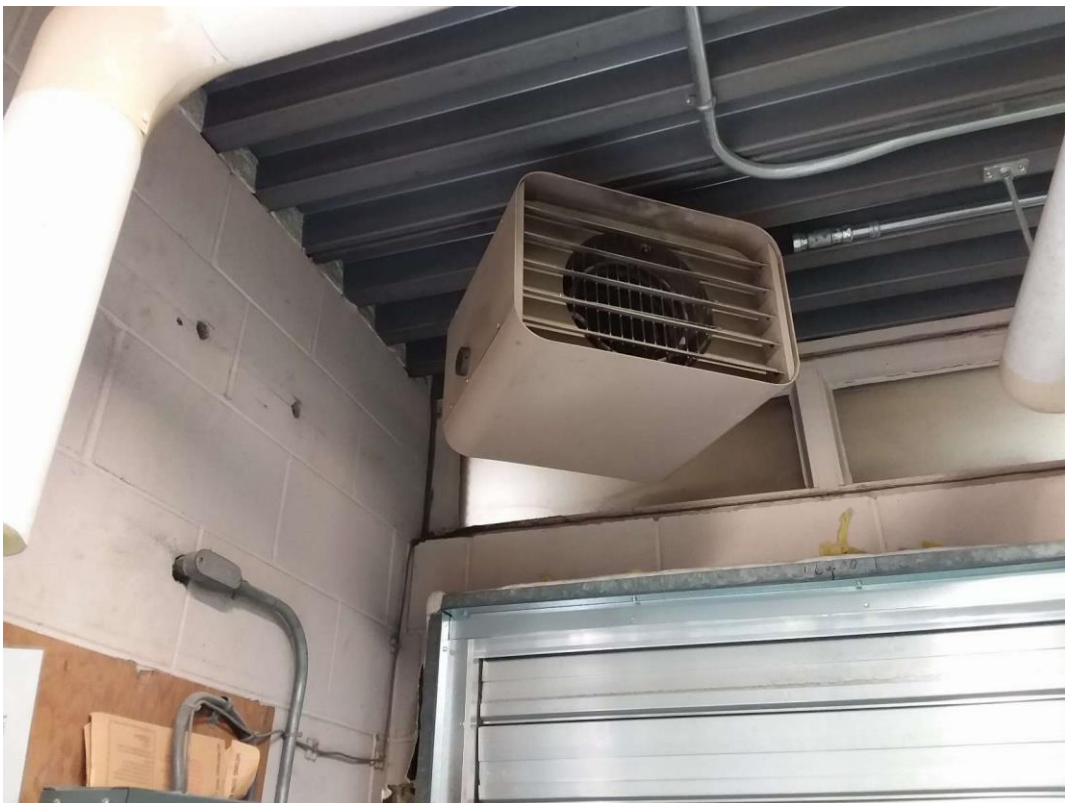
Mechanical Equipment, Unit Heater, Not Insulated, Generator Building (Location #: 3)

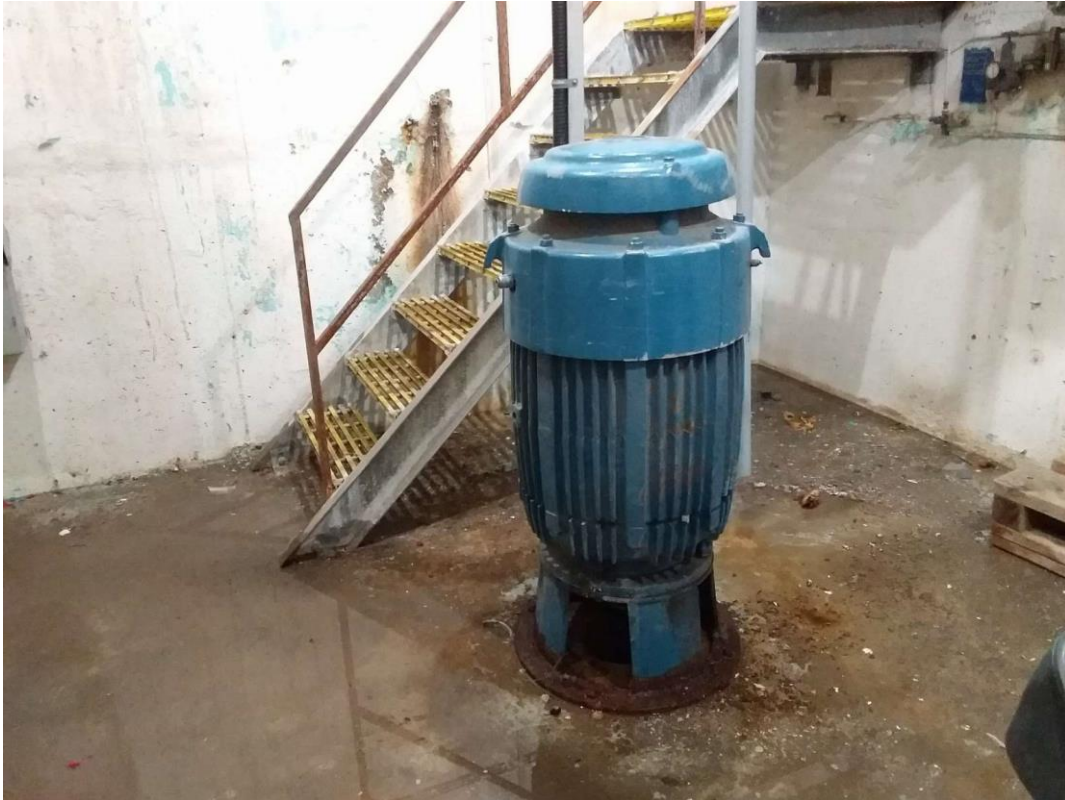
L0002(Lead, Yes), Blue, Mechanical Equipment, Motor Room (Location #: 1)  
Blue

Items painted with paints containing elevated levels of lead may be a hazardous waste. Test lead-painted materials for leachable lead and other metals prior to disposal. Metallic components coated with lead paint do not require leachate testing and can be disposed of as non-hazardous construction and demolition (C&D) waste.

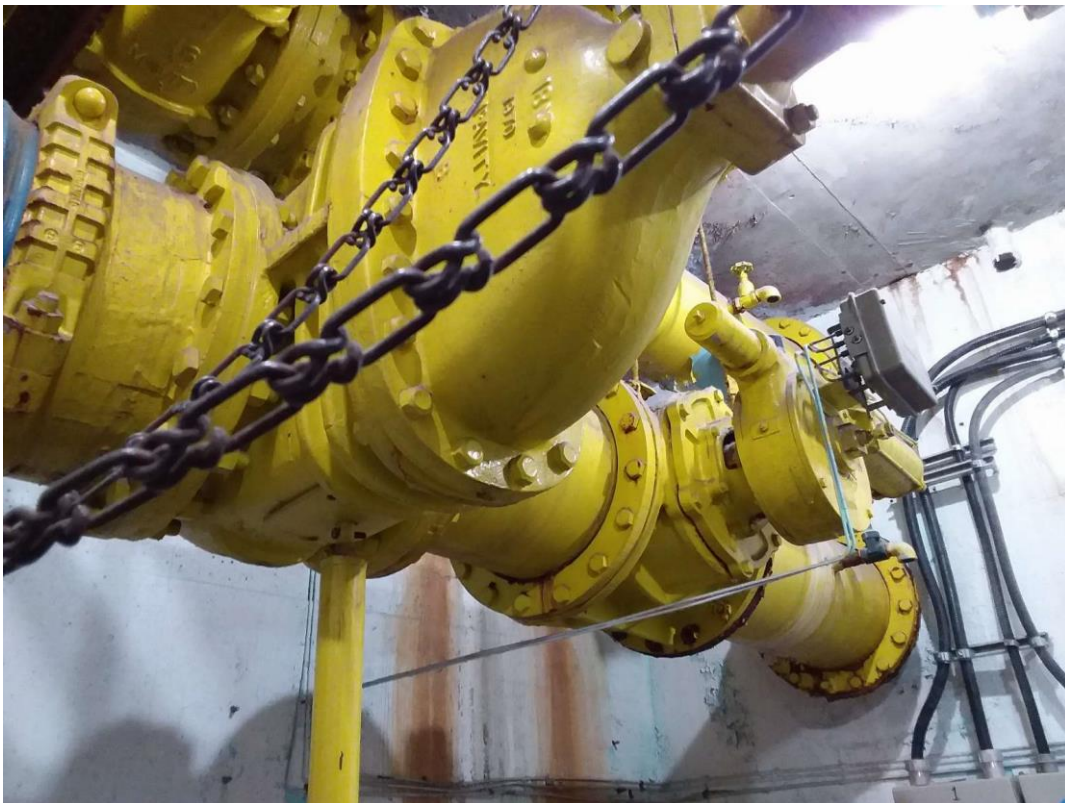
L0003(Lead, Yes), Yellow, Piping, Motor Room (Location #: 1)  
Yellow

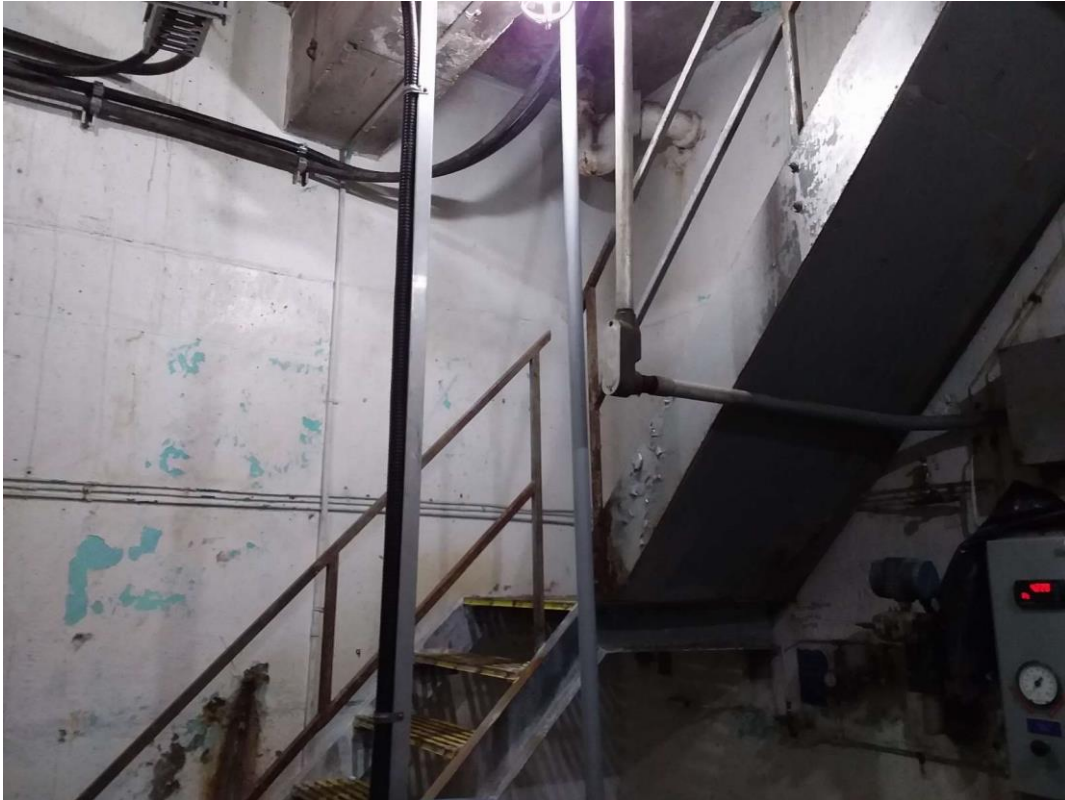
L0004(Lead, None), Silver, Floor, Motor Room (Location #: 1)  
Silver, stairs

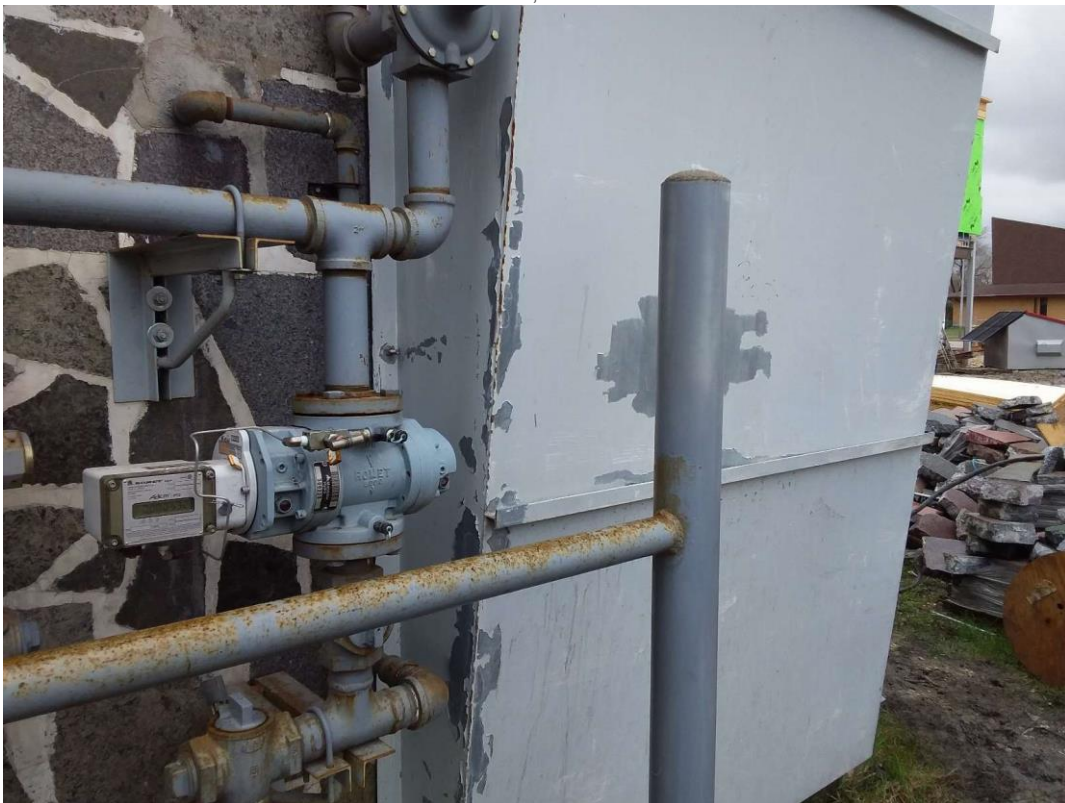
L0006(Lead, None), Grey, Duct, Generator Building (Location #: 3)  
Grey

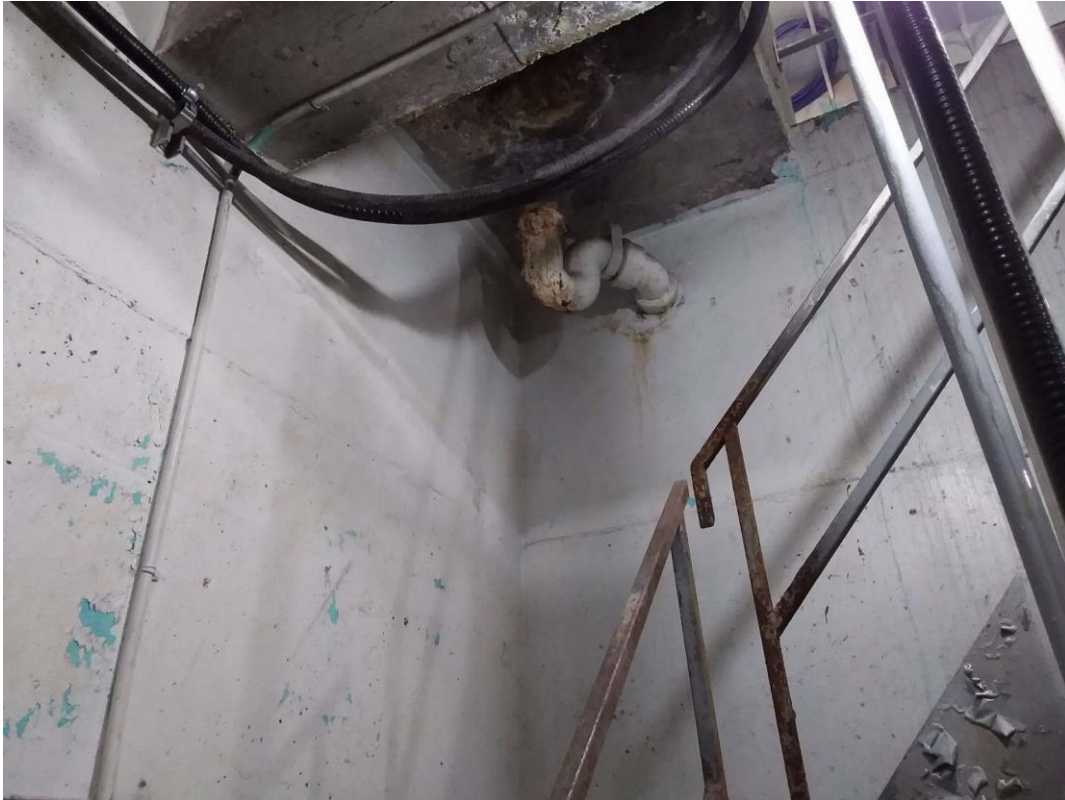
Pb Products, V9000(Yes), BELL AND SPIGOT FITTINGS, Motor Room (Location #: 1)

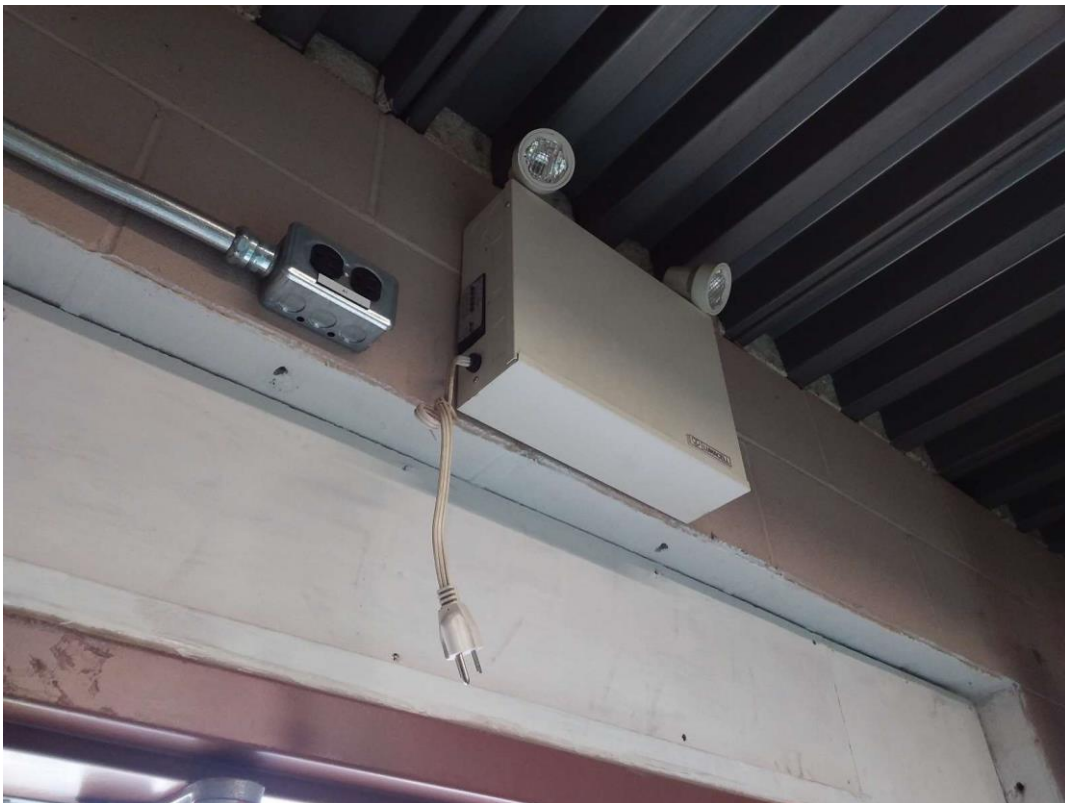
Pb Products, V9000(Yes), BATTERIES IN EMER. LIGHTS, Generator Building (Location #: 3)

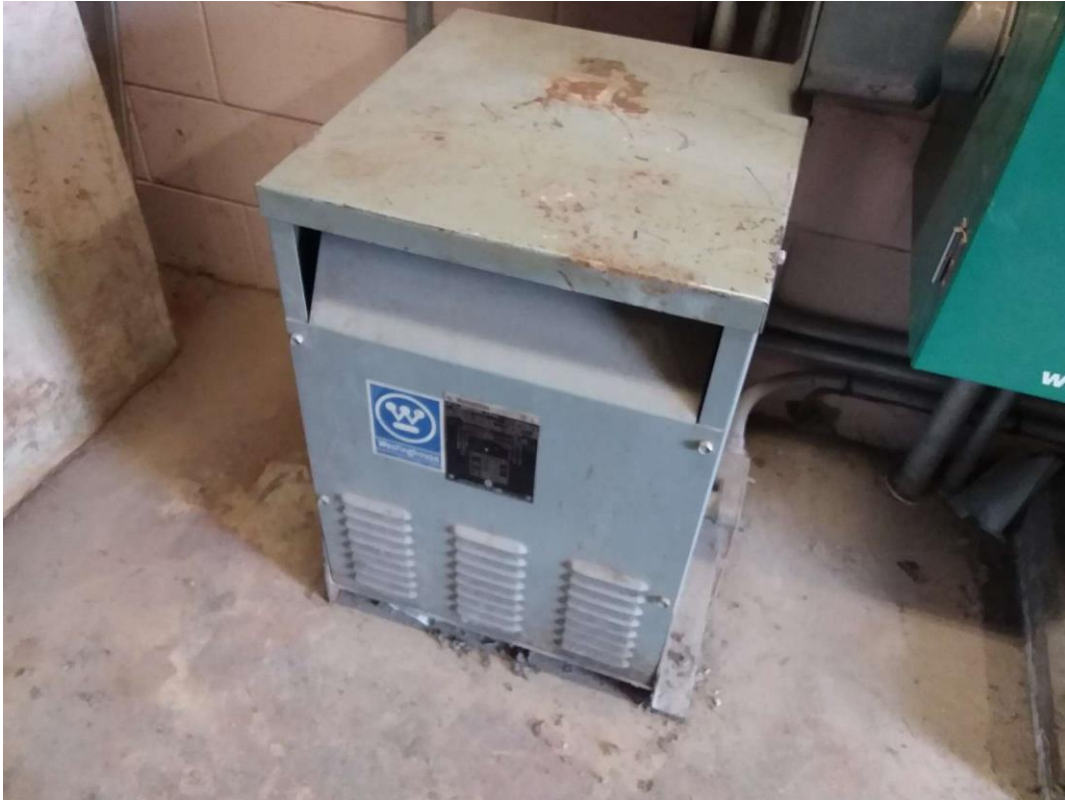
PCB, V0000(No), TRANSFORMER, Generator Building (Location #: 3)
