CITY OF WINNIPEG

WASTEWATER LIFT STATION CONDITION ASSESSMENT PHASE II - 2020

Document XII: Tylehurst Lift Station Assessment

Date: 2021-04-29

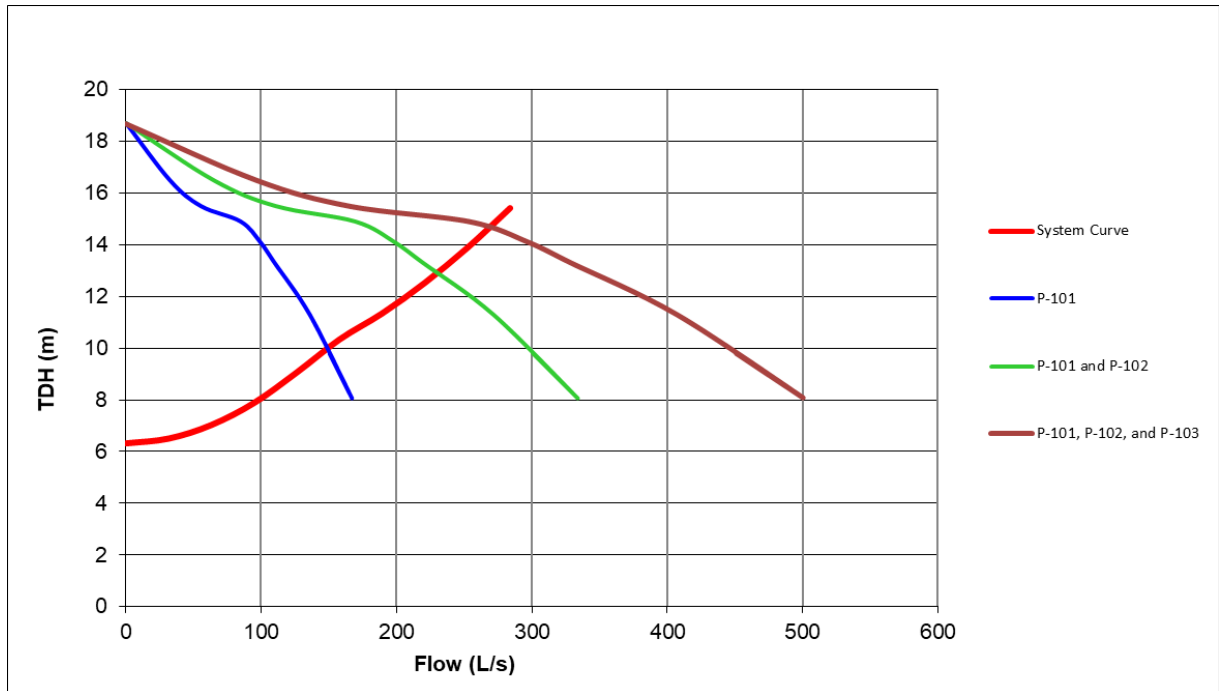
Figure 5.2– Tylehurst Lift Station Curve vs. Pump Performance Curve

The theoretical flows that can be obtained with one pump, two pumps, and three pumps in operation are 149.8 L/s, 231.8 L/s, and 270.5L/s, respectively. However, final assessment of the maximum pumping capacity requirements is outside the scope of the condition assessment and should be confirmed with CoW as the upstream and downstream systems were not considered as part of the assessment.

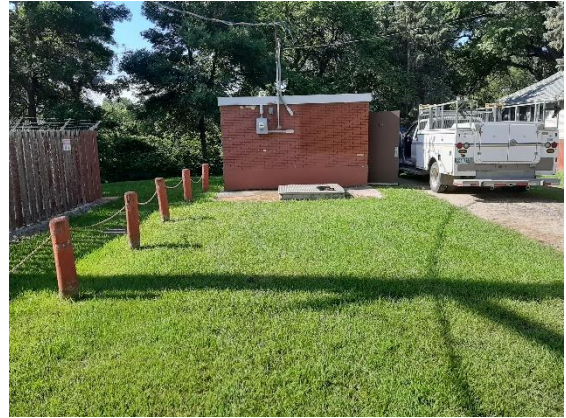
The site is accessed easily from Tylehurst Street or Wolseley Avenue. There is sufficient parking and the parking lot is in "Good" condition. Vehicles leaving the site must back out into an intersection.

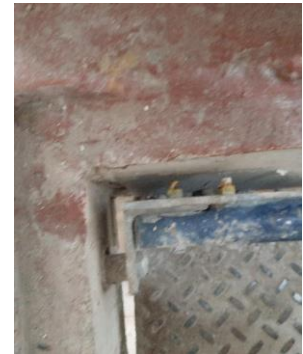
A staircase support is loose and pulling away from the supporting concrete. Some stair hand rails lack required clearance and guard rails lack kick plates. On the mid-level, a pipe penetrates the floor through a square opening. The gaps around the pipe present a tripping/falling hazard. Several floor openings are covered only with wood, which is not Code-compliant. The ladder in the wet well has corroded and is not fit for use.

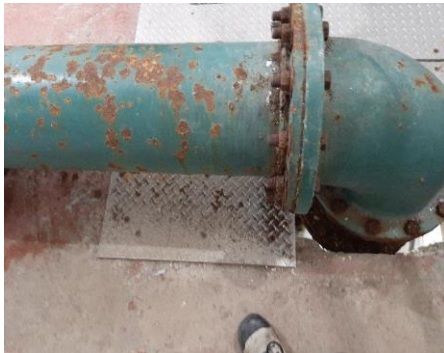
The interior walls and ceilings are in functional condition. Metal equipment bases are corroded and should be replaced with concrete bases.

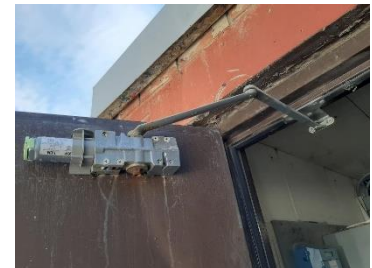
The door is at the end of its useful life. Paint is peeling off the exterior brick face. This may indicate that water is leaking into the wall air space. Door hardware is rusting, which may also indicate leakage from the roof.

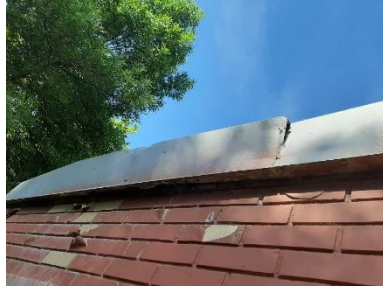
The corroding door and peeling exterior paint indicate that the roof flashing may be leaking. It is aging and damaged. The door weather stripping is also damaged. There is no sealant around exterior penetrations. Sealants should be installed.

Leakage through the roof flashing is evident by the peeling wall paint. This moisture infiltration behind the veneer will freeze resulting in increasing damage to the veneer and block walls.

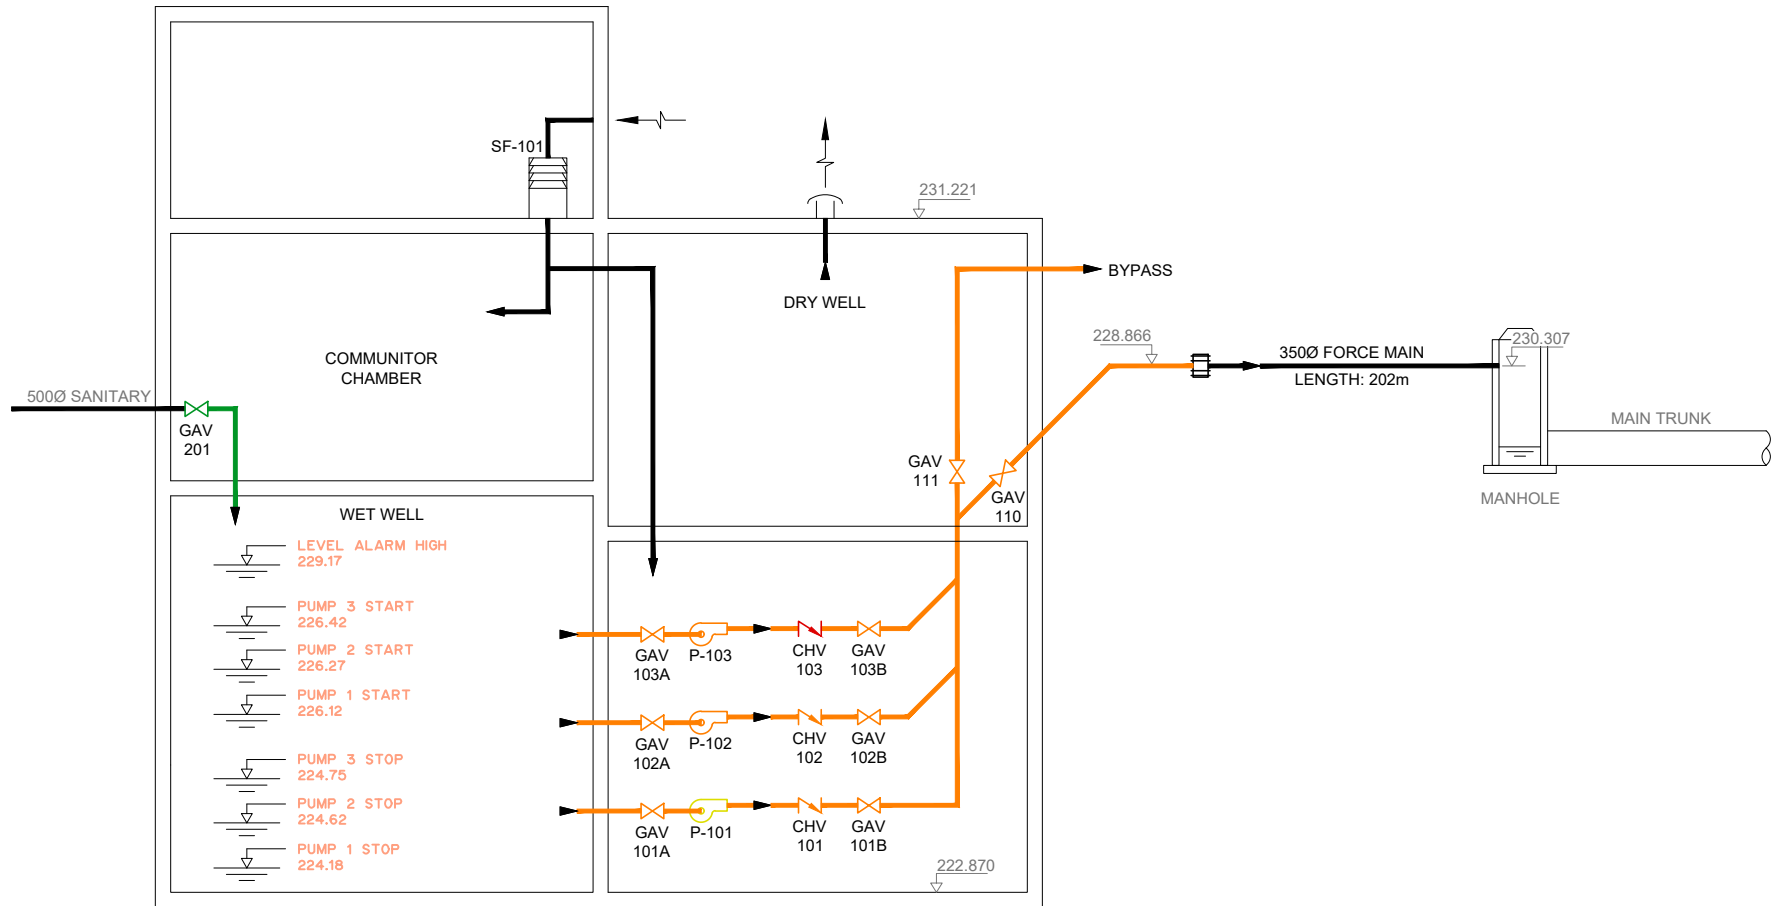
LIFT STATION ASSESSMENTS 2020
 TYLEHURST
 CONDITION ASSESSMENT SUMMARY

Figure 7.1 provides a graphical summary of the condition assessment of the mechanical components of the Tylehurst Lift Station.

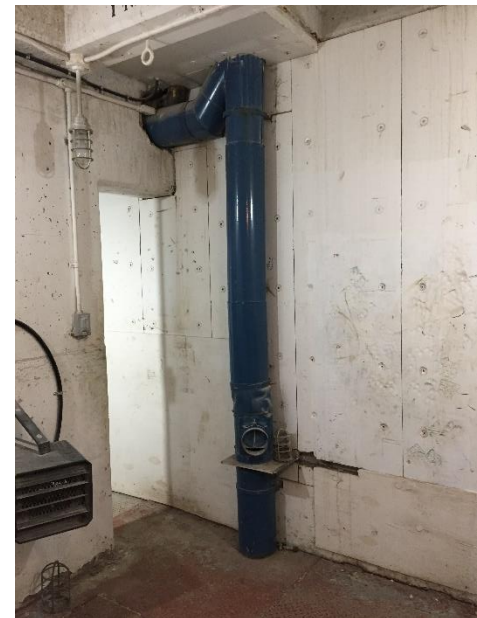
- The dry well intermittent ventilation system is undersized for the fresh air requirements.
- There is no wet well ventilation system in place. It is recommended that a portable air supply system continue to be used for the wet well ventilation system.
