Hazardous Building Materials Assessment (Pre-Demolition)

Tylehurst Lift Station
499 Tylehurst Street, Winnipeg,
Manitoba

April 24, 2025

Pinchin File: 355958.000

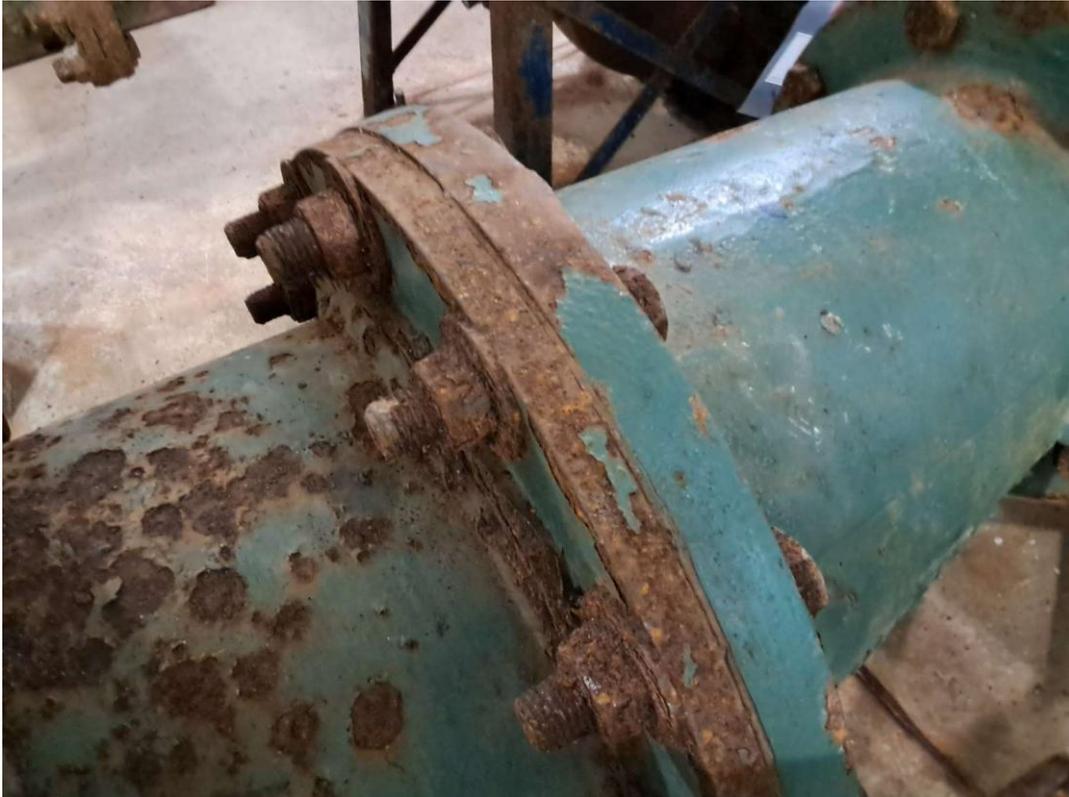
S0001C (None), Piping, Pump, Gasket, Pump Room (Location #: 5)

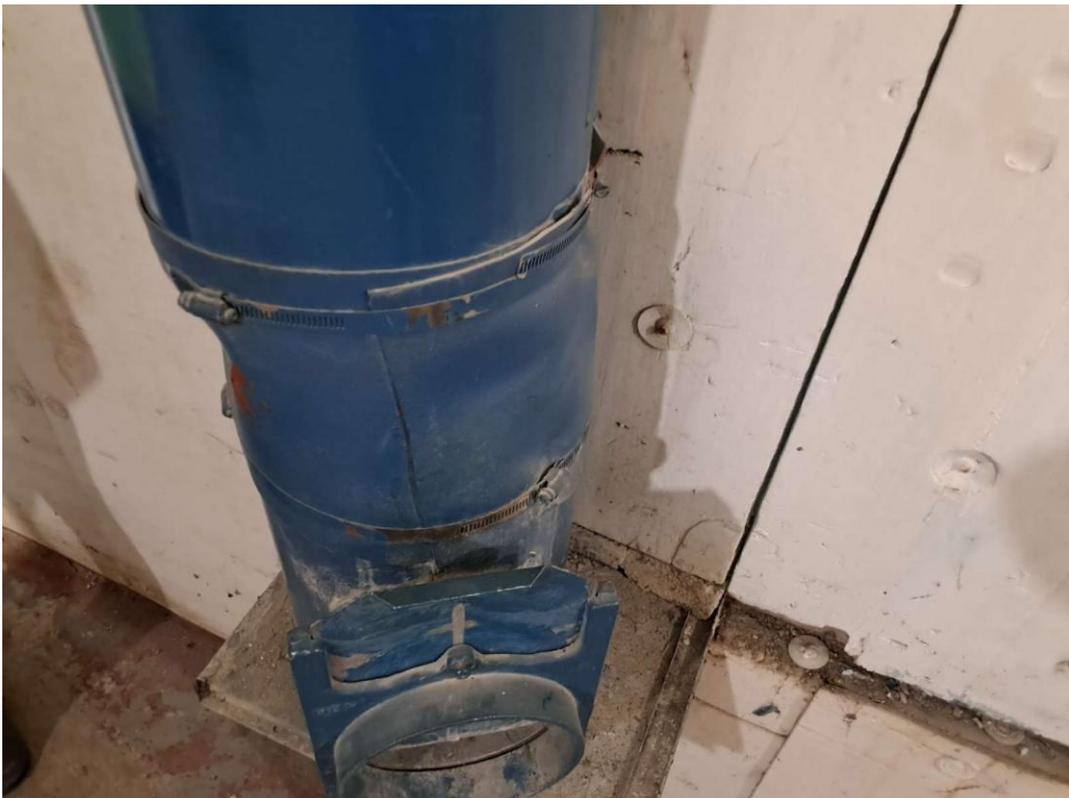
S0002A (None), Ducting, Textile Duct Connector, Comminutor Room Drywall (Location #: 2)

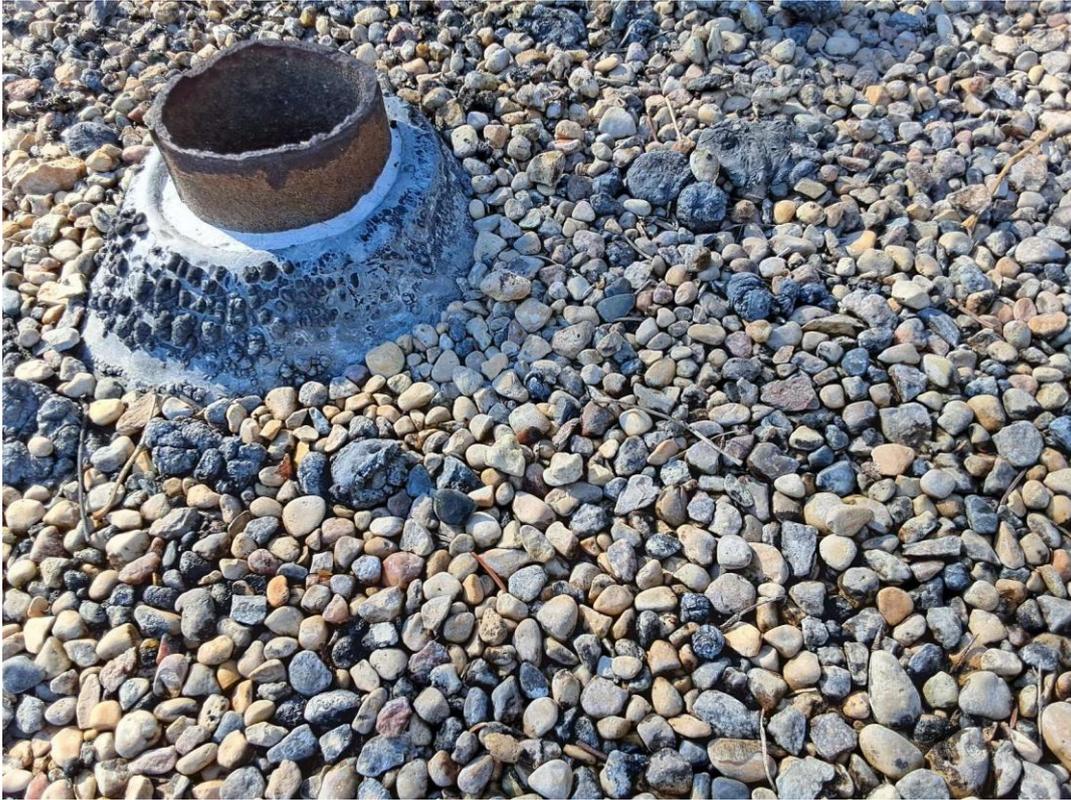
- Tar roofing material on the building is non-friable and maintained in good condition.

S0003A (Confirmed Asbestos), Other, Roof, Roofing material, Exterior of Building (Location #: 6)

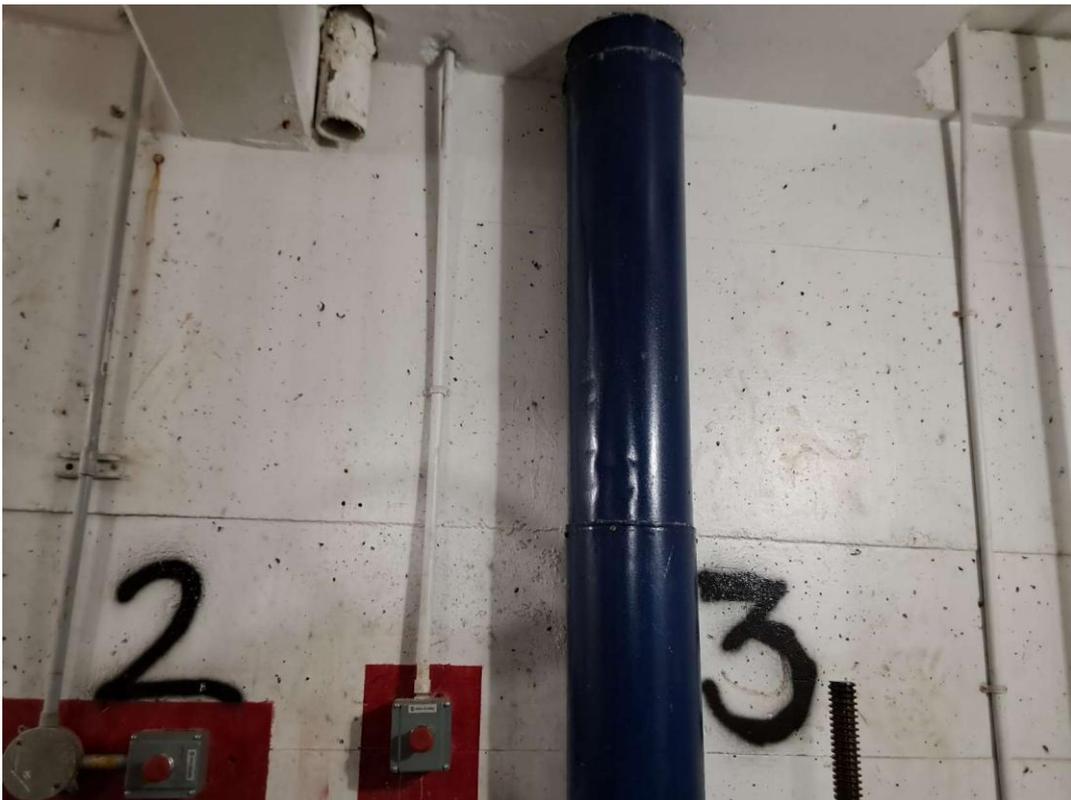
V0006(Lead, Yes), Blue, Duct, Pump Room (Location #: 5)
Blue

Items painted with paints containing elevated levels of lead may be a hazardous waste. Test lead-painted materials for leachable lead and other metals prior to disposal. Metallic components coated with lead paint do not require leachate testing and can be disposed of as non-hazardous construction and demolition (C&D) waste.

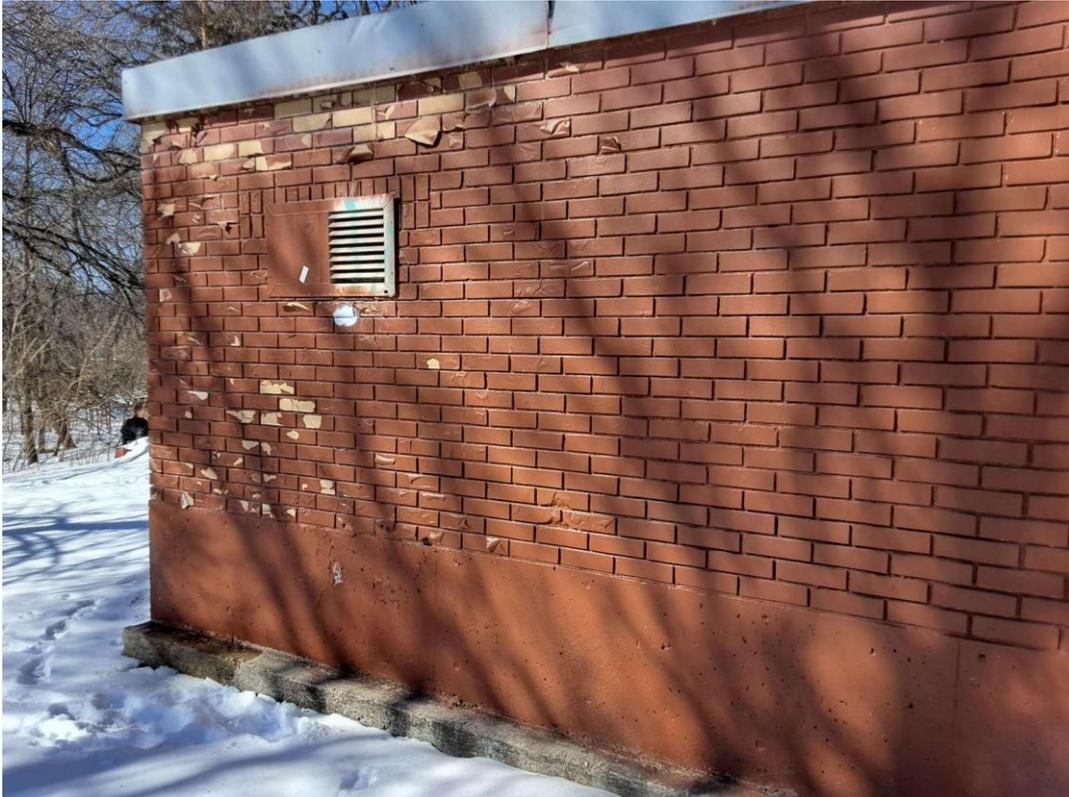
L0009(Lead, None), Red, Wall, Exterior of Building (Location #: 6)
Red

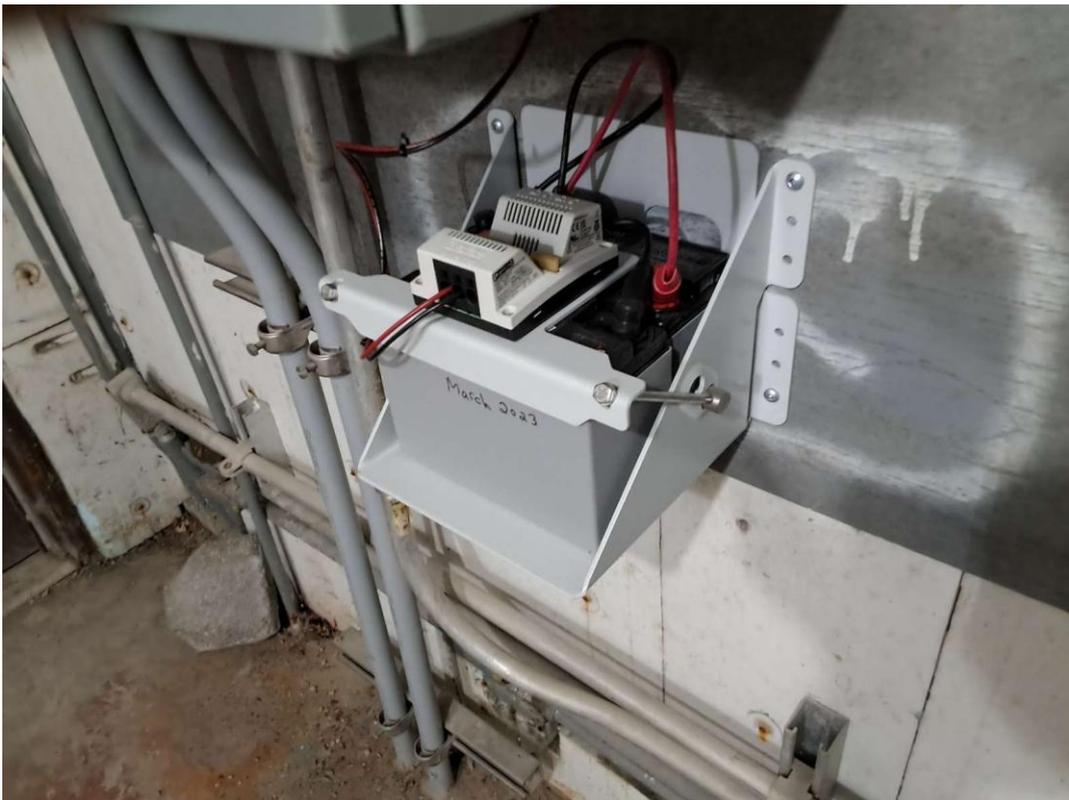
Pb Products, V9000(Yes), BATTERIES IN EMER. LIGHTS, Control Room (Location #: 1)

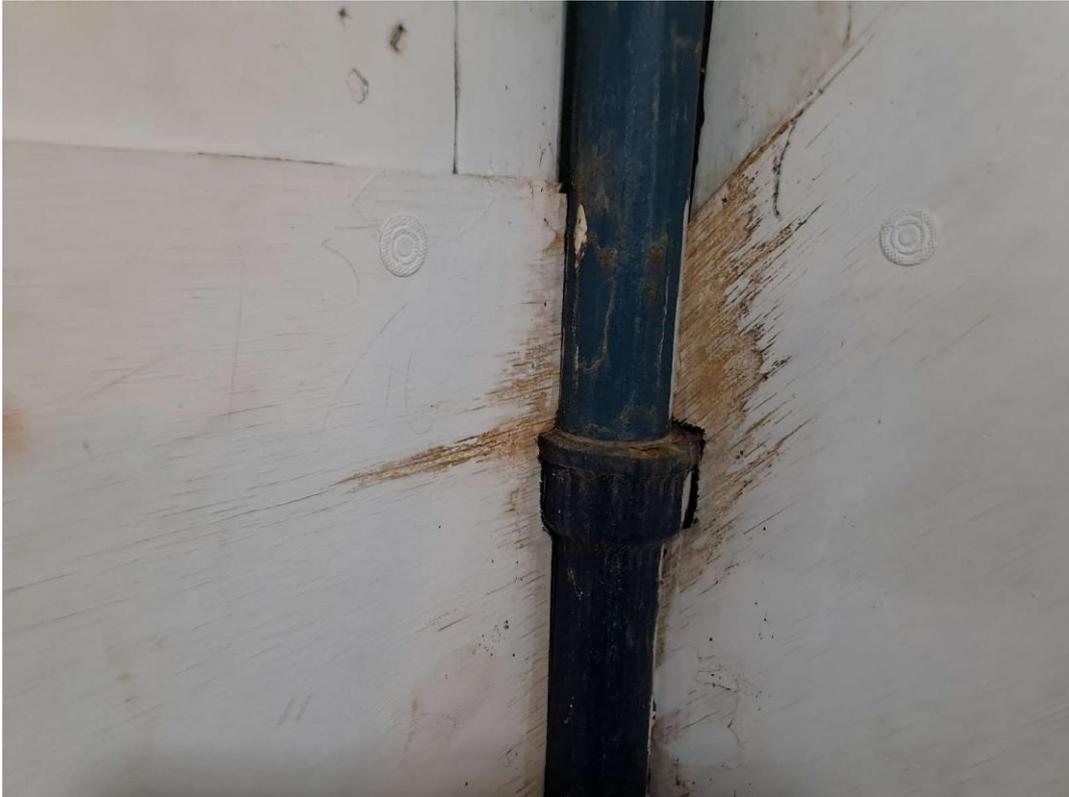
Pb Products, V9000(Yes), Bell and Spigot Fittings, Comminutor Room Drywell (Location #: 2)

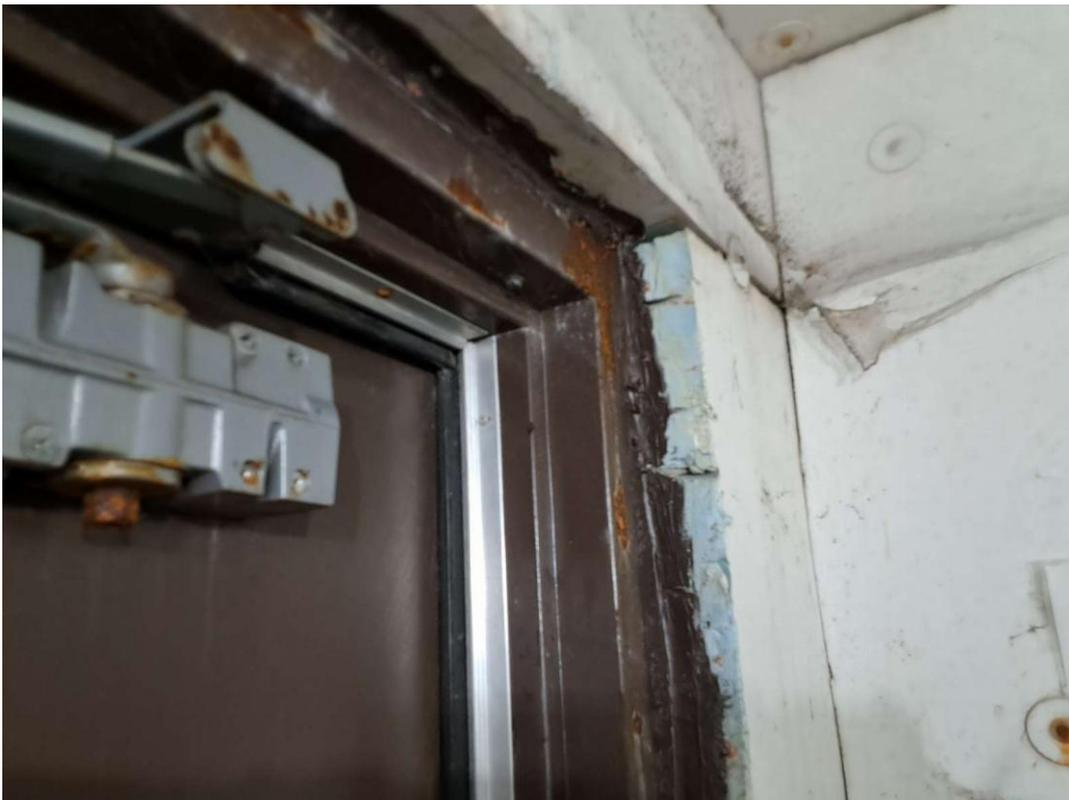
Asbestos, S0004A-C (No), CAULKING, Brown, Brown on door frame, Control Room Drywell (Location #: 1)
PCB, P0003(No), CAULKING, Brown, Brown on door, Control Room (Location #: 1)
L0007(Lead, None), Brown, Door, Control Room (Location #: 1)

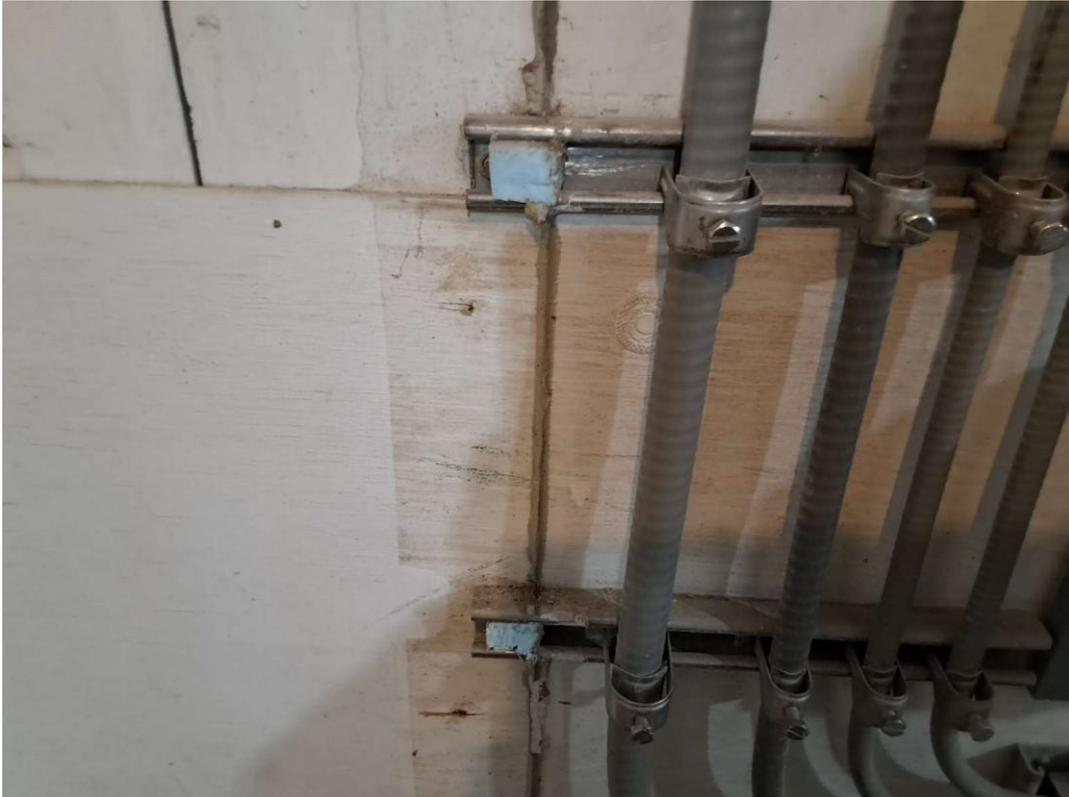
PCB, P0002 (No), CAULKING, Off-white, Off white on wall, Comminutor Room Drywell (Location #: 2)
Asbestos, S0005A-C (No), CAULKING, Off-white, Off white on wall, Comminutor Room Drywell (Location #: 2)
