Slope Failure on Northbound Lagimodiere Blvd between Betournay St and Elizabeth Rd

Geotechnical Investigation and Slope Instability Assessment Report

Project Number: 0015 037 00

Date: September 14, 2020

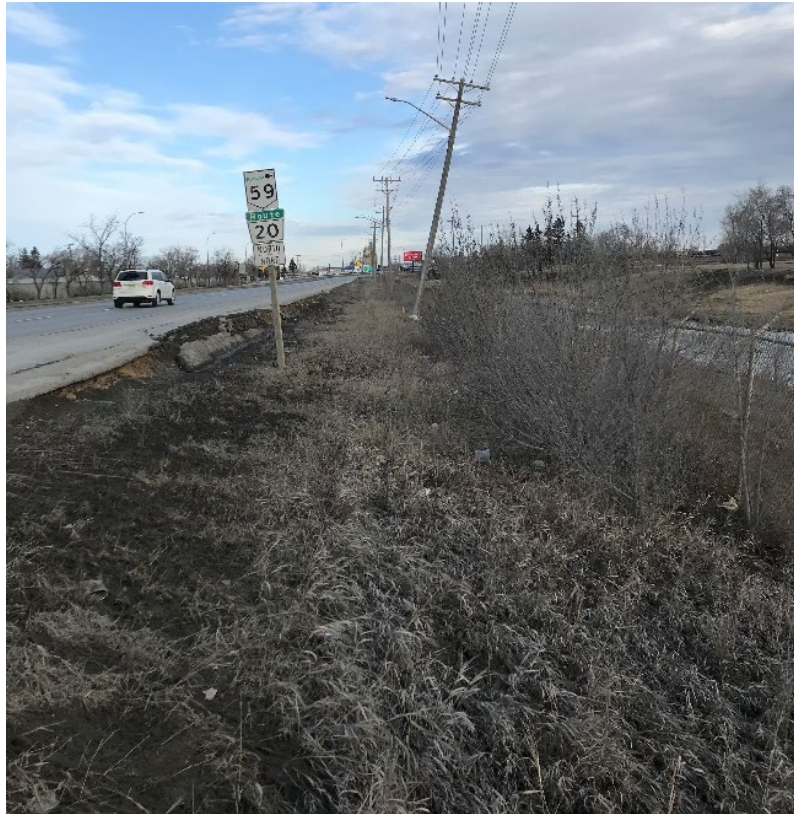
Photo 1 Looking North-East at south instability (taken 2020-Apr-01)

In between the two instabilities, there are no apparent signs of movement. However, these types of shallow, saturation driven instabilities can occur at unpredictable locations and therefore similar conditions may developed within the unfailed section in the future. The entire west slope is therefore considered unstable to marginally stable.

Given that the two options are comparable in terms of stability improvement and construction cost, but that the rockfill ribs present advantages in terms of reduced permanent impact to CN operations and option of construction from the roadway, the rockfill ribs option is recommended.

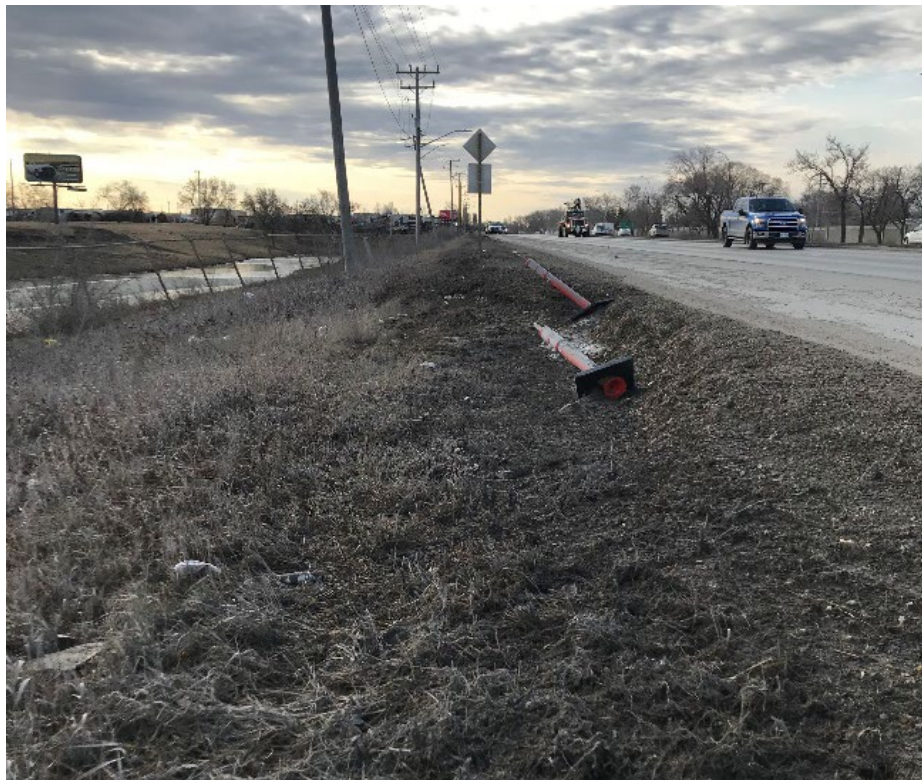
Photo 2 Looking South-West at north instability (taken 2020-Apr-01)

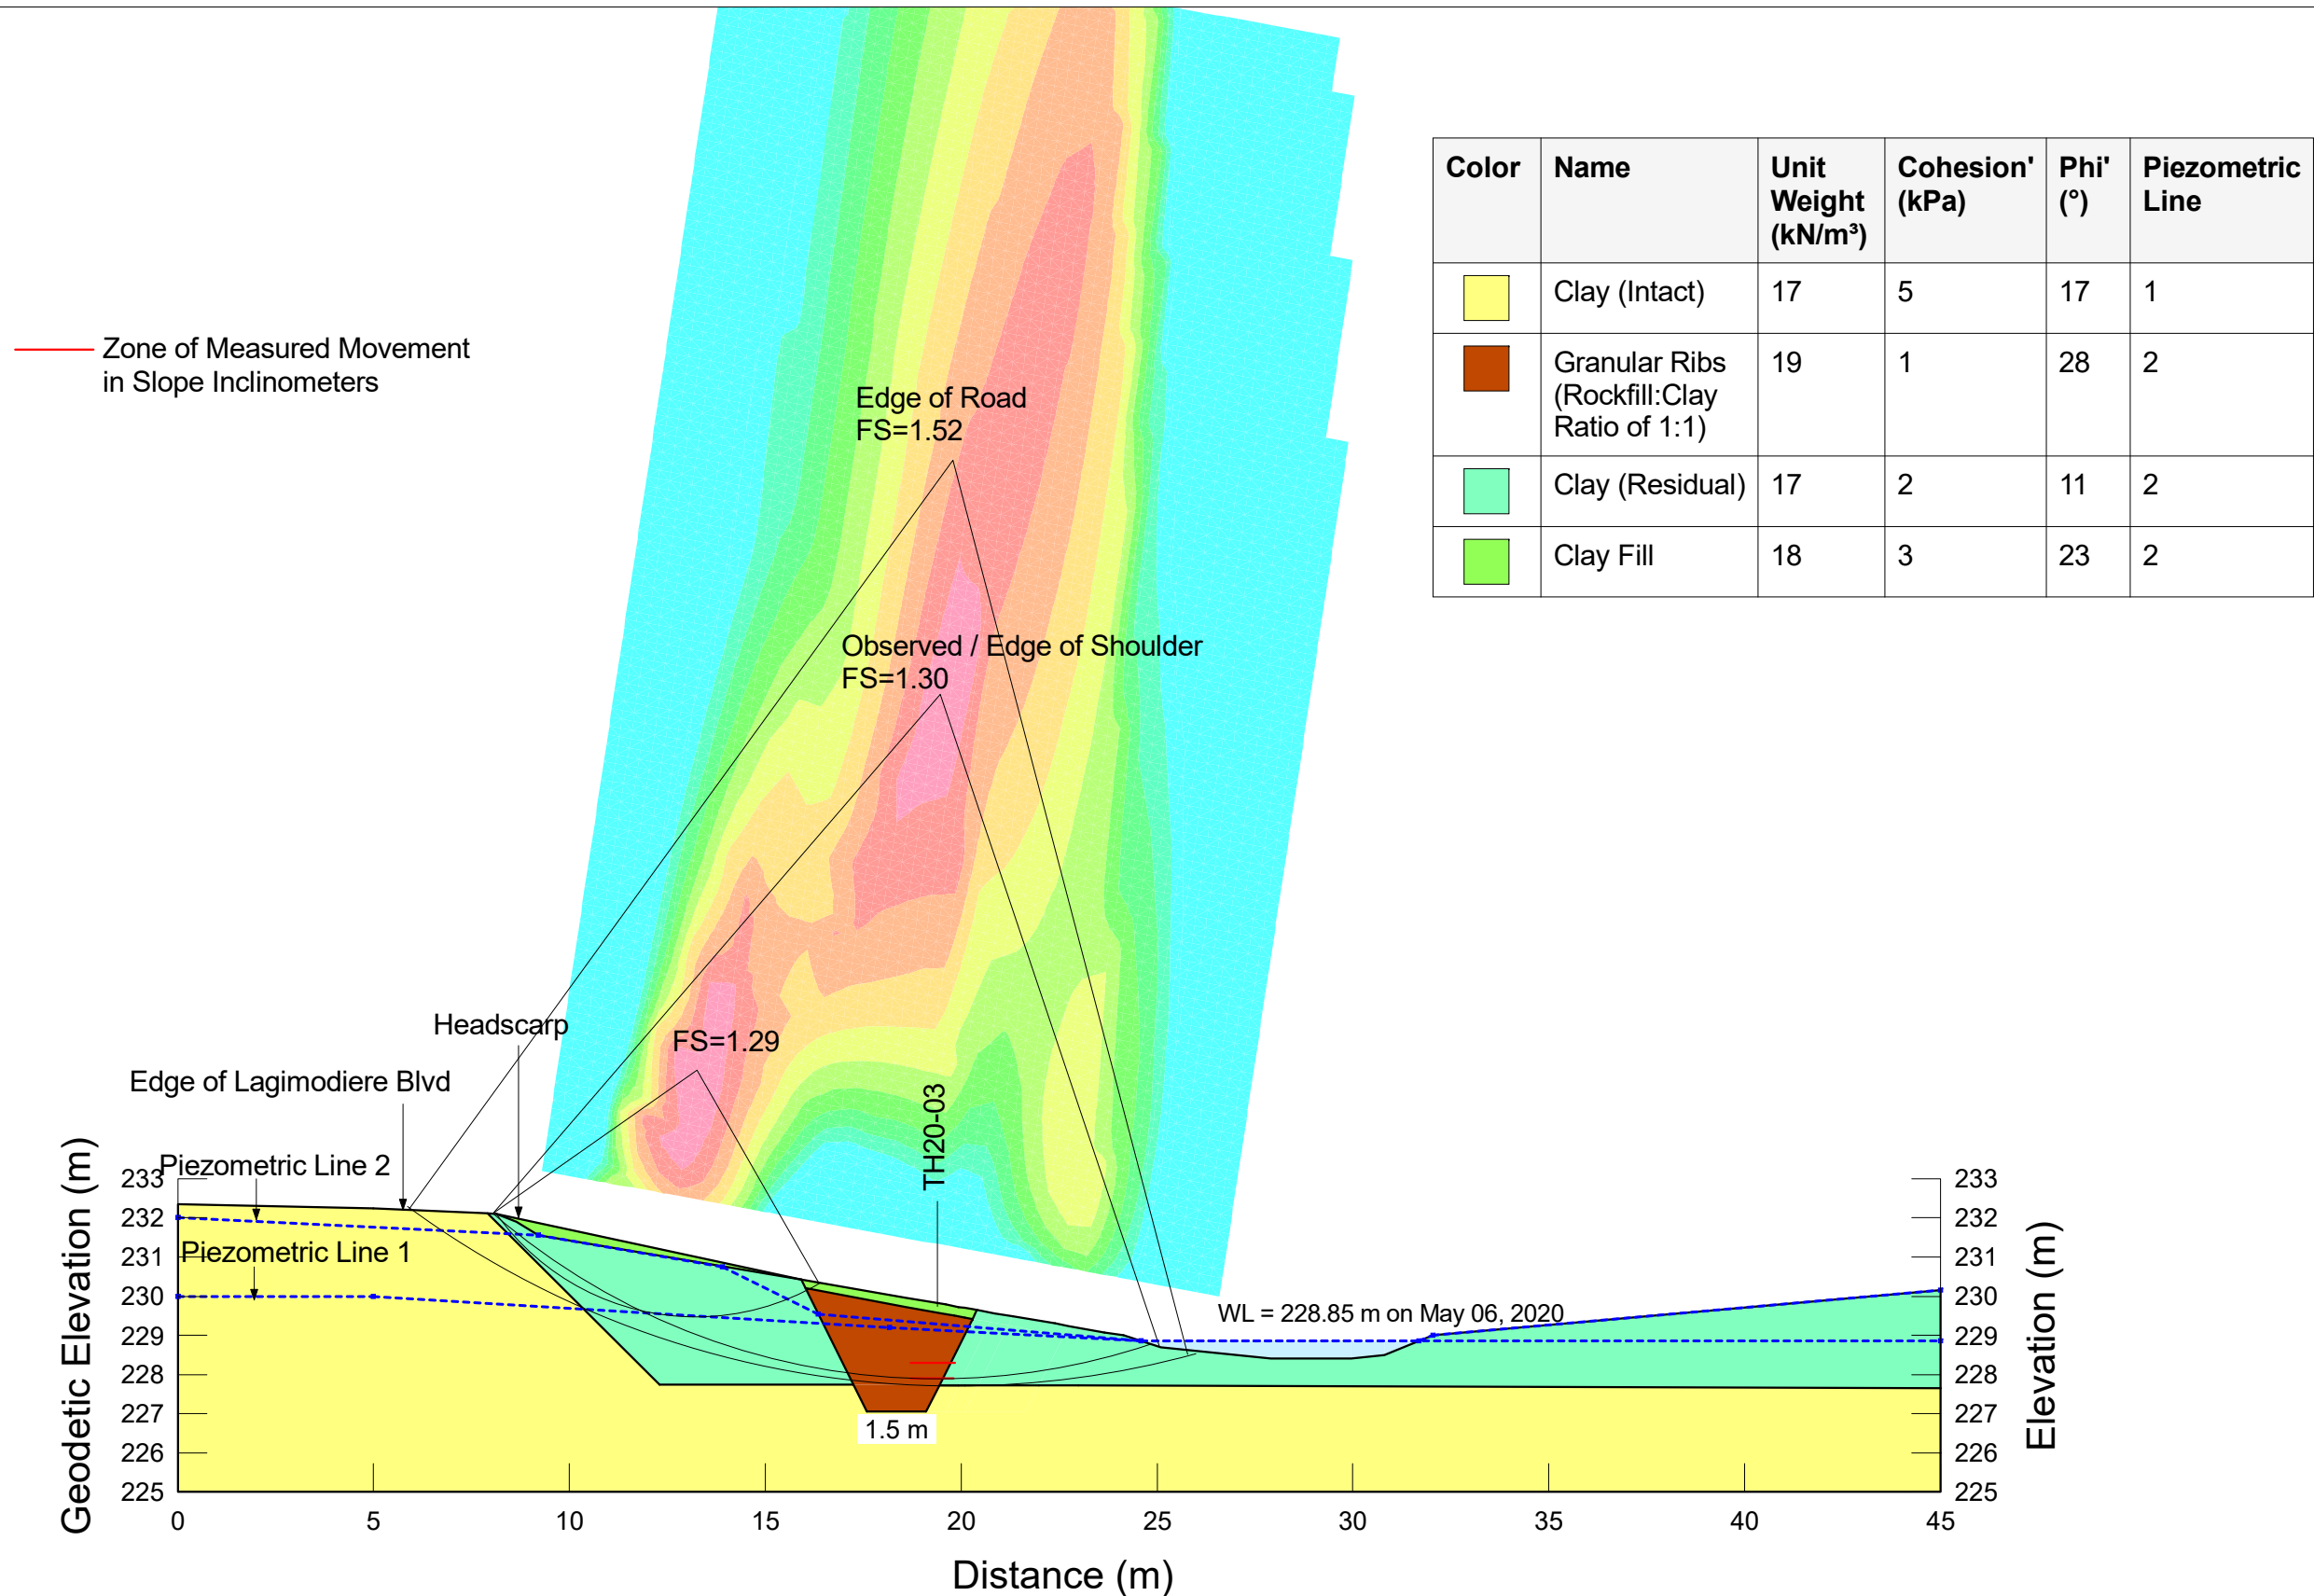
Figure D-03

Rockfill ribs installed at a 1:1 replacement ratio in plan view (e.g. 1.5 m wide with 1.5 m clear spacing between ribs) and a base width of 1.5 m for both cross-sections A and C satisfy the design stability targets (Figures D-03 and D-04). The calculated factors of safety for the observed slip surface with rockfill ribs and regrading to pre-existing grades increases to 1.30 (+21%) and 1.36 (+42%), respectively, for cross-sections A and C. The factors of safety at the edge of shoulder increase to between 1.25 and 1.29, while those at the edge of roadway increase to between 1.38 and 1.52. It should be noted that some degree of drainage improvements due to rockfill ribs were incorporated in the model by lowering the piezometric line immediately upslope of the ribs.

A rockfill toe berm extending to the bottom of the pond, approximately 1.5 m high, combined with slope regrading (flattening) with clay fill will satisfy the design stability targets (Figures D-03 and D-04). The calculated factors of safety for the observed slip surface with the rockfill toe berm and regrading increases to 1.46 (+36%) and 1.44 (+50%), respectively, for cross-sections A and C. The factors of safety at the edge of shoulder increase to between 1.24 to 1.25, while those at the edge of roadway increase to between 1.38 and 1.47.
