The City of Winnipeg

High Risk River Crossings Condition Assessment Report Water Crossings

AECOM
99 Commerce Drive 204 477 5381 tel
Winnipeg, MB, Canada R3P 0Y7 204 284 2040 fax
www.aecom.com

November 2, 2016

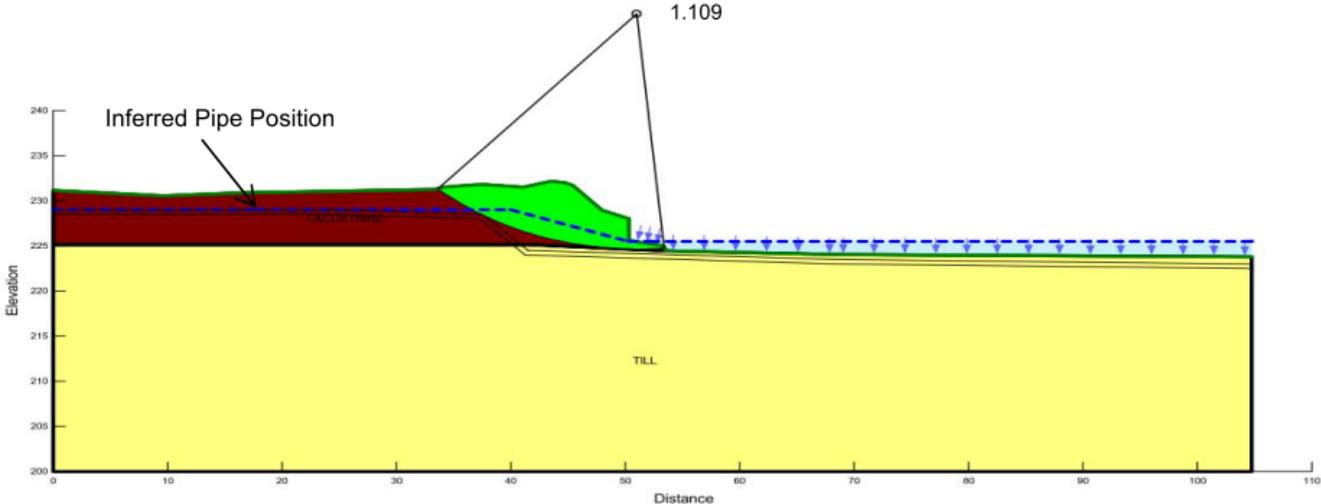
Figure 10: Slope Failure Planes – St. James Water Main

At Site 14, St. James Street Water Main the pipe elevation profile consists of shallow burial within the river channel and a till surface coincident with the river channel bottom. The potential failure surface based on the analysis may engage the pipe where the pipe elevation rises into the riverbank clay further inland, see Figure 10. At present the observed failure is confined to the oversteepened face of the riverbank with failure blocks sliding along the till surface. Arresting the erosion and flattening the slope face should be implemented to prevent the failure current failure surface from progressing inland and causing a failure surface which engages the pipe.

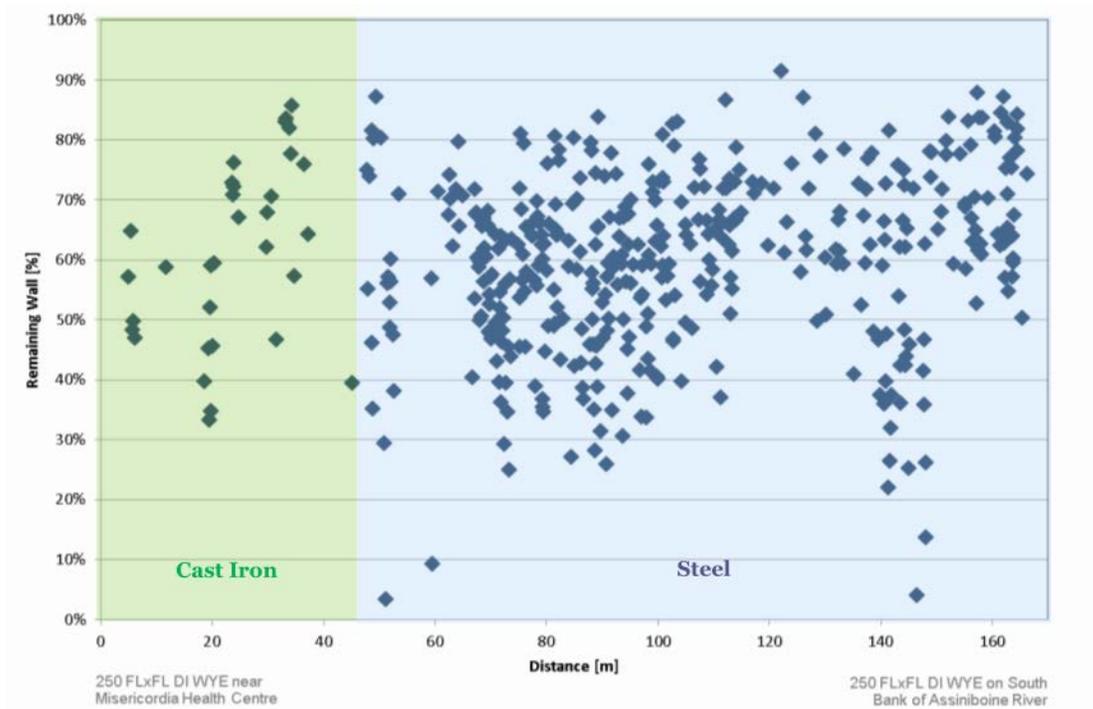
Figure 15: Maryland Bridge Water Main Corrosion Defects

The pipe was successfully pressure tested after completion of the emergency repair.

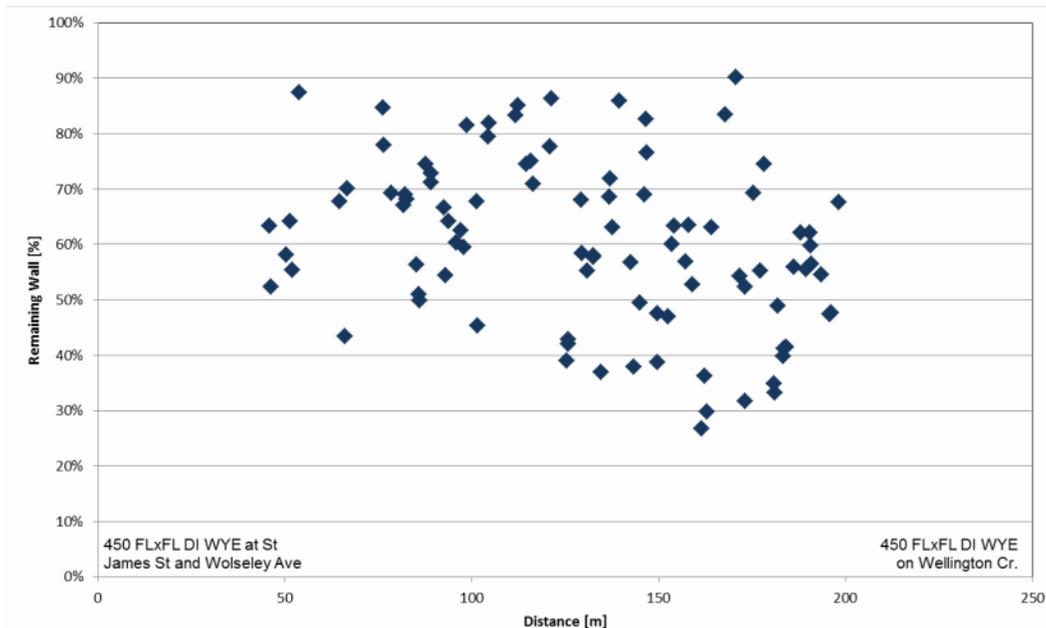
Figure 16: St. James Water Main Corrosion Defects

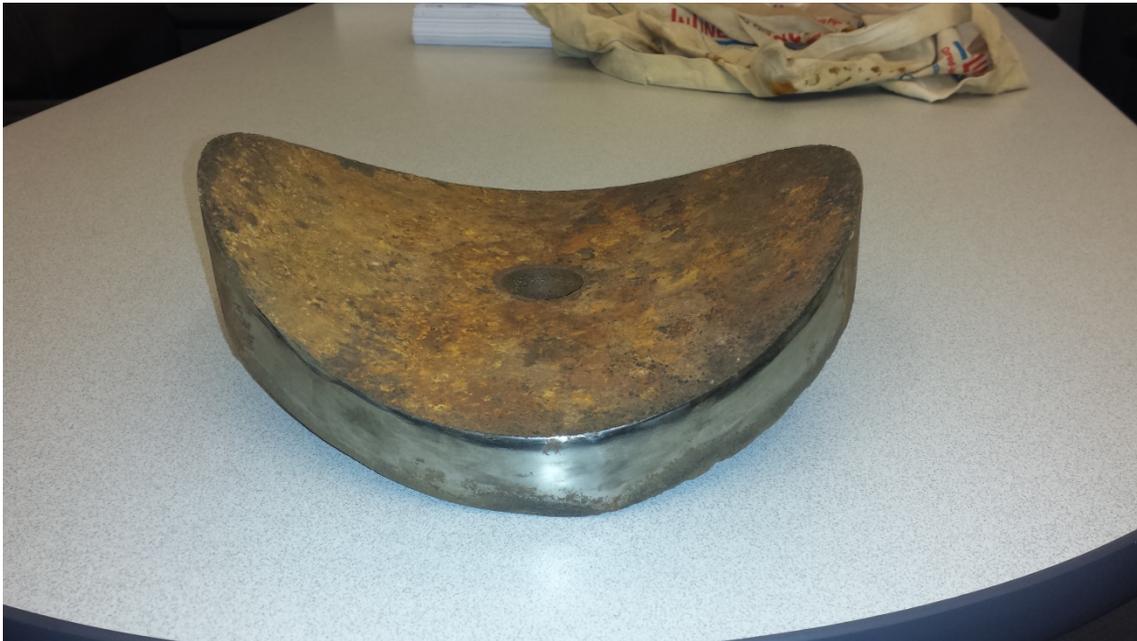
Figure 20: Cast Iron Pipe Sample Exhibiting Graphitization

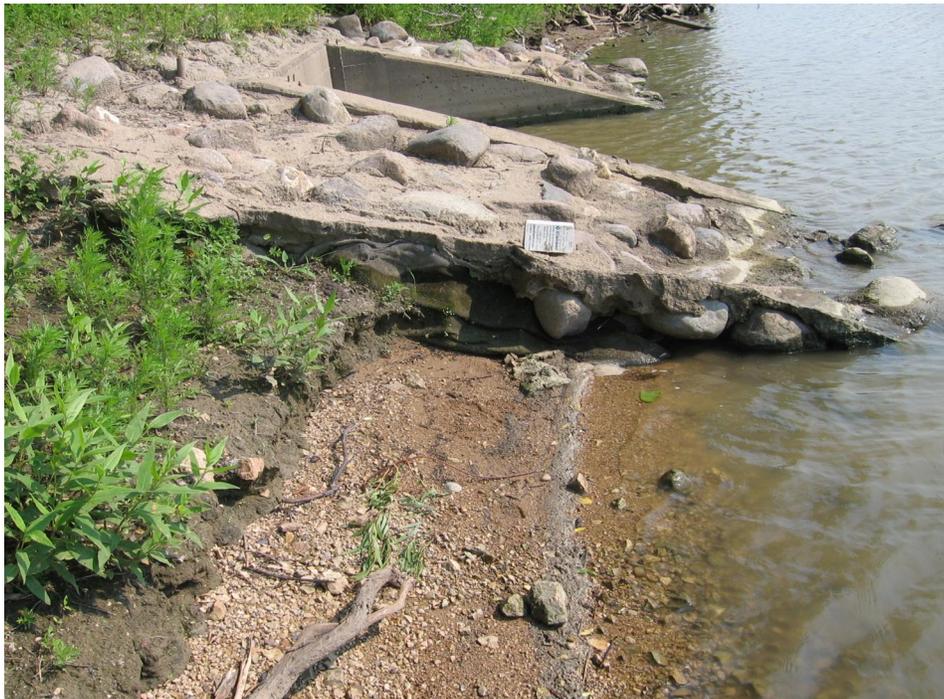
Sparse rocks are located at the toe but in insufficient quantity to be considered as a concerted effort at rip rap armoring. Erosion at the shoreline has produced a 300mm to 600mm erosion scarp. North (downstream) of the ROW there is a 2.1m high scarp (79 Scotia Street). Limestone rip rap is present at the first property south (upstream) of the station (71 Scotia Street) and at the second property north (89 Scotia Street).

Figure 10 – River bank erosion relative to grouted rip rap location at outfall pipe.

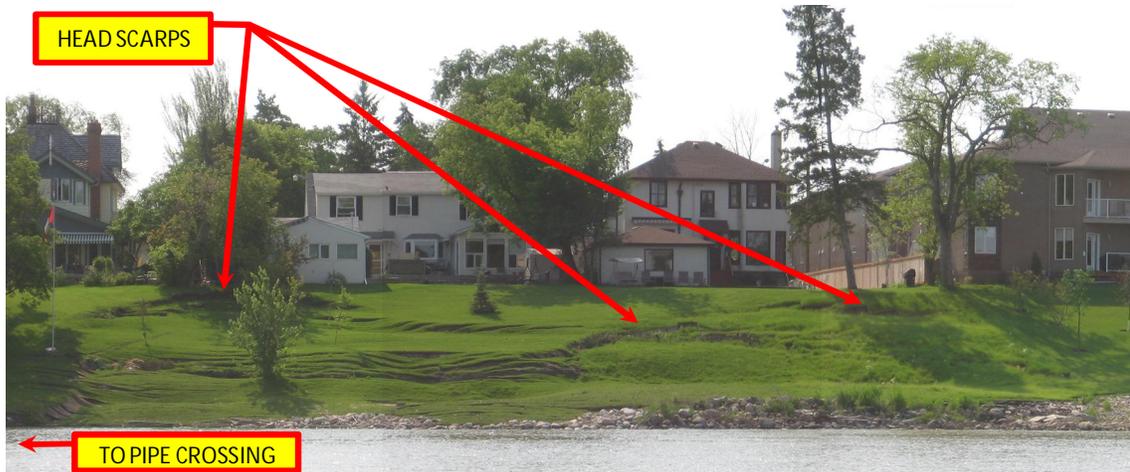
Figure 13 – Neighbouring river bank failures upstream of ROW.

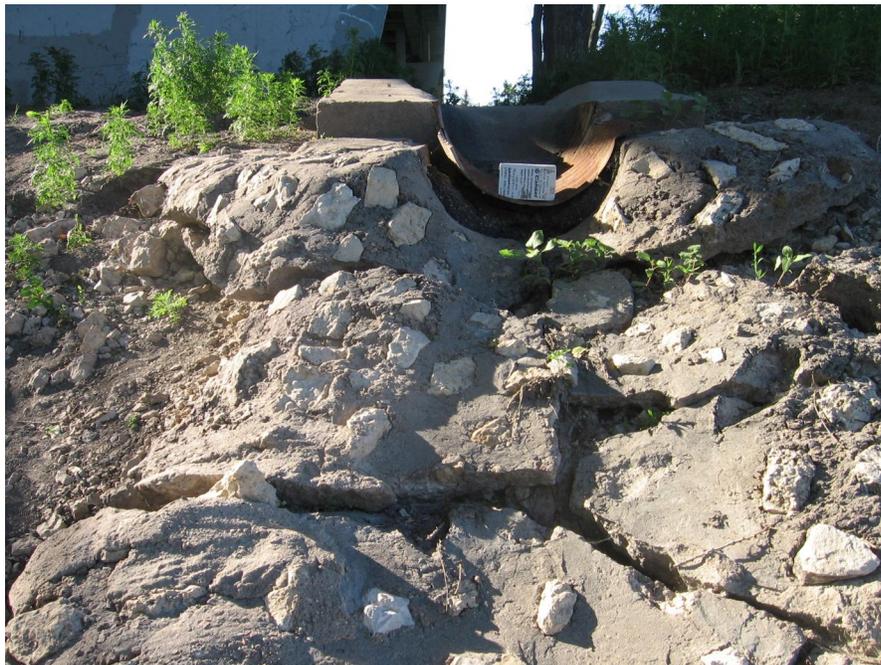
The north bank is located on Osborne Street at Churchill Drive. The pipe enters the ground upslope of the second pier from the river edge (43m from river edge). There is no evidence of river bank instability at the site. Riverbank toe is armored with loose rip rap with no erosion present. Rip rap appears to have deposition in void spaces. The rip rap extends 45m upstream and 30m downstream of the nearest edge of the bridge. Outside of this protected area the river banks are steep with evidence of bank failure due to undercutting erosion on alluvial banks. Concrete drains show no sign of structural distress. Separation of grouted rip rap at drain outlet does not appear to be related to underlying bank stability issue and may be caused by post construction settlement, freeze-thaw action, or ice floe action (Figure 15).

Figure 15 – Cracking of grouted rip rap and separation from bridge drain outlet.

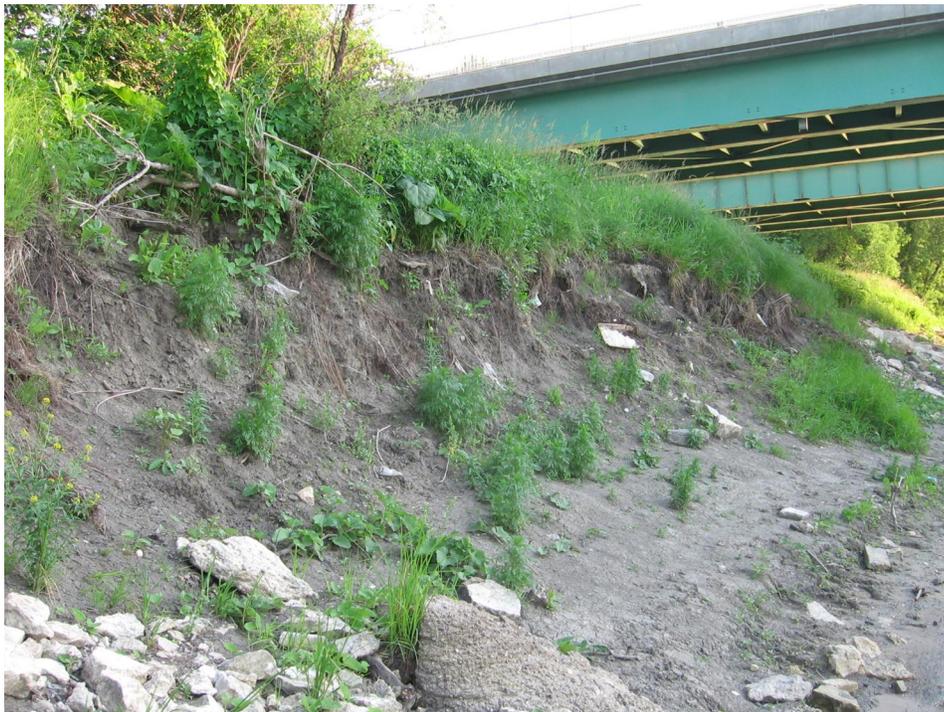
Rip rap coverage is limited to 16m west (upstream) and 10m east (downstream) of the bridge. To the west, between a distance of 16m to 28m upstream, the rip rap becomes sparsely distributed and there is evidence of surficial displacements in the upper bank. In the downstream direction (east), beyond the 10m rip rap limit the upper bank is steep (2.4m high) and overhanging which is indicative of surficial displacements (Figure 16). This oversteepened section is concerning since there are several pieces of sewer infrastructure upslope of this bank that may be engaged by these displacements in the future. This oversteepened bank also lacks consistent armoring at the bank toe that could lead to further erosive effects.

Figure 16 – Erosion and potential surficial bank displacements downstream (east) of bridge downslope of other pipe infrastructure.

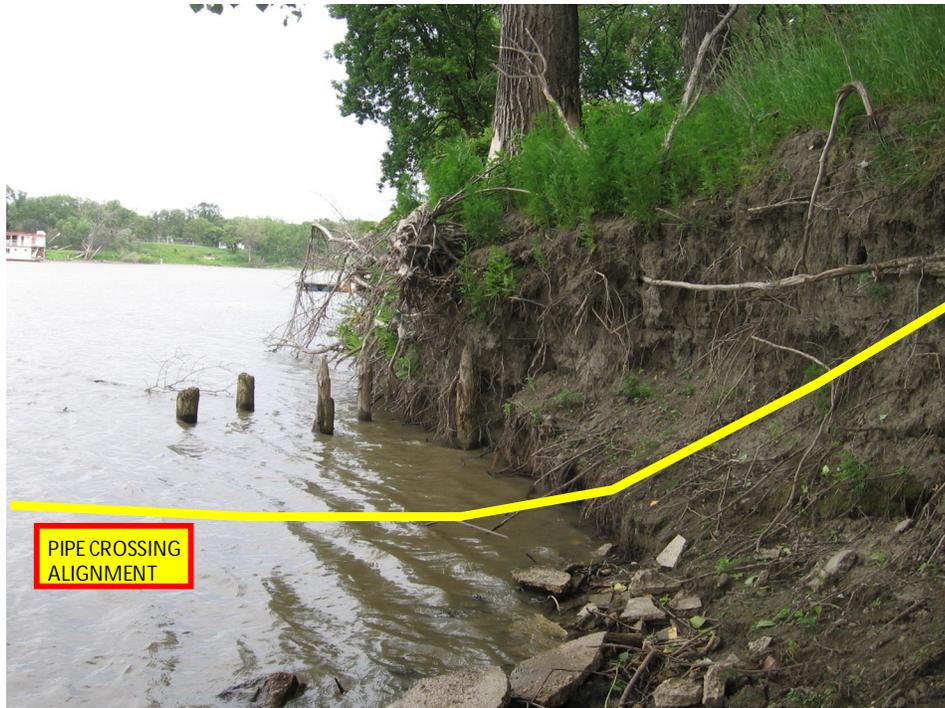
Properties farther north show more natural bank geometry with a steepened upper bank and flat bench leading to the river edge. These properties to the north also have loose limestone rip rap erosion protection at the shoreline from 166 Glenwood Crescent northward. The immediate property (164 Glenwood Crescent) north of the bridge, that's also affected by the 2.4m scarp at the river edge, does not have rip rap erosion protection.

Figure 19 – River bank erosion on pipe crossing alignment immediately downstream of Redwood Bridge.

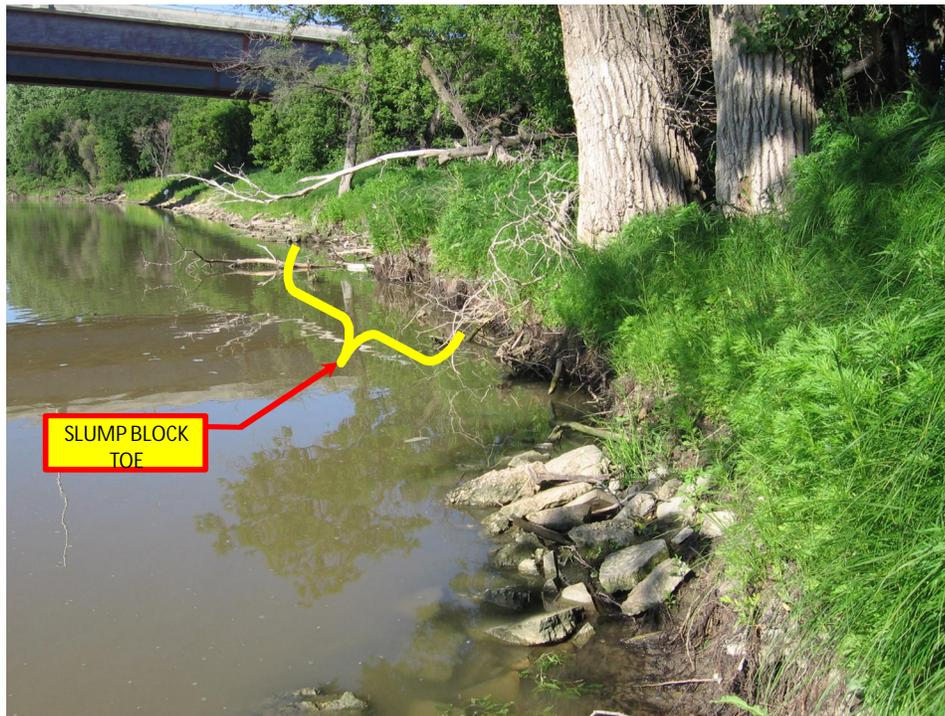
North (downstream) of the ROW there is the previously mentioned grouted rip rap and a private dock (2641 Scotia Street). Farther downstream there is evidence of sparse loose rip rap at 2647 and 2653 Scotia Street. Downstream of these locations there is no erosion protection present and similar erosion features as exist south of the ROW are prevalent.

Figure 21 – Toe erosion and toe of slump block upstream (south) of pipe crossing alignment. Photograph taken from pipe crossing.

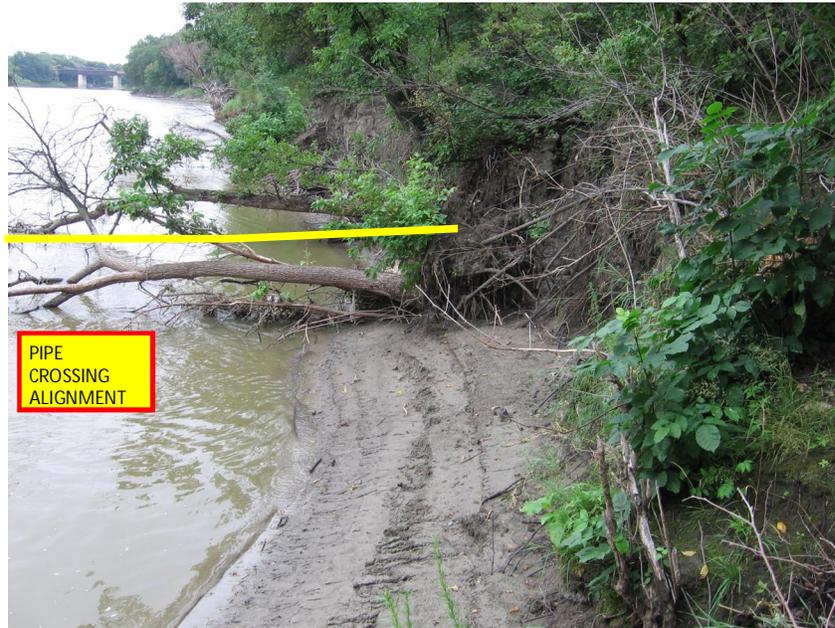
overlying root mat and soil is sufficiently undercut the mass topples as a unit. As a result these failures are shallow-seated.

Figure 24 – Eroded bank with toppling blocks of overhanging soil with root mat and trees.

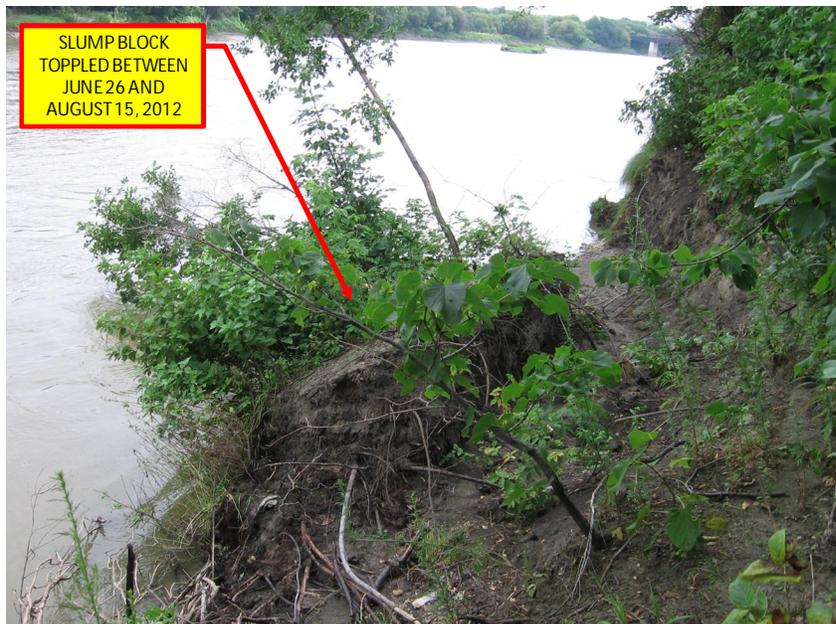
Figure 25 – Fresh slump block toppled between June 26 and August 15, 2012 indicative of active failure pattern.

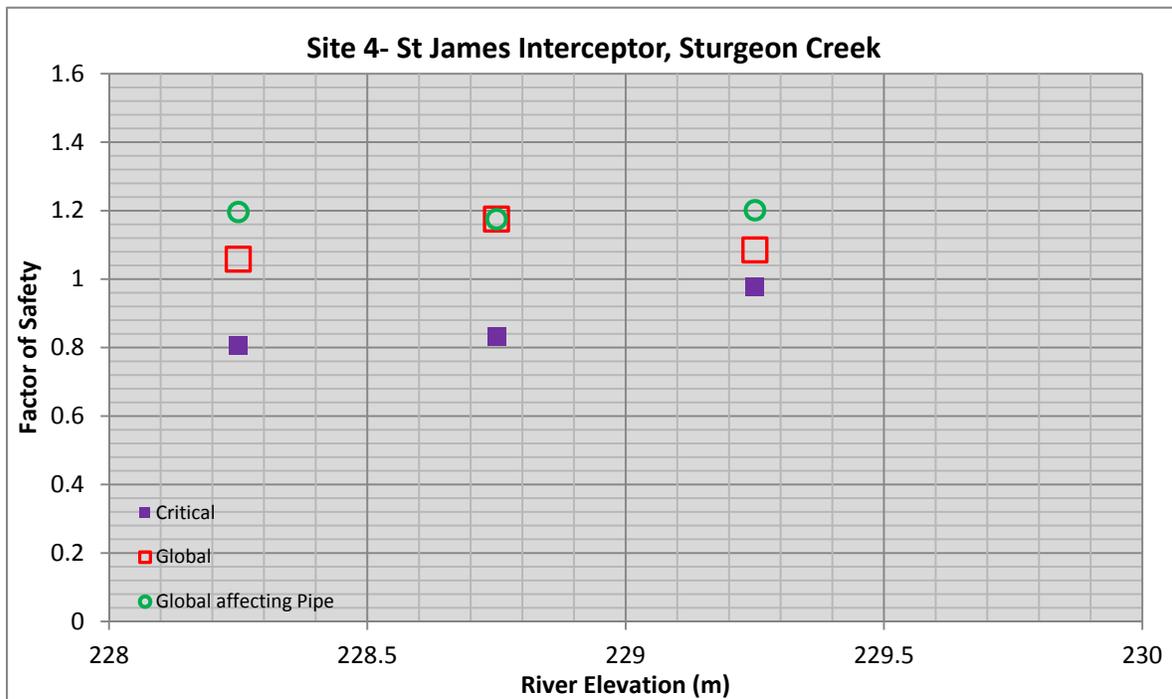
Figure 2: Factor of Safety relating to the Current Condition of Site 4

The calculated FS for selected slip surfaces (CS, GS, and GS+P) are presented in Figure 2 for the anticipated range of river water levels. The CS results indicate a case of imminent instability dependent upon the river water level, and is manifested by oversteepened river bank slopes. These CS's are primarily surficial slides which would be limited to shallow slough and can be addressed by undertaking grading works to introduce flatter slopes. The calculated FS for slip surfaces designated as GS and GS+P vary between 1.0 and 1.2. While the slope can be considered marginally stable, the presence of critical assets within the river bank call for improved river bank stability to attain acceptable FS.

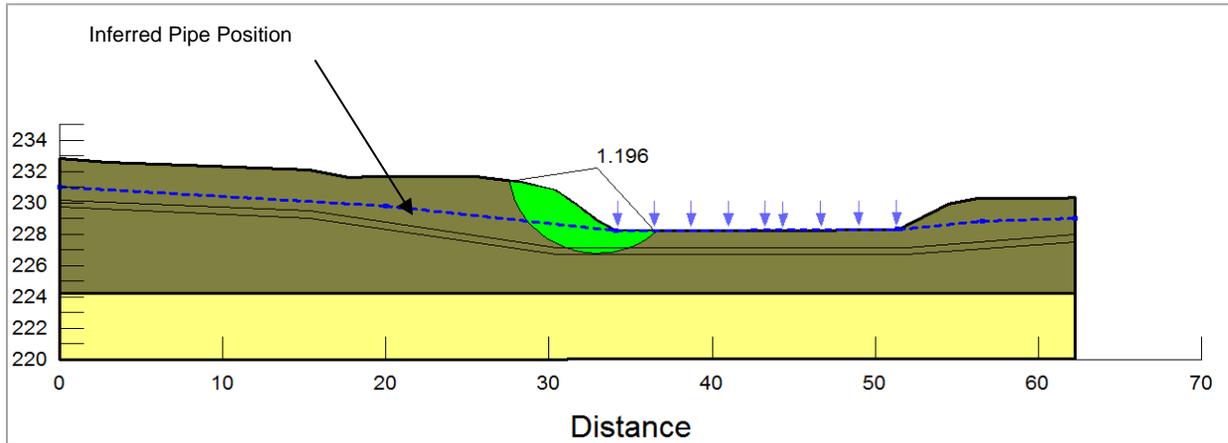
Figure 3: Site 4 St James Interceptor Global Slip Surface Engaging the Pipe (GS+P)

A stability output model illustrating the trace of the global slip surface engaging the pipe at the lowest calculated FS is shown in Figure 3 determined at a river elevation of 228.25m.

The presented graphical results indicate the trace of the GS and GS+P theoretical slip surfaces are likely to result in global instability that engage the pipe given the depth of the impacted mass. Retrogressive failure at the toe is also further likely to reduce the overall global stability of the riverbank, as potential failure surfaces migrate upslope.

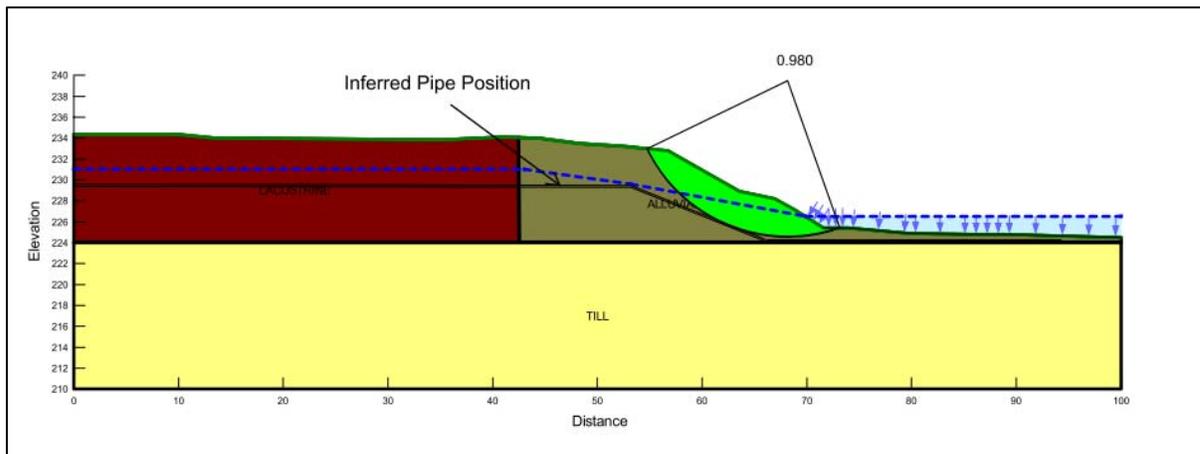
Figure 5: Site 5 Global Slip Surface Engaging the Pipe (GS+P)

While a number of slip surfaces have FS values slightly lower than 0.8, in reality the actual FS are likely higher considering the stabilizing effect of the extensive vegetation growth. A stability output model illustrating the position of the global slip surface engaging the pipe at the lowest FS is shown in Figure 5, determined at a river elevation of 226.5 m.
