## **APPENDIX B**

### **SITE PHOTOGRAPHS**

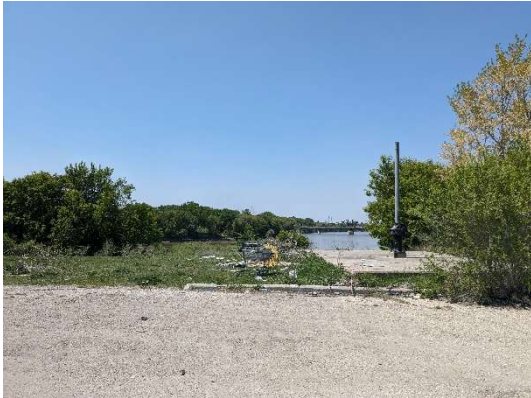
**Photo 1: Roland Outfall – Looking west towards chamber at upper bank**

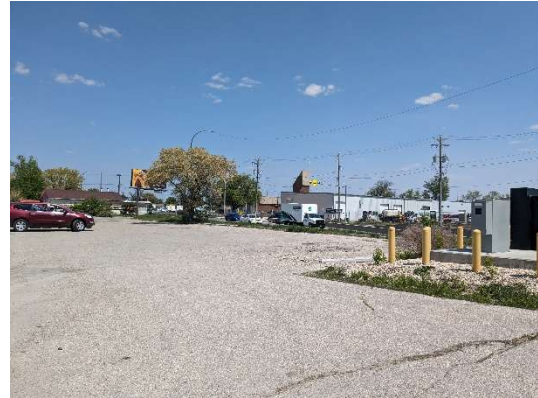
**Photo 2: Roland Outfall – Looking northeast towards Watt Street from parking lot**

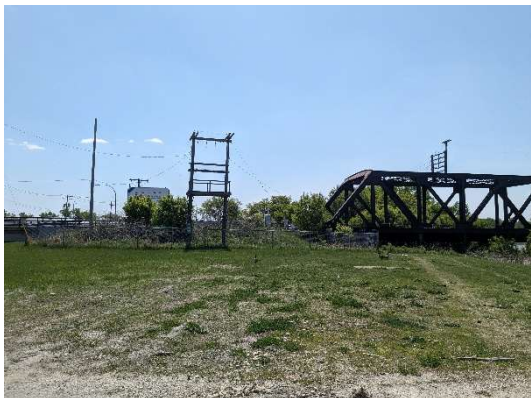
**Photo 3: Roland Outfall – Looking south from upper bank**

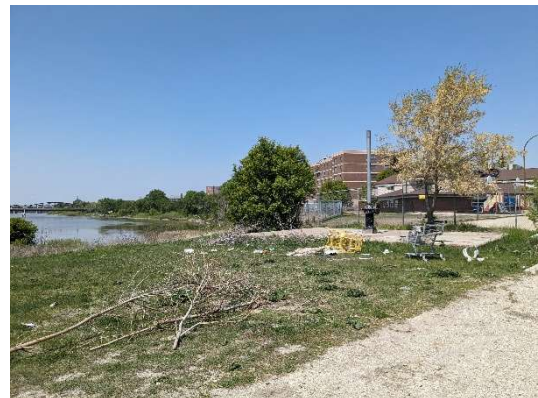
**Photo 4: Roland Outfall – Looking north towards chamber at upper bank**

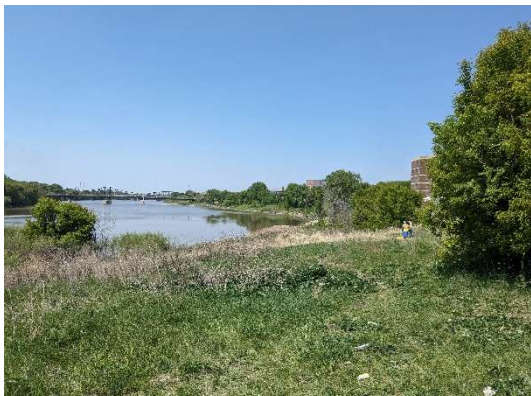
**Photo 5: Roland Outfall – Looking north along upper bank**

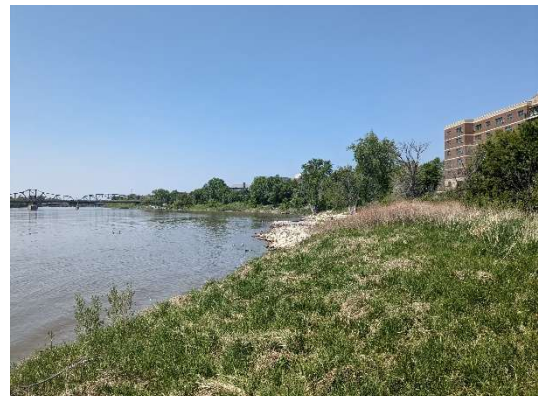
**Photo 6: Roland Outfall – Looking north along mid bank**

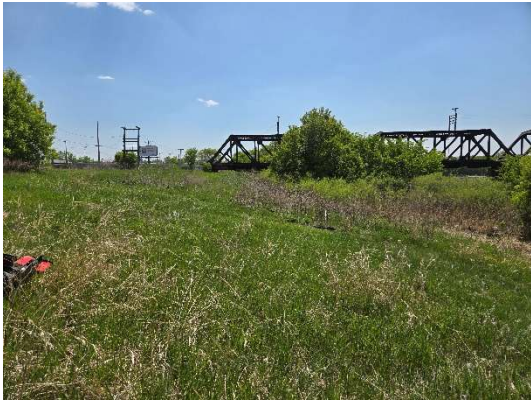
**Photo 7: Roland Outfall – Looking south along mid bank**

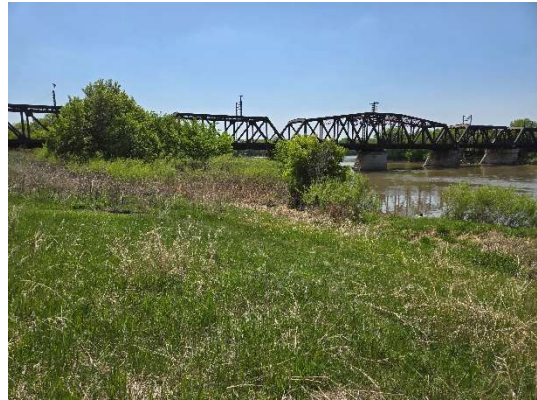
**Photo 8: Roland Outfall – Looking south west along mid bank**

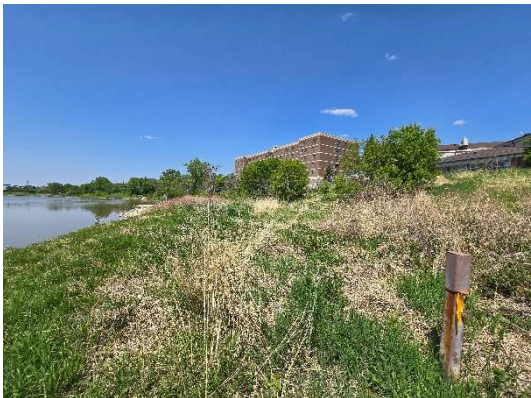
**Photo 9: Roland Outfall – Looking north along mid bank**

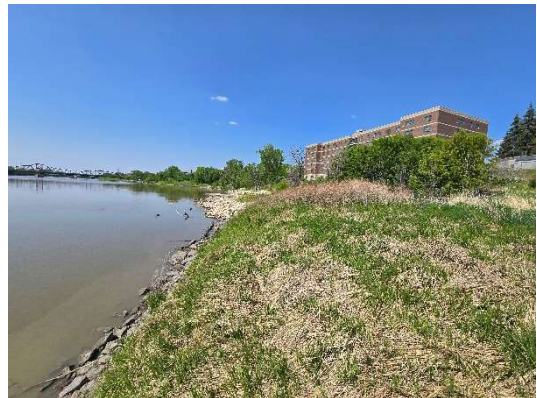
**Photo 10: Roland Outfall – Looking north along mid to lower bank**

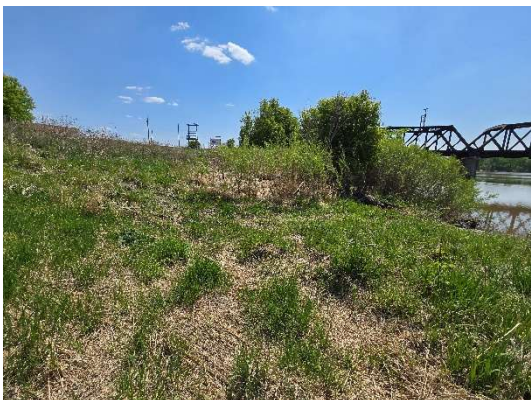
**Photo 11: Roland Outfall – Looking south along mid to lower bank**

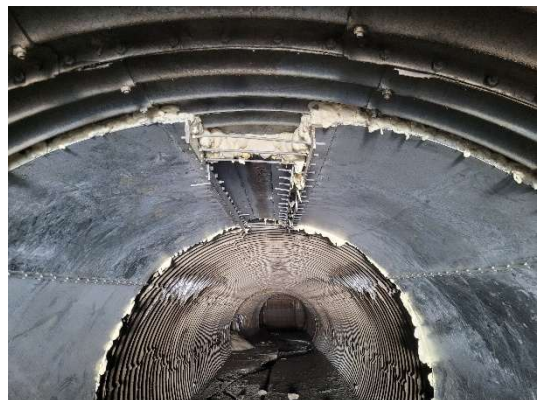
**Photo 12: Roland Outfall – Emergency repair/slip joint. Looking upstream towards 1350 SRS connection and chamber**

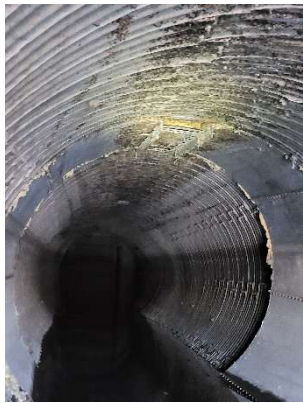
**Photo 13: Roland Outfall – emergency repair/slip joint**

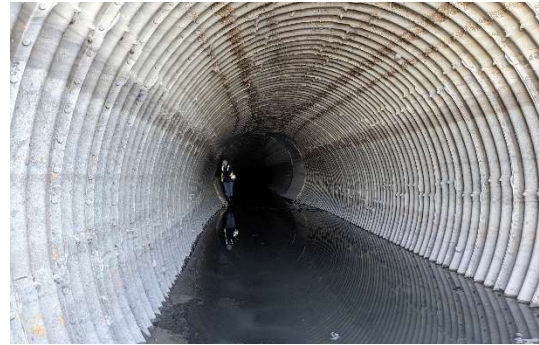
**Photo 14: Roland Outfall – emergency repair/slip joint (photo taken looking upstream from outlet)**

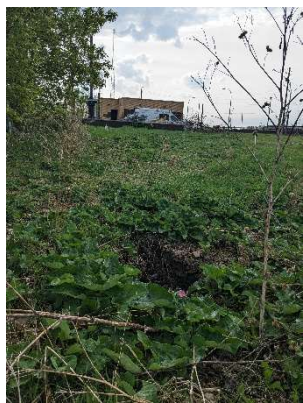
**Photo 15: Roland Outfall – small sinkhole observed at grade along mid to upper bank**

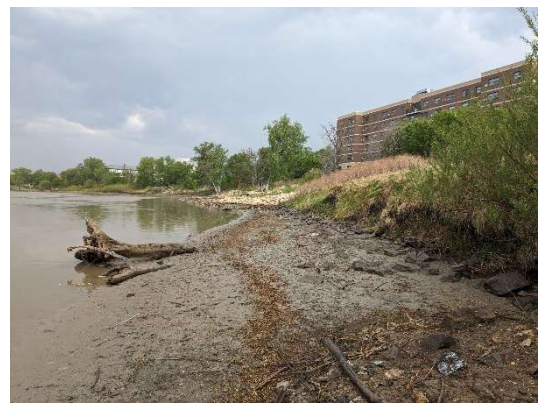
**Photo 16: Roland Outfall – looking north along lower bank**

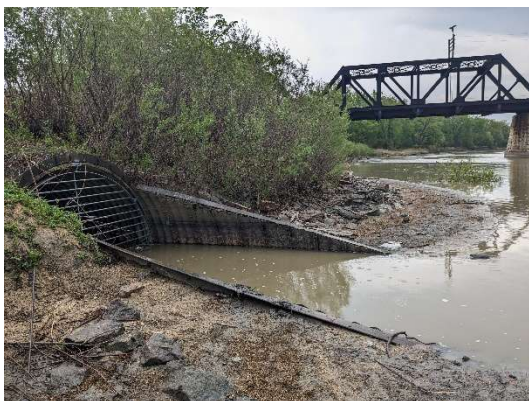
**Photo 17: Roland Outfall – looking south along lower bank**

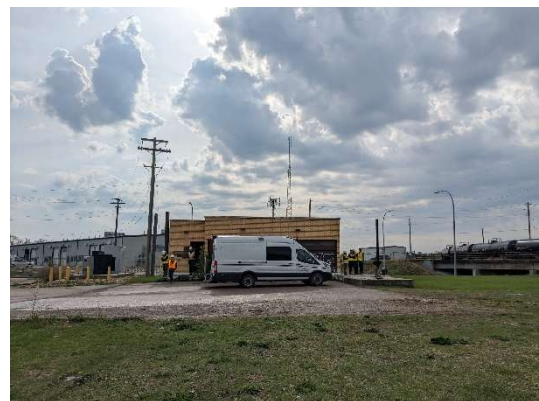
**Photo 18: Roland Outfall – looking east from upper bank towards pumping station**
