Alexander Dock Condition Assessment Report

City of Winnipeg

June 2024

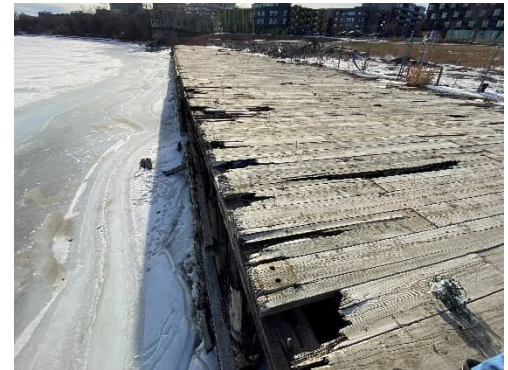
The timber deck planks consist of 70 mm x 290 mm members. The planks were in overall fair to very poor condition depending on the location within the structure. In several locations there were broken and missing planks with large holes in the deck, and many planks severely decayed and split (see **Figure 2**). Puddles, debris, and vegetation obscured the deck along the west end. At the south end of the structure, there was a larger area of missing and damaged planks with exposed stringers and substructure members. A follow-up inspection after spring thaw indicates that many planks that may look solid actually feel soft when walking on them.

Figure 2: Typical deteriorated timber deck planks

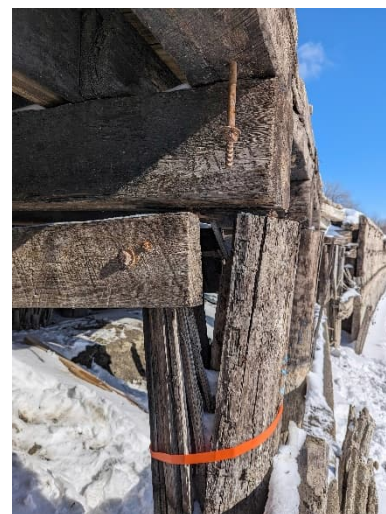
Figure 3: Deteriorated timber pile with minimal bearing (Pile E shown)

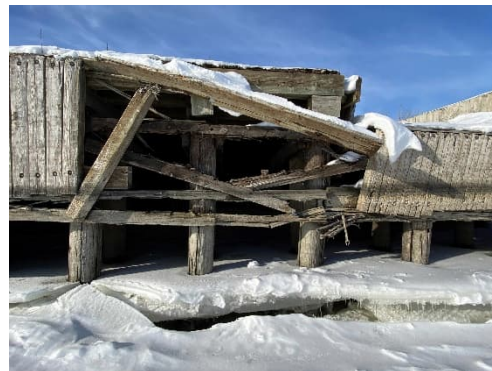
Figure 5: Typical broken and missing timber skirting

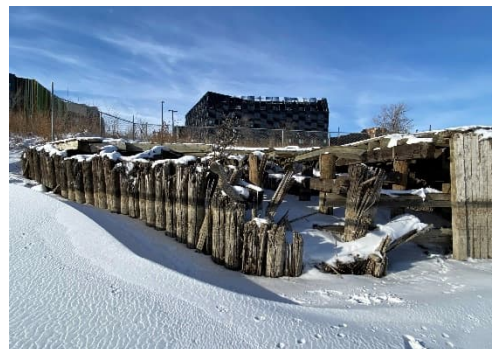
Figure 6: Damaged upstream area

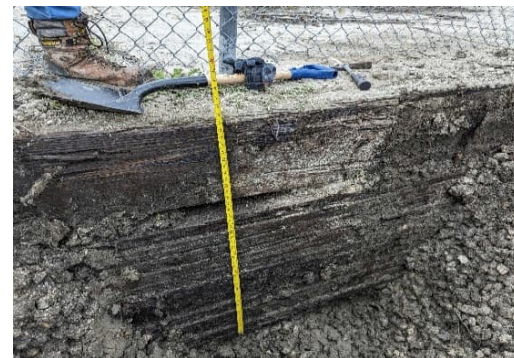
The timber backwall on the west end of the structure was exposed during the test pit excavation. The backwall consists of a 100 mm x 330 mm top stringer with several built-up 55 mm x 100 mm horizontal planks for a total height of approximately 1.1 m. Between the top stringer and the top horizontal plank was a 70 mm gap with exposed clay fill and cobblestones. The backwall was in overall poor condition with rot and splitting throughout where exposed/visible (see **Figure 7**).

Figure 7: Rotten/split timber backwall

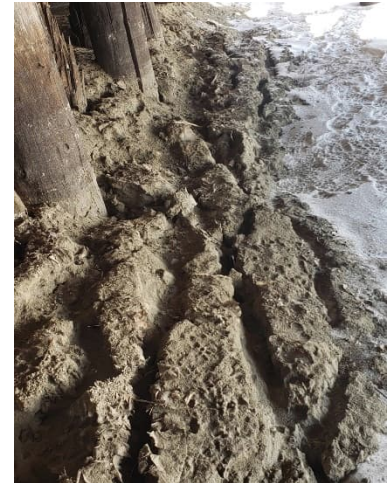
Figure 9: Erosion between Pile D1 and E

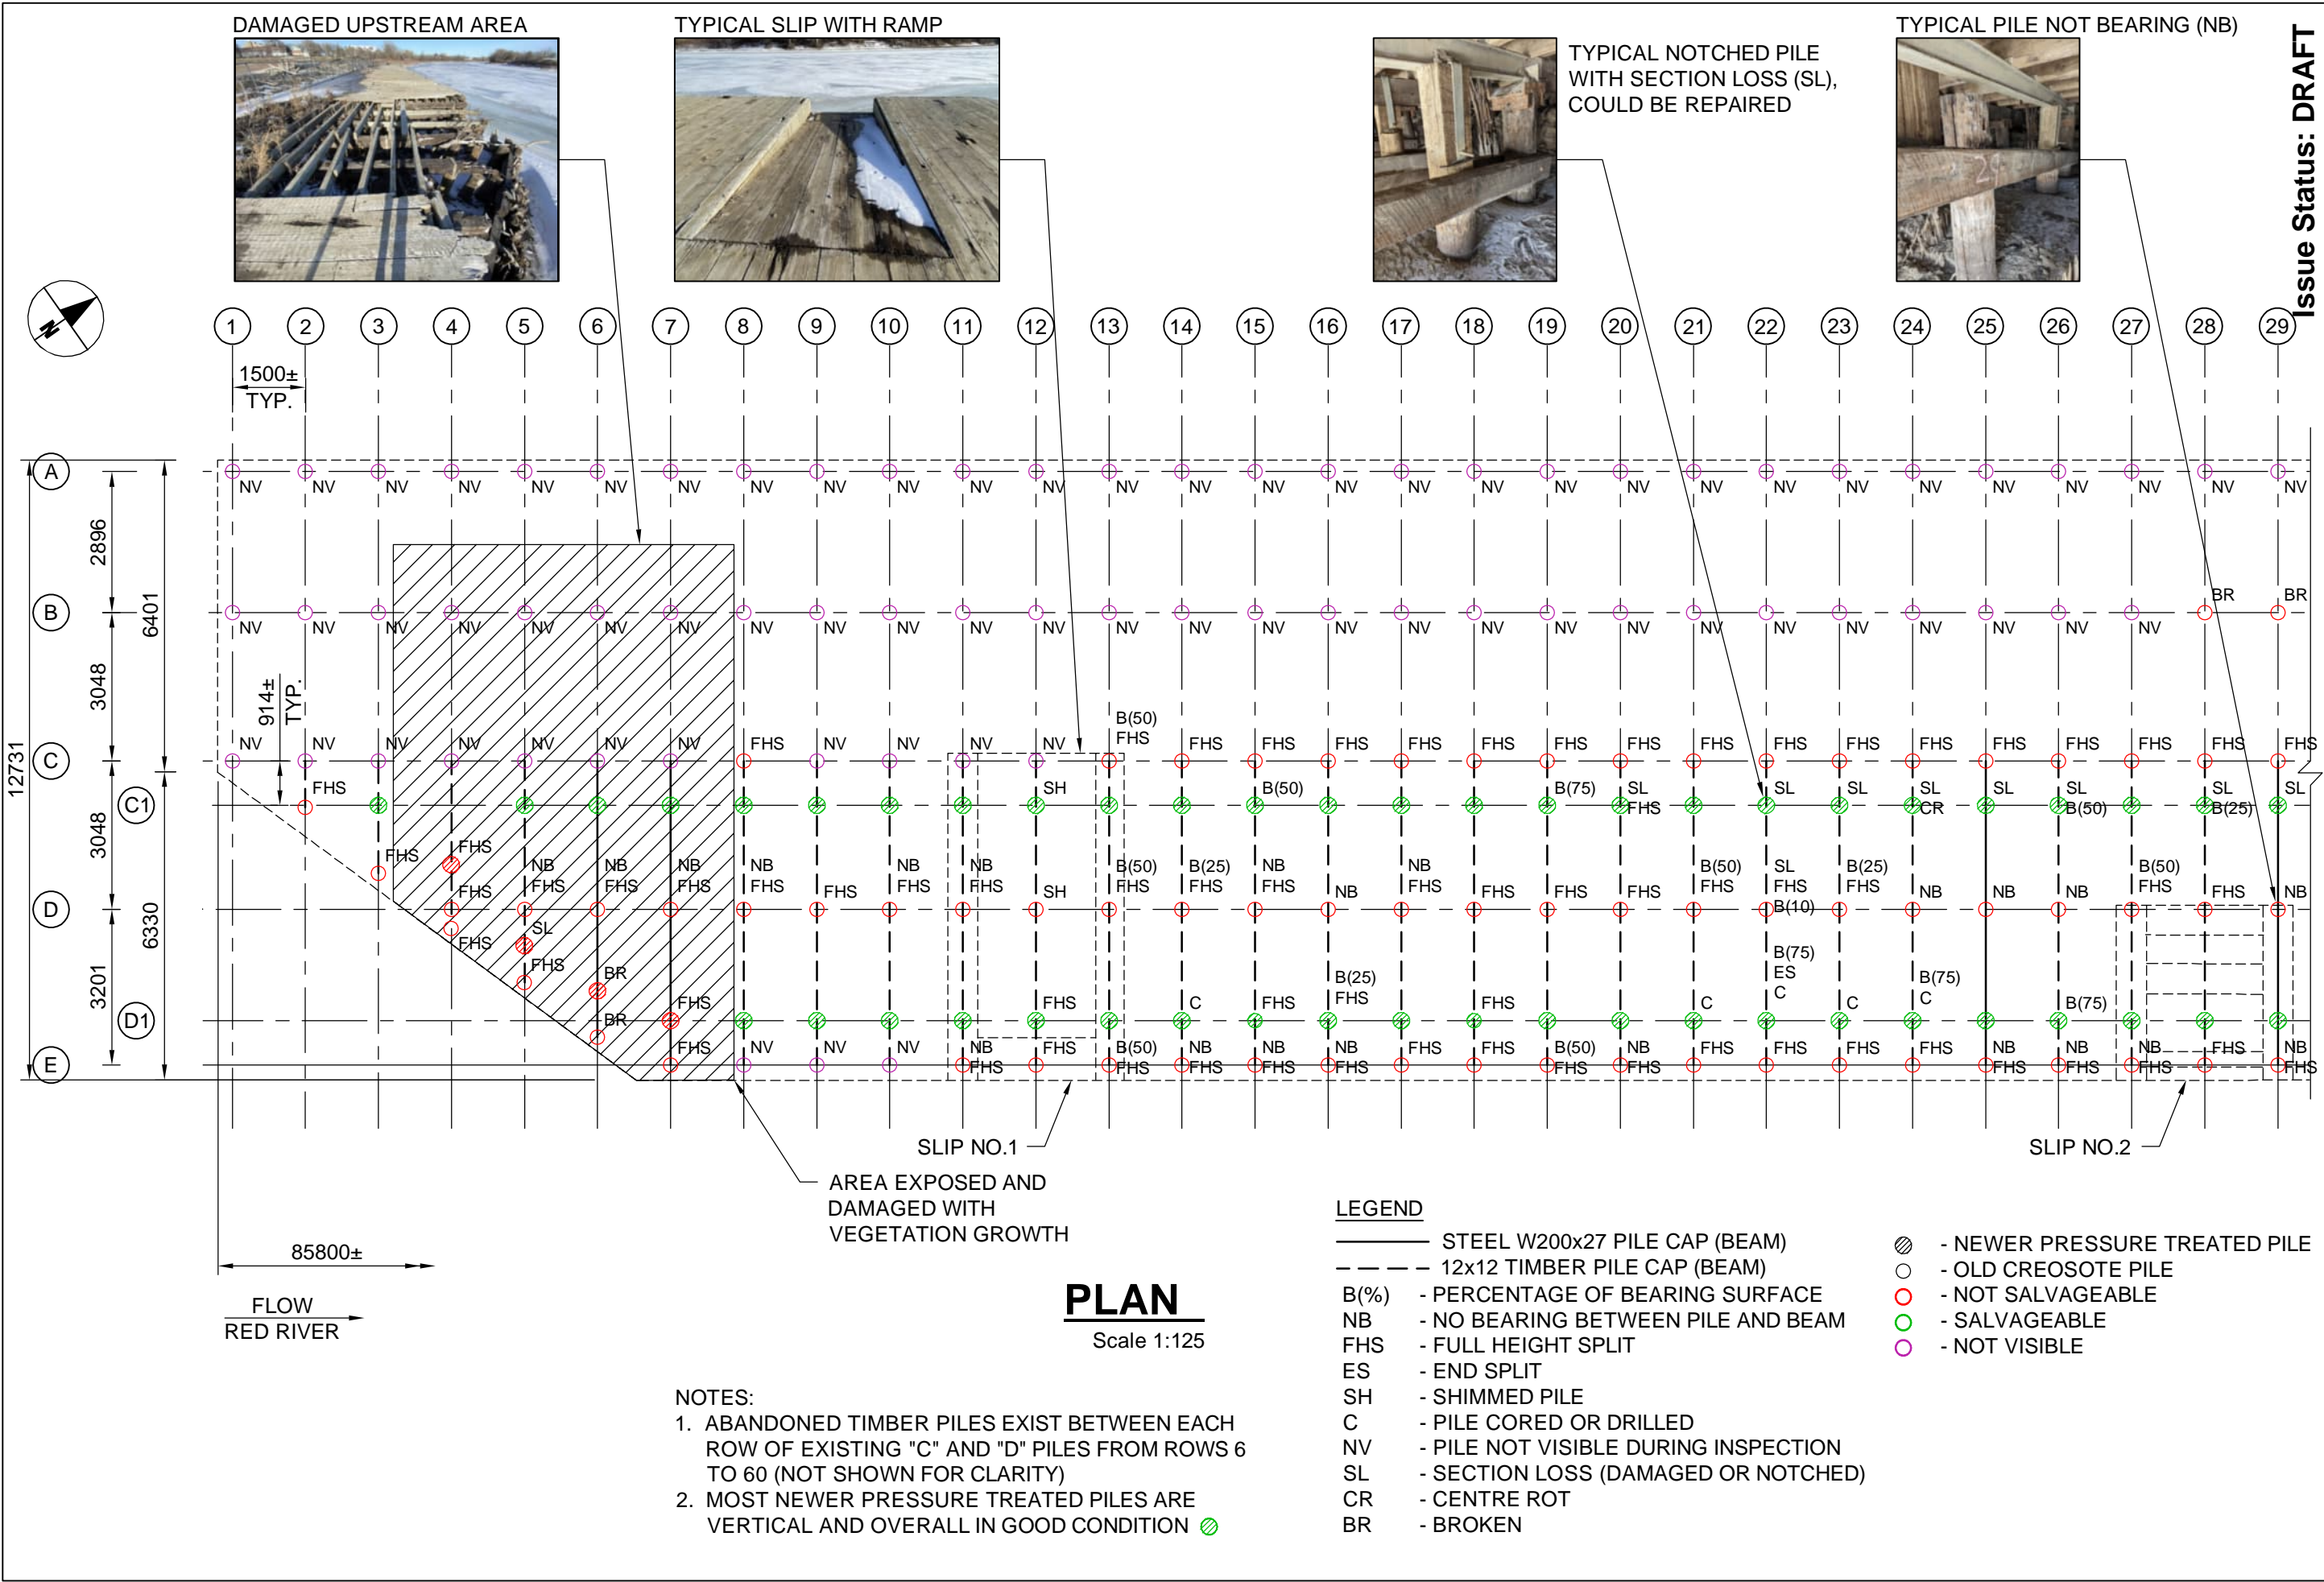
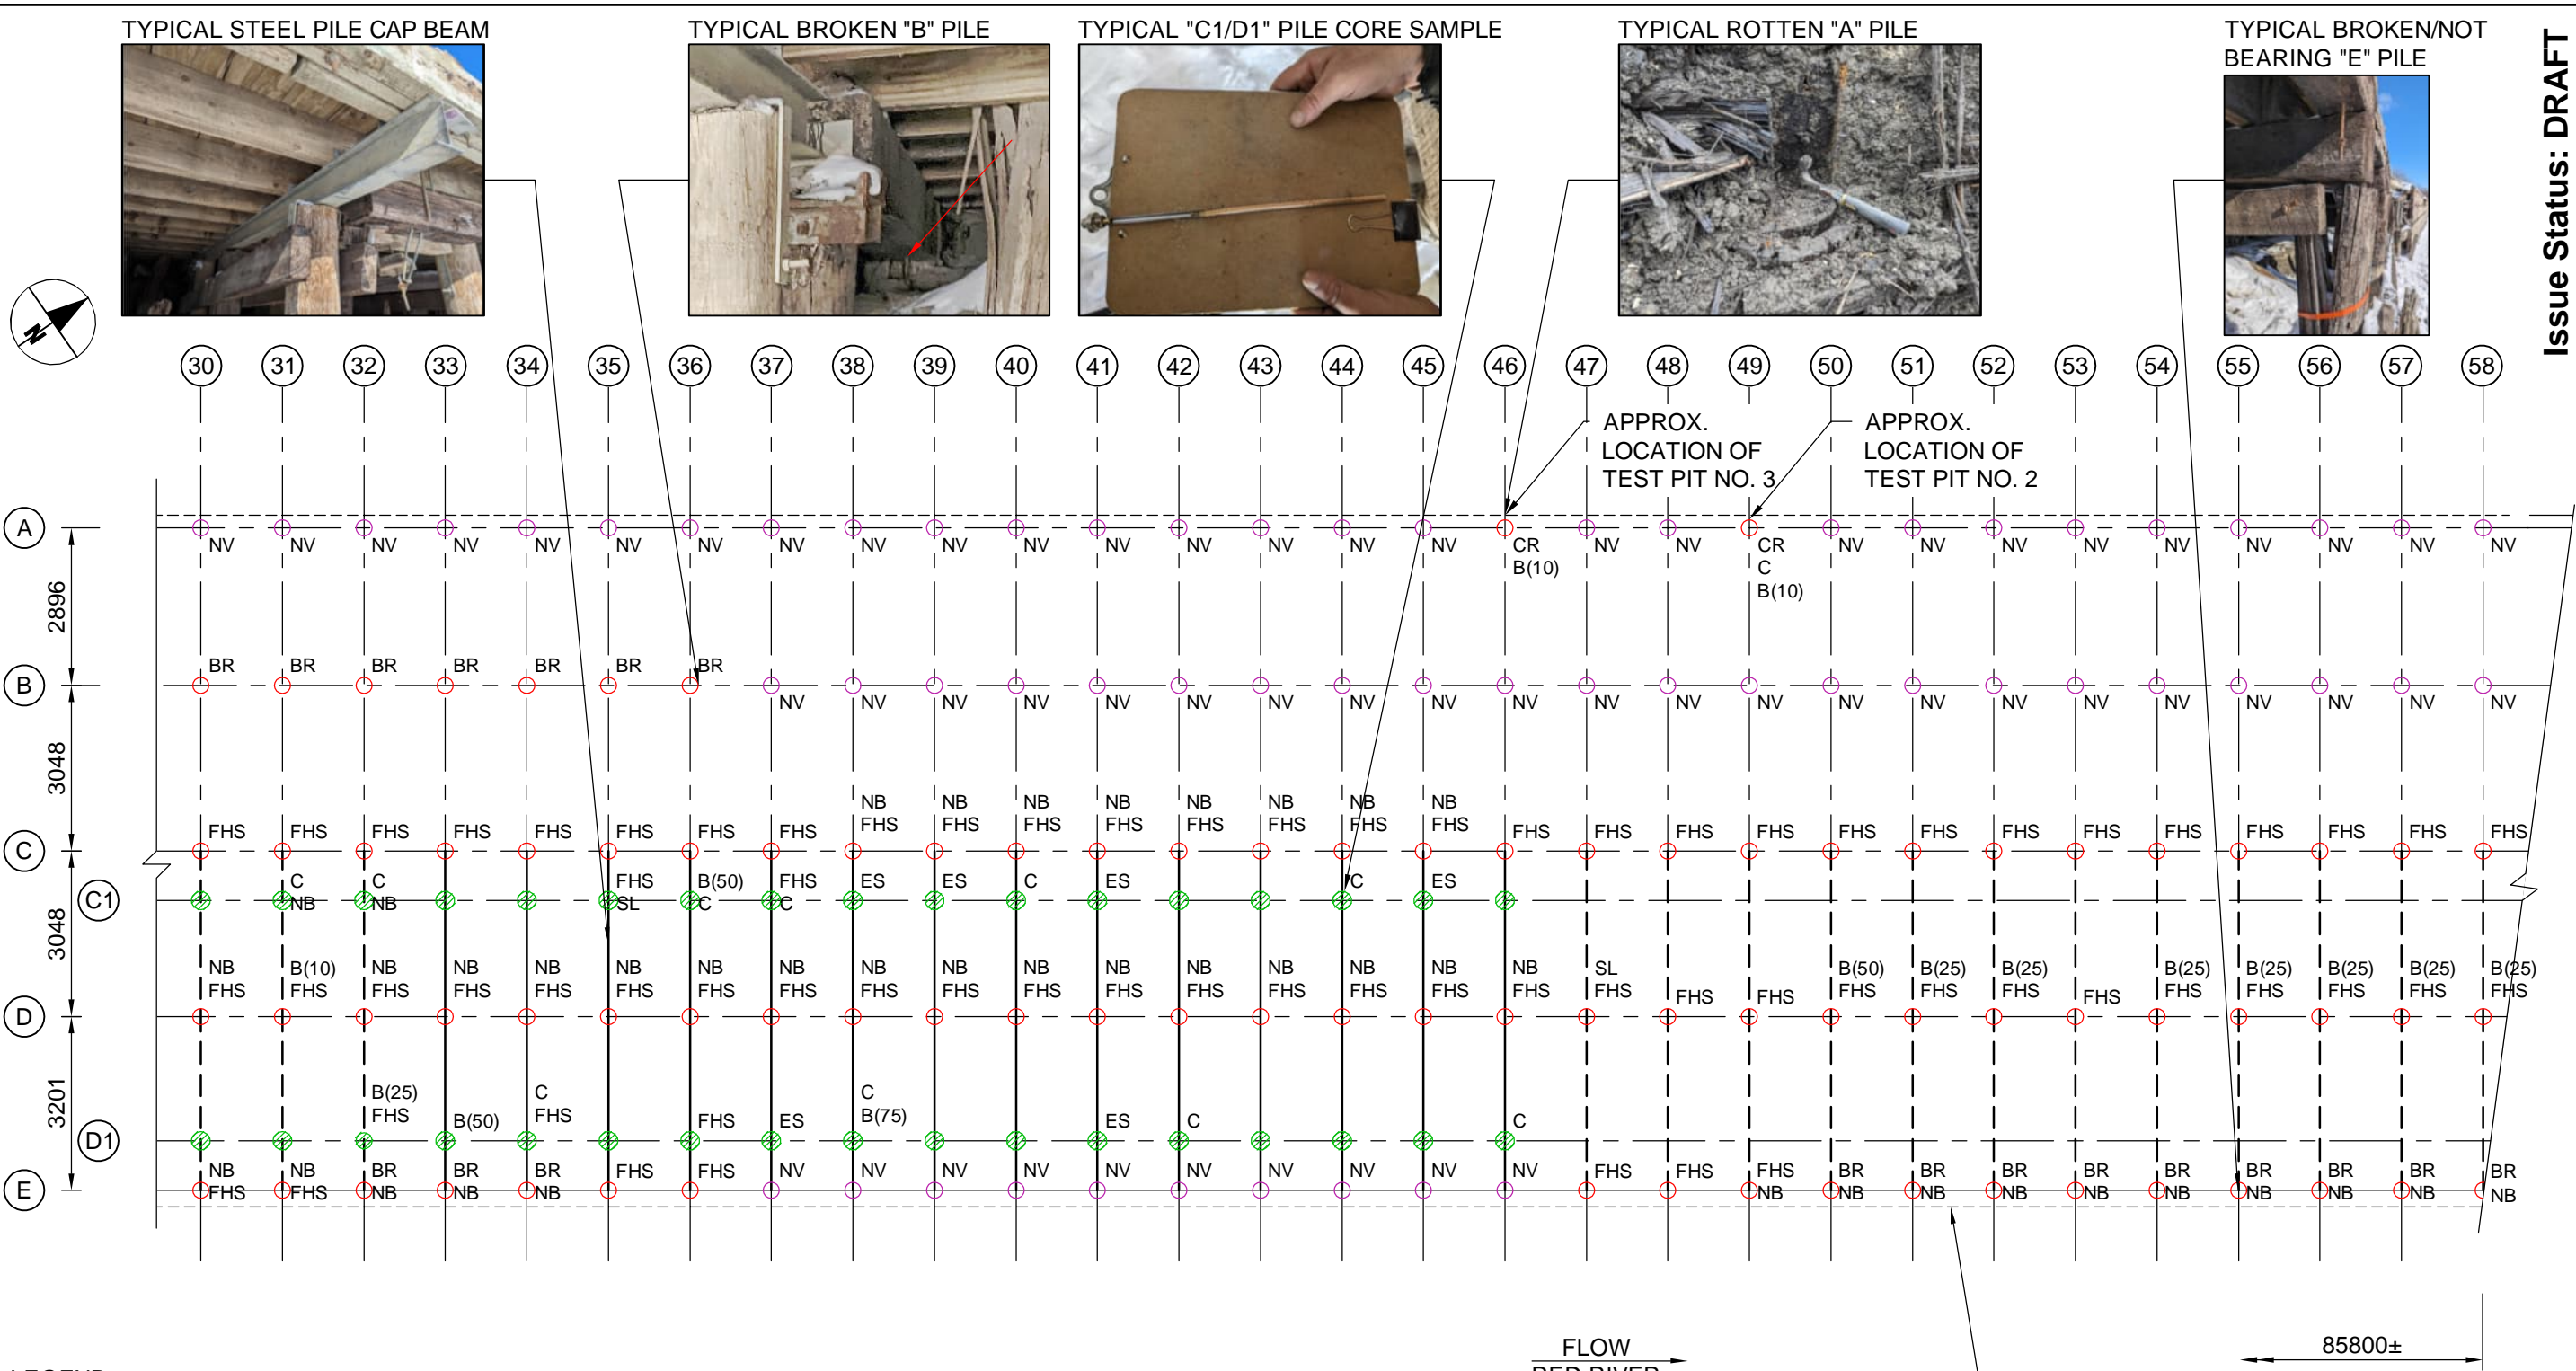
GENERAL ARRANGEMENT AND DEFICIENCIES

The general arrangement and deficiency drawings are included in **Appendix A: Drawings**. The General Arrangement and Deficiency drawings, **Sketches SK-01 to SK-03**, include considerable detail in order to properly evaluate which components could realistically be salvaged. The inspection team was able to access most of the structure that was not buried and gather significant information on all components of the structure. Photographs from the visual inspection are included in **Appendix B: Inspection Photographs**.

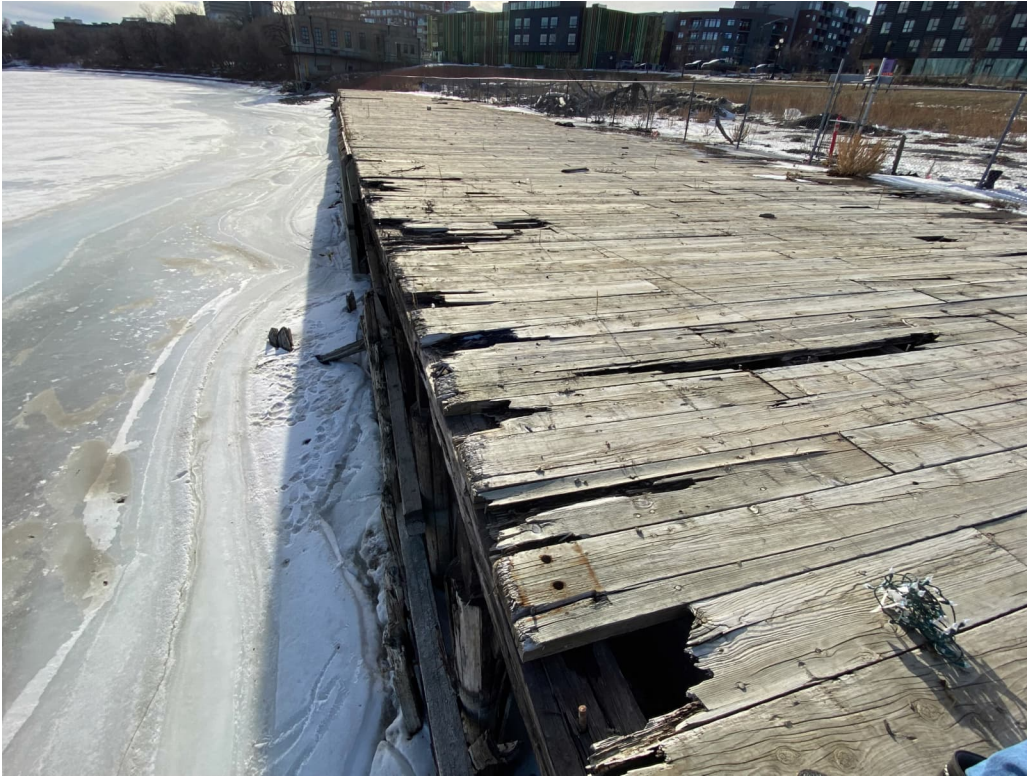
Photograph 13
Deck top. Note: Typical deteriorated planks with holes in deck.

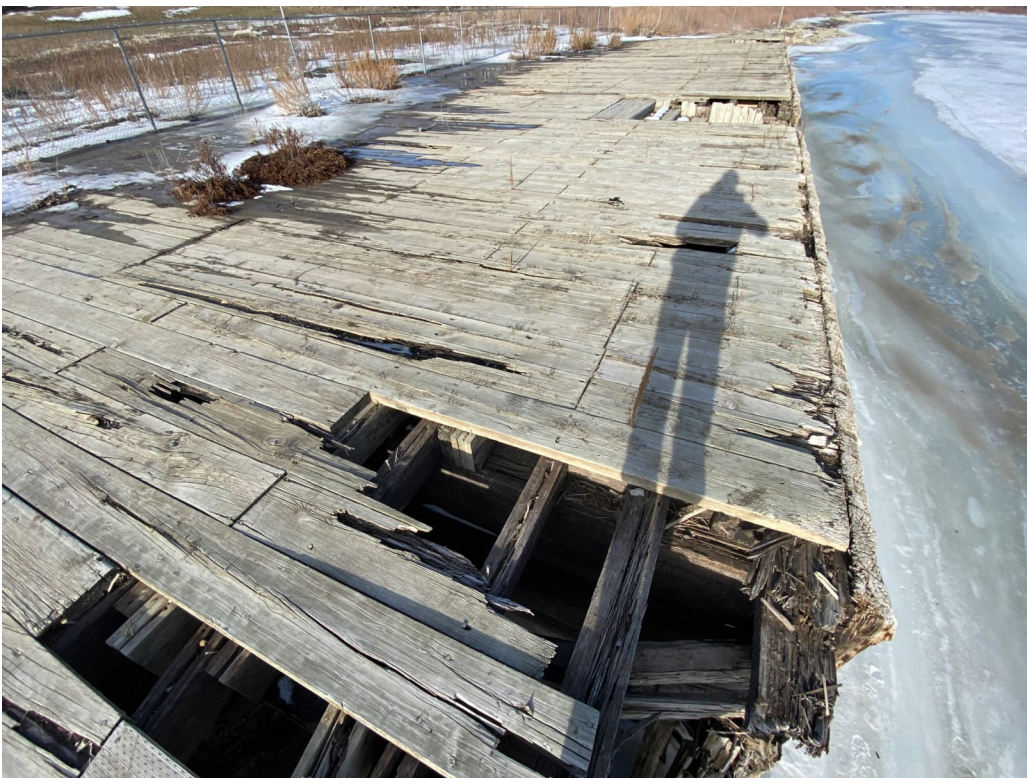
Photograph 14
Deck top. Note: Typical deteriorated planks and stringers with holes in deck.

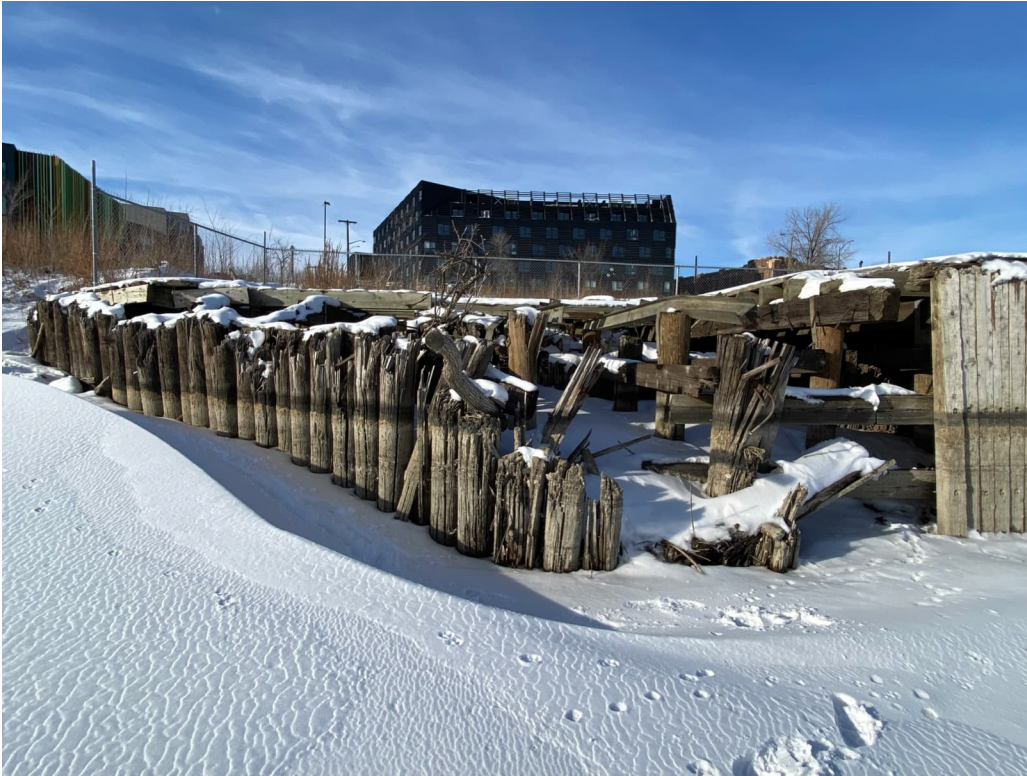
Photograph 15

South end. Note: Severe timber deterioration and steel deformations caused by ice flows.

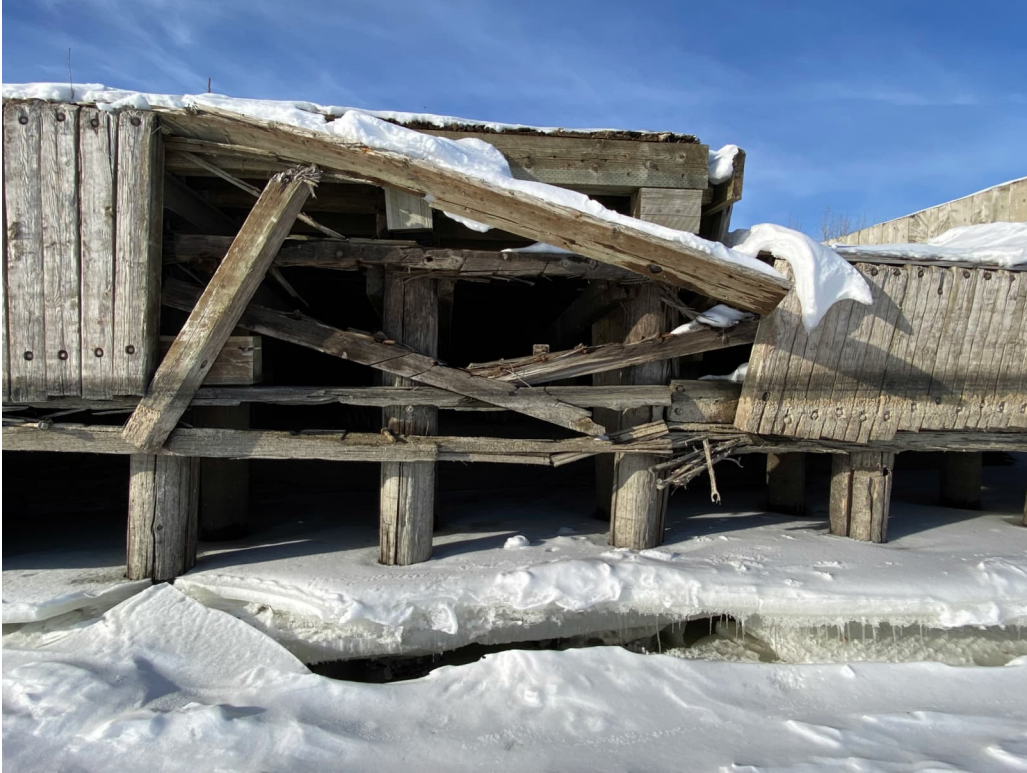
Photograph 17
Vertical face. Note: Severely deteriorated timber skirting and beams.

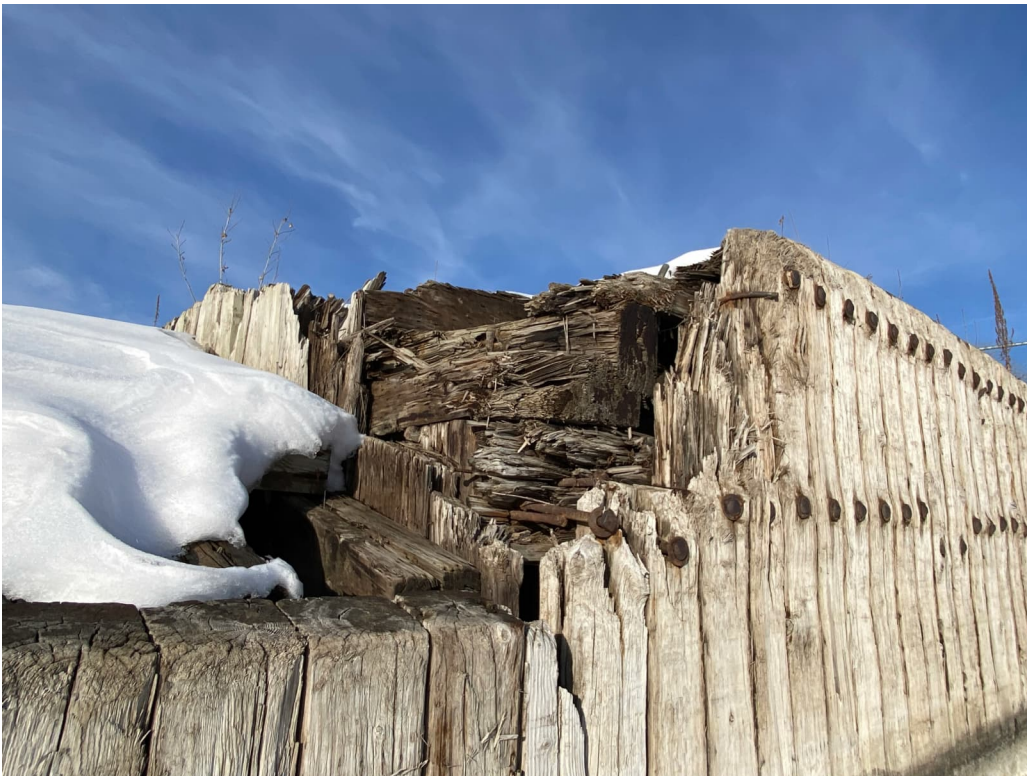
Photograph 18
Slip No. 1. Note: Severely deteriorated timbers.

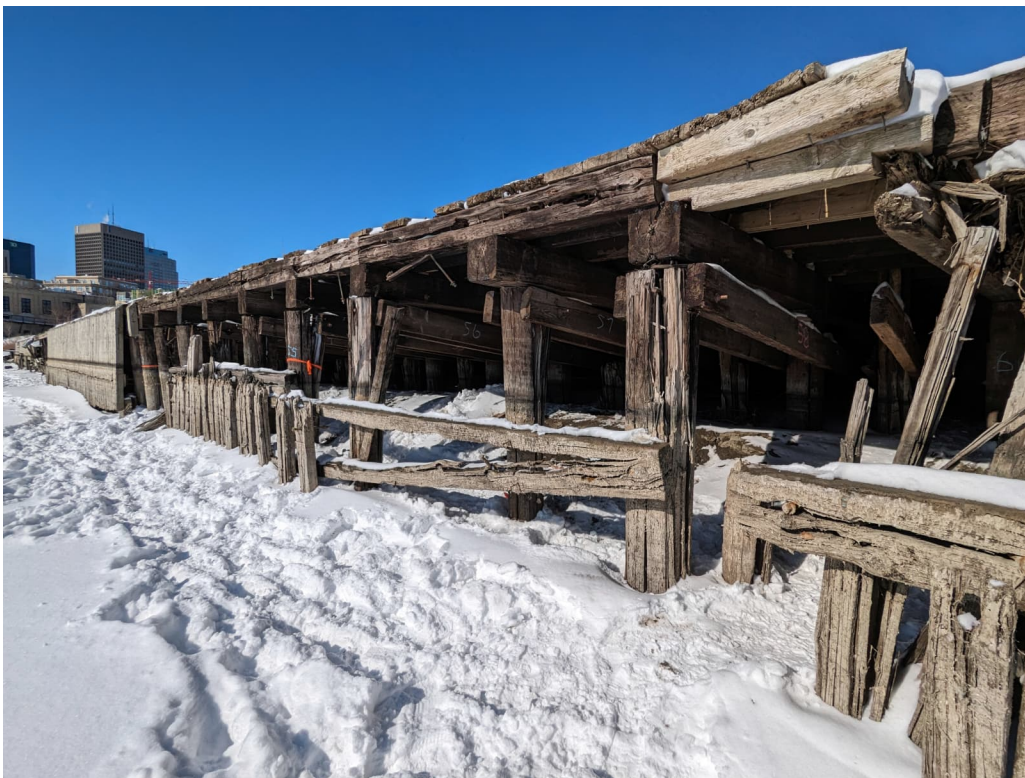
Photograph 20
South of firewall at North section. Note: Missing and deteriorated skirting throughout. Exterior piles deteriorated and not functional.

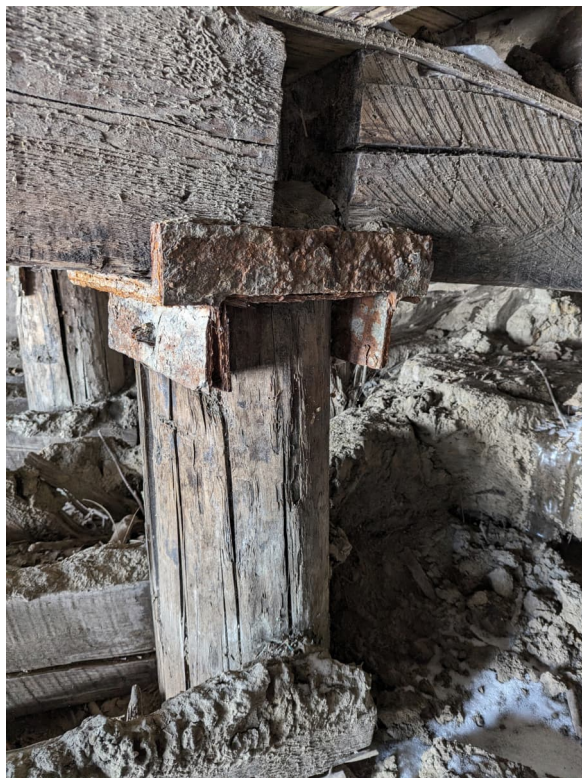
Photograph 30
Typical steel shoe at Pile C. Note: Severe corrosion throughout.

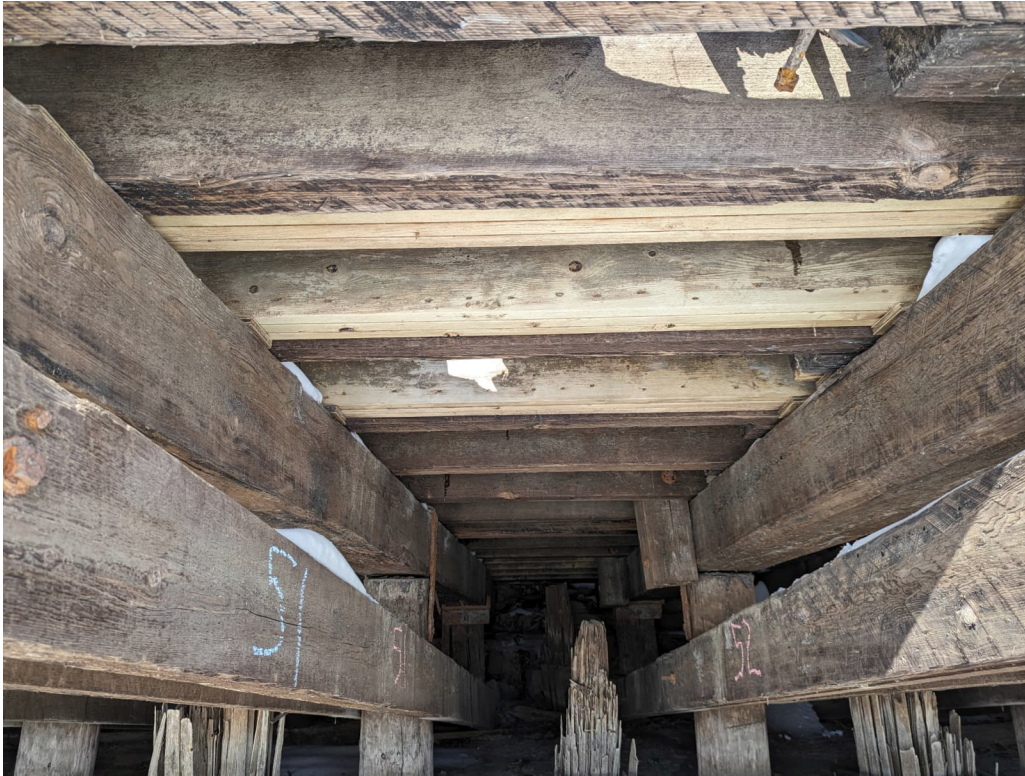
Photograph 31
Showing stringers with fire damage paired with newer built-up stringers.

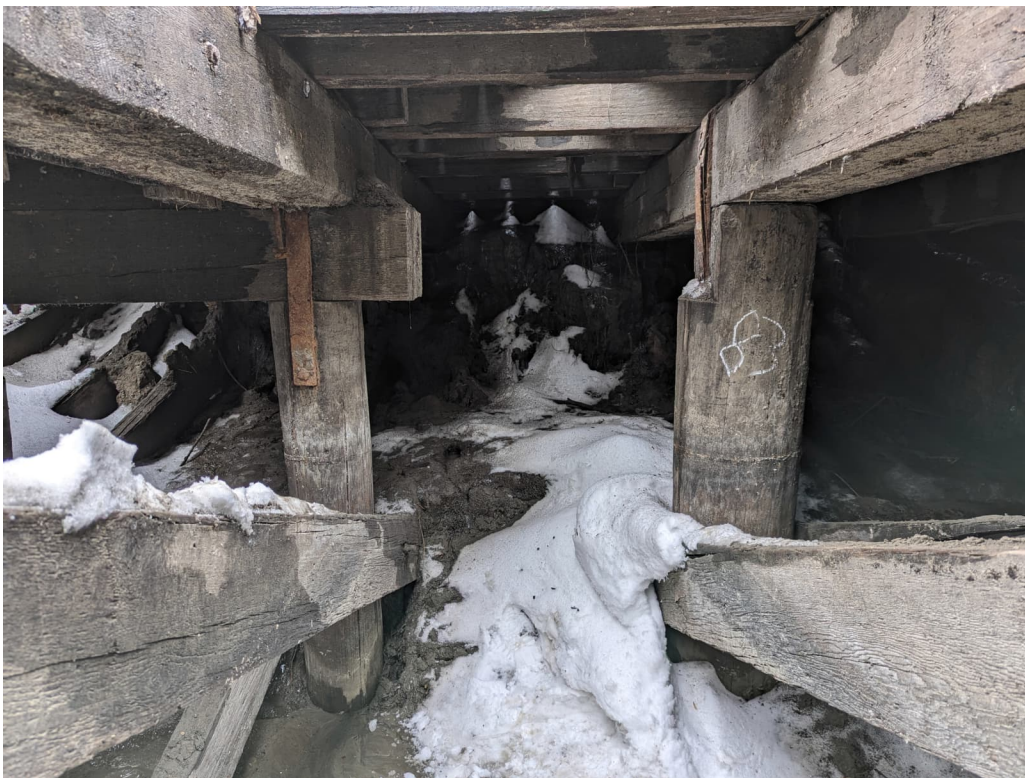
Photograph 38
Typical bay at enclosed North area. Note: Pile C buried due to riverbank height.

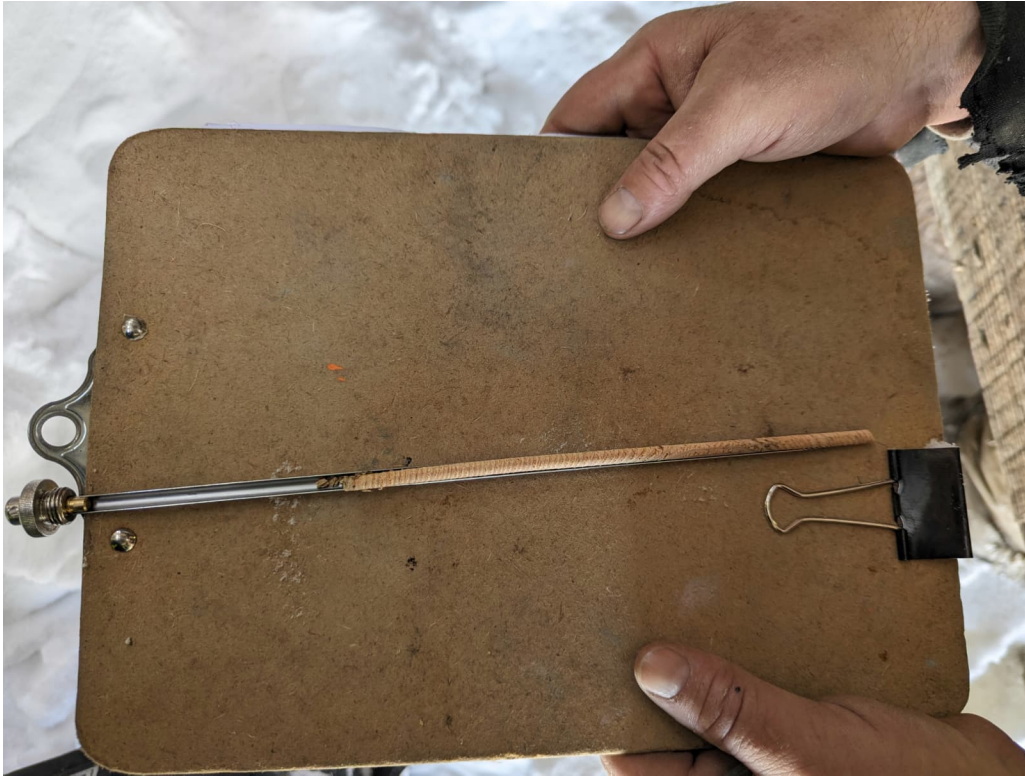
Photograph 39
Typical core sample obtained from Piles C1/D1. Note: No rot detected.

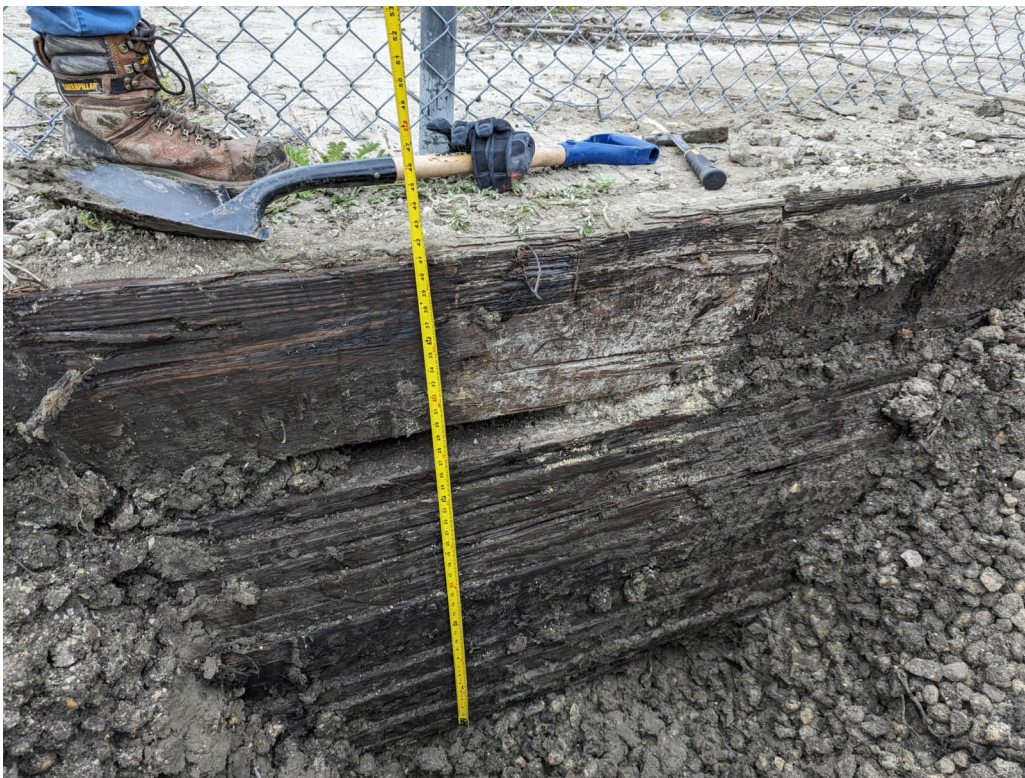
Photograph 40
Timber backwall at test pit excavation. Note: Typical rotten/split members.

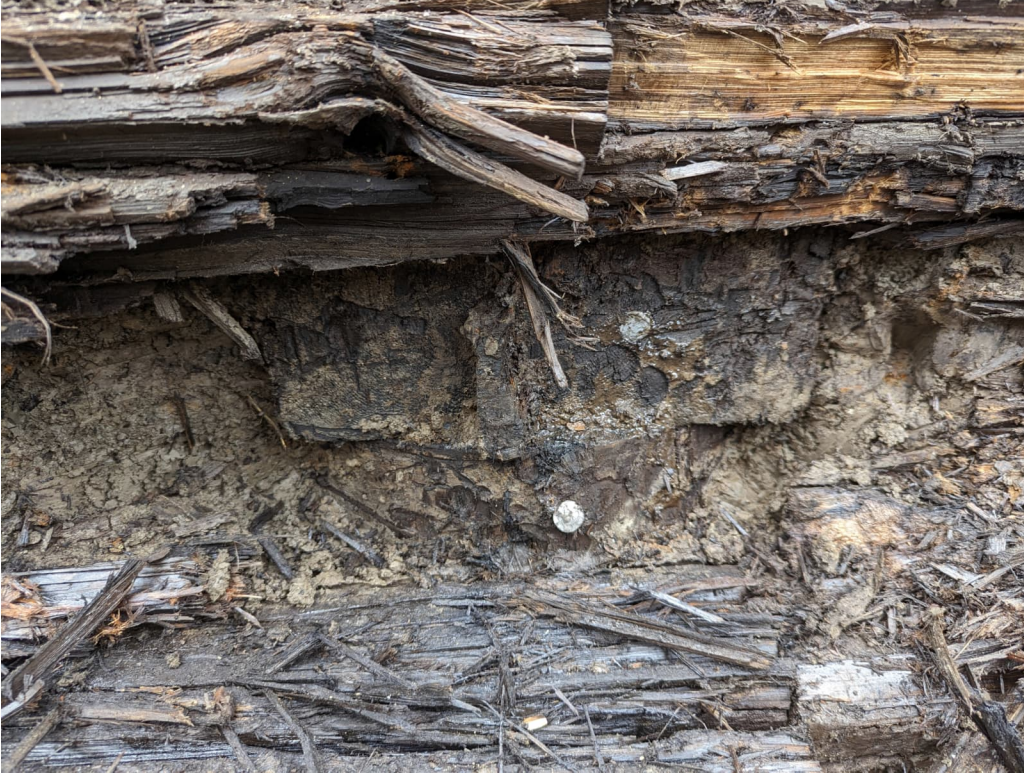
Photograph 41

Exposed pile and pile cap at Test Pit No. 1. Note: Rotten pile cap. No rot detected in pile where visible.

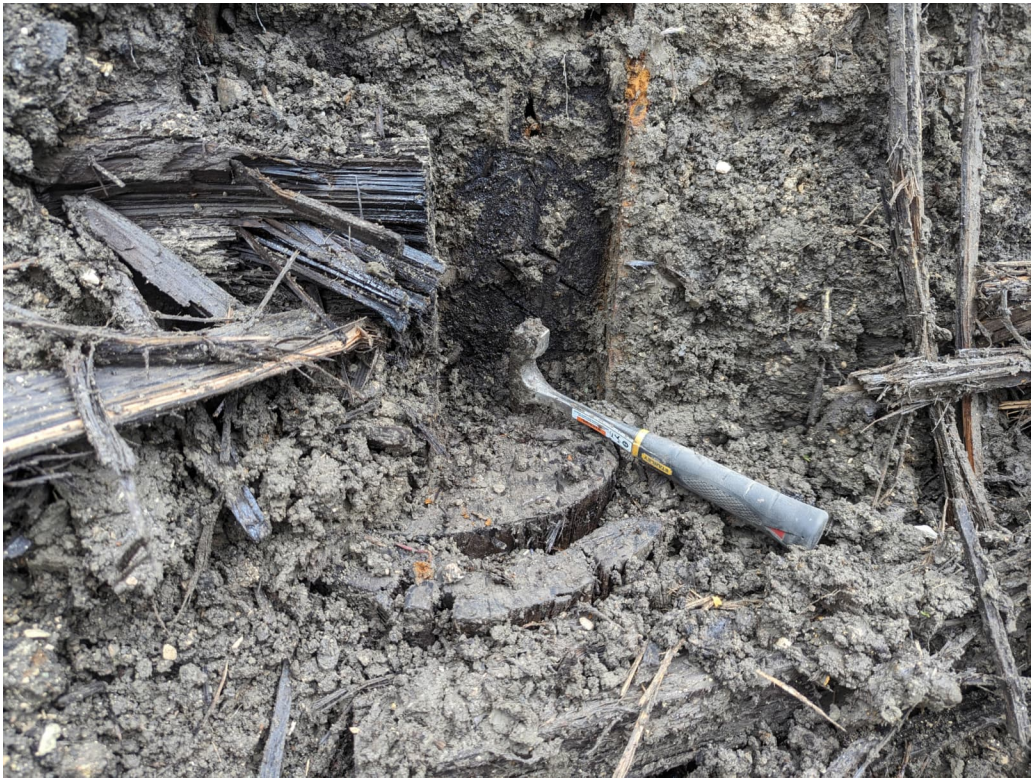
Photograph 43

Exposed pile and pile cap at Test Pit No. 3. Note: Rotten pile and pile cap. Severe shell separation in pile. Minimal bearing on pile.

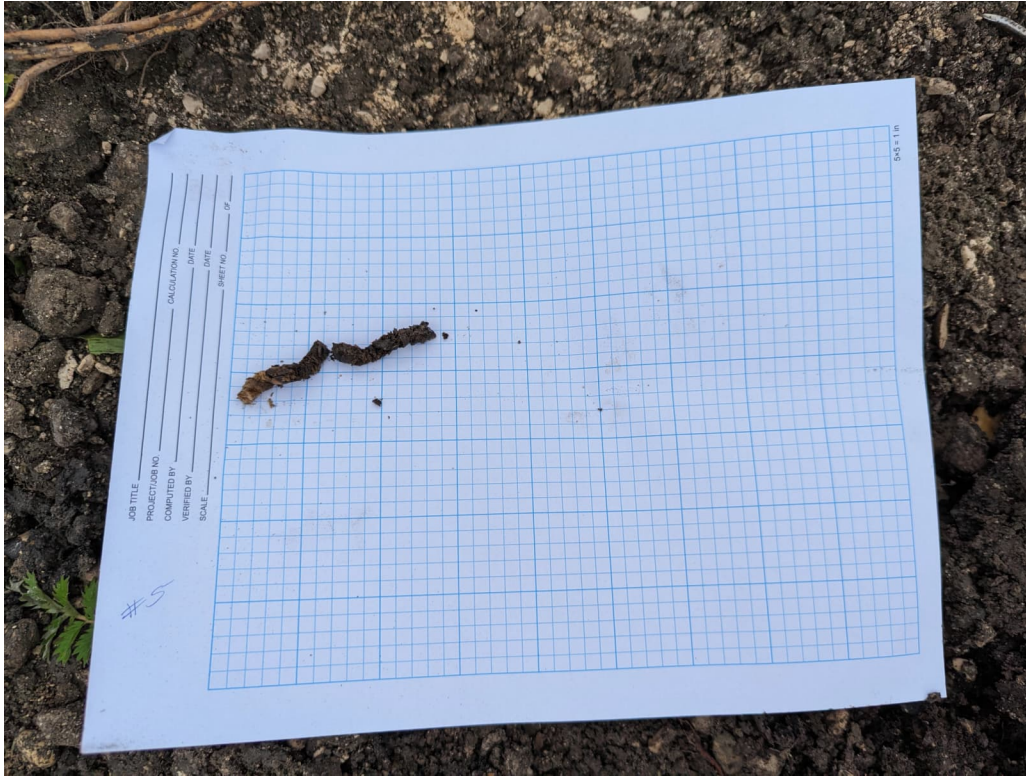
Photograph 45
Core sample obtained from pile at Test Pit No. 2. Note: Rotten.
