# ASBESTOS INVENTORY CONTROL

| <b>Building Name:</b> | Harbourview, Main Building | <b>Inspection Date:</b> | October 25, 2025 |
| <b>Building Code:</b> | HC-20 (Includes HC05, 09,10,17,and 18) | <b>Inspected By:</b> | A. Brodbeck & N Richardson |
| <b>Building Address:</b> | 1867 Springfield Rd. SEE GC-05 FOR PROSHOP | <b>Construction Date:</b> | 1982 |

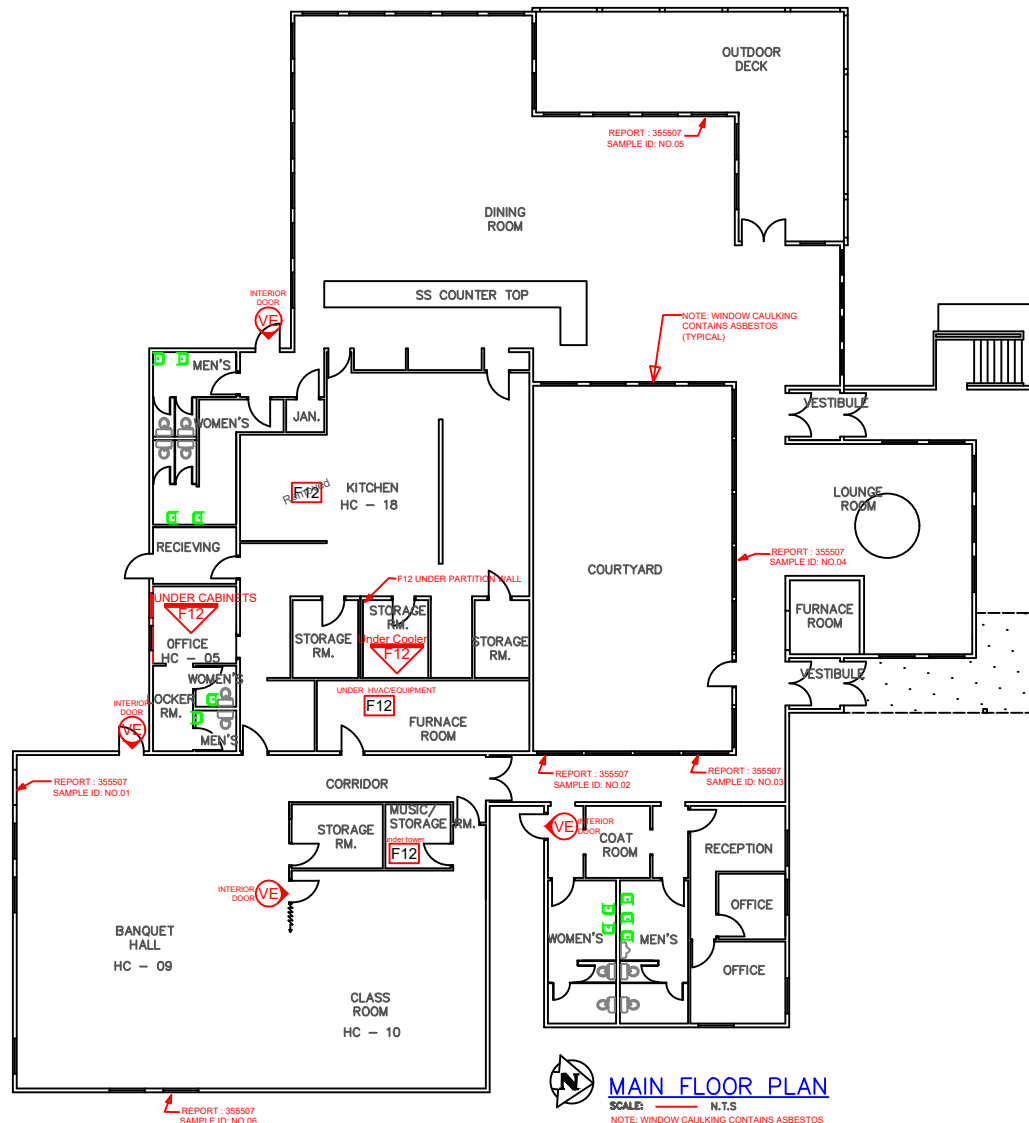
SHEET #:  
1/2

## ASBESTOS LOCATIONS

BUILDING: HC - 20 (Including HC - 18, 09, 05 and 10)  
Harbourview Main Building  
1867 Springfield Road  
WINNIPEG, MANITOBA
