GEOTECHNICAL REPORT

2026 LOCAL STREETS PACKAGE 26-R-02

RENEWAL OF LOCAL STREETS FOR THE CITY OF WINNIPEG

January 19, 2026

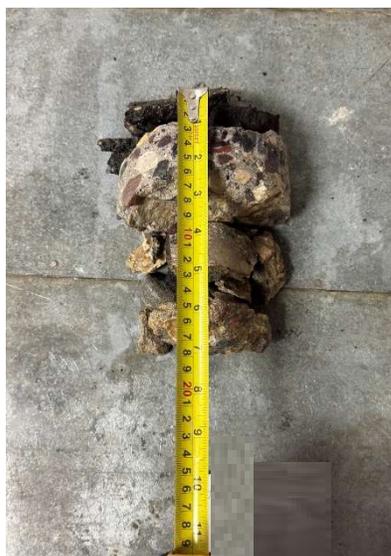
Core 2 - Poor Joint

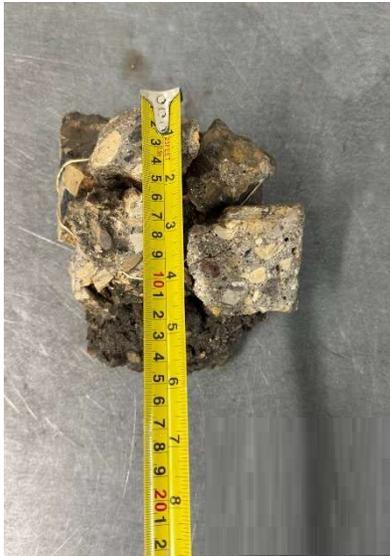
Core 3 - Poor Joint

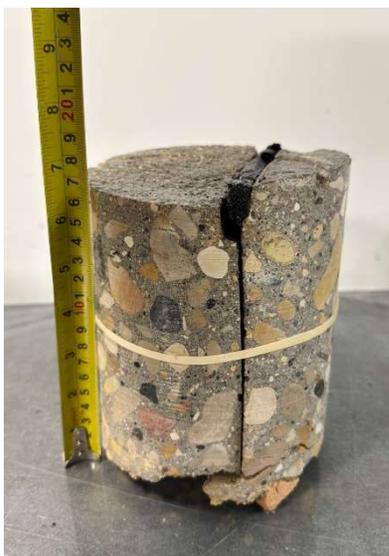
Core 2 - Poor Joint

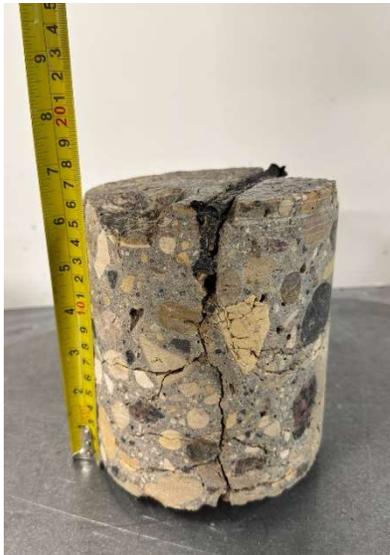
Core 3 - Poor Joint

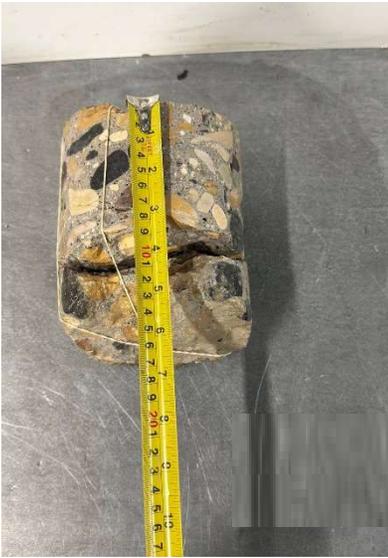
Core 5 - Poor Joint

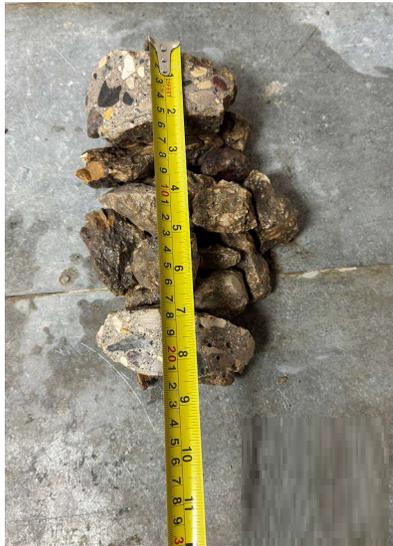
Core 1 - Poor Joint

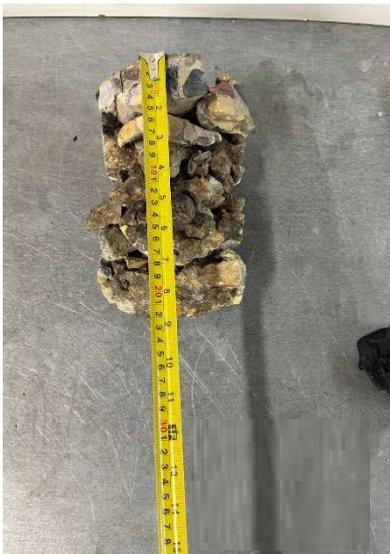
Core 2 - Poor Joint

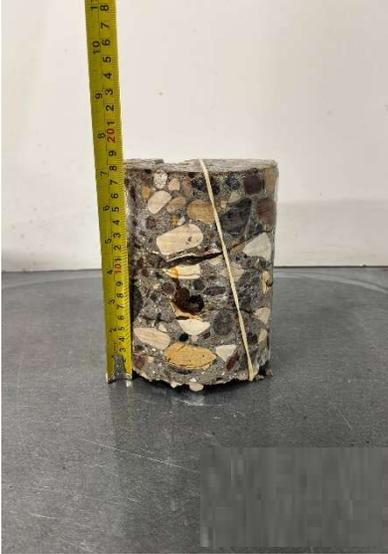
Core 5 - Poor Joint

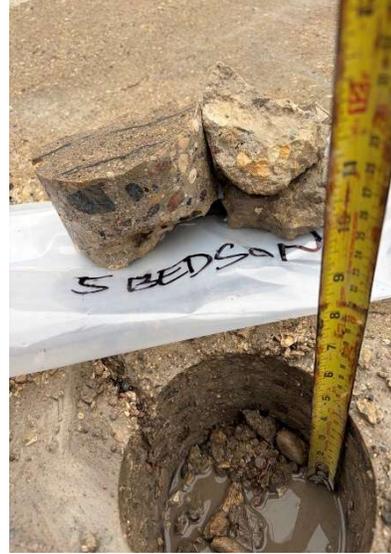
Core 5 - Poor Joint

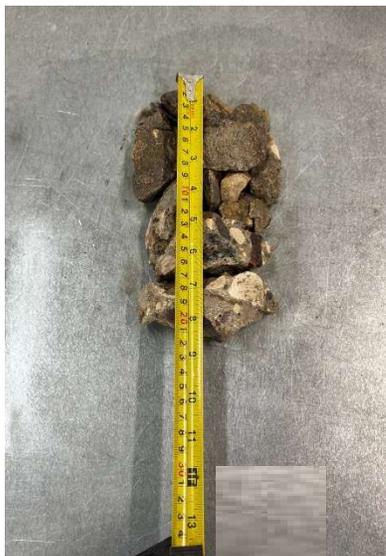
Core 6 - Poor Joint
