**S-MA40001409**

| Job Number: | 692-2015 | Waterway: | Bunn's Creek |
| Map Number: | 7 | Asset Location: | 671 MCIVOR AVE |
| Inspection Date: | 2015-11-13 | Surveyed By: | Darren Yarechewski |

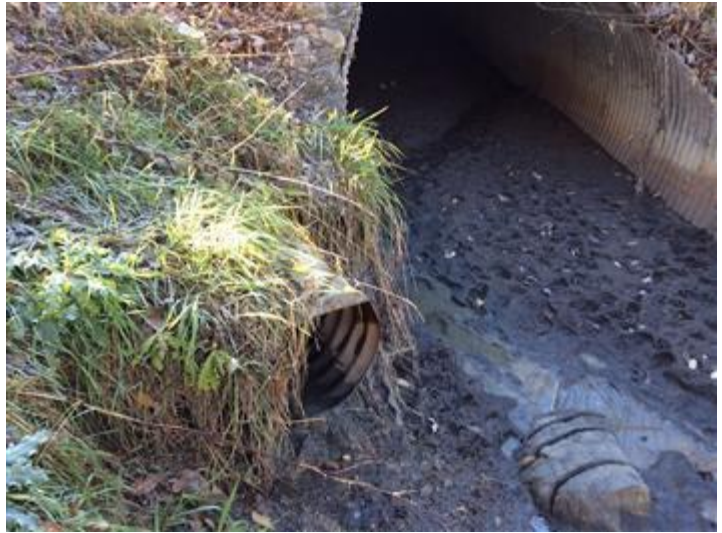
**007-01**

| Instability Type | ID | Location | Angle | Vegetation | Terrain |
|---|---|---|---|---|---|
| Rotation | 007-01 | Toe | Steep | Small Trees | Graded |

| | ID | Height | Location | Angle | Vegetation | Surface Soil |
|--|---|---|---|---|---|---|
| | 007-01 | 600 | Toe | Steep | Small Trees | |

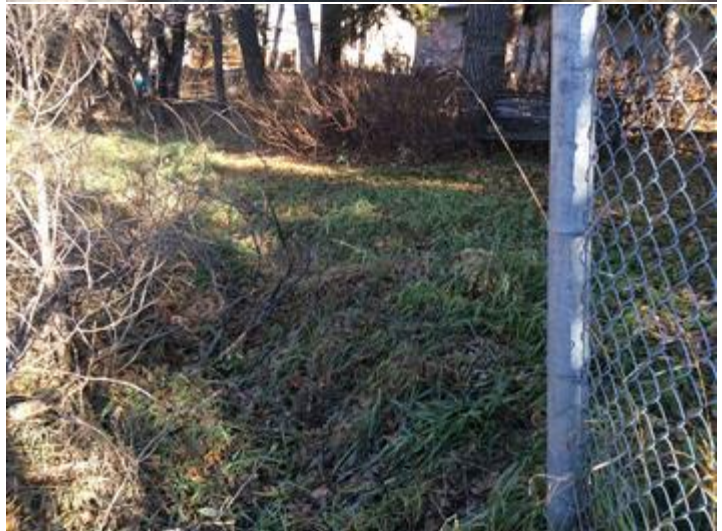
**007-03**

| | ID | Height | Location | Angle | Vegetation | Surface Soil |
|--|---|---|---|---|---|---|
| | 007-03 | 500 | | | | |

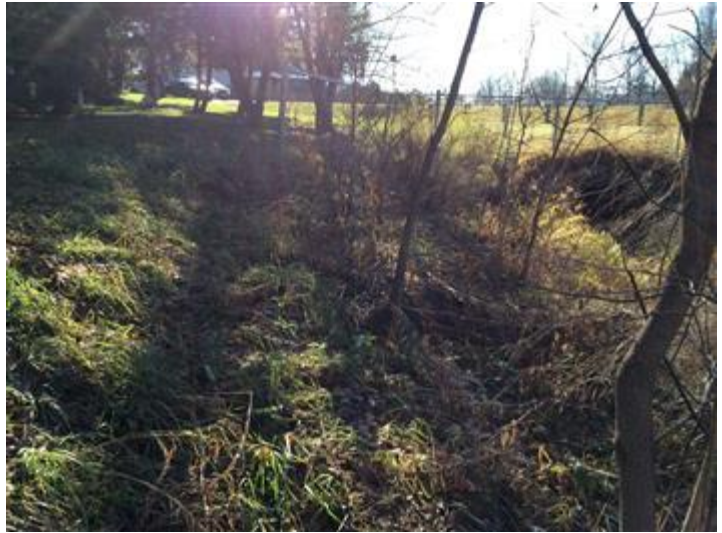
**007-04**

| | ID | Height | Location | Angle | Vegetation | Surface Soil |
|--|---|---|---|---|---|---|
| | 007-04 | 400 | | | | |

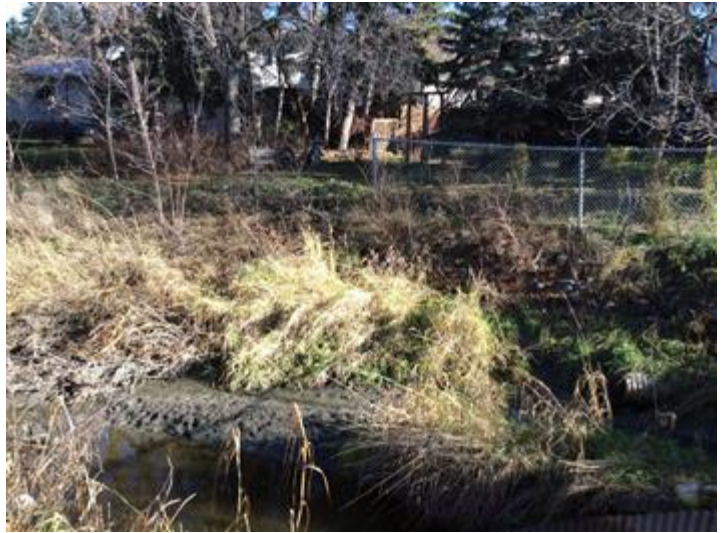
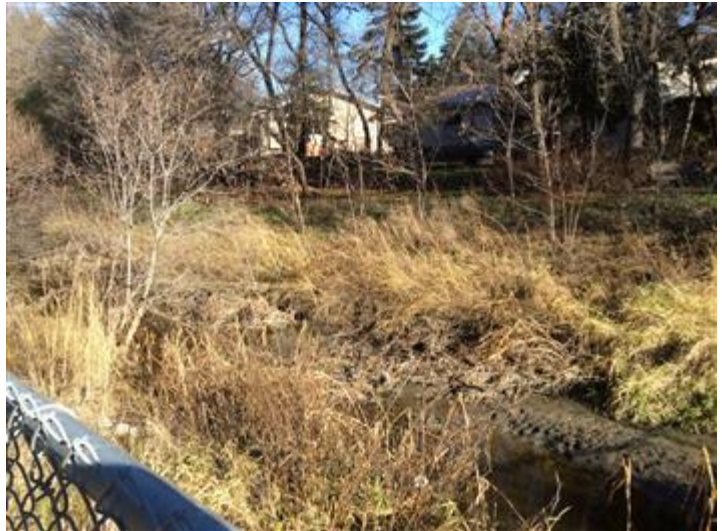
**007-06**

| ID | Rip Rap Type | Geotextile | Rip Rap Location |
|---|---|---|---|
| 007-06 | Loose Rip Rap | Not Observed | Surrounding Outfall Only |
