# City of Winnipeg 2015:

## 400mm (16-in) Doucet St - Goulet St Watermain Seine River Crossing

Condition Assessment Report, Standard Analysis

**PICA Project: Winnipeg 8007**

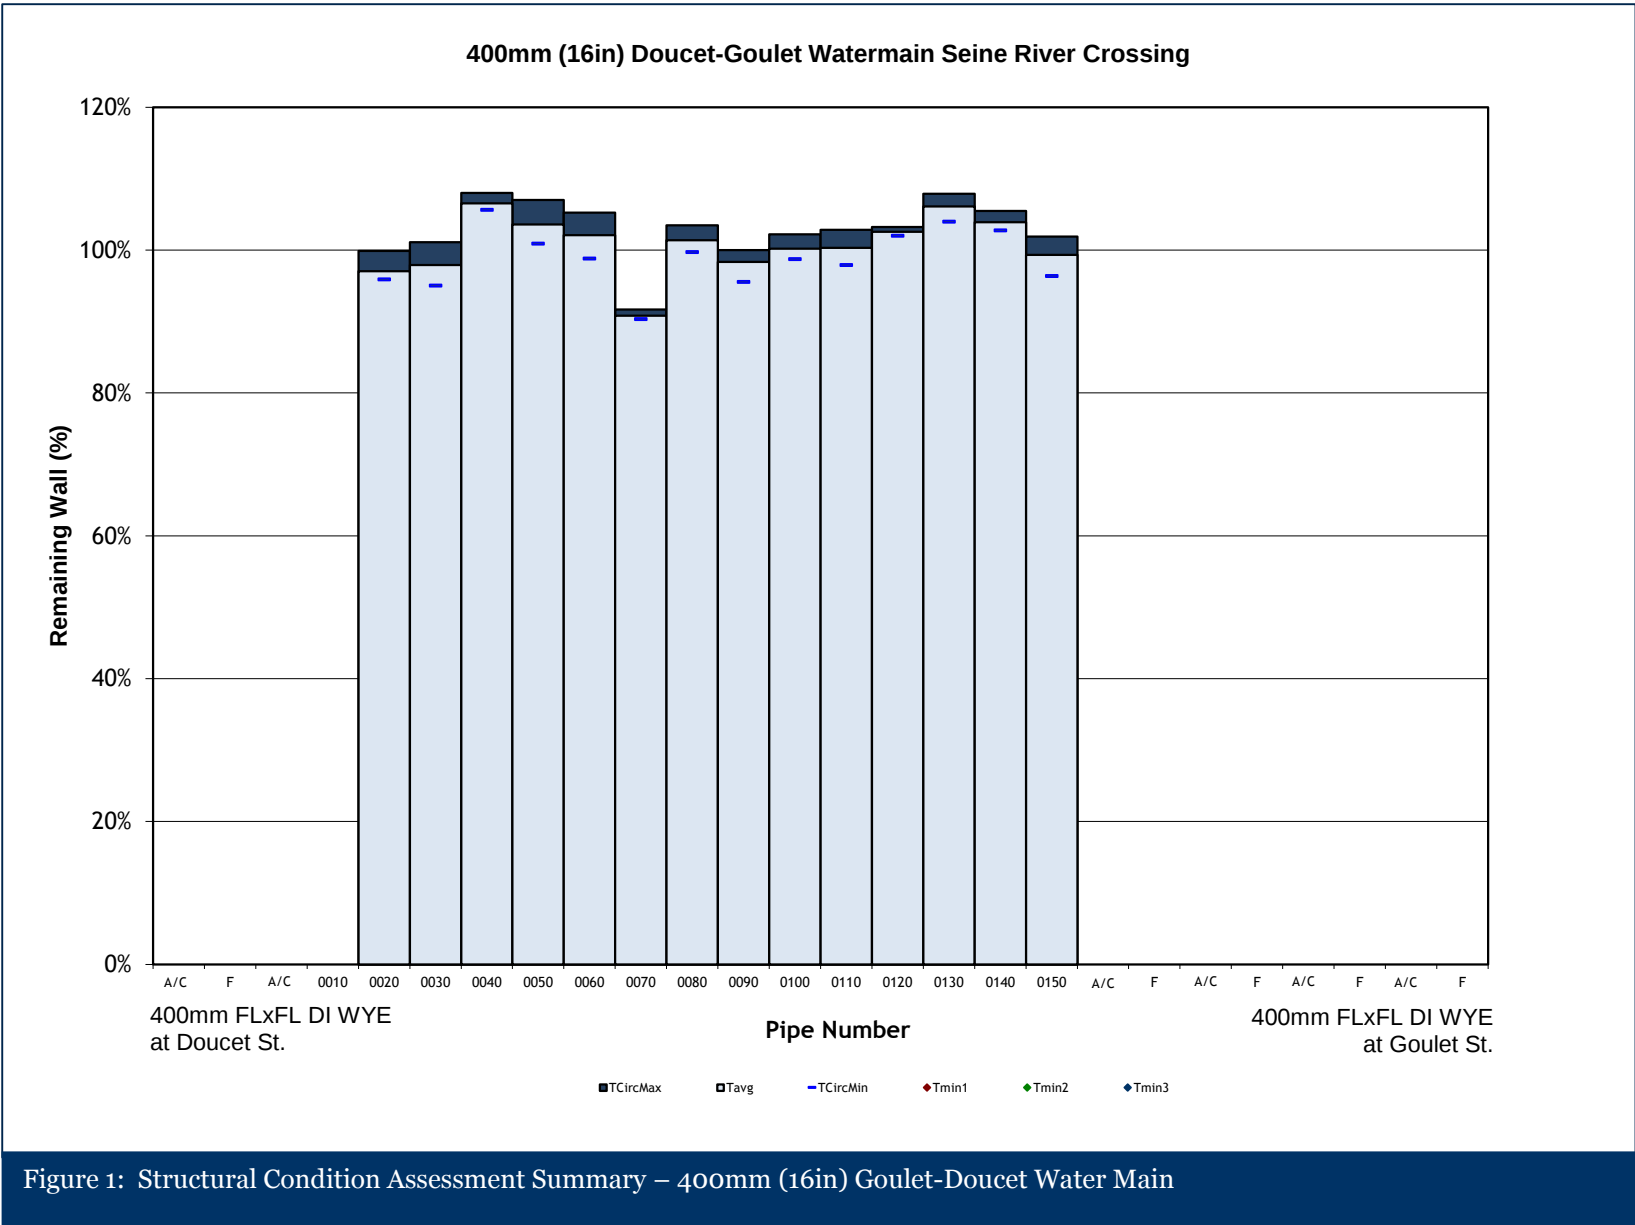
Figure 1: Structural Condition Assessment Summary – 400mm (16in) Goulet-Doucet Water Main

The RFT analysis found the inspected steel section to be in *excellent* condition, as there was no localized wall loss detected above the threshold-of-detection for the RFT Tool.

Pipe sections longer than 1.5m were analysed to obtain the average remaining wall thickness calculated over the length of the section. The measured average wall thickness for the steel section of the 16in Doucet-Goulet Watermain River Crossing is 100.0%.

Due to manufacturing tolerances, fluctuations of  $\pm 10\%$  in the individual PARW values are common. Variations outside the normal  $\pm 10\%$  spread can be an indicator of a different nominal wall thickness (NWT) or point towards a problem like aggregate pitting or general wall loss. Largely, the inspected pipes exhibited PARW values that are within the manufacturing tolerances. Pipe 0070 was found with the lowest PARW value of 91%, which is still within the aforementioned tolerance.

The RFT analysis found the inspected steel section to be in *excellent* condition, as there were no localized wall loss detected above the Threshold-of-Detection for the tool.
