**CITY OF WINNIPEG**

**WASTEWATER LIFT STATION CONDITION ASSESSMENT PHASE II**

**Document IX: Cornish Lift Station Assessment**

Date: March 16, 2020

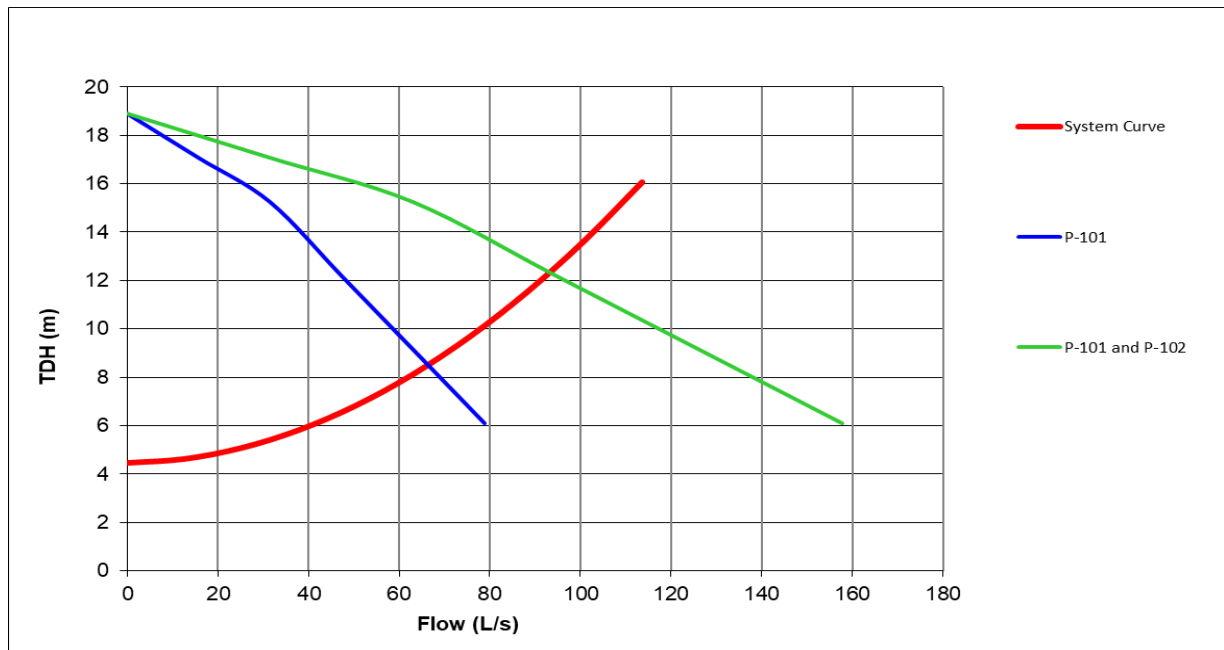
**Figure 5.2: Lift Station Curve vs. Pump Performance Curve**

The theoretical flows that can be obtained with one pump and two pumps in operation are 66.2 L/s and 93.1 L/s, respectively.

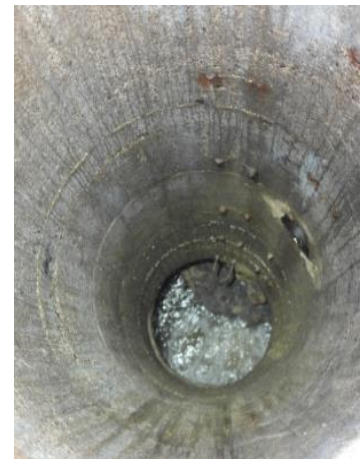
The wet well was examined by camera. Concrete deterioration and significant grease buildup were noted. Despite the deterioration, no structural concerns were noted. The concrete rim at the entrance to the wet well is damaged and in need of replacement. The access vault is in "Good" structural condition, but access has been removed; either the ladder rungs have been corroded or they have been cut off.

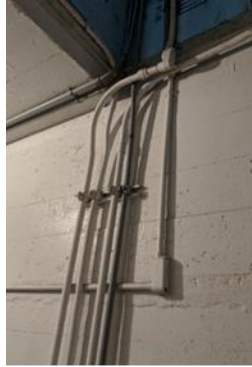
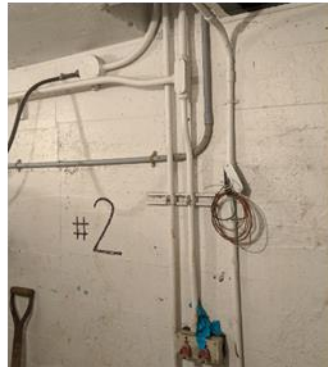
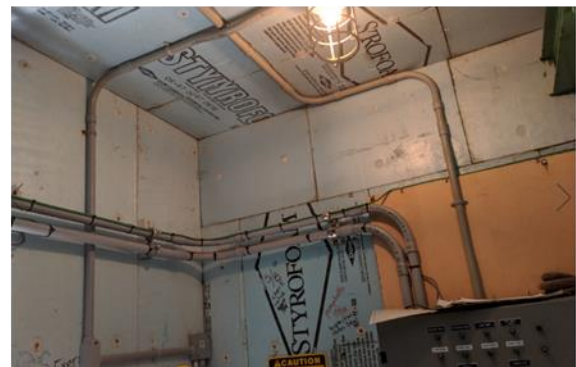
The wiring style in Cornish Lift Station is primarily run using RPVC and threaded rigid conduit. RPVC does not meet Zone 1 requirements.
