## **D**

Project Number: 7004

# Lead Exposure Survey

Please find below the results of the lead worker exposure survey performed for Winnipeg Transit in Building B located at 421 Osborne Street, Winnipeg on September 29<sup>th</sup>, 2023.

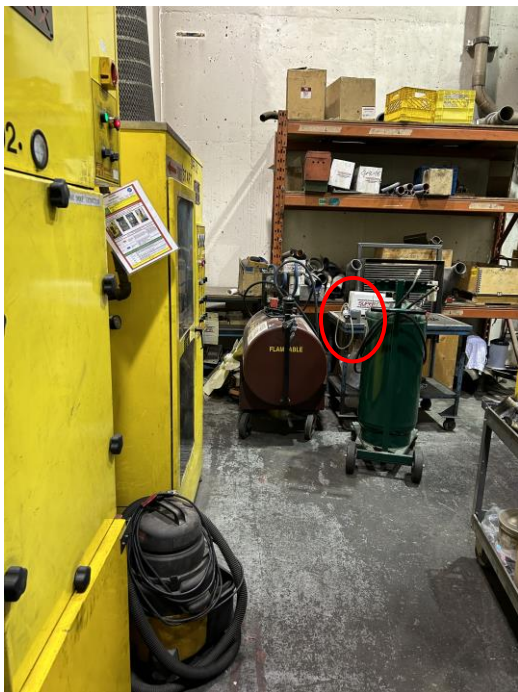
**Dyno 2**

| <b>Work Station</b> | <b>Lead Concentration (µg/m<sup>3</sup>)</b> |
|---|--|
| Dyno 2 | <0.56 |

The airborne lead levels were very low and well within the allowable exposure limit. Workers wear a half-face particulate respirator when in the Dyno 2 Room. These respirators, when used as part of a comprehensive respiratory protection program (which includes fit testing, worker education, workers that are clean shaven, etc.) have an assigned protection factor of 10. That is to say that the worker's exposure when using such a respirator is 10 times less than the concentration outside the mask. Based on these sampling results, no respiratory protection is needed to reduce lead exposures for workers in Dyno 2.

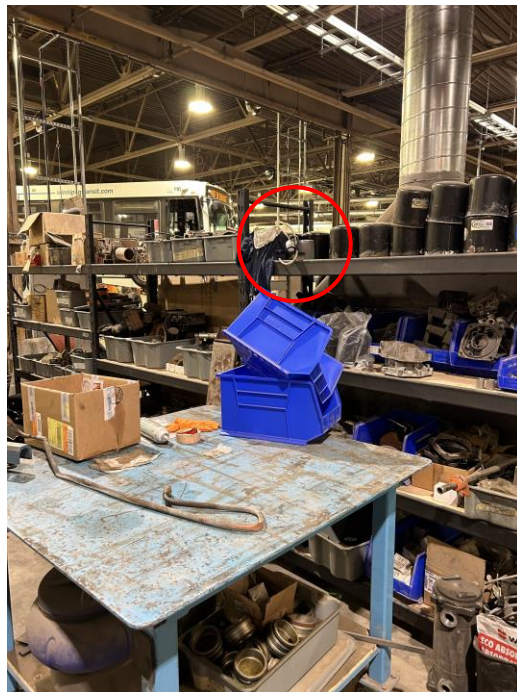
**Rebuild – Rad Shop**

| <b>Work Station</b> | <b>Lead Concentration (µg/m<sup>3</sup>)</b> |
|---|--|
| Rebuild – Rad Shop | <0.57 |

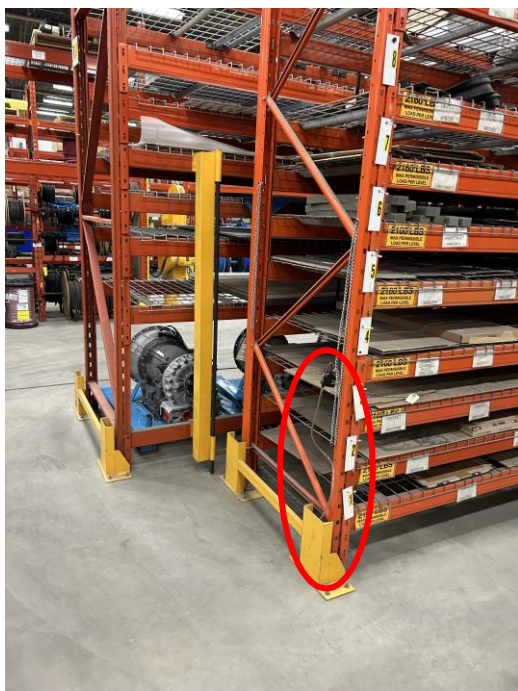
**Stores – Row 13-15 Near Back Wall**

| <b>Work Station</b> | <b>Lead Concentration (µg/m<sup>3</sup>)</b> |
|---|--|
| Stores – Row 13-15 Near Back Wall | <0.57 |

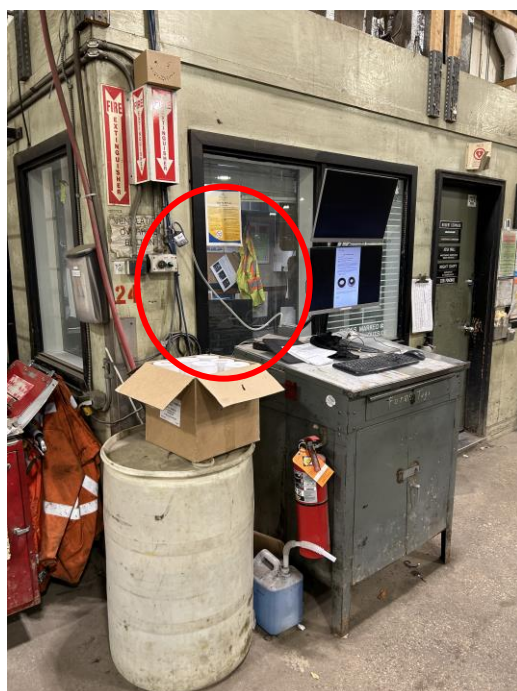
**Brakes – Outside Office**

| <b>Work Station</b> | <b>Lead Concentration (µg/m<sup>3</sup>)</b> |
|---|--|
| Brakes – Outside Office | <0.60 |

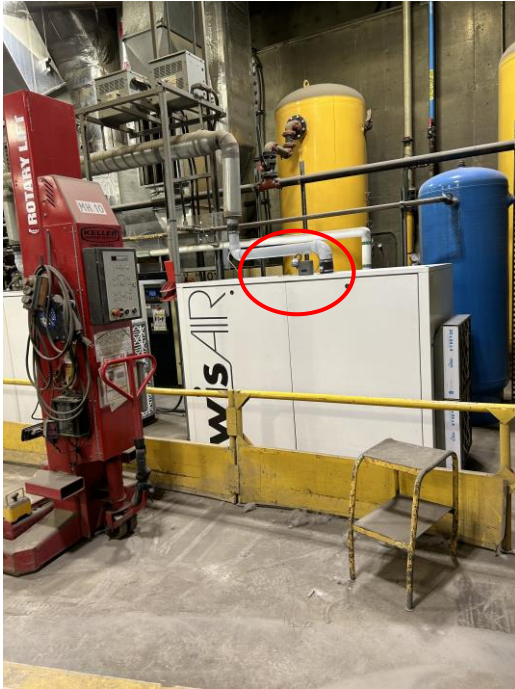
## Paint Shop – Outside Paint Booths

| <b>Work Station</b> | <b>Lead Concentration (µg/m<sup>3</sup>)</b> |
|---|--|
| Paint Shop – Outside Paint Booths | <0.63 |

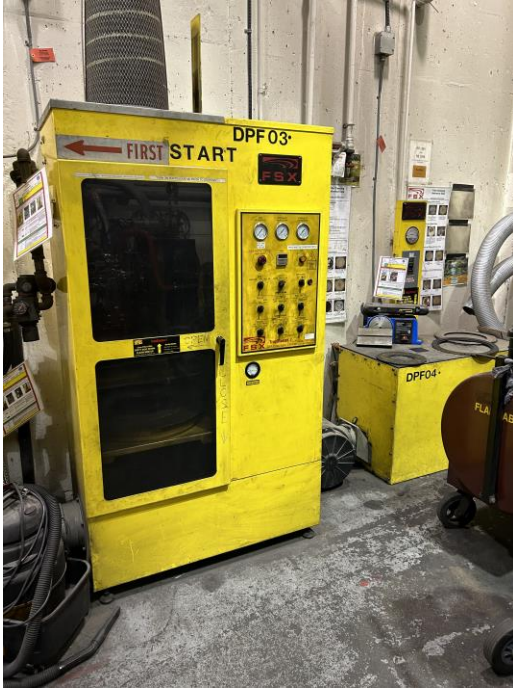
Dyno 2: Control Panel

| Work Station | Surface Sampled | Lead Concentration<br>( $\mu\text{g}/100\text{ cm}^2$ ) |
|--|---|---|
| Dyno 2 | Control Panel* | <1.0 |

While it is unfair to hold a large industrial shop to lunchroom standards, all of the high touch areas sampled (control panel, computers, desk) had levels within the criteria for surface lead levels in a lunchroom.

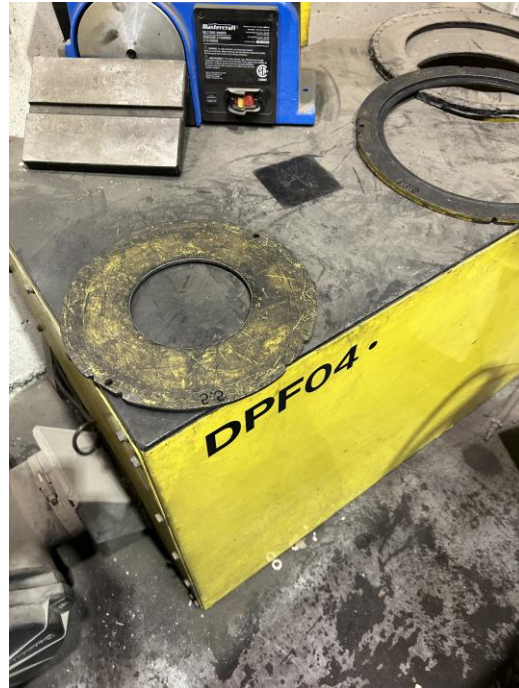
Dyno 2: Top of DPF04

| Work Station | Surface Sampled | Lead Concentration<br>( $\mu\text{g}/100\text{ cm}^2$ ) |
|--|---|---|
| | Top of DPF04* | 18.1 |

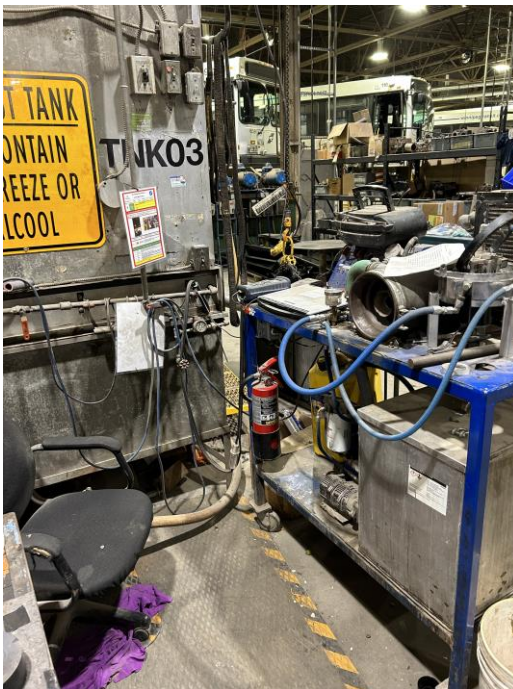
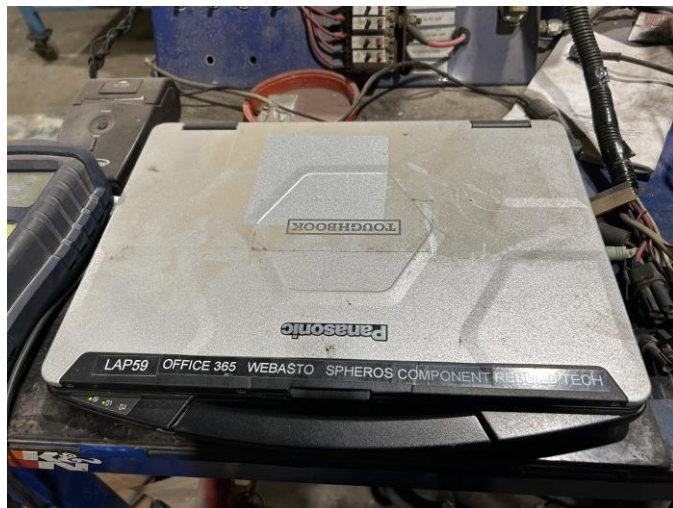
Rebuild – Rad Shop: Computer

| Work Station | Surface Sampled | Lead Concentration<br>( $\mu\text{g}/100\text{ cm}^2$ ) |
|--|---|---|
| Rebuild – Rad Shop | Computer | 12.3 |

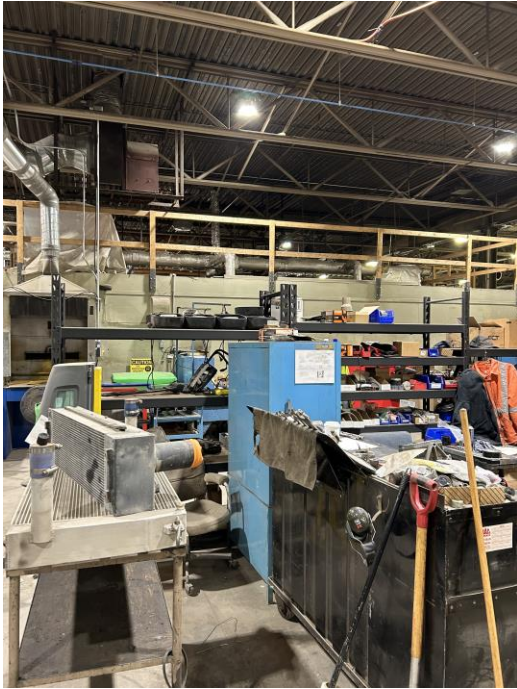
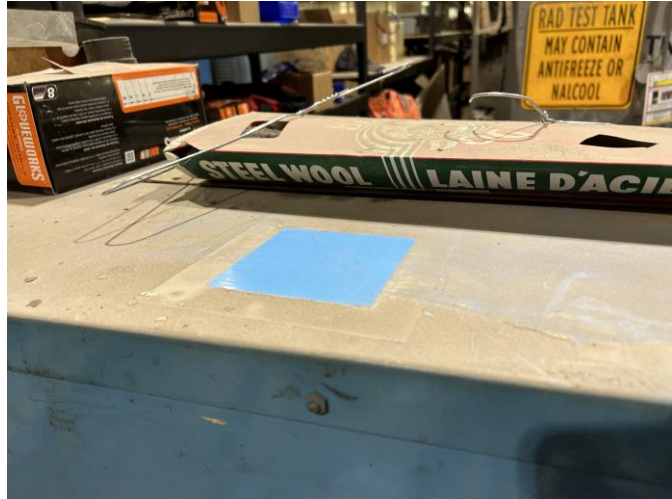
## Rebuild – Rad Shop: Top of Blue Cabinet

| Work Station | Surface Sampled | Lead Concentration<br>( $\mu\text{g}/100\text{ cm}^2$ ) |
|--|---|---|
| | Top of Blue Cabinet | 53.7 |

Higher, but not unusual, levels of lead were found on the high-dust areas. These areas are not touched or used often and some lead accumulation has occurred. Good hygiene practices, including washing hands after touching dirty/dusty objects prior to eating, drinking, or smoking, significantly reduces the potential for lead ingestion.

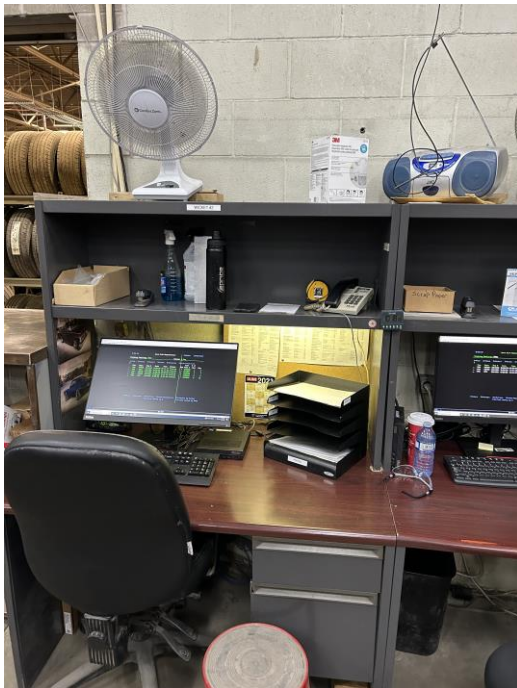
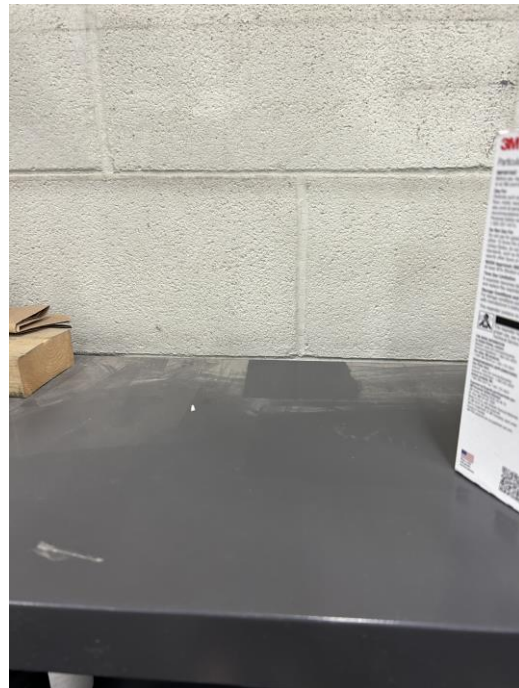
## Stores – Row 13-15 Near Back Wall: Top of Front Desk

| Work Station | Surface Sampled | Lead Concentration<br>( $\mu\text{g}/100\text{ cm}^2$ ) |
|--|---|---|
| Stores – Row 13-15<br>Near Back Wall | Top of Front Desk | 3.1 |

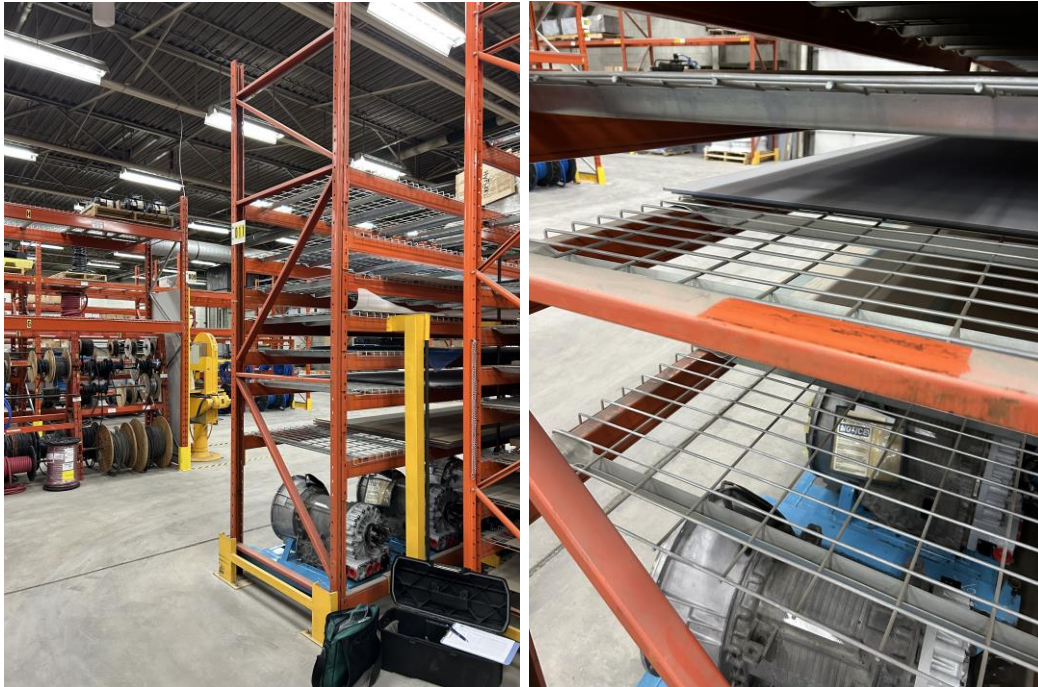
## Stores – Row 13-15 Near Back Wall: Shelving Rack 11

| Work Station | Surface Sampled | Lead Concentration<br>( $\mu\text{g}/100\text{ cm}^2$ ) |
|--|---|---|
| | Shelving Rack 11 | 110 |

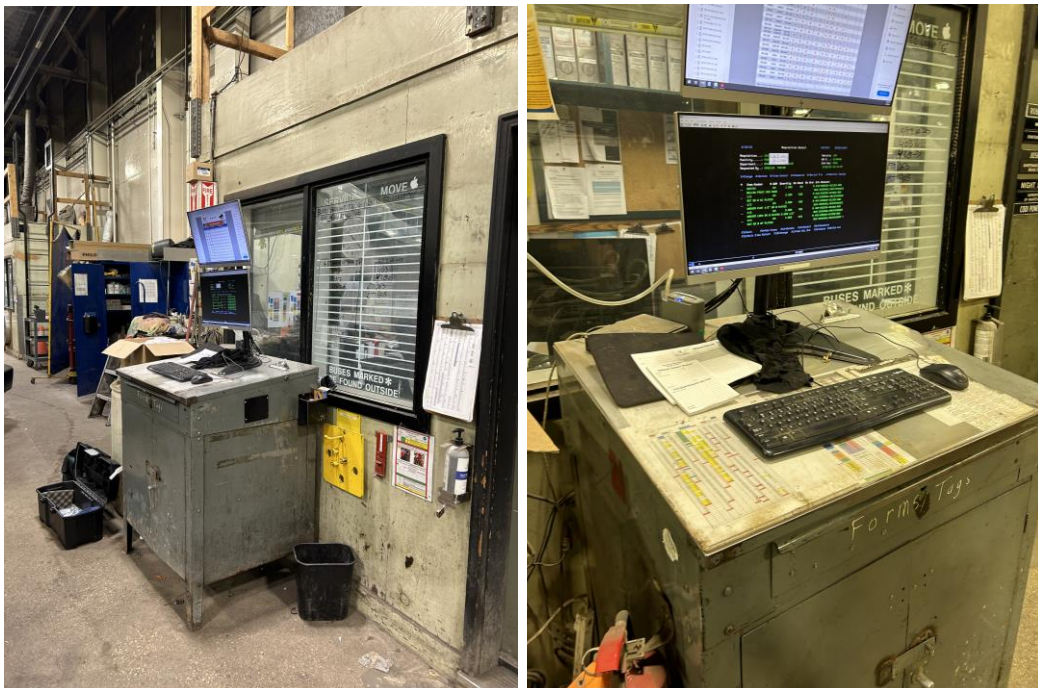
## Brakes – Outside Office: Computer Mouse and Keyboard

| Work Station | Surface Sampled | Lead Concentration<br>( $\mu\text{g}/100\text{ cm}^2$ ) |
|--|---|---|
| Brakes – Outside Office | Computer Mouse and Keyboard | 1.7 |

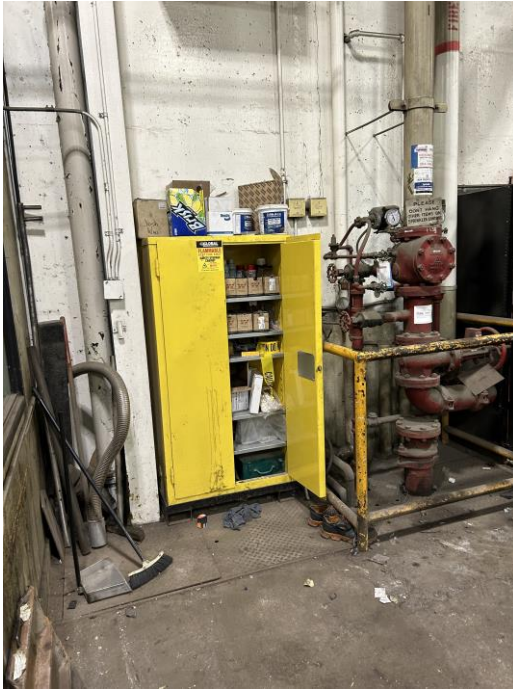
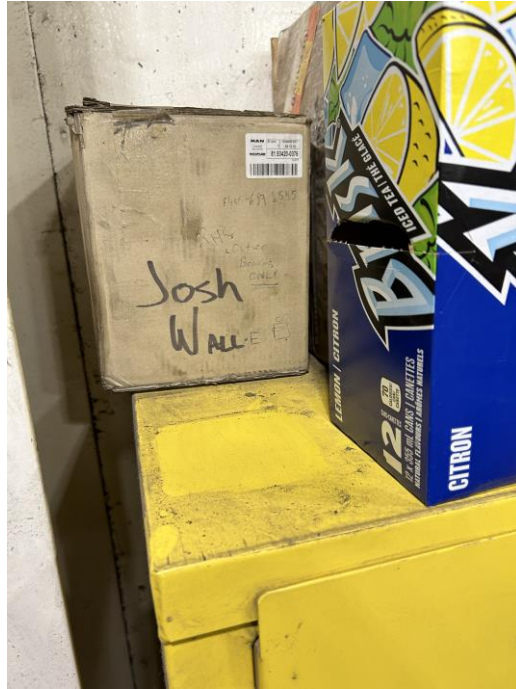
## Brakes – Outside Office: Top of Safety Storage Cabinet

| Work Station | Surface Sampled | Lead Concentration<br>( $\mu\text{g}/100\text{ cm}^2$ ) |
|--|---|---|
| | Top of Safety Storage Cabinet | 5.2 |

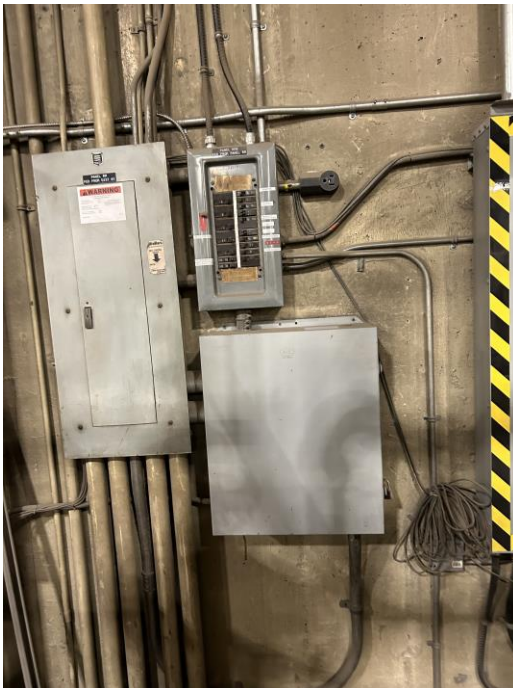
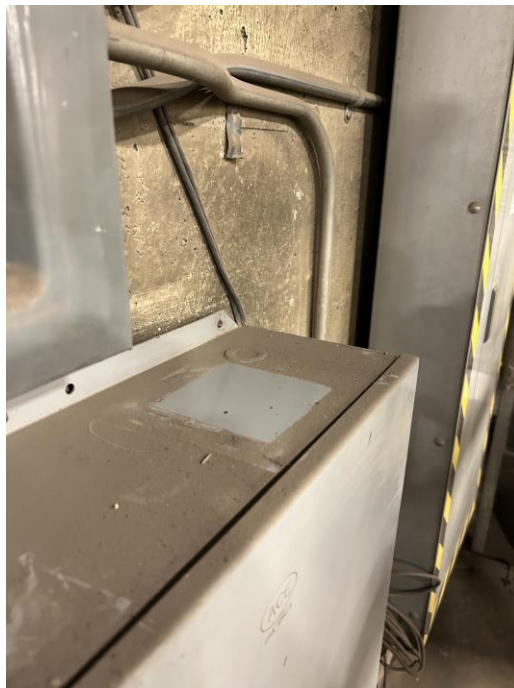
## Paint Shop – Outside Paint Booths: Top of Electrical Panel

| Work Station | Surface Sampled | Lead Concentration<br>( $\mu\text{g}/100\text{ cm}^2$ ) |
|--|---|---|
| Paint Shop – Outside<br>Paint Booths | Top of Electrical Panel | 50.8 |

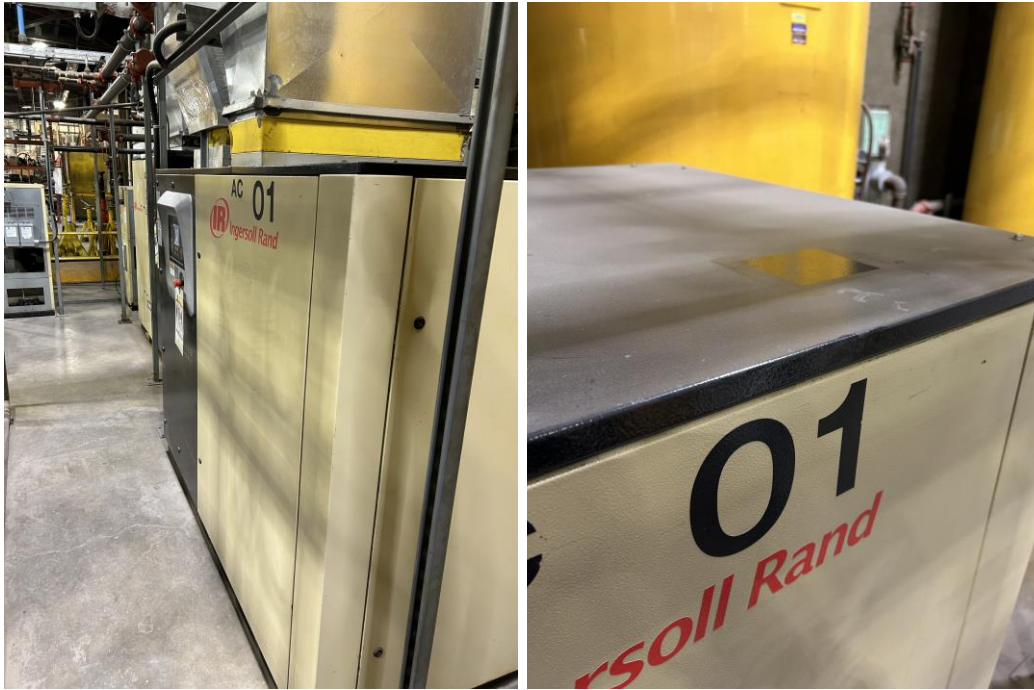
## Paint Shop – Outside Paint Booths: Top of AC01 Ingersoll Rand

| Work Station | Surface Sampled | Lead Concentration<br>( $\mu\text{g}/100\text{ cm}^2$ ) |
|--|---|---|
| | Top of AC01 Ingersoll Rand | 3.4 |
