# APPENDIX E

# ASBESTOS INVENTORY CONTROL

<b>Building Name:</b>	Building A, Maintenance Shop	<b>Inspection Date:</b>	August 2025
<b>Building Code:</b>	TR01	<b>Inspected By:</b>	Winnipeg Air Testing
<b>Building Address:</b>	421 Osborne Street	<b>Construction Date:</b>

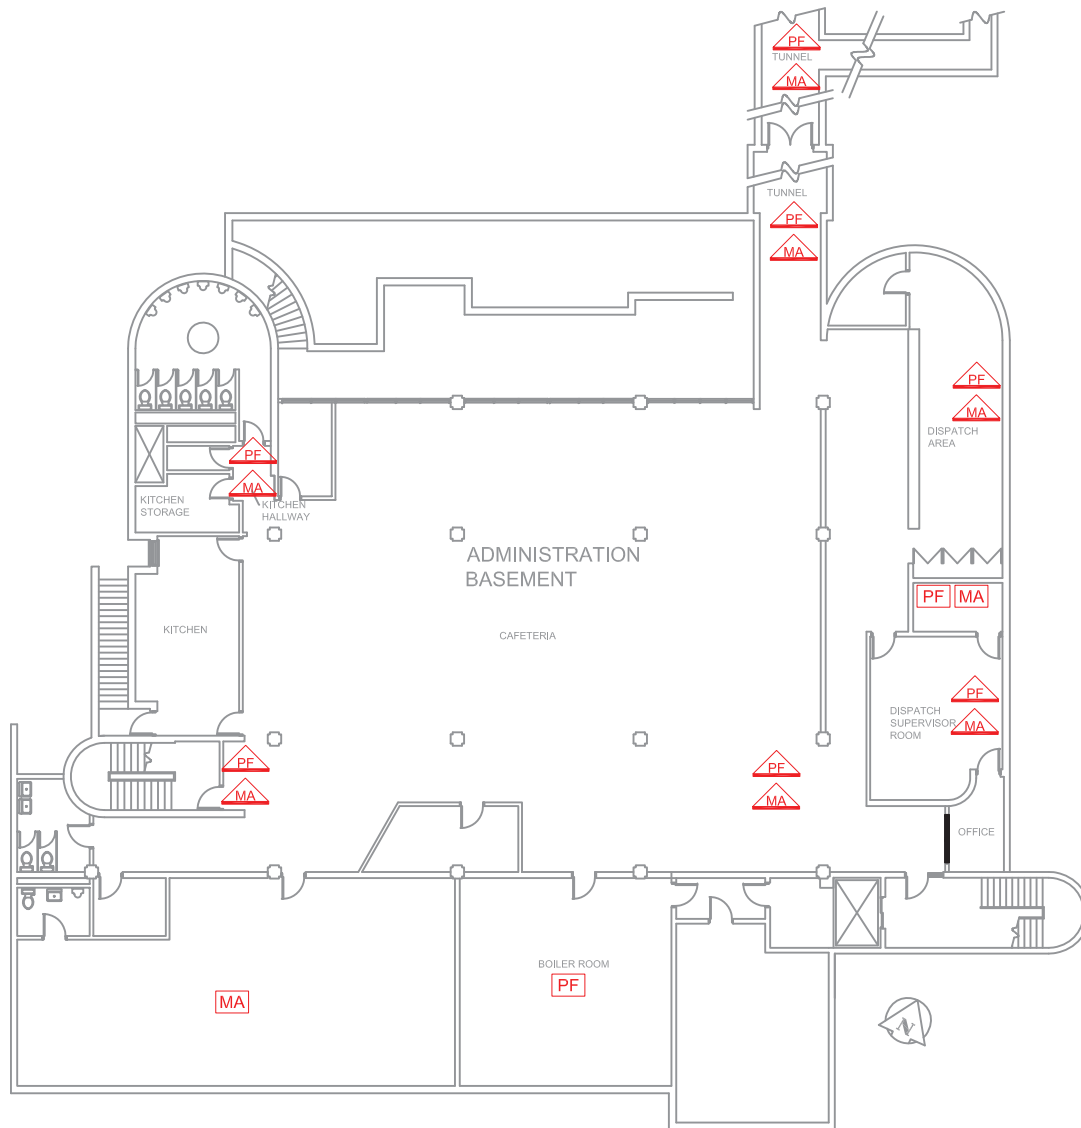
SHEET #:  
5/6

Material Location	Material Description		Drawing Label	Material Condition	Testing Status	Date M/Y	Test %	Est. %
	<b>Stucco Column Cladding Throughout Building Should Be Tested Before Any Work Is Performed</b>							
	<b>Various Areas Have Been Tested See Inventory for Details</b>							
<b><u>Basement</u></b>								
Cafeteria Storage	12x12 Ceiling Tile	NON ASBESTOS		Good	Tested	May'09	0	
Cafeteria	Mastic - Pipe - Above Ceiling		MA	not accessible	Tested	May'10	25-50	
	Pipe Fitting Insulation - Above Ceiling		PF	not accessible	Tested	May'10	0.1-1	
Furnace Room	Pipe Fitting Insulation		PF	Removed				
Kitchen Hallway	Mastic - Pipe - Above Ceiling		MA	Good	Tested	May'10	25-50	
	Pipe Fitting Insulation - Above Ceiling		PF	Good	Tested	May'10	0.1-1	
Kitchen	wall plaster	NON ASBESTOS			Tested	July 16	00	
	brown/grey floor cement	NON ASBESTOS			Tested	July 16	00	
	pipe insulation	NON ASBESTOS			Tested	July 16	00

tile mortar	NON ASBESTOS			Tested	July 16	00	
Dispatch Area	Pipe Insulation - Above Ceiling		PI	Removed	Tested	Sept 15	1-5	
	Pipe Fitting Insulation - Above Ceiling		PF	Removed				25-50
Dispatch Supervisor Office	Pipe Insulation - Above Ceiling		PI	Removed				25-50
	Pipe Fitting Insulation - Above Ceiling		PF	Removed				25-50
Tunnel	Pipe Insulation - Above Ceiling		PI	Good				25-50
	Pipe Fitting Insulation - Above Ceiling		PF	Good				25-50
Boiler Room	Pipe Fitting Insulation		PF	Removed				
	Asbestos Fabric - Isolation Gasket			good	Tested	Nov 16		60
Stairwells	Stucco - Walls	NON ASBESTOS			Tested	May'09	0	
	HVAC isolation gaskets, each floor in ceiling space			Removed	Tested	Dec 21		
Stairwell by women's washroom	Pipe Insulation - tar paper			good	tested	Jul 20	1-10	
	pipe insulation - white canvas	NON ASBESTOS		good	tested	Jul 20	0	
Sign Up Room	Pipe Insulation			Good				
<b><u>Admin Area- Main Floor</u></b>
