**September 2015**

# **Landfill Status Report for Closed Landfills Winnipeg, Manitoba**

**Submitted to:**  
City of Winnipeg

**Report Number: 1522283/1000**

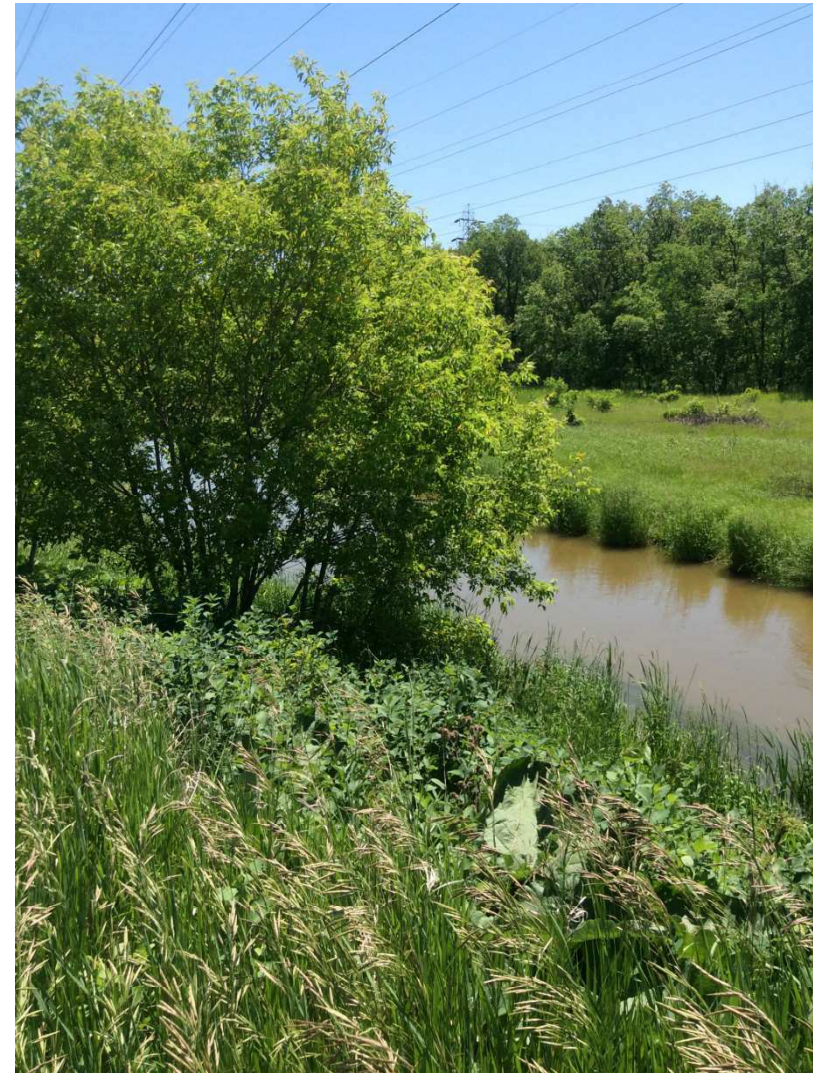
Photo A2  
East slope of landfill looking east across the  
Seine River

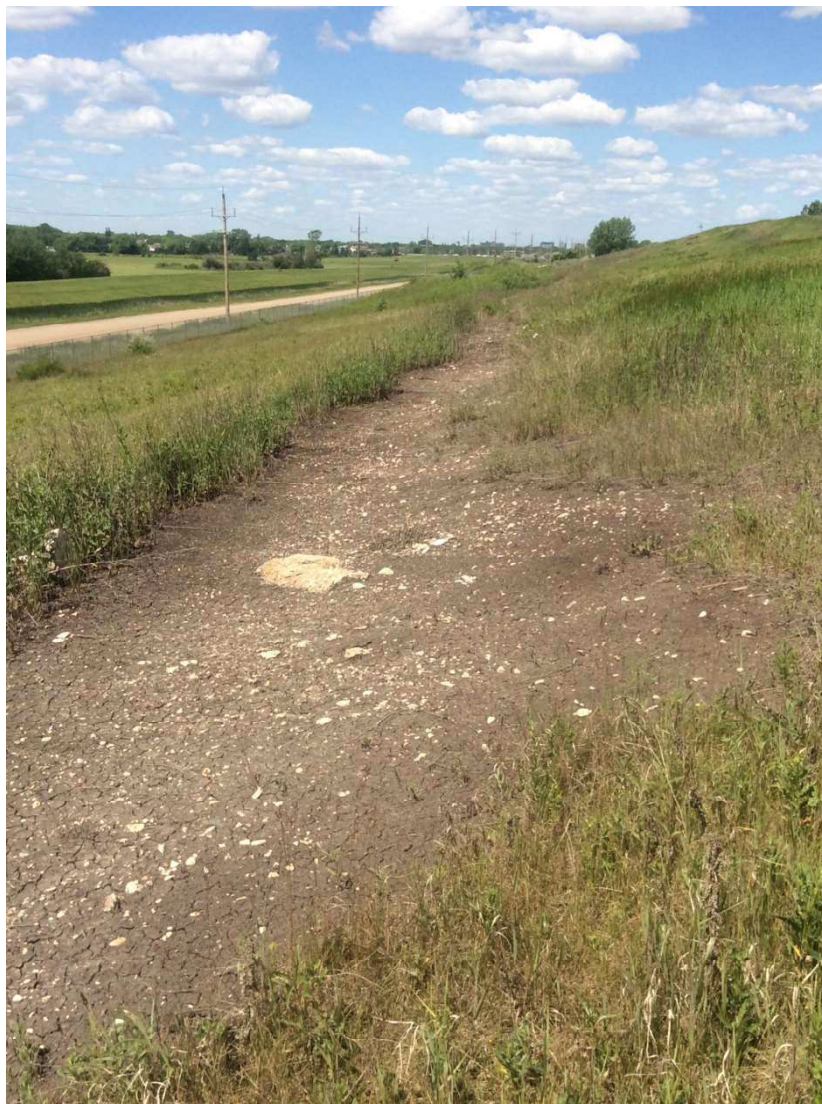
**Photo H7**  
**Stressed/bare vegetation along the south slope of the landfill looking west**

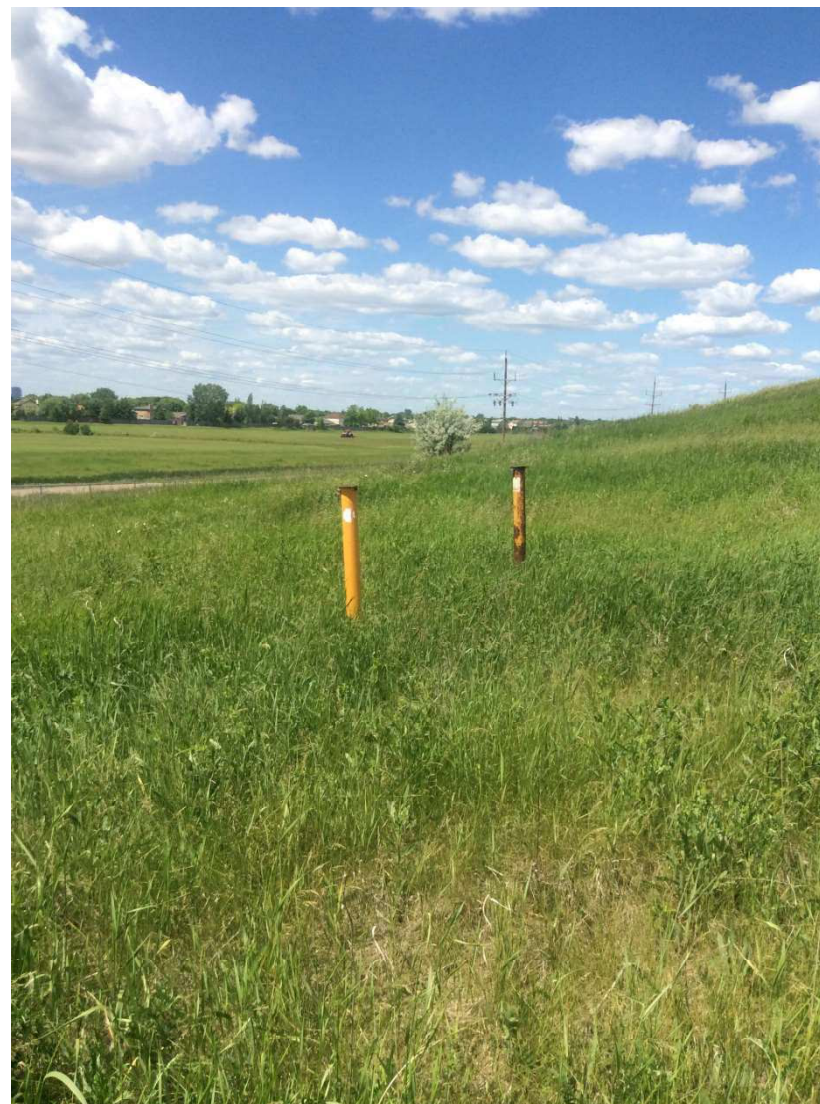
**Photo H8**  
**Landfill gas probes located on the south slope of the landfill**

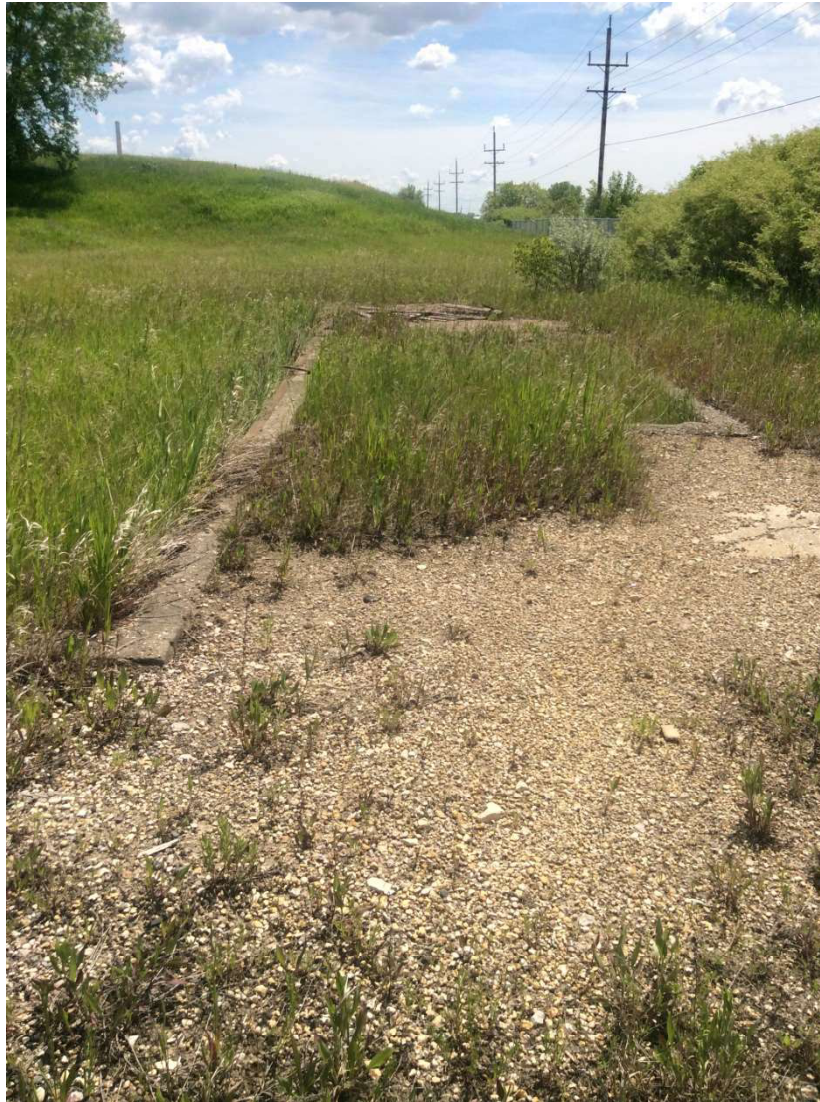
**Photo H9**  
**Vertical drains located in the southwest corner**  
**of the landfill looking east**

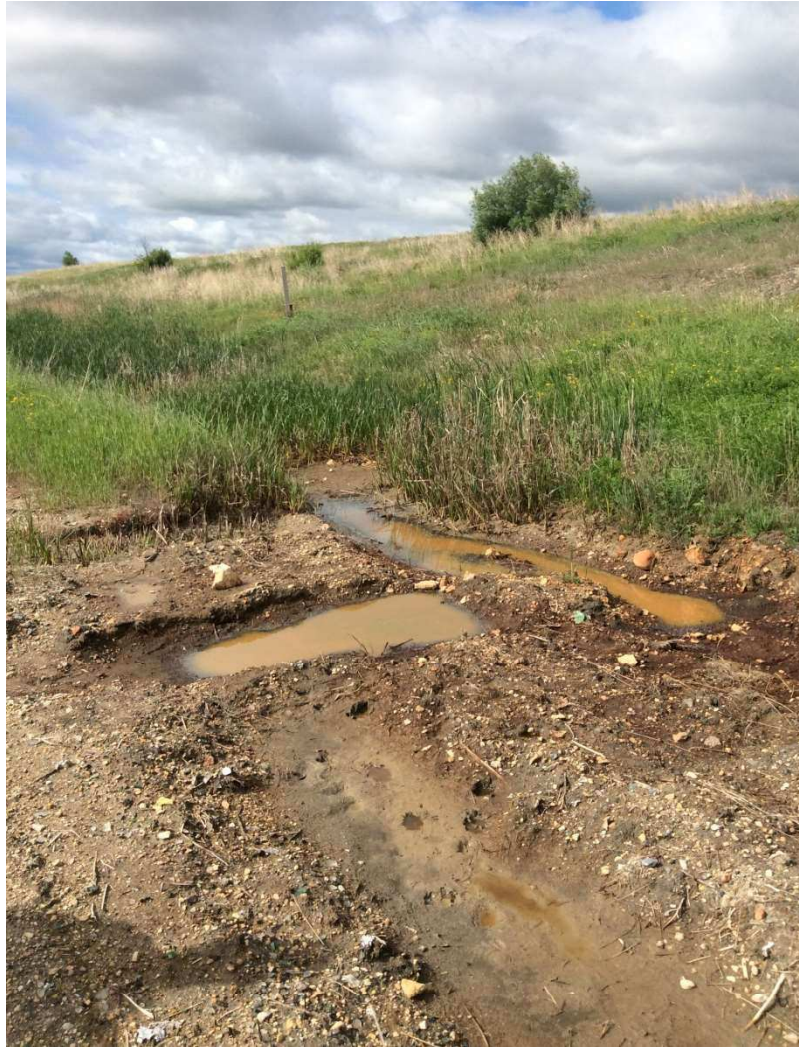
**Photo R5**  
**Leachate seep noted on the east side of the  
north end of landfill**

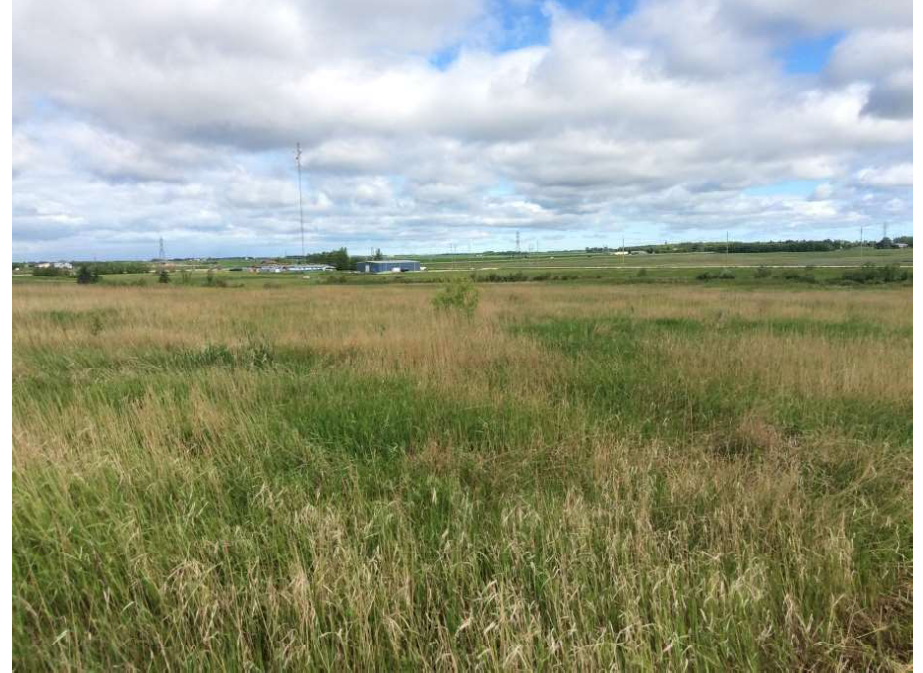
**Photo R6**  
**North end of landfill, looking north**

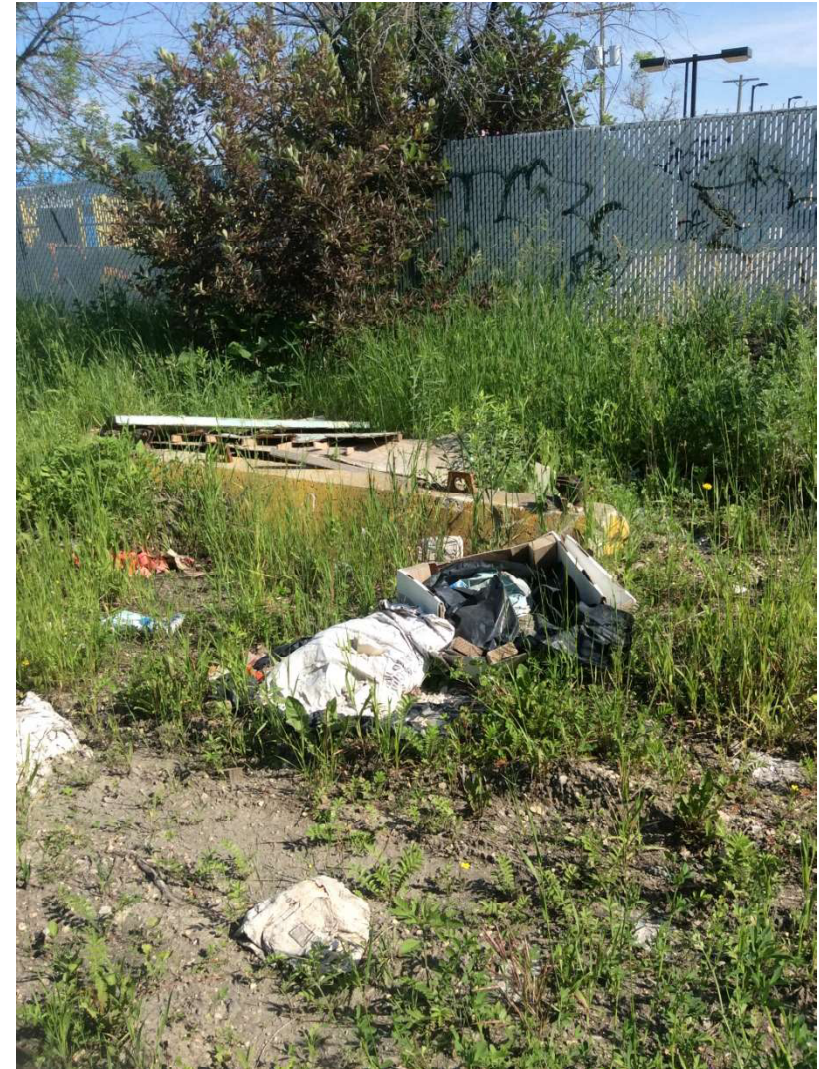
**Photo X6**  
**Elmwood Landfill – private property with**  
**dumping of waste**

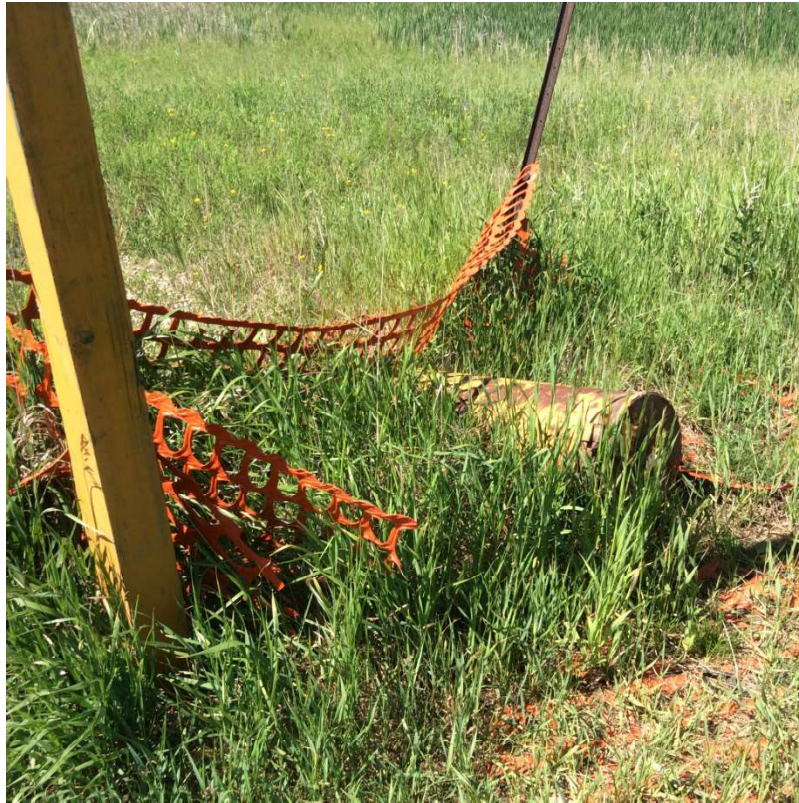
**Photo FF1**  
Leachate riser pipe

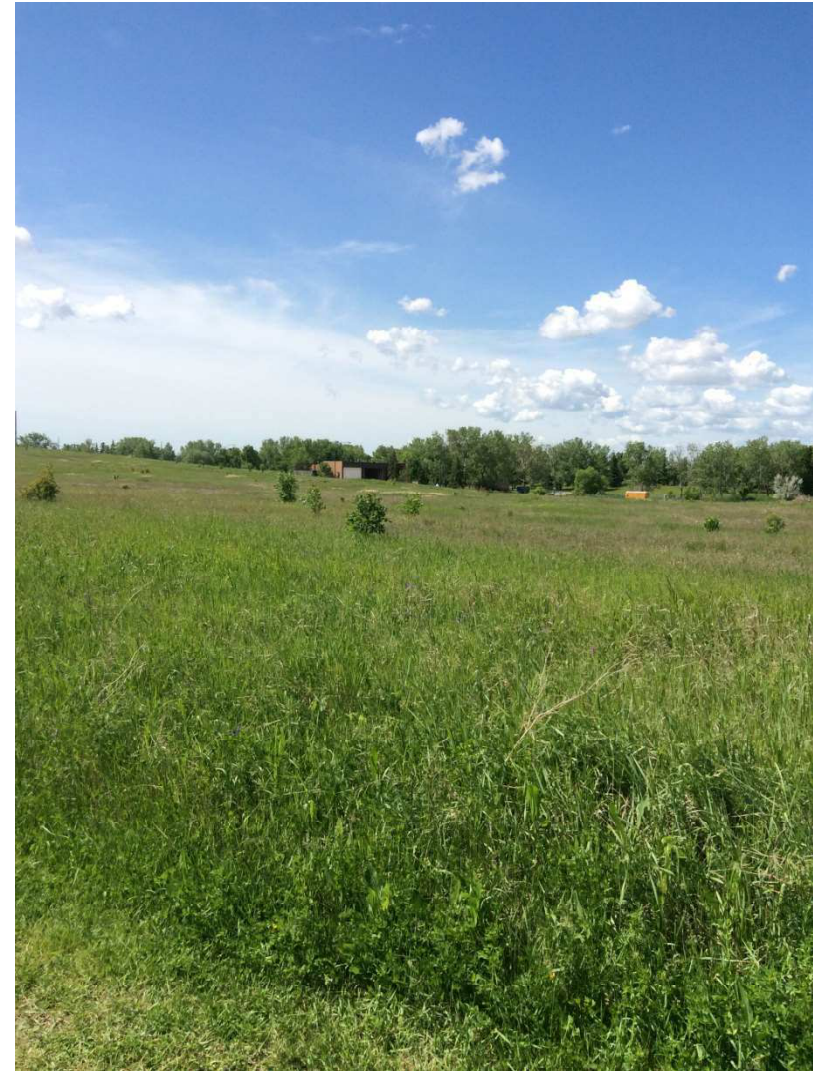
**Photo FF8**  
**Maintenance garage in the area between the  
 two mounds**
