MEMORANDUM

RE:	Supplemental Drilling at the Conway Gate Chamber
PROJECT NO:	08-107-07
DATE:	September 26, 2008
FROM:	Rob Kenyon, Ph.D., P.Eng. and Anne-Marie Hamilton, P.Eng.
TO:	Darcy Strandberg, C.E.T.

SITE PHOTOGRAPHIC LOG – The City of Winnipeg 2008 Outfall Gate Chamber Geotechnical Investigations Winnipeg, Manitoba

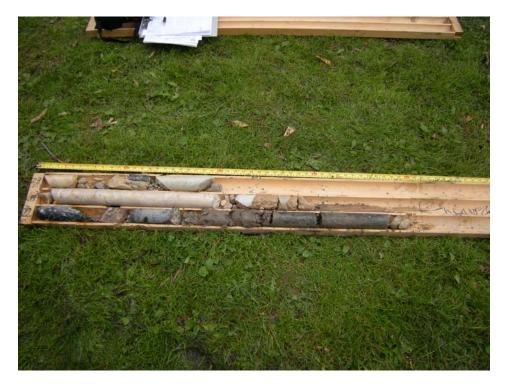
Below 4.3 m \pm , where coring methods were utilized, the recovery of the fine grained components of the till was poor. In general, at those depths, where fine grained components were recovered, the till was buff to grey in colour, damp, dense, non to low plastic, and contained varying amounts of sand, gravel, cobbles and boulders as shown on Photo 1. Numerous large cobbles and boulders were encountered between depths of 4.3 m and 7.3 m \pm .

Photo 1 – Runs1, 2 and 3 (14 to 24 foot depth) at Conway Gate Chamber (September 22, 2008)

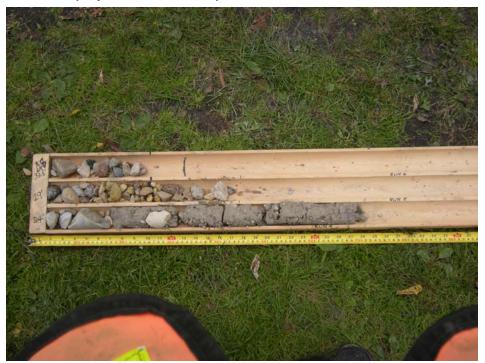
Below 7.3 m \pm the cobble and boulder content of the till decreased with recovered material consisting primarily of coarse grained gravel as shown on Photo 2. A significant loss of drilling fluid circulation occurred at a depth of 7.9 m \pm . The drilling Contractor also noted difficult drilling below 9.9 m \pm as the till material felt loose and gravelly with the drill bit experiencing difficulty cutting through the loose granular material.
