## **GEOTECHNICAL AND ENVIRONMENTAL REPORTS**

Morrison Hershfield  
**Polo Park Infrastructure Upgrades**

**Project Number:**  
0035 008 00

**RE: Sub-Surface Investigation Report for  
Polo Park Infrastructure Upgrades**

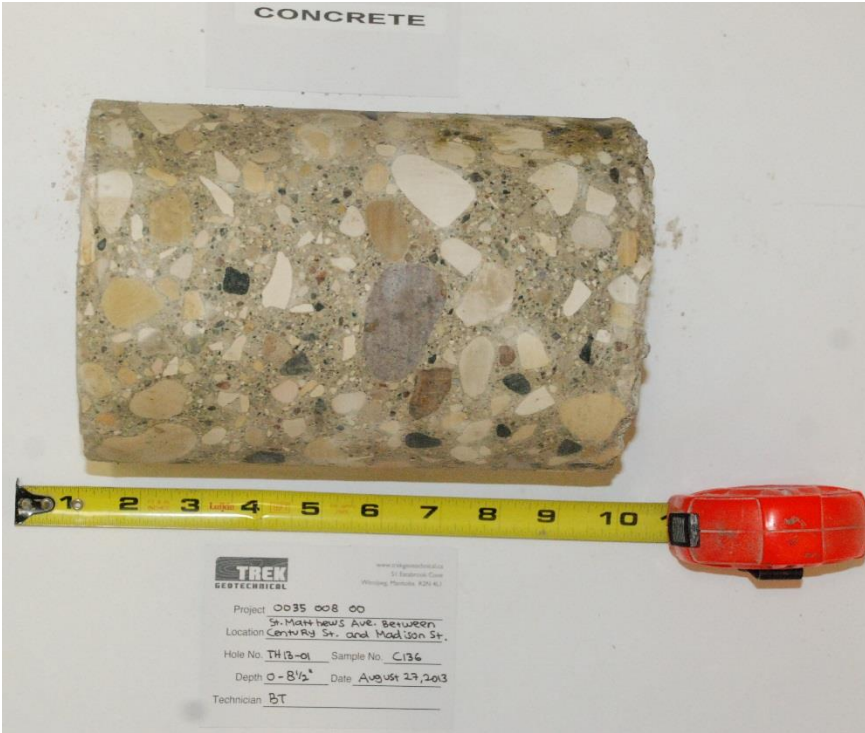
Photo 1: Concrete Core Sample from Test Hole TH13-01

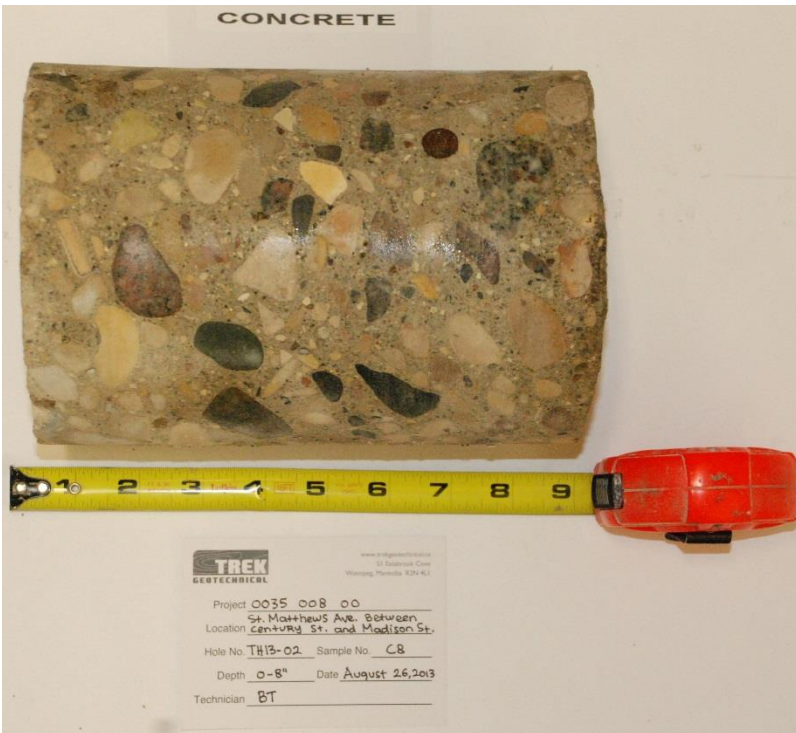
Photo 2: Concrete Core Sample from Test Hole TH13-02

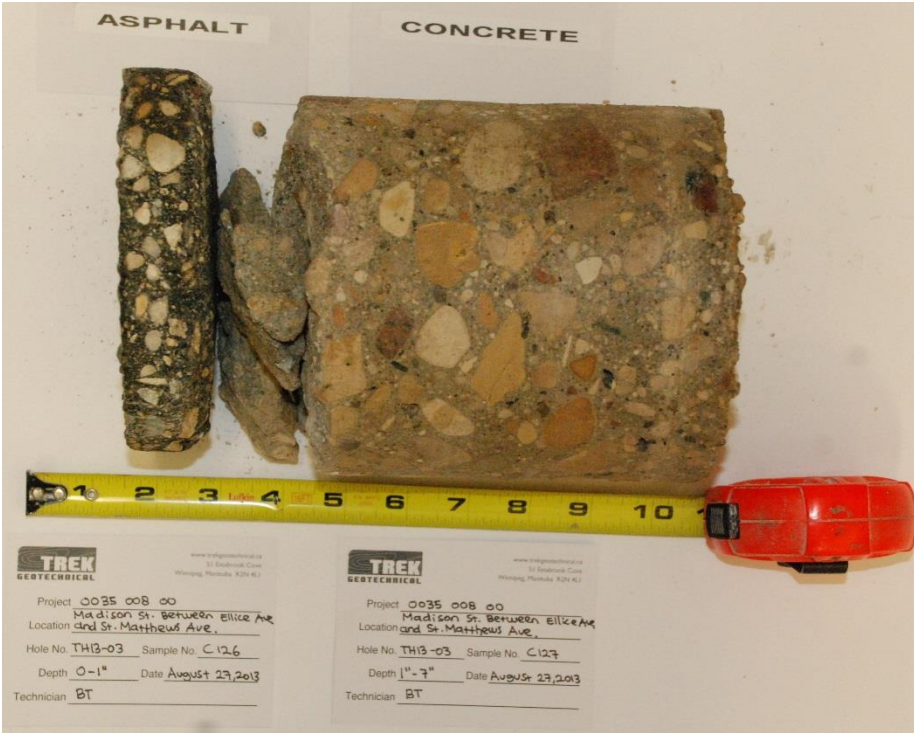
Photo 3: Asphalt and Concrete Core Sample from Test Hole TH13-03

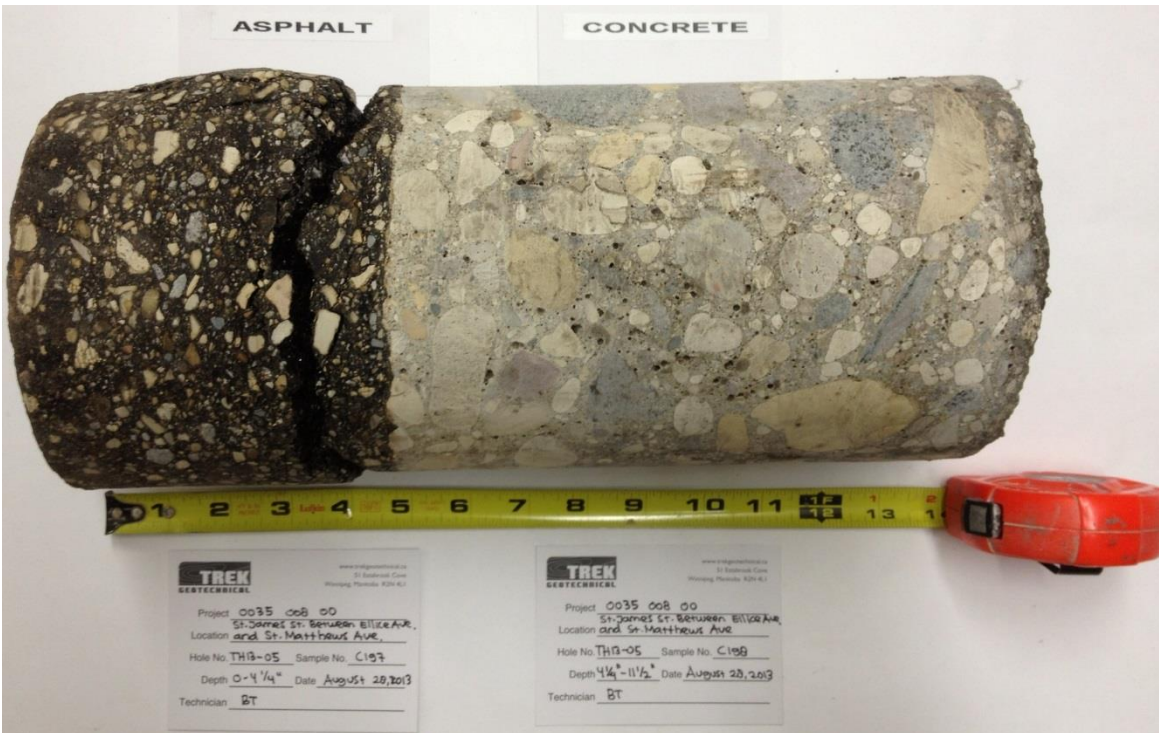
Photo 4: Asphalt and Concrete Core Sample from Test Hole TH13-05

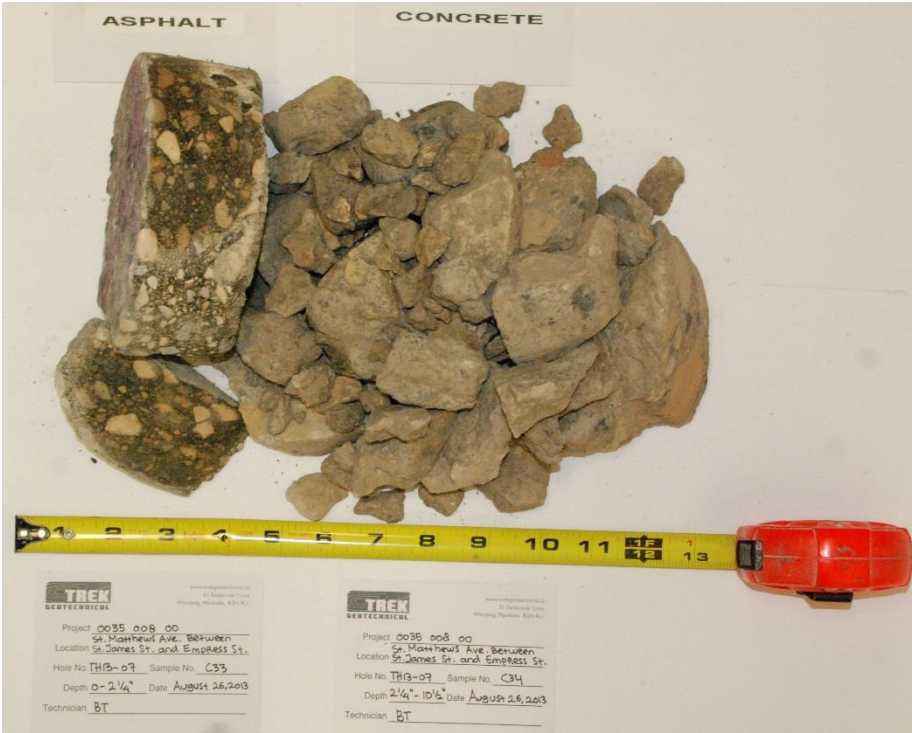
Photo 5: Asphalt and Concrete Core Sample from Test Hole TH13-07

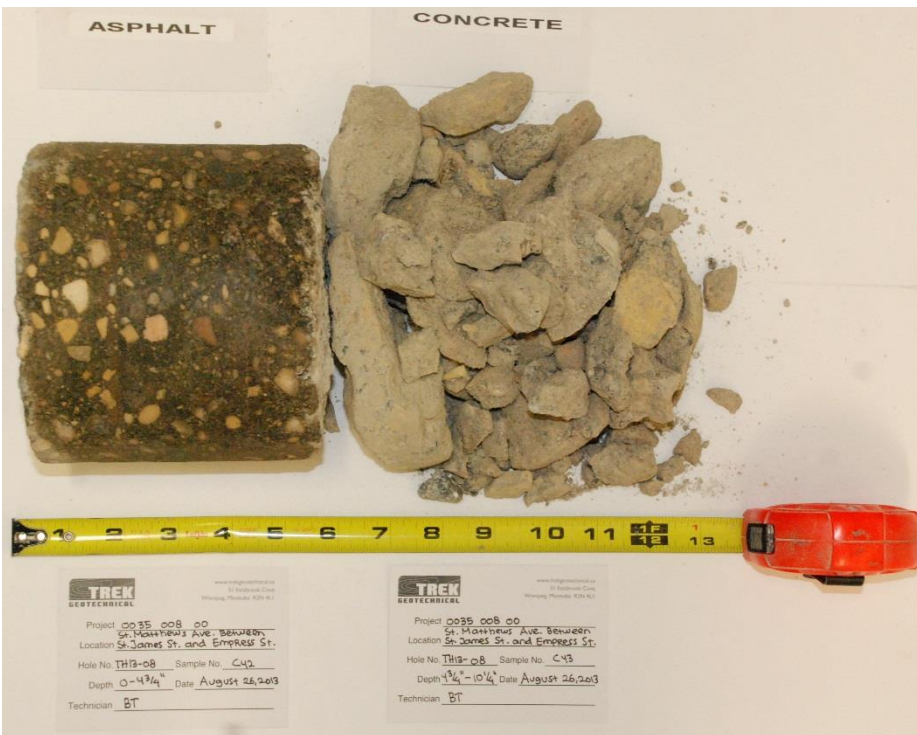
Photo 6: Asphalt and Concrete Core Sample from Test Hole TH13-08

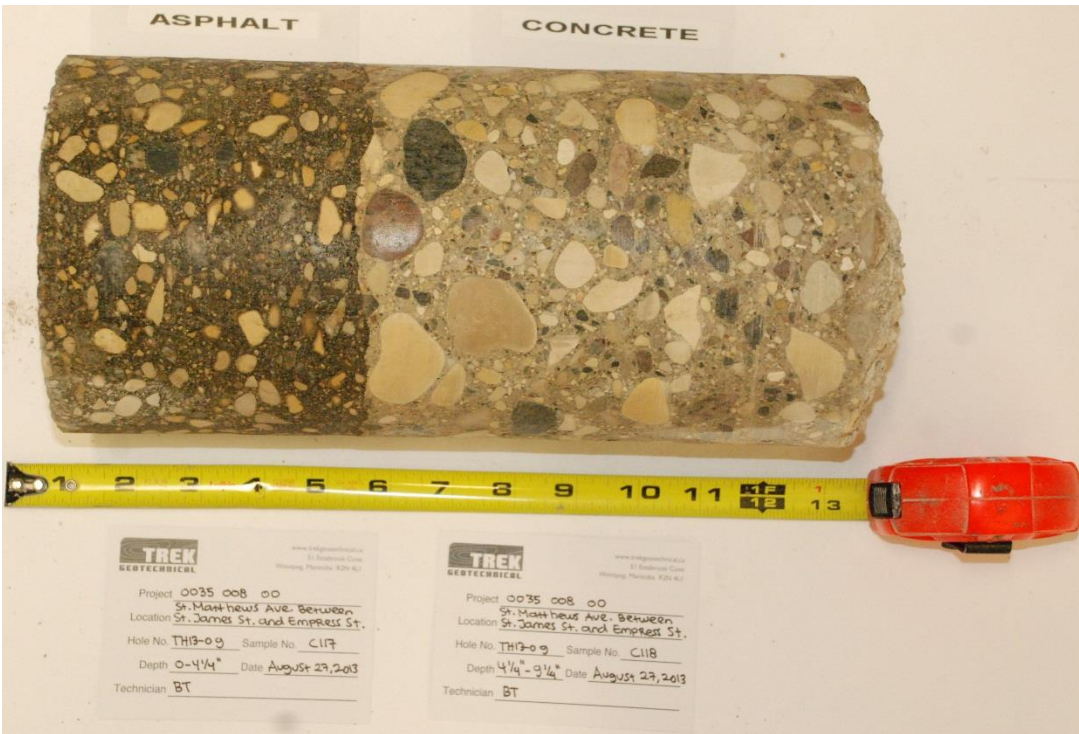
Photo 7: Asphalt and Concrete Core Sample from Test Hole TH13-09

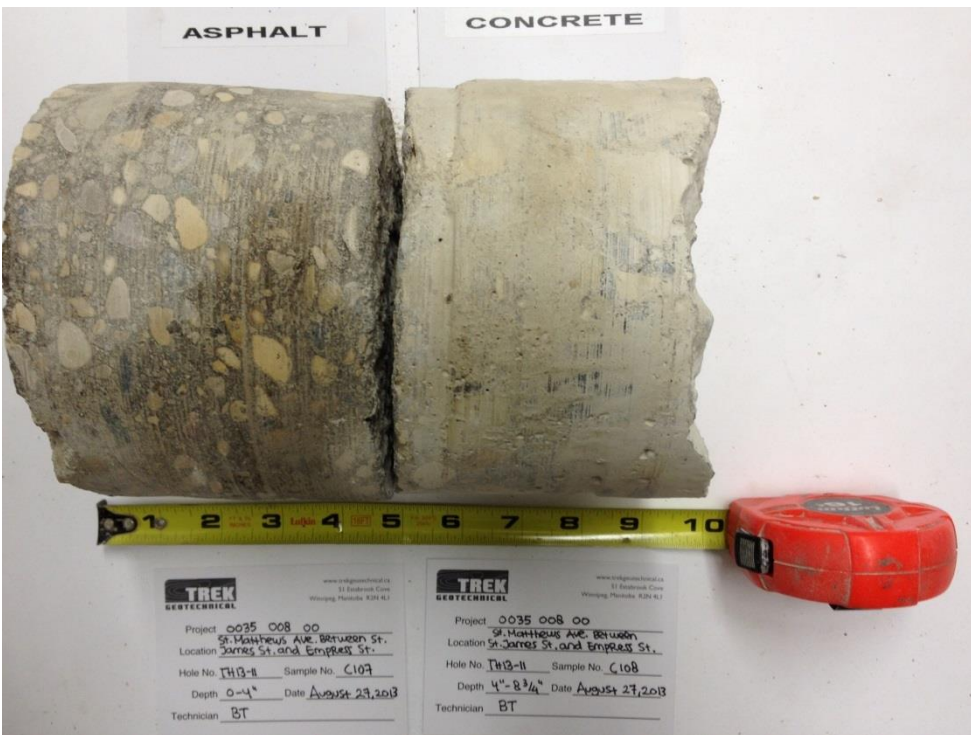
Photo 8: Asphalt and Concrete Core Sample from Test Hole TH13-11

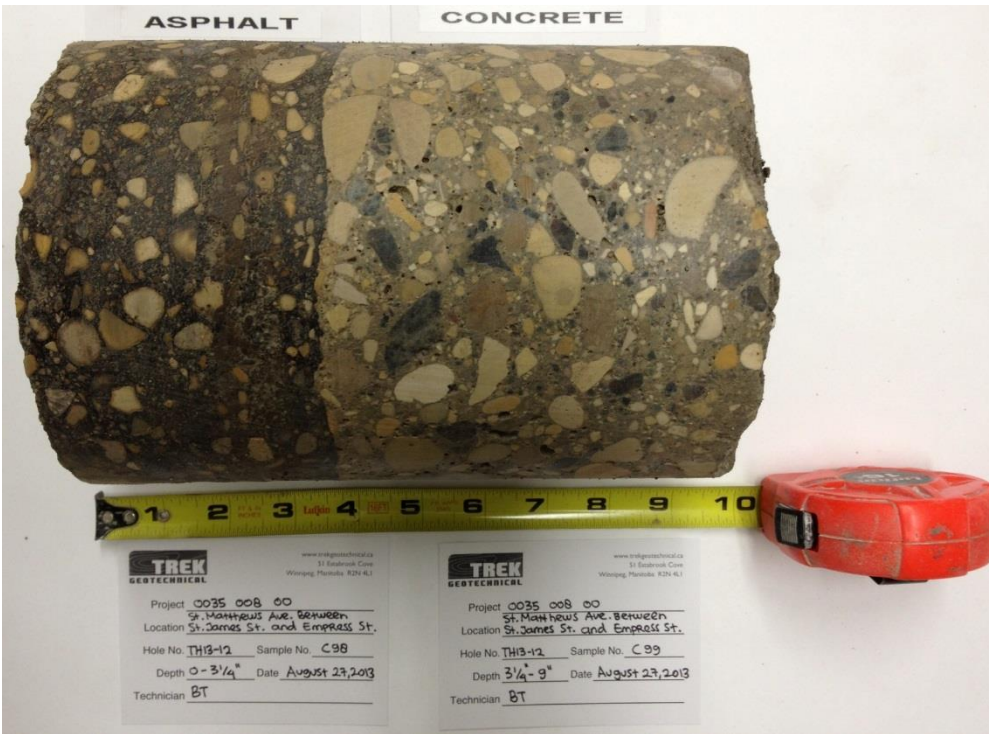
Photo 9: Asphalt and Concrete Core Sample from Test Hole TH13-12

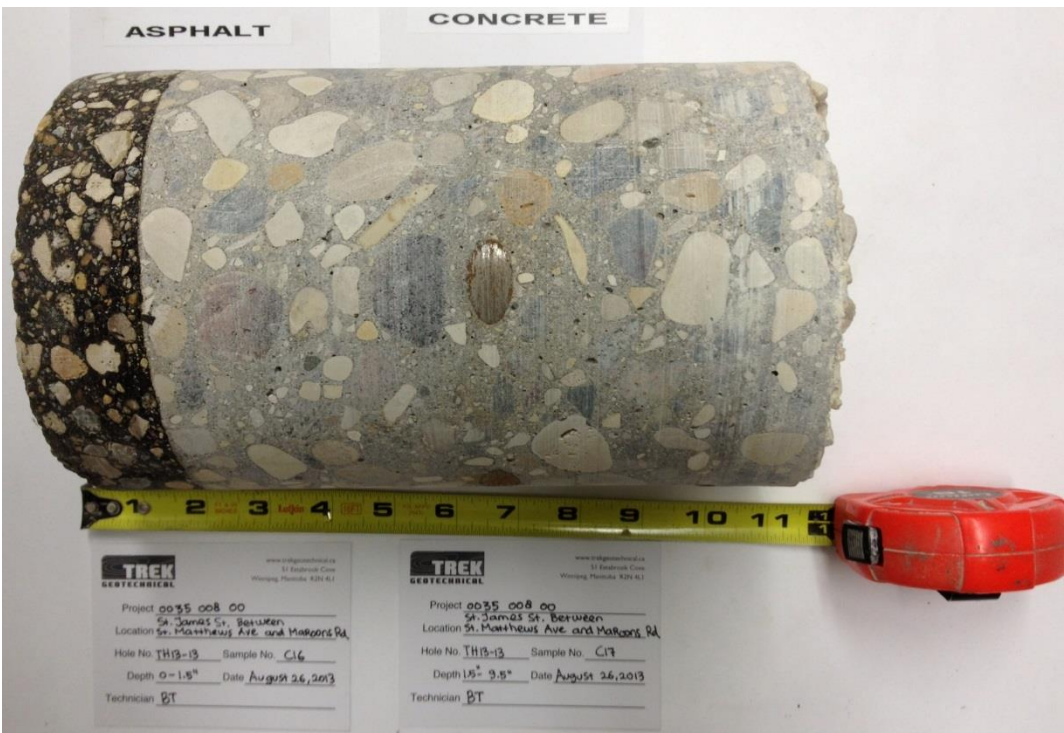
Photo 10: Asphalt and Concrete Core Sample from Test Hole TH13-13

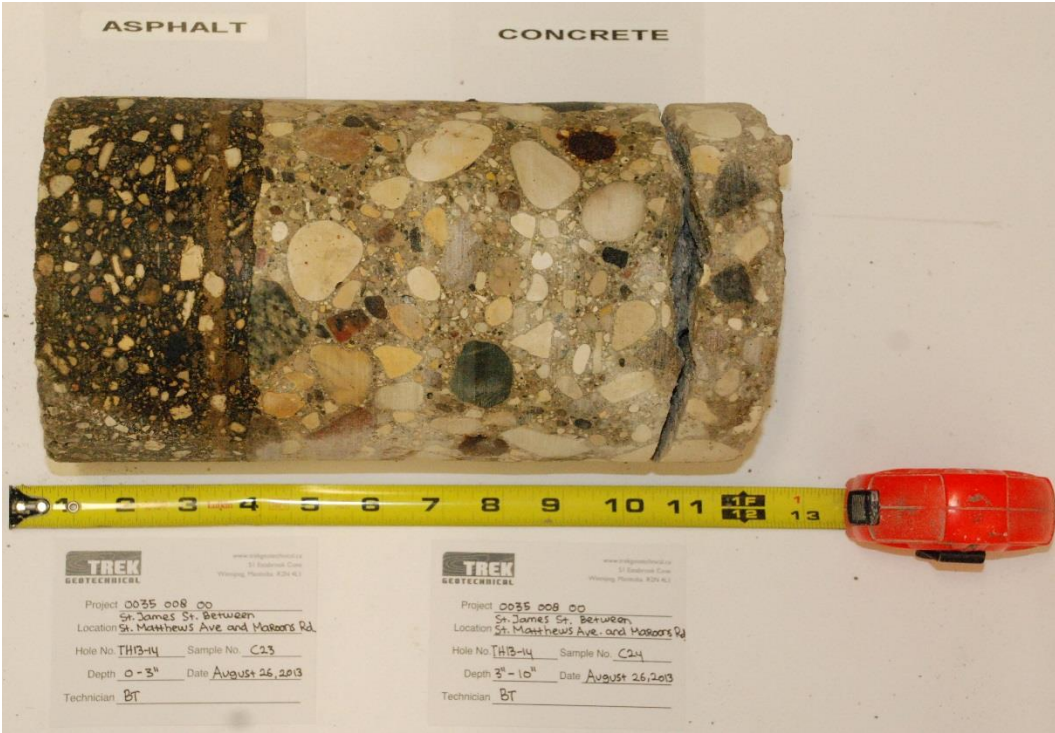
Photo 11: Asphalt and Concrete Core Sample from Test Hole TH13-14

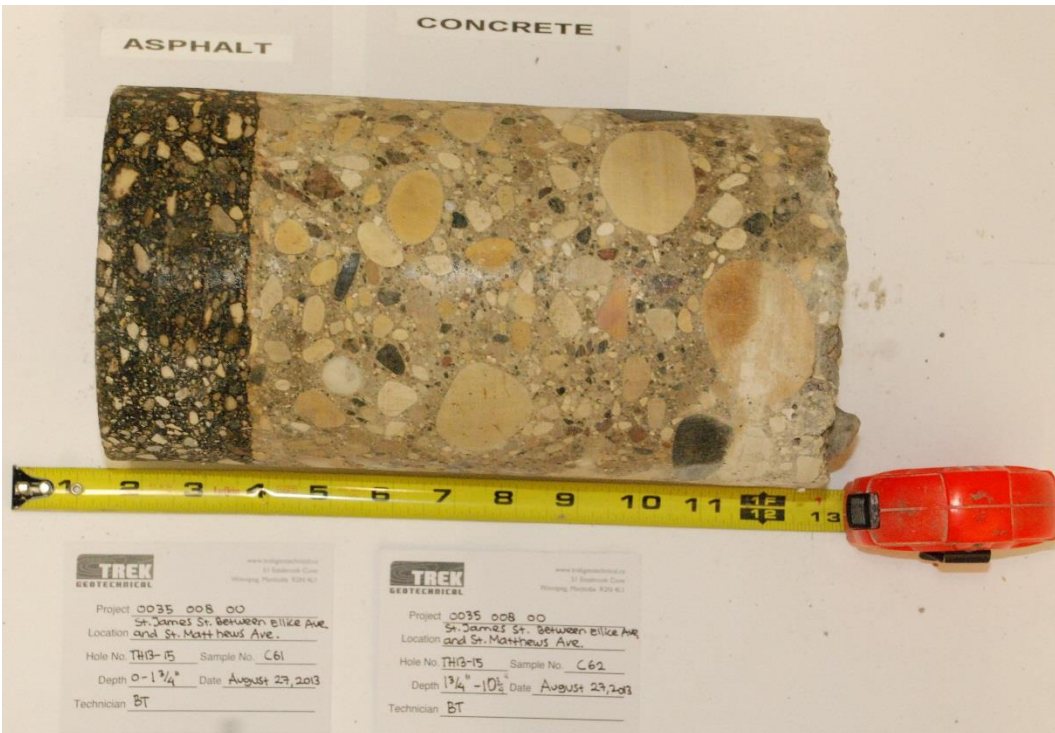
Photo 12: Asphalt and Concrete Core Sample from Test Hole TH13-15

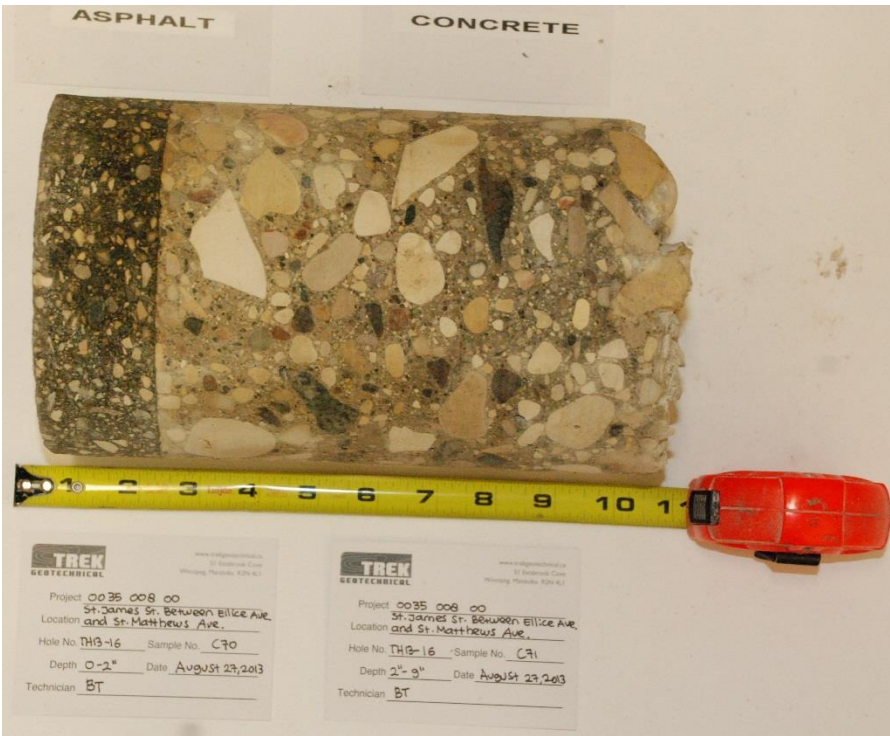
Photo 13: Asphalt and Concrete Core Sample from Test Hole TH13-16

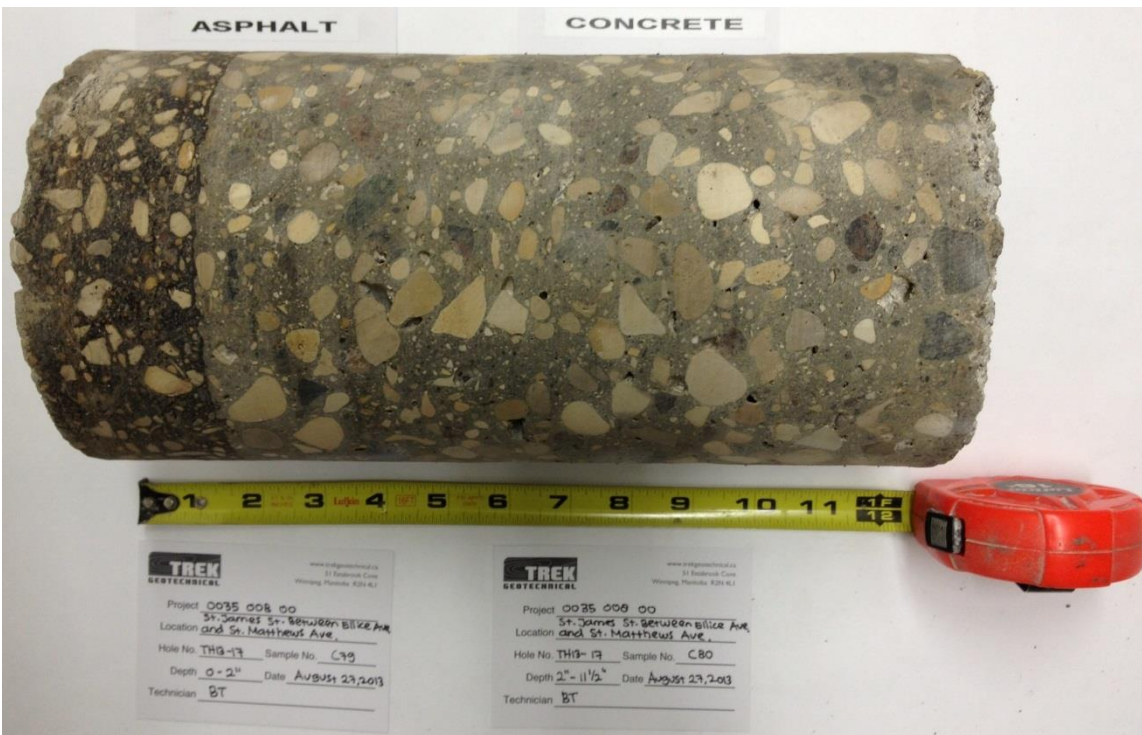
Photo 14: Asphalt and Concrete Core Sample from Test Hole TH13-17

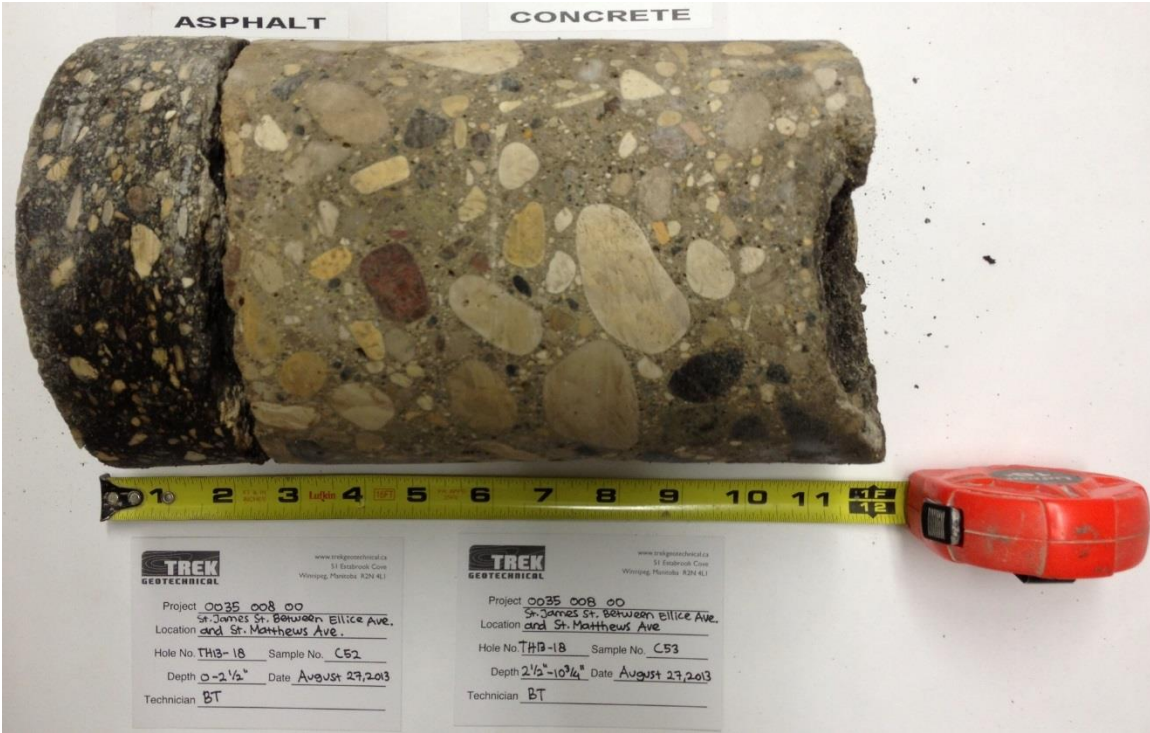
Photo 15: Asphalt and Concrete Core Sample from Test Hole TH13-18

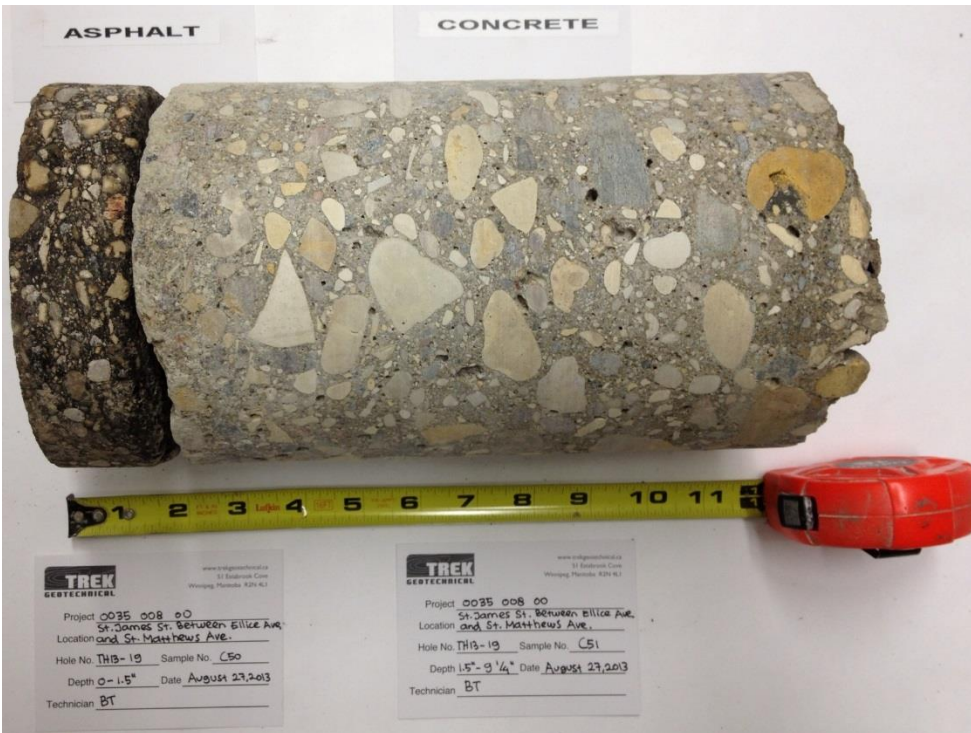
Photo 16: Asphalt and Concrete Core Sample from Test Hole TH13-19

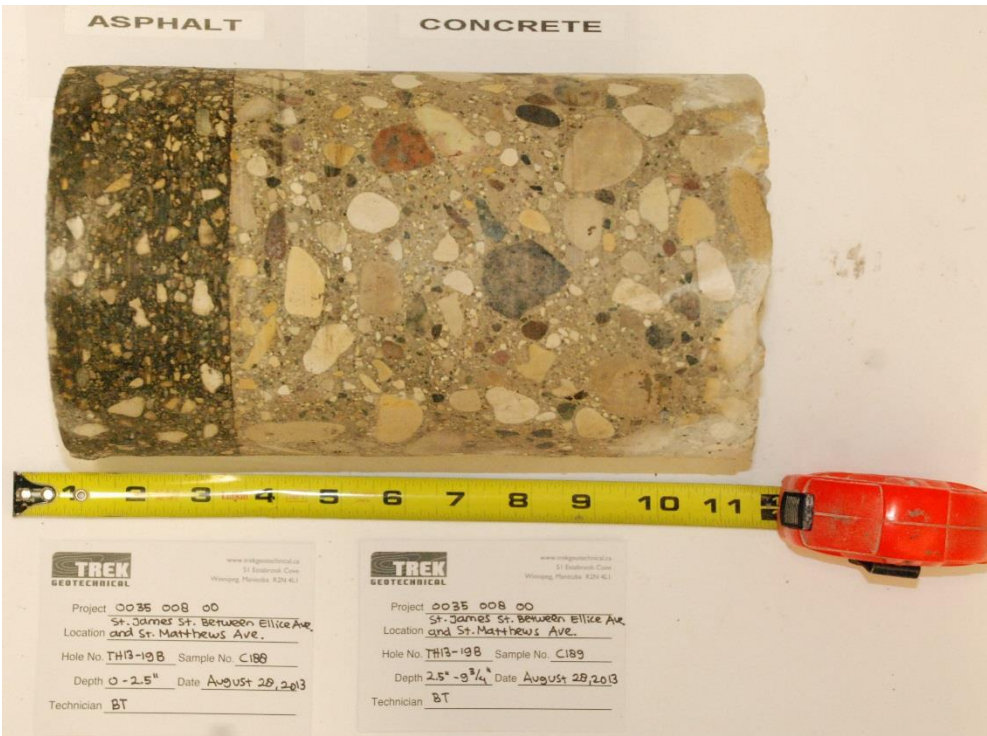
Photo 17: Asphalt and Concrete Core Sample from Test Hole TH13-19B

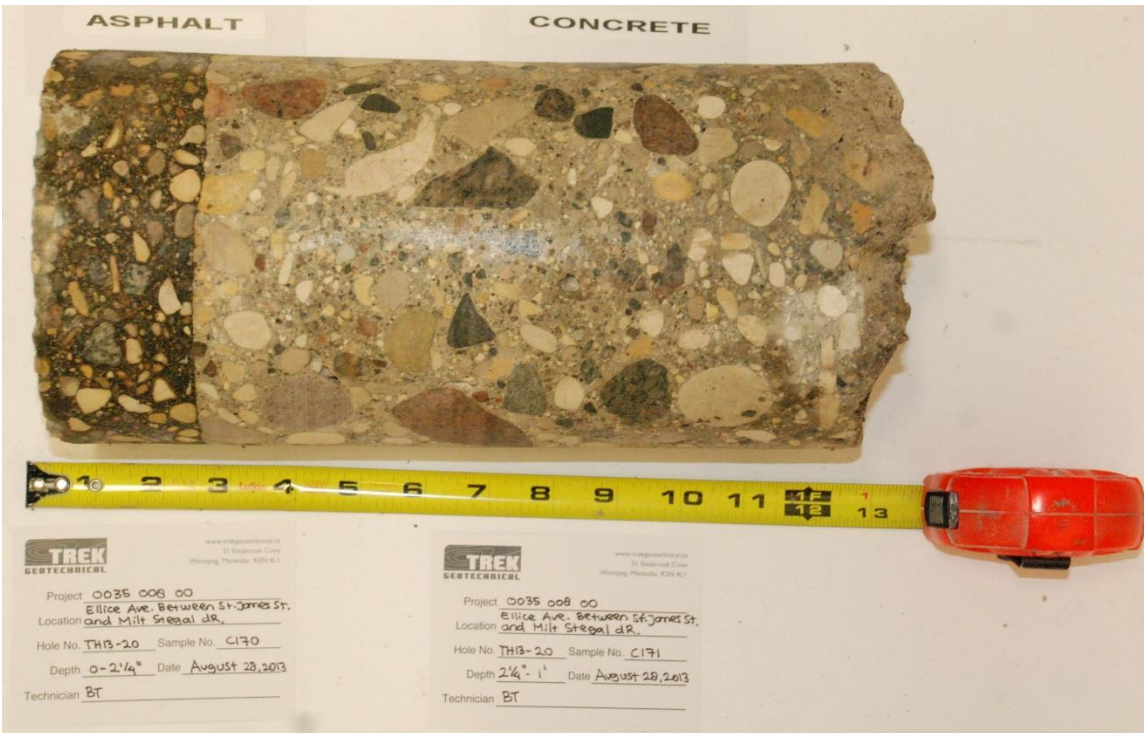
Photo 18: Asphalt and Concrete Core Sample from Test Hole TH13-20

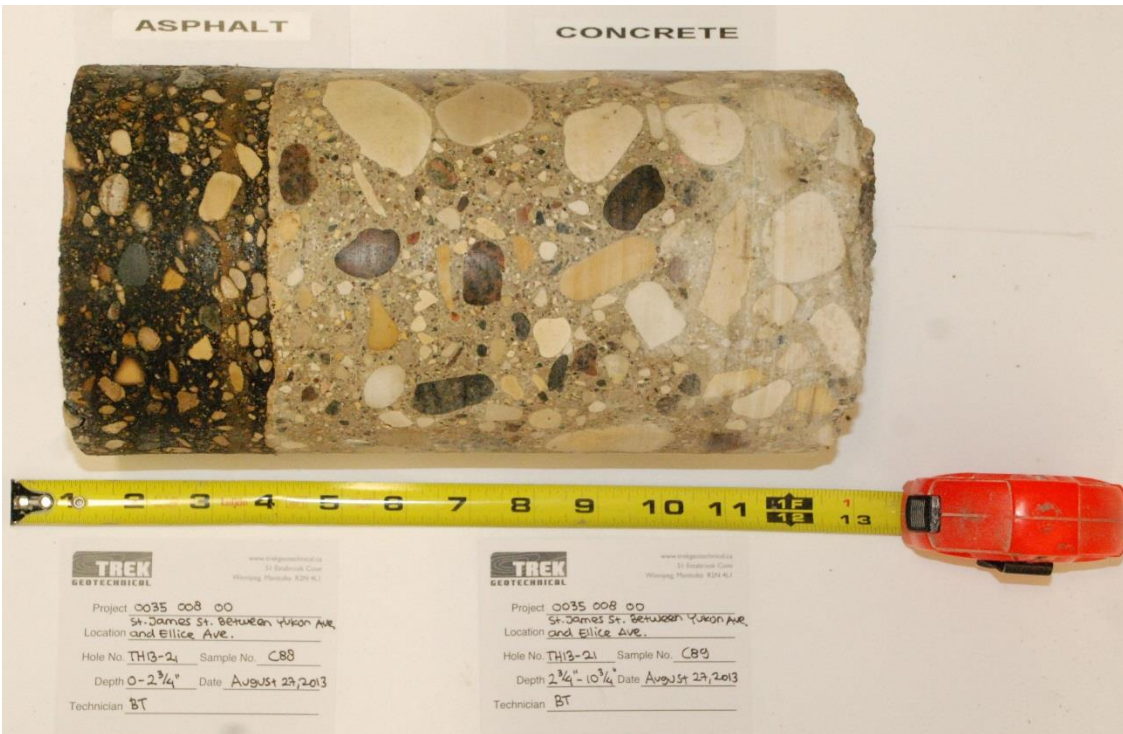
Photo 19: Asphalt and Concrete Core Sample from Test Hole TH13-21

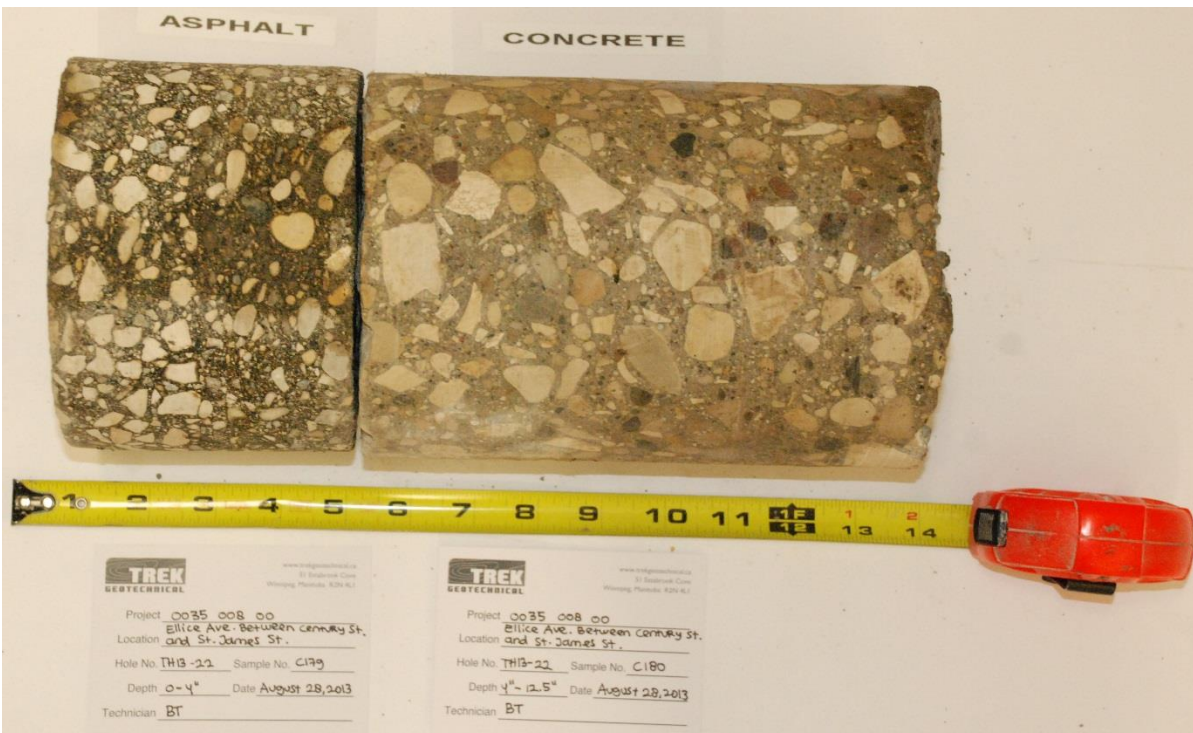
Photo 20: Asphalt and Concrete Core Sample from Test Hole TH13-22

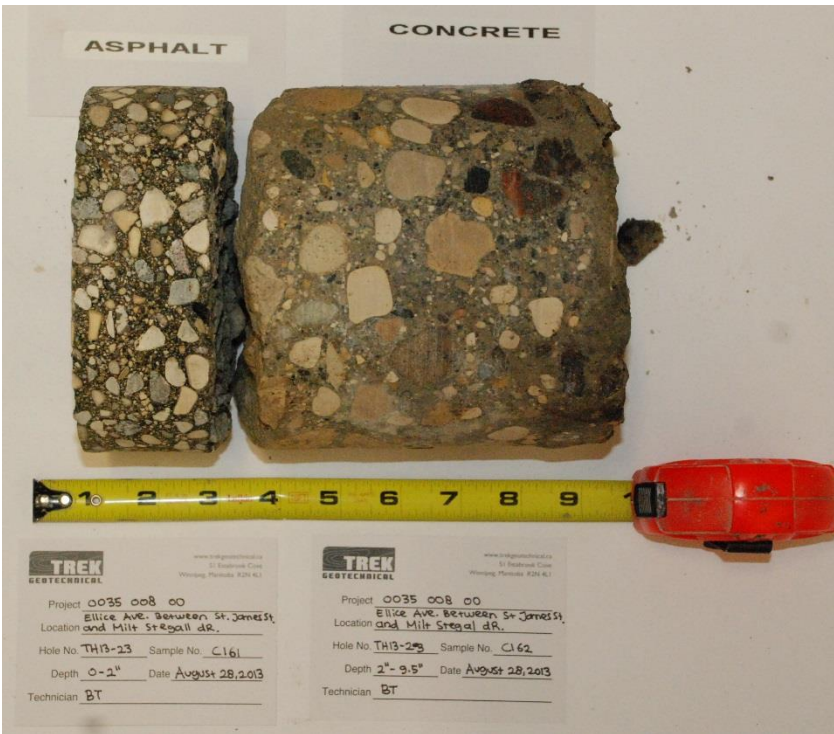
Photo 21: Asphalt and Concrete Core Sample from Test Hole TH13-23

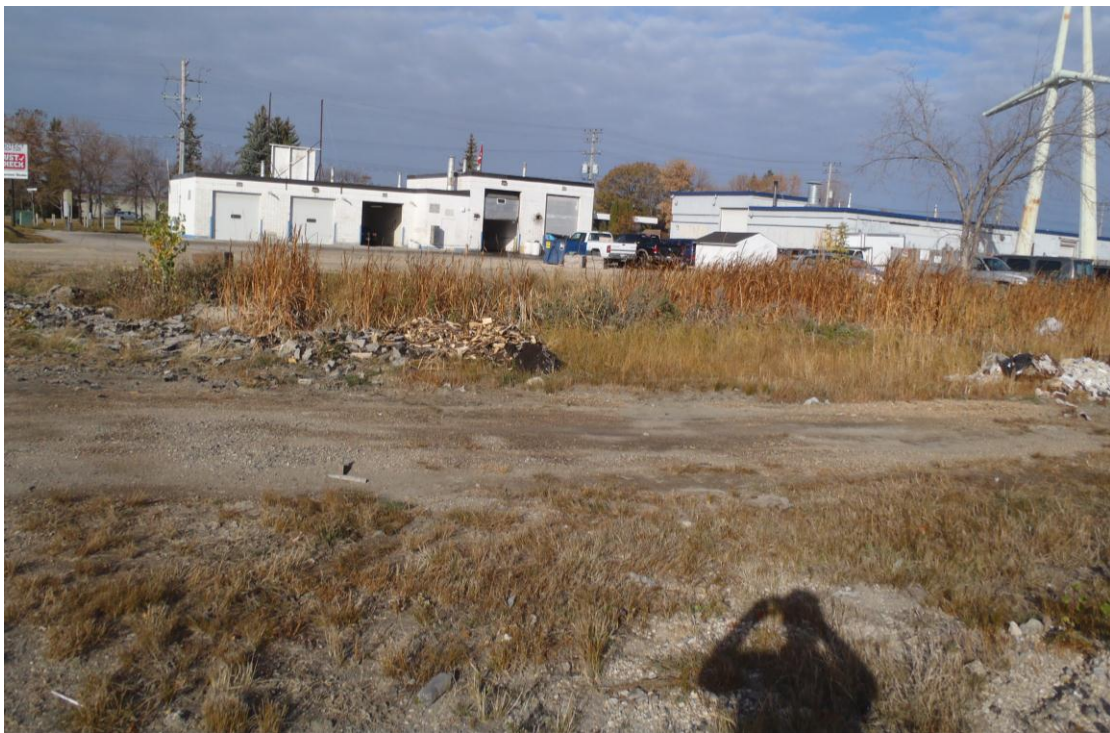
Photo 2: View looking west across former Oak Point Railway Branch right-of-way showing debris pile and rear of car wash operation through proposed St. Matthew Avenue extension.
