Olive Wastewater Pumping Station Upgrades Preliminary Design Report

City RFP No. 1100-2014

KGS Group No. 14-0107-043

March 2015

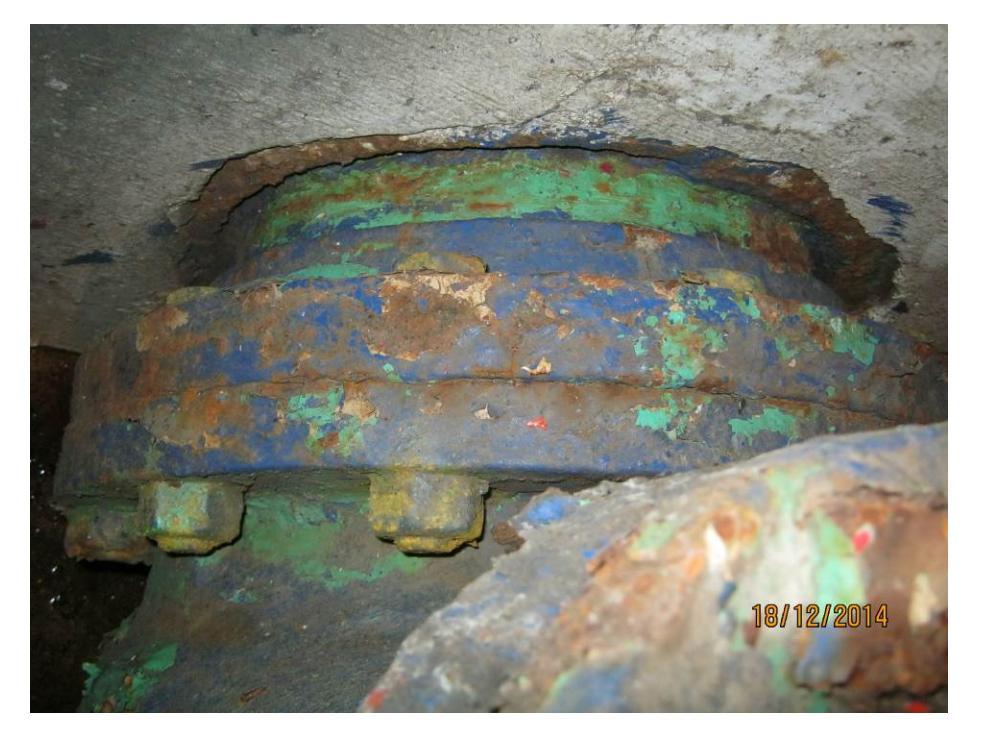
Photo 1 - Pump Suction Wall Insert

The pump suction wall inserts are cast iron and have corroded significantly over the years. Although they appear to not be leaking from the wet well around the outside seal between the pipe and concrete, it would be best to replace these inserts so as to ensure a complete as new system is provided when upgrades are completed.

The existing suction line wall inserts can be cored out and replaced with new piping along with a water tight resealing detail between the new pipe and existing concrete.

Replace the pump suction lines including the wall inserts to the wet well. In addition, the wet well itself should be thoroughly cleaned to remove grit and other materials that may have collected there over time.

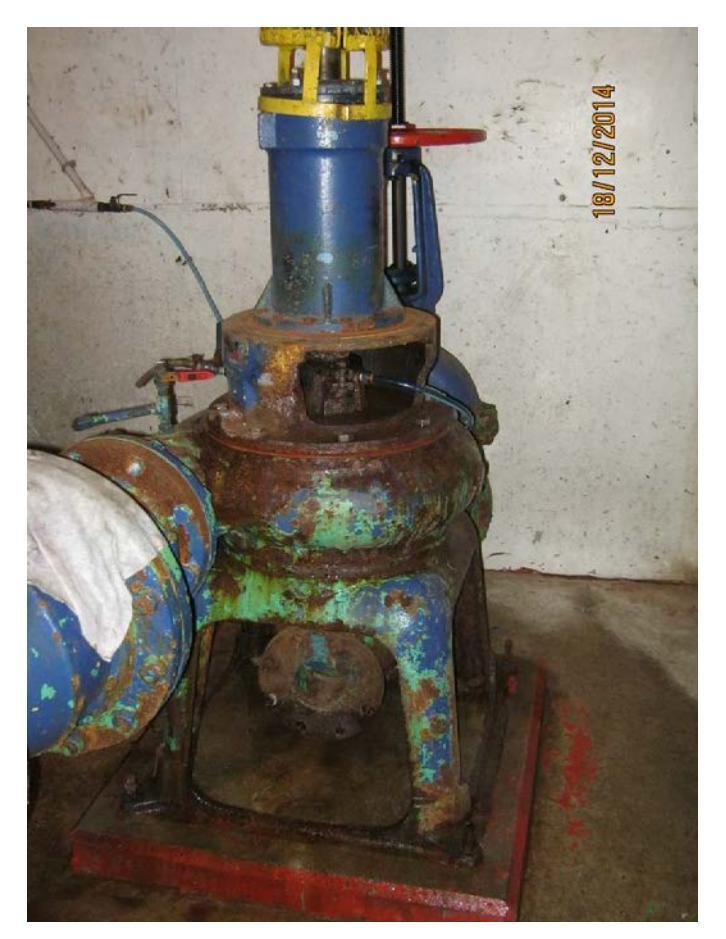
Photo 2 - One of Two Existing Pumps

The original pumps installed appear to have been replaced in 1983, with the original 50hp motors replaced with the existing 30hp motors which were taken from another station. Impeller and pump casing rings inside the pumps are worn to the point where pump casing opening is required on occasion to remove rags jammed between the impeller and casing.

It is recommended the pumps be replaced with pumps of similar vertical line shaft configuration and that a third pump be installed as backup should one of the two duty pumps be out of service during the summer season. This approach of installing backup pumps has previously been implemented at other stations.

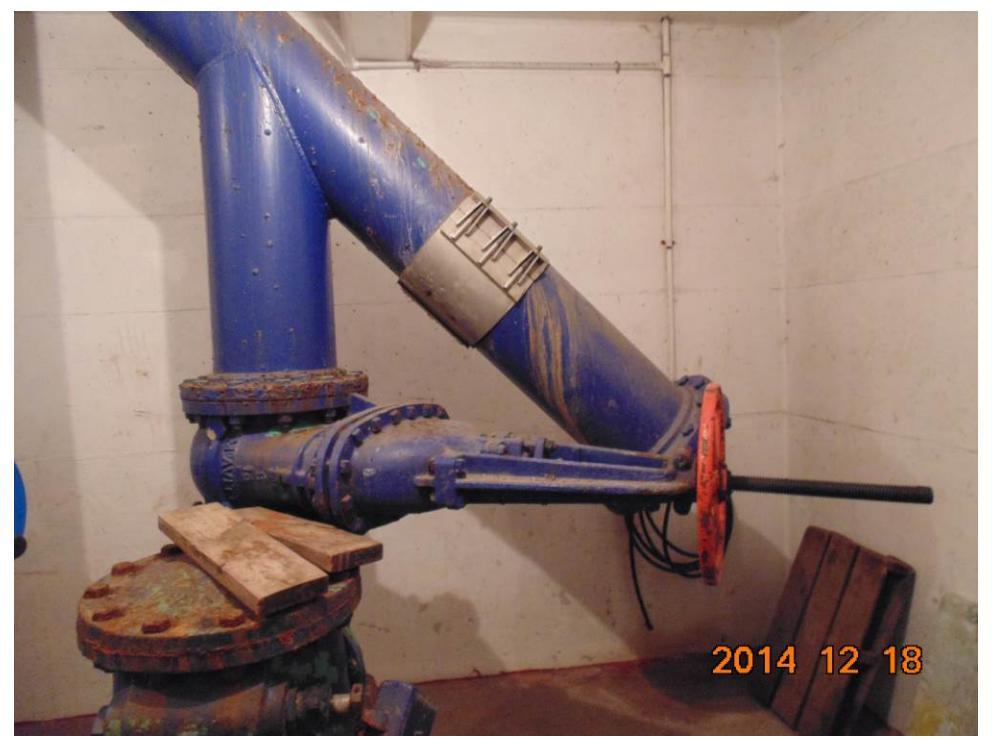
Photo 3 - Existing Piping

The piping and valves are well worn and have reached the end of their useful life. On the header connection to the future third pump, a repair clamp has already been installed to stop leakage through the pipe sidewall. This indicates significant wear is underway on the inside of this section of piping.

Although from the outside, the 16" wall insert pipe section leaving the building appears in good condition, the inside of the pipe may have experienced significant corrosion and should be replaced.

All process piping, including the discharge pipe wall insert, and related valves in the station should be replaced. Schedule 40 steel pipe, painted inside and out with a suitable paint system is recommended. Shut-off valves should be solid or rotating disk, ductile iron flanged or Victaulic coupled gate valves with bronze seats and hand wheel operators. Check valves should be ductile iron, flanged check valves with rubber flappers, position indication and backflow actuators.

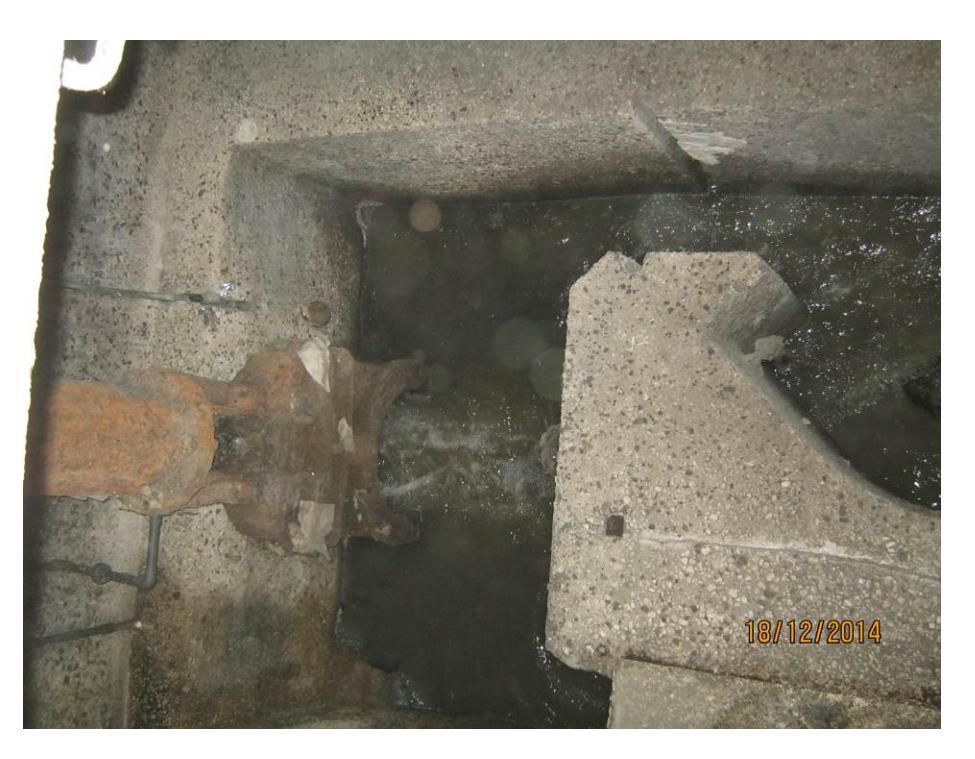
Photo 4 - 20" Comminutor Inlet Valve

This shut-off valve and related water operating system are original equipment. This system has reached the end of its useful life. The automatic water operating system is complex and no longer required.

The existing valve should be replaced with a new gate valve complete with a manual handwheel operator provided on the floor level above. The handwheel operator should remain on the comminutor motor level above as the comminutor chamber itself remains subject to flooding from the inlet sewer entering the wet well directly from the north.

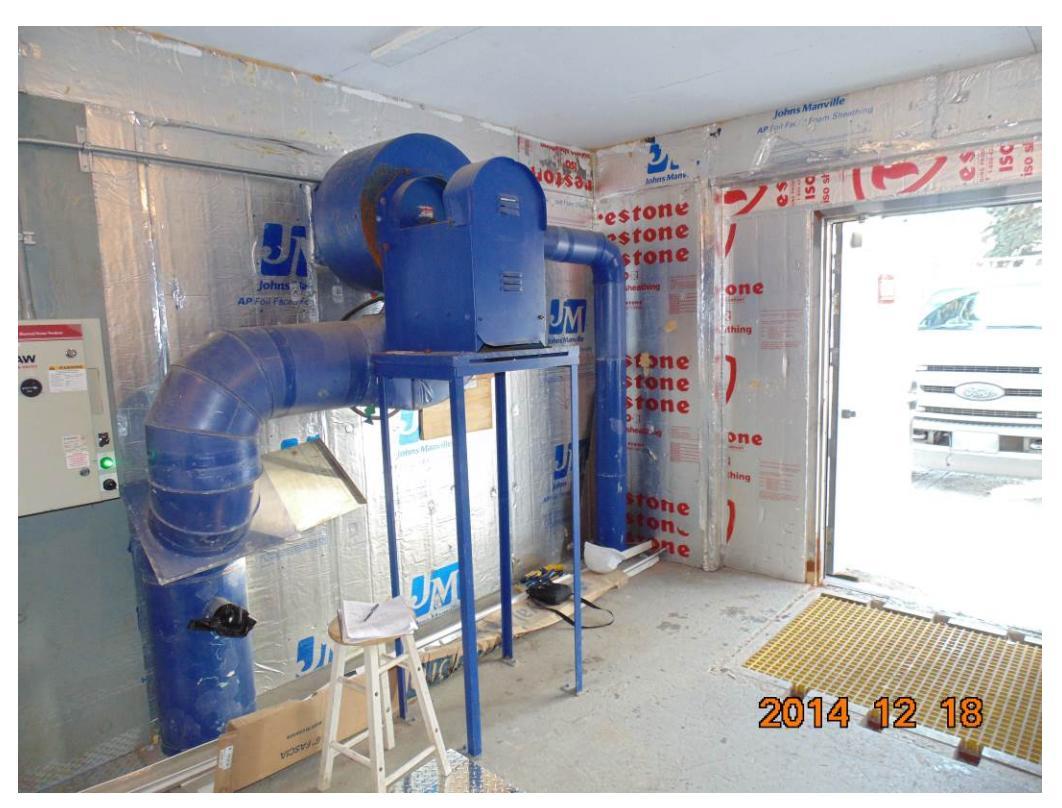
Photo 5 - Supply Fan Location in Main Floor Electrical Room

A supply fan located on the main floor, supplies unfiltered, unheated outdoor air throughout the lower levels of the station. This fan is manually operated via a wall switch and can be turned on to clear unsafe gases from the lower levels before personnel are allowed to enter. Ducting carries the outdoor air to different areas of the lower levels. The volume flow of supply air is regulated via manual blast gate dampers. A 200 mm duct then carries the relief air from the lower levels to the outdoors. Air from the comminutor chamber is vented to outdoors directly by a dedicated 100 mm PVC relief vent pipe. No ventilation is supplied to the main floor electrical room.

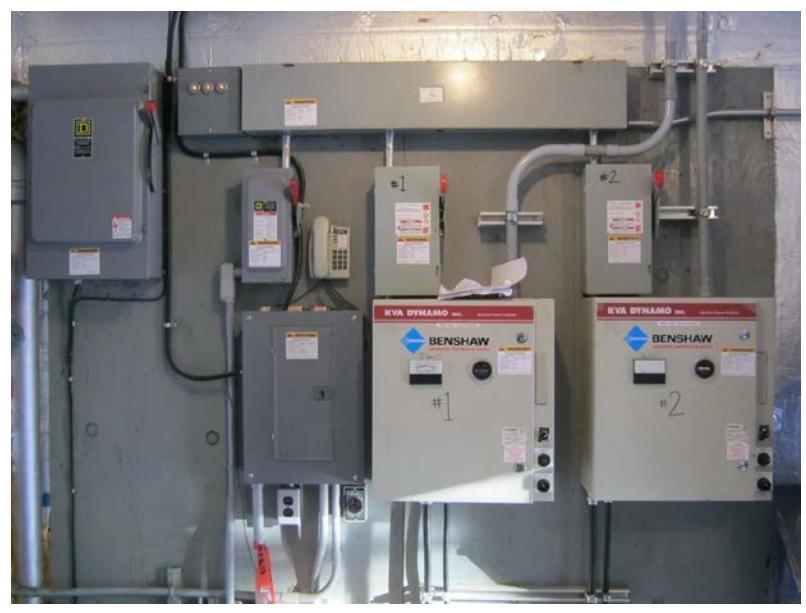
Figure 6 - Existing Power Distribution

Currently the equipment is all individually mounted. Wiring between this equipment is TECK90, PVC conduit and in some cases rigid metallic conduit. The current equipment is not hazardous location rated.
