SECTION: TYPICAL NORTH PIER COLUMN DELAMINATION REPAIR SCALE: 1:5

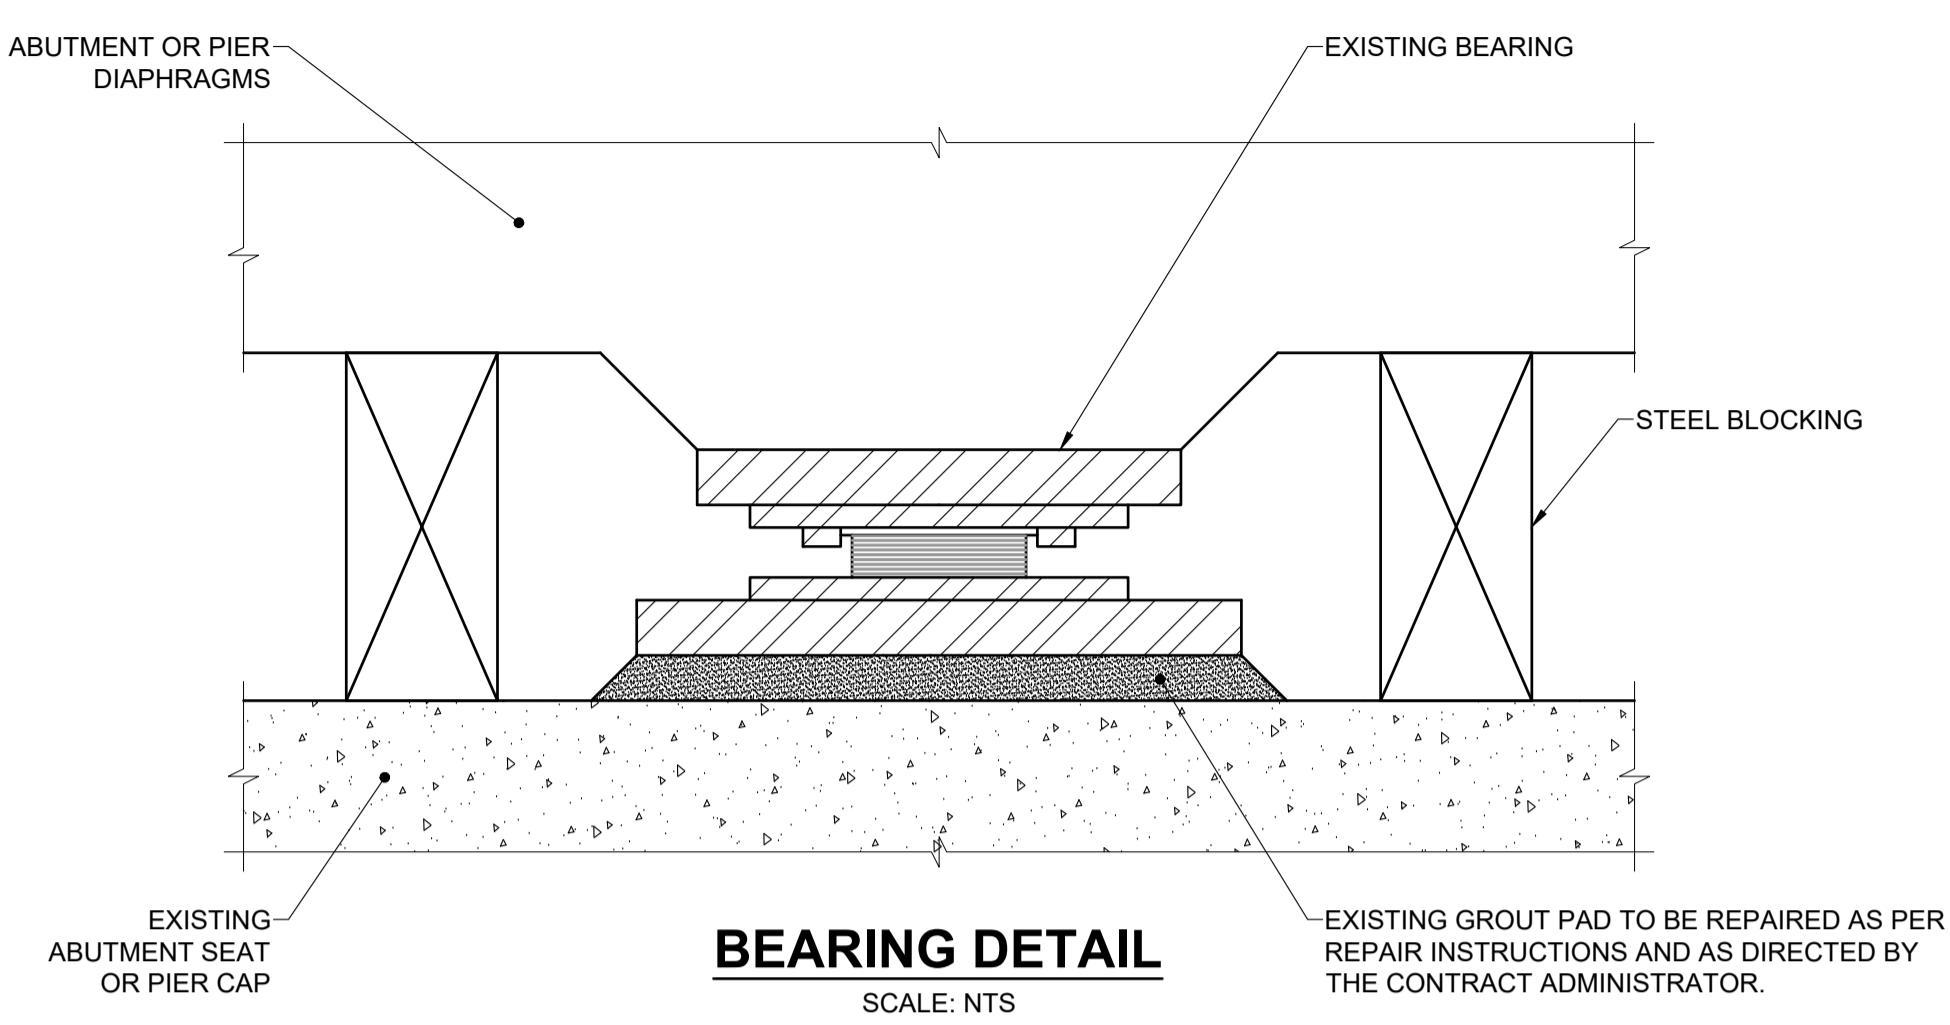
NOTES: 1. CONFIRMED REPAIR LOCATIONS: TWO BEARINGS AT WEST END OF SOUTH ABUTMENT

REPAIR INSTRUCTIONS:

2. REMOVE DETERIORATED GROUT. 3. PLACE NEW GROUT TO APPROXIMATE LIMITS OF EXISTING GROUT PAD.

1. INSTALL STEEL BLOCKING TO SUPPORT DIAPHRAGM.

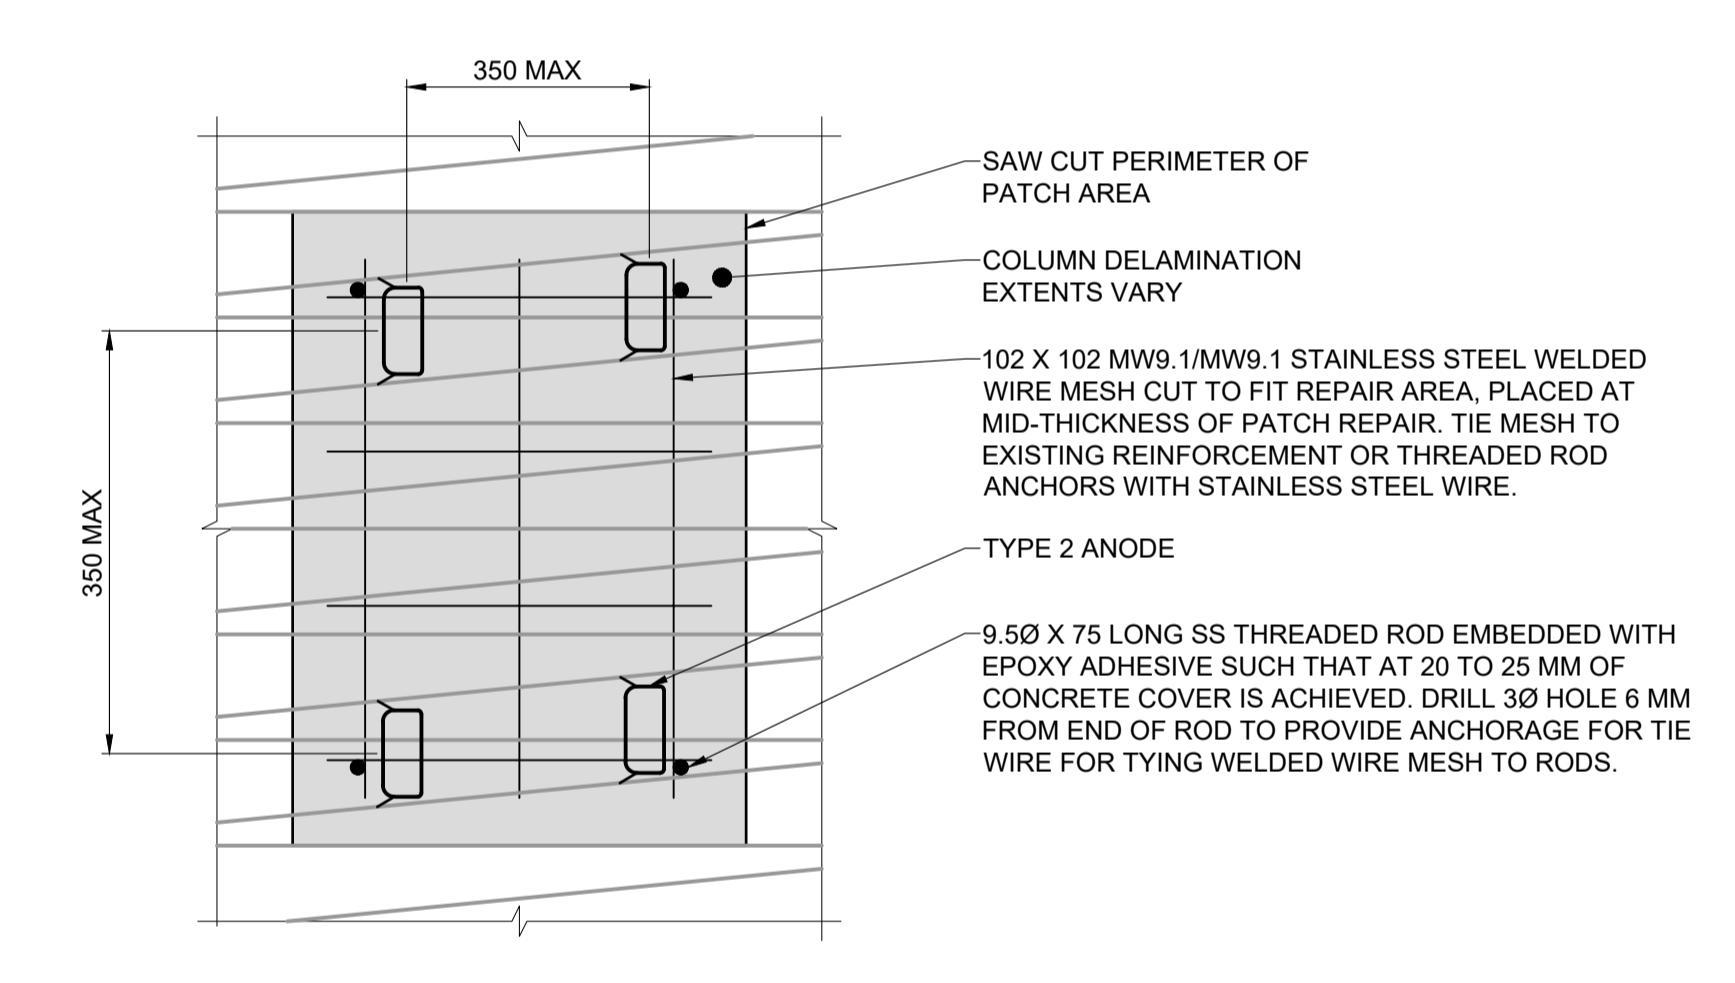
ER COLUMNS 12 AND 14

9. NARROW CRACKS TO BE REPAIRED WITH SILANE

NOTES: 1. SAWCUT PERIPHERY OF REPAIR AREA TO 25 DEEP. 2. DRILL HOLES AND INSTALL THREADED RODS. 4. SANDBLAST ALL EXPOSED REINFORCING STEEL. TIE REINFORCING MESH TO THREADED RODS.

7. PLACE NEW CONCRETE TO COMPLETE PATCH REPAIR. REPAIR LOCATIONS:
