# APPENDIX C SHOAL LAKE AQUEDUCT INTAKE RESIDENCE UPGRADE – SITE PHOTOS

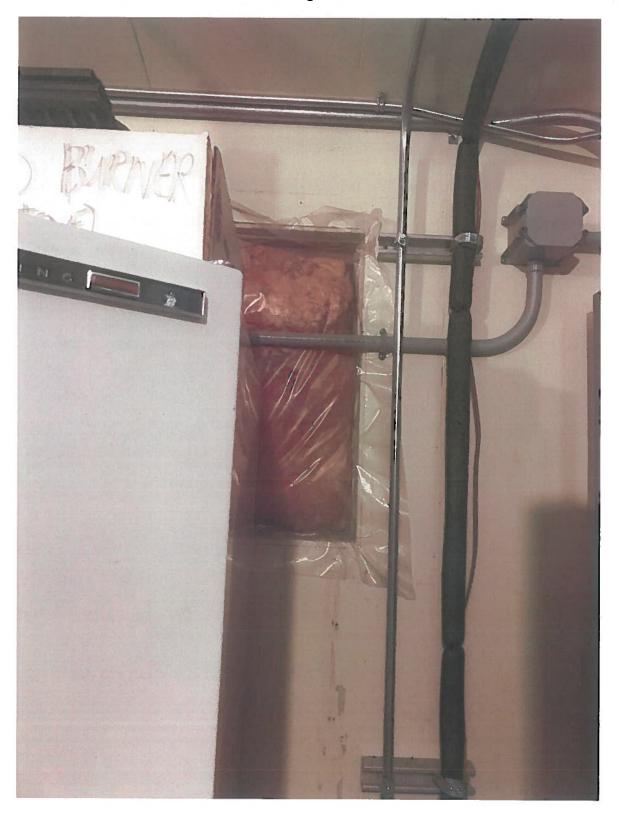
Staffhouse Room 111 – Existing Window to Remove and Infill

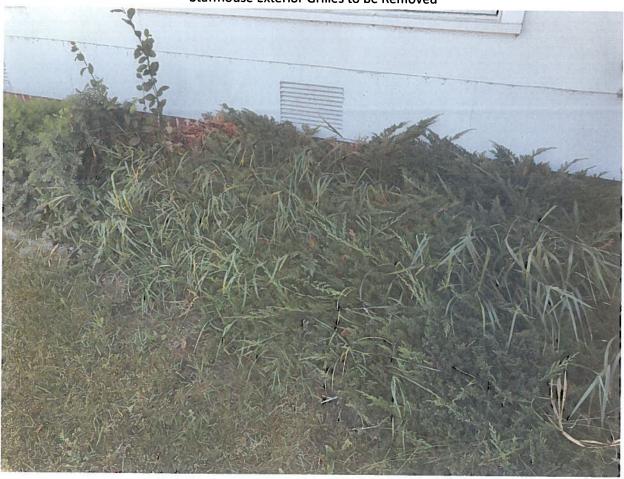
Staffhouse Exterior Grilles to be Removed
