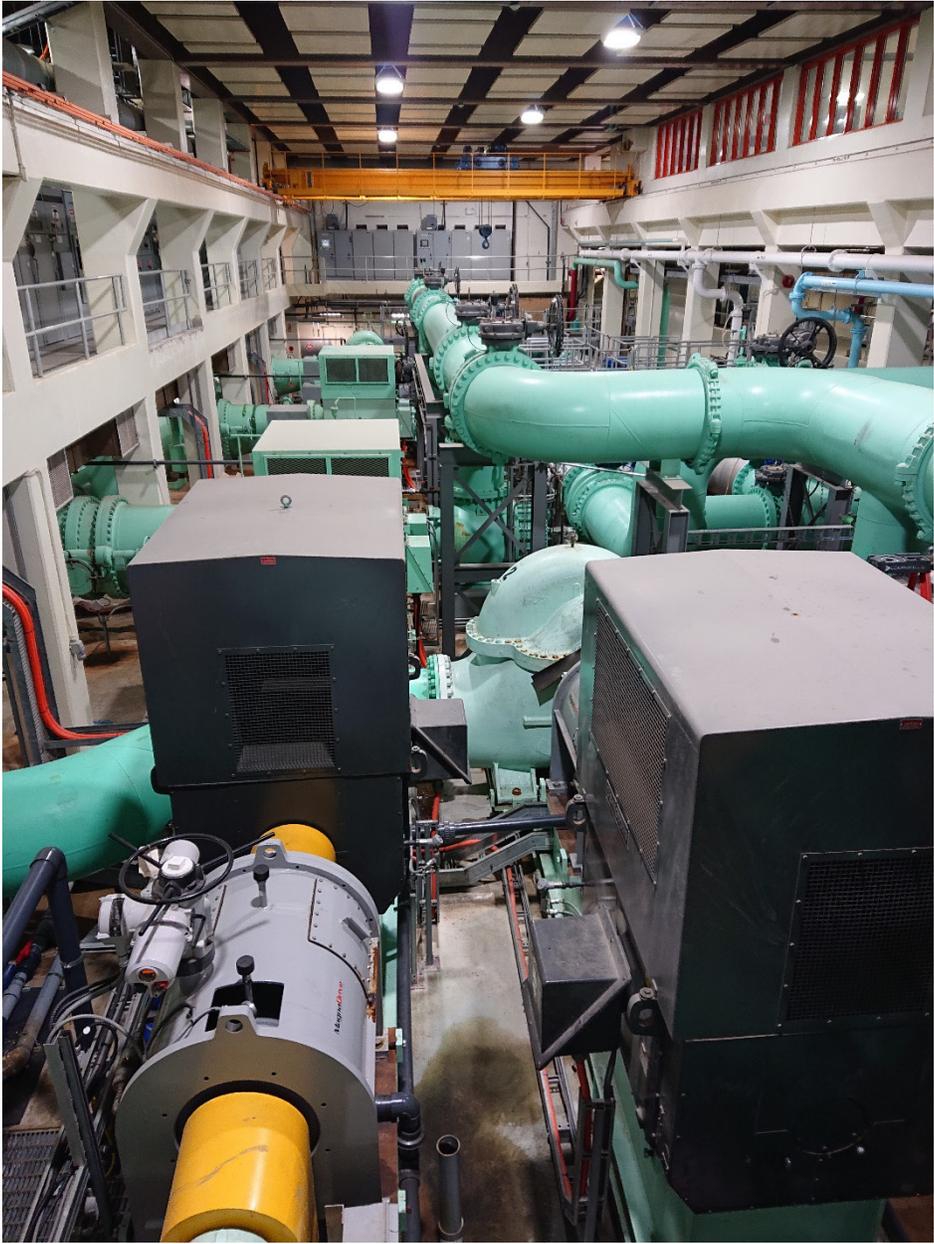
Figure 1: View from West Side of Deacon Pump Floor

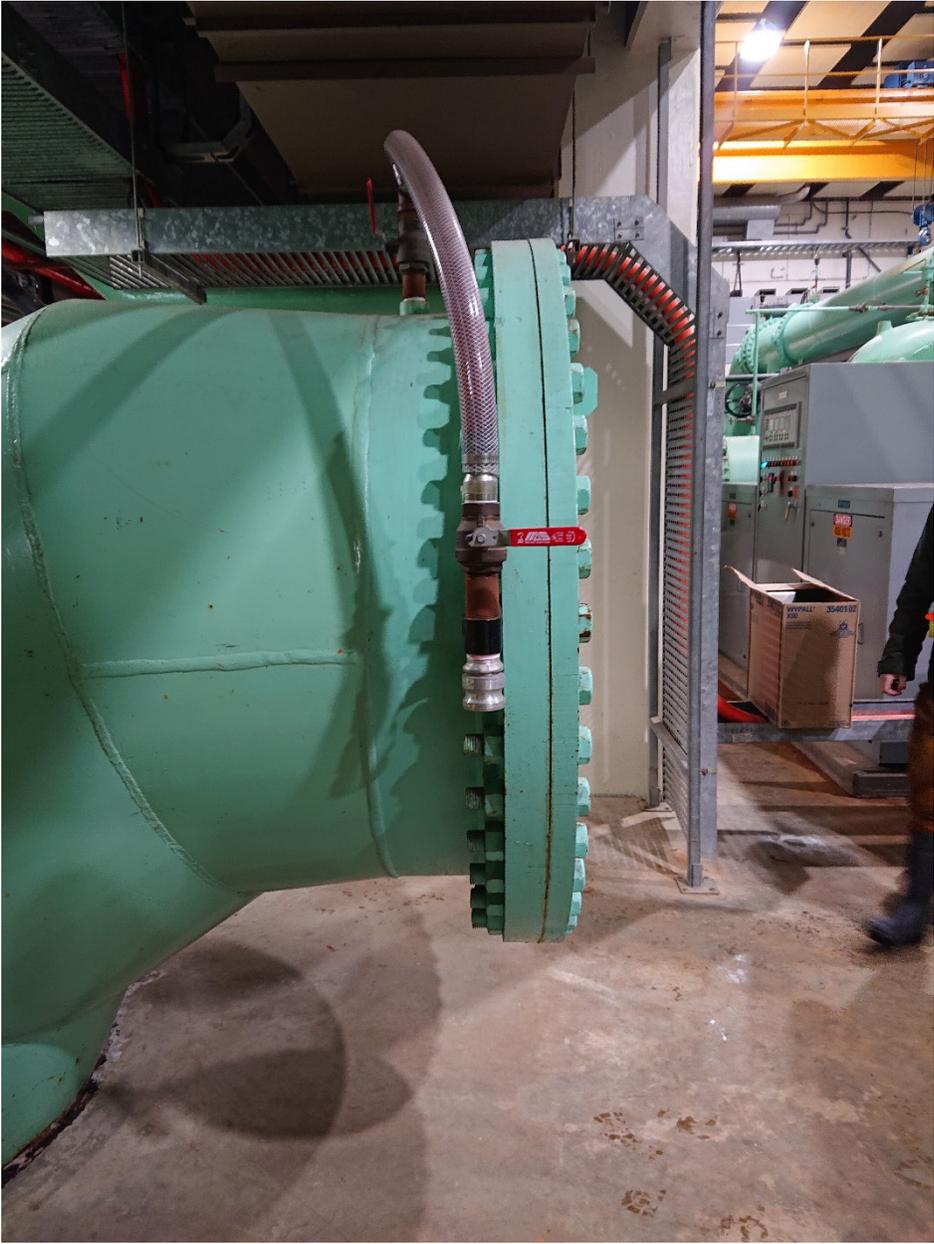
Figure 2: View of Pipe Bend Reducer and Blind Flange to be Removed

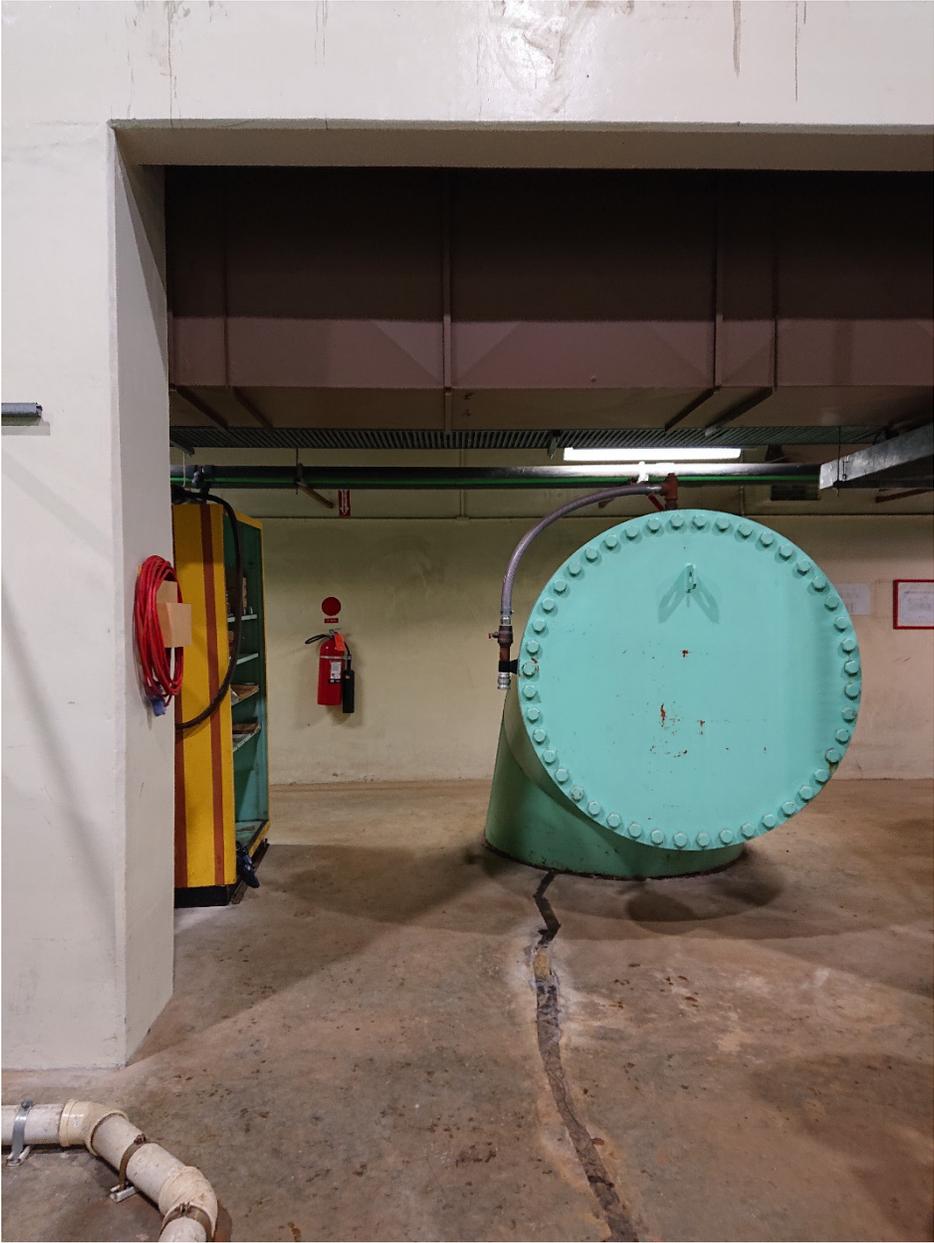
Figure 3: View of Work Area at Pipe Bend Reducer Facing North

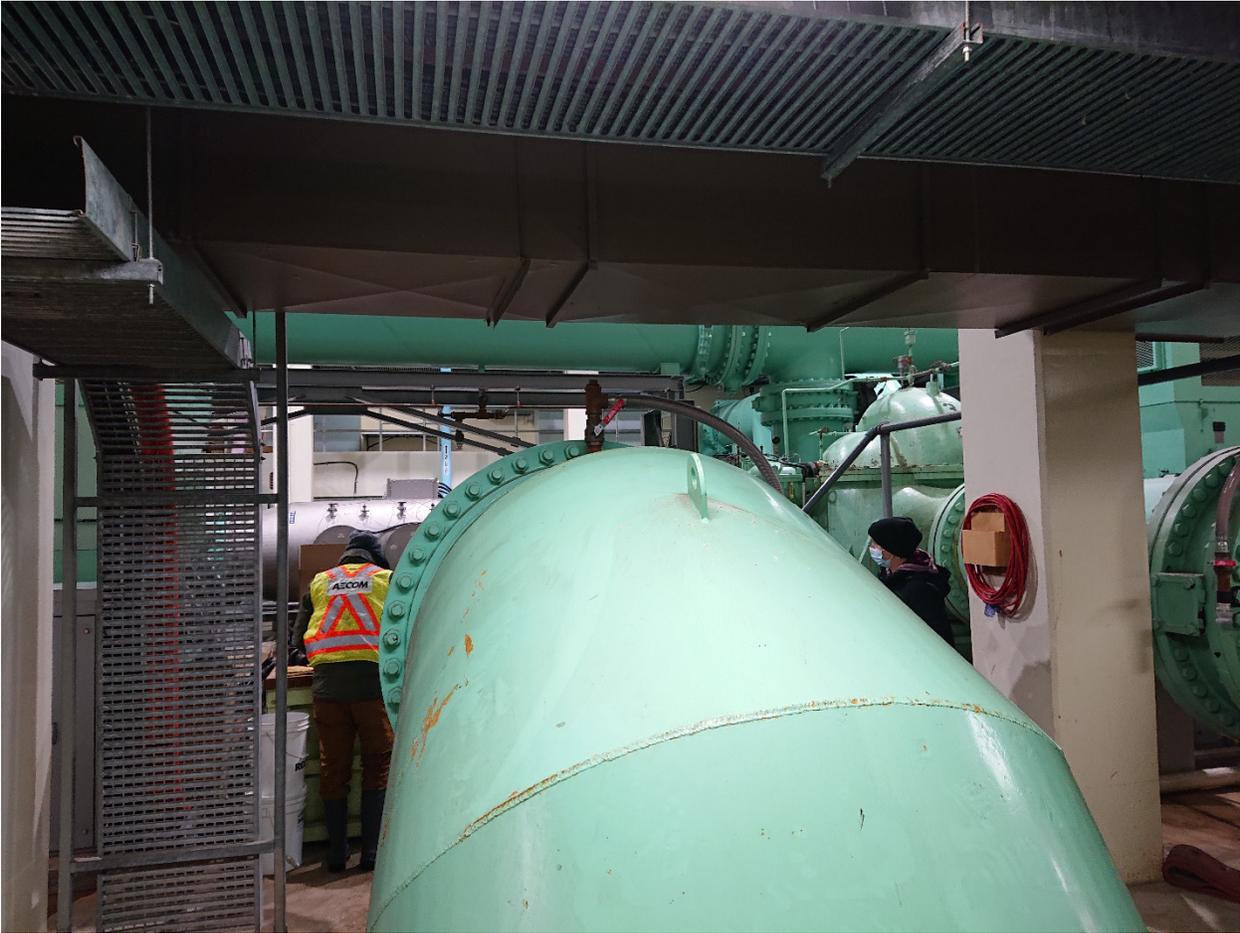
Figure 4: View of Work Area at Pipe Bend Reducer Facing South
