Report on the Geotechnical Aspects of the Old St. Vital Riverwalk Project

FILE NO. 7016

DATE; MARCH 23, 1998

PREPARED BY; A. DEAN GOULD P.ENG

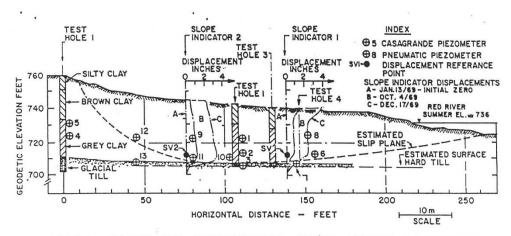
FIGURE I - ST. VITAL SITE, RIVER BANK CROSS-SECTION, LOCATIONS OF PIEZOMETERS, SLOPE INDICATORS, TEST HOLES AND REFERENCE POINTS.

Analysis of the riverbank stability using the following soil strength parameters has been performed by the writer. The non circular failure surface shown, reflects the soil profile and slope indicator data by Ripley Klohn and Leonoff of 1972.

TYPICAL SLOPE INDICATOR HORIZONTAL DISPLACEMENTS, ESTIMATED SLIP PLANE

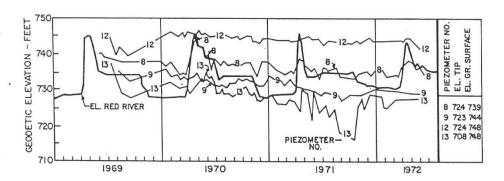
FIGURE 2- ST. VITAL SITE - RIVER BANK SLIDE PIEZOMETRIC ELEVATIONS FOR SELECTED PIEZOMETERS. ELEVATION RED RIVER

Applying piezometric pressures in the analysis from the 1994 City of Winnipeg Rivers and Streams Report on "Role of Ground water in Riverbank Stability" the Computed Factors of Safety against sliding are;
