Appendix B

Geotechnical Data Report

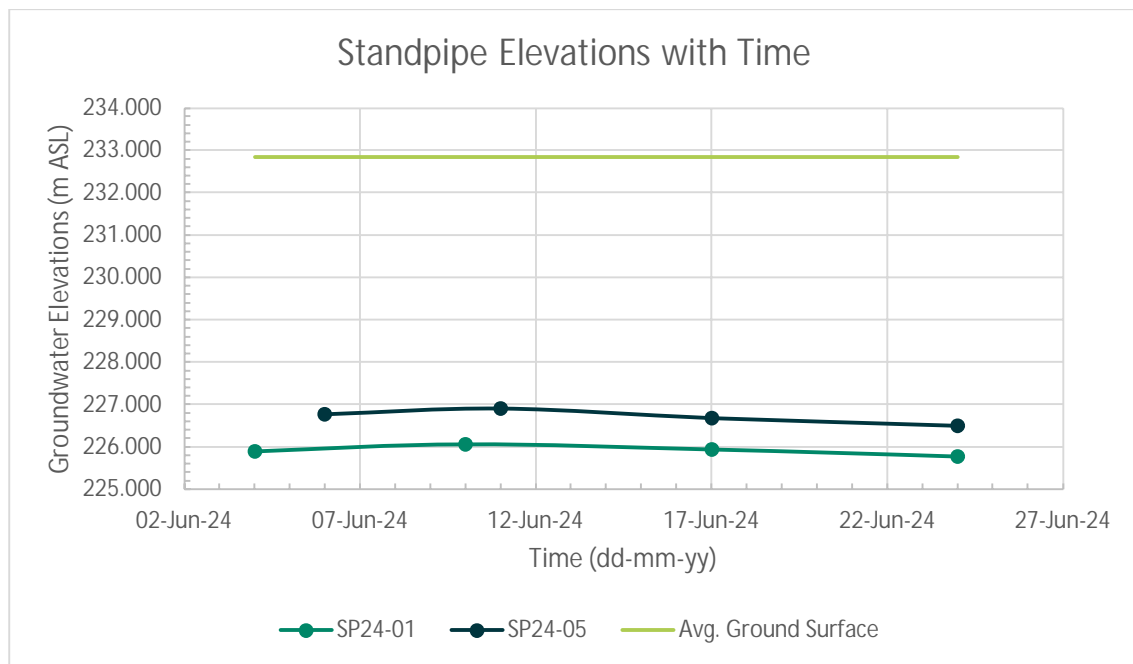
Figure 6-1: Graph of Groundwater Elevations Versus Time

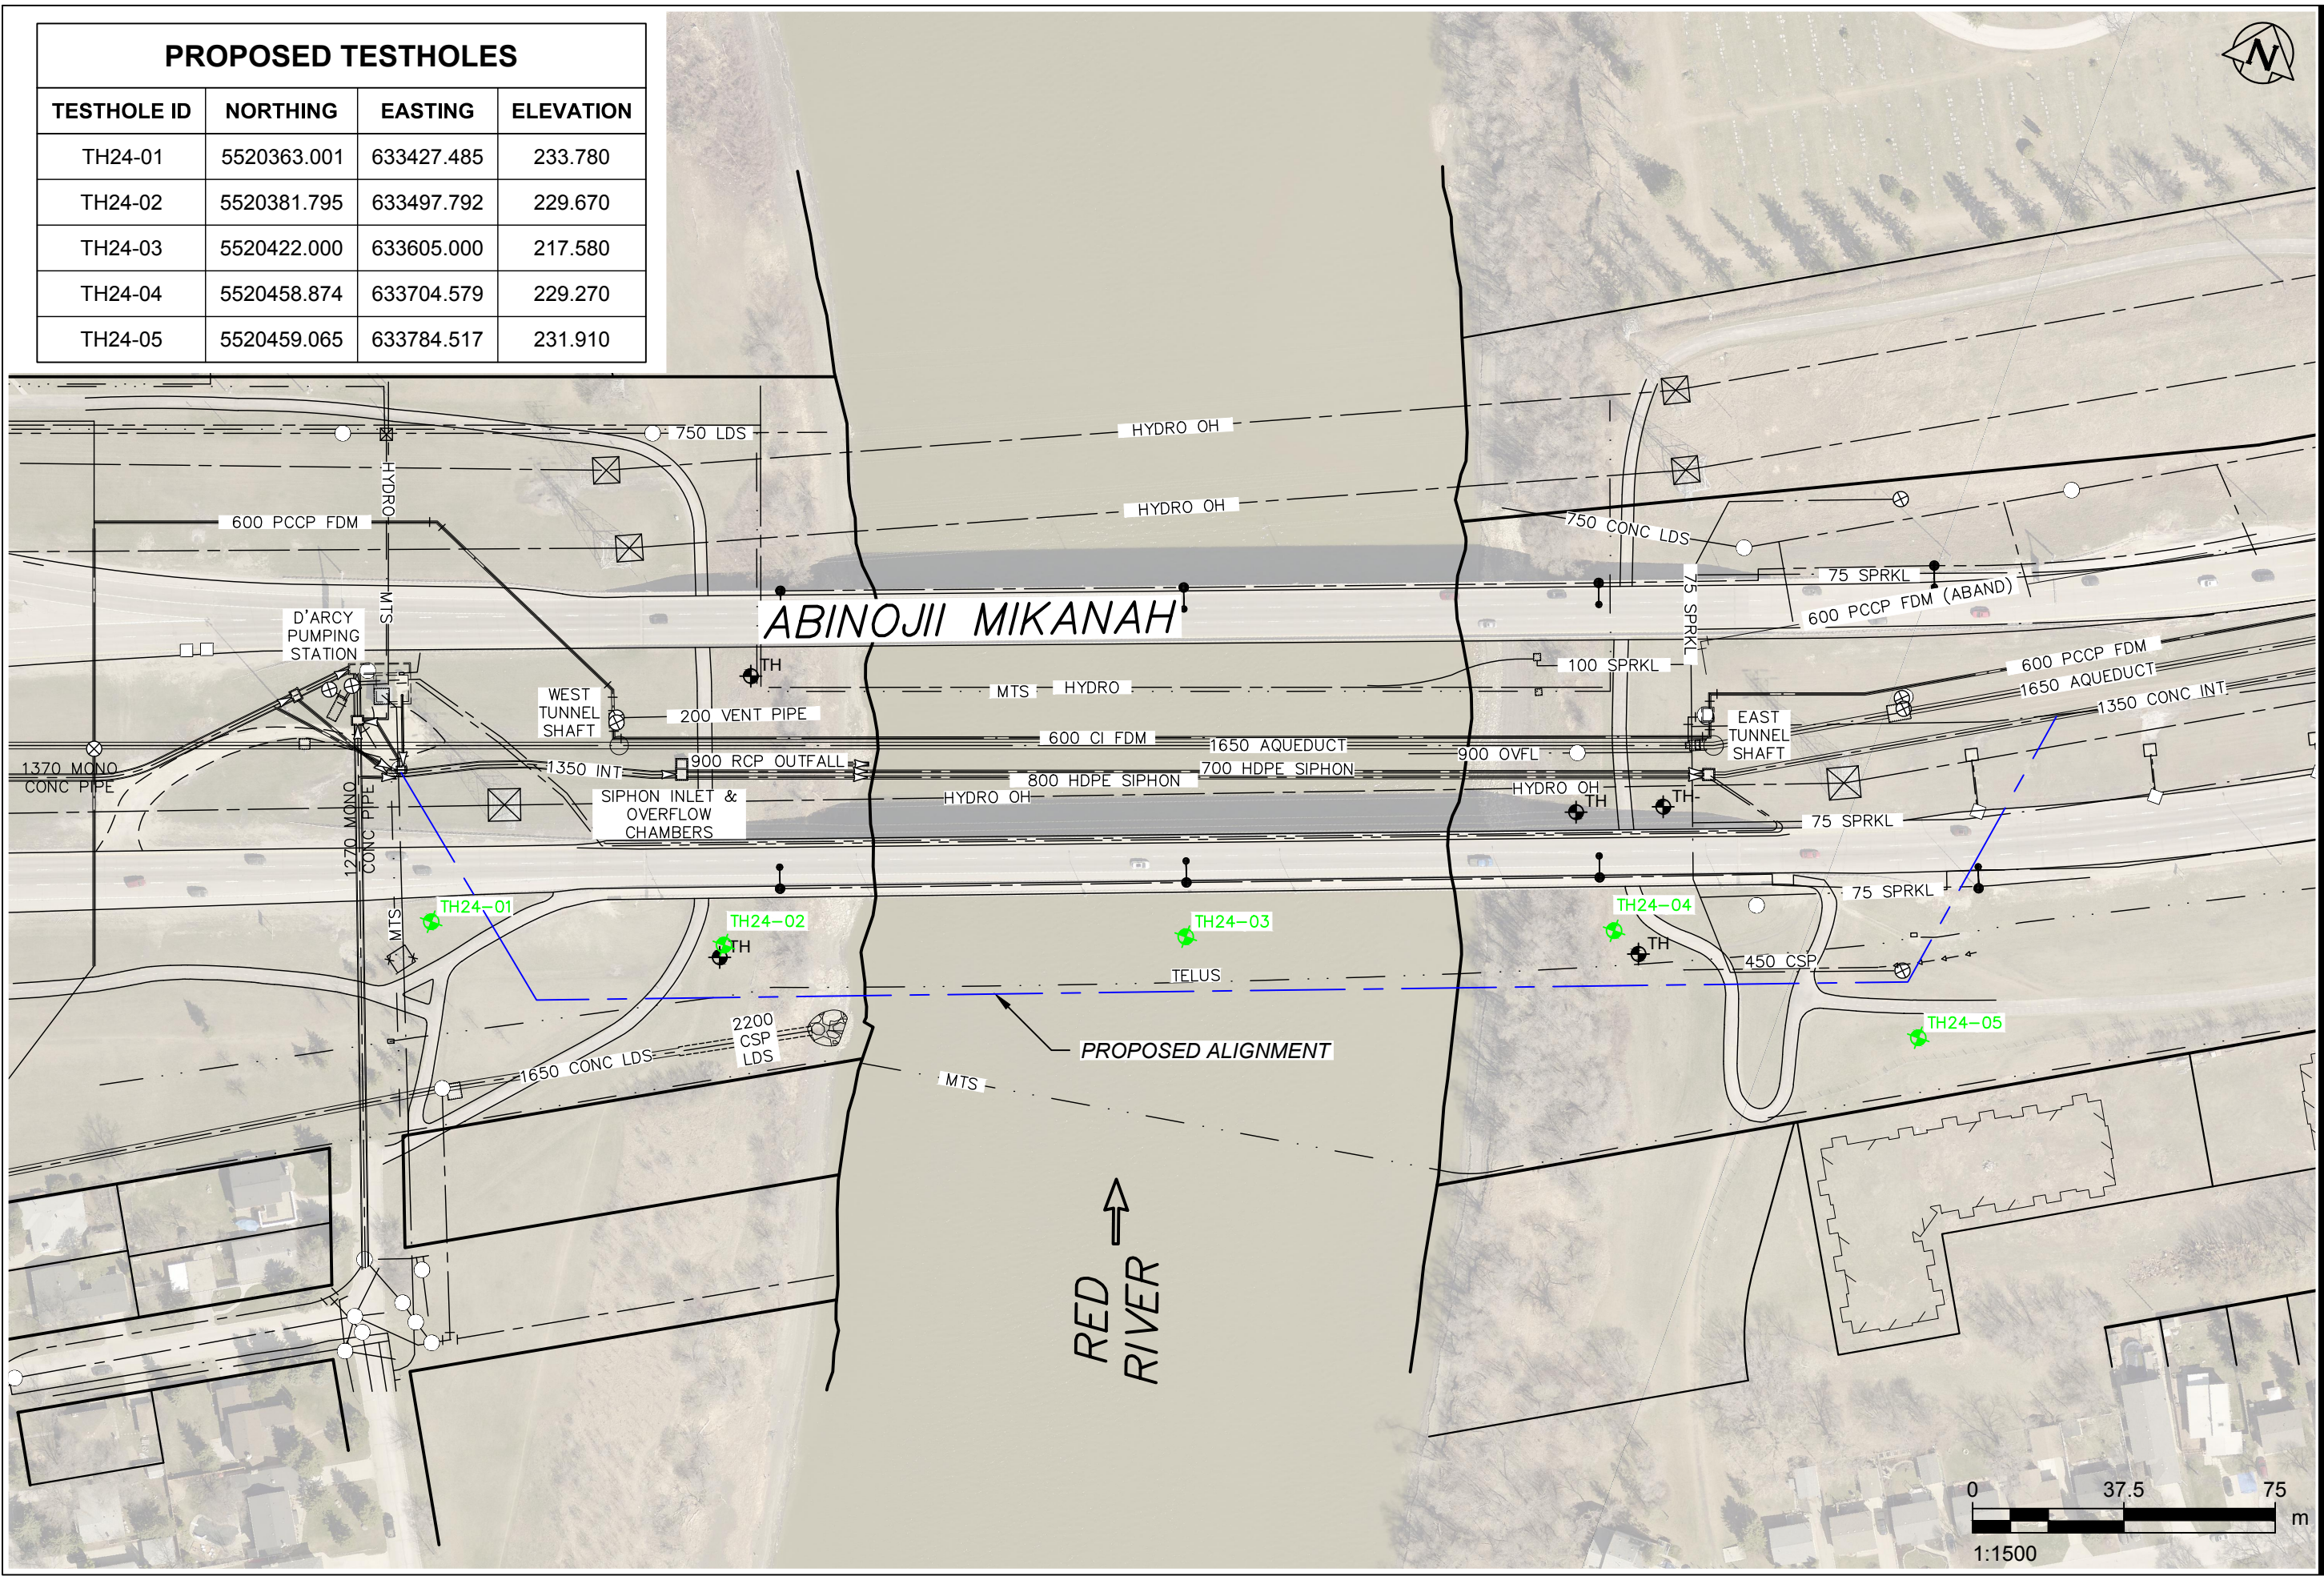
Appendix C
Testhole Logs

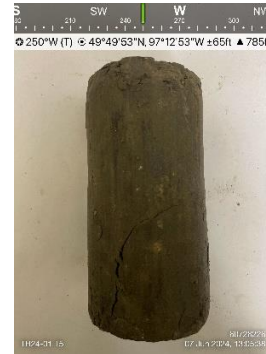
Torvane	Undrained Shear Strength (kPa)	34.3
Pocket Pen.	Undrained Shear Strength (kPa)	95.8

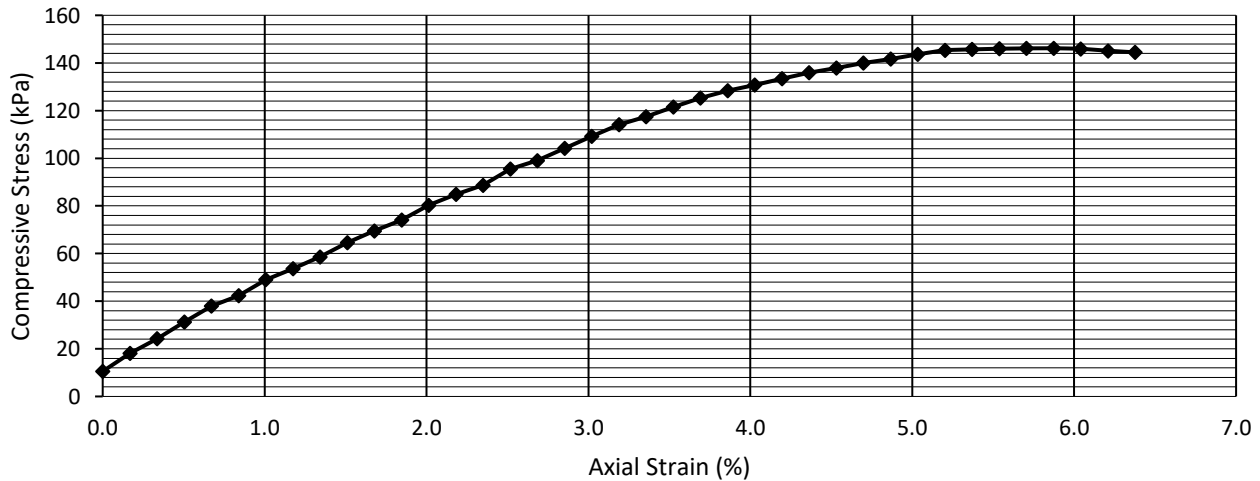
Unconfined Compressive Strength

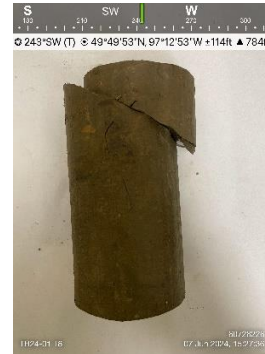
Torvane	Undrained Shear Strength (kPa)	88.3
Pocket Pen.	Undrained Shear Strength (kPa)	48.7

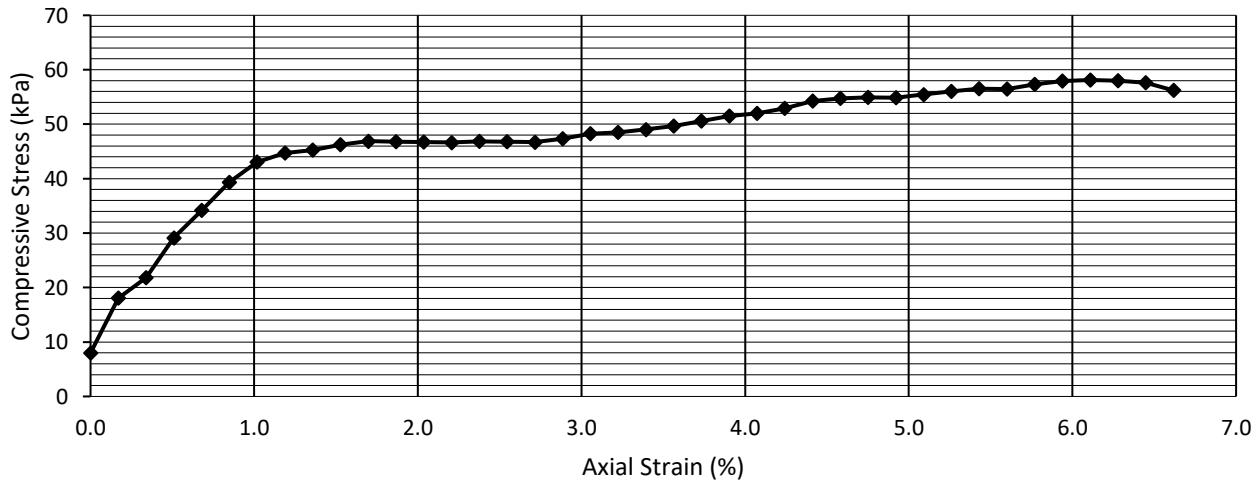
Unconfined Compressive Strength

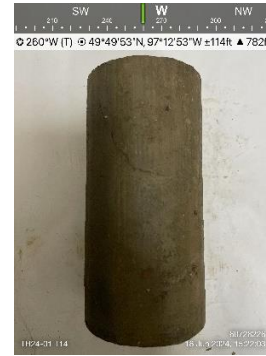
Torvane	Undrained Shear Strength (kPa)	58.8
Pocket Pen.	Undrained Shear Strength (kPa)	47.9

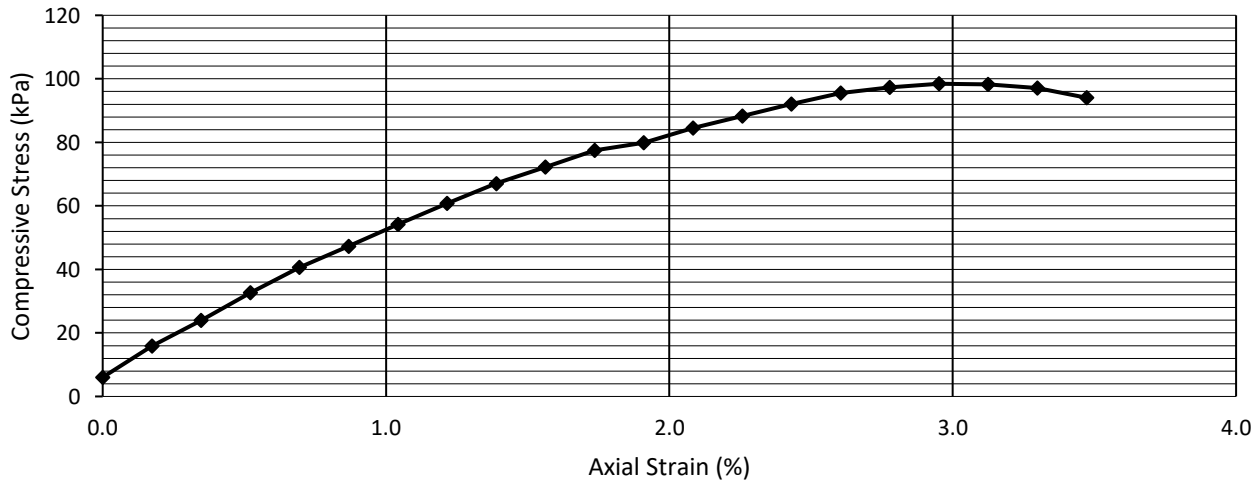
Unconfined Compressive Strength

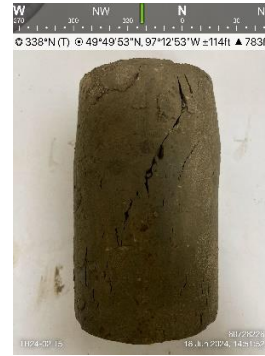
Torvane	Undrained Shear Strength (kPa)	51.0
Pocket Pen.	Undrained Shear Strength (kPa)	30.3

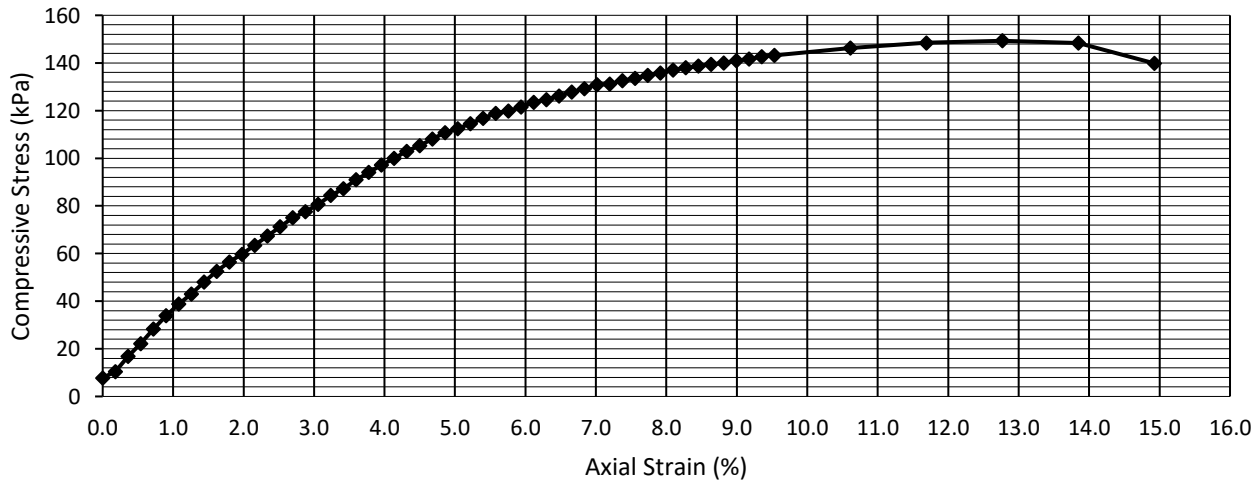
Unconfined Compressive Strength

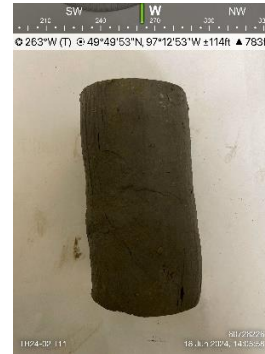
Torvane	Undrained Shear Strength (kPa)	49.0
Pocket Pen.	Undrained Shear Strength (kPa)	54.3

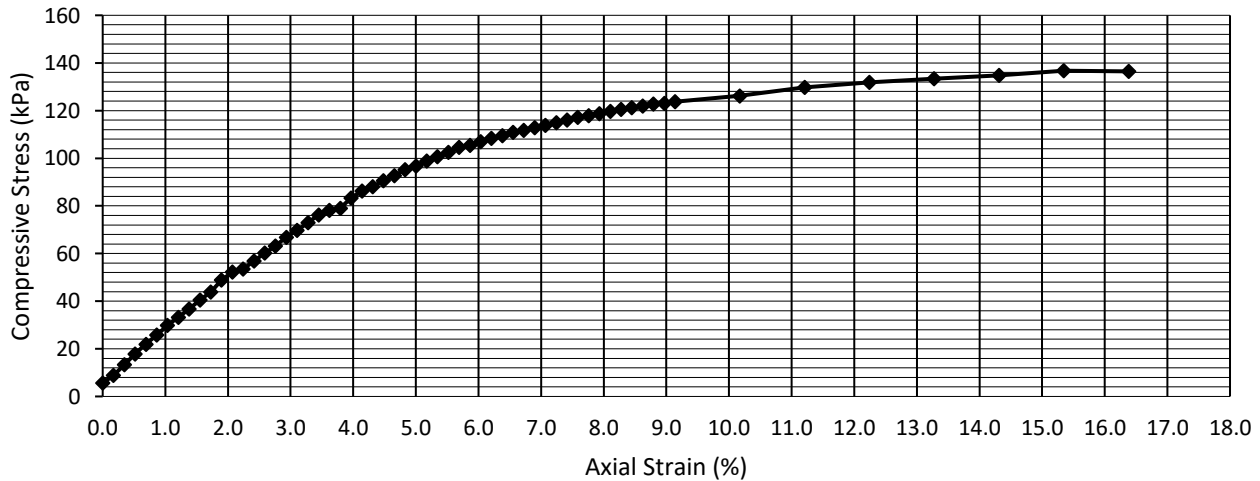
Unconfined Compressive Strength

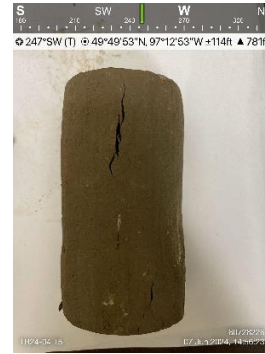
Torvane	Undrained Shear Strength (kPa)	66.7
Pocket Pen.	Undrained Shear Strength (kPa)	39.9

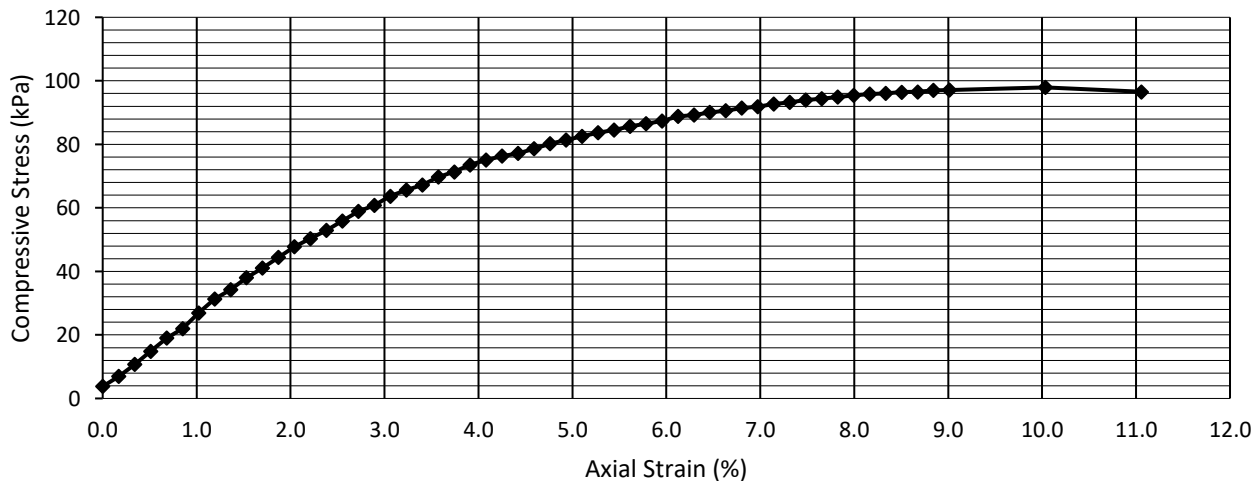
Unconfined Compressive Strength

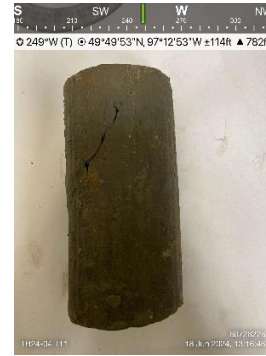
Torvane	Undrained Shear Strength (kPa)	39.2
Pocket Pen.	Undrained Shear Strength (kPa)	39.9

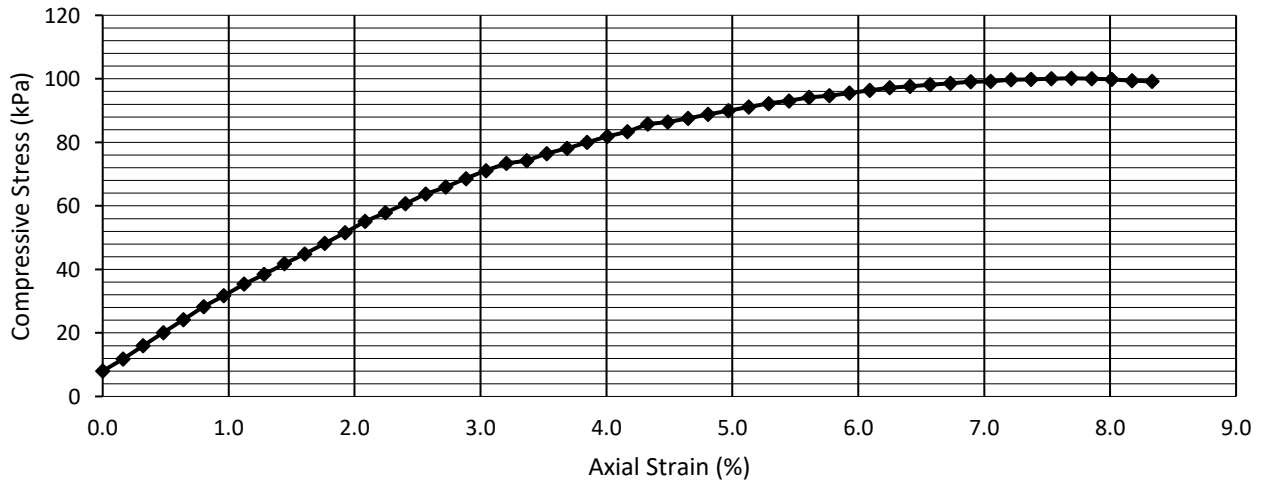
Unconfined Compressive Strength

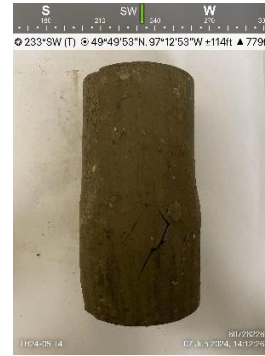
Torvane	Undrained Shear Strength (kPa)	83.4
Pocket Pen.	Undrained Shear Strength (kPa)	79.8

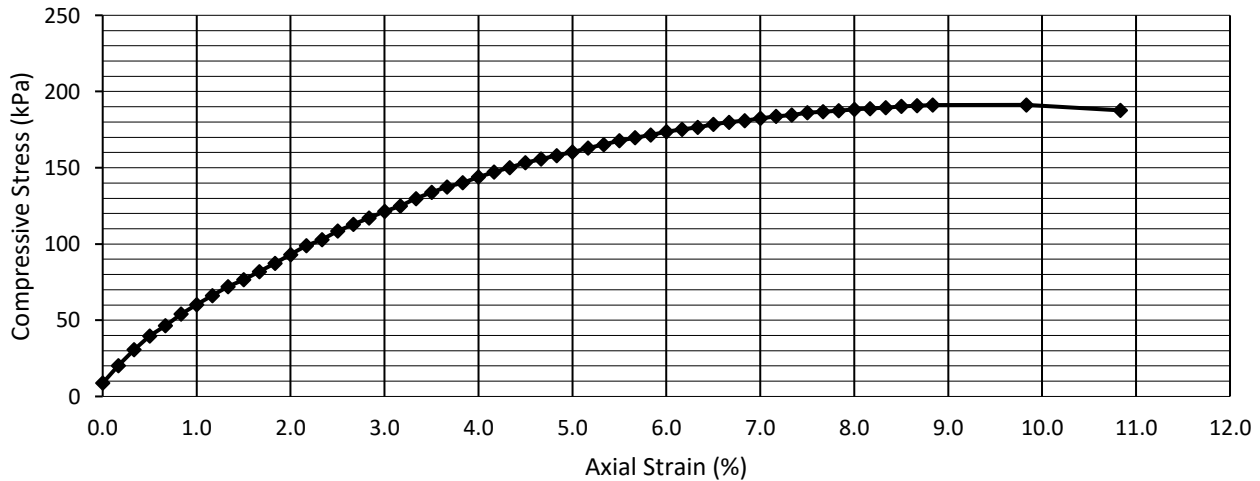
Unconfined Compressive Strength

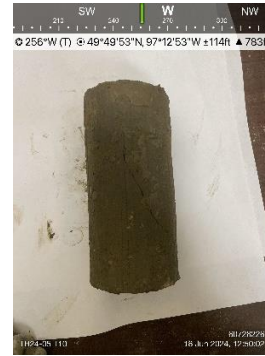
Torvane	Undrained Shear Strength (kPa)	66.7
Pocket Pen.	Undrained Shear Strength (kPa)	54.3

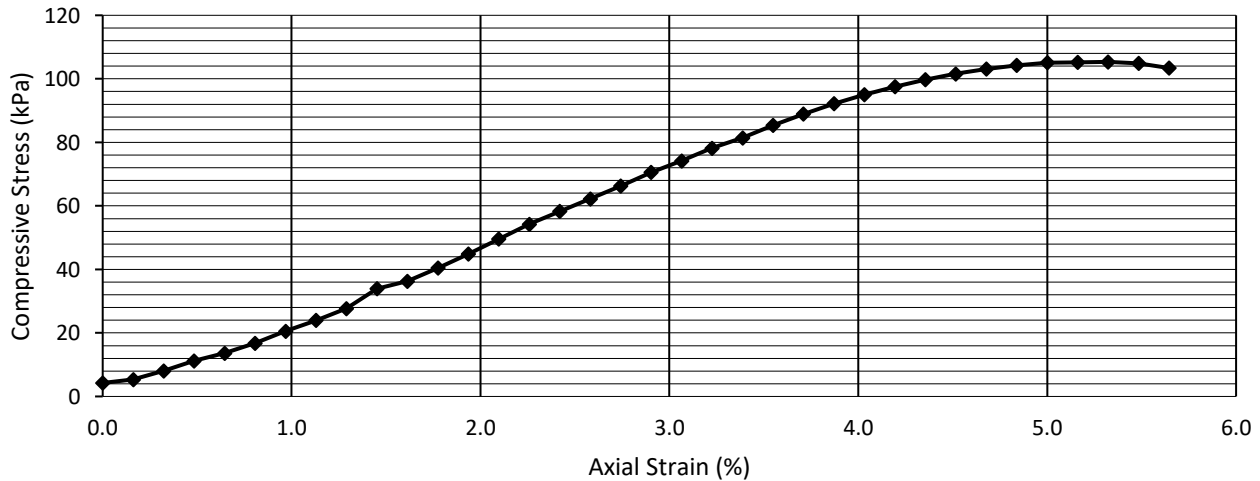
Unconfined Compressive Strength

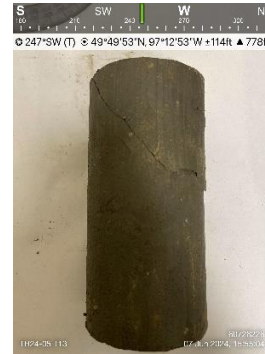
Torvane	Undrained Shear Strength (kPa)	44.1
Pocket Pen.	Undrained Shear Strength (kPa)	23.9

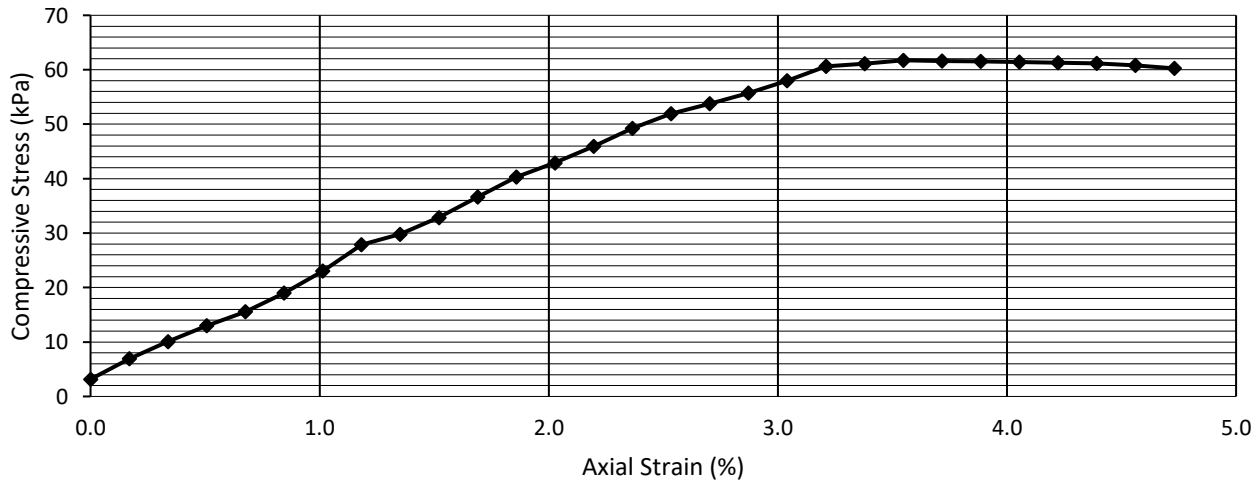
Unconfined Compressive Strength

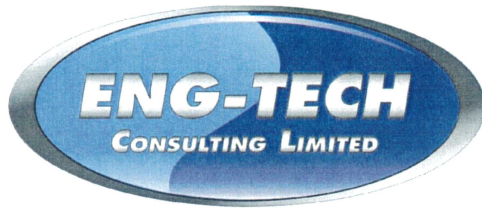
420 Turenne Street
Winnipeg, Manitoba
R2J 3W8
engtech@mymts.net
www.eng-tech.ca

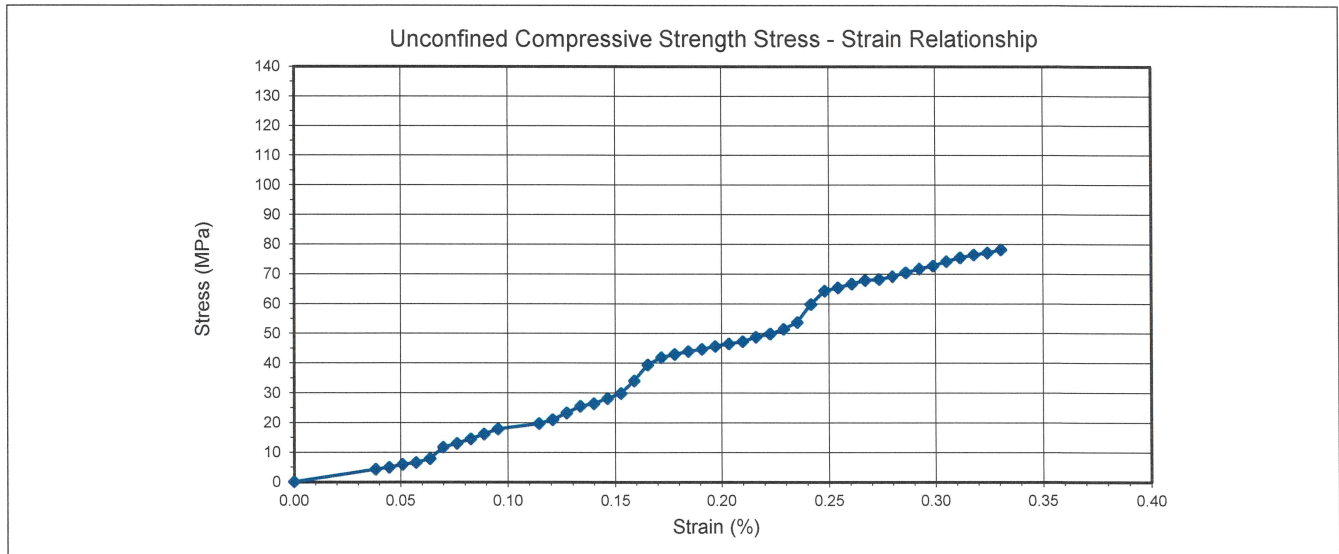
Test Data			
Specimen Moisture Condition:	As received moisture	Specimen Temperature:	24°C
Average Length of Specimen:	157.25 mm	Average Diameter of Specimen:	63.00 mm
Load Rate:	0.7 kN/s	Maximum Load:	243.3 kN
		Compressive Strength:	78 MPa

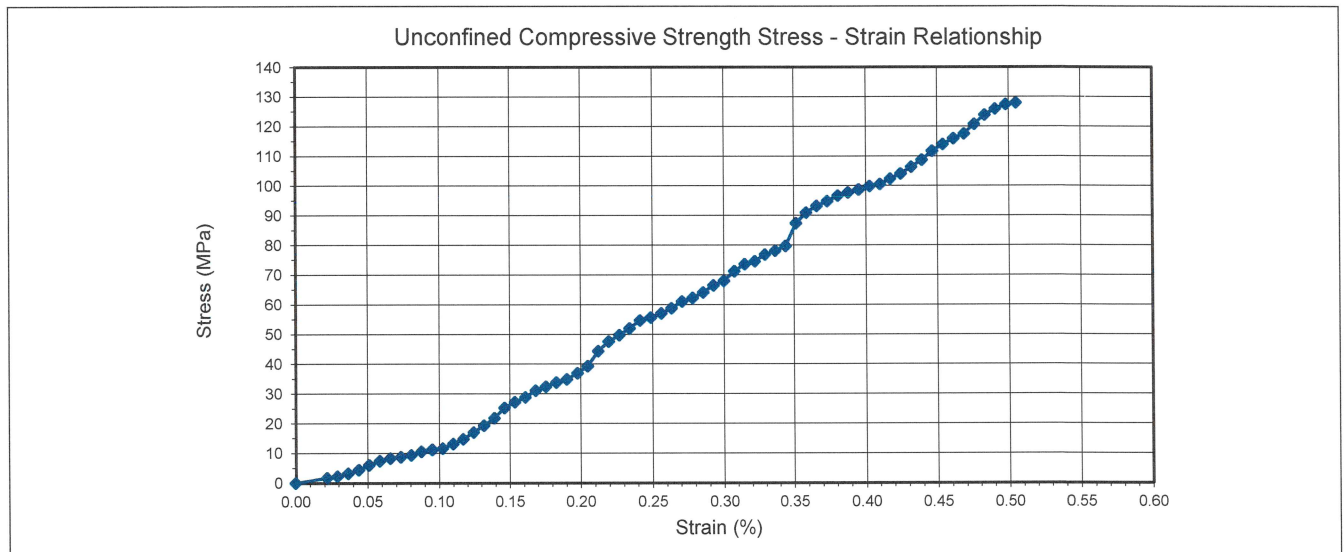
Test Data			
Specimen Moisture Condition:	As received moisture	Specimen Temperature:	24°C
Average Length of Specimen:	136.50 mm	Average Diameter of Specimen:	63.00 mm
Load Rate:	0.7 kN/s	Maximum Load:	398.5 kN
		Compressive Strength:	128 MPa

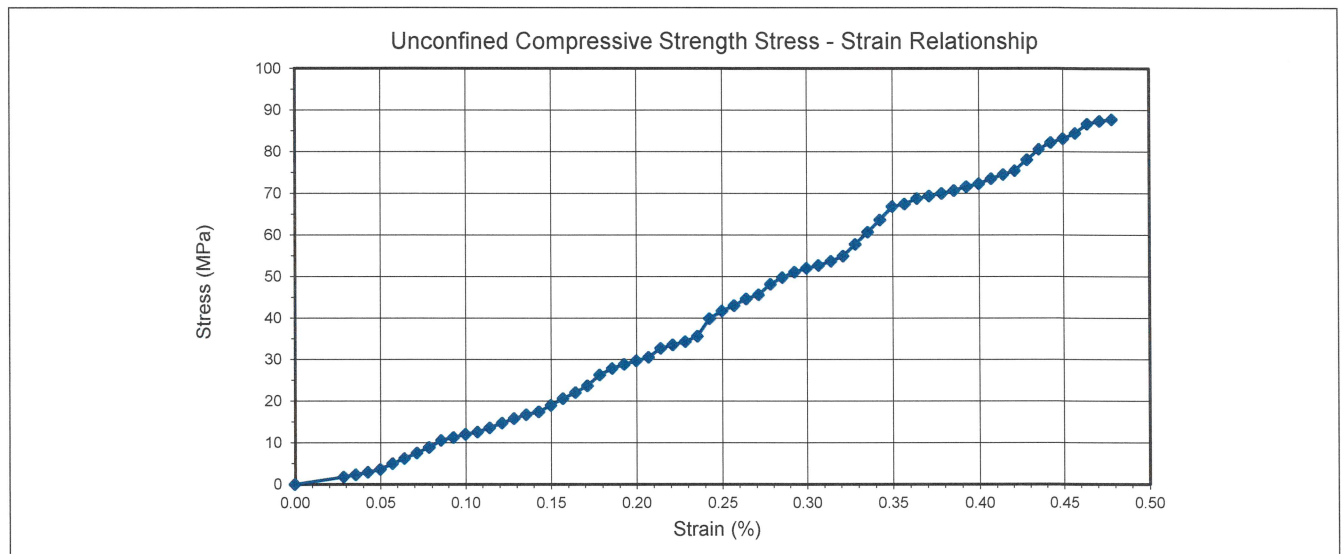
Test Data			
Specimen Moisture Condition:	As received moisture	Specimen Temperature:	24.0°C
Average Length of Specimen:	140.00 mm	Average Diameter of Specimen:	63.00 mm
Load Rate:	0.7 kN/s	Maximum Load:	273.4 kN
		Compressive Strength:	87.7 MPa

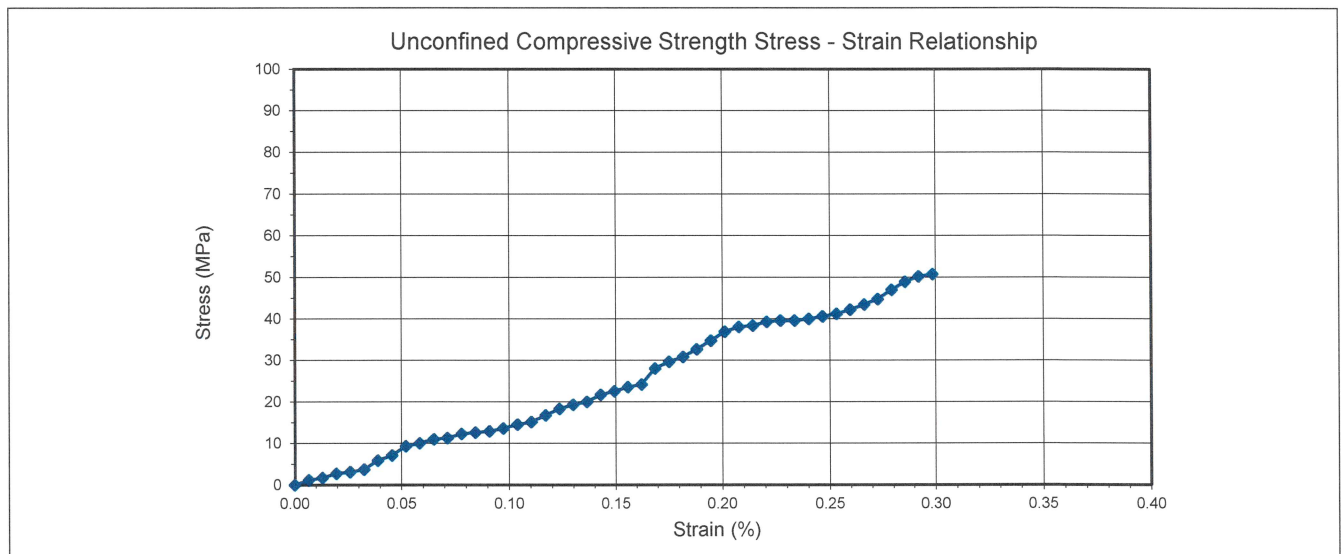
Test Data			
Specimen Moisture Condition:	As received moisture	Specimen Temperature:	24°C
Average Length of Specimen:	154.00 mm	Average Diameter of Specimen:	63.00 mm
Load Rate:	0.7 kN/s	Maximum Load:	157.7 Kn
		Compressive Strength:	50.6 MPa

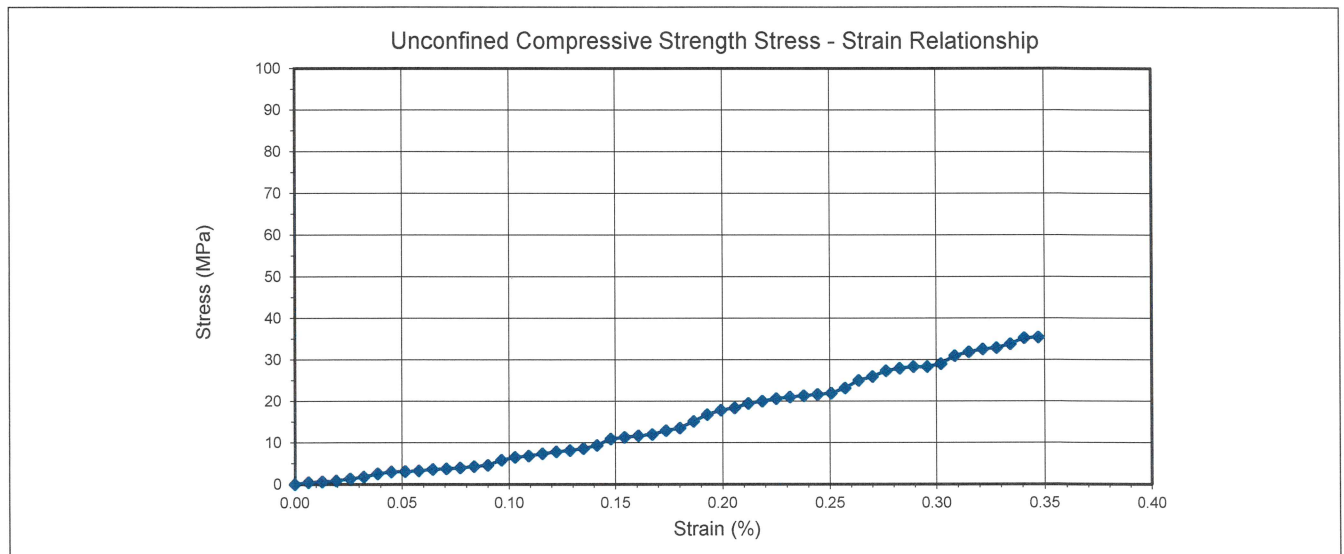
Test Data			
Specimen Moisture Condition:	As received moisture	Specimen Temperature:	24°C
Average Length of Specimen:	155.50 mm	Average Diameter of Specimen:	63.00 mm
Load Rate:	0.7 kN/s	Maximum Load:	110.0 kN
		Compressive Strength:	35.3 MPa

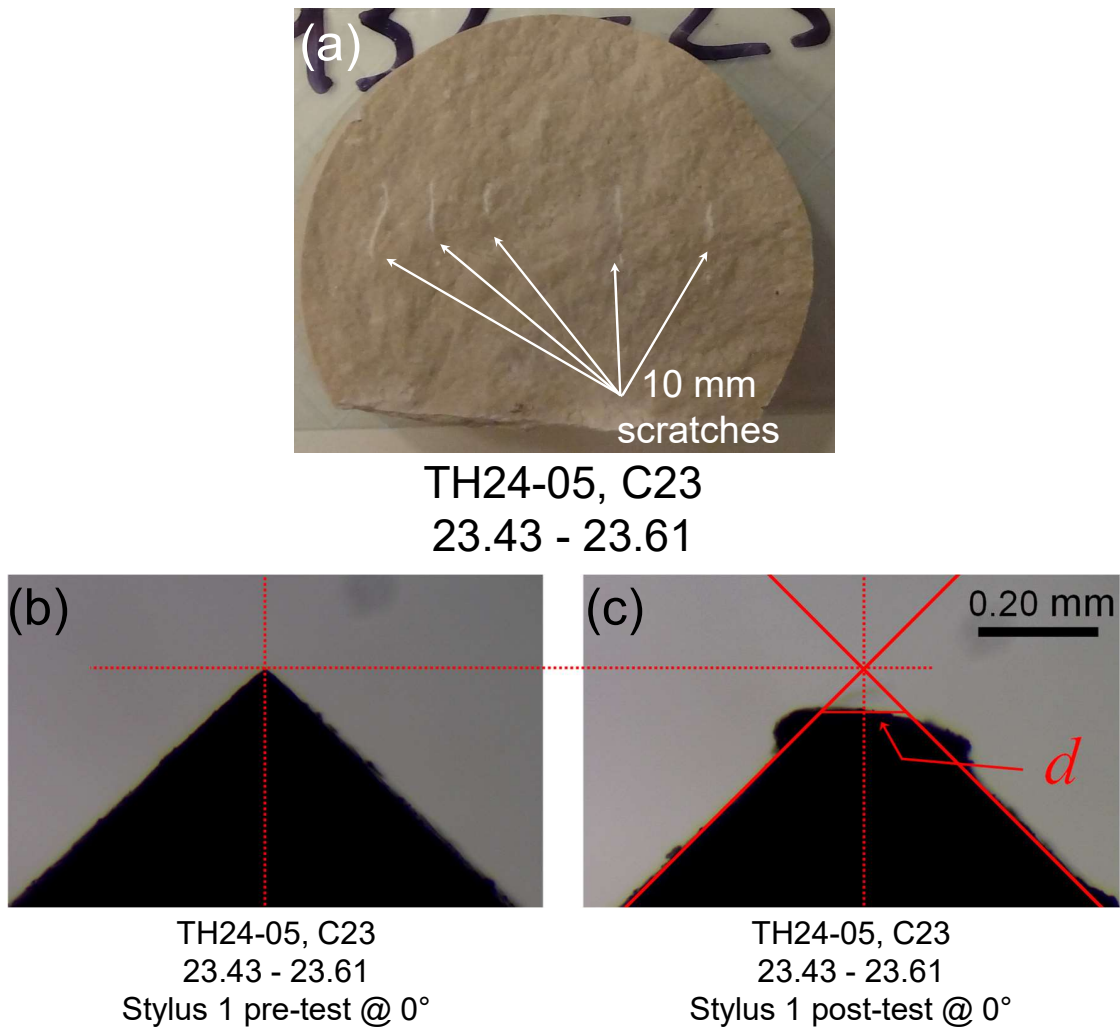
Figure 2: (a) Photograph showing an example of the five 10 mm scratches on a test specimen; (b) microscope image of select stylus prior to testing at the noted position; and (c) microscope image of the same stylus at the same position following testing with the wear flat, d , denoted.

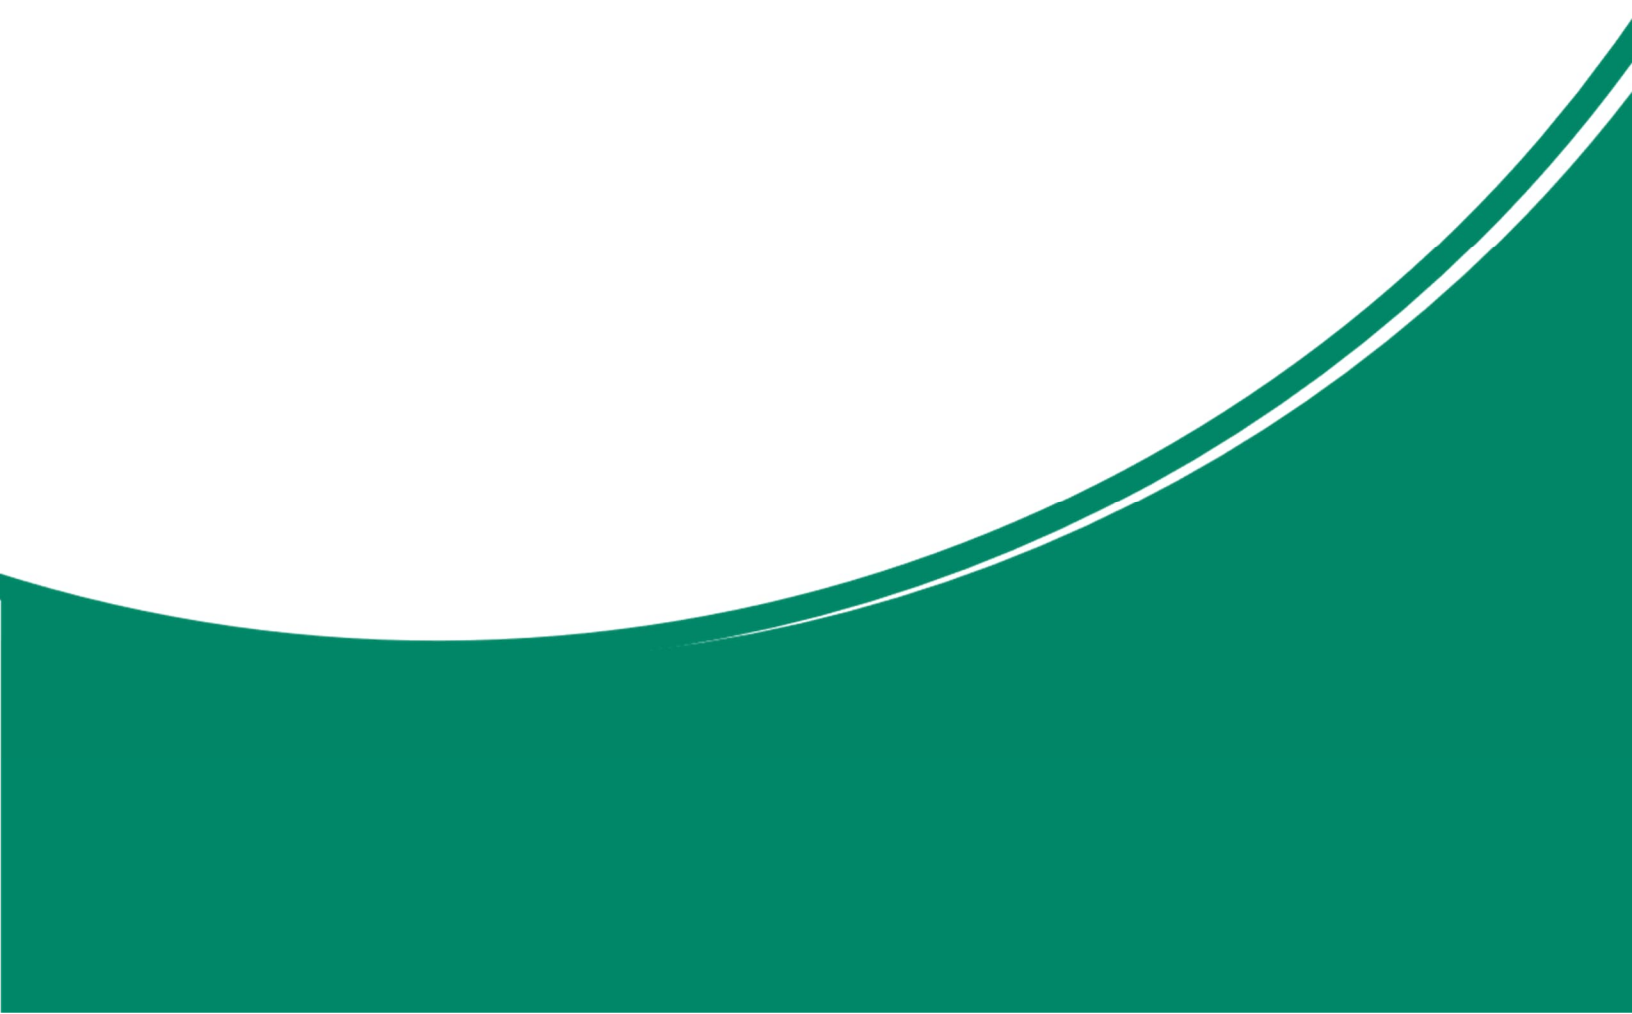
Seismic Hazard Values

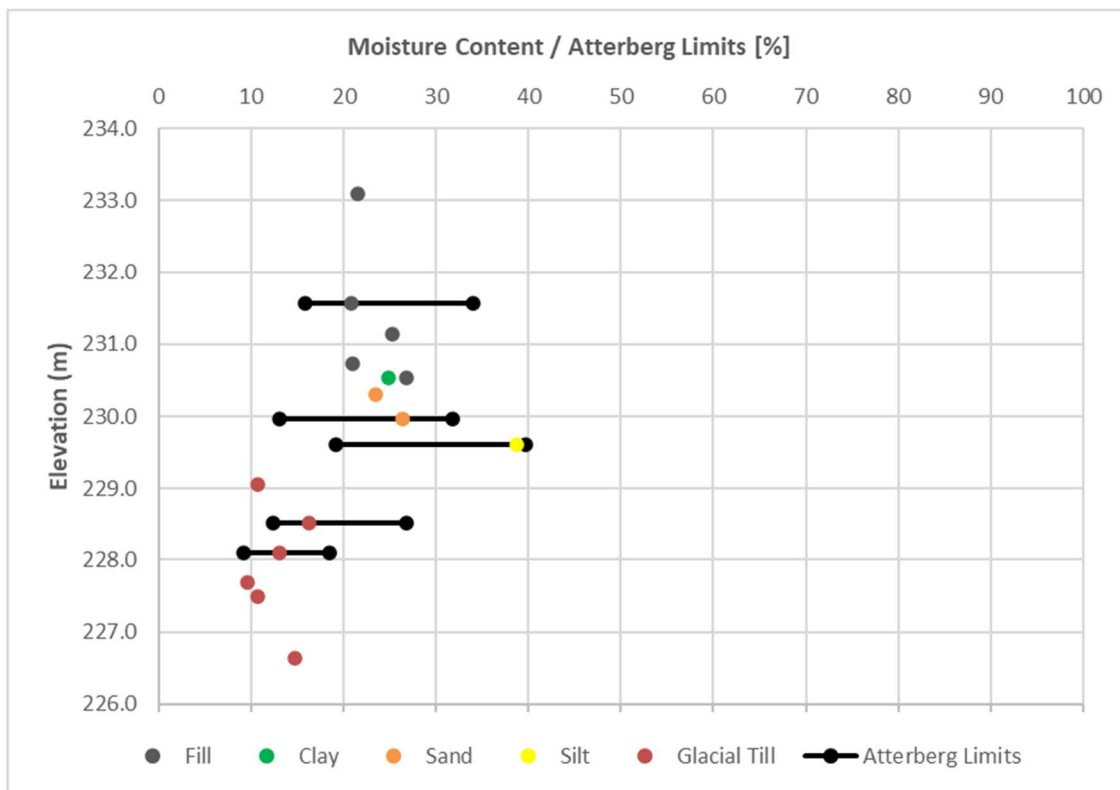
Figure 4-1 - Summary of Moisture Content and Atterberg Limits vs. Depth (Site 5)

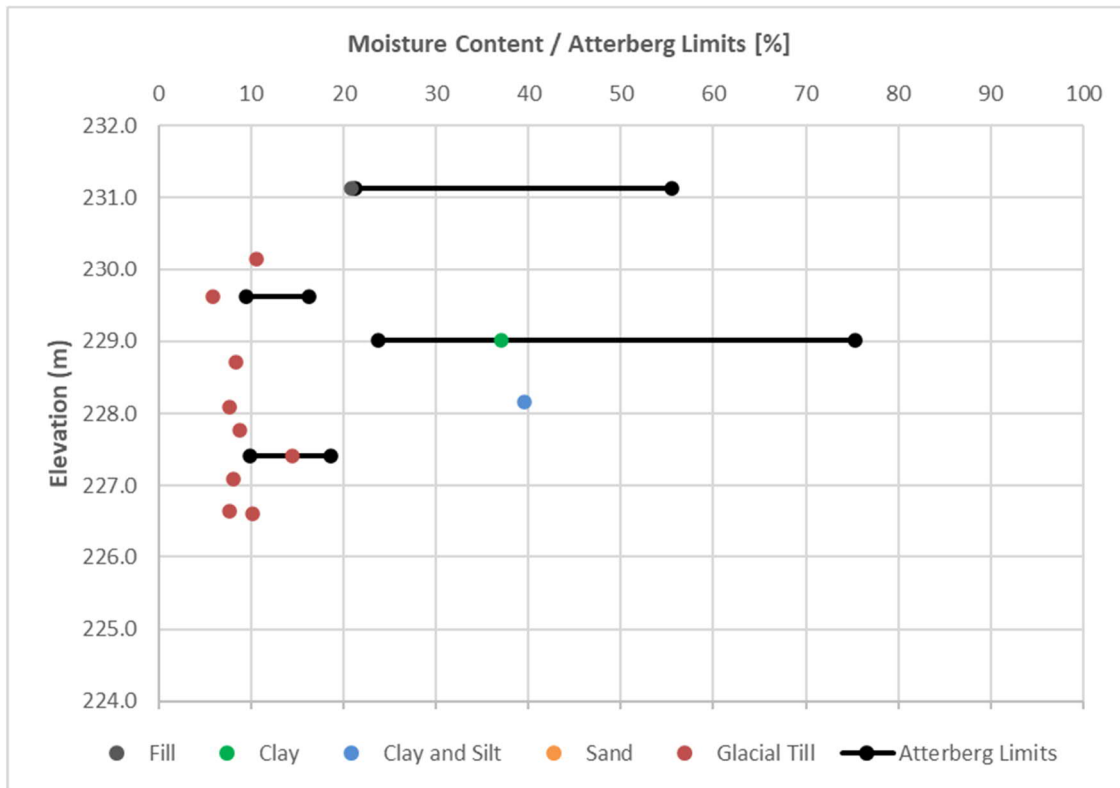
Figure 4-2 - Summary of Moisture Content and Atterberg Limits vs. Depth (Site 10)

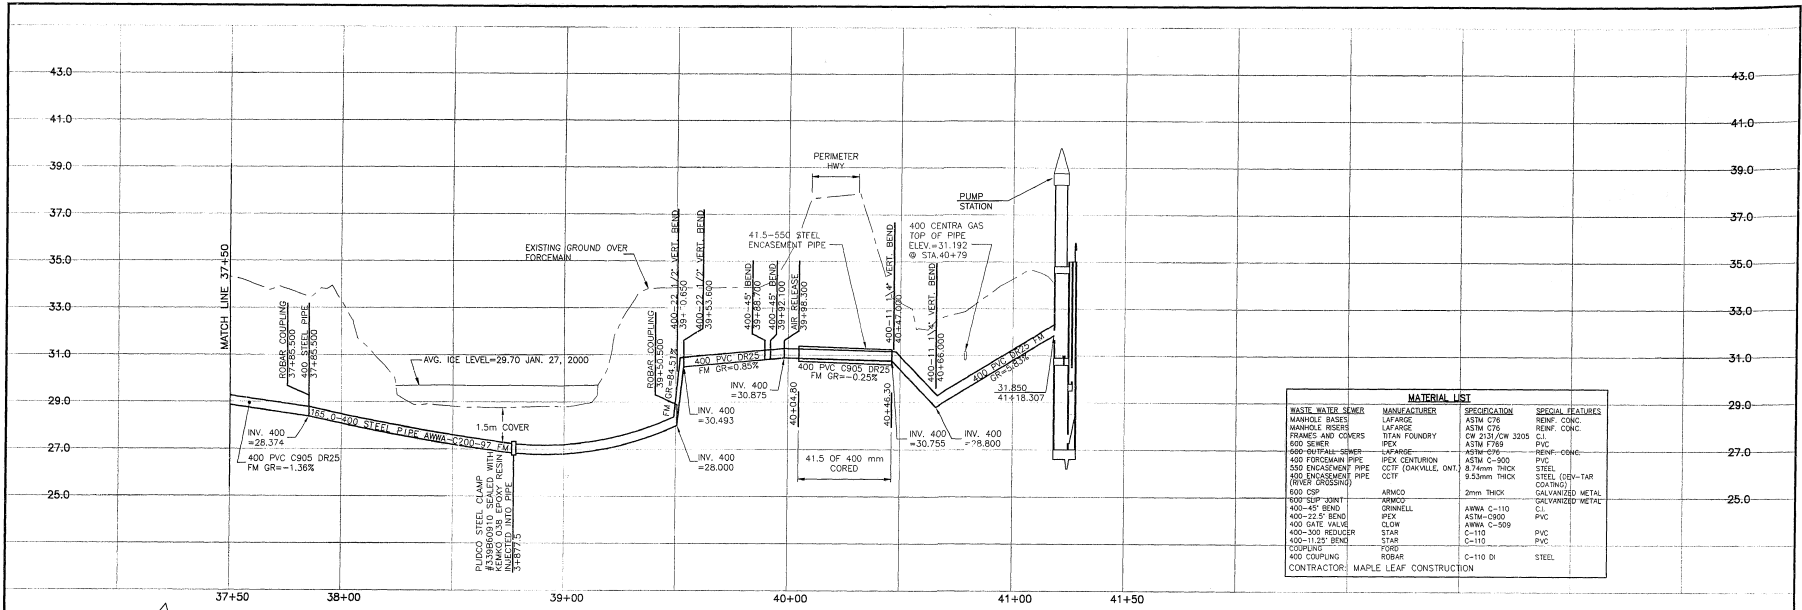
MATERIAL LIST			
WASTE WATER SEWER	MANUFACTURER	SPECIFICATION	SPECIAL FEATURES
MANHOLE BASES	LAFARGE	ASTM C78	RENF. CONC.
MANHOLE RINGS	LAFARGE	ASTM C78	RENF. CONC.
FRAMES AND COVERS	TITAN FOUNDRY	CW 231/FW 3205	C.I.
600 SEWER	PEX	ASTM F759	PVC
600 OUTFALL SEWER	LAFARGE	ASTM C78	RENF. CONC.
400 PROPOSED PIPE	PEX GENTRON	ASTM C-909	PVC
300 ENCASUREMENT PIPE	OCIF (ONKVILLE ONT)	8.7mm THICK	STEEL (EPOXY-TAR COATING)
400 ENCASUREMENT PIPE	OCIF	9.5mm THICK	STEEL (EPOXY-TAR COATING)
600 GSP	ARMCO	2mm THICK	DALVANIZED METAL
600 SUP. JOINT	ARMCO		DALVANIZED METAL
400-45° BEND	ORINELL	ARMCO C-110	PVC
400-22.5° BEND	PEX	ASTM C-909	PVC
400 GATE VALVE	CLOW	ARMCO C-909	PVC
400-100 REDUCER	STAR	C-110	PVC
400-11.5° BEND	STAR	C-110	PVC
COUPLING	FORD	C-110 DI	STEEL
400 COUPLING	ROBAR		
CONTRACTOR: MAPLE LEAF CONSTRUCTION

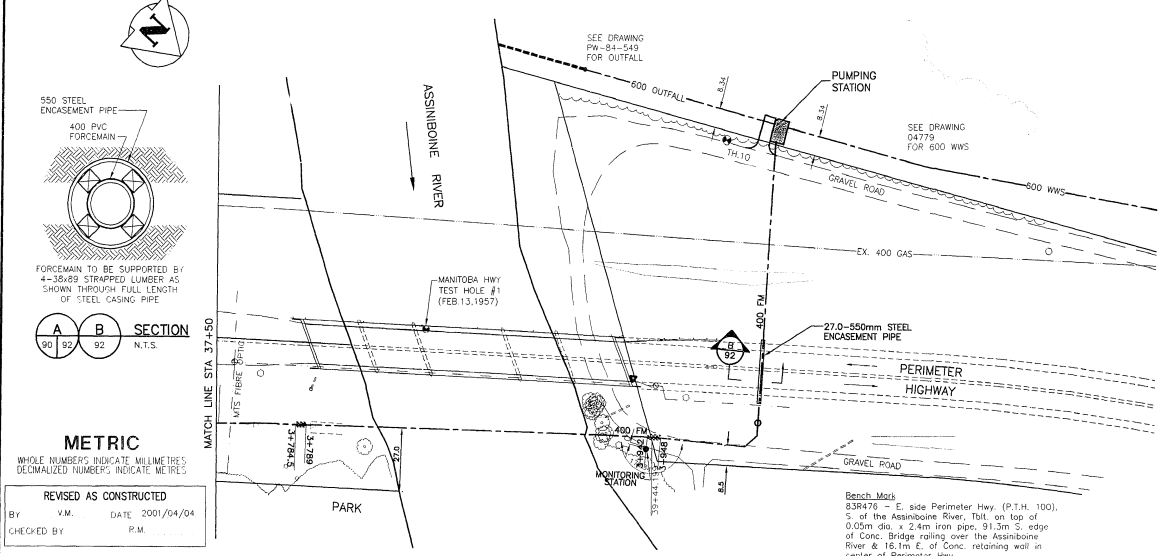
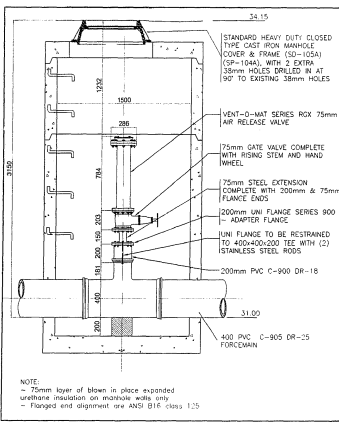
AIR RELEASE VALVE CHAMBER AT STATION 39+98.300
