Appendix B

Geotechnical Data Report

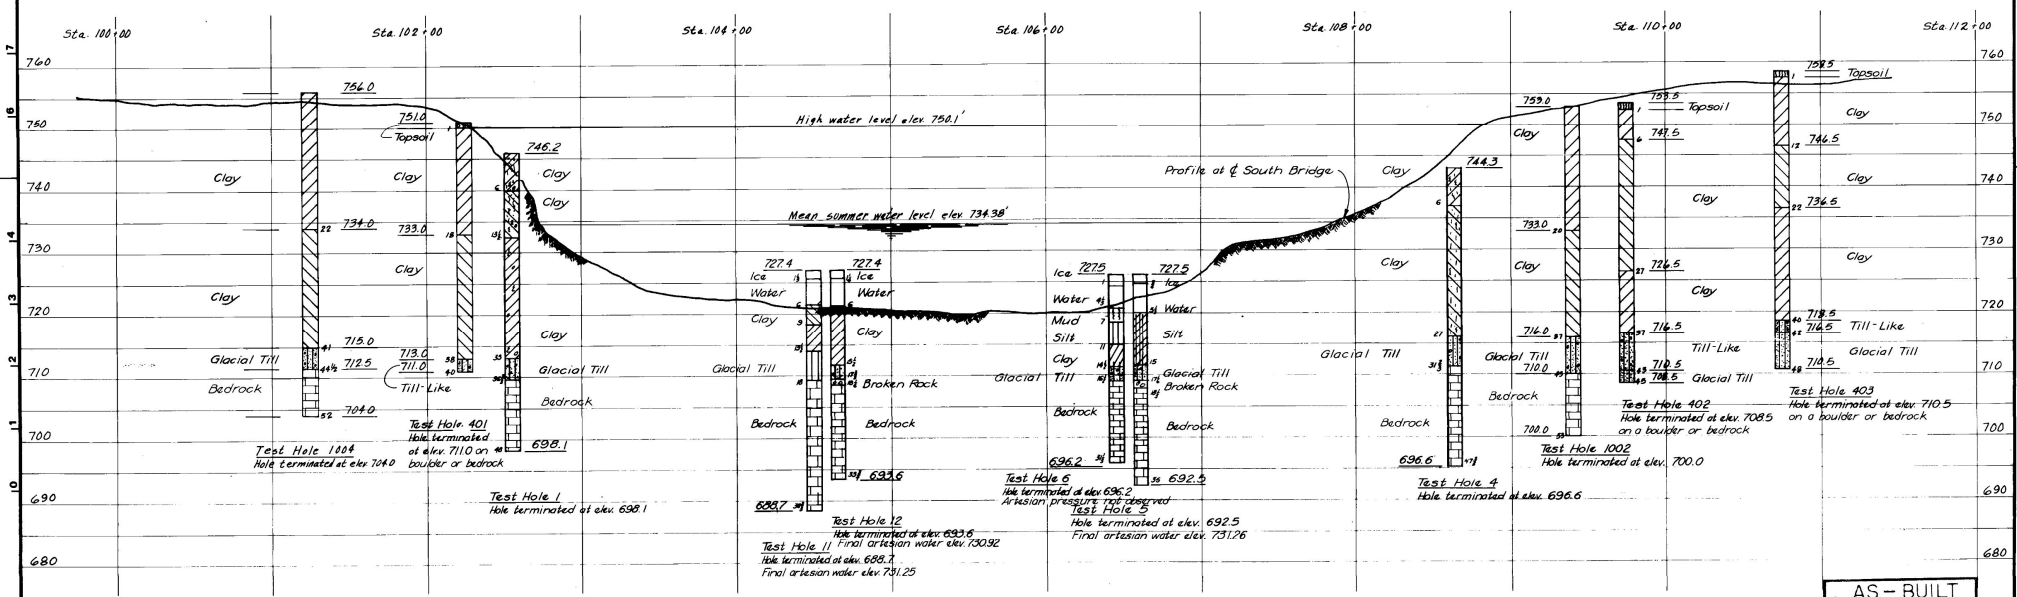
TEST HOLE DATA
Scale: Horiz. 1"=40'-0"
Vert. 1"=10'-0"

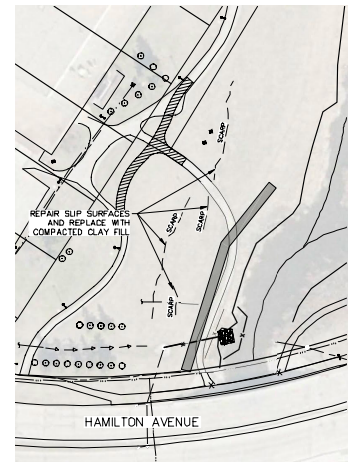
SLIP SURFACE REPAIR PLAN
SCALE: N.T.S.

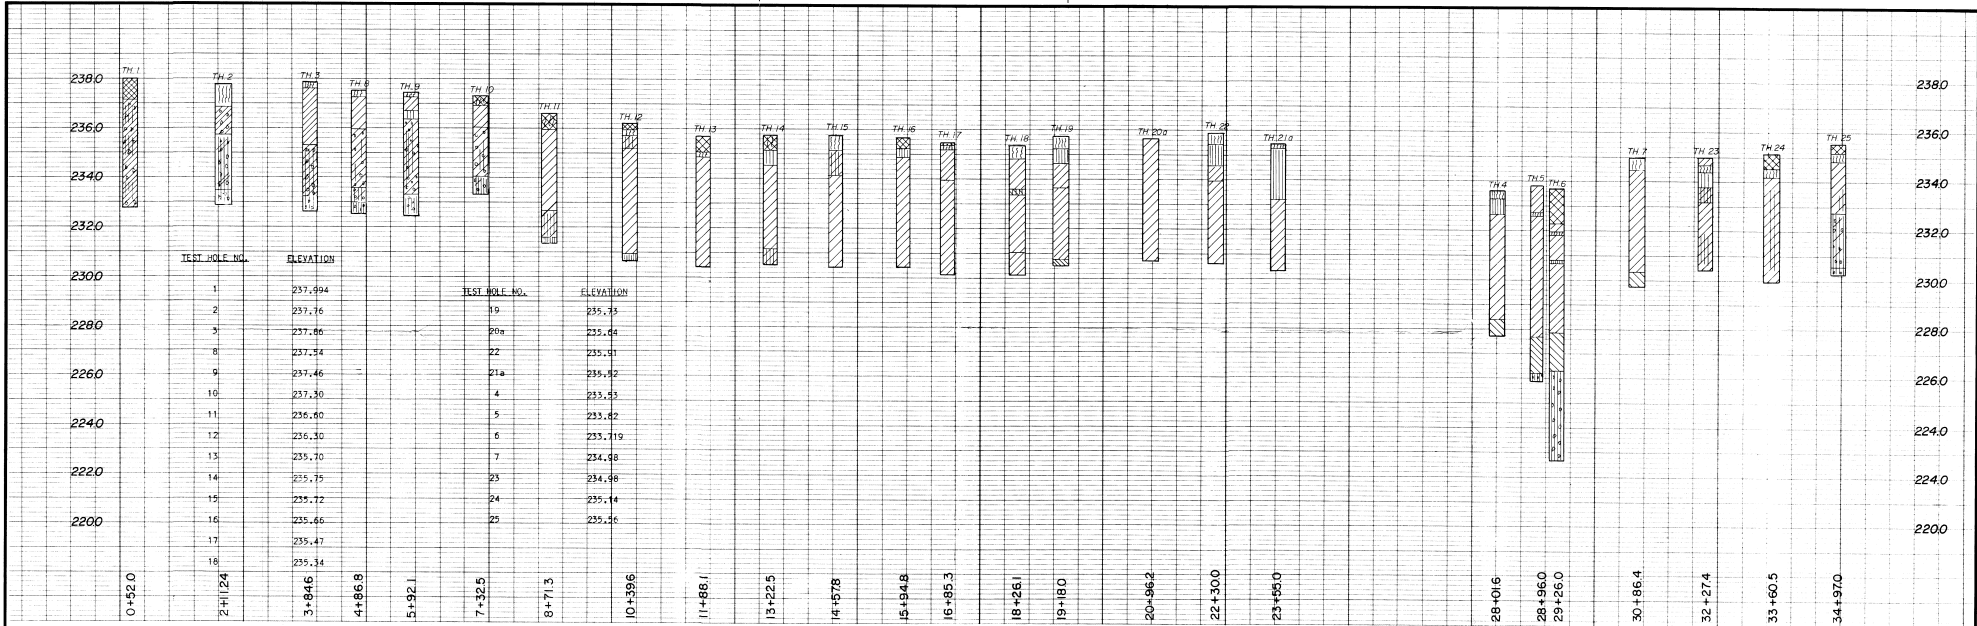
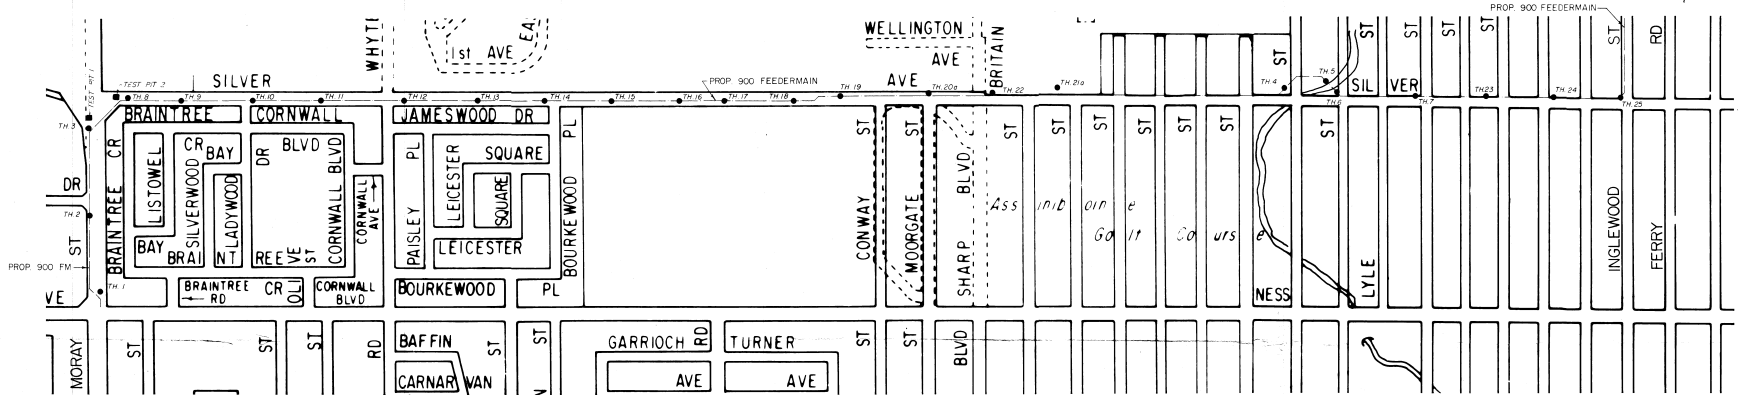
- LEGEND**
- TOPSOIL
 - FILL
 - CLAY
 - SILT
 - TILL

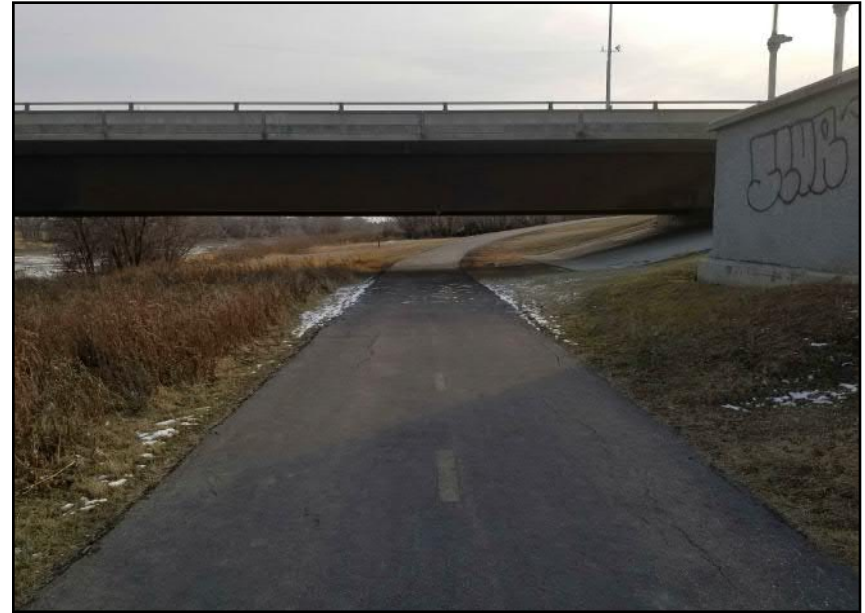
Site 4 - Western Riverbank | Asphalt paved pedestrian pathway. Minor cracking observed parallel to bank crest (facing S)

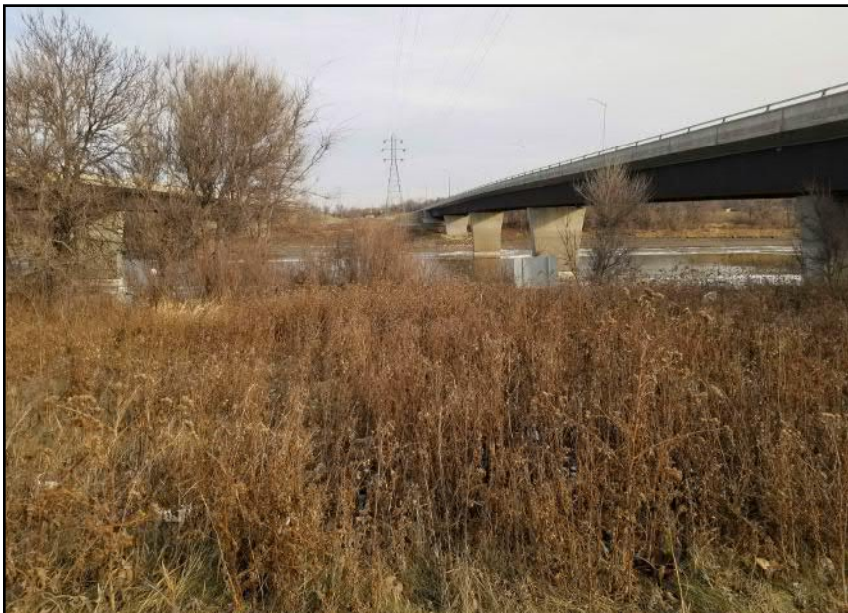
Site 4 - Western Riverbank | Densely vegetated riverbank crest to the east of the pedestrian pathway (facing E)

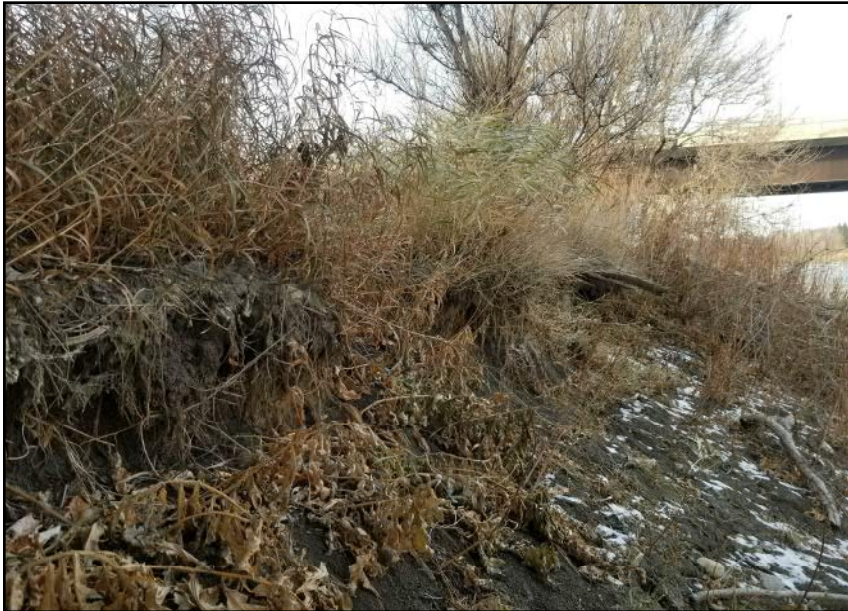
Site 4 - Western Riverbank | Observed scarp near oversteepened riverbank crest in adjacent to crossing alignment (facing N)

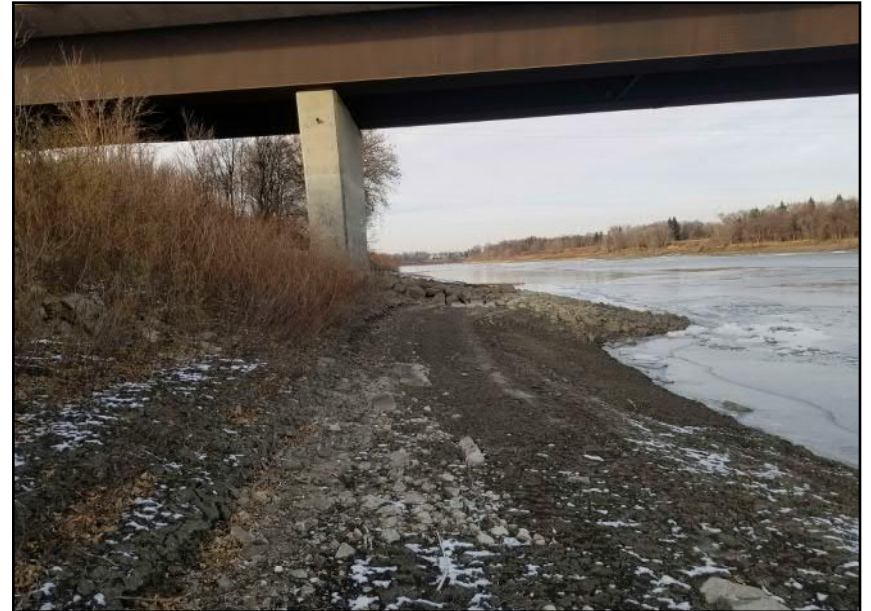
Site 4 - Western Riverbank | Short erosion scarps, localized rip-rap, gradual toe slope within crossing alignment (facing N)

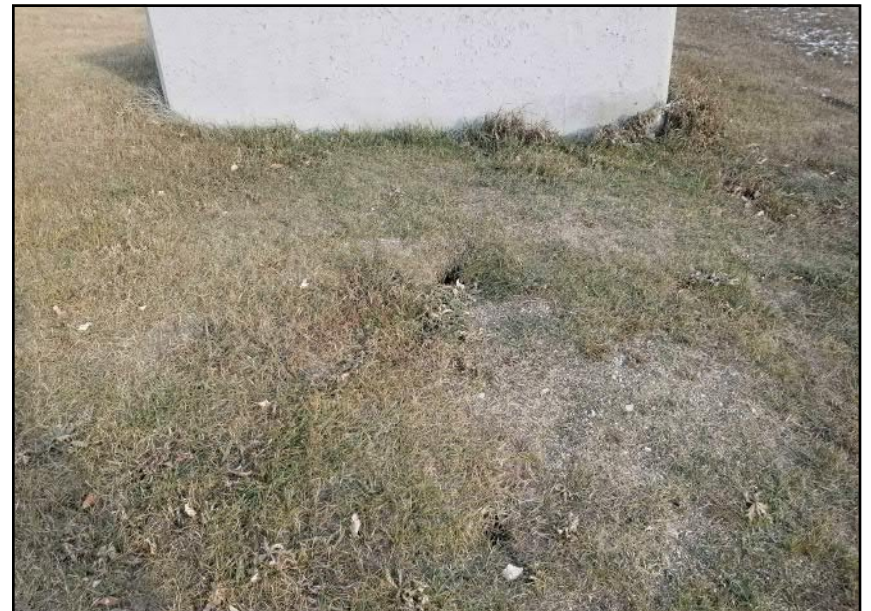
Site 4 - Eastern Riverbank Animal burrows observed in front of siphons inlet chamber structure (facing W)

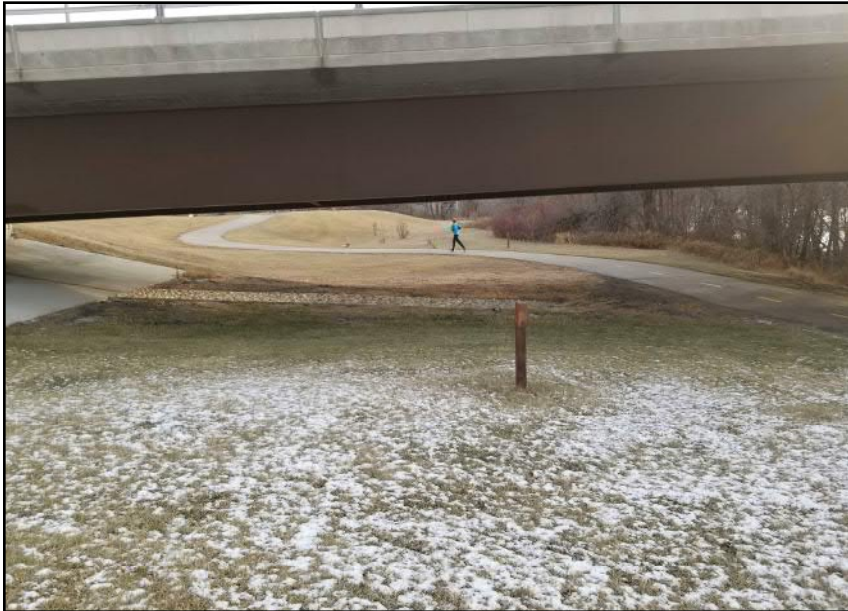
Site 4 - Eastern Riverbank Gradually sloping riverbank crest east of pedestrian pathway, groundwater well (facing S)

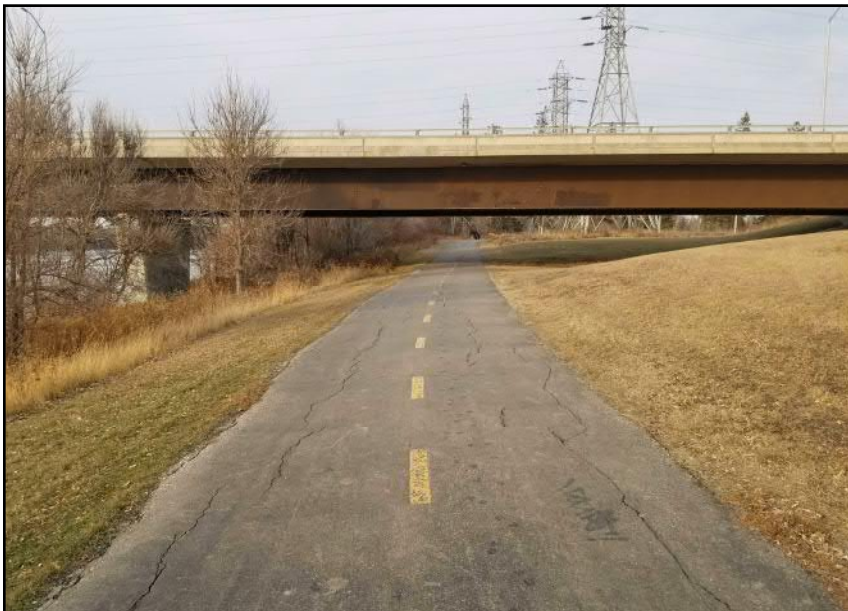
Site 4 - Eastern Riverbank Asphalt paved pedestrian pathway. Minor cracking observed parallel to bank crest (facing N)

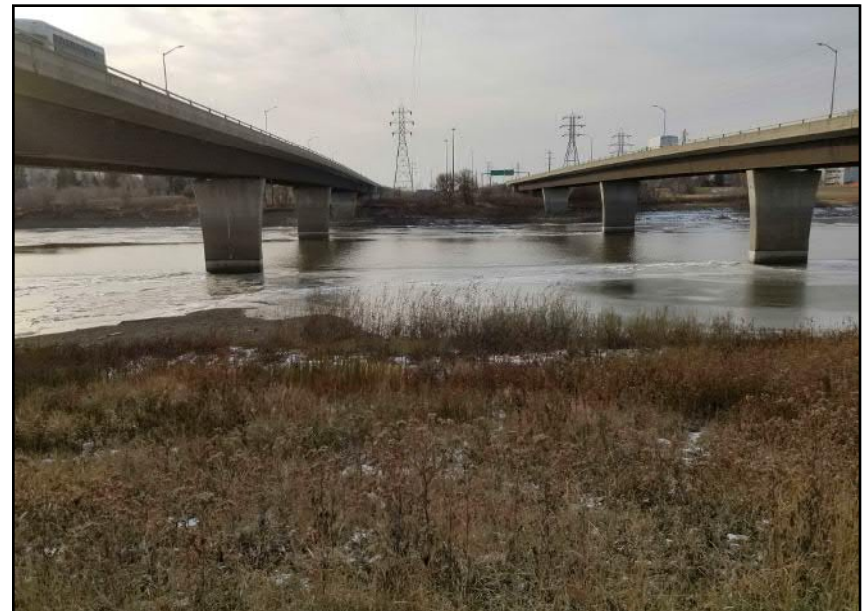
Site 4 - Eastern Riverbank Brush and shrubs observed along riverbank crest west of pedestrian pathway (facing W)

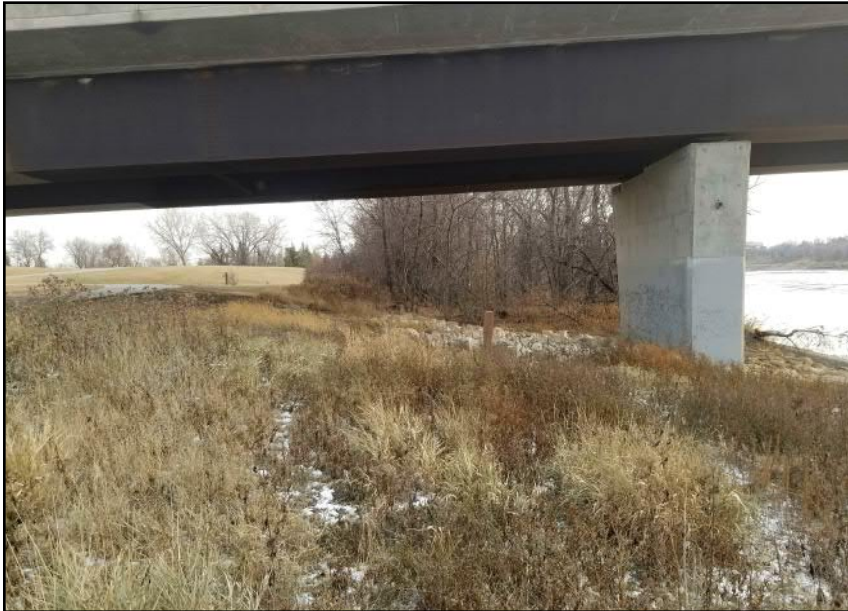
Site 4 - Eastern Riverbank | Riverbank slightly steepening west of pedestrian pathway, groundwater well (facing S)

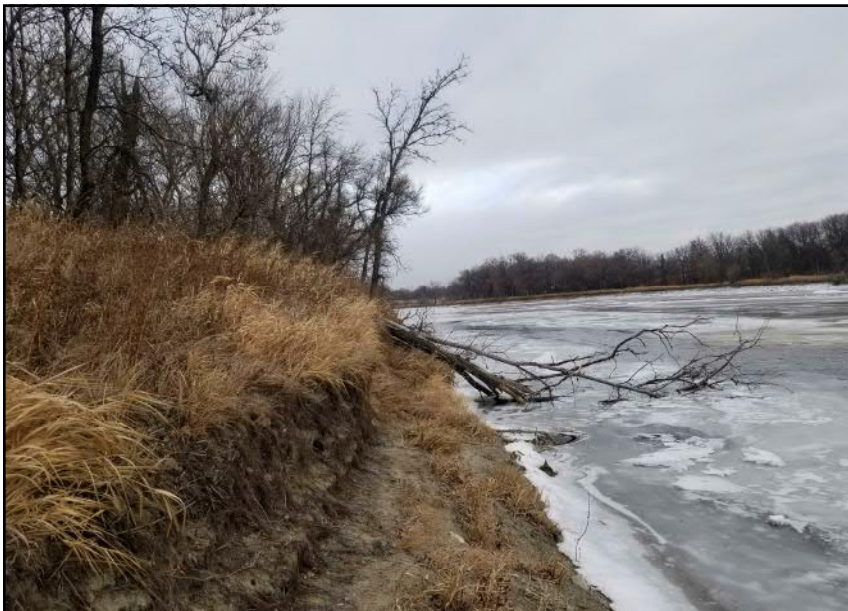
Site 5 - Northern Riverbank | Erosion scarp observed near bank toe within eastern portion of study area (facing E)

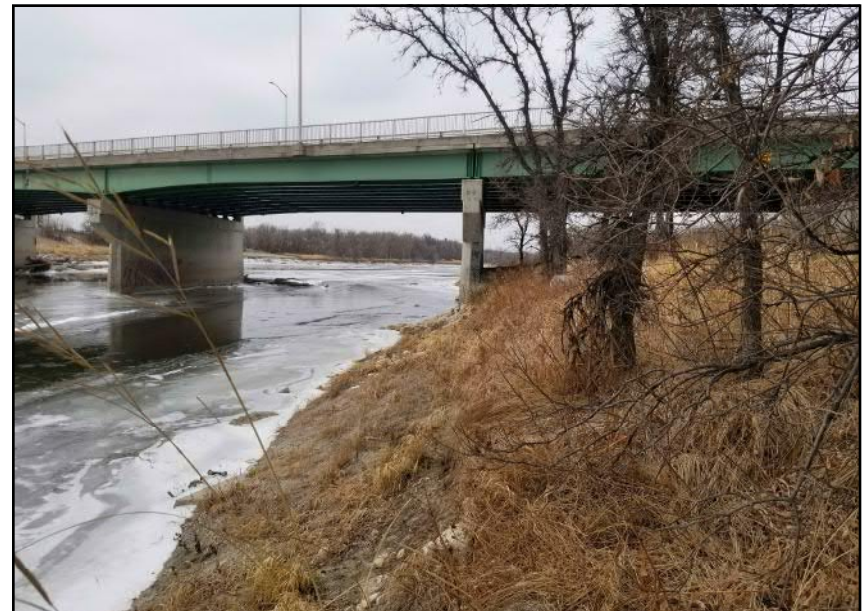
Site 5 - Northern Riverbank | Slightly steepened bank slope down towards river within western portion of study area (facing W)

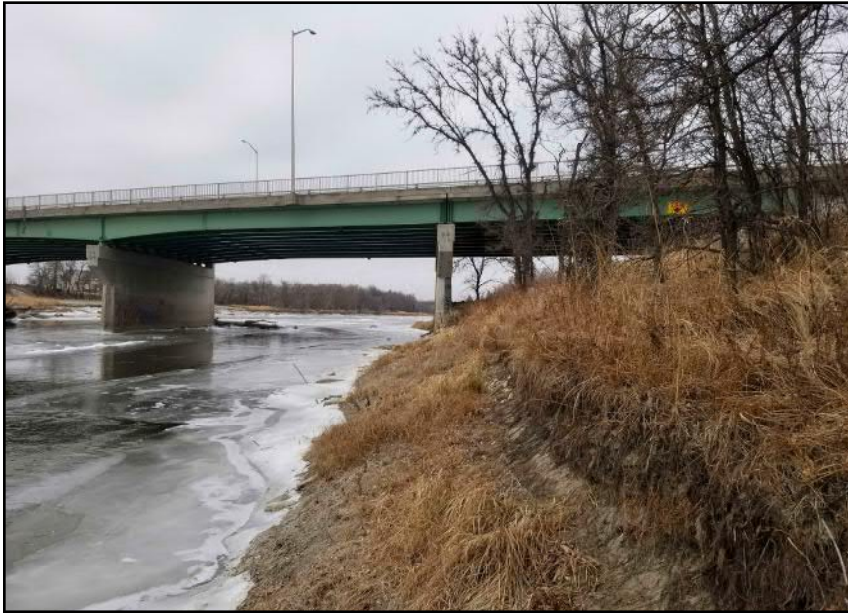
Site 5 - Northern Riverbank Erosion scarp observed near bank toe within western portion of study area (facing W)

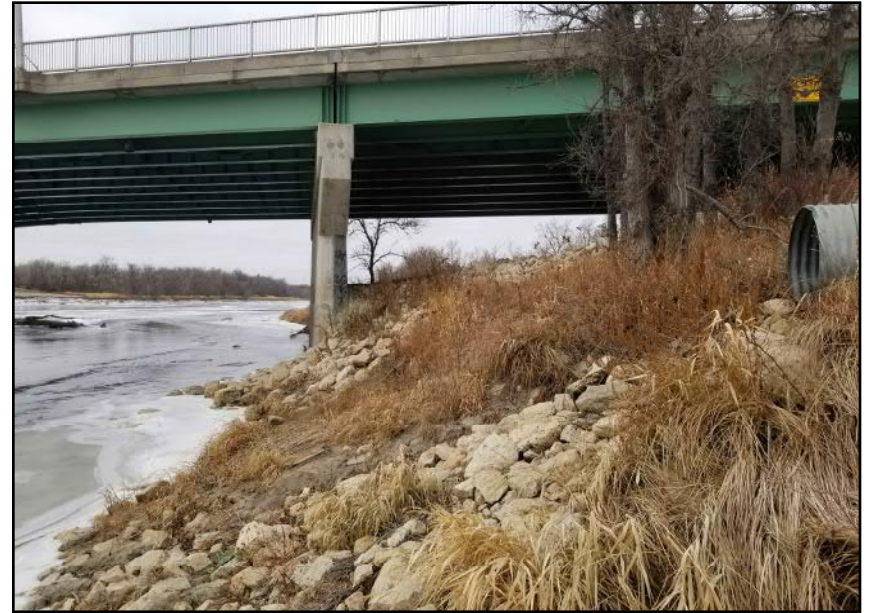
Site 5 - Northern Riverbank Rip-rap along slope within discharge path of CSP outfall in western portion of study area (facing W)

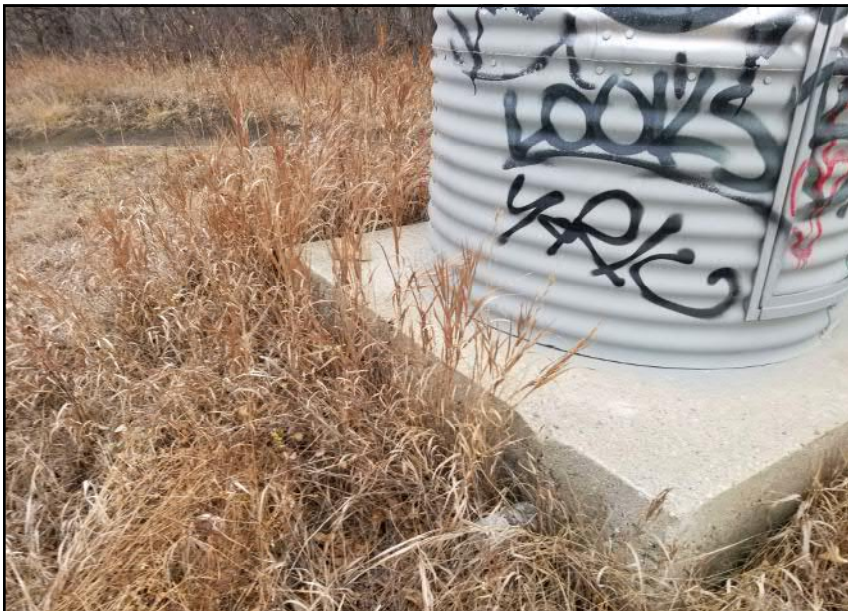
Site 5 - Southern Riverbank | No observed movement of lift station located at east crest of rip-rap drainage channel (facing E)

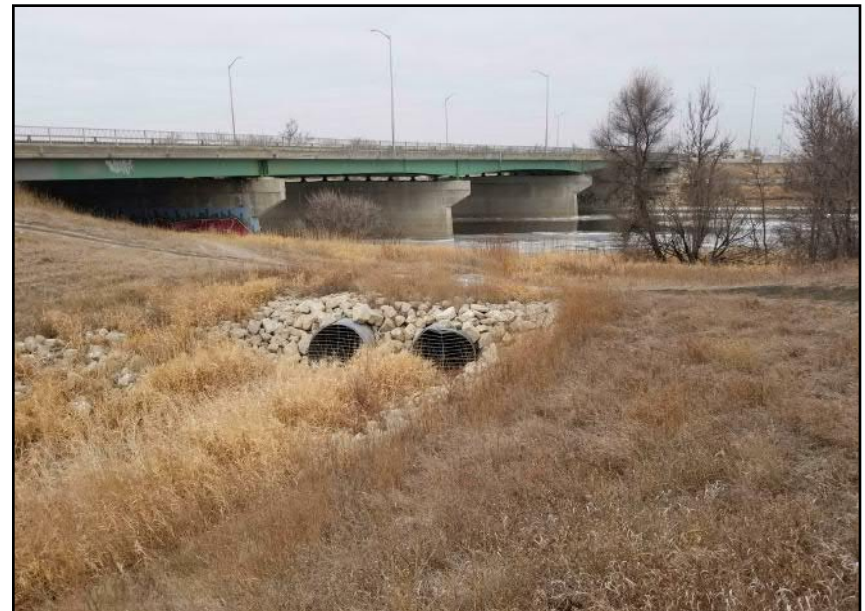
Site 5 - Southern Riverbank | Drainage channel sloped towards CSP culverts west of crossing alignment (facing NW)

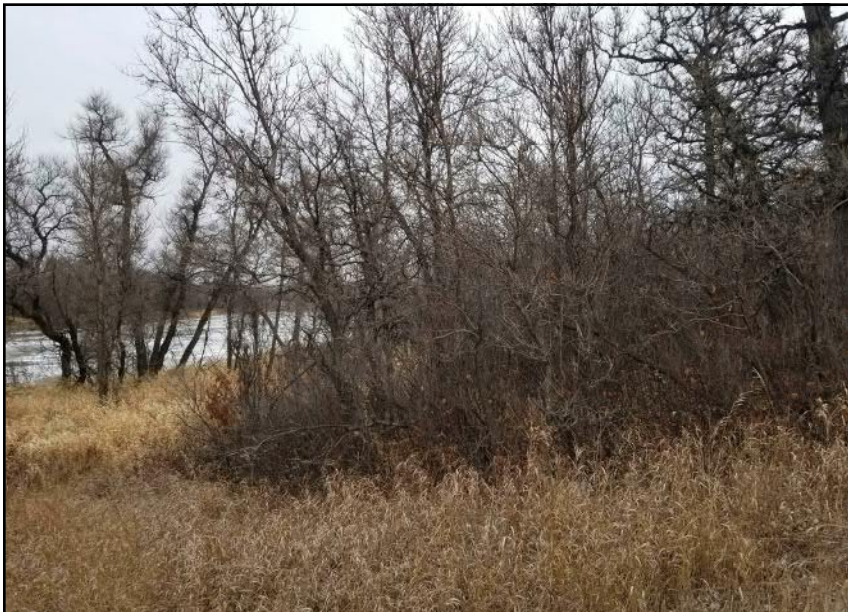
Site 5 - Southern Riverbank Gradual slopes, brush, shrubs, and trees observed along bank crest near crossing alignment (facing E)

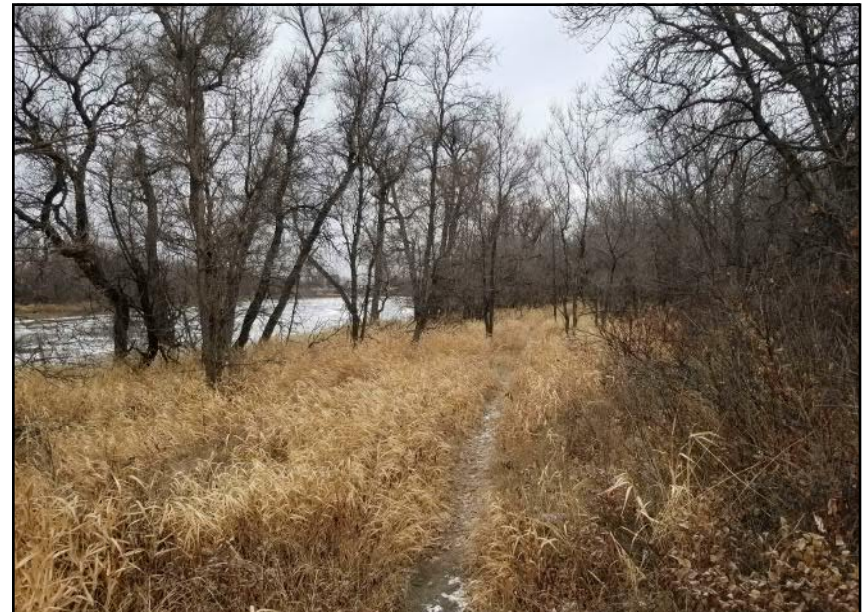
Site 5 - Southern Riverbank Flattened bank crest slope closer to river edge, signs of pedestrian passage (facing E)

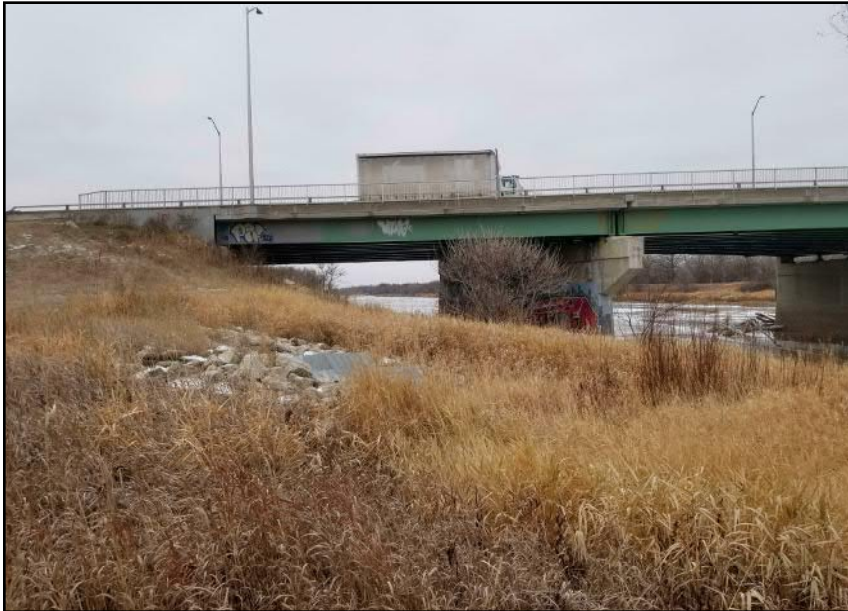
Site 5 - Southern Riverbank Gradual slopes, brush, trees observed along bank crest west of crossing alignment (facing W)

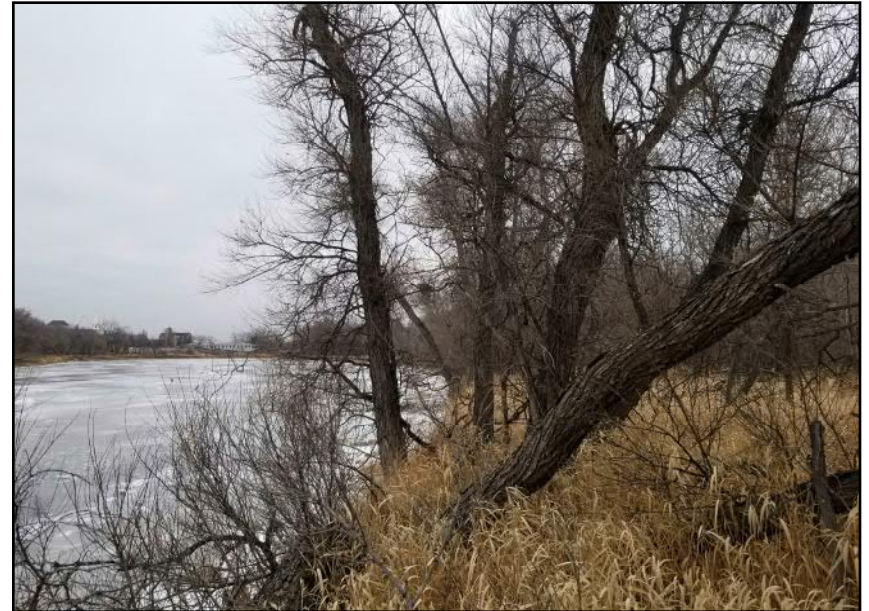
Site 5 - Southern Riverbank Fallen tree in close proximity to crossing alignment and erosion scarp at river edge (facing NE)

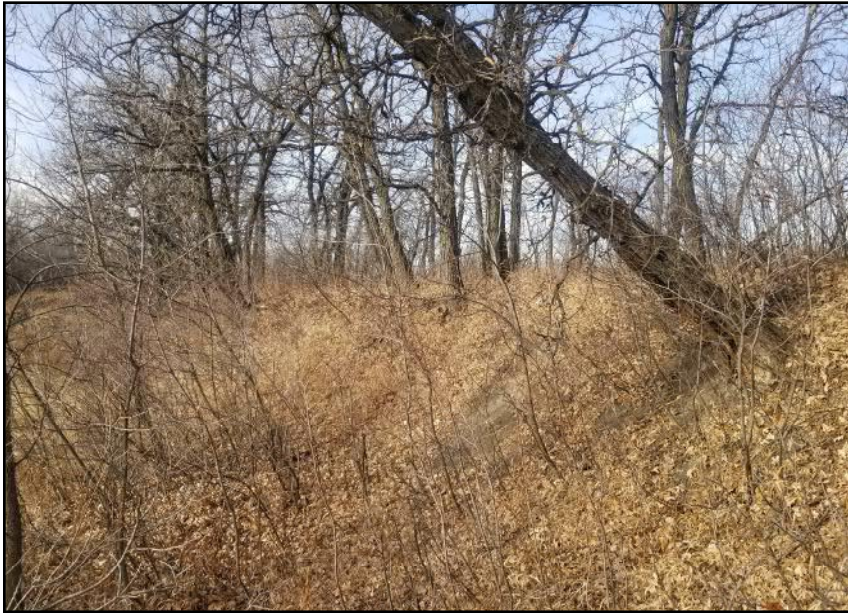
Site 6A - Northern Bank | Scarps from slope instabilities observed along oversteepened portion of banks (facing NW)

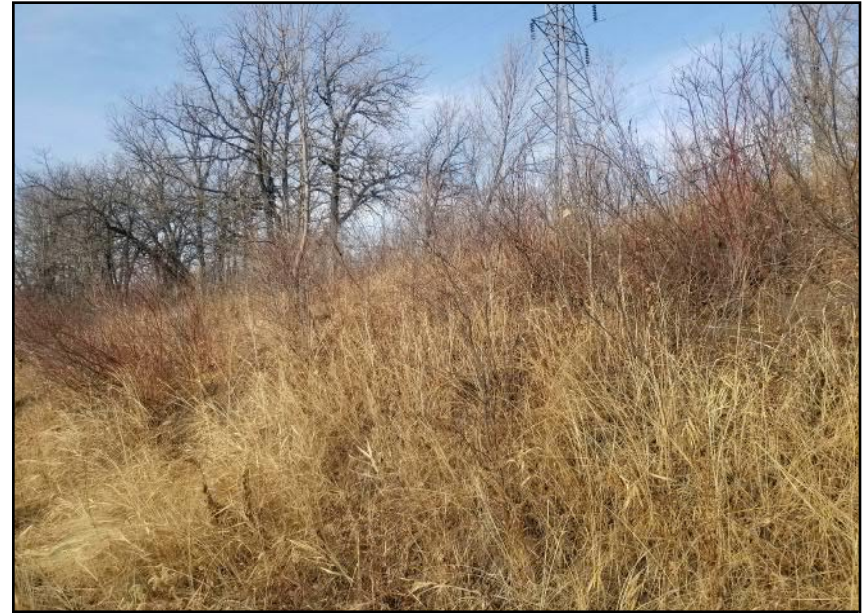
Site 6A - Northern Bank | Consistently sloping ground from crest to bank toe east of crossing alignment (facing NW)

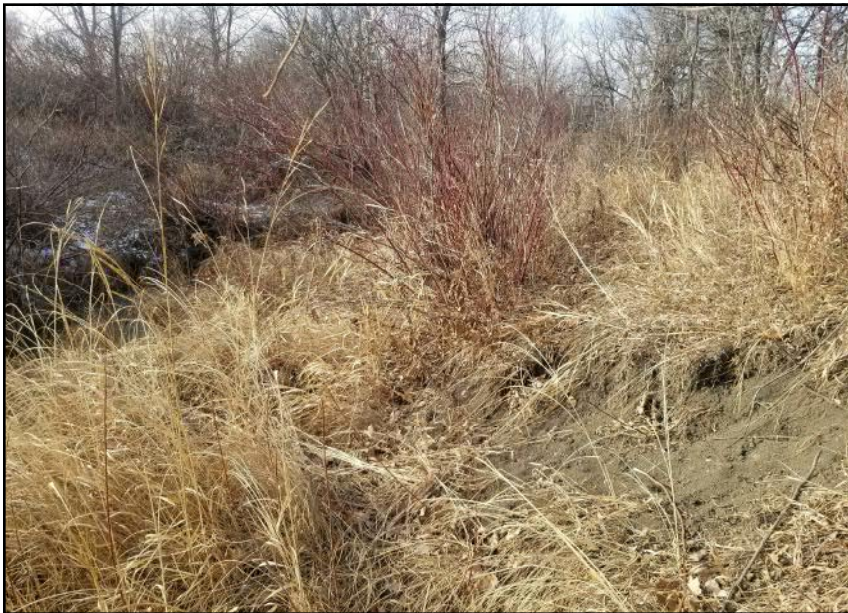
Site 6A - Northern Bank | Scarps observed near flatter portion near drain in vicinity of crossing alignment (facing W)

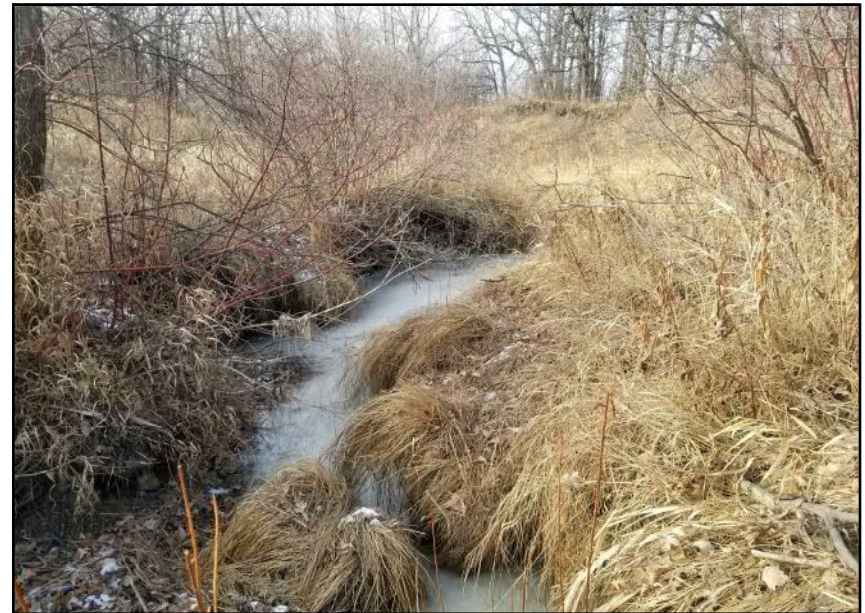
Site 6A - Northern Bank | Erosion scarp observed along drain edges, varying in height (facing W)

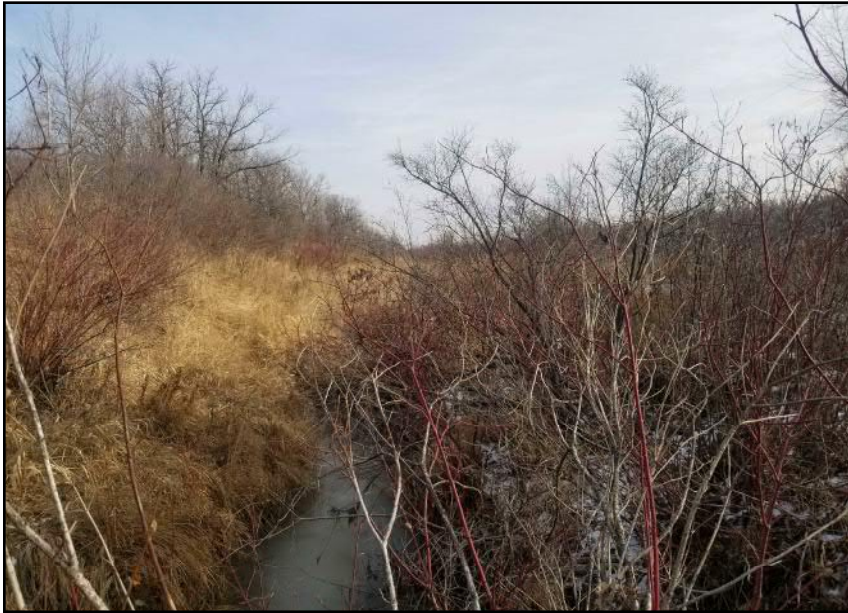
Site 6A - Southern Bank | Flatter slopes around drain, steepening sharply towards bank crest (facing E)

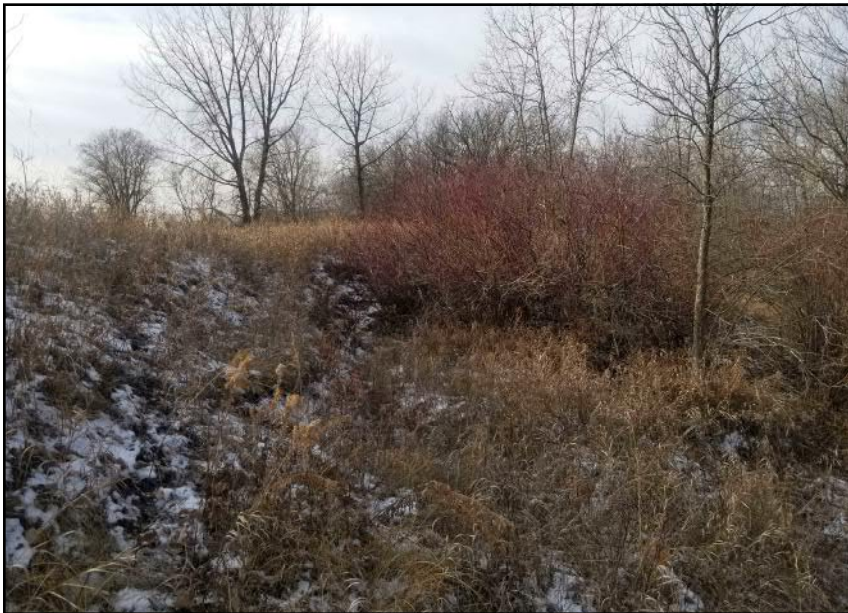
Site 6A - Southern Bank | Progressive slope instabilities observed in close proximity to crossing alignment (facing W)

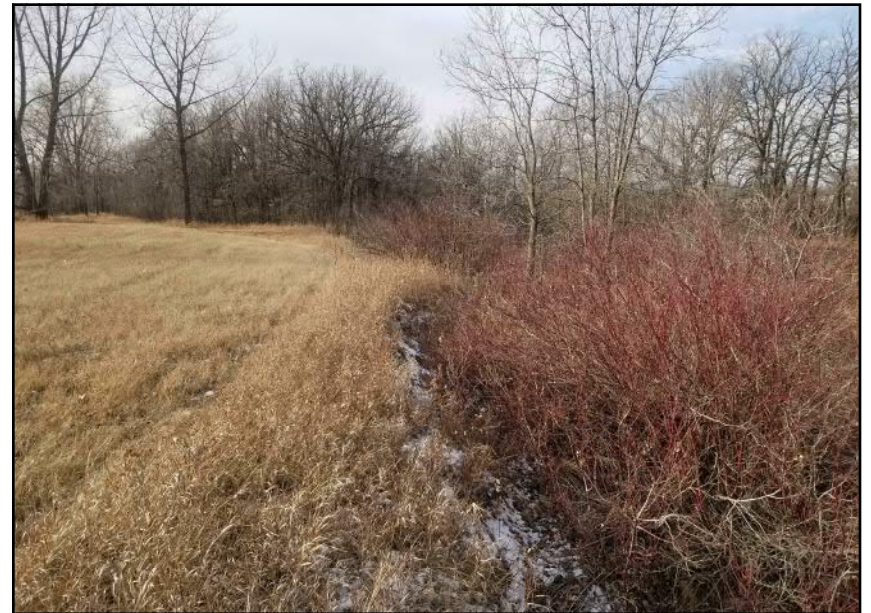
Site 6A - Southern Bank | Progressive slope instabilities have progressed towards the bank crest (facing W)

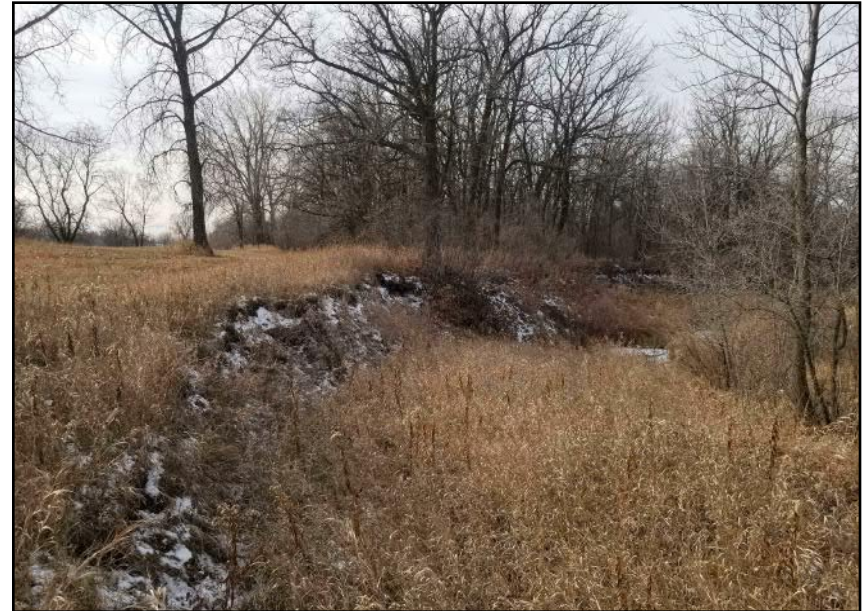
Site 6A - Southern Bank	Slope instability ridges observed near bank crest west of the crossing alignment (facing W)
--------------------------------	---

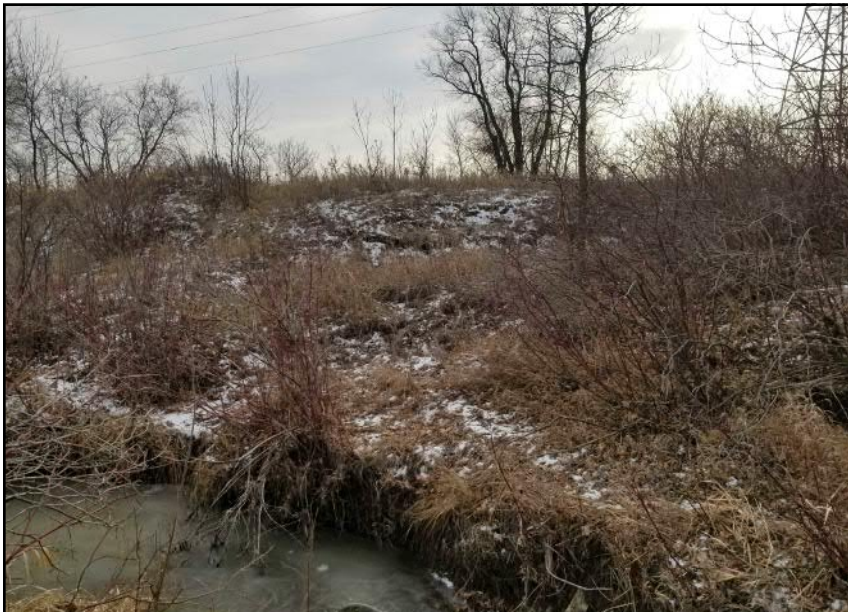
Site 6A - Southern Bank	Progressive slope instabilities along bank slope near crossing alignment (facing SE)
--------------------------------	--

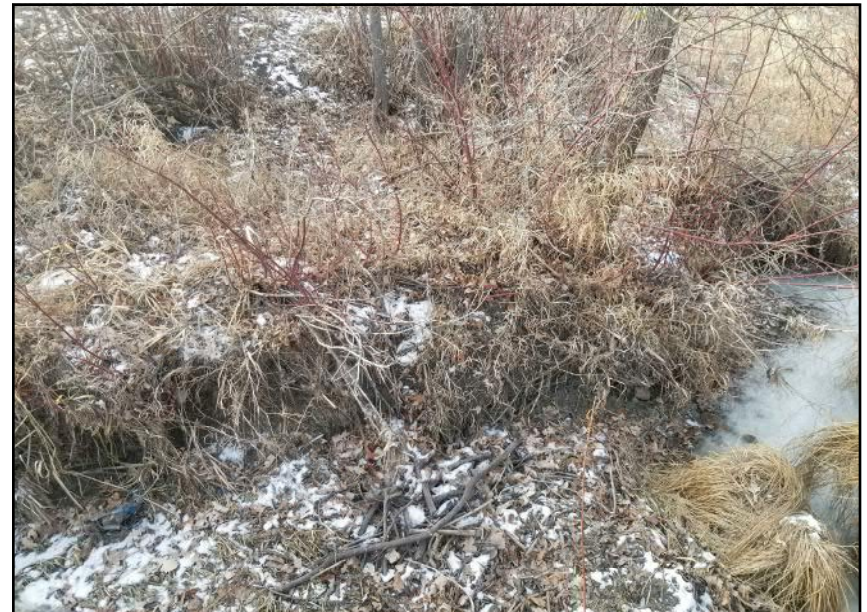
Site 6A - Southern Bank	Shallow slope instabilities observed at localized areas along bank toe (facing S)
--------------------------------	---

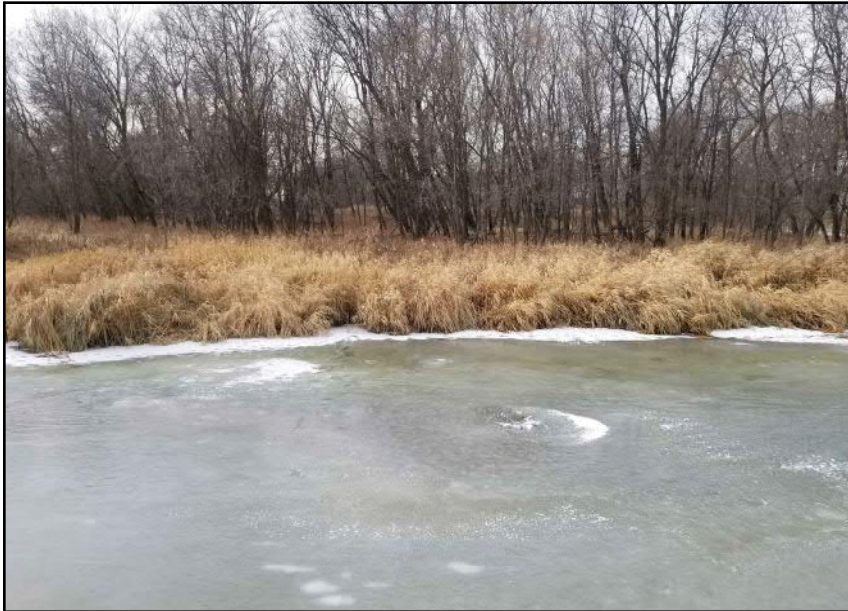
Site 6B - Western Bank	View of western riverbank from eastern riverbank near crossing alignment (facing W)
-----------------------------------	---

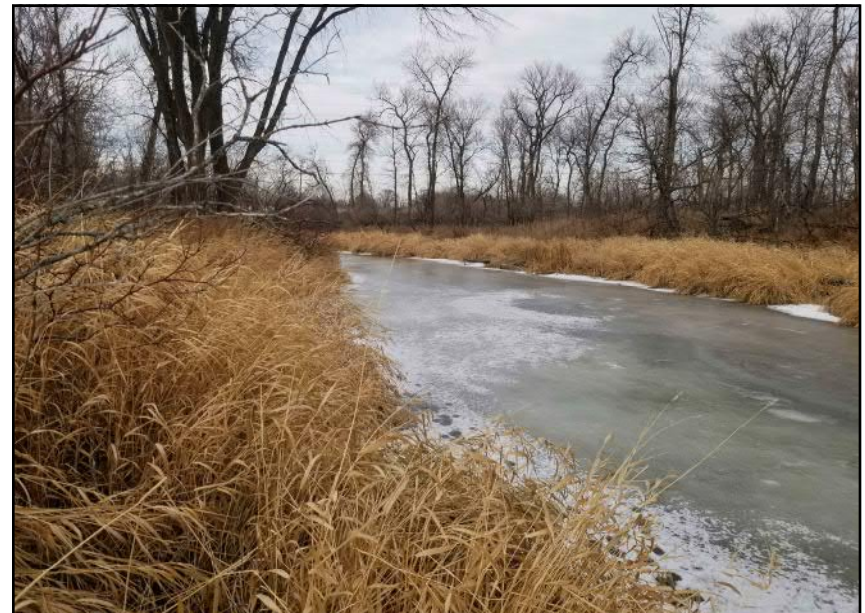
Site 6B - Western Bank	Minor erosion observed at localized areas along bank toe (facing N)
-----------------------------------	---

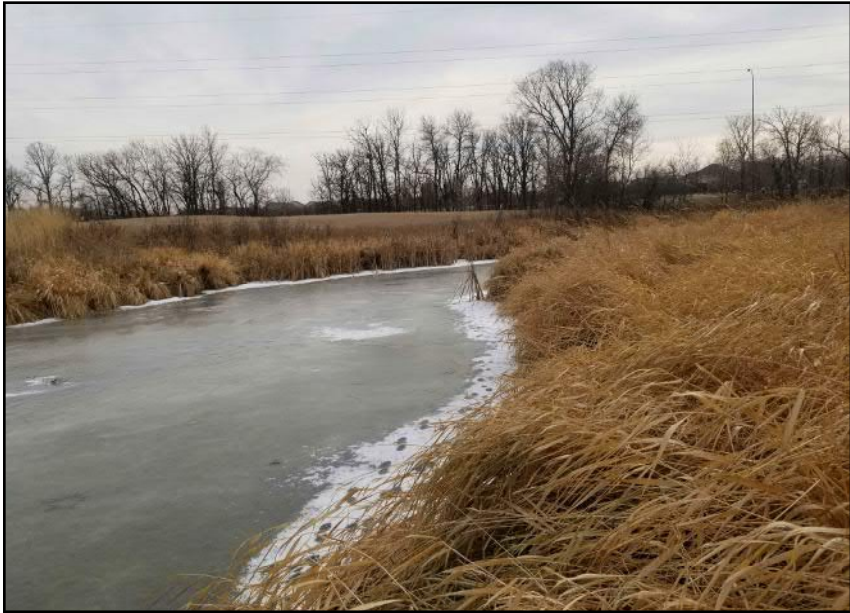
**Site 6B -
Western Bank**

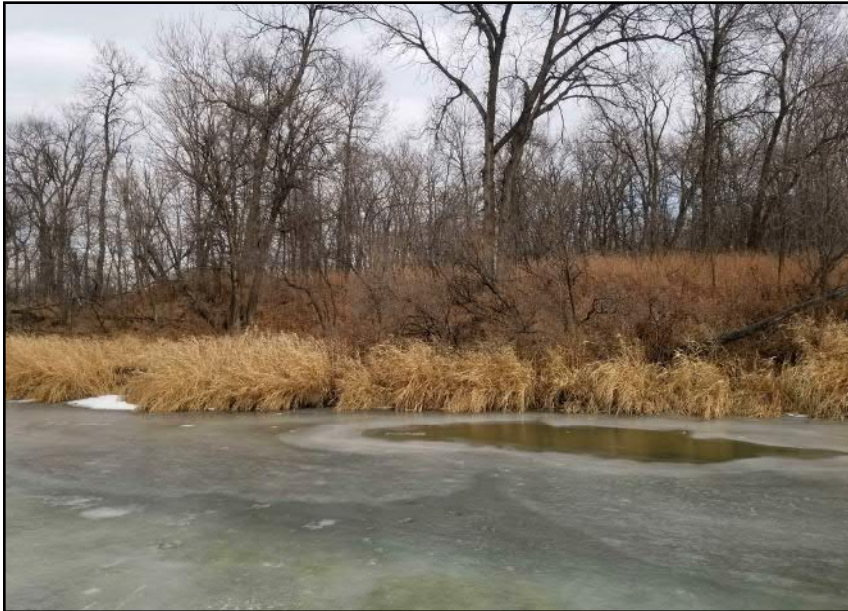
Site 6B - Eastern Bank	View of eastern riverbank from western riverbank near crossing alignment (facing E)
-------------------------------	---

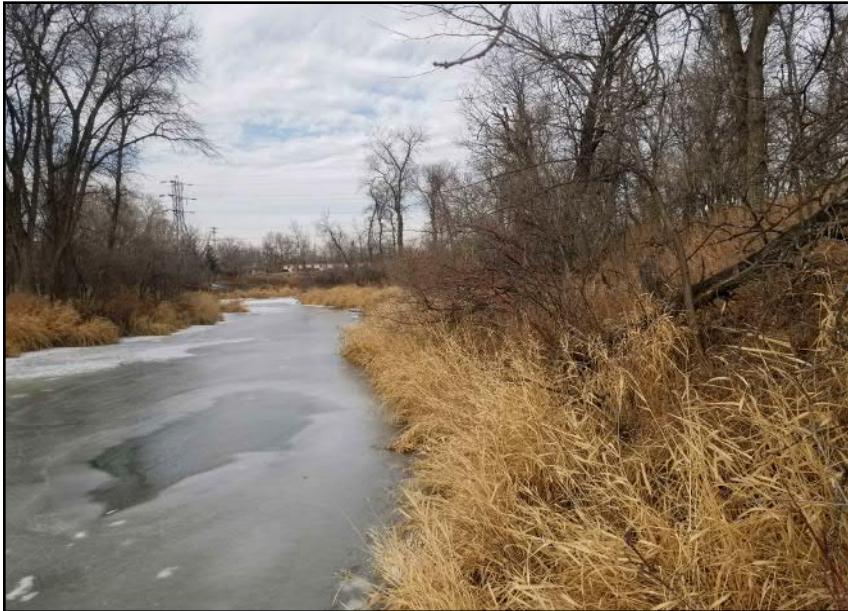
Site 6B - Eastern Bank	Minor erosion observed at localized areas along bank toe (facing N)
-------------------------------	---

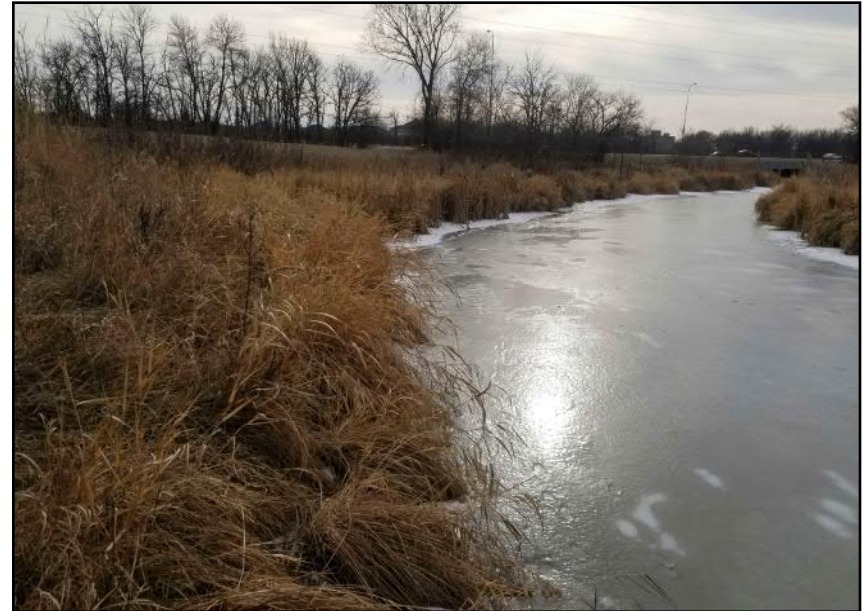
Site 6B - Eastern Bank	Minor erosion observed at localized areas along bank toe (facing S)
-------------------------------	---
