Appendix B

Geotechnical Data Report

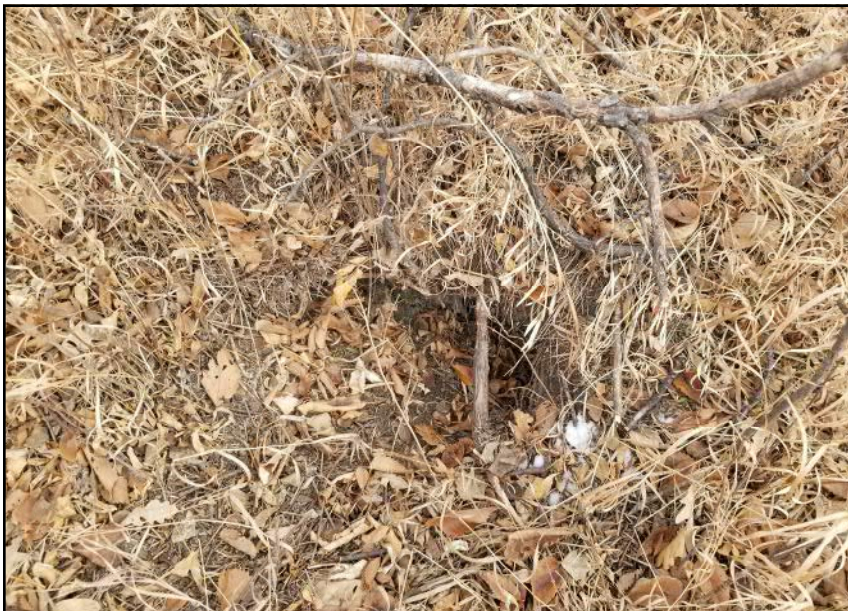
Site 6B - Eastern Bank	Animal burrows observed within the steeper bank slopes (facing E)
-------------------------------	---

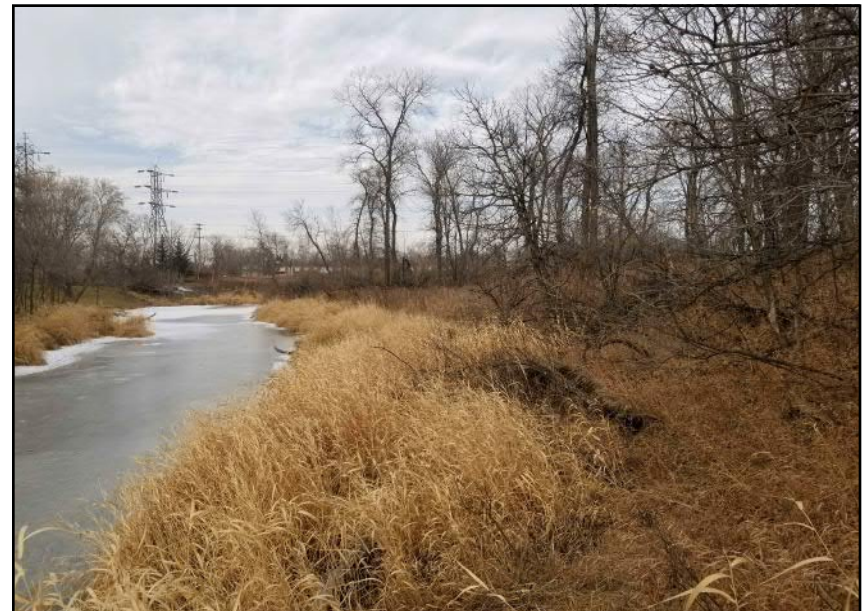
Site 6B - Eastern Bank	Bank slopes flatten out near the river edge north of the study area (facing N)
-------------------------------	--

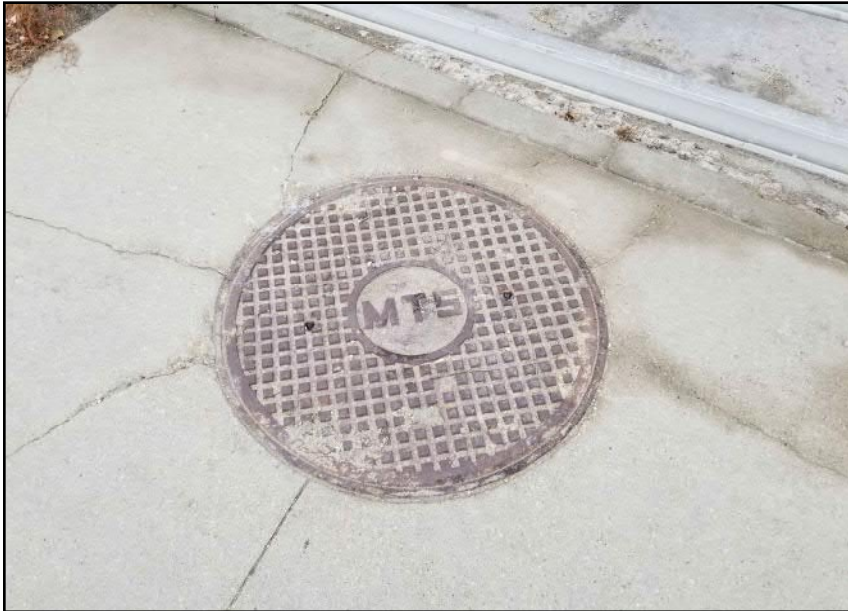
Site 7 - Western Bank Cracks around MTS manhole located in paved bridge sidewalk near abutment

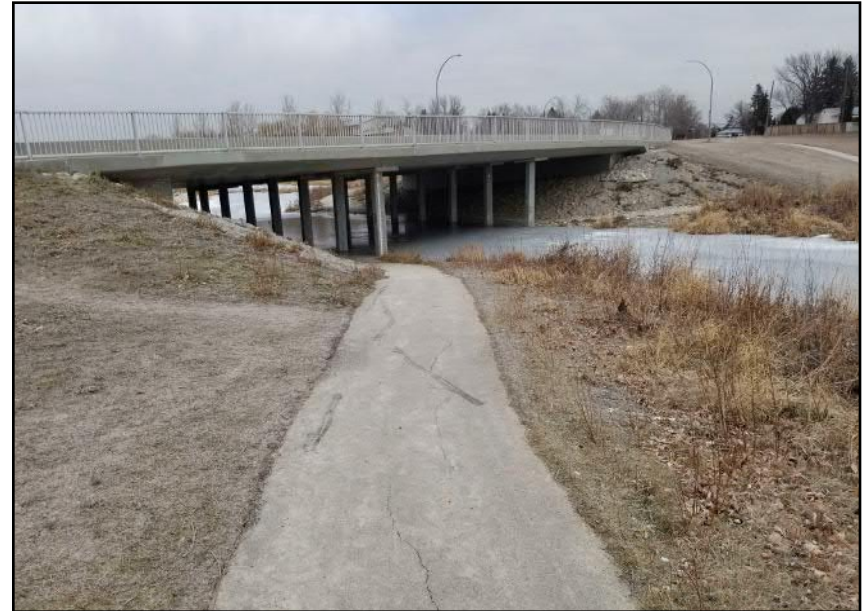
Site 7 - Western Bank Steeper slope around bridge abutment and minor cracking along pedestrian pathway (facing NE)

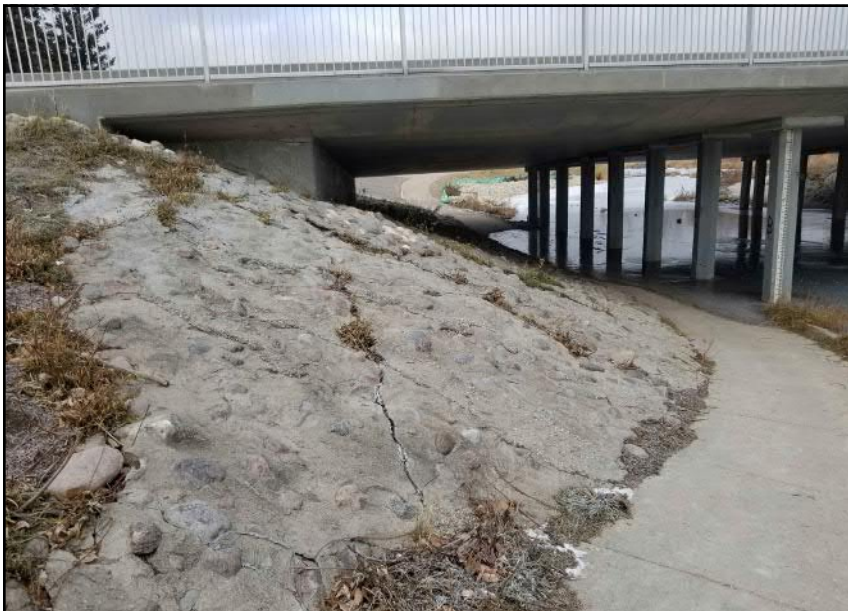
Site 7 - Western Bank Grouted rip-rap armorment along steeper banks in close proximity to bridge abutment (facing N)

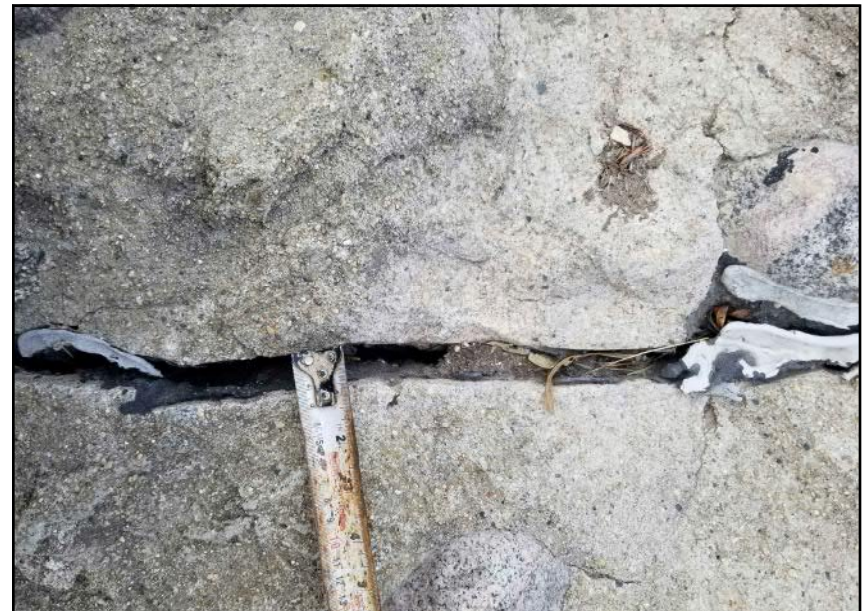
Site 7 - Western Bank Cracks observed within grouted rip-rap armorment at various orientations

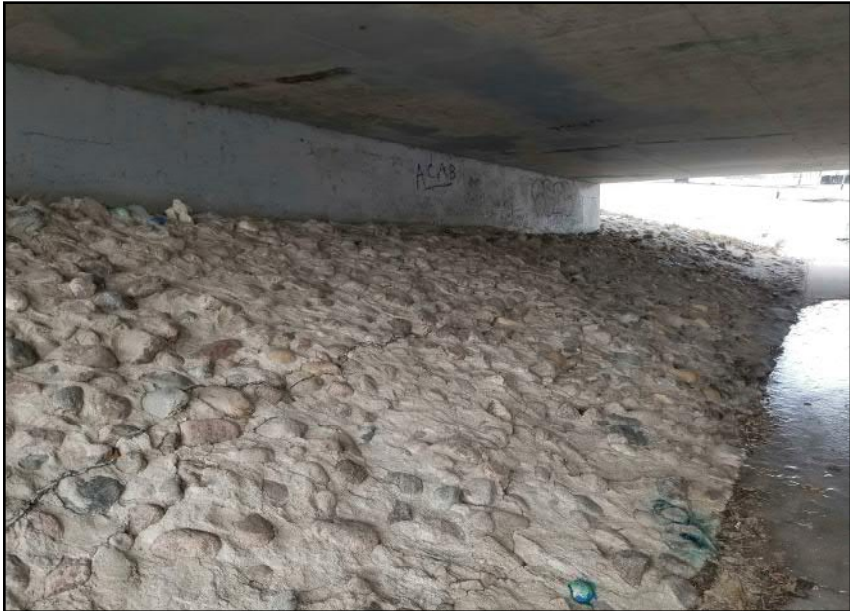
Site 7 - Western Bank Grouted rip-rap along abutment head slope below bridge structure (facing NW)

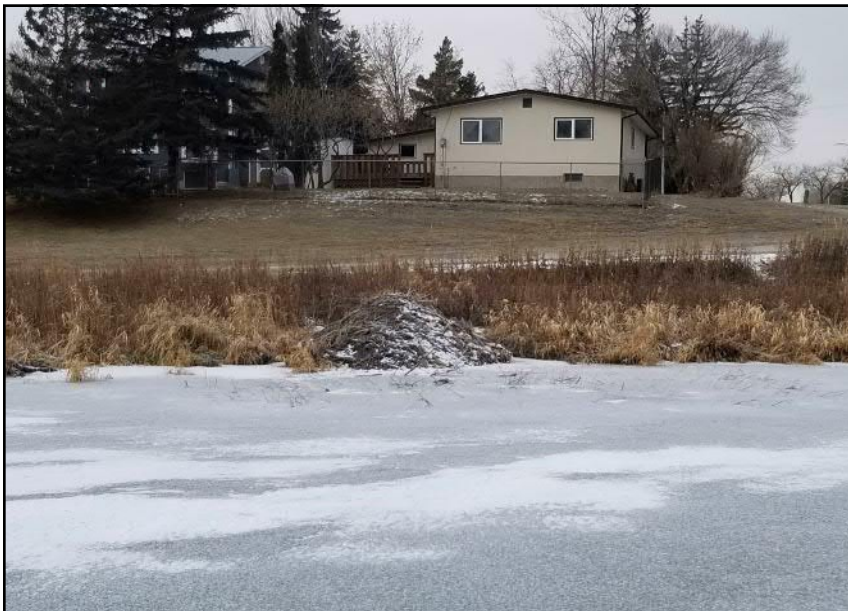
Site 7 - Eastern Bank	Beaver den observed across the creek near the bank edge (facing W)
------------------------------	--

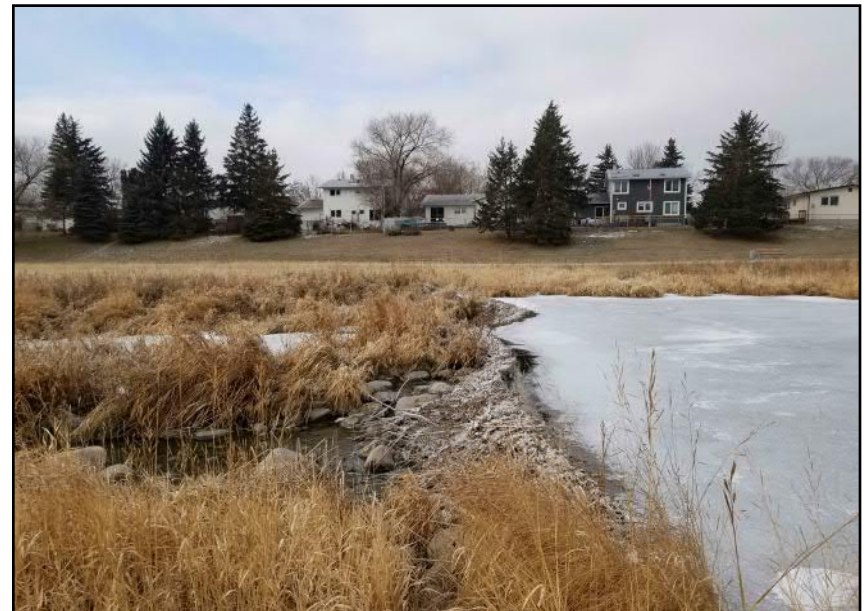
Site 7 - Eastern Bank	Beaver dam south of study area causing higher water levels within the study area (facing W)
------------------------------	---

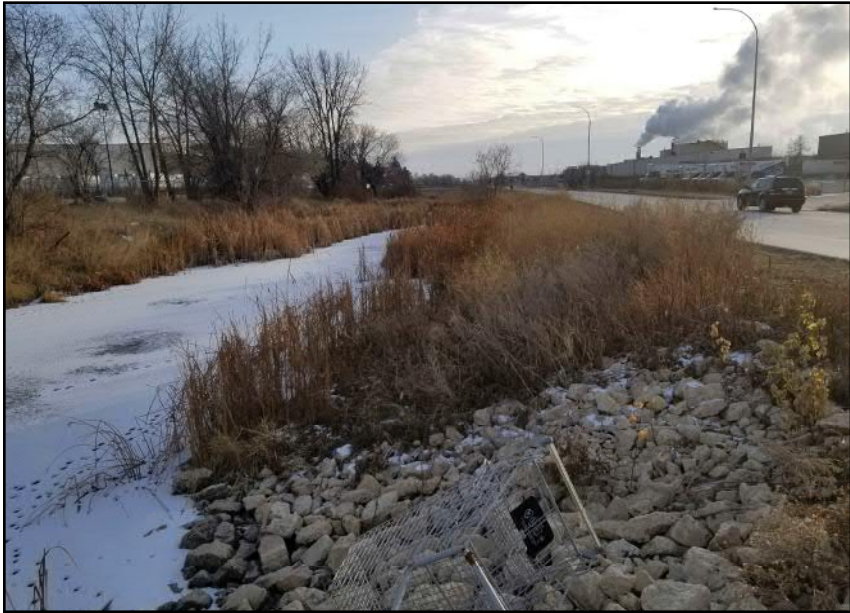
Site 8 - Western Bank	Gradual bank slopes and dense brush and shrub coverage observed south of rip-rap (facing S)
------------------------------	---

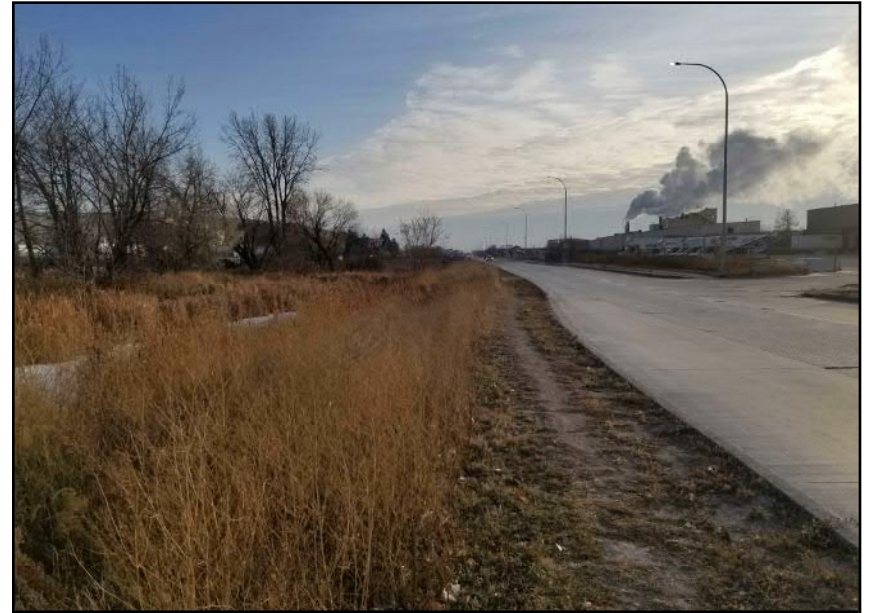
Site 8 - Western Bank	Partially grasses bank crest between Empress St. and the bank slope (facing S)
------------------------------	--

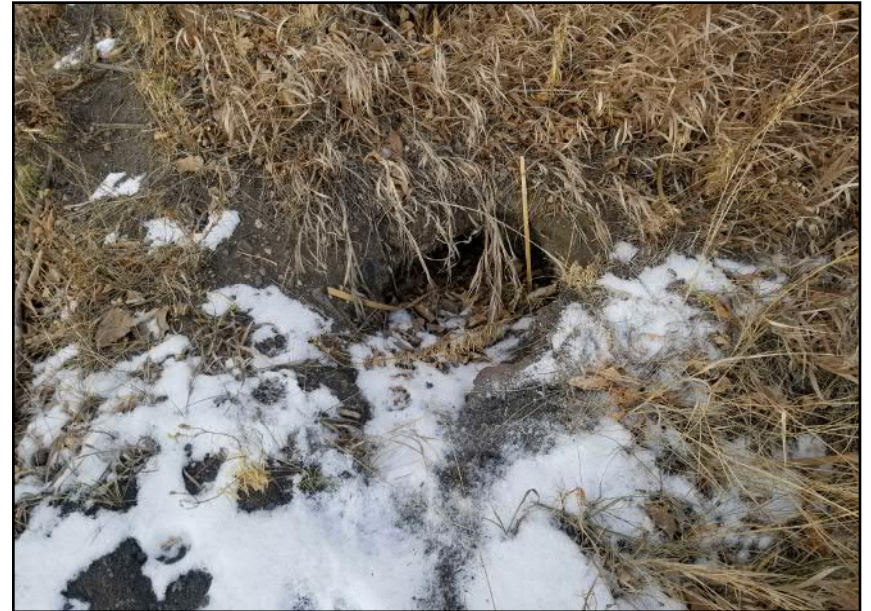
Site 8 - Eastern Bank	Animal burrows observed along bank slopes.
------------------------------	--

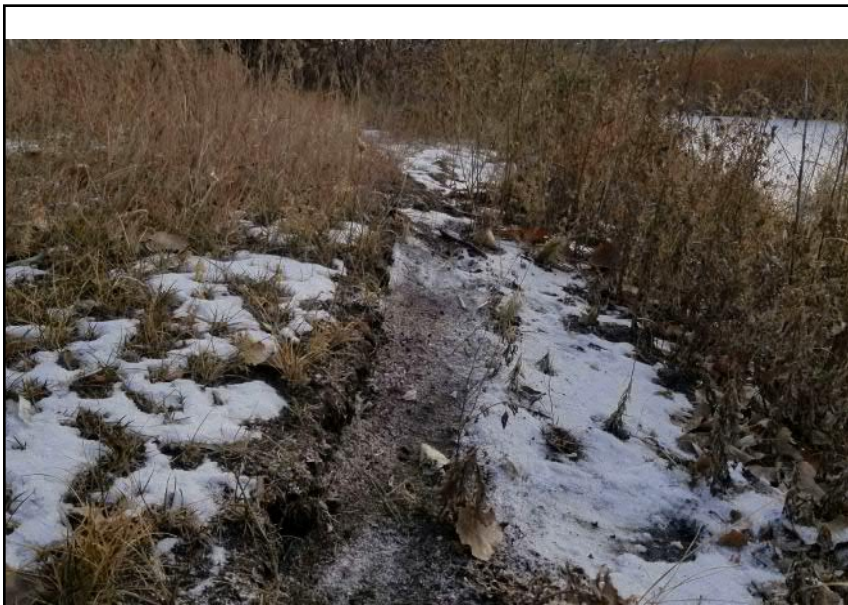
Site 8 - Eastern Bank	Scarp ridge observed near bank crest at oversteepened bank south of rip-rap area (facing S)
------------------------------	---

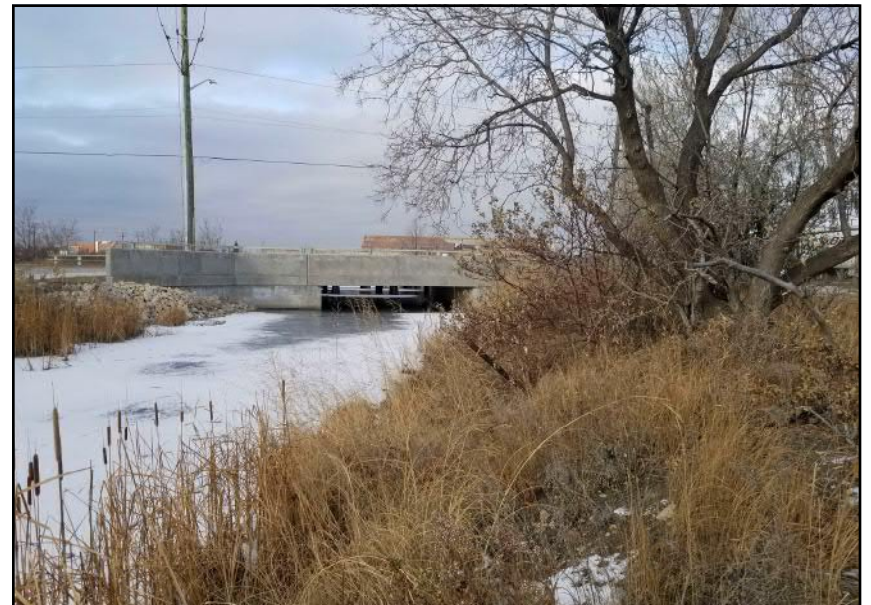
Site 8 - Eastern Bank	Oversteepened banks observed within southern portion of the study area (facing N)
------------------------------	---

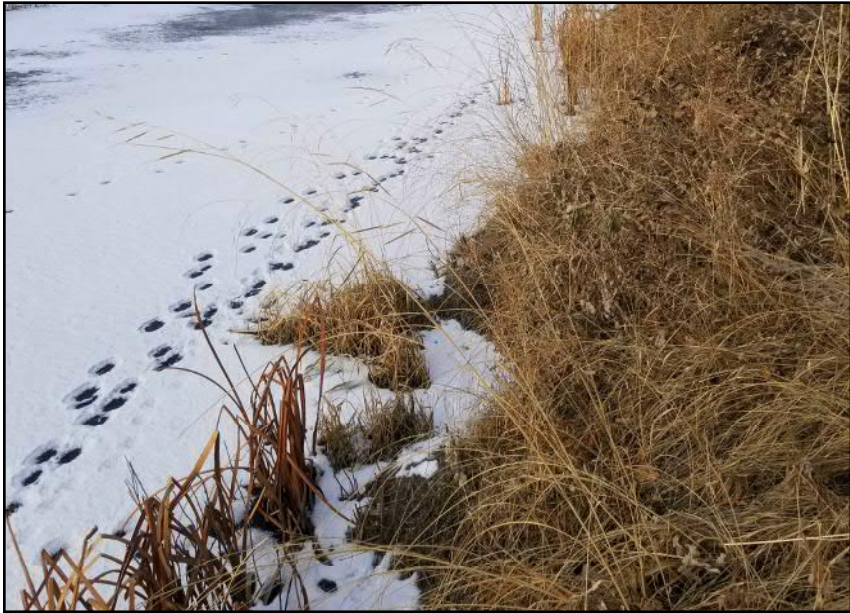
Site 8 - Eastern Bank	Minimal erosion observed along bank toe south of the rip-rap area (facing N)
------------------------------	--

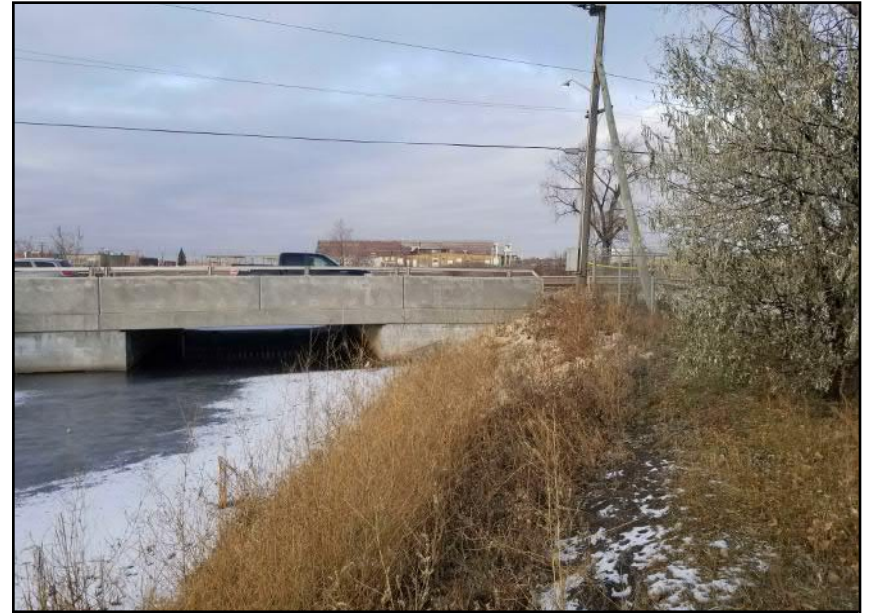
Site 8 - Eastern Bank	Observed bank slope change due to regrading near start of rip-rap area (facing N)
------------------------------	---

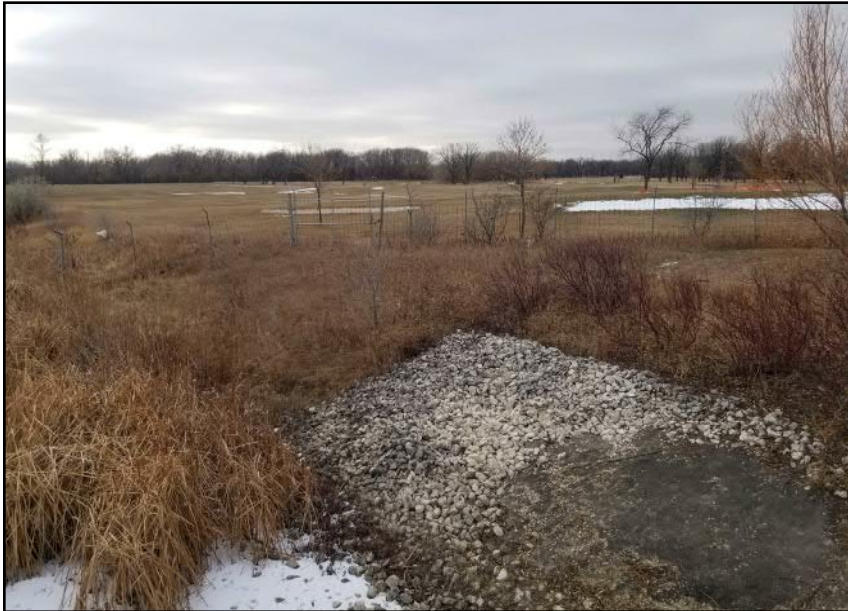
Site 9 - Western Bank	View of western riverbank from pedestrian bridge north of study area (facing W)
------------------------------	---

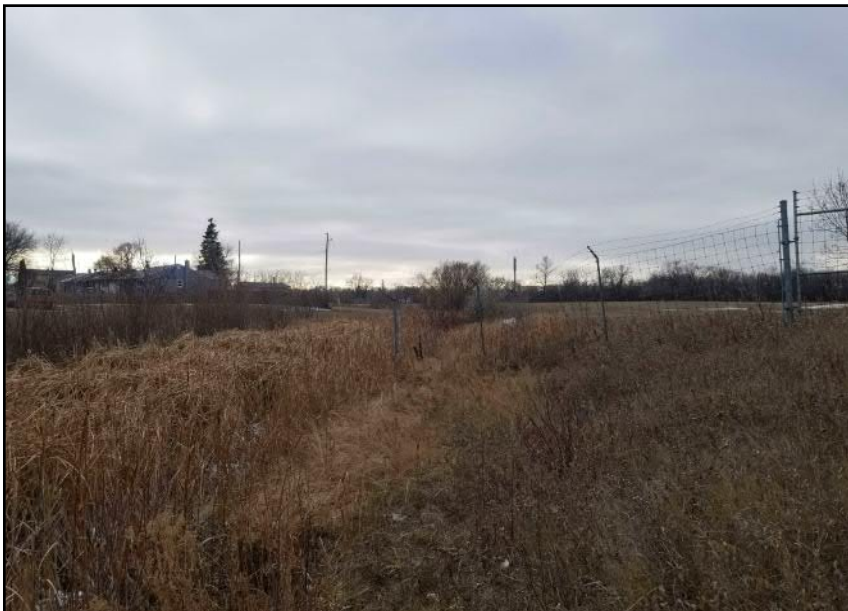
Site 9 - Western Bank	Gradual slopes down from bank crest to toe, heavily damaged fence (facing SW)
------------------------------	---

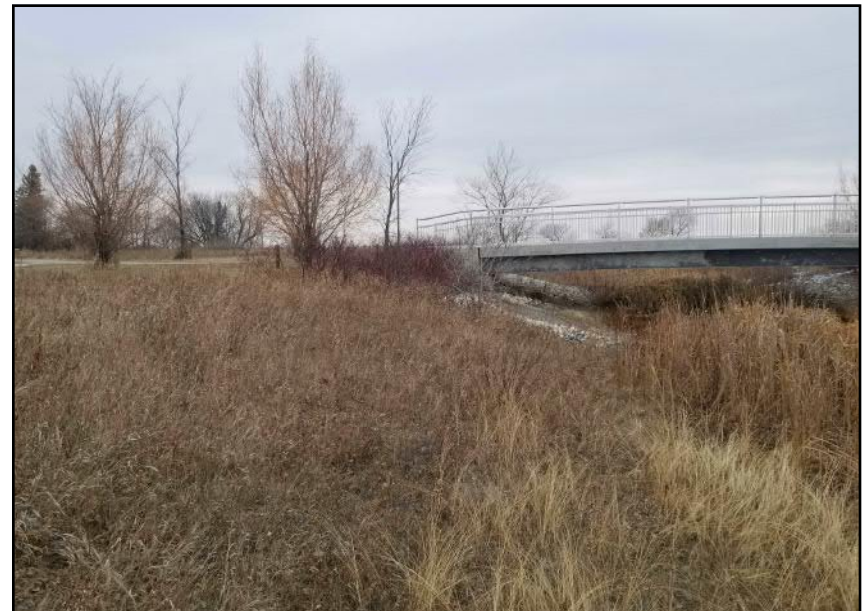
Site 9 - Western Bank	Moderate to dense brush vegetation along bank slope, groundwater well near bridge (facing N)
------------------------------	--

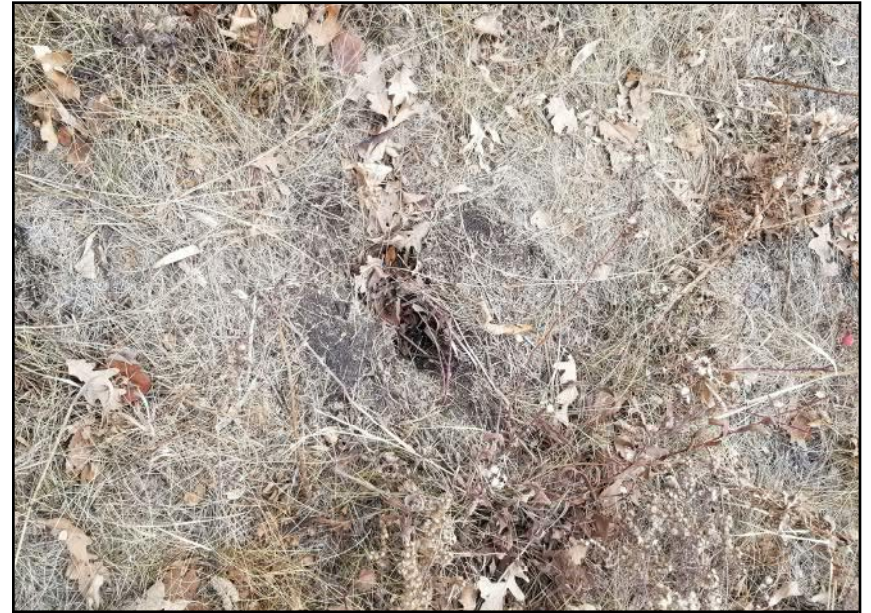
Site 9 - Western Bank	Animal burrows observed within bank slopes.
------------------------------	---

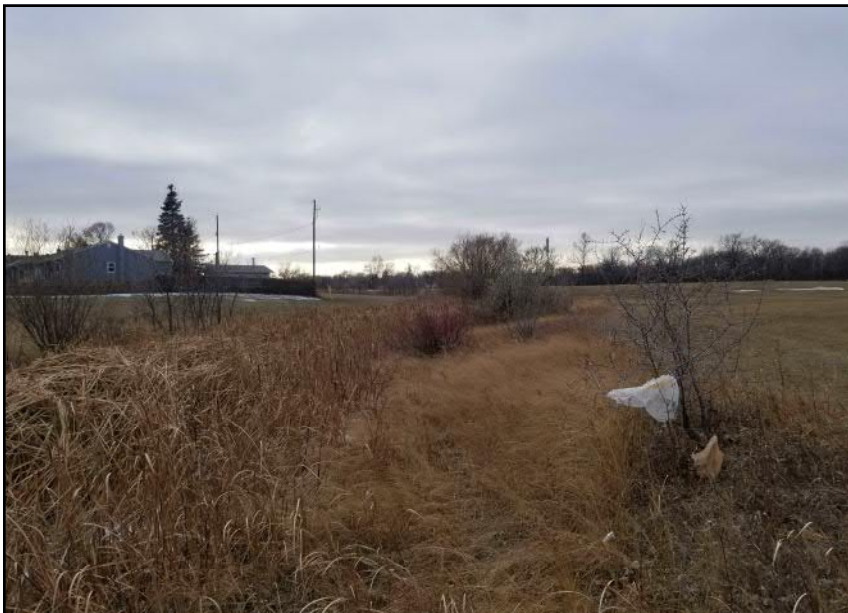
Site 9 - Western Bank	Relatively flat bank crest (Assiniboine Golf Course) becoming steeper towards creek (facing SW)
------------------------------	---

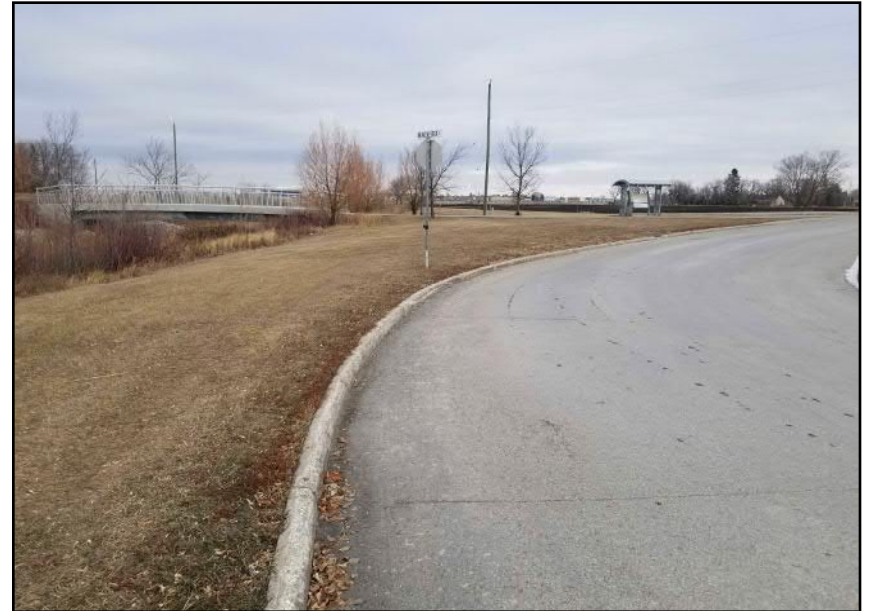
Site 9 - Eastern Bank	N-S portion of Silver Avenue, no significant cracks observed, generally flat bank crest (facing N)
------------------------------	--

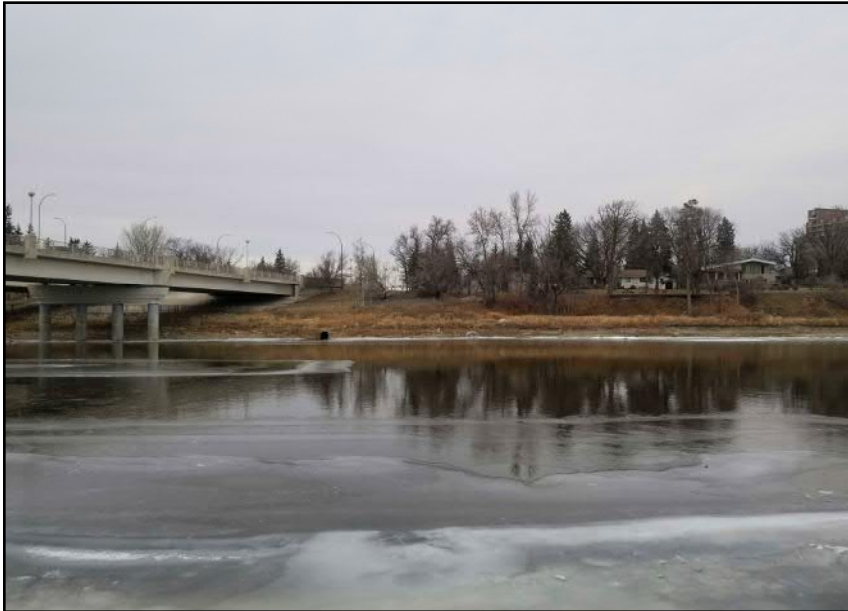
Site 10 - Northern Riverbank | View of northern bank from southern bank along approximate crossing alignment (facing N)

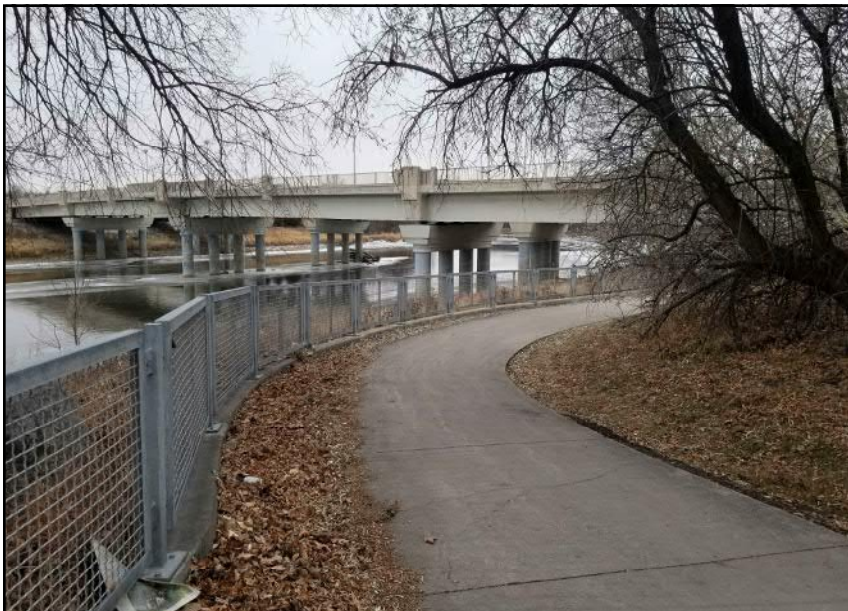
Site 10 - Northern Riverbank | Pedestrian pathway with minor cracking and railing along bank slope (facing SW)

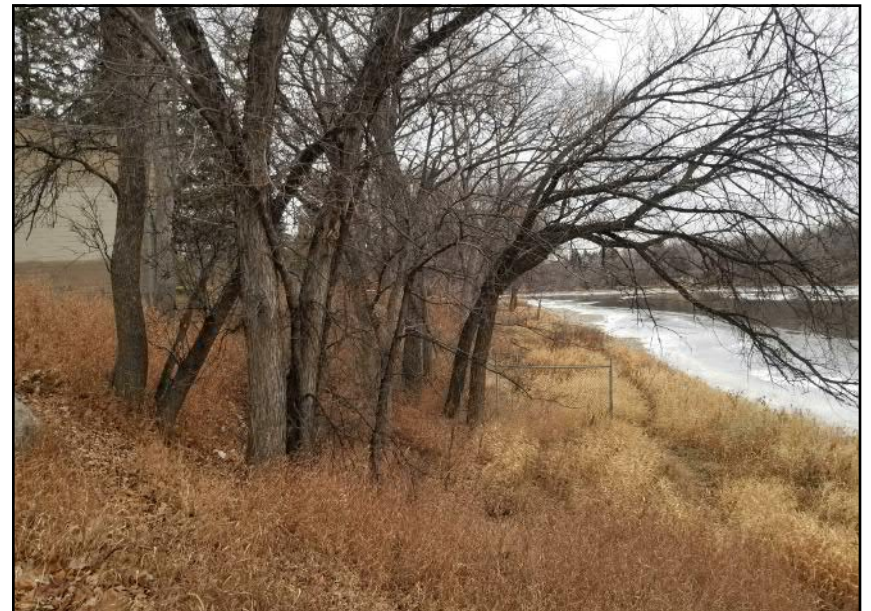
Site 10 - Northern Riverbank | Slope that flattens out closer to the river edge within southern portion of study area (facing E)

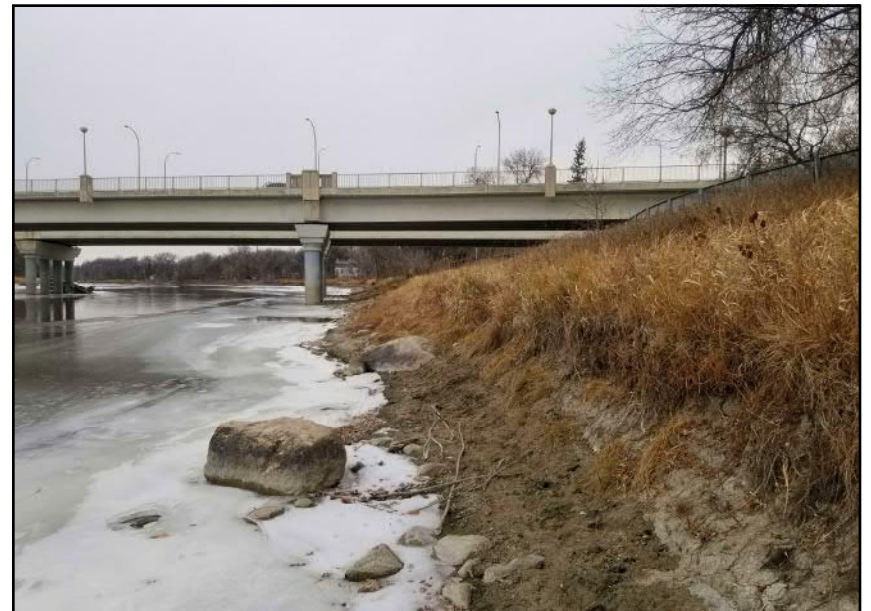
Site 10 - Northern Riverbank | Scarp near river edge observed along full length of bank toe within study area (facing W)

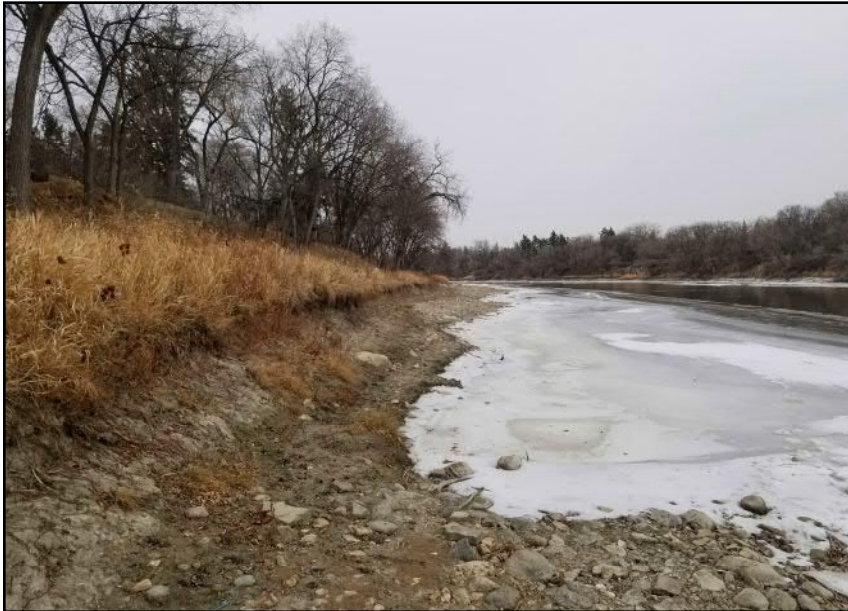
Site 10 - Northern Riverbank	Scarp near river edge observed along full length of bank toe within study area (facing E)
-------------------------------------	---

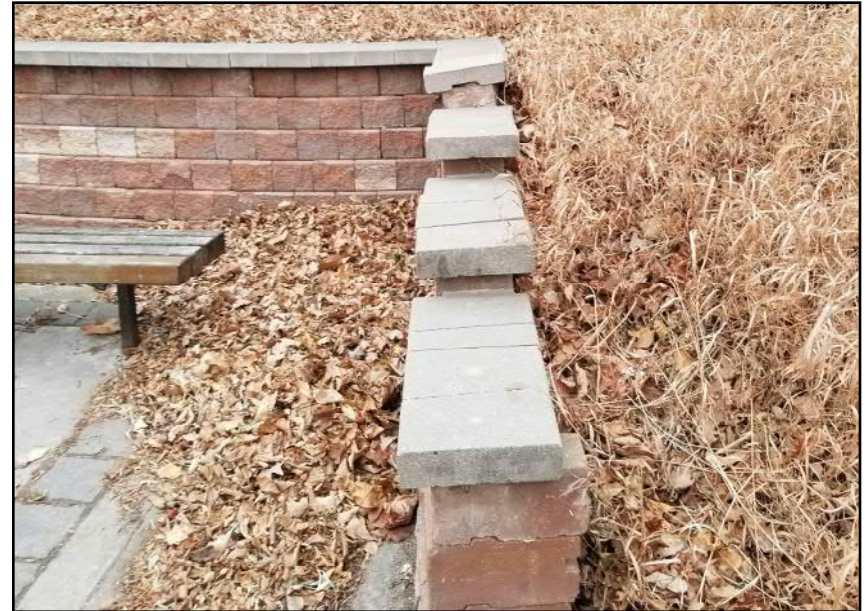
Site 10 - Northern Riverbank	Masonry retaining wall structure near pedestrian pathway shows small signs of movement (facing W)
-------------------------------------	---

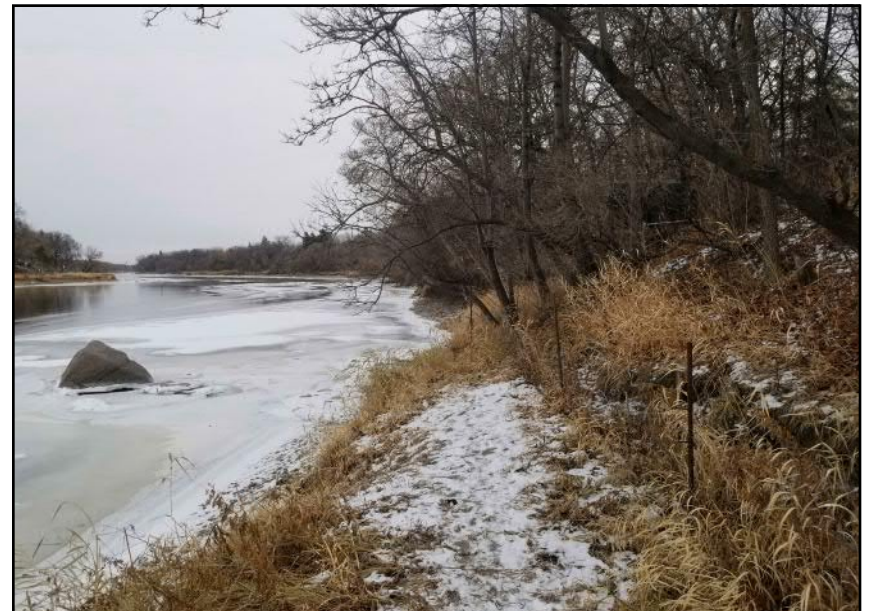
Site 10 - Southern Riverbank | Oversteepened banks and instabilities observed within eastern portion of study area (facing E)

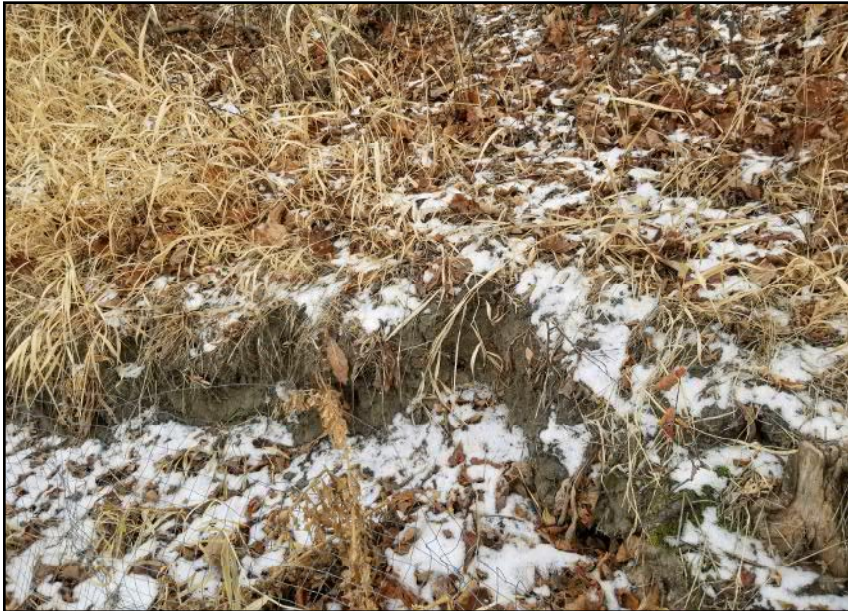
Site 10 - Southern Riverbank Scarp face observed along oversteepened slope within eastern portion of study area

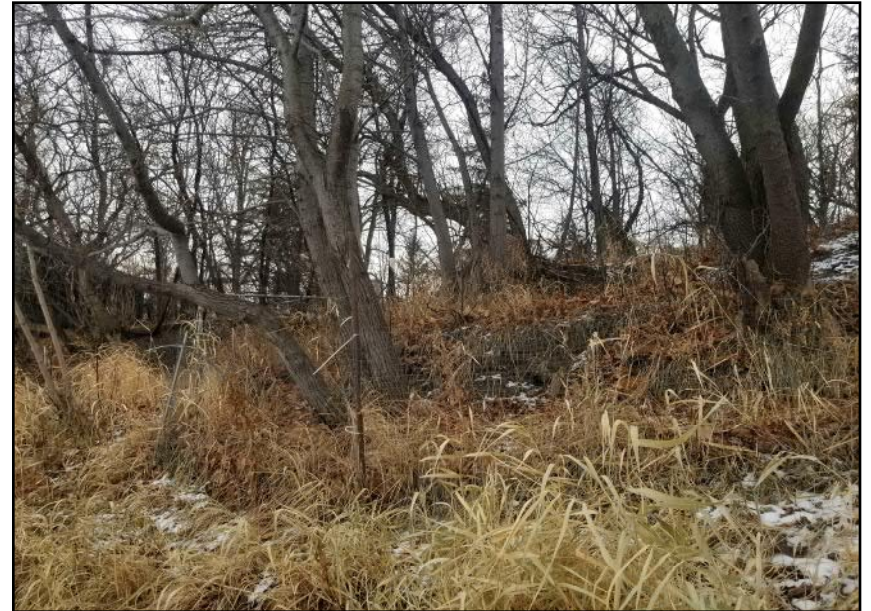
Site 10 - Southern Riverbank Larger scarps and leaning trees observed along banks in eastern portion of study area (facing SE)

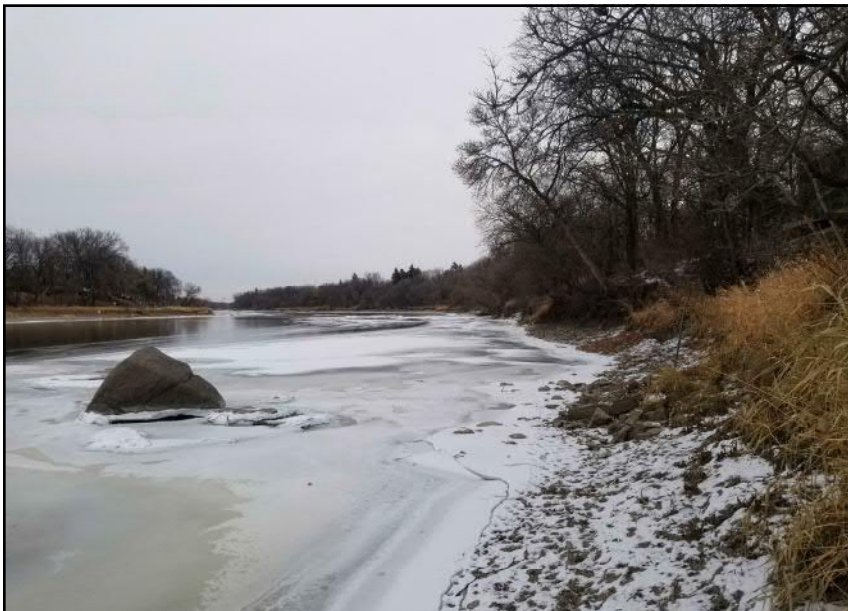
Site 10 - Southern Riverbank Scarp near river edge observed within southern portion of study area (facing E)

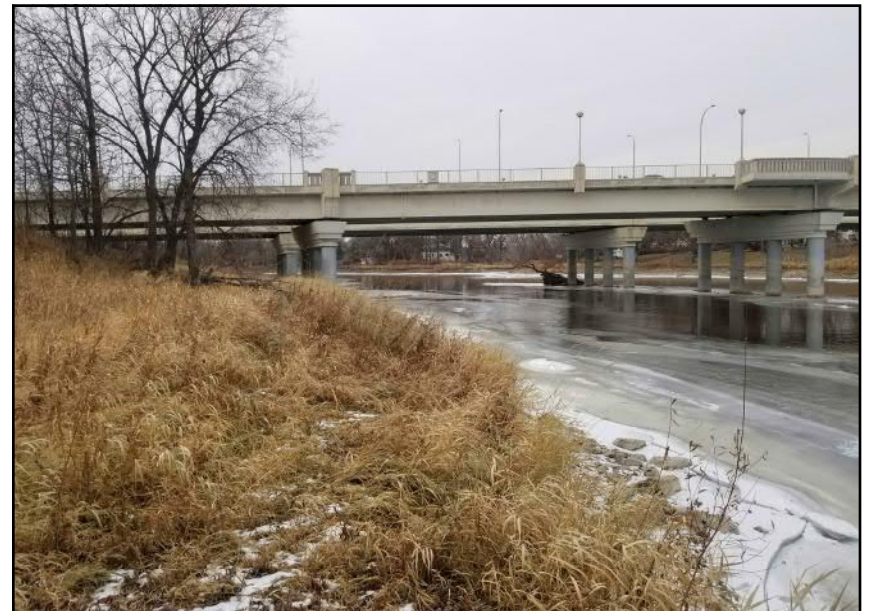
Site 10 - Southern Riverbank Gradually sloping bank crest within western portion of study area (facing W)

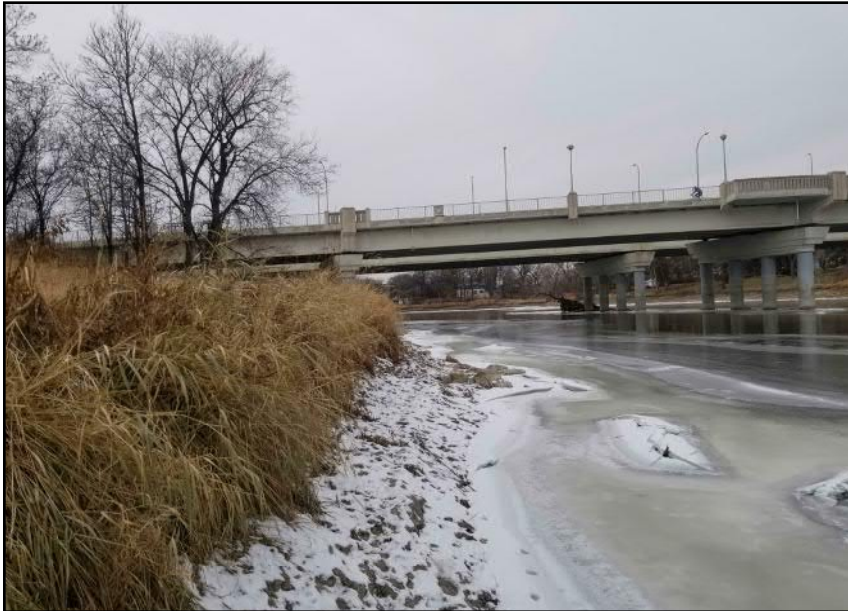
Site 10 - Southern Riverbank Scarp near river edge observed within eastern portion of study area (facing W)

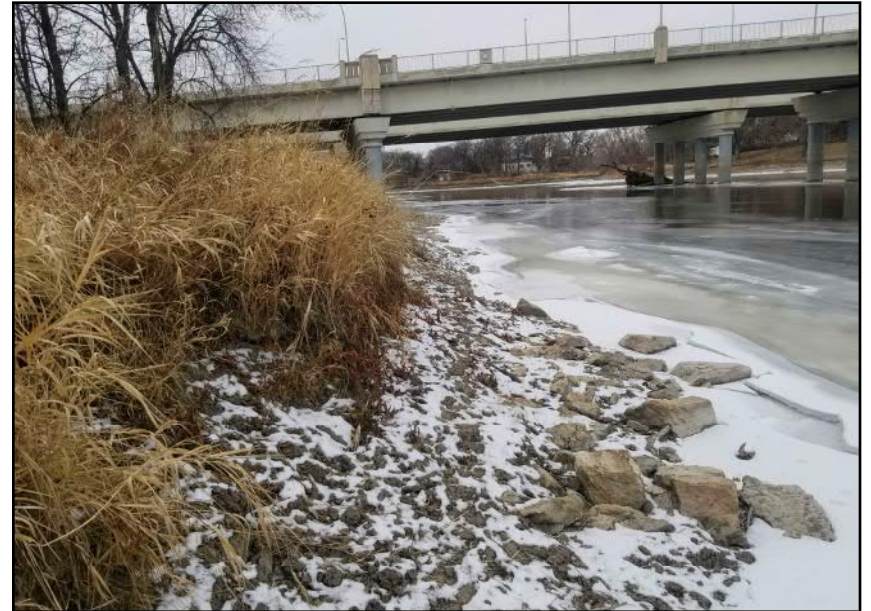
Site 10 - Southern Riverbank Local rip-rap observed along the bank toe near the crossing alignment (facing W)

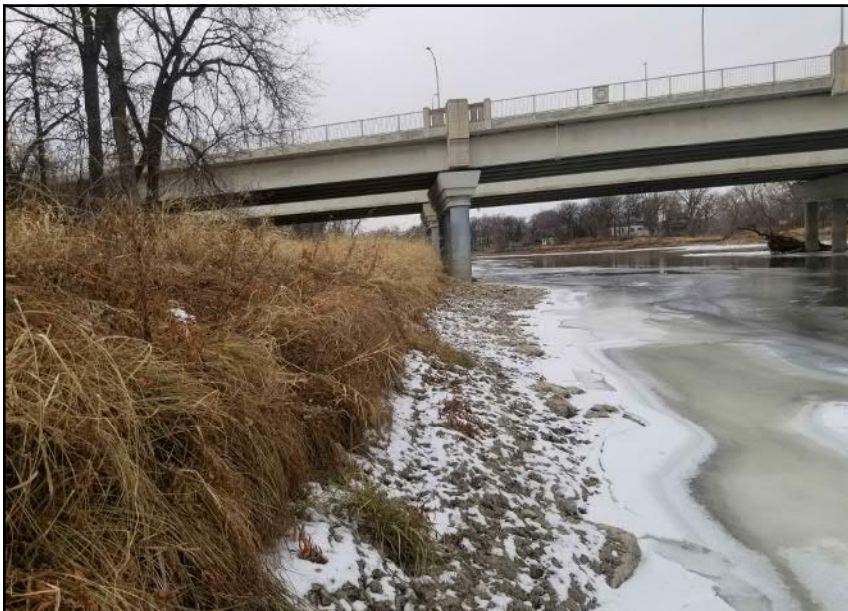
Site 10 - Southern Riverbank Scarp near river edge observed within western portion of study area (facing W)

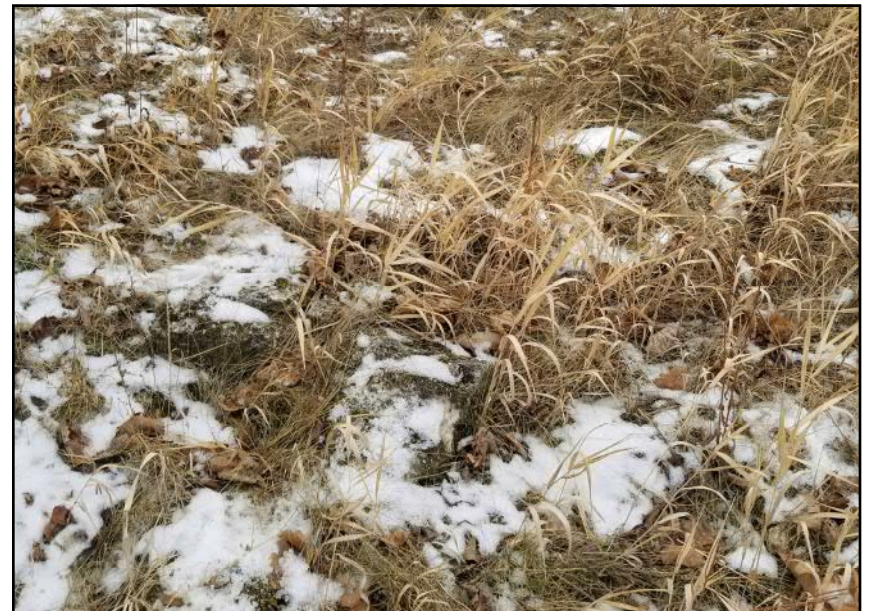
Site 10 - Southern Riverbank Small scarp and crack observed along flat portion of bank crest near crossing alignment (facing S)

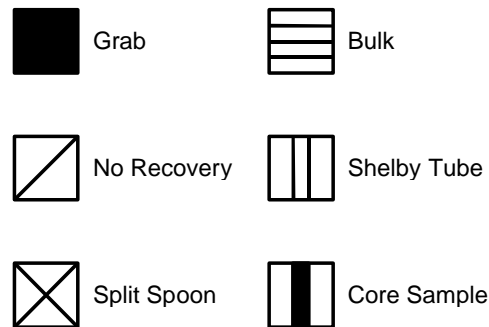
6. WATER SOLUBLE SULPHATE CONCENTRATION

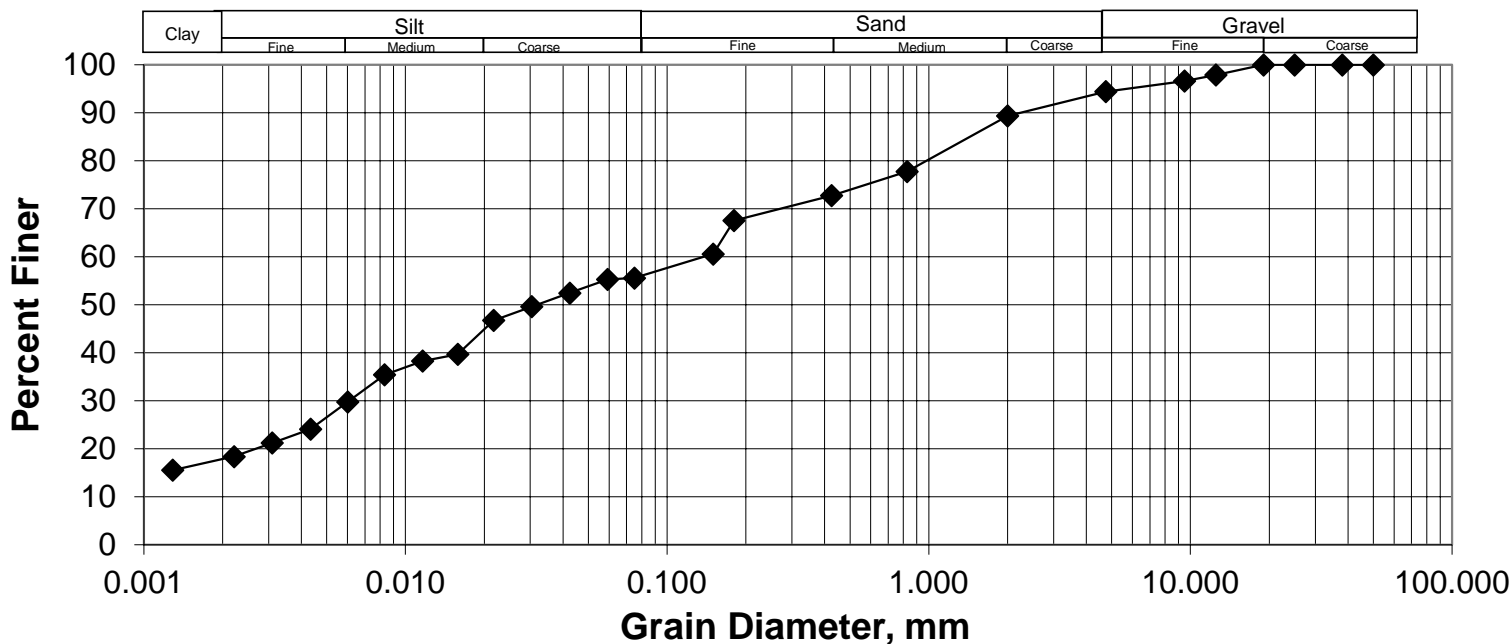
Gravel	5.6%	Silt	37.8%
Sand	38.8%	Clay	17.8%
